**ALBERTA TRANSPORTATION AND
ECONOMIC CORRIDORS GRMP
NORTH CENTRAL (ATHABASCA AND FORT
McMURRAY DISTRICTS)
INSTRUMENTATION MONITORING- SPRING 2024**

Site Number	Location	Name	Hwy	km
NC093	HWY 813:06, C1 4.631	Rock Island Bridge	813:06	Km 4.6
Legal Description: 9-5-74-22 W4		UTM Co-ordinates		
		12U E 351689	N	6139948

Current Monitoring:	13-June-2024	Previous Monitoring	07-Oct-2023
Instruments Read By:	Mr. Niraj Regmi, G.I.T and Mr. Nixson Mationg, of Thurber

**SITE NC093: HWY 813 ROCK ISLAND RIVER BRIDGE NW APPROACH FILL LANDSLIDE
(BF79692)**

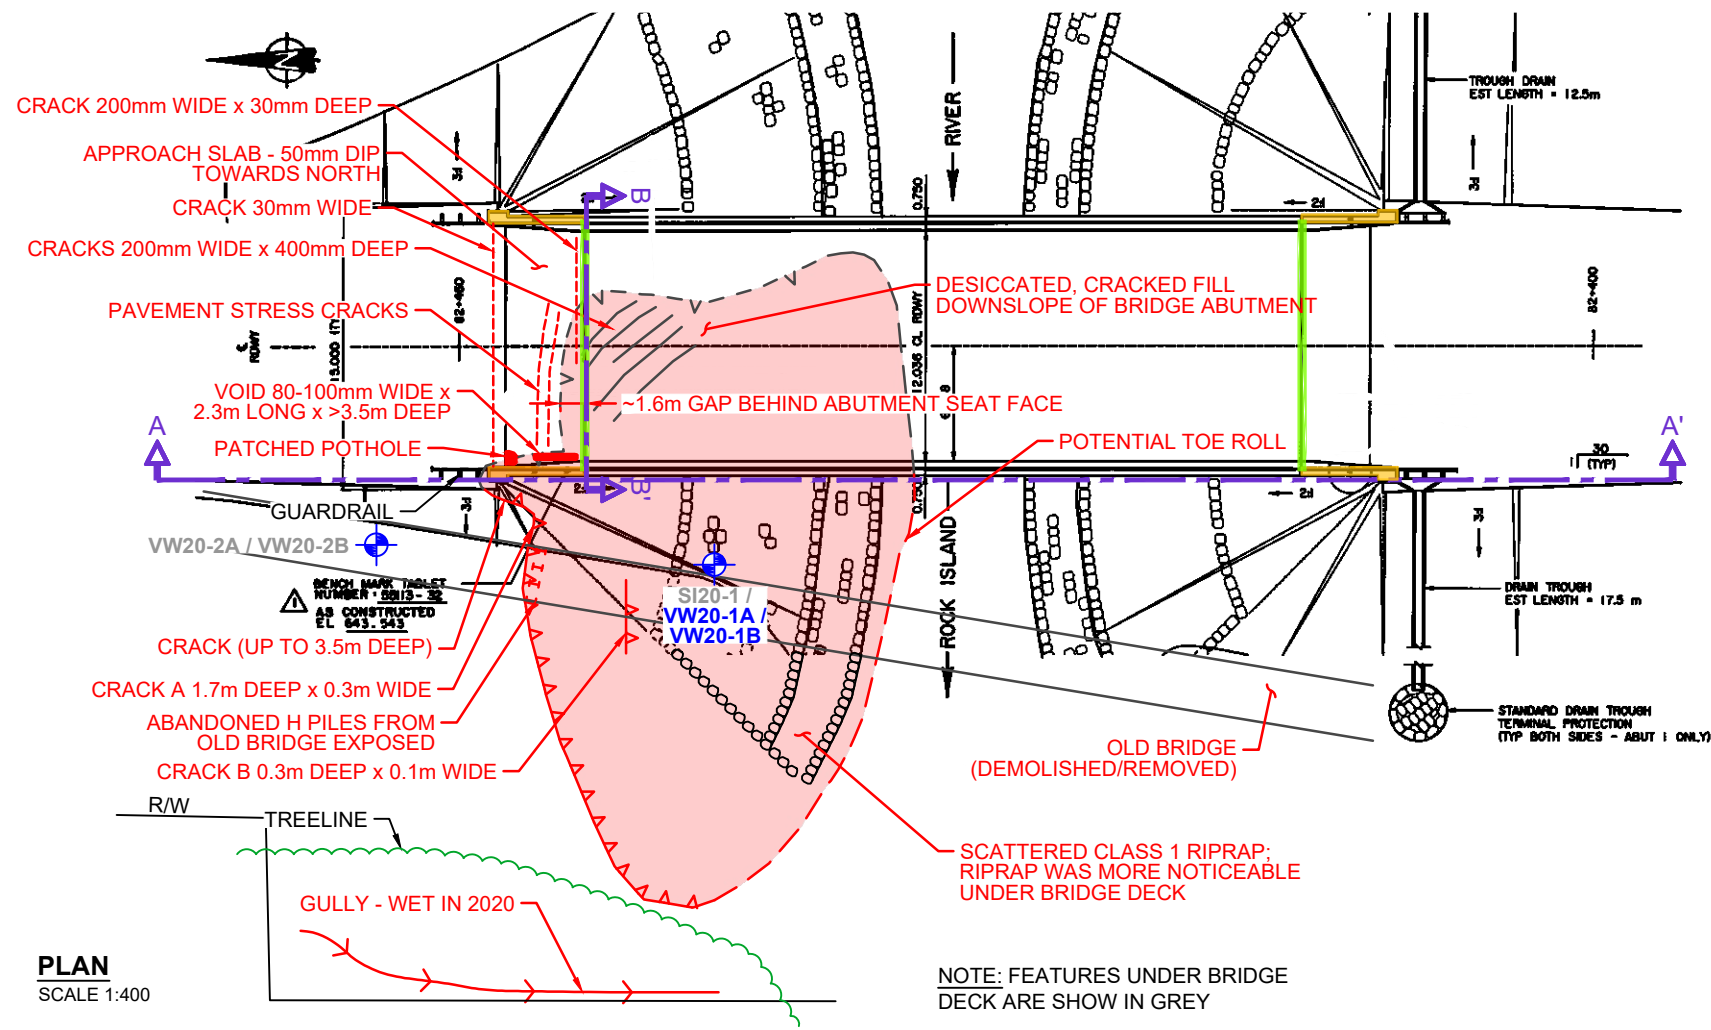
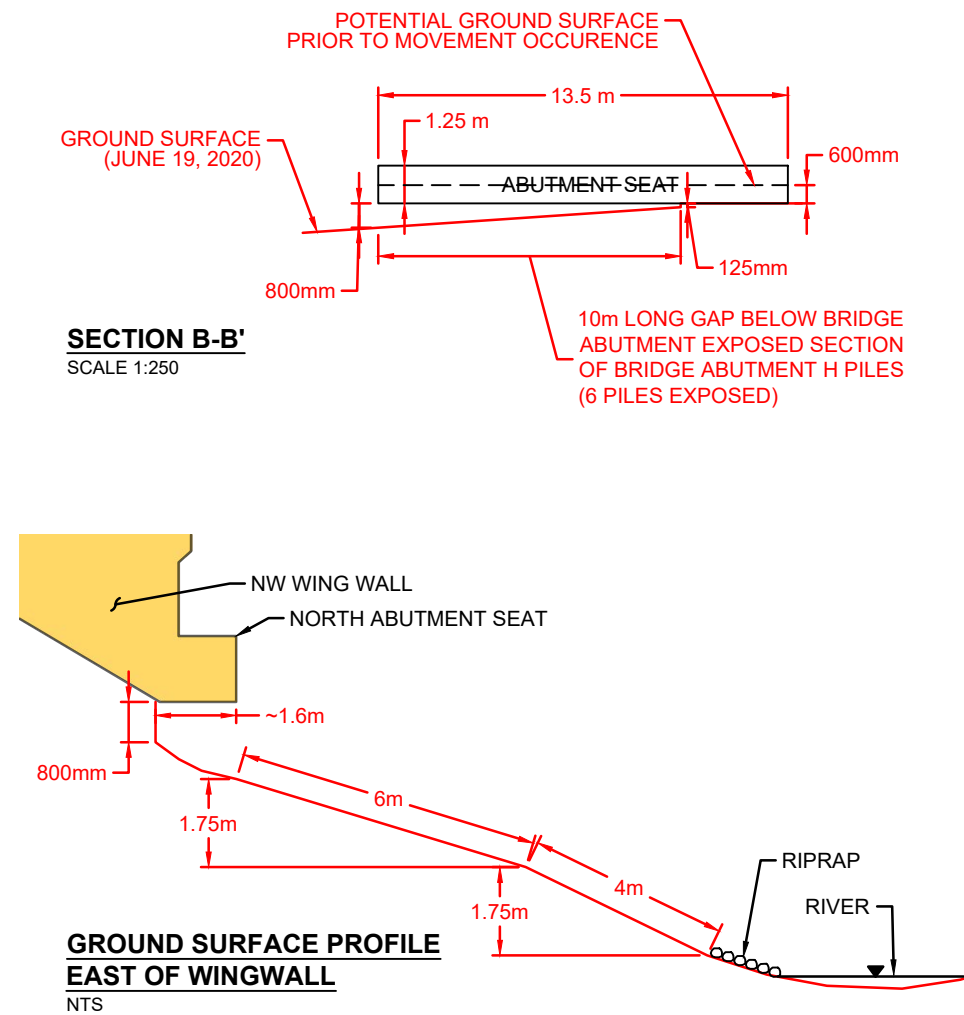
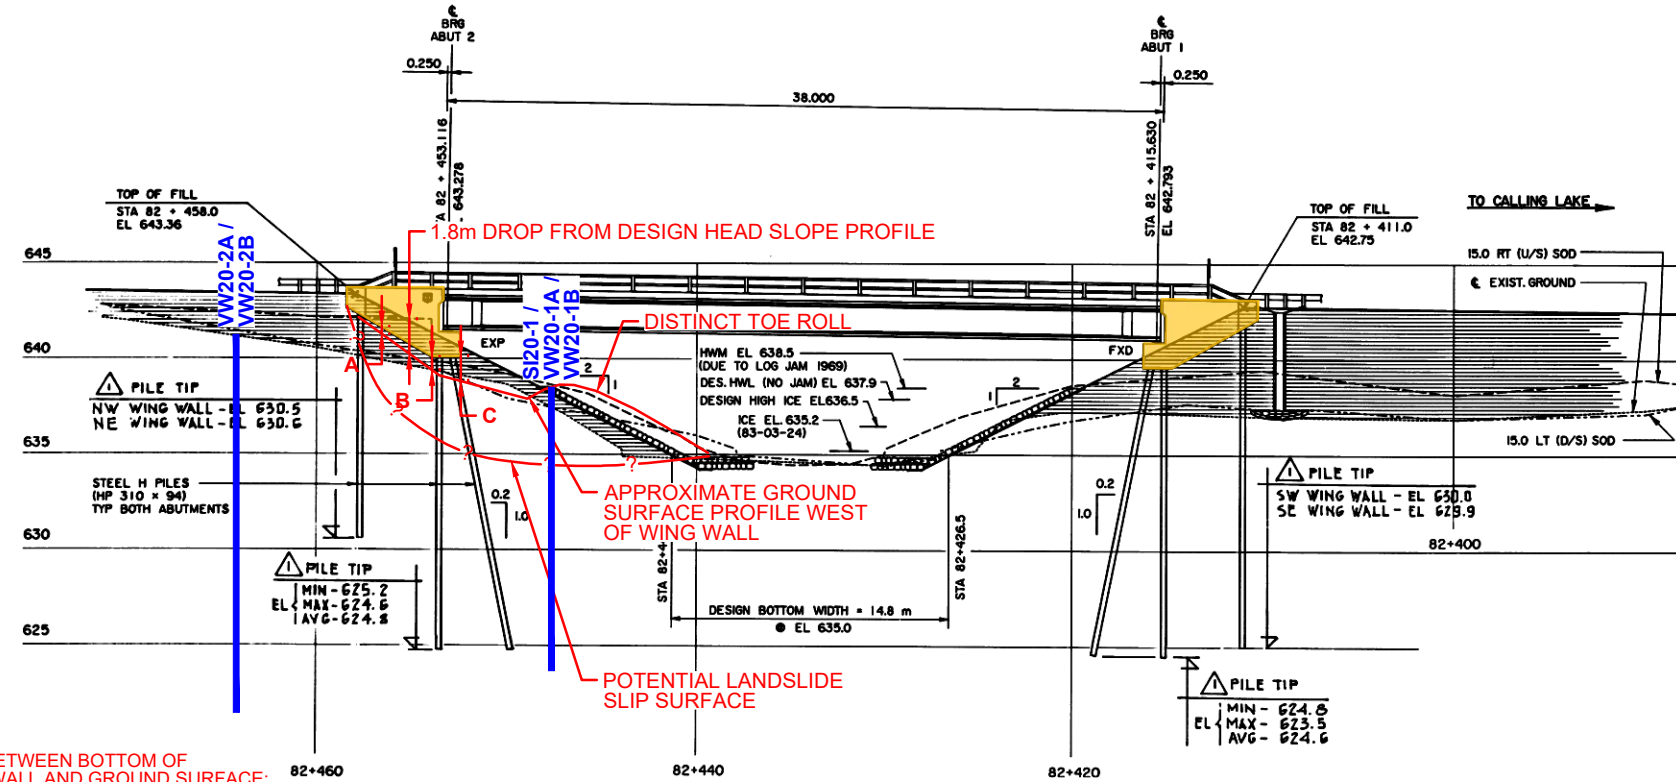
**NORTH CENTRAL
(ATHABASCA AND FORT McMURRAY DISTRICTS)
NC093 HWY 813 ROCK ISLAND RIVER
BRIDGE NW APPROACH FILL
SITE PLAN SHOWING APPROXIMATE
INSTRUMENT LOCATIONS
DWG NO. 32122-NC093**

GAP BETWEEN BOTTOM OF WINGWALL AND GROUND SURFACE:
A: 300mm
B: 200mm
C: 800mm

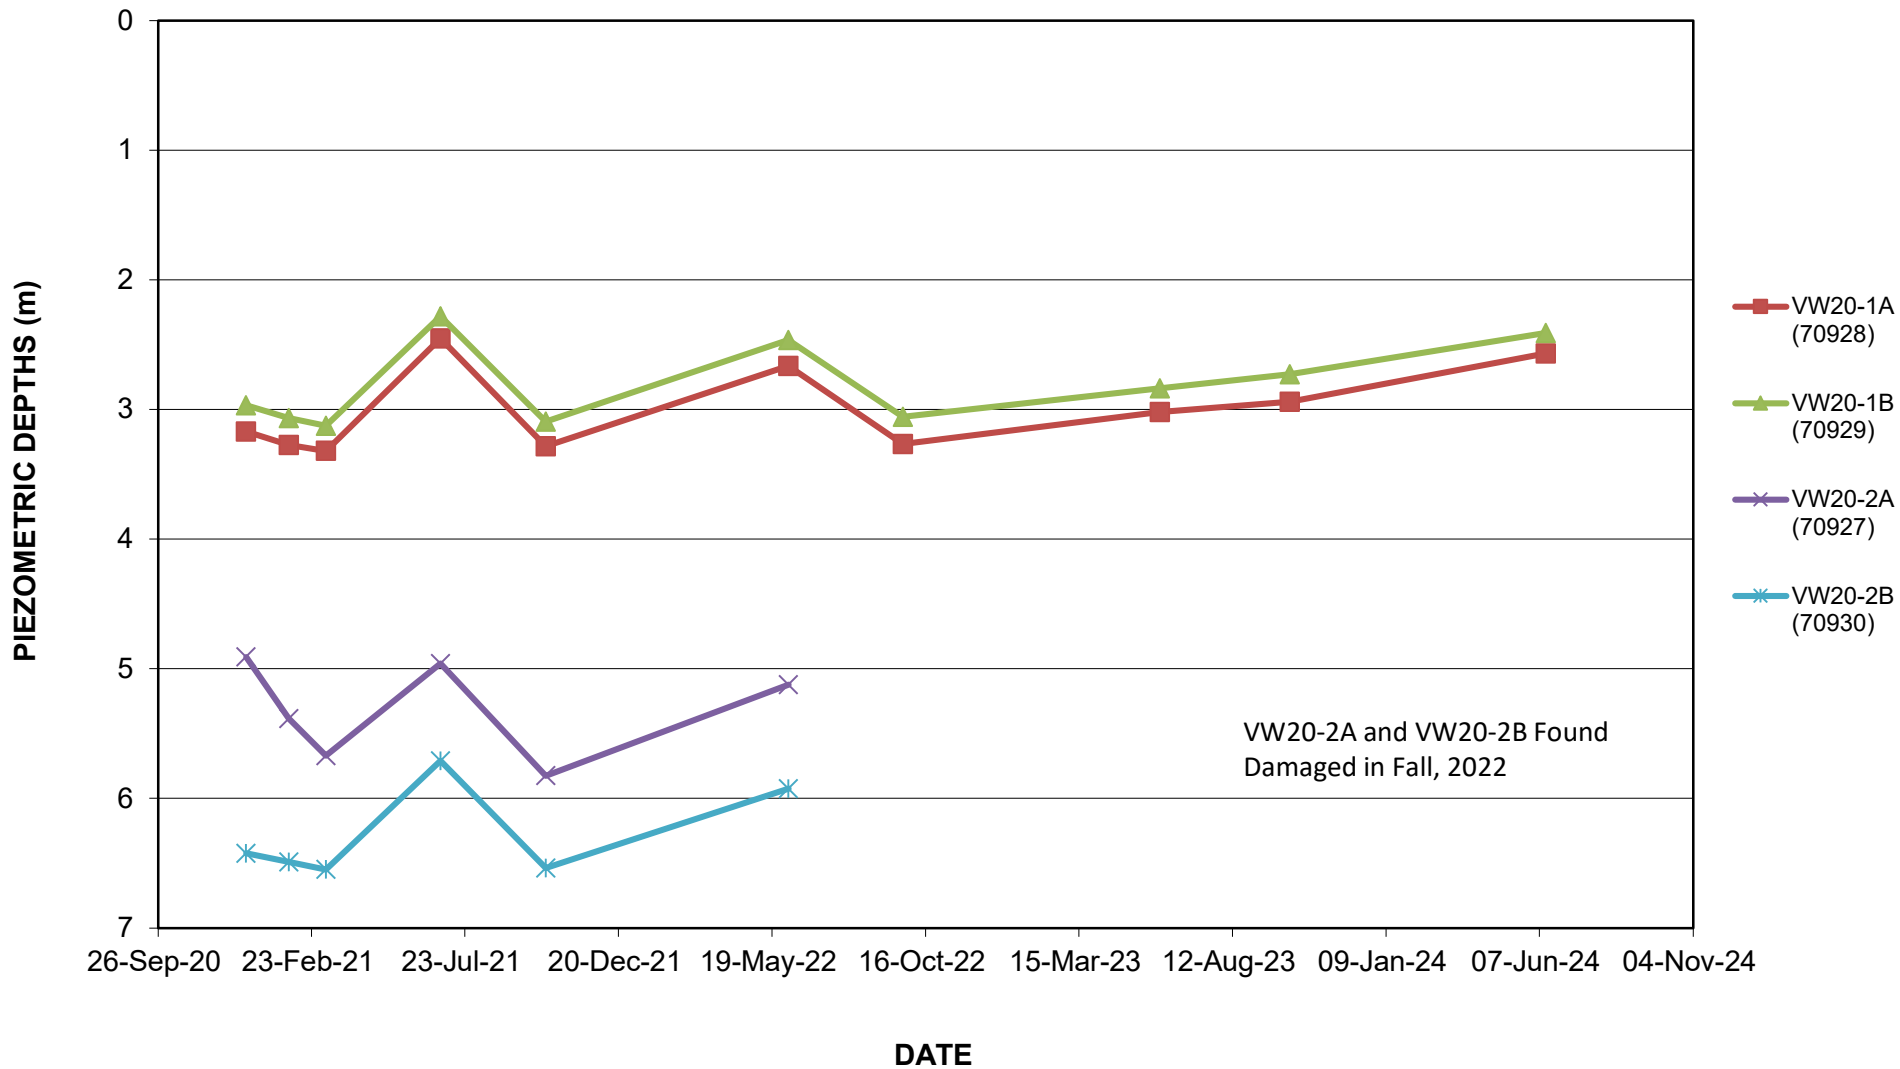
**FIGURE NC093-1
 HWY 813 ROCK ISLAND RIVER BRIDGE (BF79692)
 VIBRATING WIRE PIEZOMETER DATA**

Discussion	
Zones of New Movement:	None
Interpretation of Monitoring Results:	SI20-1 was found to have been sheared or blocked at 0.91 m below ground surface since the fall of 2023 readings. Vibrating wire piezometers VW20-1A and VW20-1B showed increases in groundwater level of 0.37 m and 0.32 m, respectively, since the fall of 2023 readings. The current groundwater levels are within the historical levels.
Future Work:	The instruments should be read again in the fall of 2024.
Instrumentation Repairs:	VW20-2A and VW20-2B will not be repaired as requested by TEC, and hence they will be removed from the program. Consideration should be given to repairing SI20-1 to continue monitoring the landslide movement rate at this site. A mechanical or hydrovac excavation will be required to repair the SI.
Additional Comments:
