**ALBERTA TRANSPORTATION AND
ECONOMIC CORRIDORS GRMP
NORTH CENTRAL (ATHABASCA AND FORT
McMURRAY DISTRICTS)
2024 SITE INSPECTION**

Site Number	Location	Name	Hwy	km
NC093	22 Km north of Calling Lake	Rock Island Bridge (79692) Landslide	813:06	4.70
Legal Description		UTM Co-ordinates (NAD 83)		
NE 5-74-22-W4		12	6139937.91	E 351682.46

**NC093: HWY 813:06 ROCK ISLAND BRIDGE
HEADSLOPE (km 4.7)**

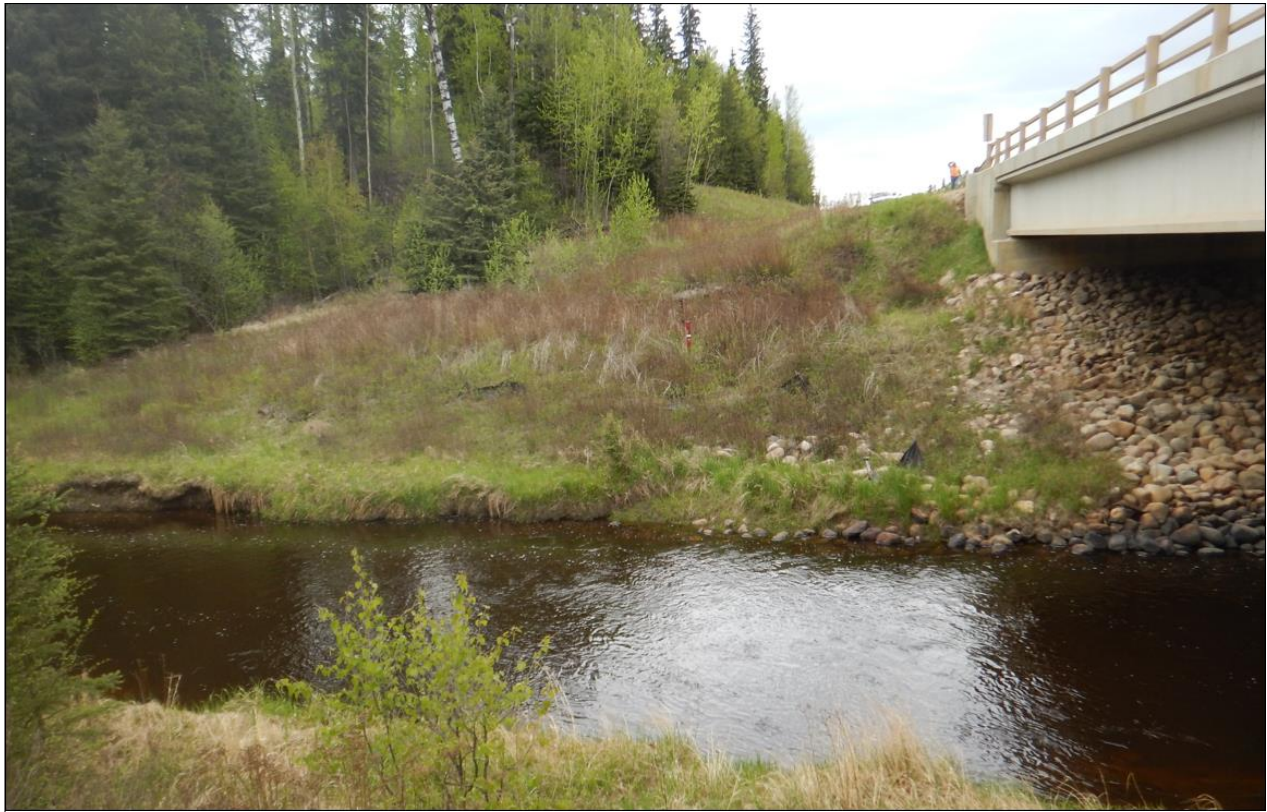
Photo 1. Landslide Area (Looking North).

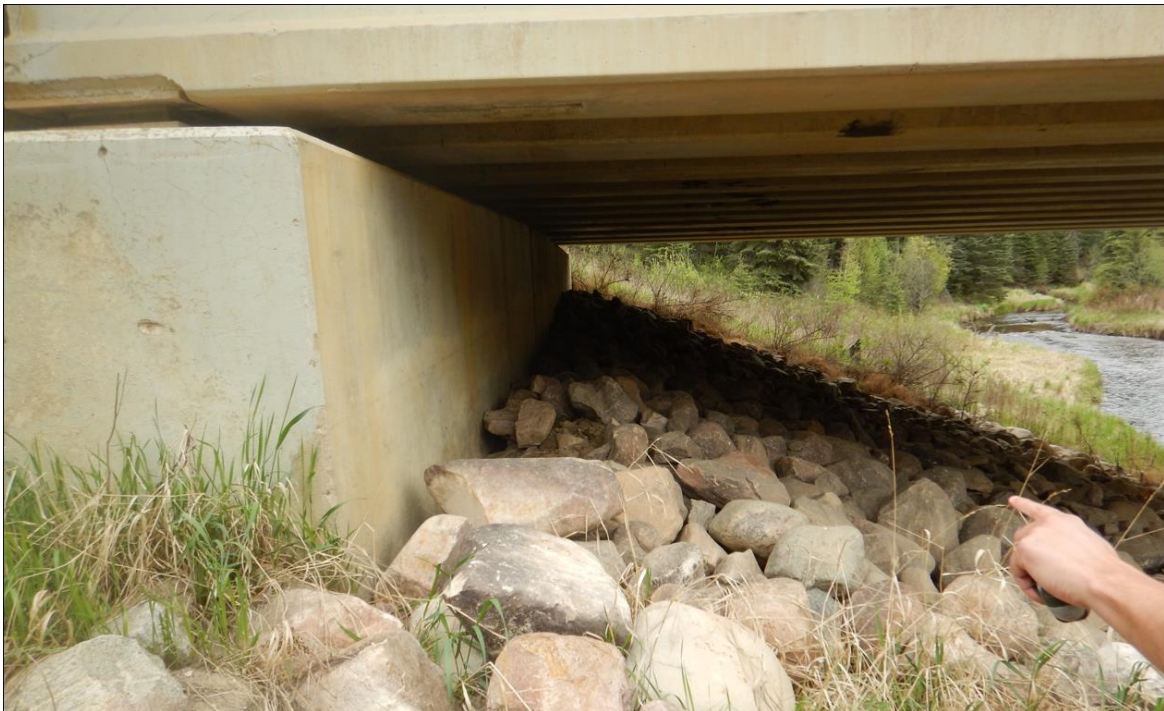
The temporary repairs completed by TEC have performed relatively well to date. However, the landslide is still active as evidenced from the existing vertical and lateral movements of the riprap within the bridge headslope, and the existing drop along the approach slab. The gap formed along and below the abutment seat will continue to get bigger unless repaired and may result in the exposure of a few of the abutment supports.

Photo 2. North Abutment (Looking East) showing riprap placed by TEC in 2021; The riprap top surface appears to have dropped for a distance of about 10 m along the face of the abutment seat and the riprap along this zone shifted laterally towards the river.

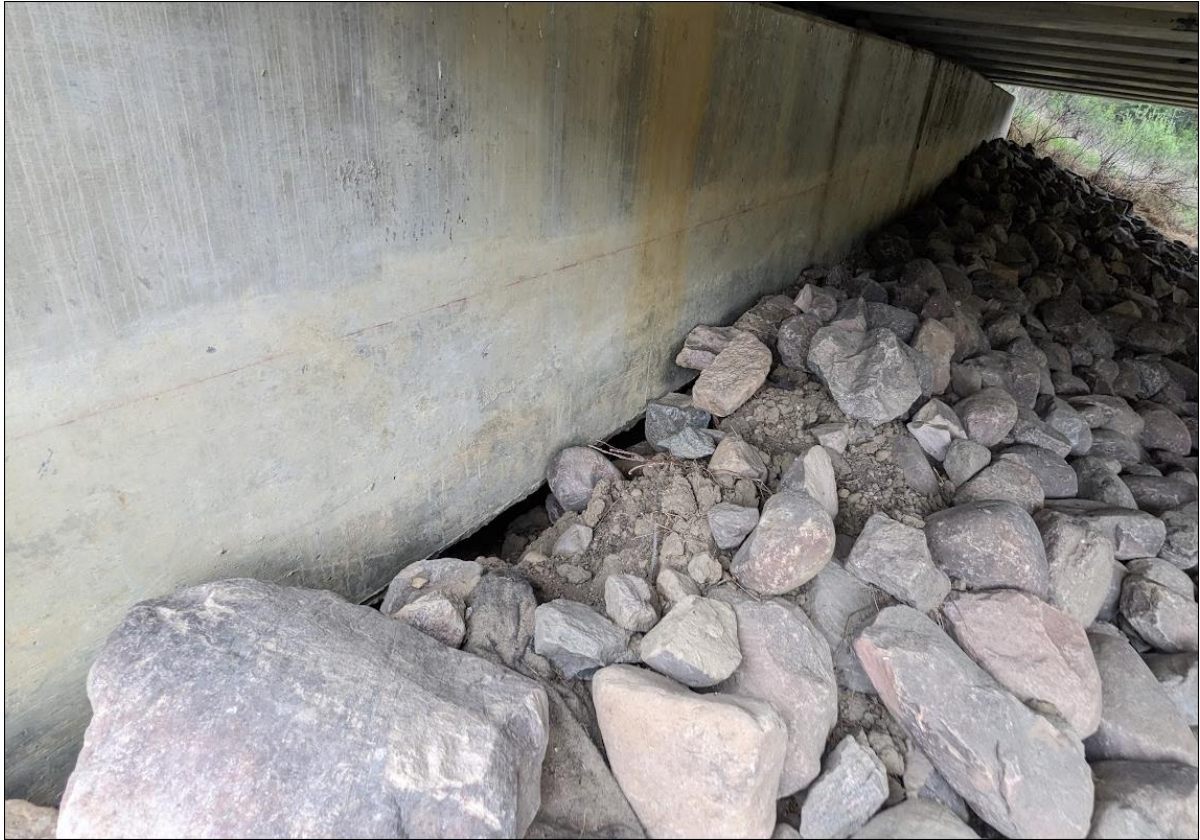
Photo 3. A closer look at the NW corner of the abutment seat. There is a 2.7 m long gap formed along the face of the abutment seat.

- Place additional gravel or low strength fillcrete to fill the gap formed along the face of the abutment seat.
- Place an ACP patch on the north side of the bridge. The patch should be designed to eliminate the dip on the highway, provide a smooth ride to motorists, eliminate existing low spot near the northern edge of the NW concrete curb, and divert highway runoff away from the wing wall and landslide area; consider placing sandbags or extending the NW concrete curb further north to ensure that runoff is diverted away from the landslide area. Consideration may also be given to installing a half CSP pipe along the highway NW side slope to direct surface water away from the landslide area and the northern edge of the wingwall.
- Add granular fill or riprap to backfill the erosion gully developed near the NW wing wall.
- Place riprap within eroded areas at the toe of the slope.

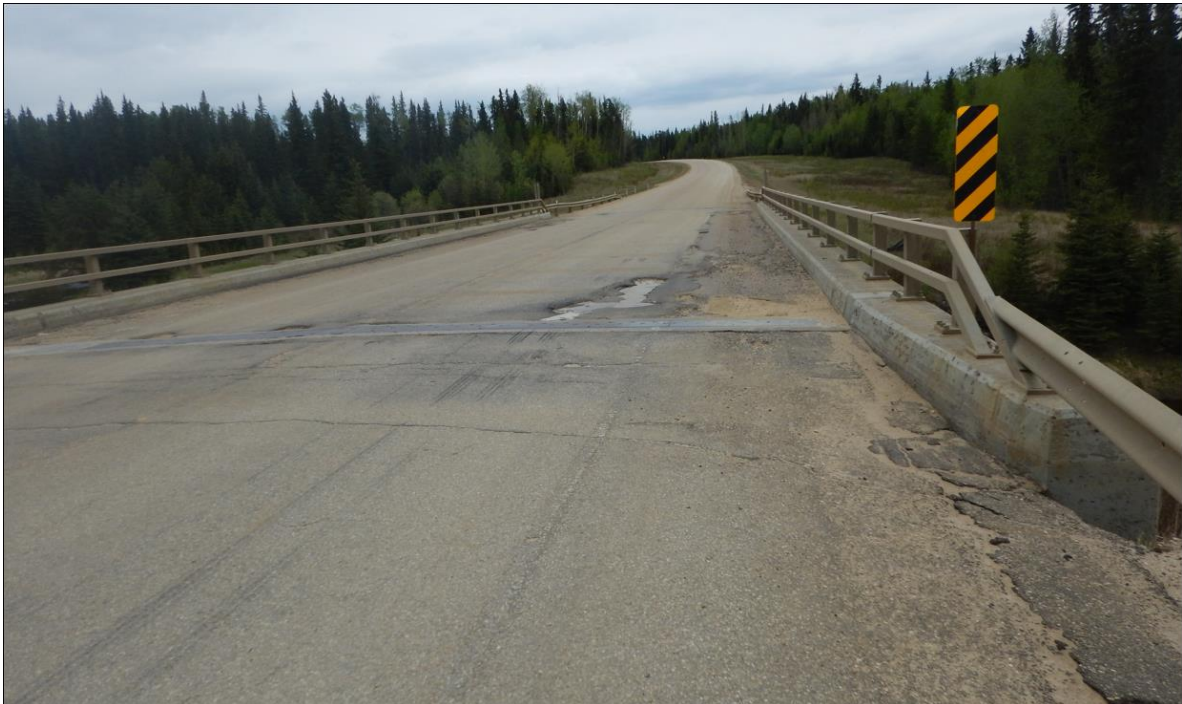
The site condition did not change significantly since the 2023 site inspection, with the exception of the deterioration of the bridge deck condition.

Photo 4. Bridge deck and highway surface condition (Looking north at the south expansion joint).

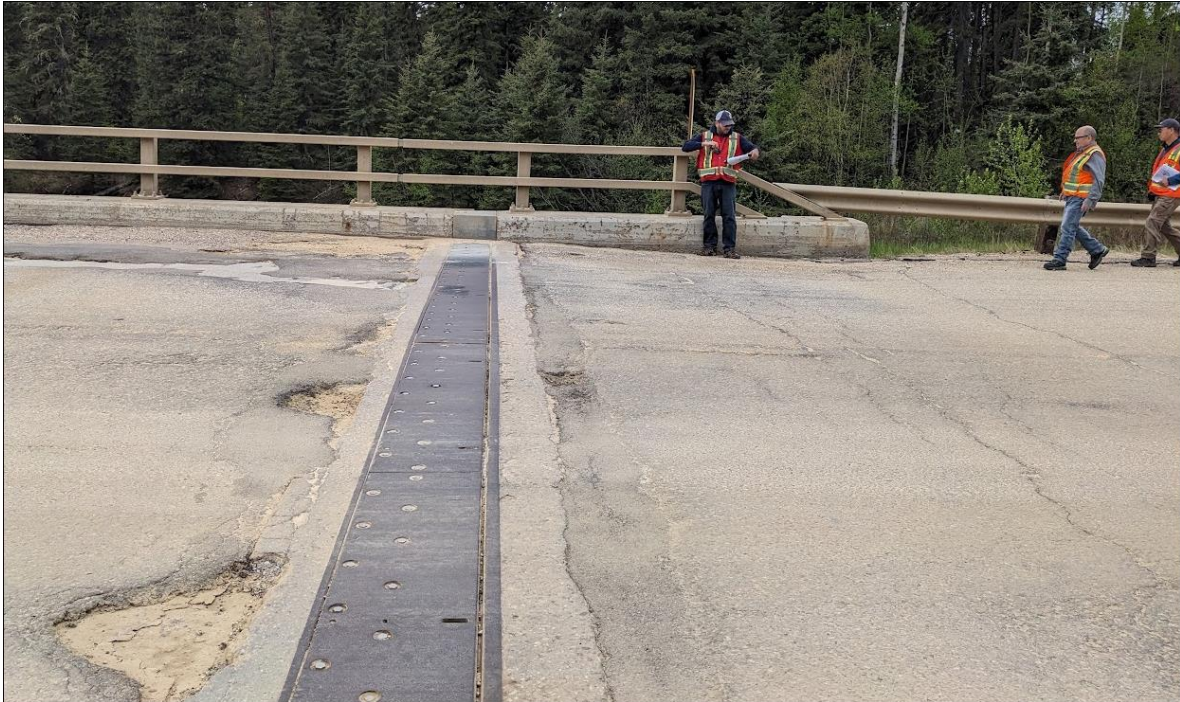
The settlement of the approach slab created a low spot at the north edge of the NW wing wall (on highway side) and hence surface drainage from the highway is currently directed towards the NW approach fill side slope rather than to the south side of the bridge as per the original design. The erosion gully developed within the recently placed gravel fill is a direct consequence of concentrated surface water runoff along the face of the NW wing wall. The erosion gully will likely continue to grow bigger in size, and this may result in future exposure of the underside of the wing wall.

Photo 5. Looking at the north expansion joint. The approach slab dip by the NW wingwall has not changed since 2023.

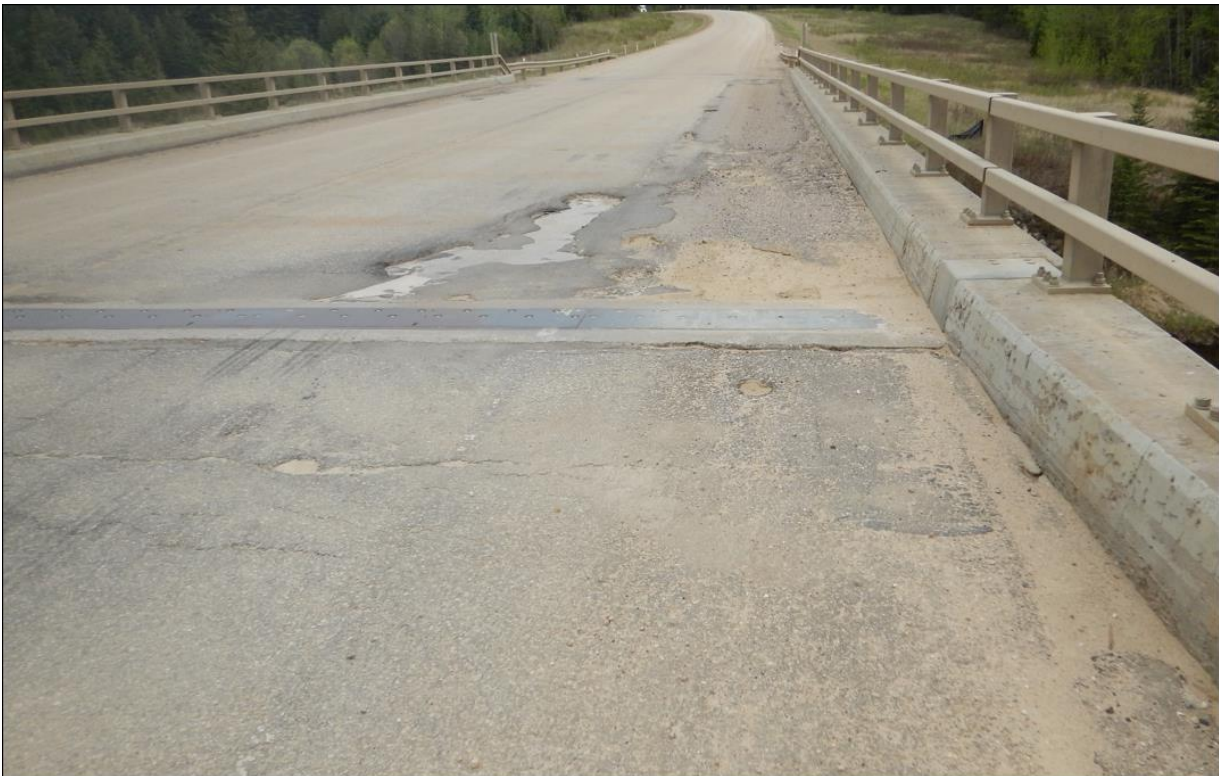
Photo 6. Sealed Cracks along north expansion joint (Looking east). ACP patch placed on the bridge deck in 2022 has failed.

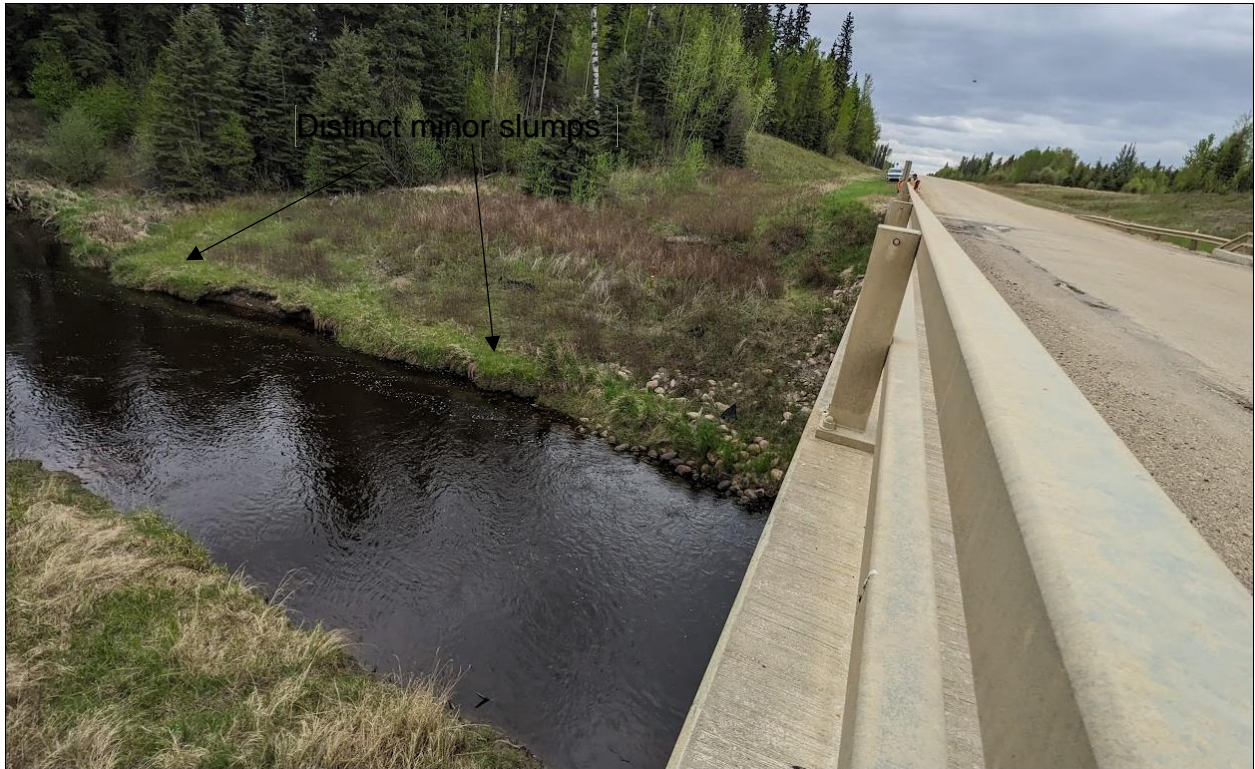
Ongoing toe erosion by the river resulted in the development of two distinct slumps immediately above the stream level. These slumps may get bigger in size and result in a significant loss of toe support at the base of the slope and hence an accelerated movement of the landslide.

Photo 7. NW approach fill headslope; note two distinct slumps just above the stream level.

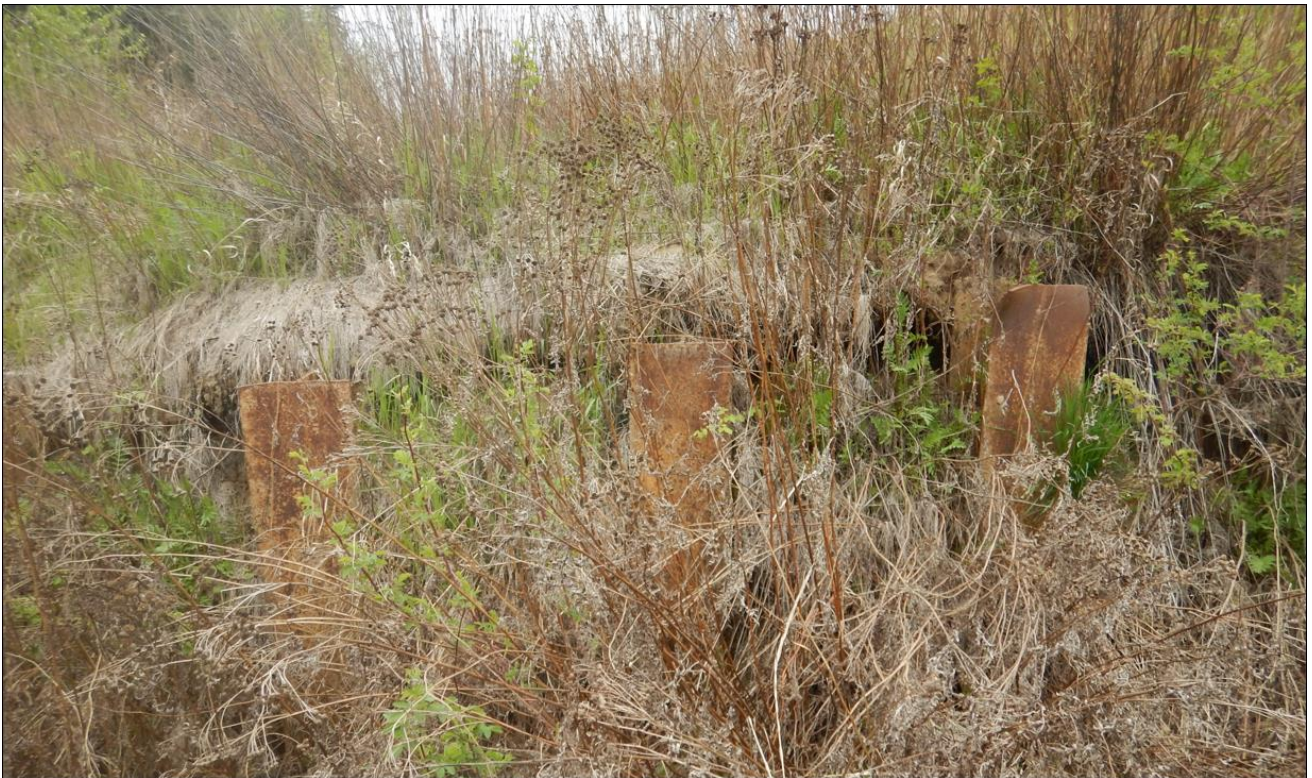
Photo 8. Exposed old bridge H piles within the active landslide mass.

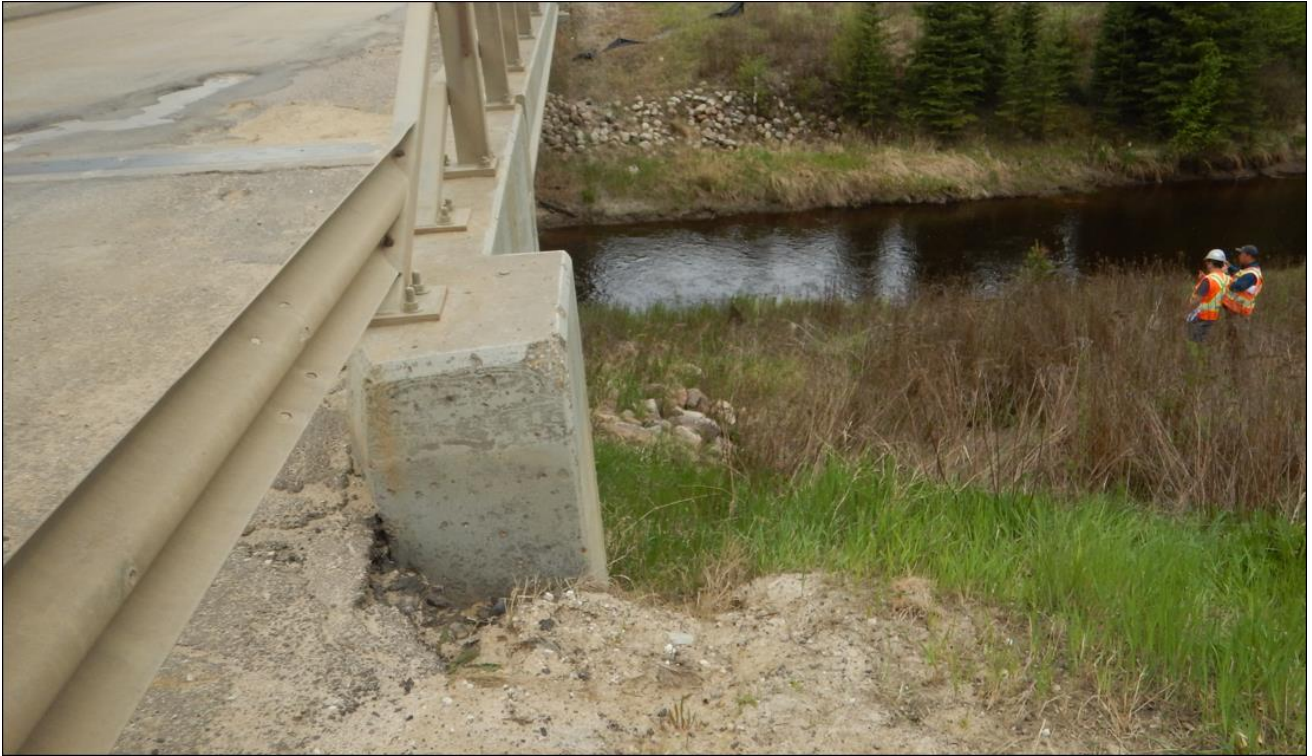
Photo 9. A void forming between the highway side slope and the top edge of the NE wingwall

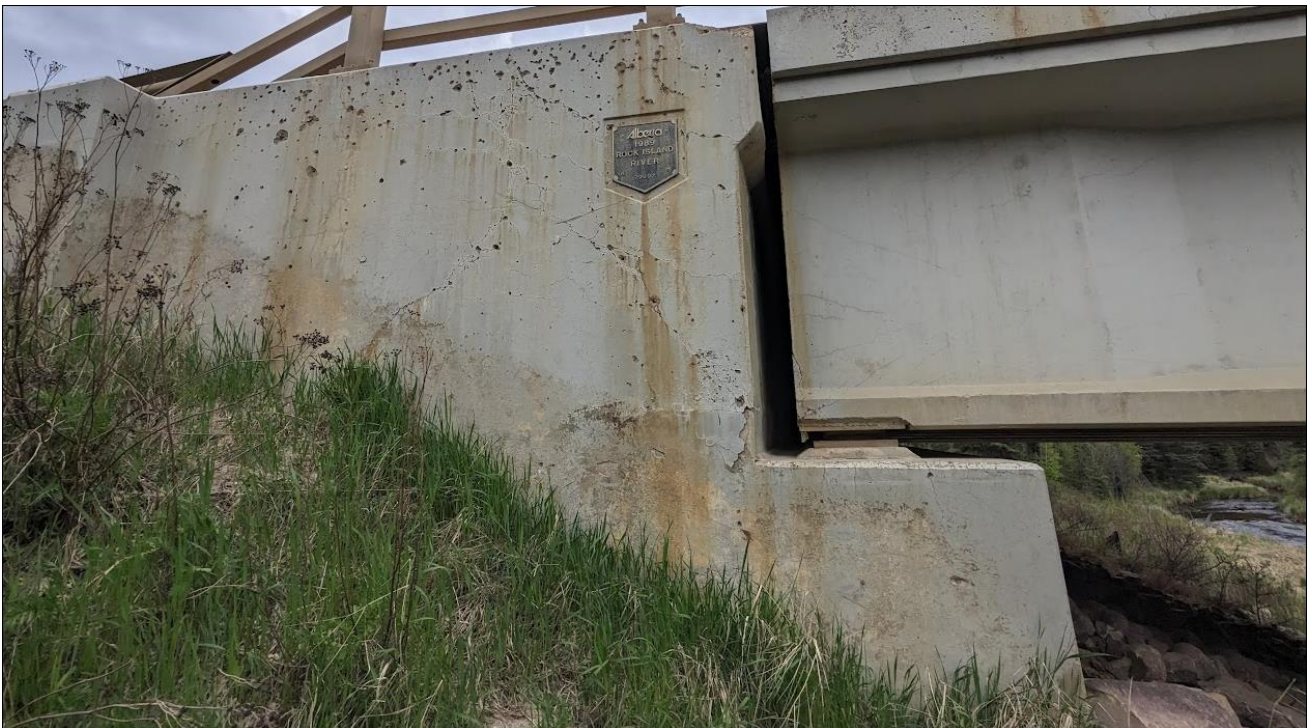
Photo 10. Northwest wingwall: soil staining on the wall face shows original design elevation of fill; approximately 1 m of gravel was placed in 2020 to buttress/cover the gap formed below the wing wall; vegetation has grown within the backfilled area since 2020; erosion up to 500 mm at the top developed within new fill placed against the wing wall. |
