**ALBERTA TRANSPORTATION  
GEOHAZARD ASSESSMENT PROGRAM  
NORTH CENTRAL REGION – ATHABASCA  
2019 INSPECTION**

Site Number	Location	Name	Hwy	km
NC 058-1 (NC58, Eastbound lane Landslide) NC058-2 (NC58A, Westbound lane Landslide)	6.5 km west of the junction between Hwy 881 and 858 to the north of Lac La Biche	North of Lac La Biche	858:02	45.85
Legal Description		UTM Co-ordinates		
SW- 30-68-13-W4M		1 2 N 6085029	E 436771

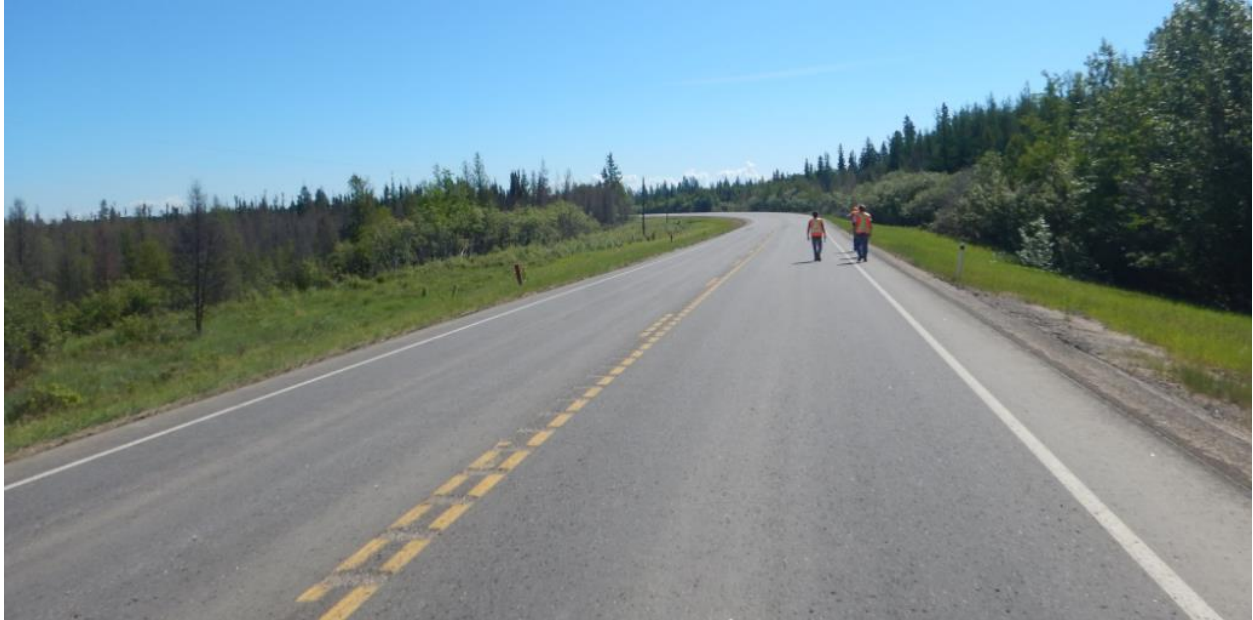
Photo No.1 - General view of the highway lanes at the landslide locations (looking east); the highway was overlaid in July 2018

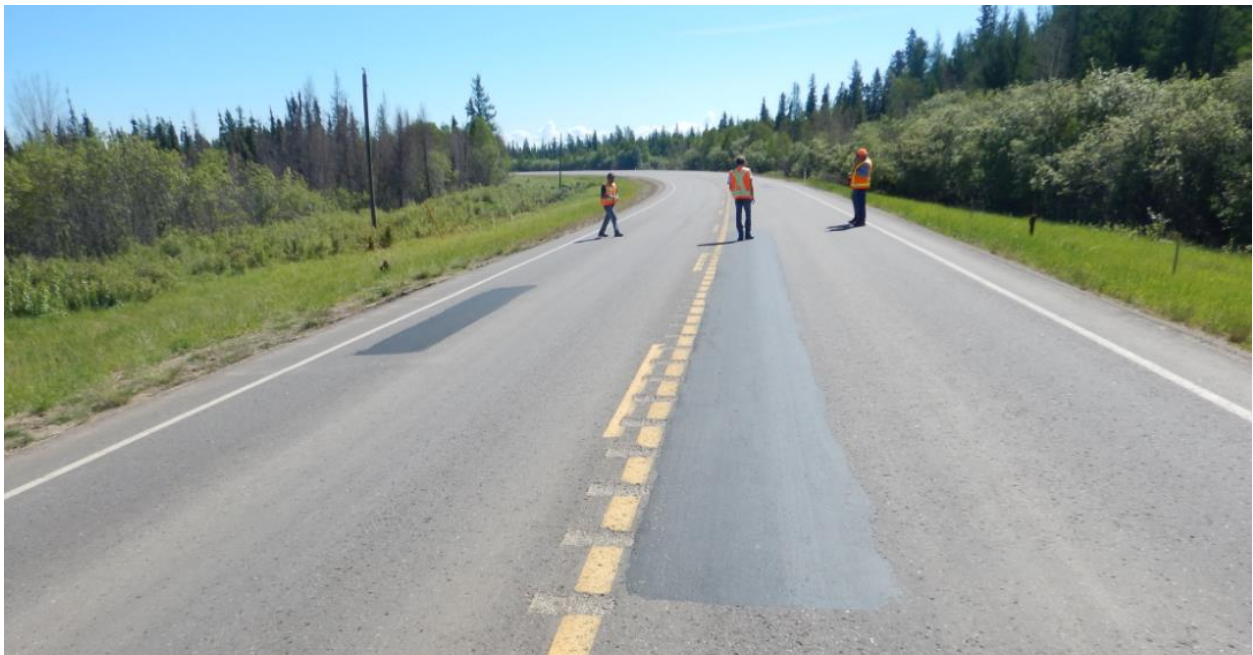
Photo No.2 - Looking east from the western flank of the eastbound landslide (NC58) at the 2019 crack seals

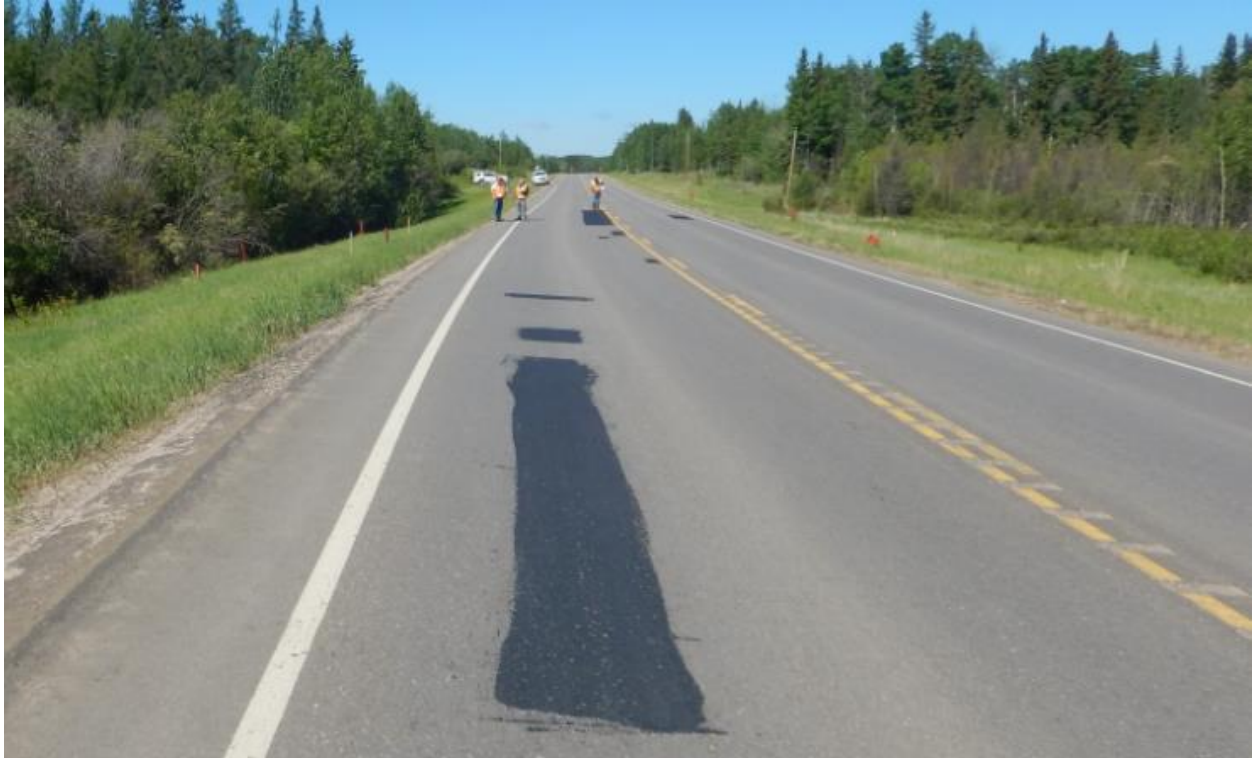
Photo No.3 - Looking west from the eastern flank of the EBL landslide (NC58) at the 2019 crack seals

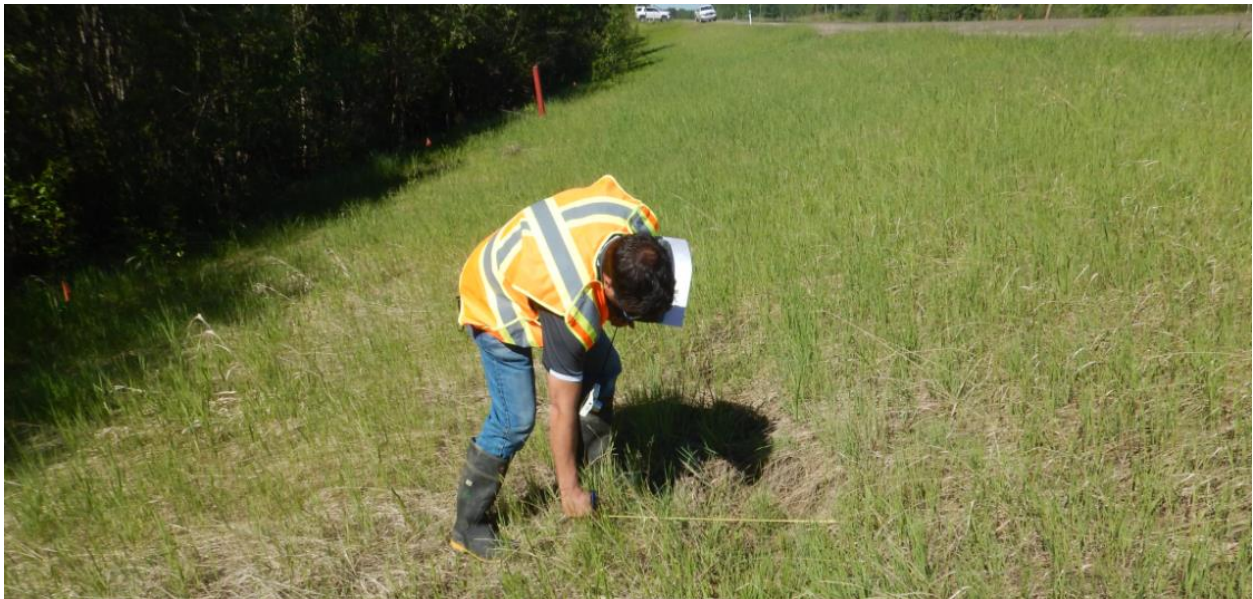
Photo No.4 - Looking at a void formed along the tops of the piles (NC58)

<b>Assessment</b> (Refer to attached Figure):		
The implemented remedial measures have been effective in stabilizing the EBL and WBL landslides. However, future crack sealing and/or patching (as needed) should be anticipated until the pile walls mobilize the full magnitudes of the landslide stabilizing forces.		
<b>Recommendations:</b>		
<b>NC058 and NC058A:</b> The local MCI should continue to monitor the site and watch closely for the development of any new cracks or depressions on the highway surface. As discussed, this site should be visited again in 2021 to confirm the effectiveness of the repair measures.		
Existing voids along the tops of the eastbound lane landslide piles should be filled with compacted clay or gravel to eliminate tripping hazards.
