**A LBERTA TRANSPORTATION  
GEOHAZARD ASSESSMENT PROGRAM  
NORTH CENTRAL REGION – ATHABASCA &  
FORT MCMURRAY DISTRICTS  
2021 SITE INSPECTION**

Site Number	Location	Name	Hwy	km
NC058	6.5 km west of the junction between Hwy 881 and 858 to the north of Lac La Biche	Slide 45 Km N of Hwy 55	858:02	45.85
Legal Description		UTM Co-ordinates		
SW- 30-68-13-W4M		1 2 N 6085029		E 436771

**NC058: HWY 858:02 SLIDE 45km NORTH OF HWY 55  
(km 45.85)**

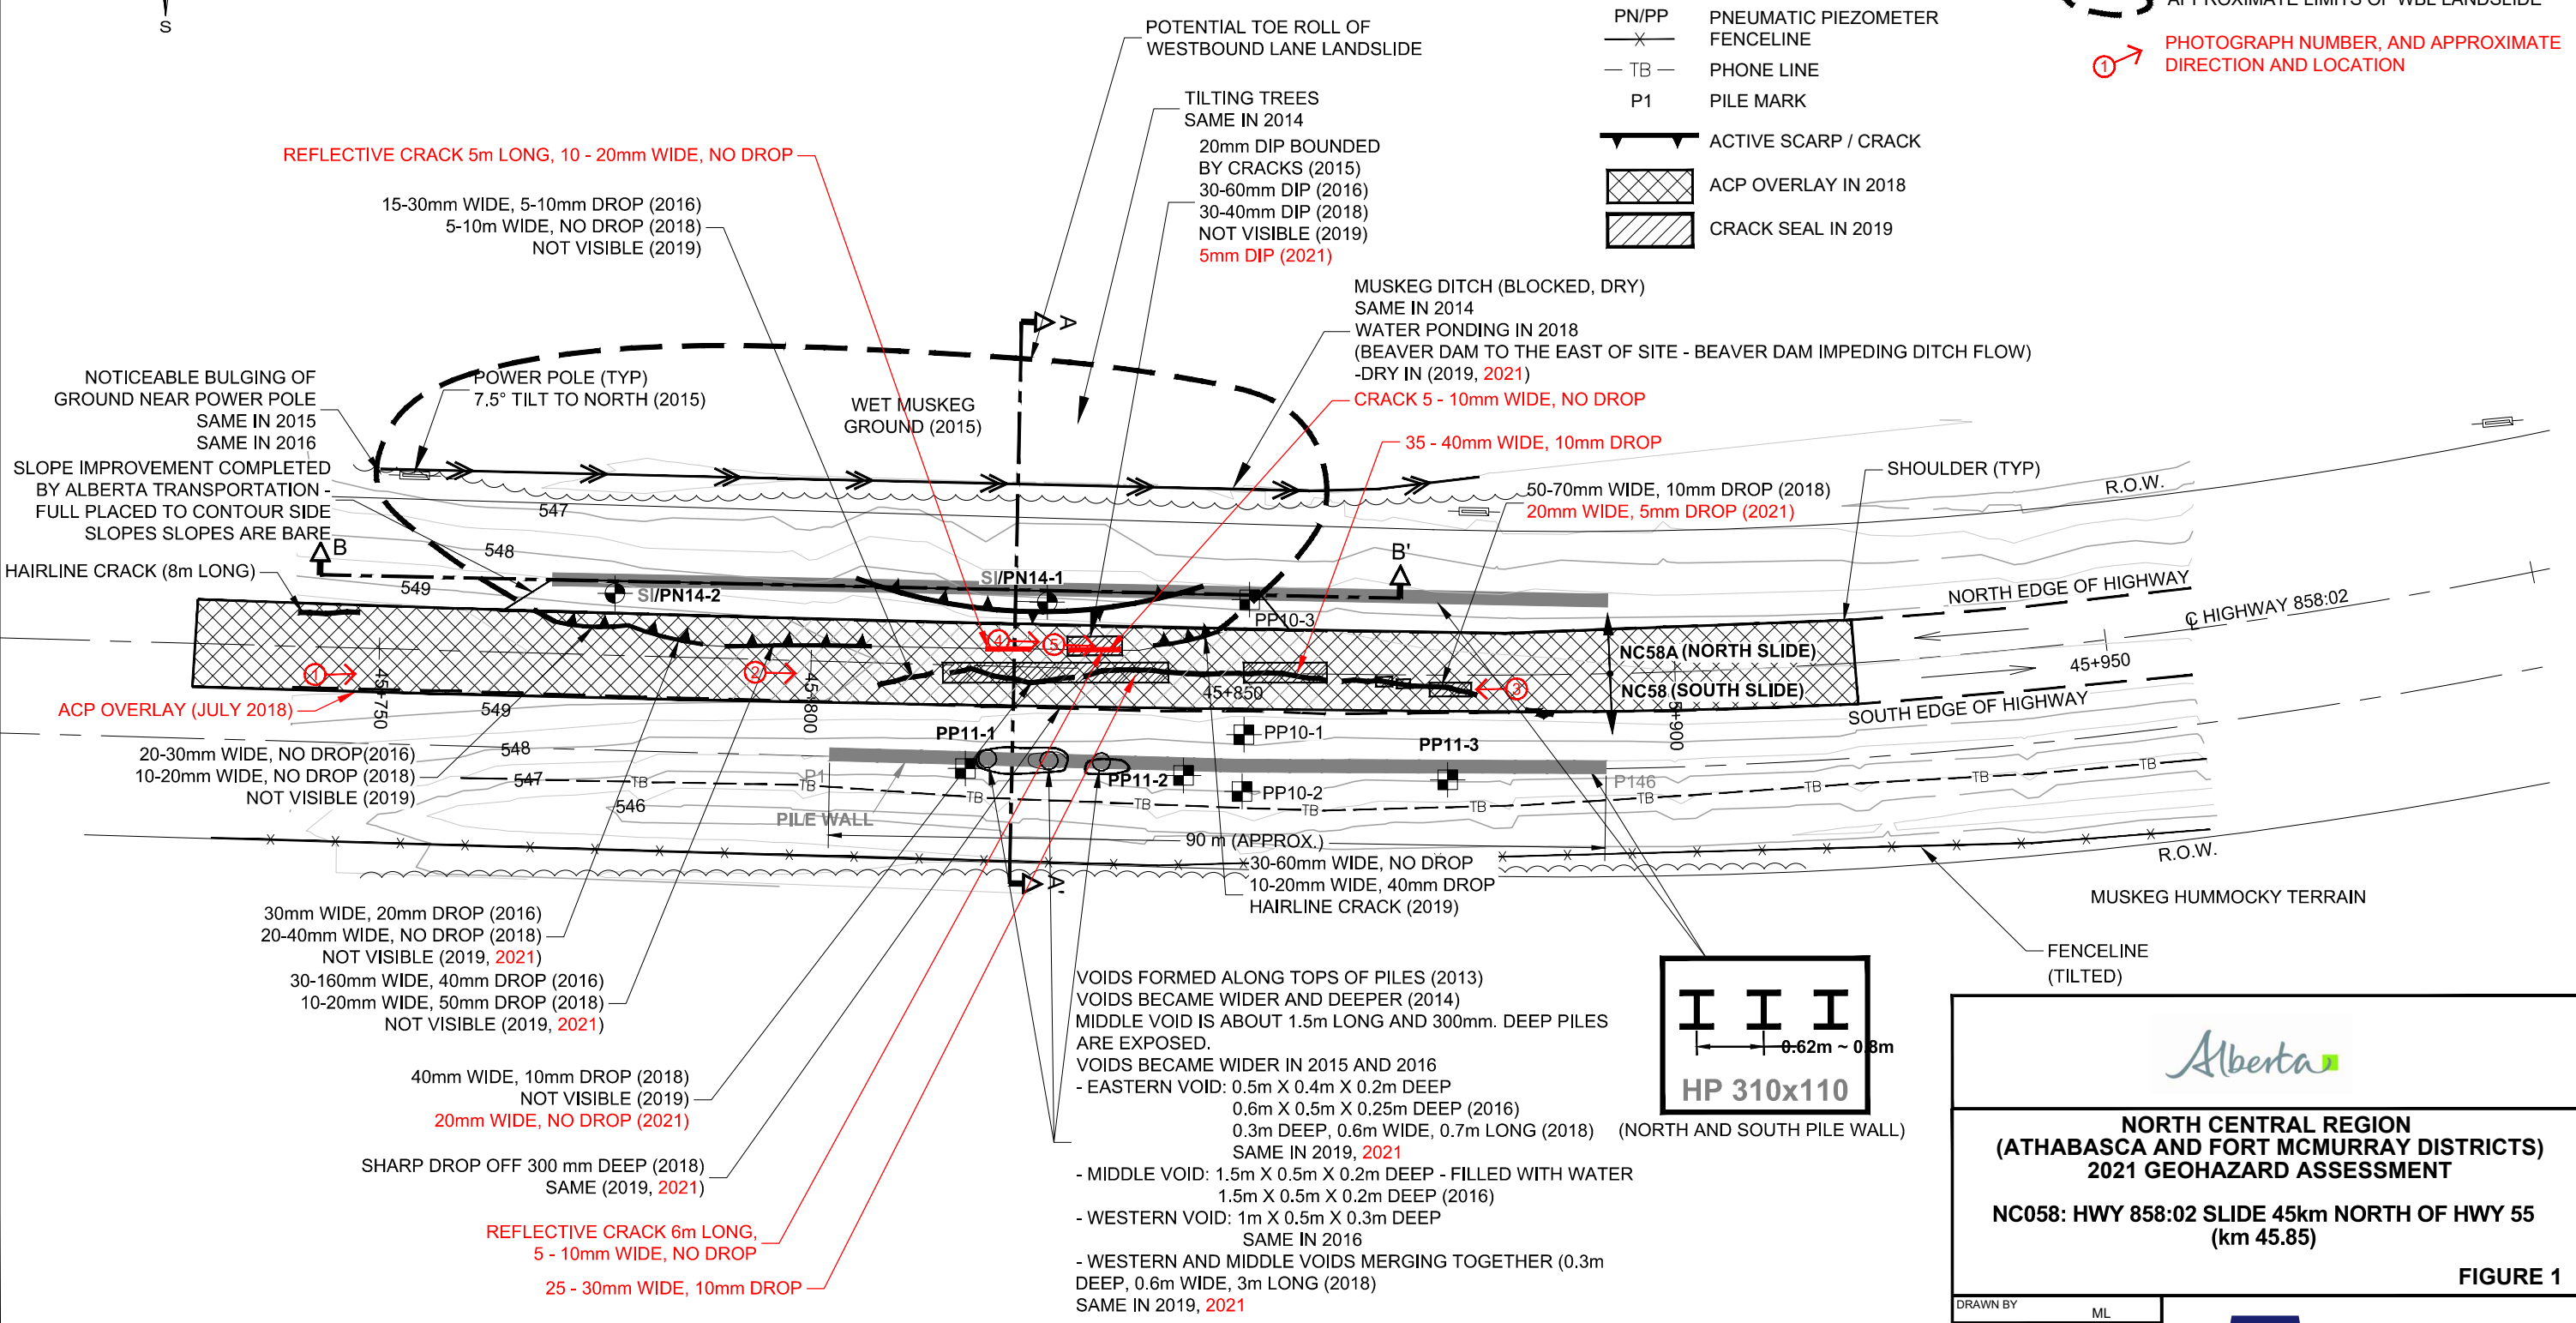
**FIGURE 1**

**NOTE:**  
JUNE 25, 2021 OBSERVATIONS ARE SHOWN IN RED

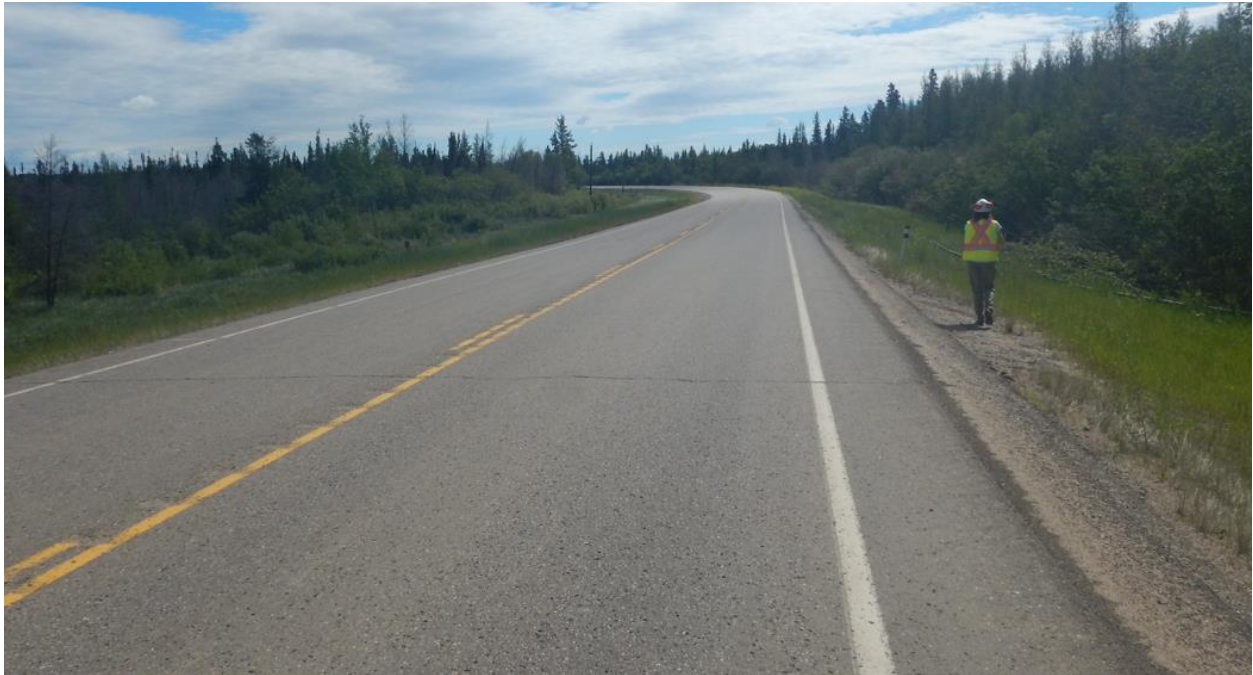
Photo No.1 - General view of the highway lanes at the landslide locations (looking east); the highway was overlaid in July 2018

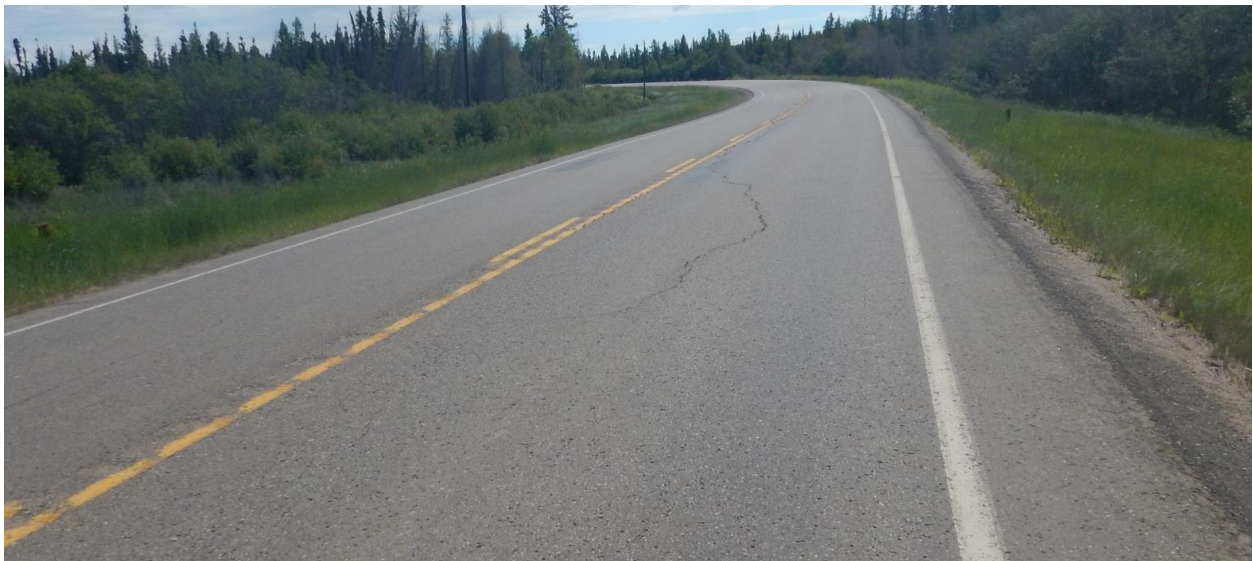
Photo No.2 - Looking east from the western flank of the eastbound landslide (South Slide) at a reflective crack (20 mm wide, no drop) on the east bound lane

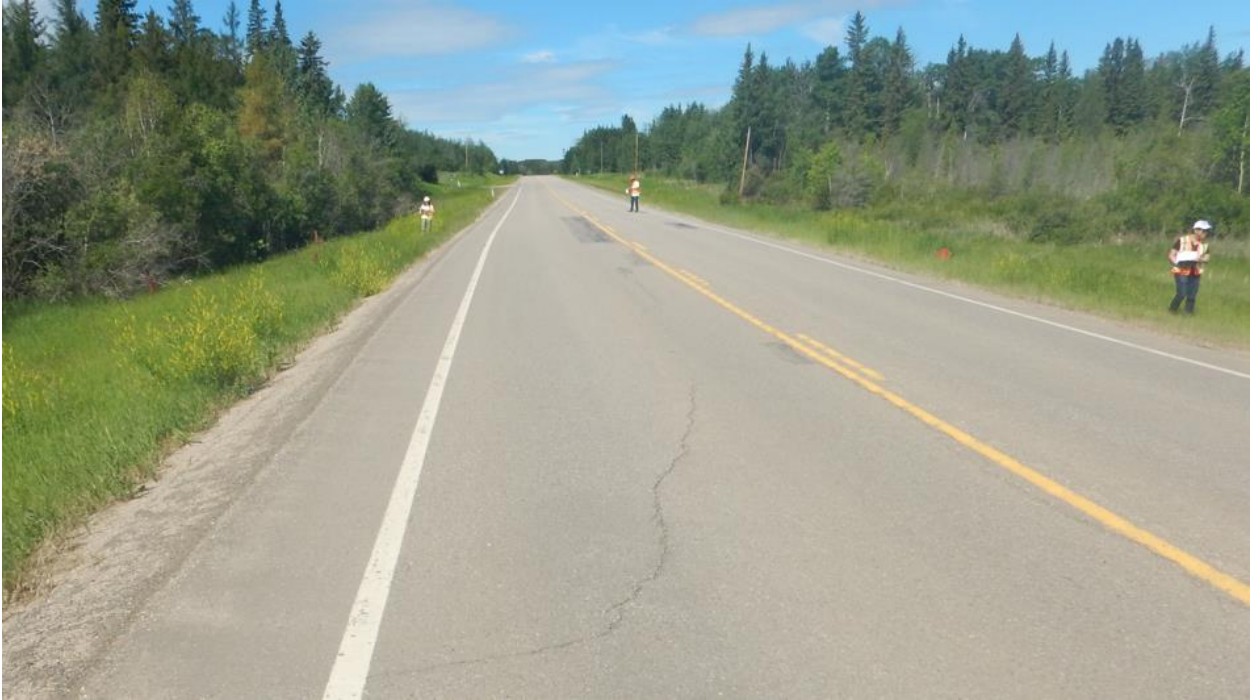
Photo No.3 - Looking west from the eastern flank of the eastbound lane landside at a reflective crack (20 mm wide, 5 mm drop) on the eastbound lane

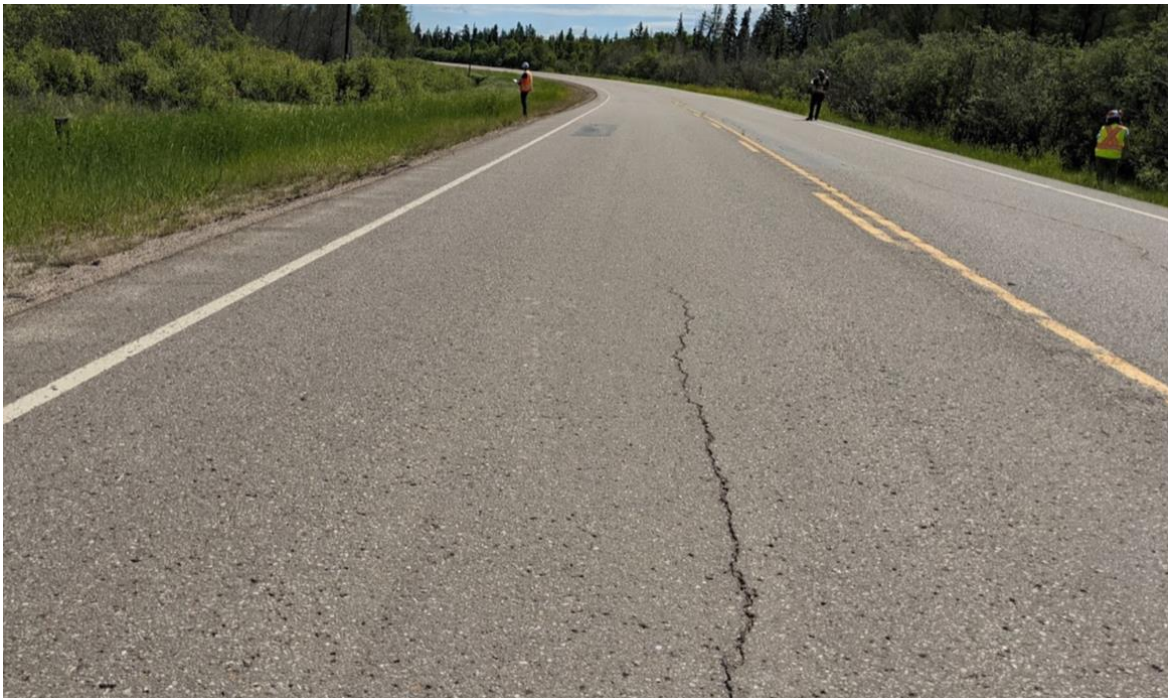
Photo No.4 - Looking east at a reflective crack on the highway westbound lane (10 to 20 mm wide, no drop)

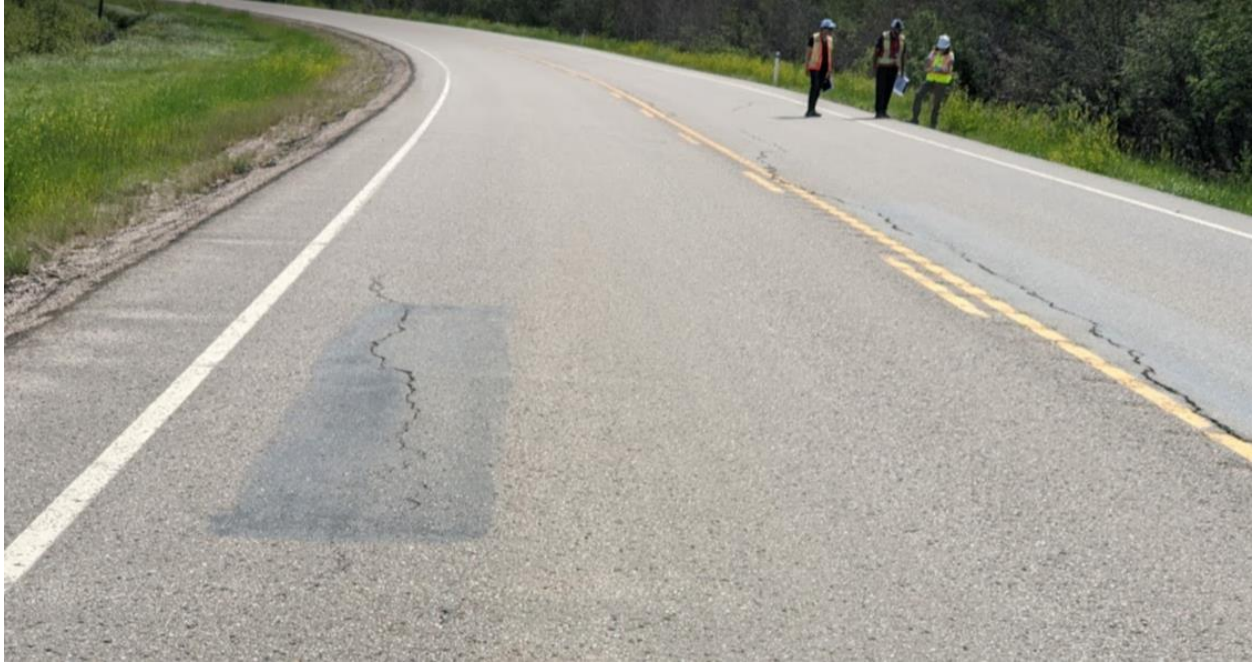
Photo No.5 - Looking east at a reflective crack on the westbound lane (5 to 10 mm wide, no drop)
