**ALBERTA TRANSPORTATION  
GEOHAZARD ASSESSMENT PROGRAM  
NORTH CENTRAL REGION – ATHABASCA  
2019 INSPECTION**

Site Number	Location	Name	Hwy	km
NC 62	3.3 km south of the junction between Hwy 881:15 and 55:14	<b>SOUTH OF BEAVER RIVER</b>	881:16	29
Legal Description		UTM Co-ordinates (NAD 83)		
SE- 12-63-9-W4M		12 N 603423	E 480622

**NORTH CENTRAL REGION (ATHABASCA AREA)  
2019 GEOHAZARD ASSESSMENT**

**NC 62: HWY 881: 16 SOUTH OF BEAVER RIVER (km 3.3)  
SITE PLAN AND CROSS - SECTION**

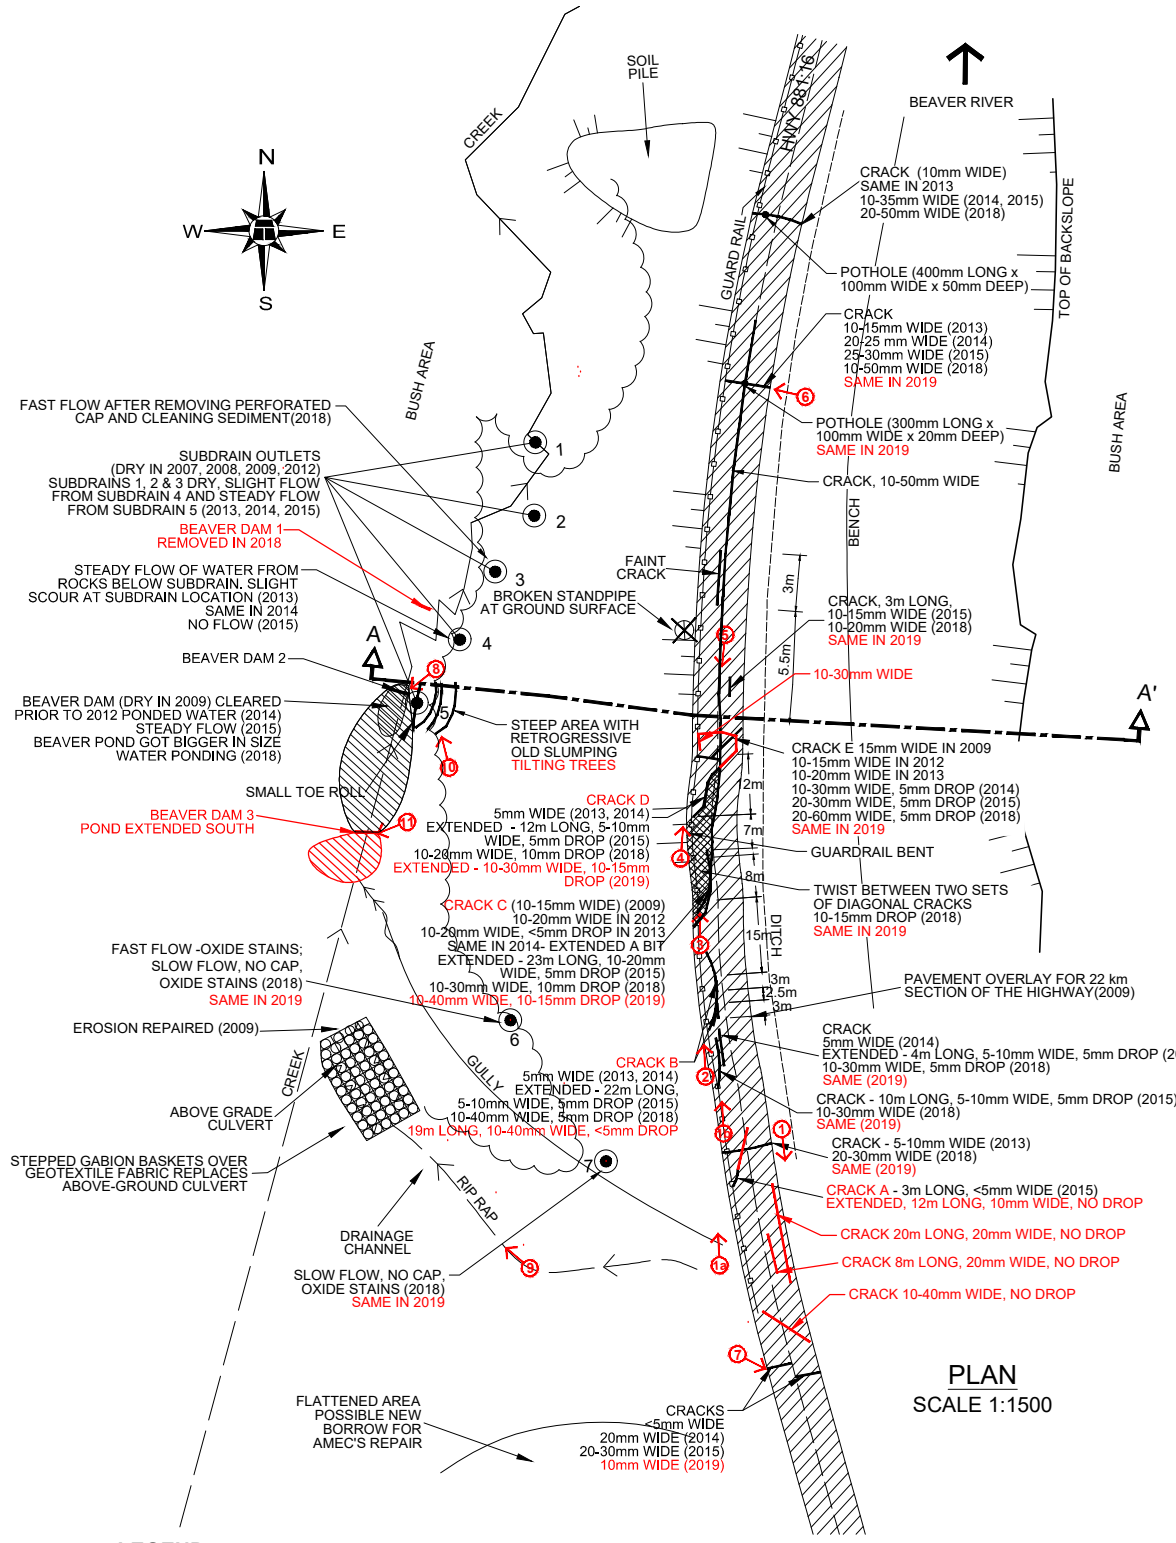
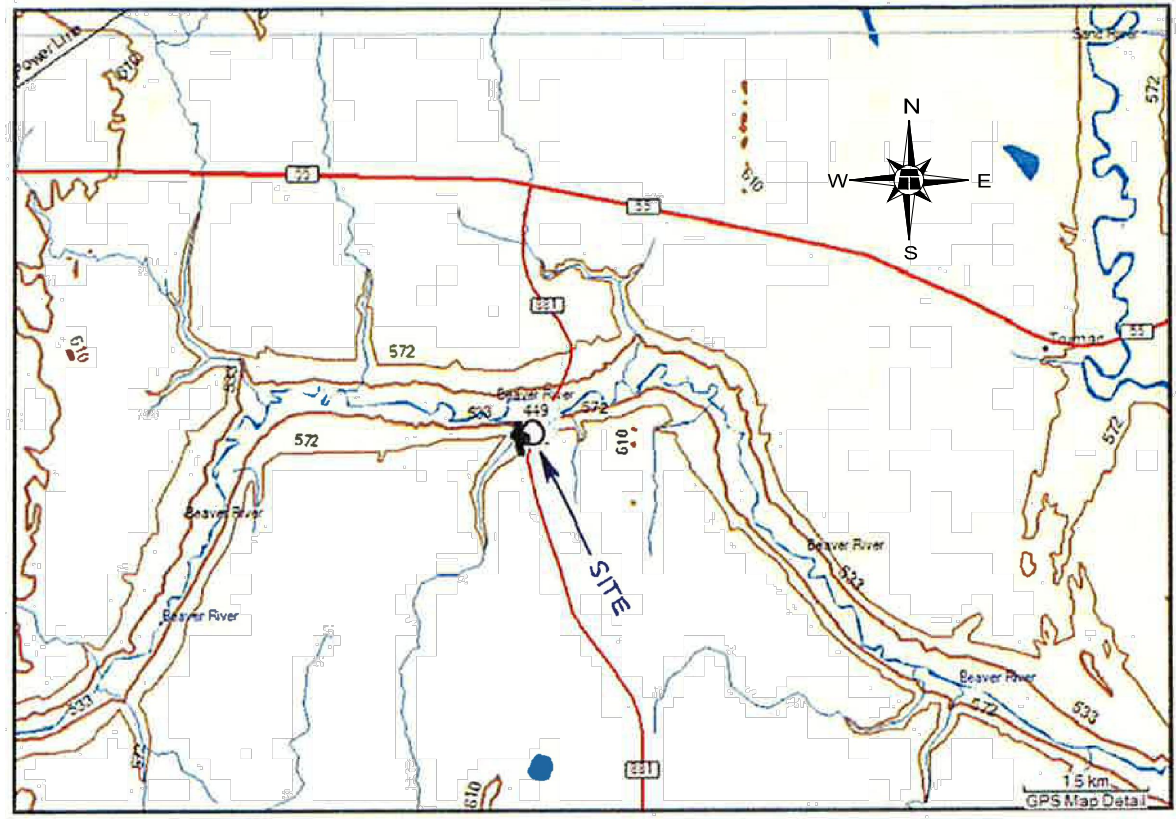
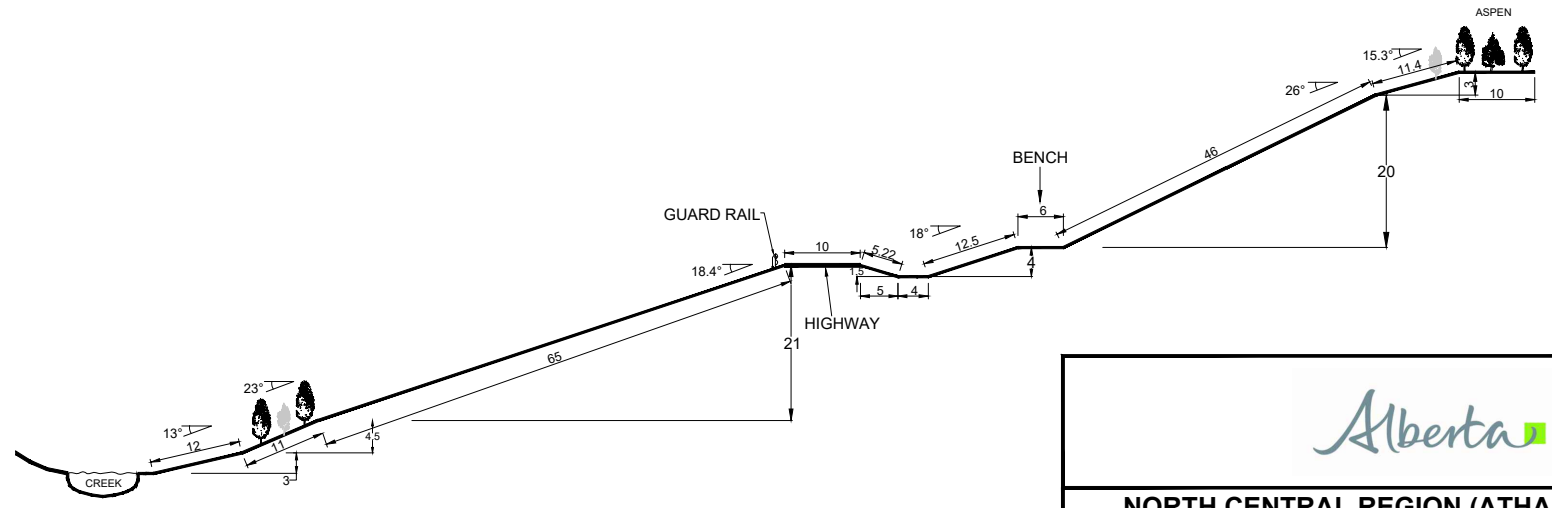
FIGURE NC62-1

NOTE: JUNE 12, 2019 OBSERVATIONS SHOWN IN RED

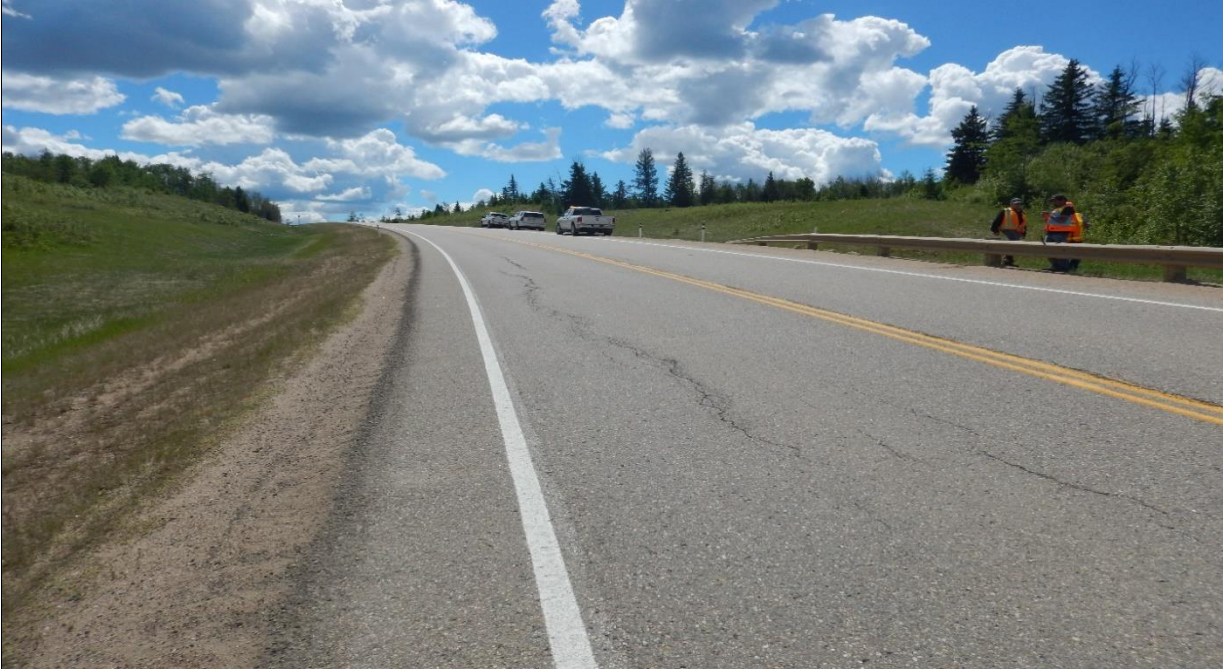
Photo No.1 - Looking south from the southern limit of the site at new longitudinal cracks on the southbound lane

- Seal all open cracks in the highway surface to prevent surface water infiltration into the landslide mass.
- Watch closely for new cracks or extension of existing cracks.
- Place ACP patch at the twist location to provide a smooth ride to motorists
- Clear the beaver dam(s) and re-locate the beaver(s) to reinstate proper creek flow and avoid damming of water within the limits of the repaired slope area.
- Clean up the subdrains located at the toe of the slope.

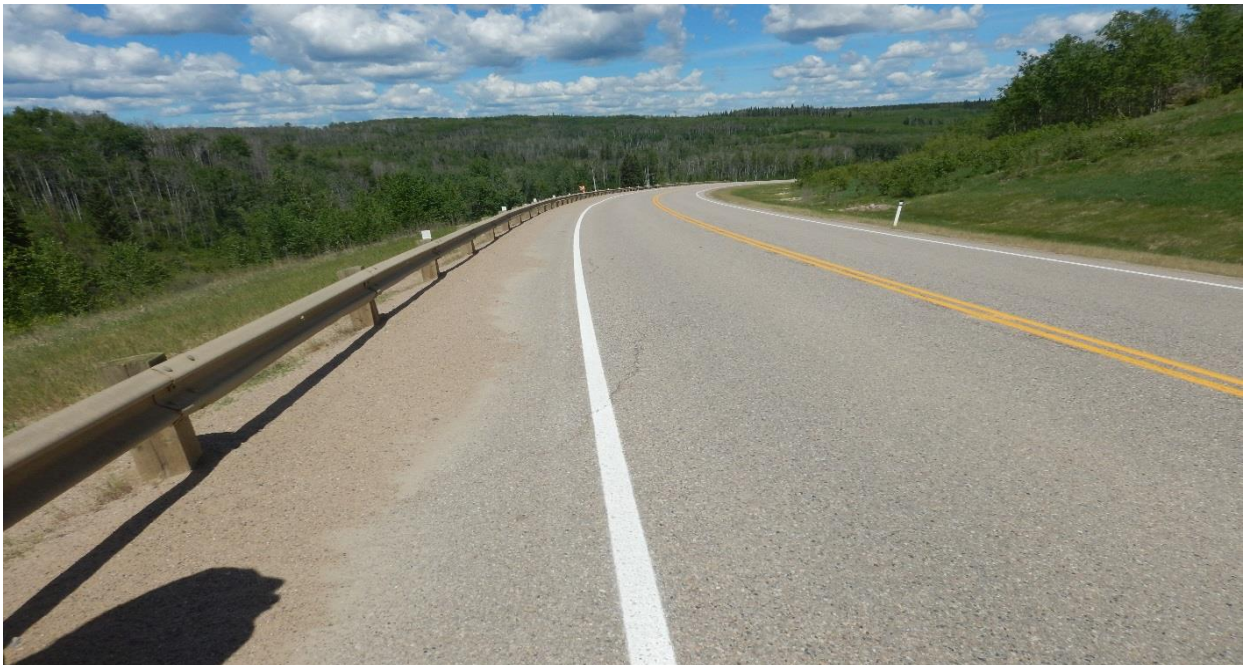
Photo No.1a - Looking south from the southern limit of the site at 10 mm wide diagonal crack A

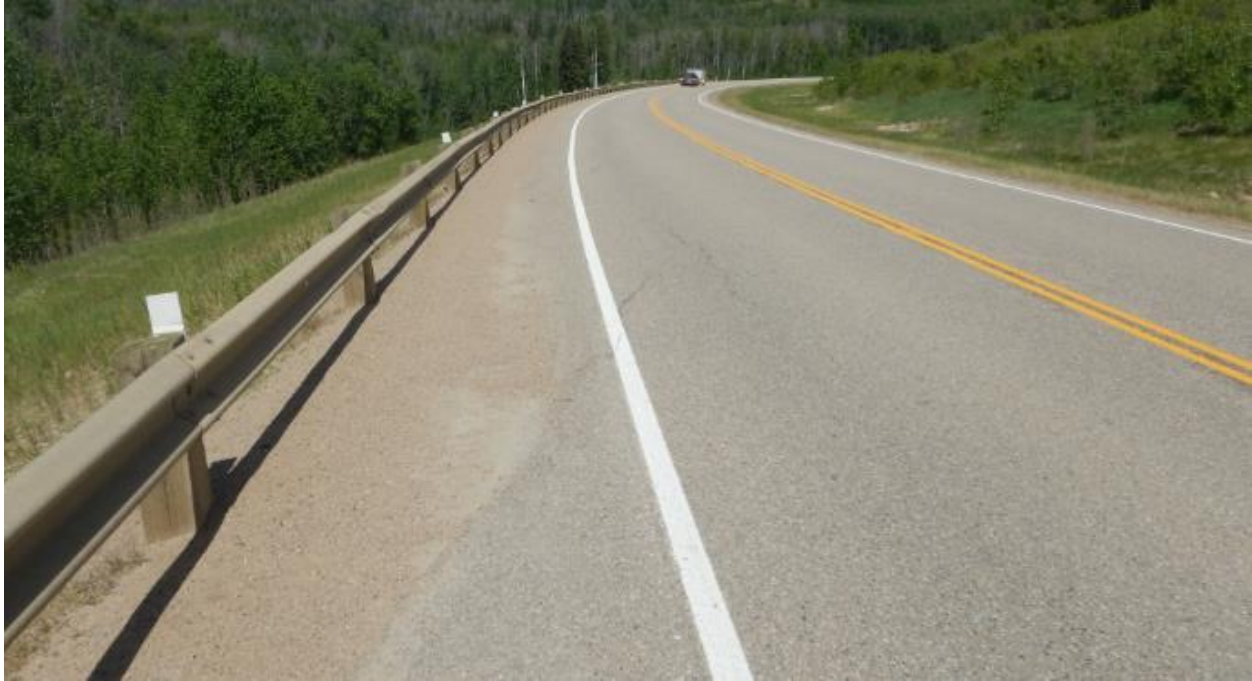
Photo No.1b - Looking north from the southern limit of the site at 10 -30 mm wide diagonal Crack B

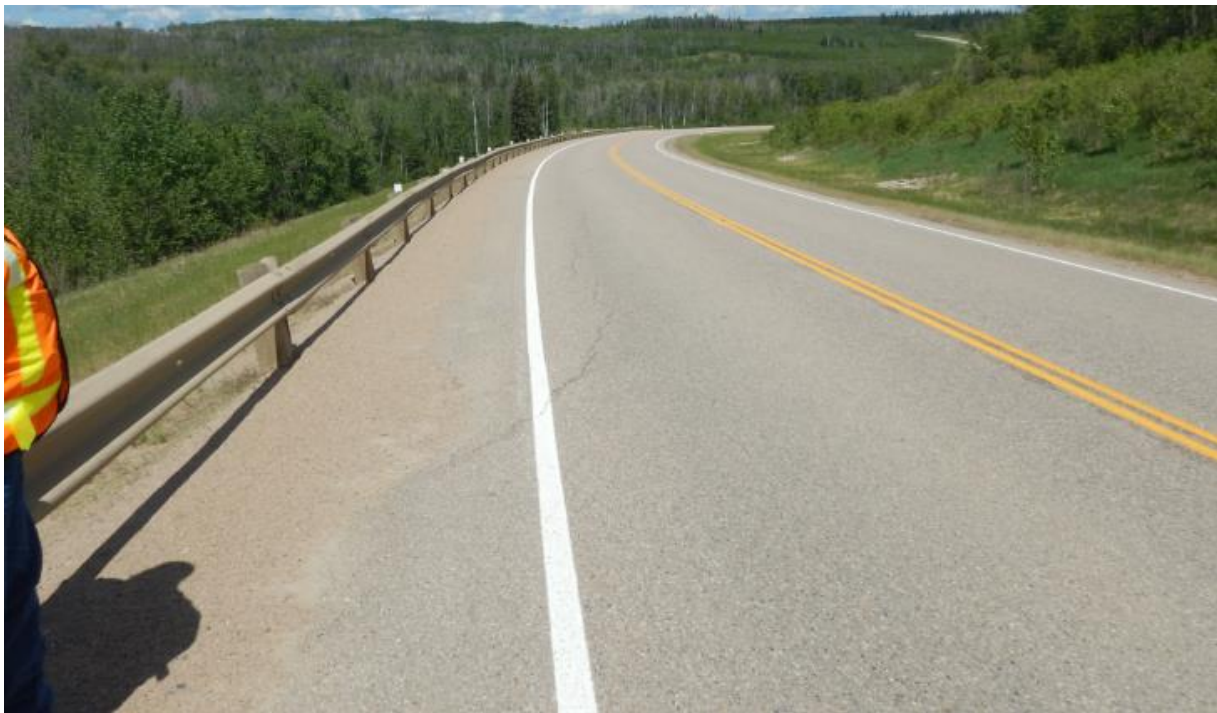
Photo No.2 - Looking north at a 10-40 mm wide arc-shaped reflective Crack B

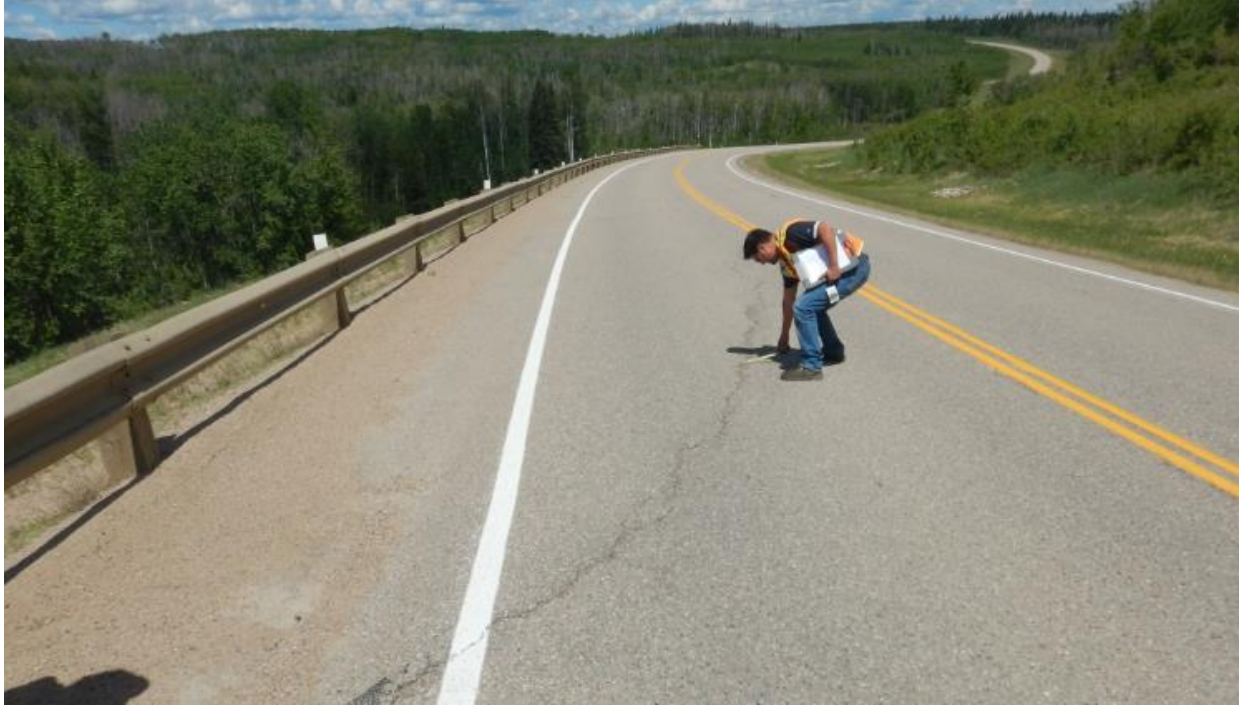
Photo No.3 - Looking north at a 10-40 mm wide arc-shaped reflective Crack C on the highway surface

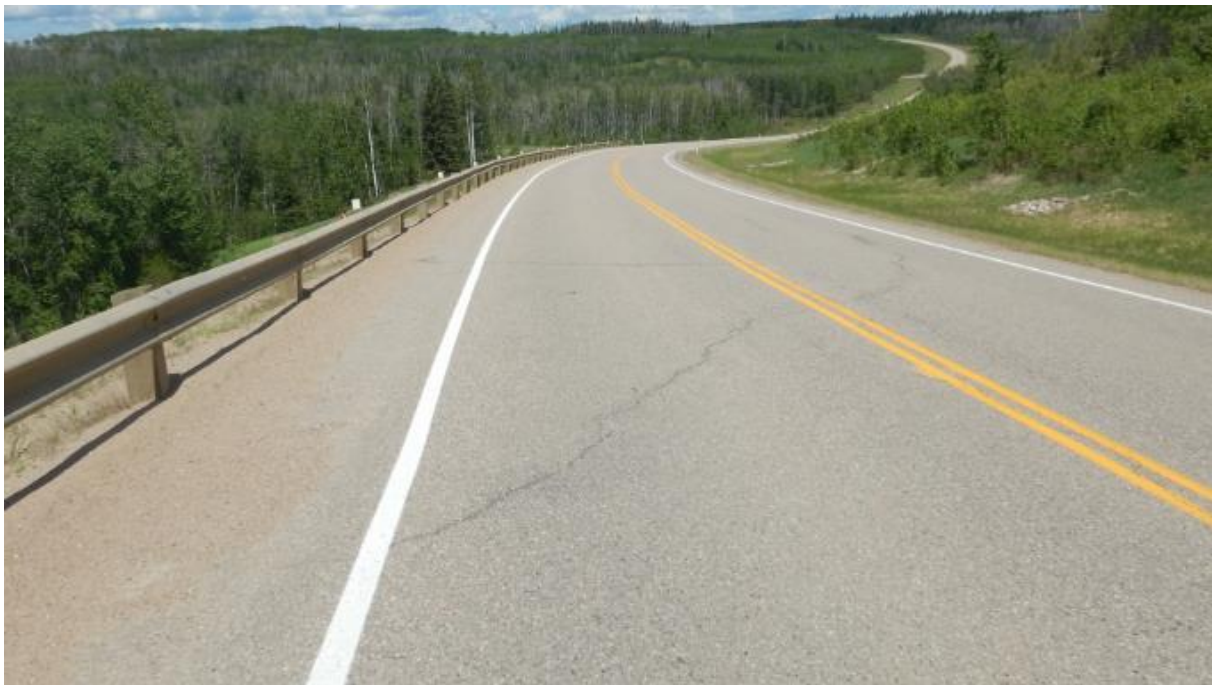
Photo No.4 - Looking north at a 10-30 mm wide arc-shaped reflective Crack D

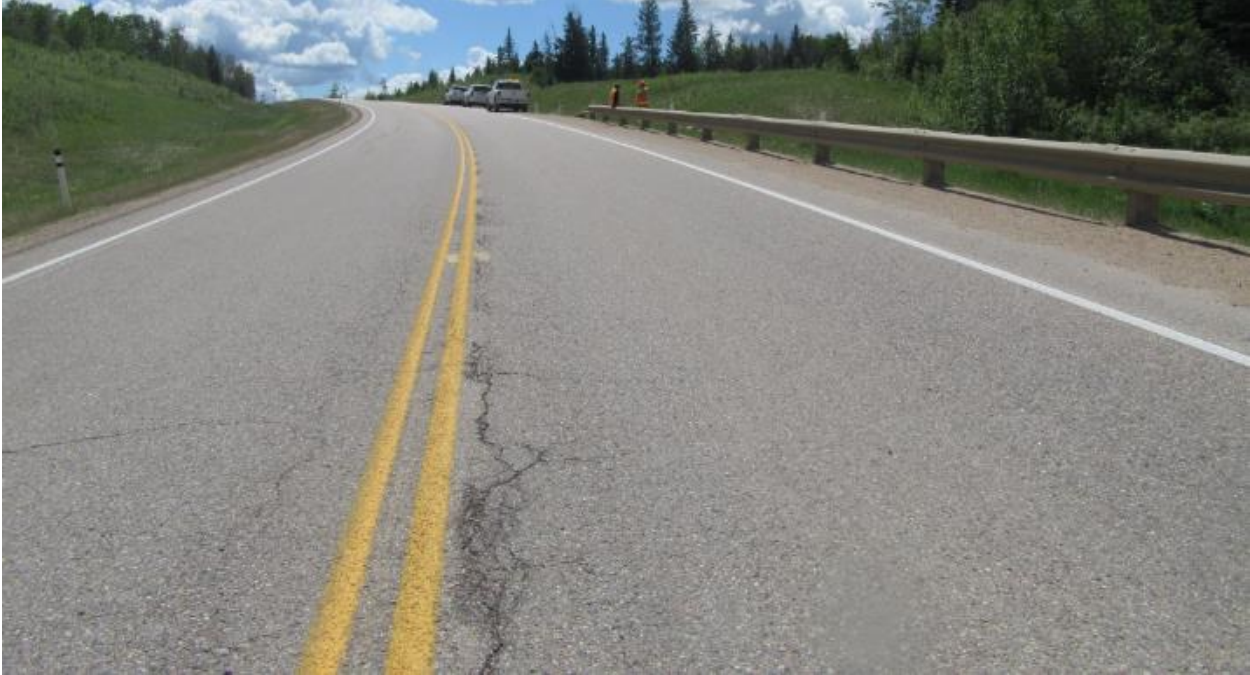
Photo No.5 - Looking south at a 10 to 15 mm wide reflective crack along the highway centerline

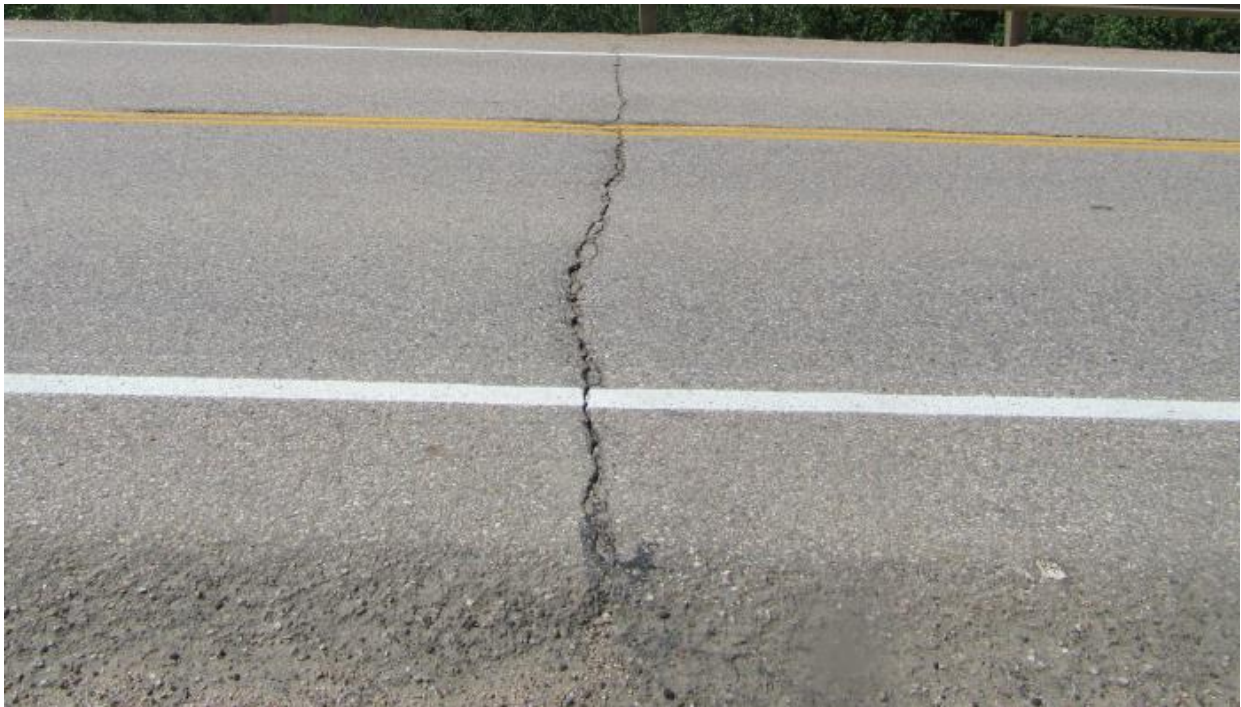
Photo No.6 - Looking west at a 10 to 50 mm wide transverse crack near the northern limit of the site

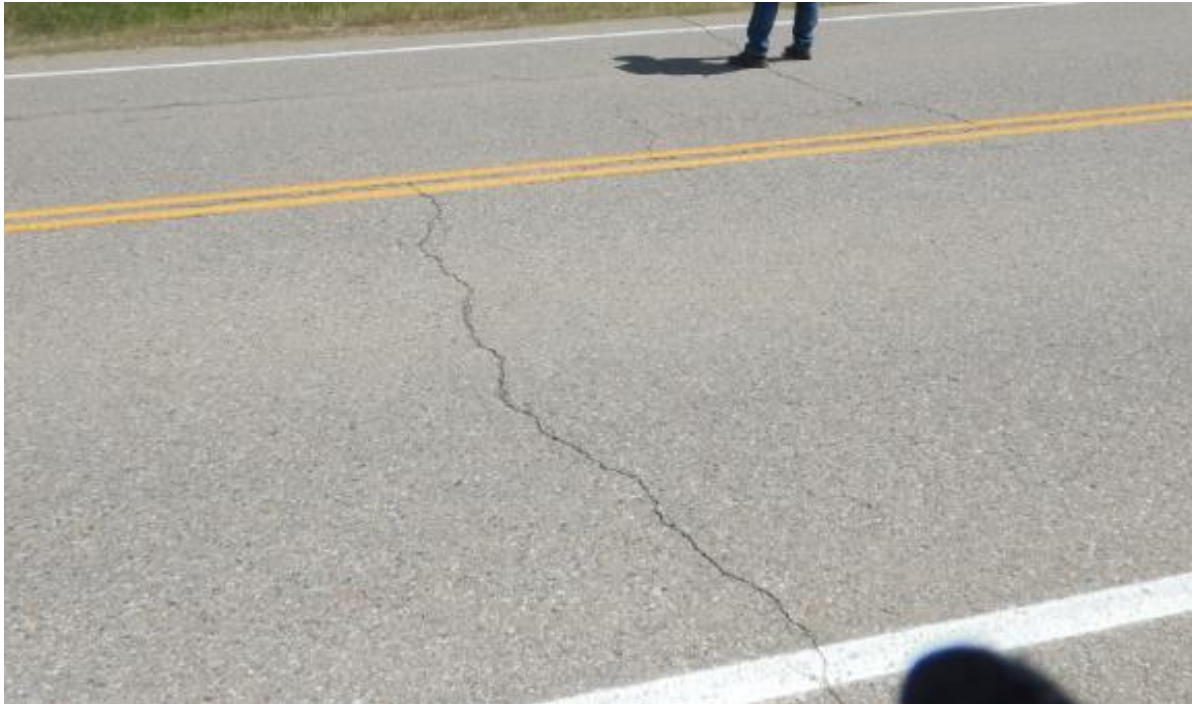
Photo No.7 – Looking east at 10 mm wide transverse crack near the southern limit of the site

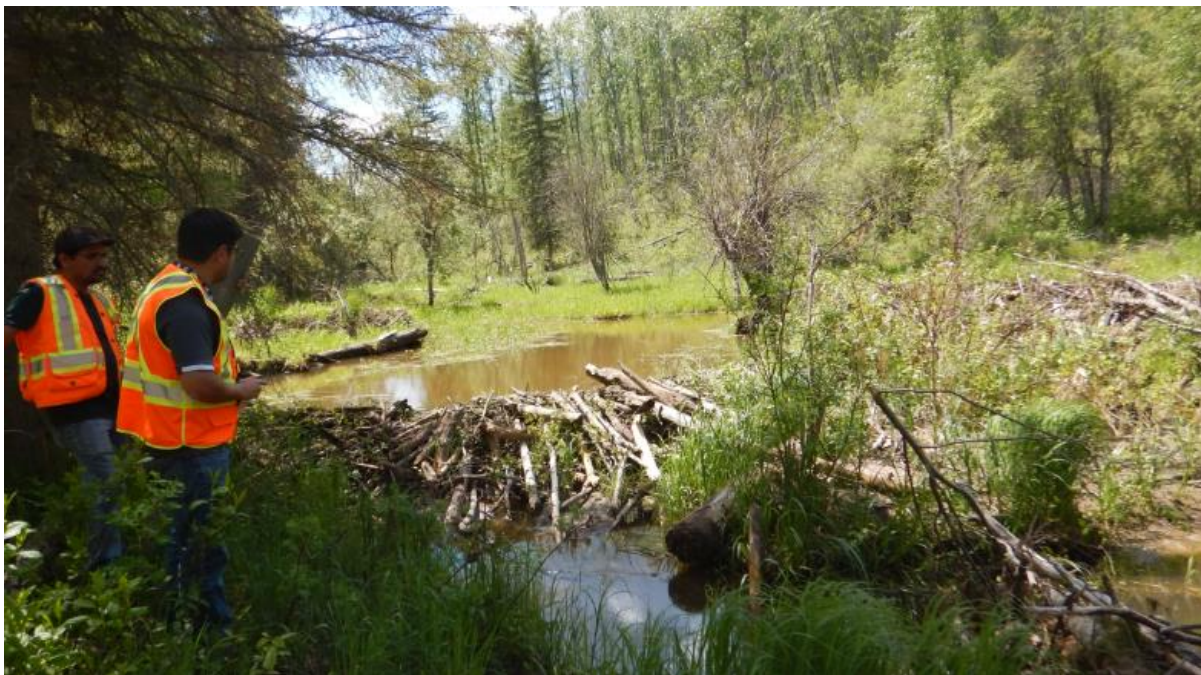
Photo No.8 - Looking south at Beaver Dam 2

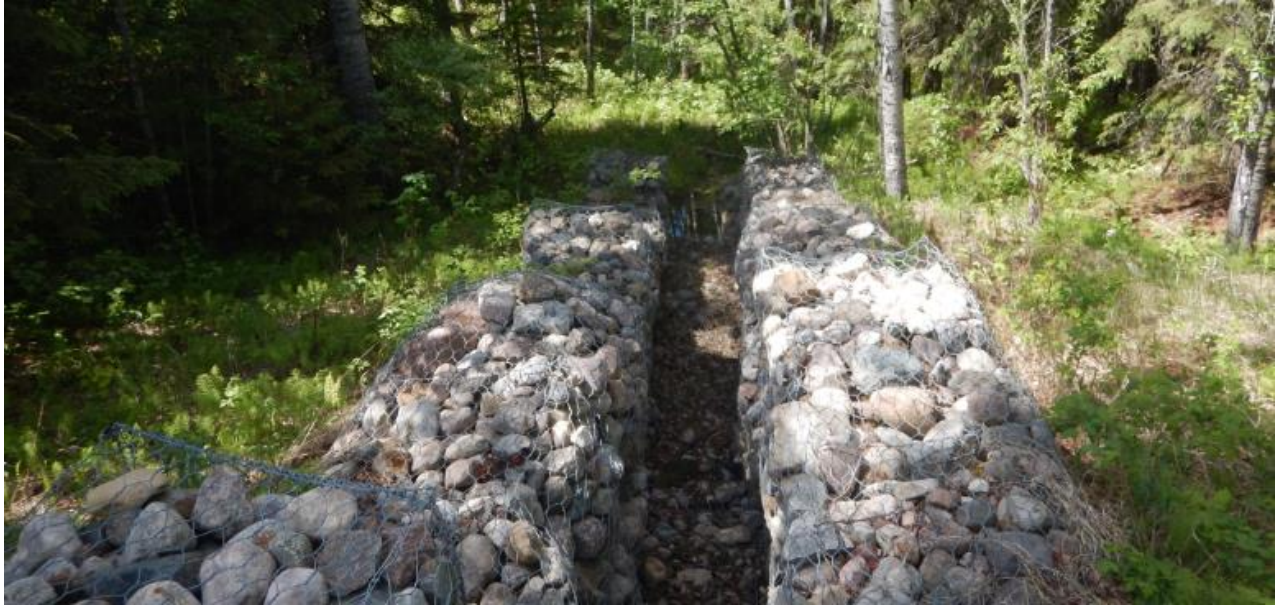
Photo No.9 - Looking west at the gabion basket channel

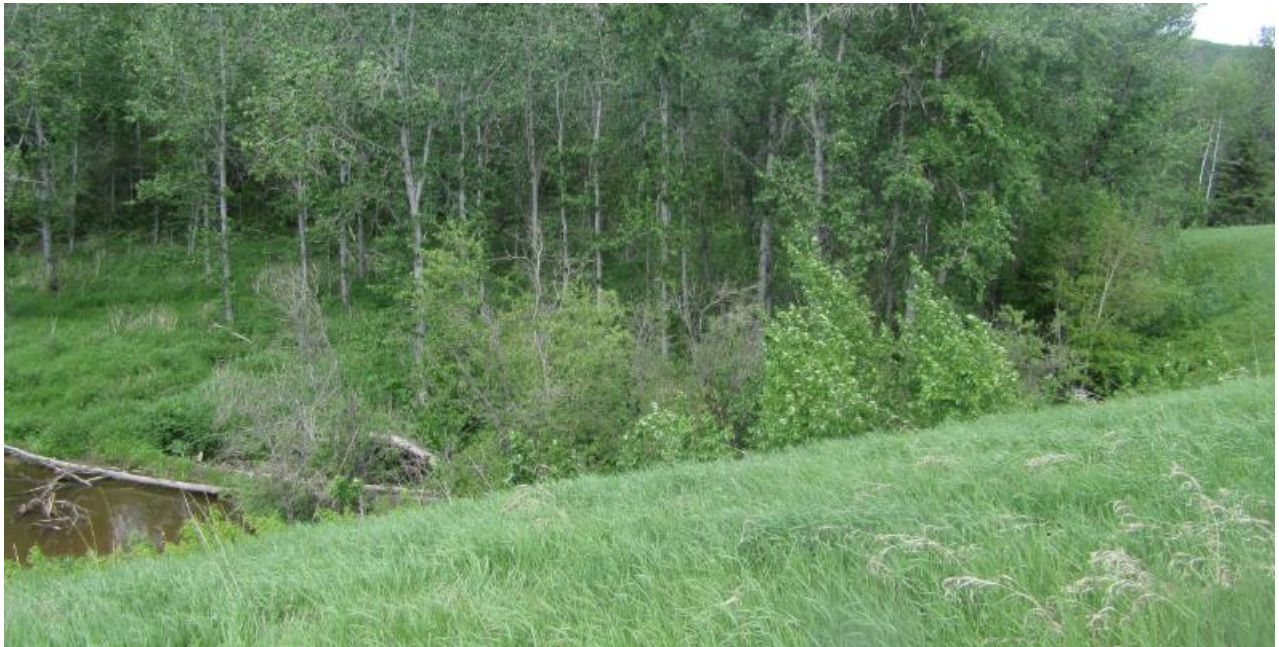
Photo No.10 – Looking west at an old slump above Beaver Dam 2

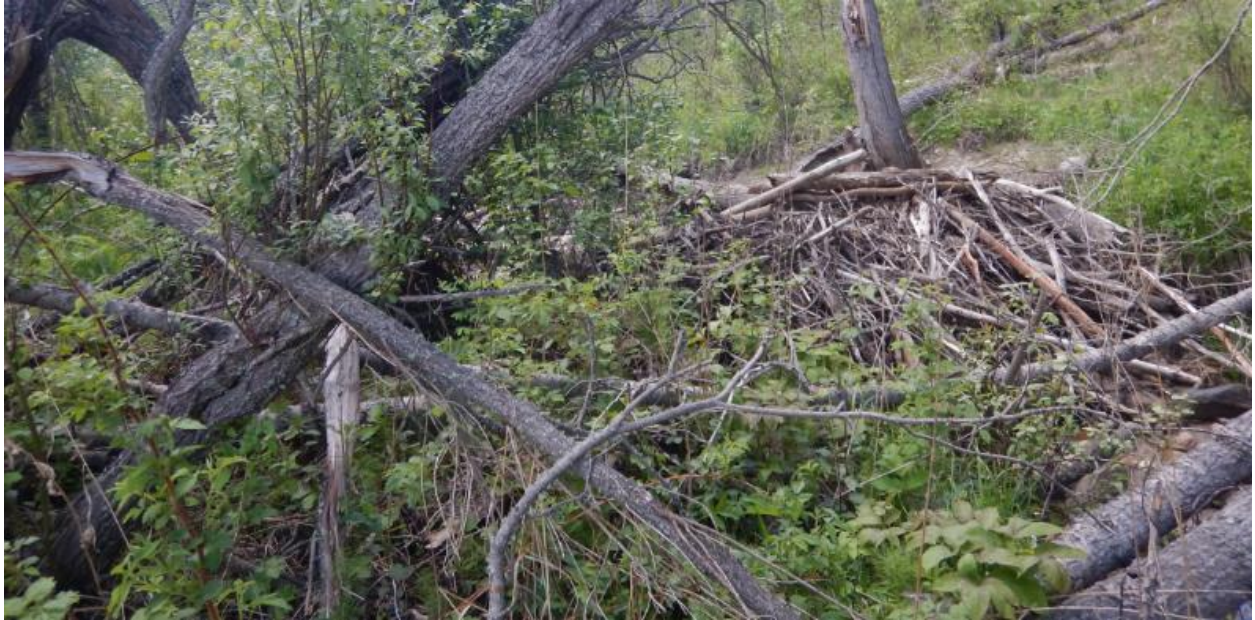
Photo No.11 - Looking south at Beaver Dam 3
