**ALBERTA TRANSPORTATION
GEOHAZARD ASSESSMENT PROGRAM
NORTH CENTRAL REGION – ATHABASCA & FORT
MCMURRAY DISTRICTS
2022 INSPECTION**

Site Number	Location	Name	Hwy	km
NC 62	3.3 km south of the junction between Hwy 881:15 and 55:14	SOUTH OF BEAVER RIVER	881:16	29
Legal Description		UTM Co-ordinates (NAD 83)		
SE- 12-63-9-W4M		12 N 603423	E 480622

**NC 62: HWY 881: 16 SOUTH OF BEAVER RIVER (km 3.3)
SITE PLAN AND CROSS - SECTION**

DWG NO. 32122-NC062-1

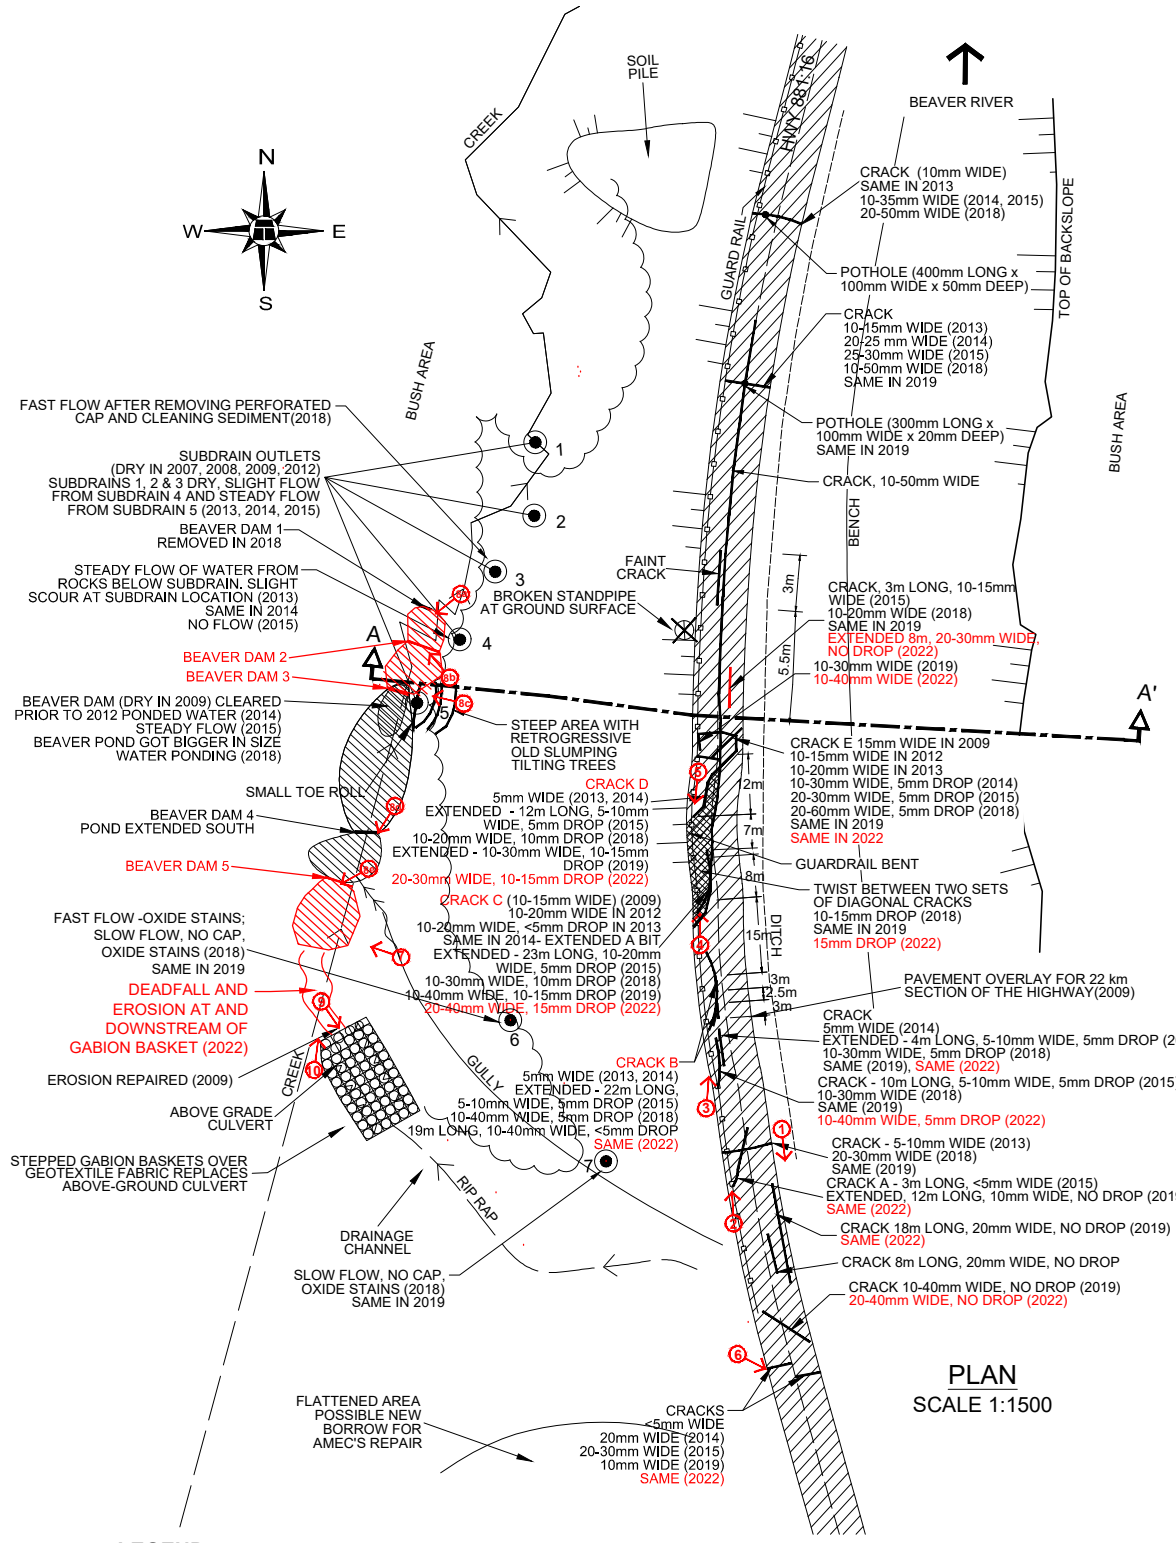
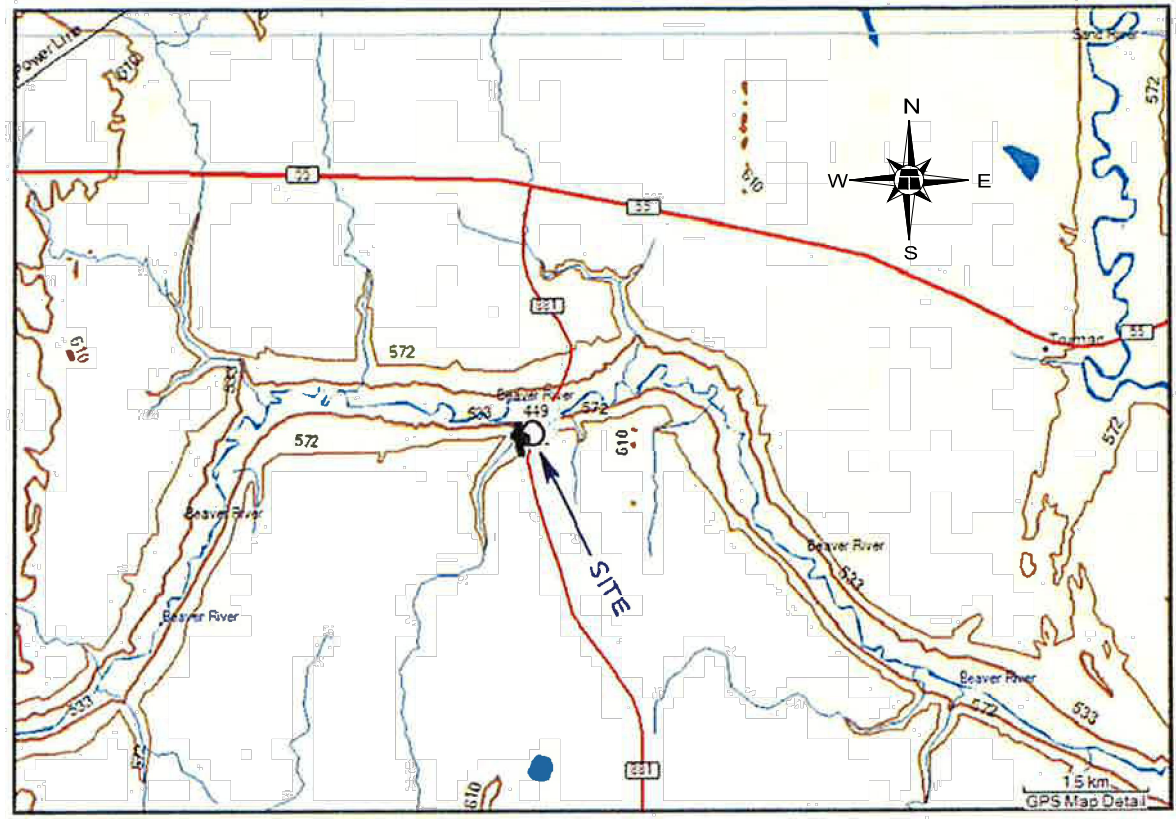
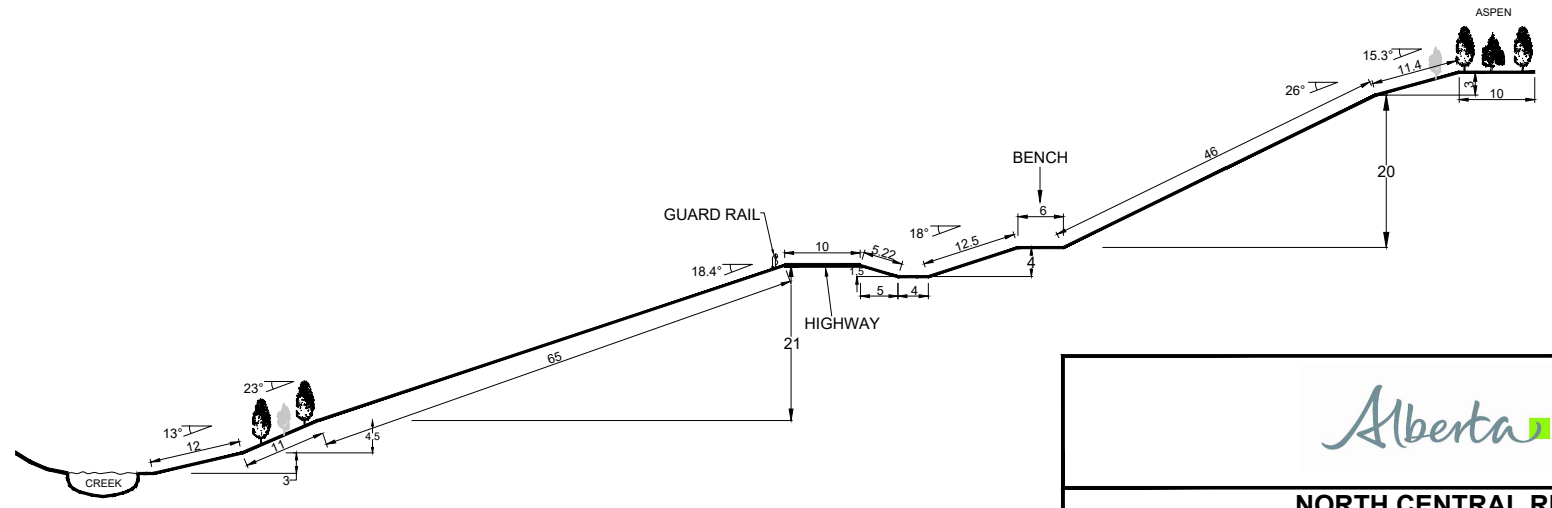
NOTE: JUNE 8, 2022 OBSERVATIONS SHOWN IN RED

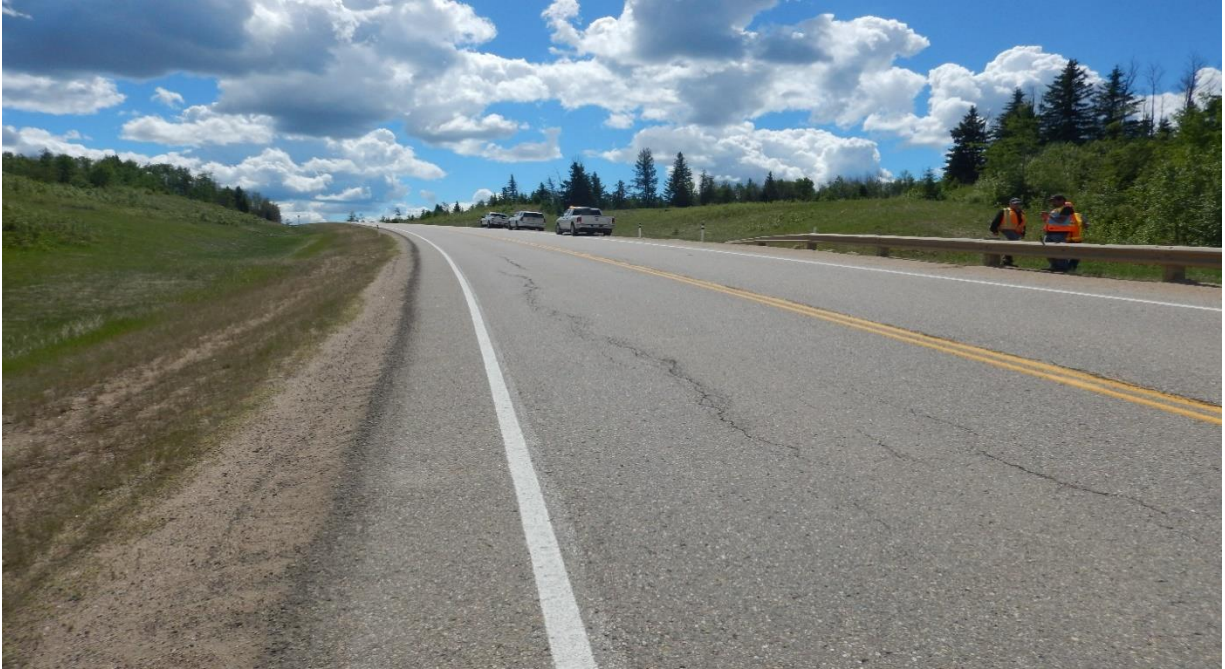
Photo No.1 - Looking south from the southern limit of the site at longitudinal cracks on the southbound lane

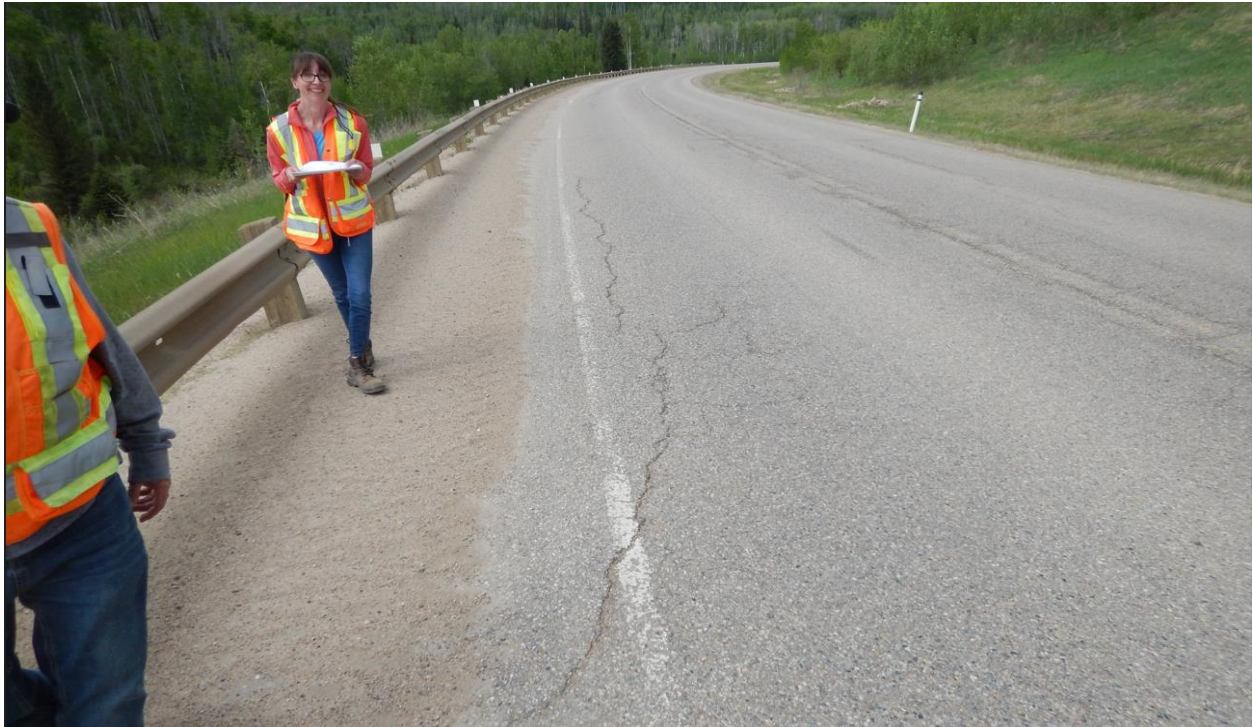
Photo No.2 - Looking north from the southern limit of the site at 10 mm wide diagonal Crack A

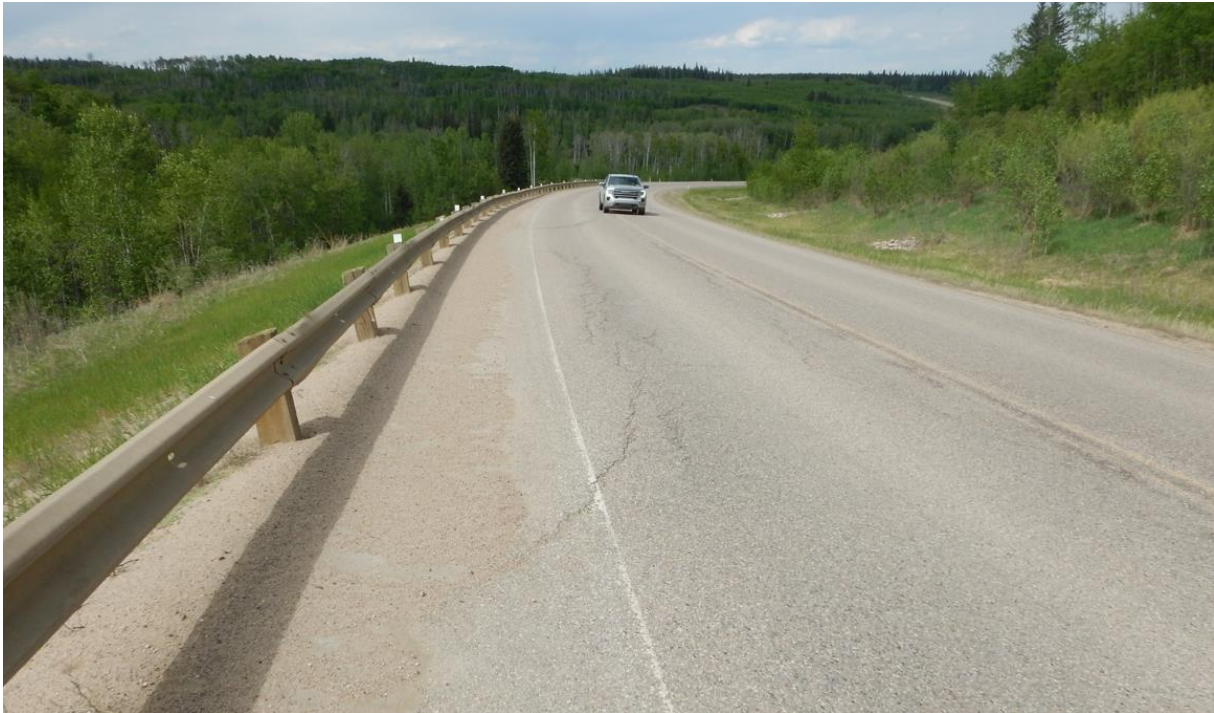
Photo No.3 - Looking north from the southern limit of the site at 10 -40 mm wide diagonal Crack B

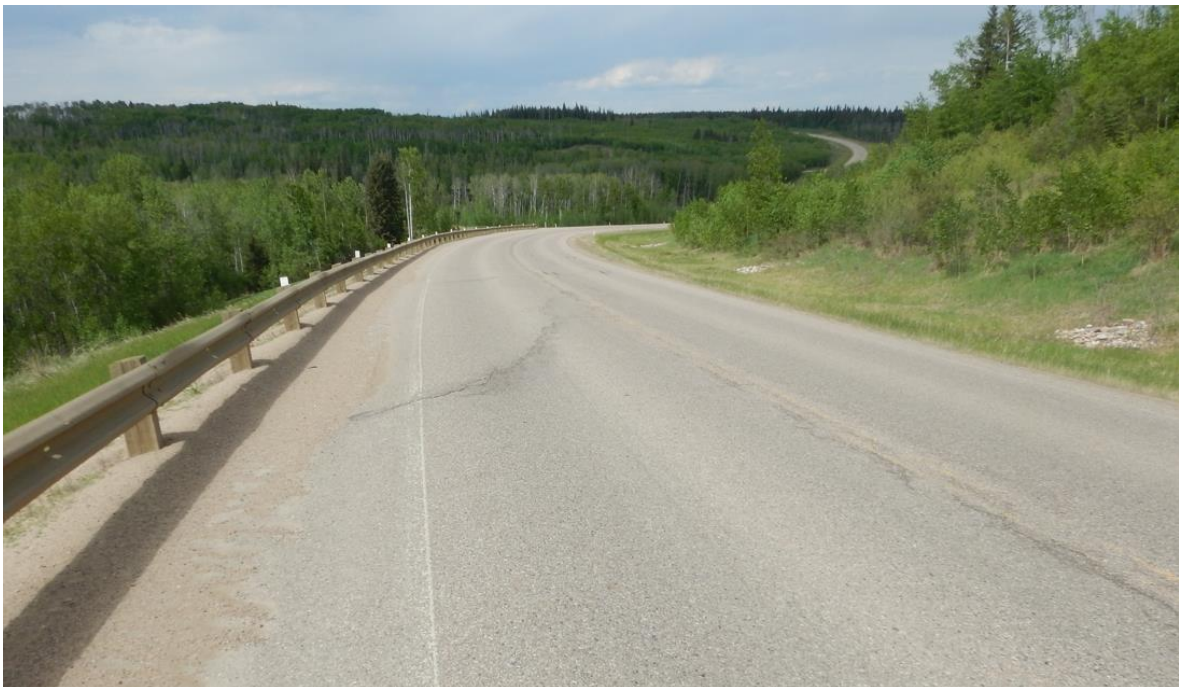
Photo No.4 – Looking north at a 20-40 mm wide arc-shaped reflective Crack C

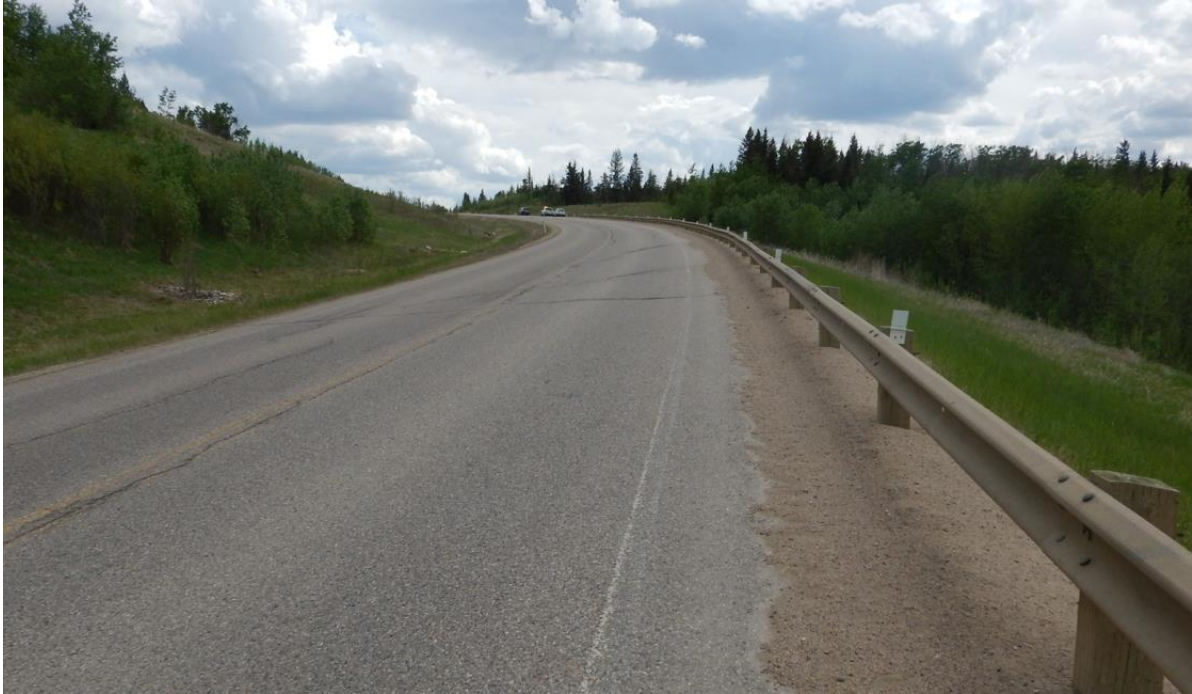
Photo No.5 – Looking south at a 20-30 mm wide arc-shaped reflective Crack D

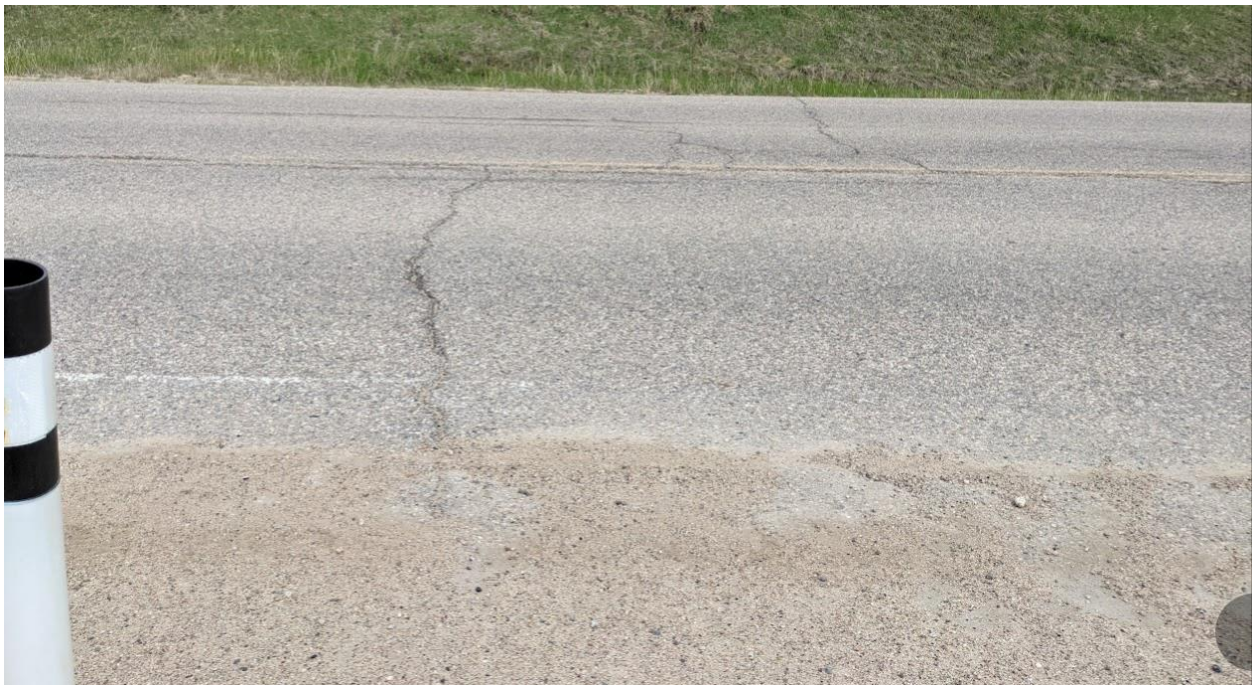
Photo No.6 – Looking east at a 10 mm wide transverse crack near the southern limit of the site

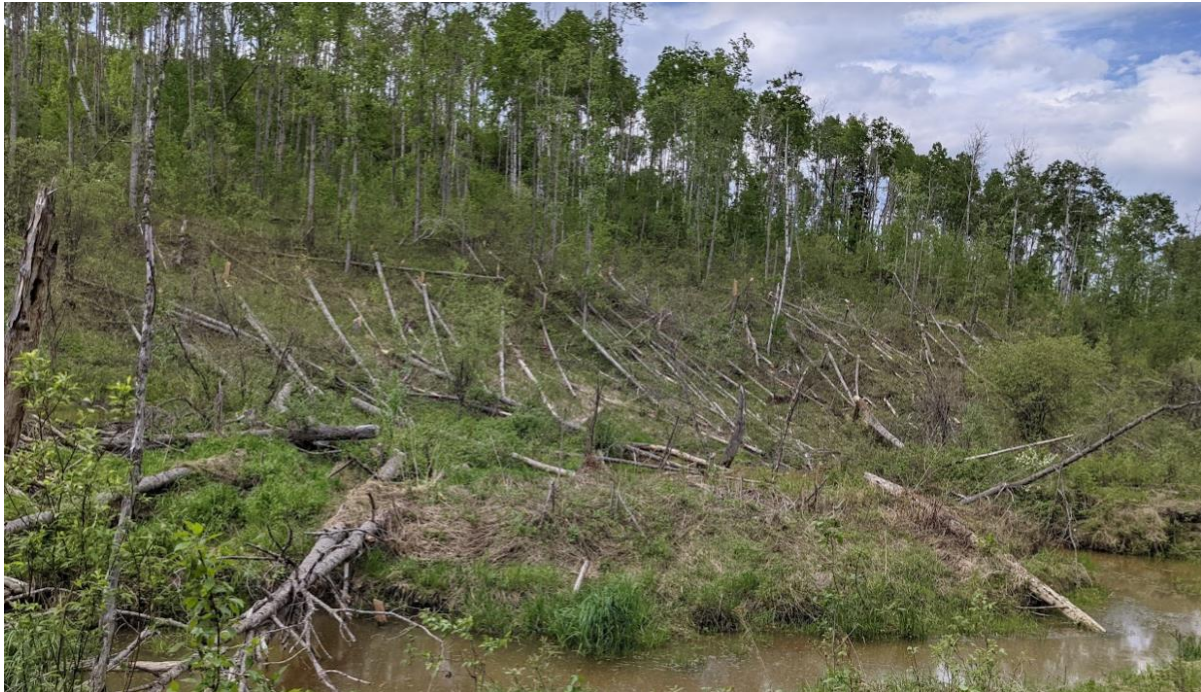
Photo No. 7 – Looking west at fallen trees and creek valley slumping south of Beaver Dam 5

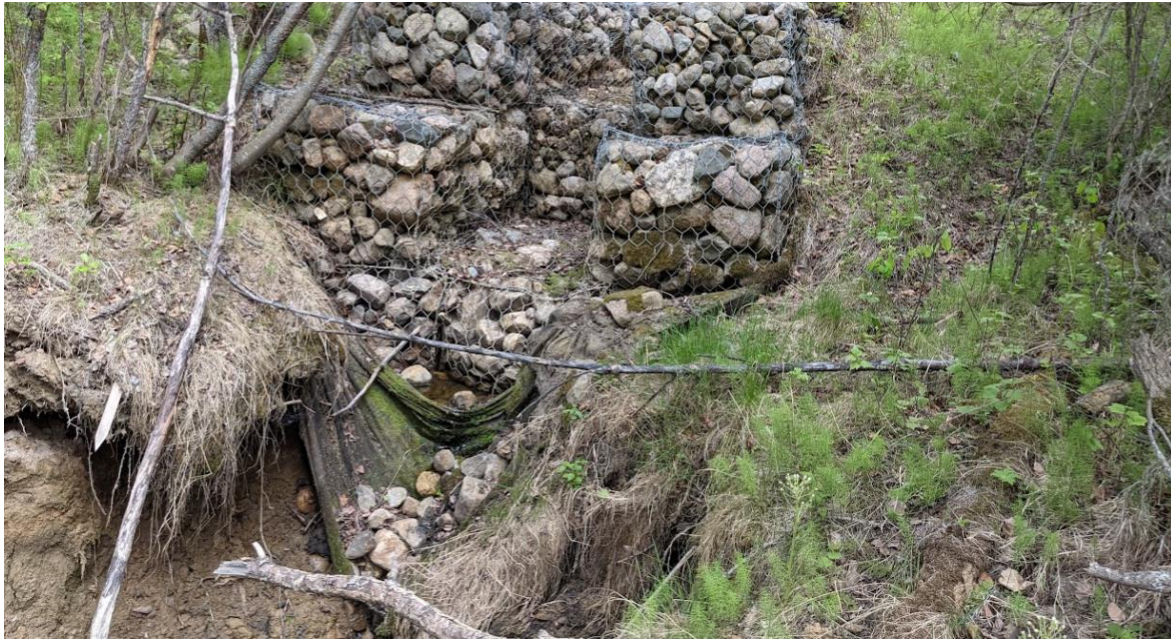
The gap developed below the mouth of the gabion basket channel should be treated; otherwise, it may get bigger and wider, and retrogress to undermine the integrity of the entire channel.

Photo No.9 - Looking at the mouth of the gabion basket channel. Note erosion around and below the base of the gabion basket

- Seal all open cracks in the highway surface to prevent surface water infiltration into the landslide mass.
- Watch closely for new cracks or extension of existing cracks.
- Place ACP patch at the twist location to provide a smooth ride to motorists
- Clear the beaver dam(s) and re-locate the beaver(s) to reinstate proper creek flow and avoid damming of water within the limits of the repaired slope area.
- Locate and clean up the subdrains located at the toe of the slope.
- Monitor erosion developing around the mouth of the gabion basket. If it becomes worse with time, the gap below the gabion basket should be backfilled, and riprap rock should be placed at the mouth of the channel to reduce the likelihood of undermining the entire channel.

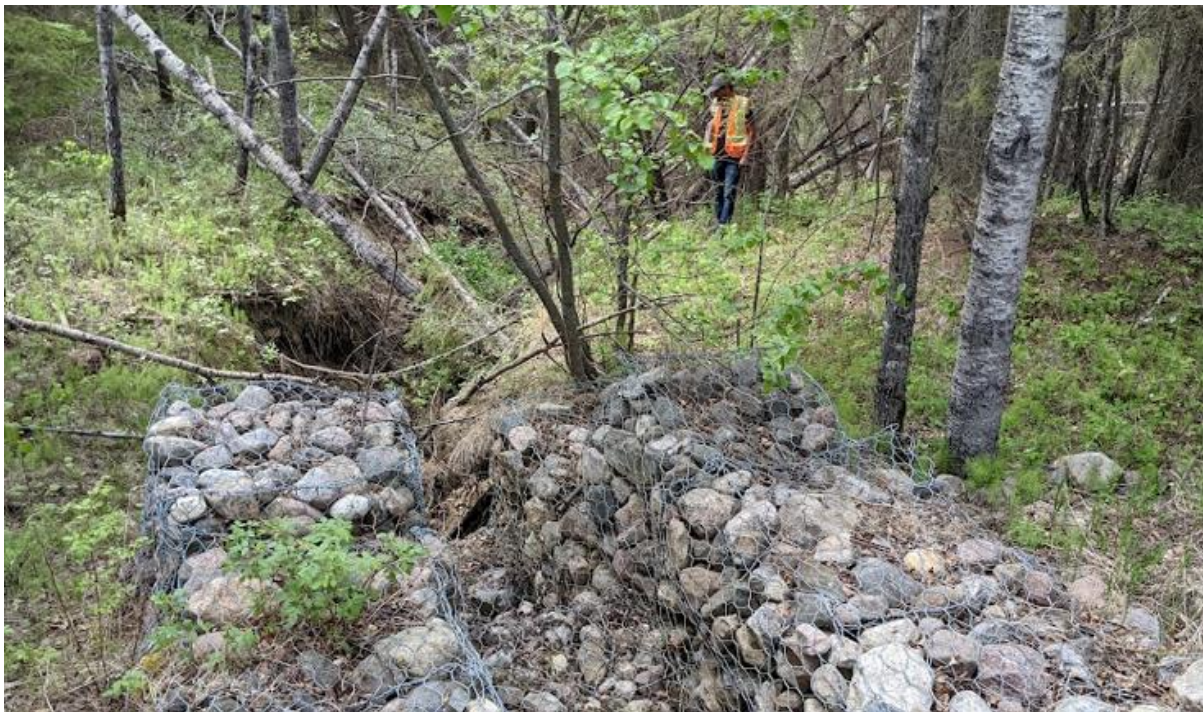
Photo No.10 – Looking north at erosion and fallen trees beyond the mouth of the gabion basket channel
