**ALBERTA TRANSPORTATION AND  
ECONOMIC CORRIDORS GRMP  
NORTH CENTRAL (ATHABASCA AND FORT  
McMURRAY DISTRICTS)  
2024 SITE INSPECTION**

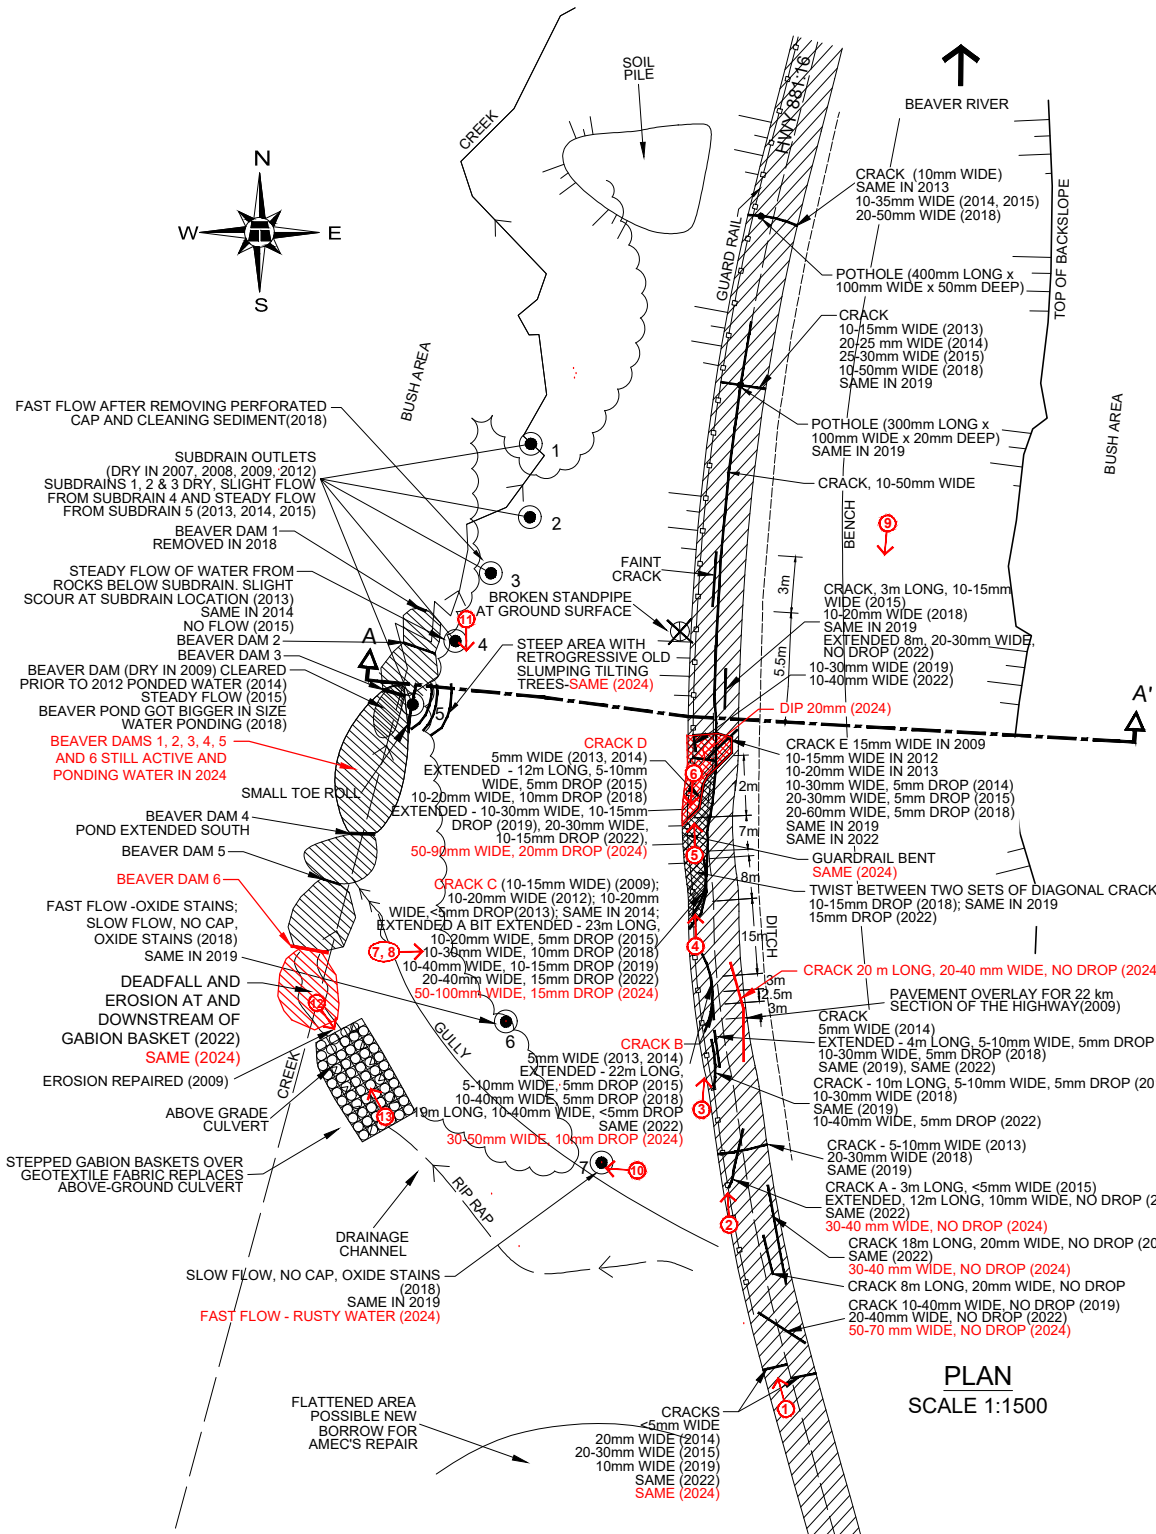
The information, interpretations and conclusions in the Report are based on Thurber's interpretation of conditions revealed through limited investigation conducted within a defined scope of services. Thurber does not accept responsibility for independent conclusions, interpretations, interpolations and/or decisions of the Client, or others who may come into possession of the Report, or any part thereof, which may be based on information contained in the Report. This restriction of liability includes but is not limited to decisions made to develop, purchase or sell land.

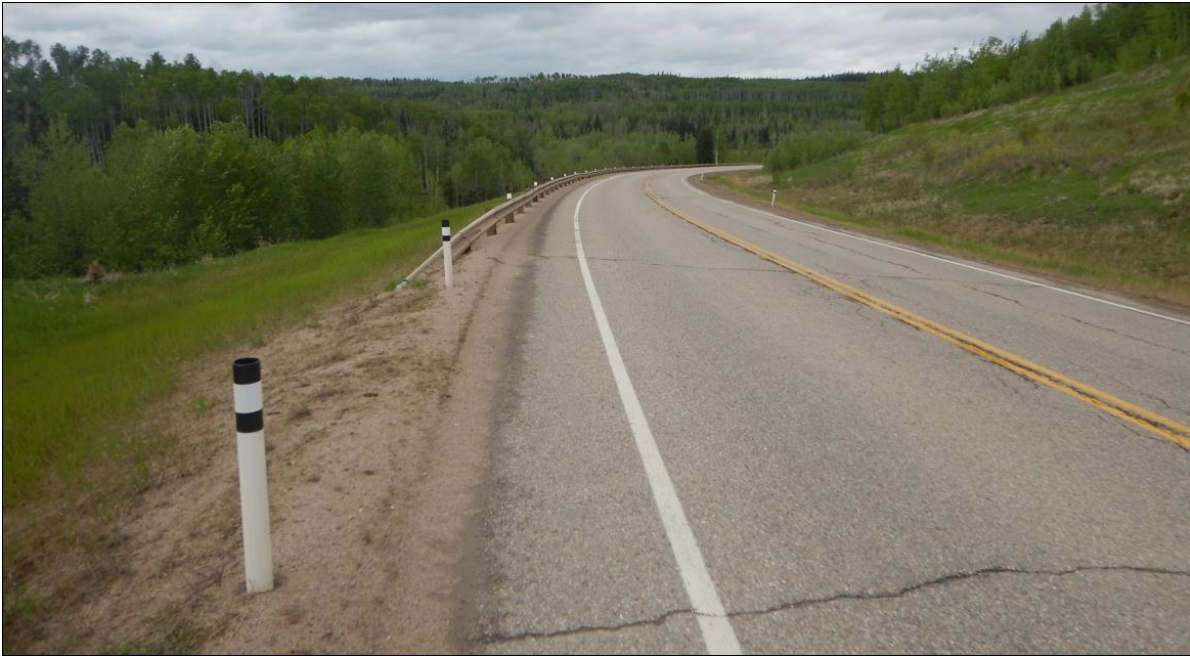
Photo No.1 - Looking north from the southern limit of the site at transverse and longitudinal cracks on the highway

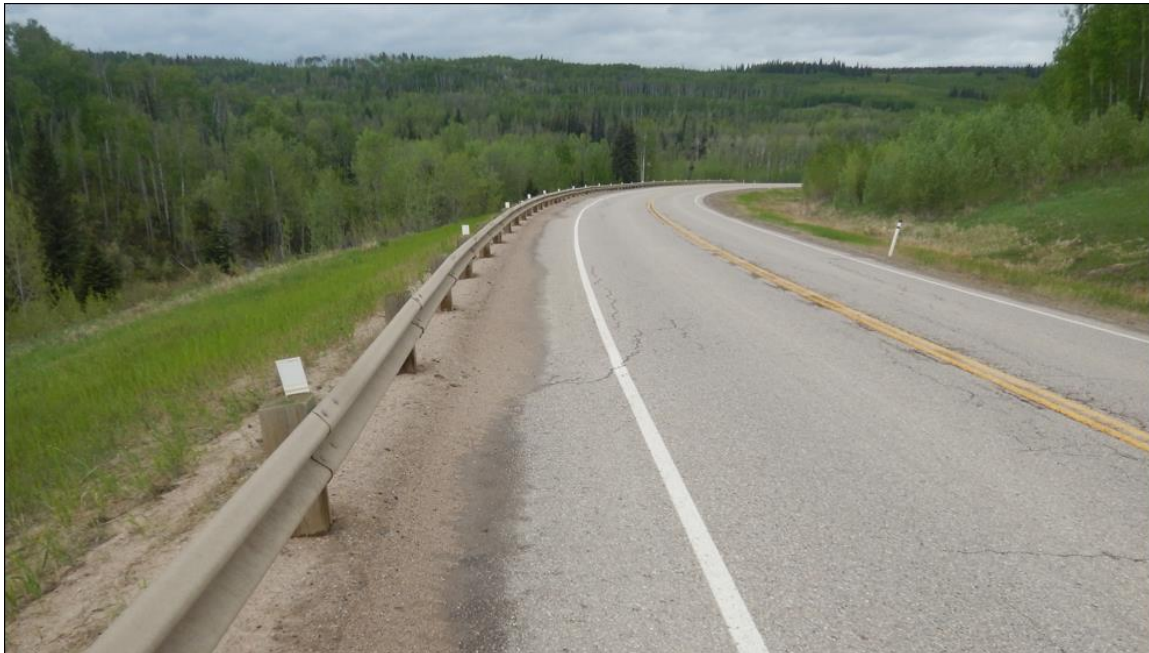
Photo No.2 - Looking north from the southern limit of the site at diagonal Crack A

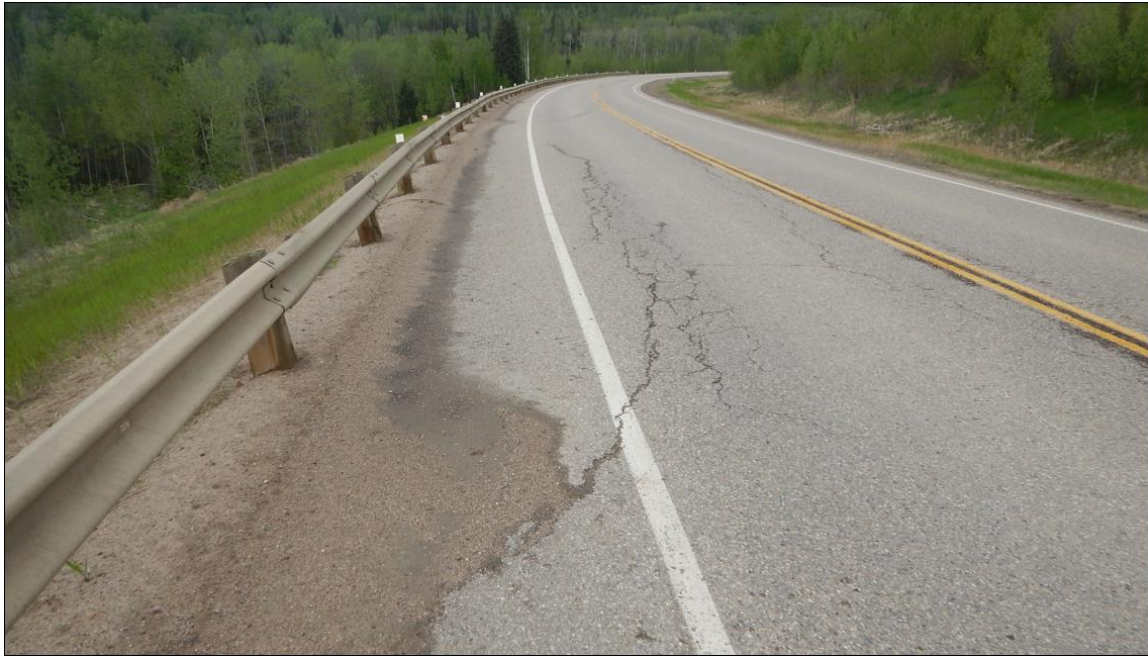
Photo No.3 - Looking north from the southern limit of the site at 30-50 mm wide diagonal Crack B, no drop

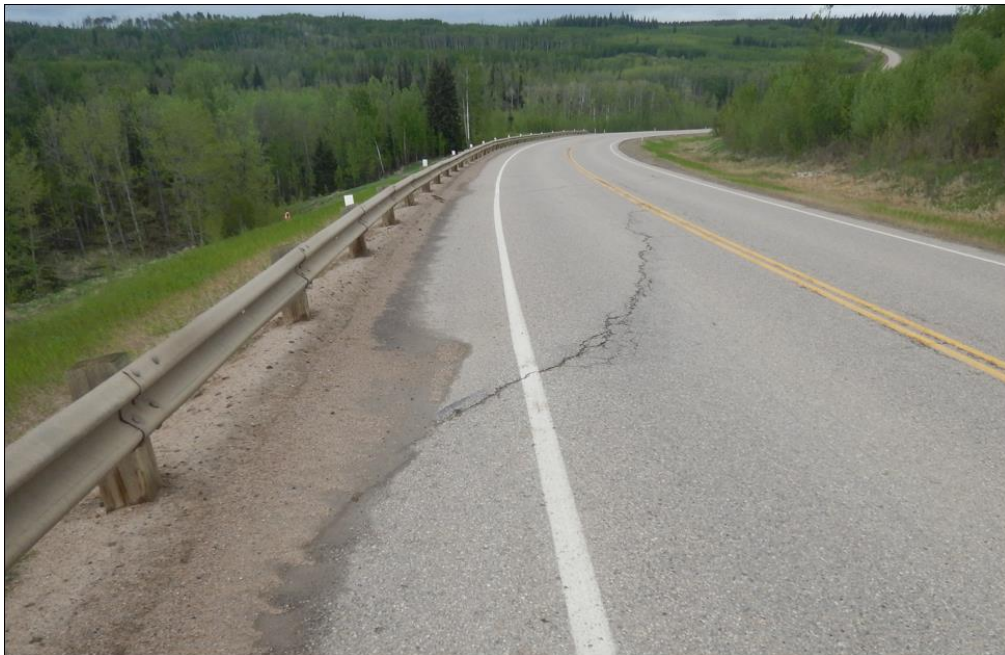
Photo No.4 – Looking north at the arc-shaped reflective Crack C (50 -100 mm wide, 15 mm drop)

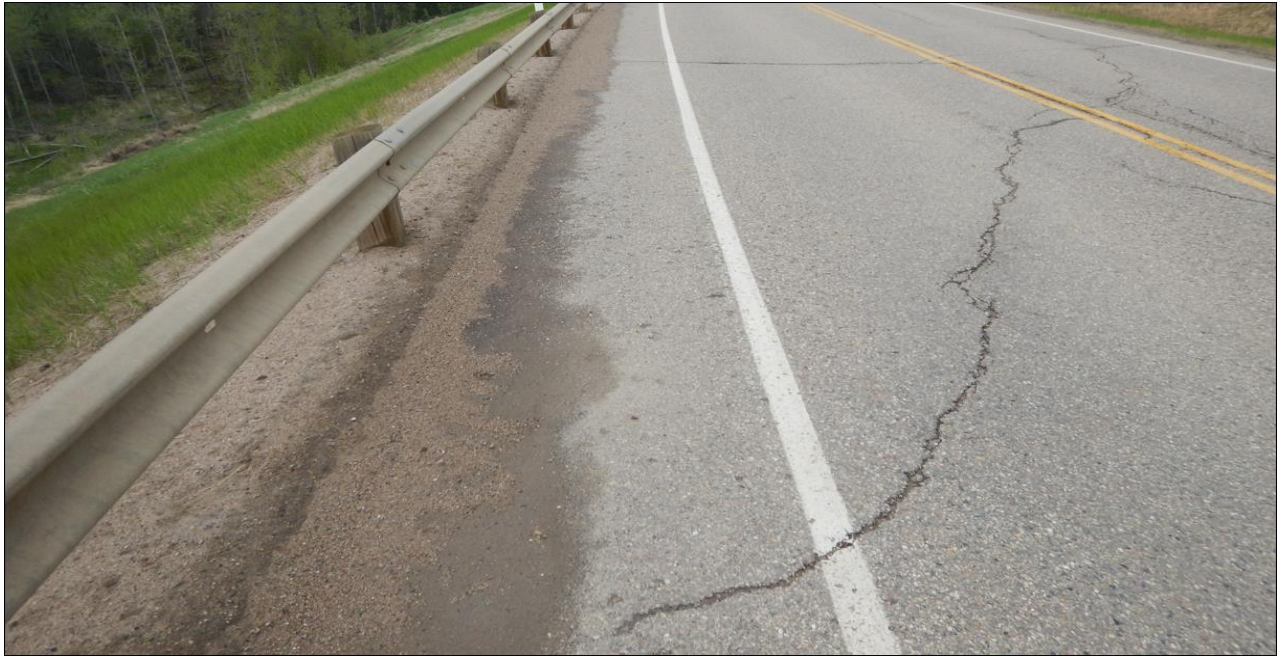
Photo No. 5 Looking north at the arc-shaped reflective Crack D (50-90 mm wide)

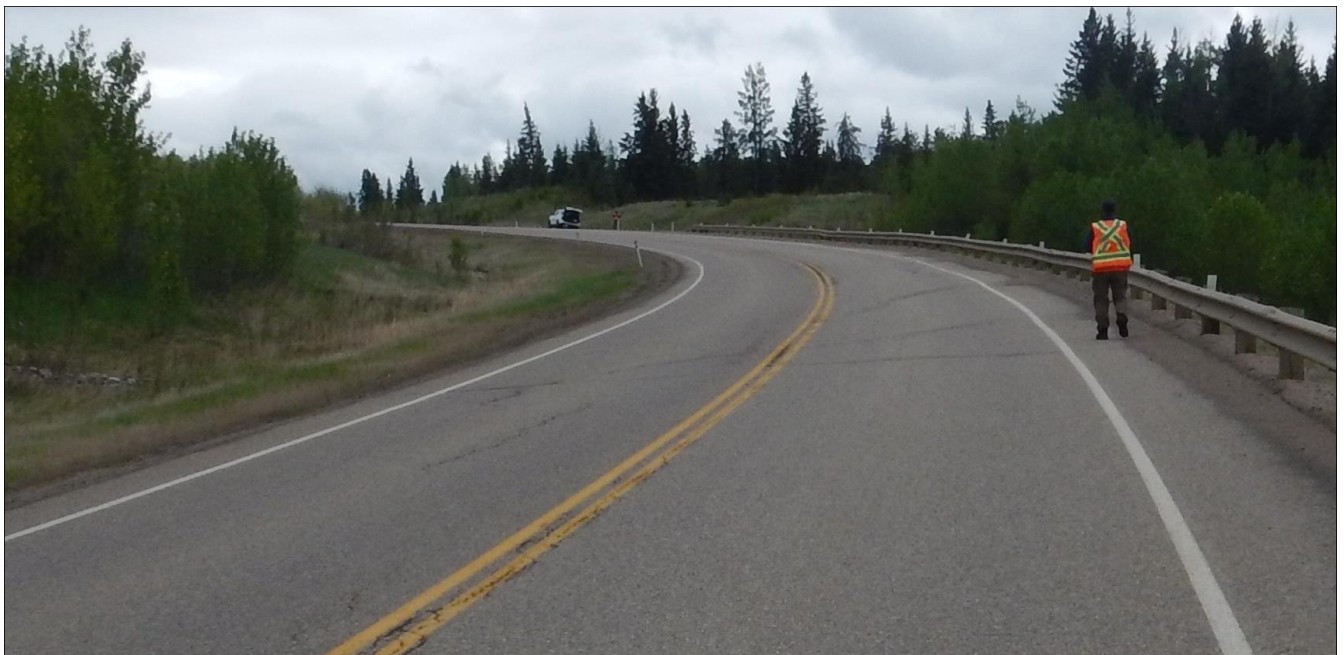
Photo No. 6 – Looking south at arc-shaped reflective Crack D

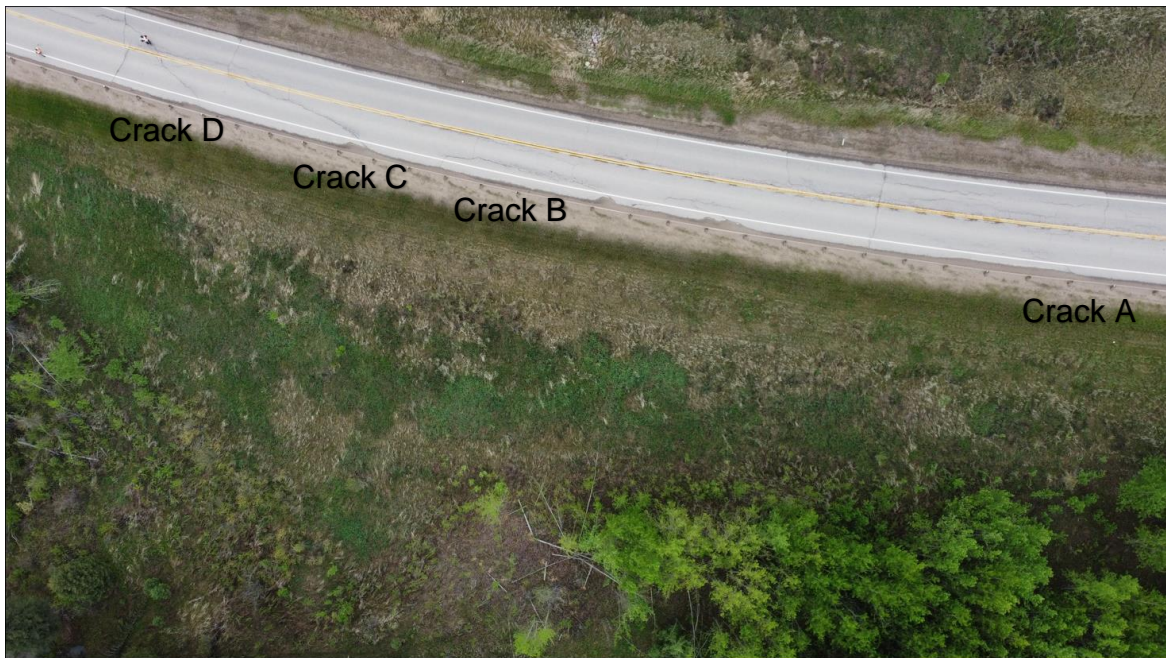
Photo No. 7 – Aerial photo showing Cracks A, B, C, and D

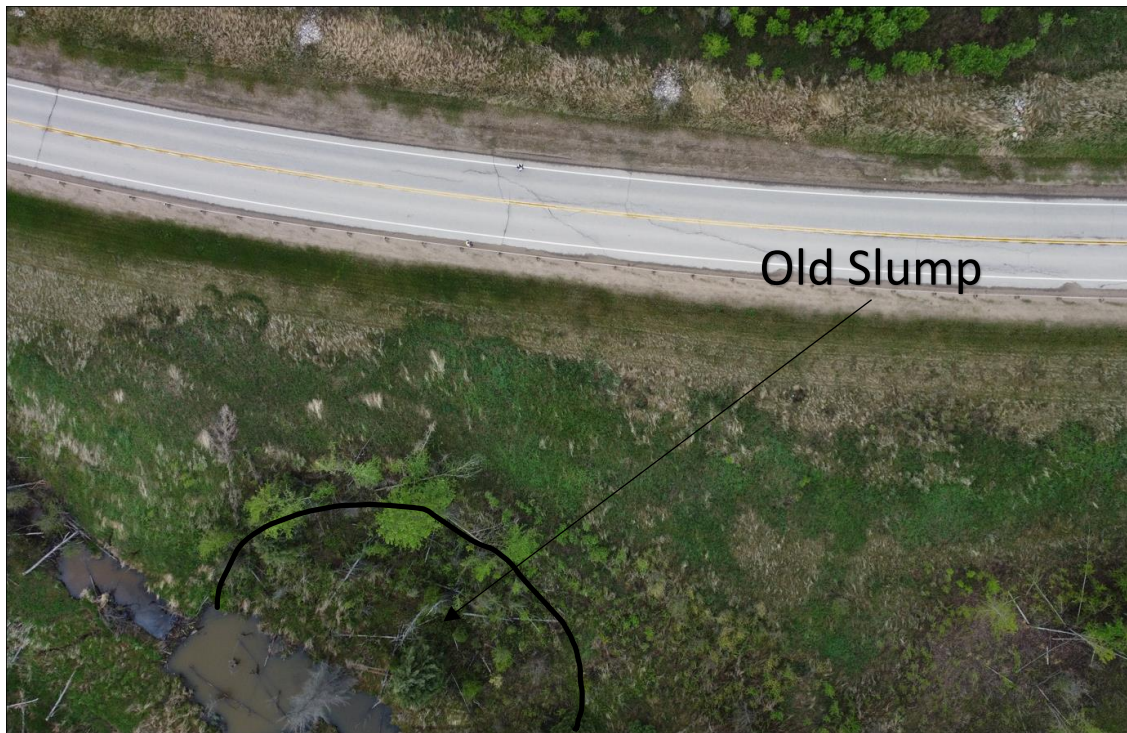
Photo No. 8 – Close up aerial photo showing Cracks B, C, and D above a steep area on the lower portion of the side slope where a retrogressive old slumping ( possibly a remnant of original creek bank) with tilting trees and exists above the creek channel

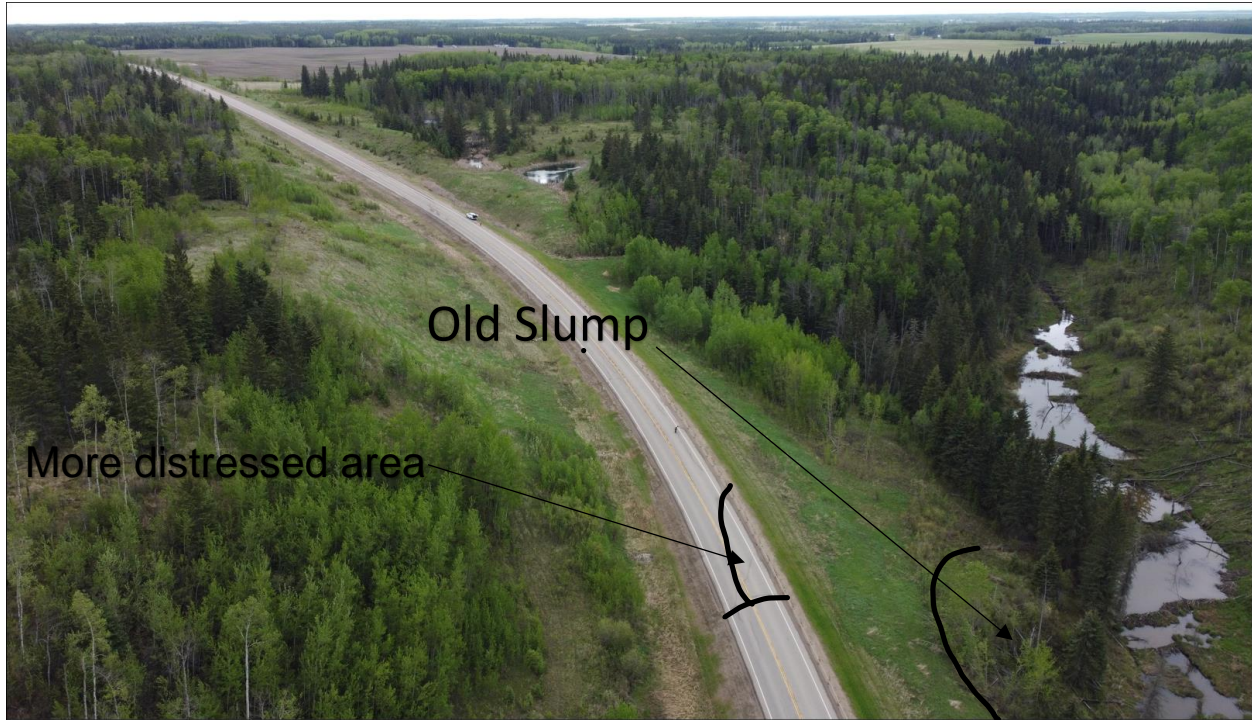
Photo No. 9 – Aerial photo looking south showing overall site features. Backslope does not show signs of slope movement. The more prominent cracks on the highway are located above an old slump on the bottom right corner of the photo. Note the presence of at least five beaver dams within the creek channel.

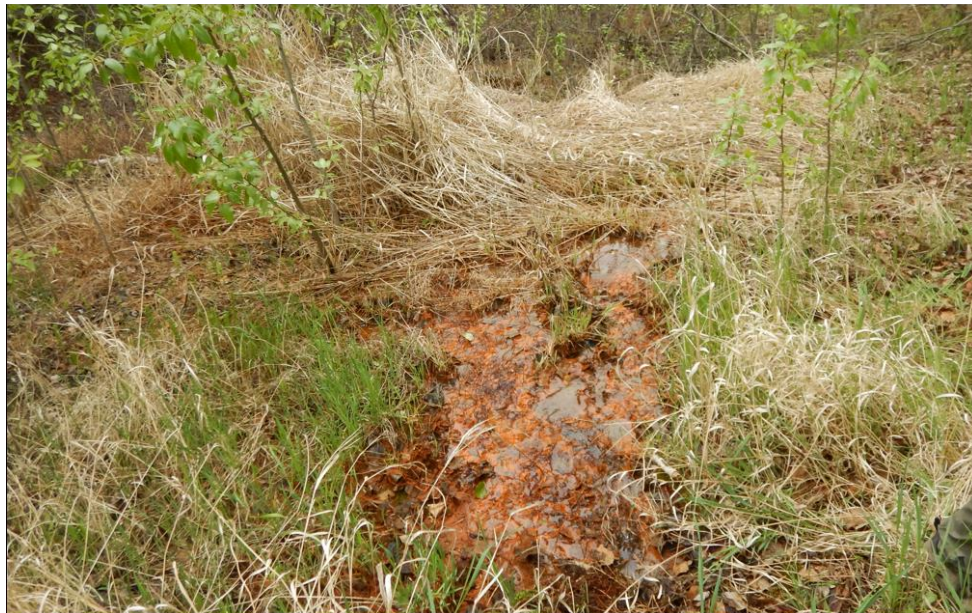
Photo No.10 – Rusty water flowing out of Subdrain 7 outlet

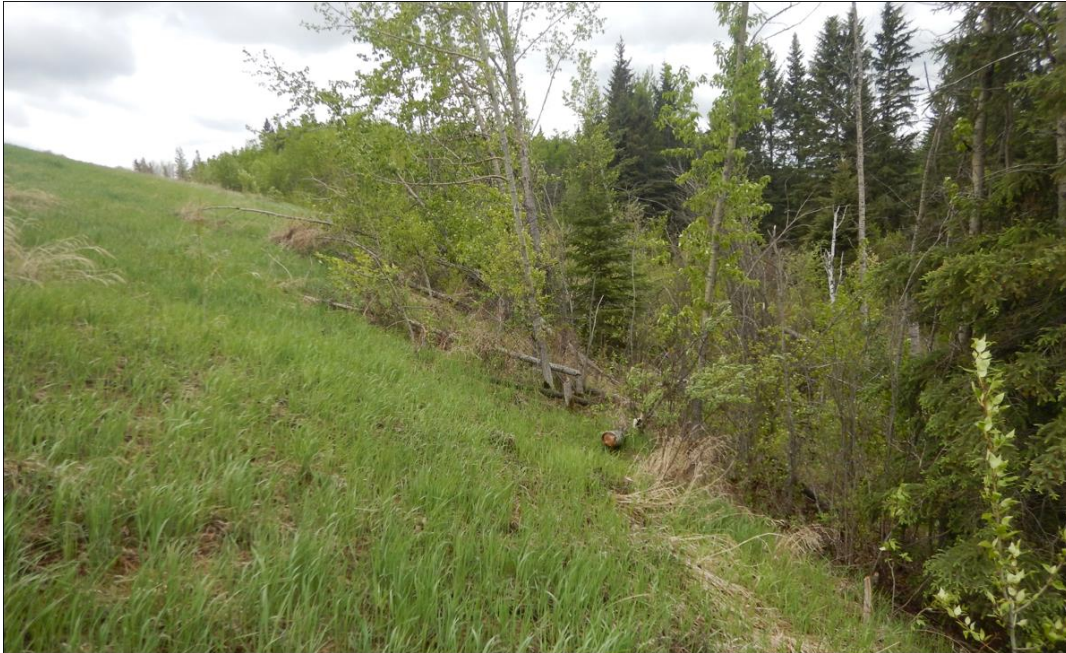
Photo No.11 – Tilting trees and deadfall downslope of the most distressed area on the highway surface (i.e. location of old slump above creek channel).
