GEOHAZARD ASSESSMENT PROGRAM
NORTH CENTRAL REGION – ATHABASCA
2010 INSPECTION

Site Number	Location	Name	Hwy	km
NC 6	11 km E. of Slave Lake	Mitsue Lake	2:46	47.5
Legal Description		UTM Co-ordinates (NAD 83)		
NW-7-72-4-W5M		11 N 6177576	E 664053

FIGURE NC6-1A SITE PLAN
NC6 - HWY2:46 km 47.5 MITSUE LAKE
NW 7-72-4-W5M

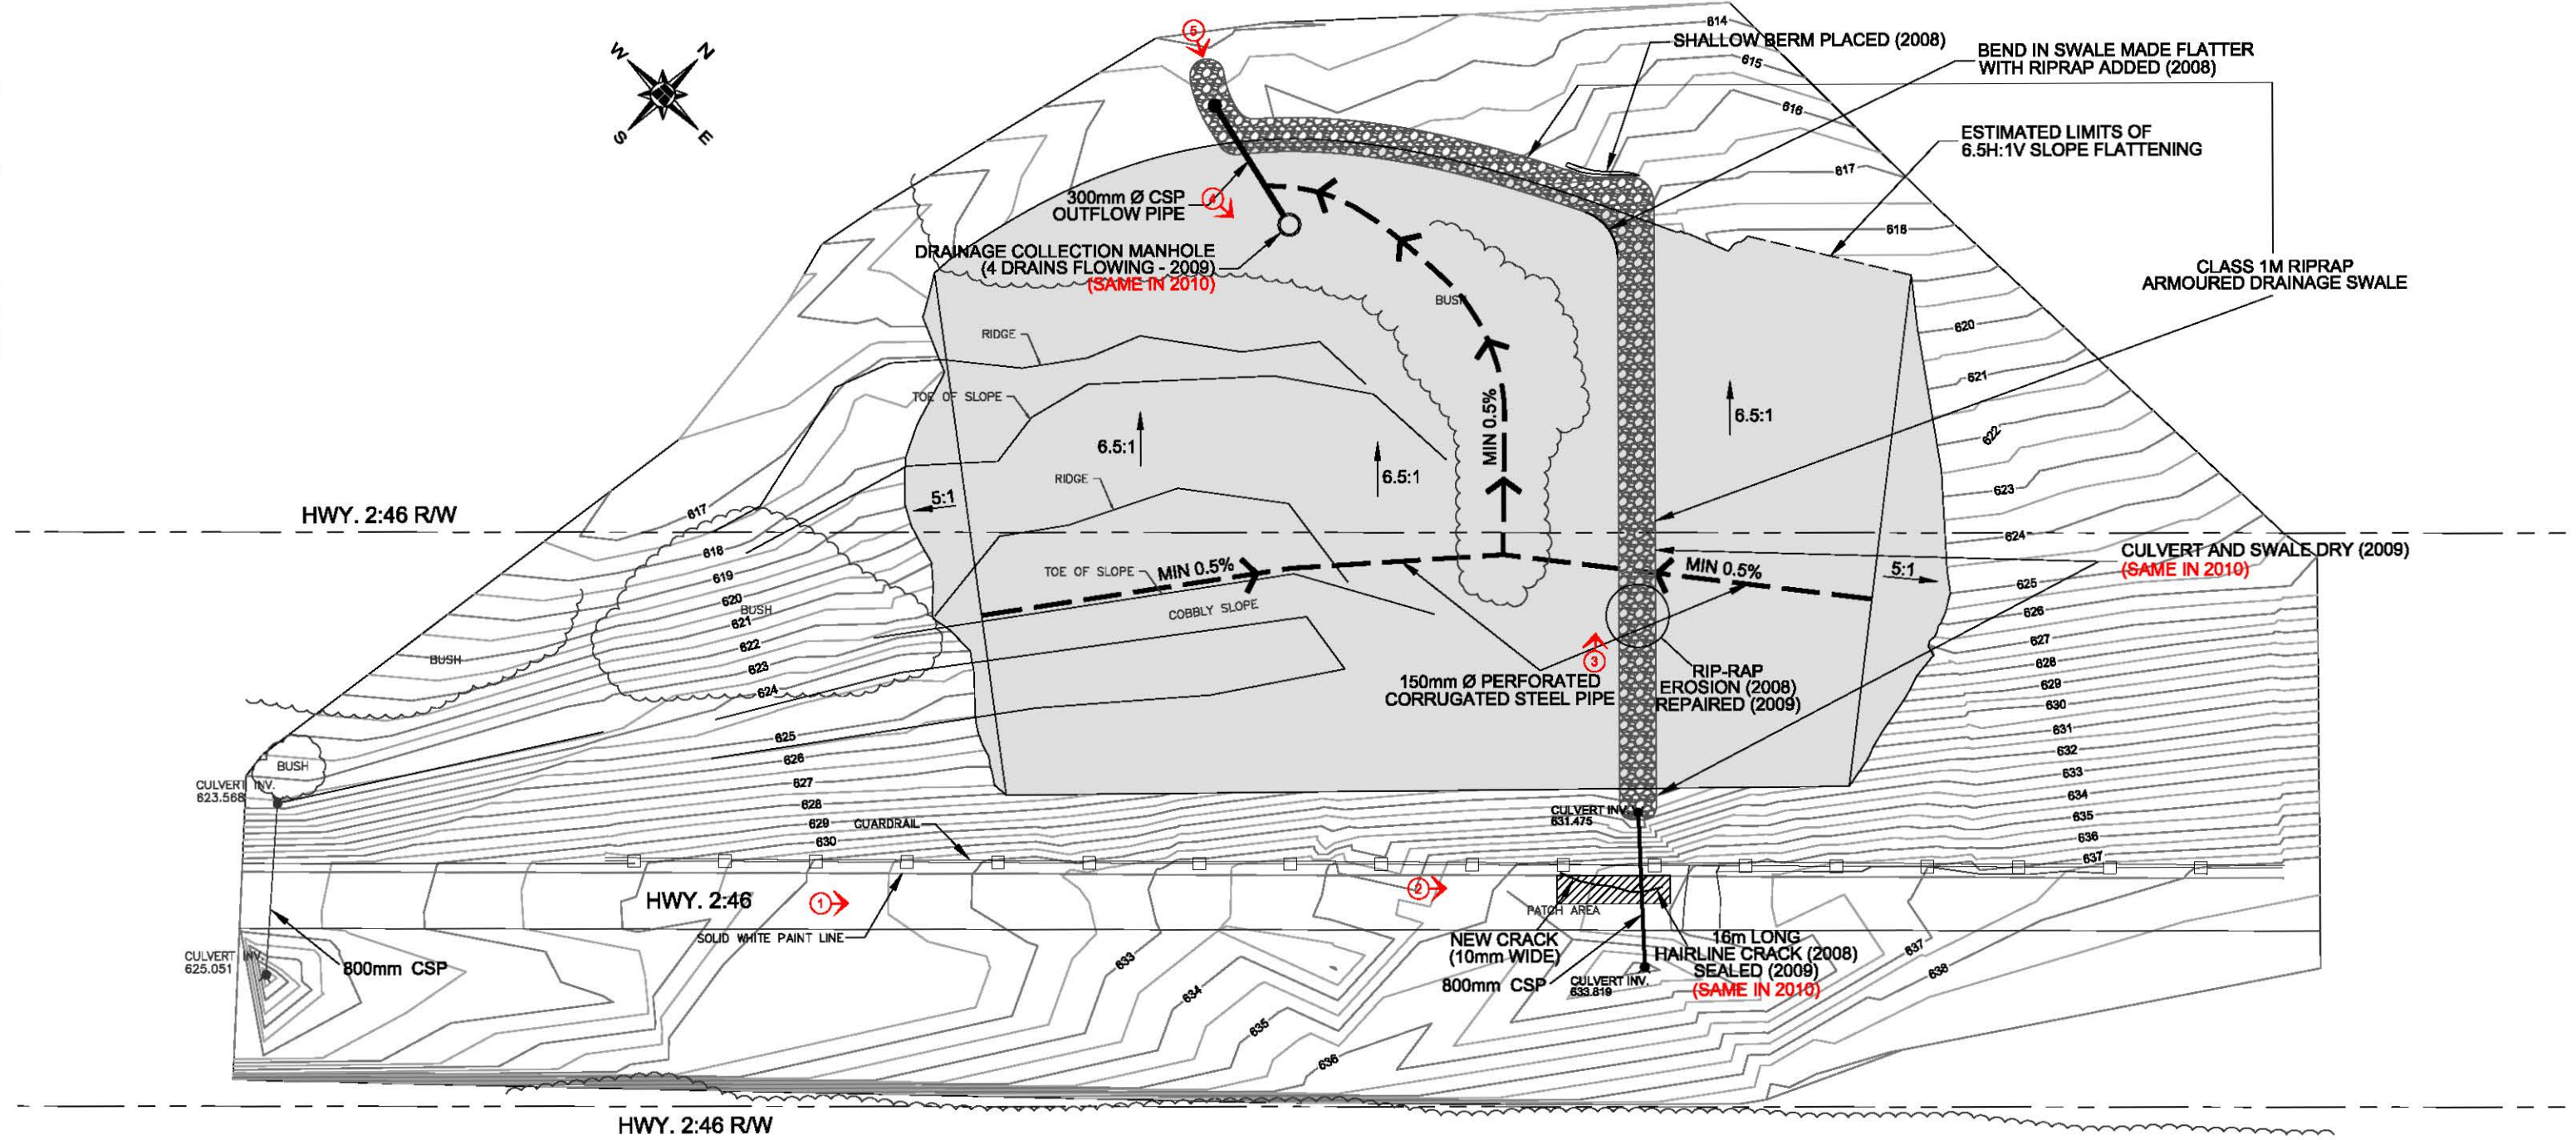
MAY 28, 2010 OBSERVATIONS ARE SHOWN IN RED

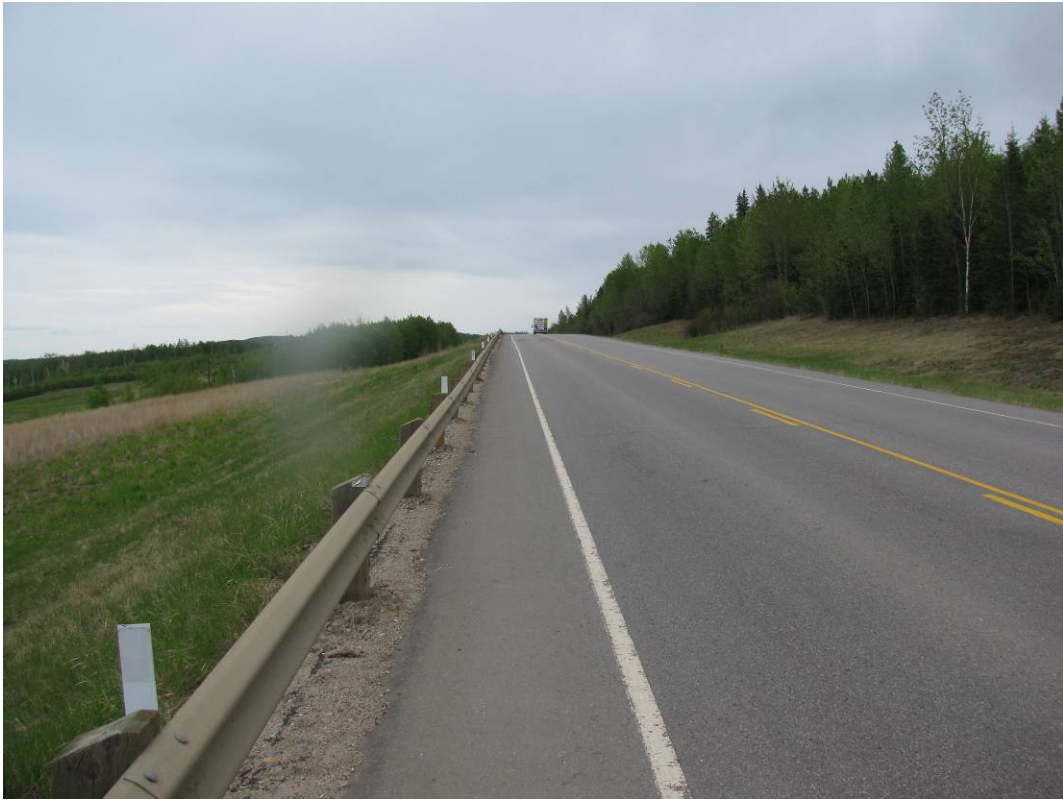
No signs of slope instability or pavement distress were noted during the site visit. The site observations and the instrument readings reflect the effectiveness of the implemented remedial measures.

Photo#1 General view of highway surface conditions, looking northeast

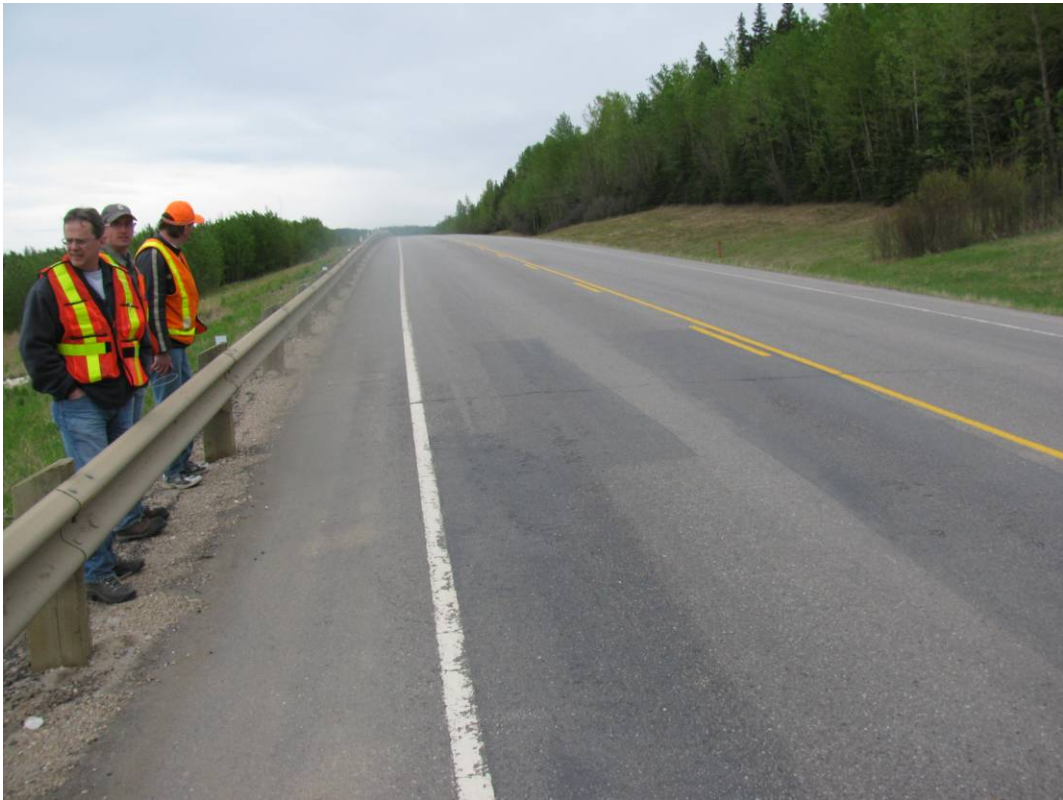
Photo#2 General view of the highway surface at the sealed crack location, looking northeast

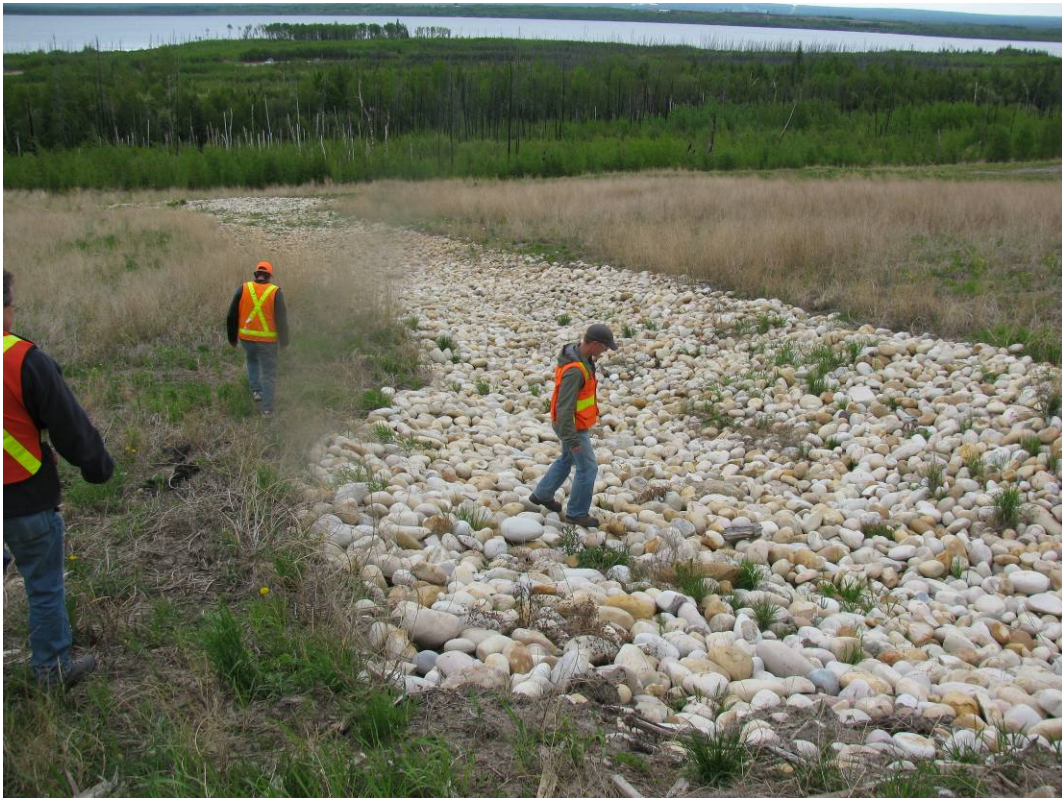
Photo#3 Looking towards the riprap-lined swale from the crest of the slope (looking west)

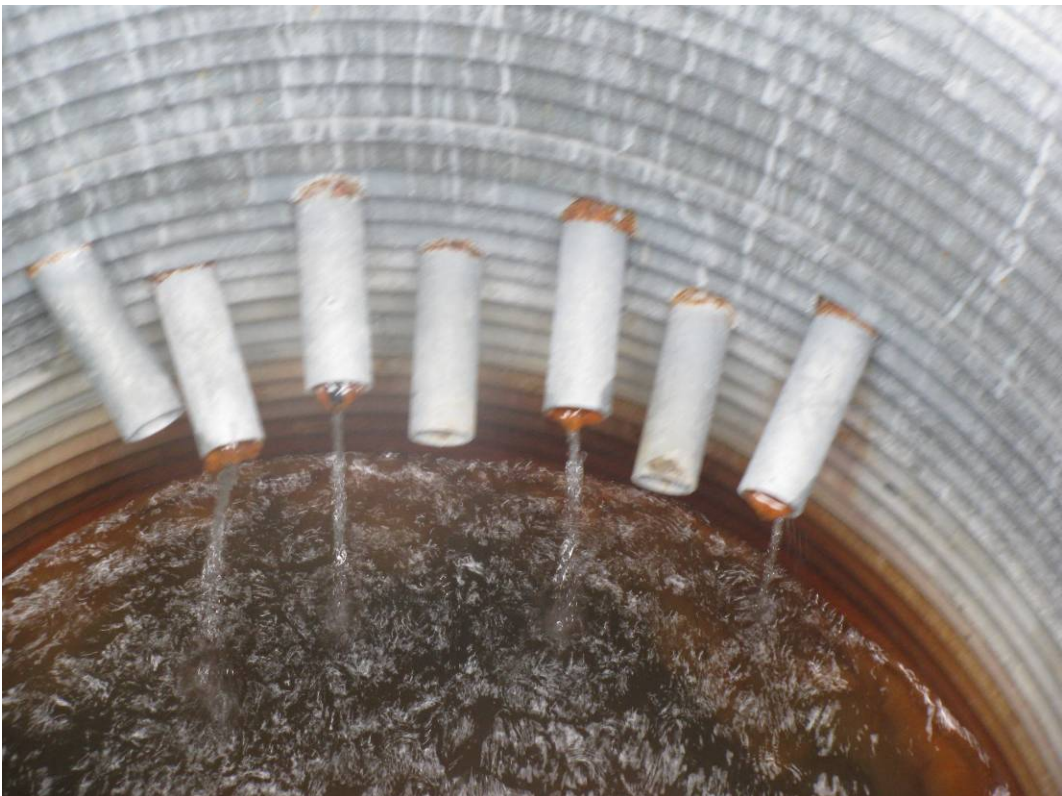
Since the implementation of the remedial measures, the operational slope inclinometers continued to show either creep movement or no discernable movement. The operational four sub-horizontal drains continued to yield flow. The water level inside the manhole raised by about 1.5 m compared to last year, presumably indicating that the flow rates increased significantly since our last site inspection in 2008.

Photo#4 Looking inside the drainage collection manhole

A Standard Alberta Transportation's lock was used to tie down the manhole lid.

The MCI should watch for any signs of movement and particularly after heavy precipitation events. We also recommend that the local MCI undertake a periodic inspection of the drains inside the manhole. If the flowing drains become plugged and dry in the future, it will be necessary to flush these drains to avoid the probably of raising ground water levels within the repaired slope area. The standpipe water levels will provide another indication of the ongoing effectiveness of the drains.

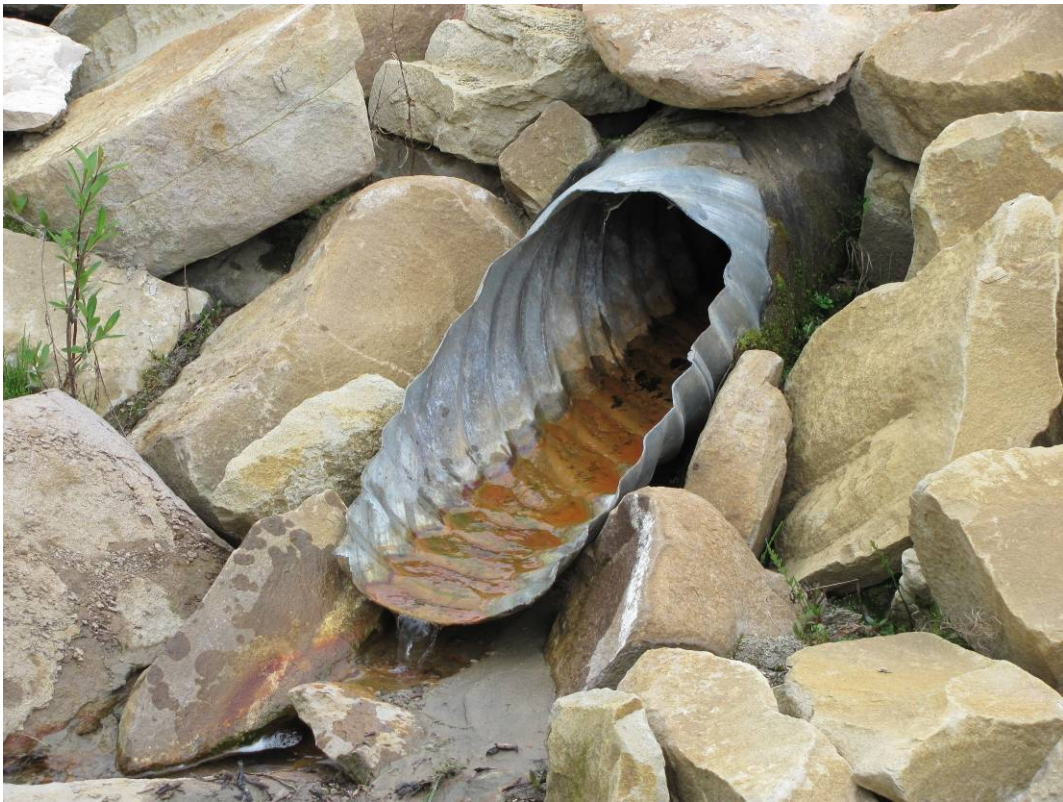
Photo#5 Looking at the outlet flow pipe from the bottom of the slope
