GEOHAZARD ASSESSMENT PROGRAM
NORTH CENTRAL REGION – ATHABASCA
2012 INSPECTION

Site Number	Location	Name	Hwy	km
NC 6	11 km E. of Slave Lake	Mitsue Lake	2:46	47.5
Legal Description		UTM Co-ordinates (NAD 83)		
NW-7-72-4-W5M		11 N 6177576	E 664053

**NC6: HWY 2:46 MITSUE LAKE (km 47.5)
SITE PLAN**

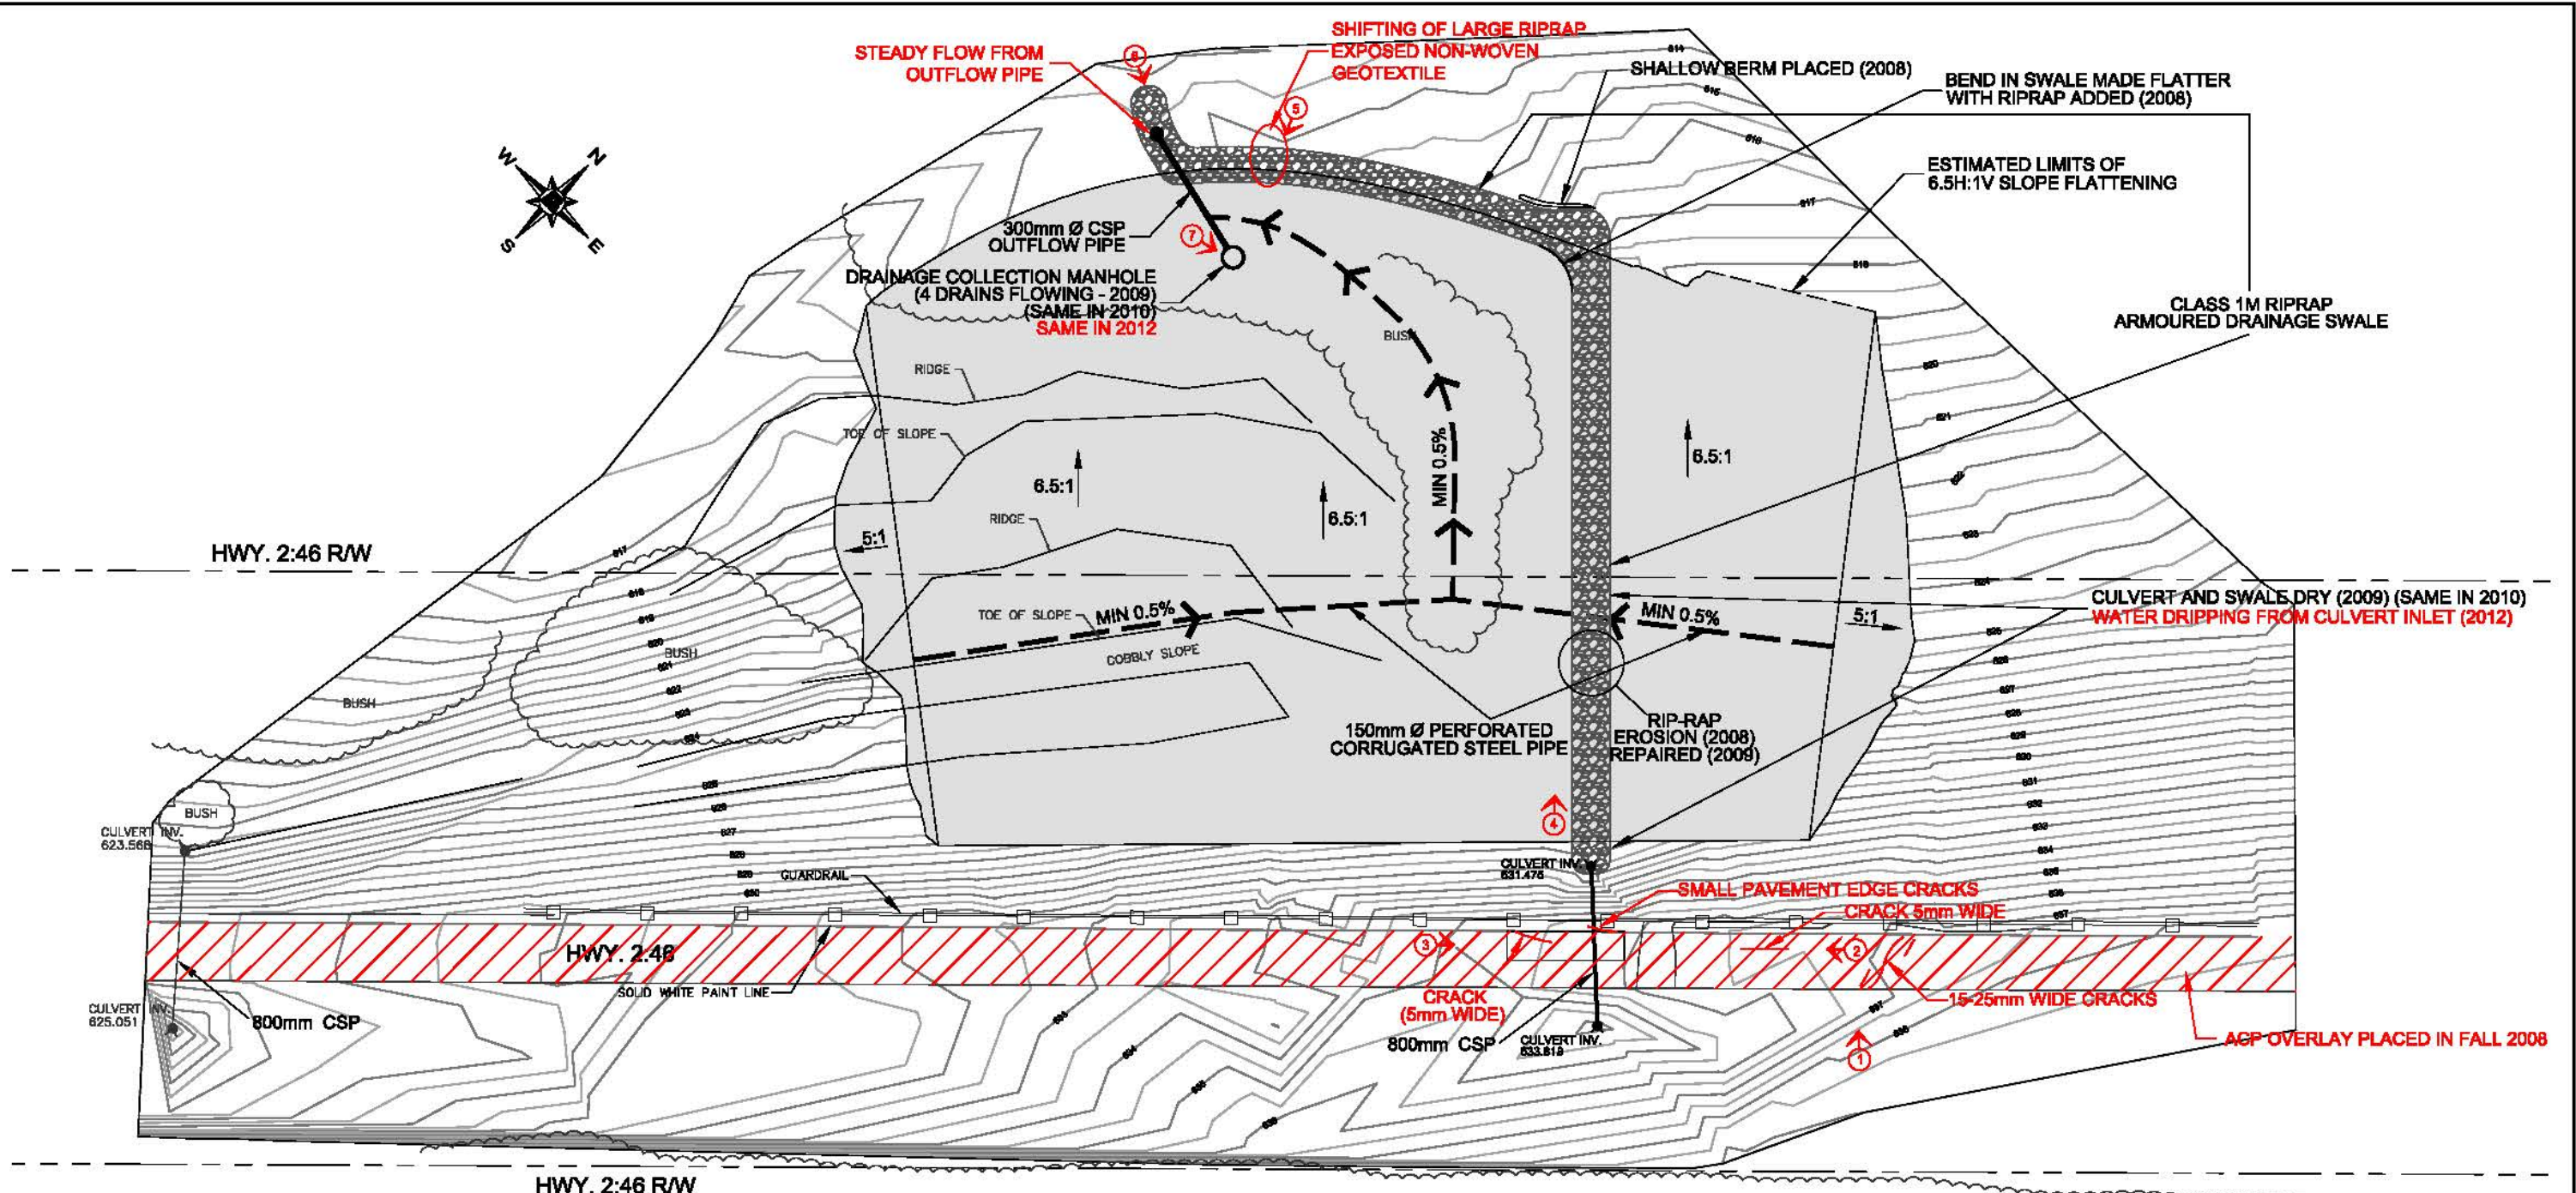
FIGURE NC6-1A

JUNE 11, 2012 OBSERVATIONS ARE SHOWN IN RED

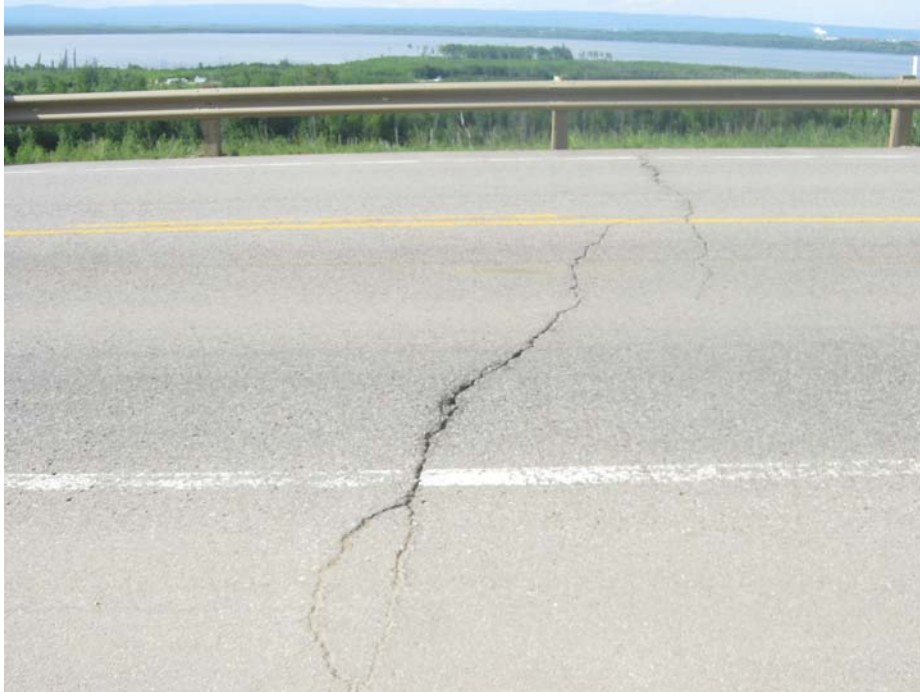
The site conditions have not changed since the 2010 site visit. A few reflective cracks were visible on the highway paved surface. The existing 15-25 mm wide diagonal cracks don't appear to be landslide-related cracks.

Photo#1 Looking northwest at a diagonal crack near the northeast limit of the site

The MCI should seal any open cracks and continue to watch for any signs of movement and particularly after heavy precipitation events. We also recommend that the local MCI undertake a periodic inspection of the drains inside the manhole. If the flowing drains become plugged and dry in the future, it will be necessary to flush these drains to reduce the probability of raising ground water levels within the repaired slope area. The standpipe water levels will provide another indication of the ongoing effectiveness of the drains.

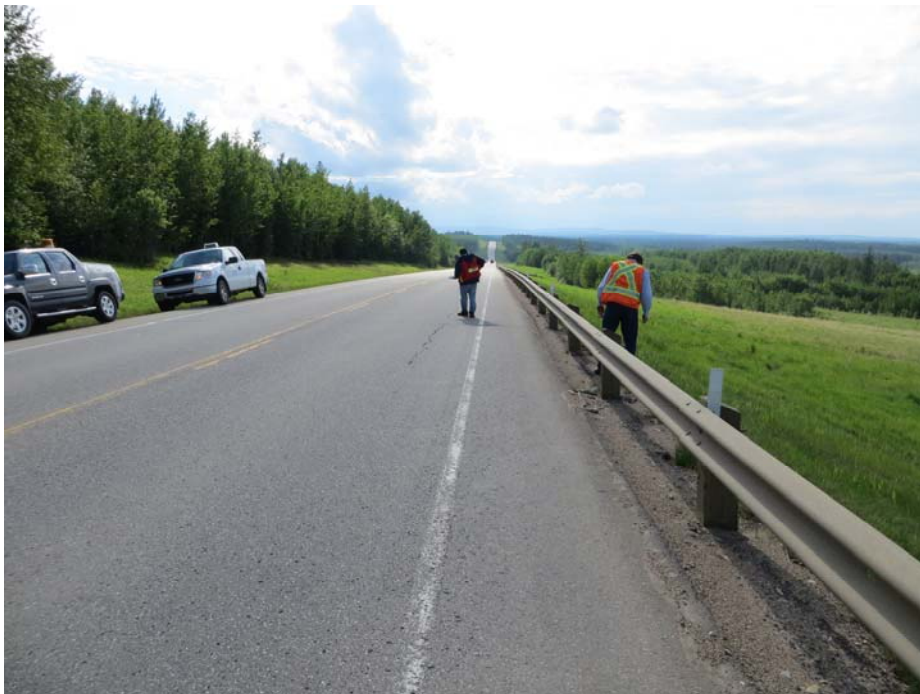
Photo#2 Looking northwest at a longitudinal reflective crack

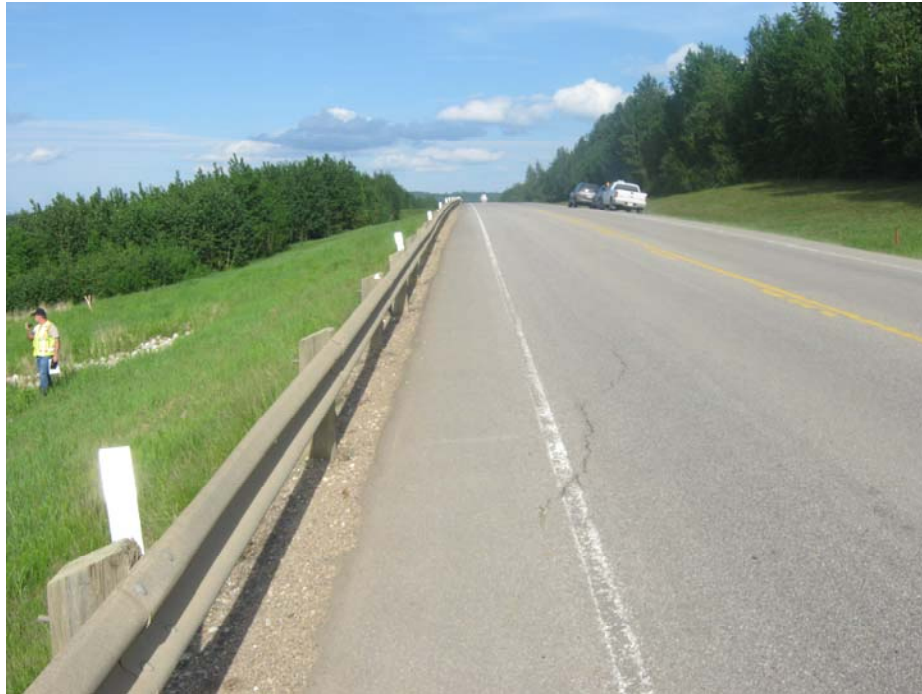
Photo#3 Looking northeast at a diagonal reflective crack

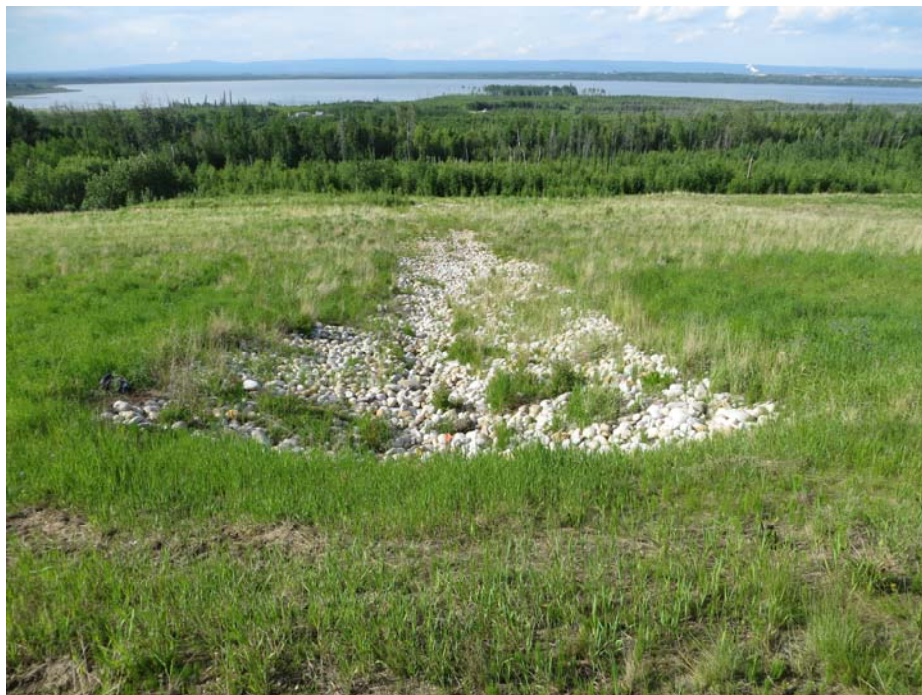
Photo#4 Looking towards the riprap-lined swale from the crest of the slope (looking west)

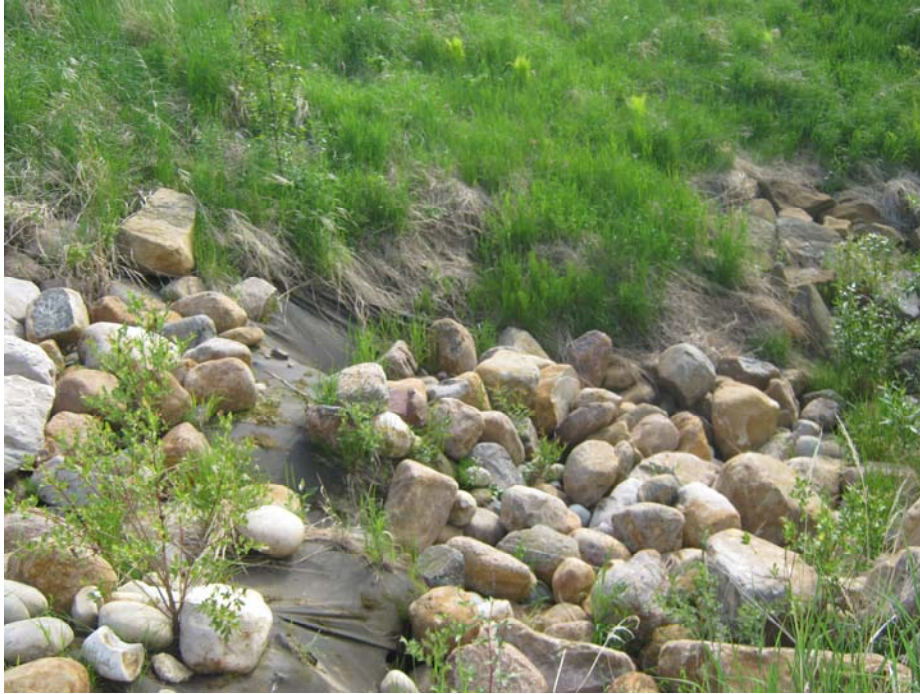
Photo#5 Exposed non-woven geotextile fabric below heavy rock riprap (looking south)

At the location where the riprap has been shifted, it is recommended to place additional riprap on the top of the exposed geotextile fabric to reduce the likelihood of future erosion.

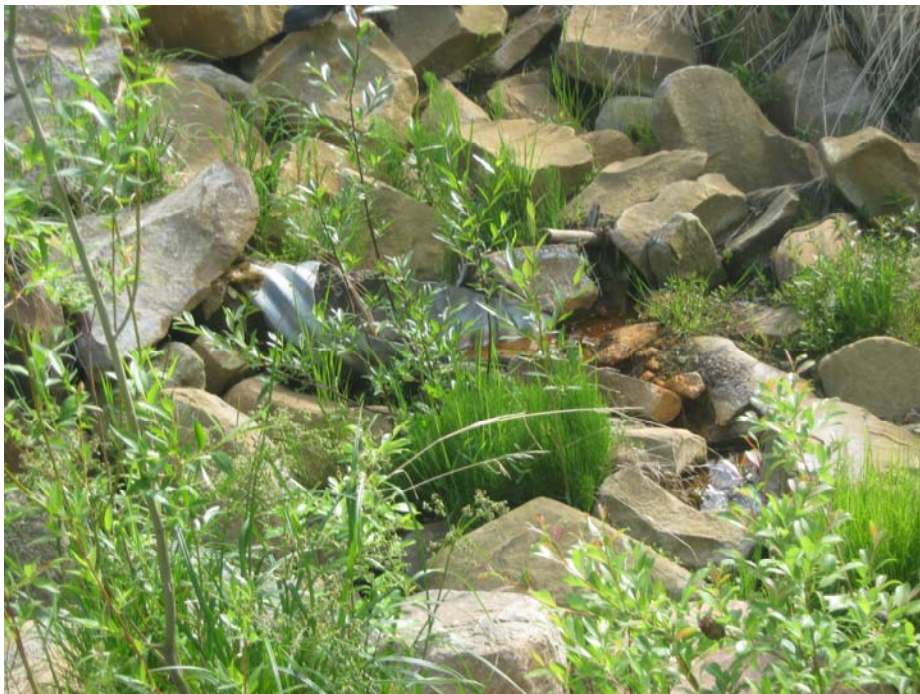
Photo#6 Looking at the outflow pipe from the bottom of the slope

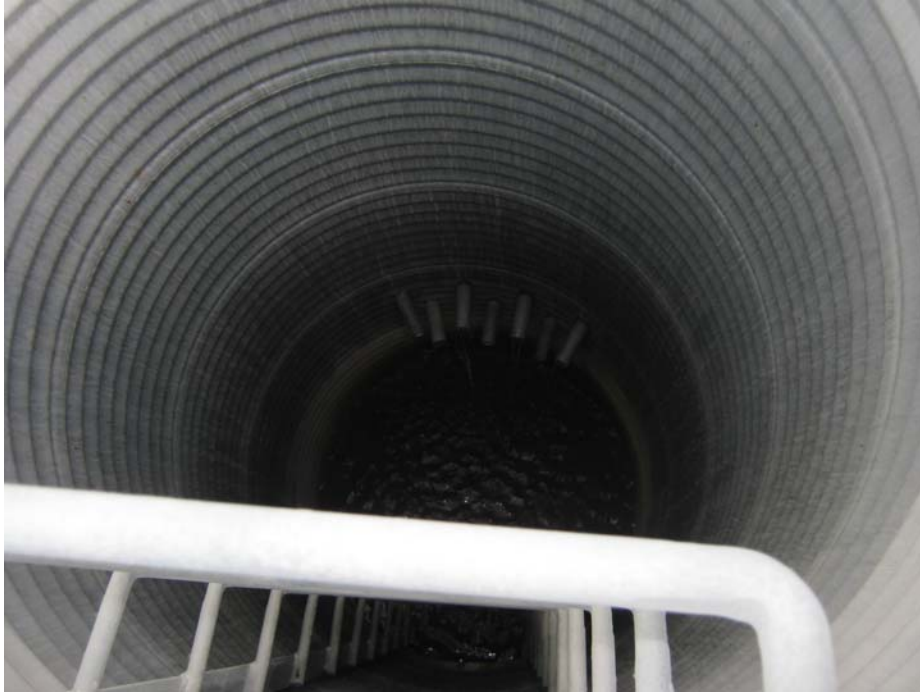
<input type="checkbox"/> Erosion		<input type="checkbox"/>
<input checked="" type="checkbox"/> Seepage	Four of the sub-horizontal drains were flowing into the manhole. Water was flowing steadily from the manhole outflow pipe.	<input type="checkbox"/>
<input type="checkbox"/> Bridge/Culvert Distress		<input type="checkbox"/>
<input checked="" type="checkbox"/> Other	To the east of the manhole outflow pipe, the heavy rock riprap in the swale shifted and exposed the underlying non woven geo-textile fabric	<input type="checkbox"/>
Instrumentation: (2SIs, 3 SPs)		
Rate of movement of 3.5 mm/yr in SI1 and 7.3 mm/yr in SI3. Water levels decreased or remained unchanged in all of the standpipe piezometers.

Photo#7 Looking inside the drainage collection manhole
