ALBERTA TRANSPORTATION NORTH CENTRAL REGION – ATHABASCA AREA INSTRUMENTATION MONITORING RESULTS

FALL 2020

SITE NC006-1: MITSUE RECREATION AREA

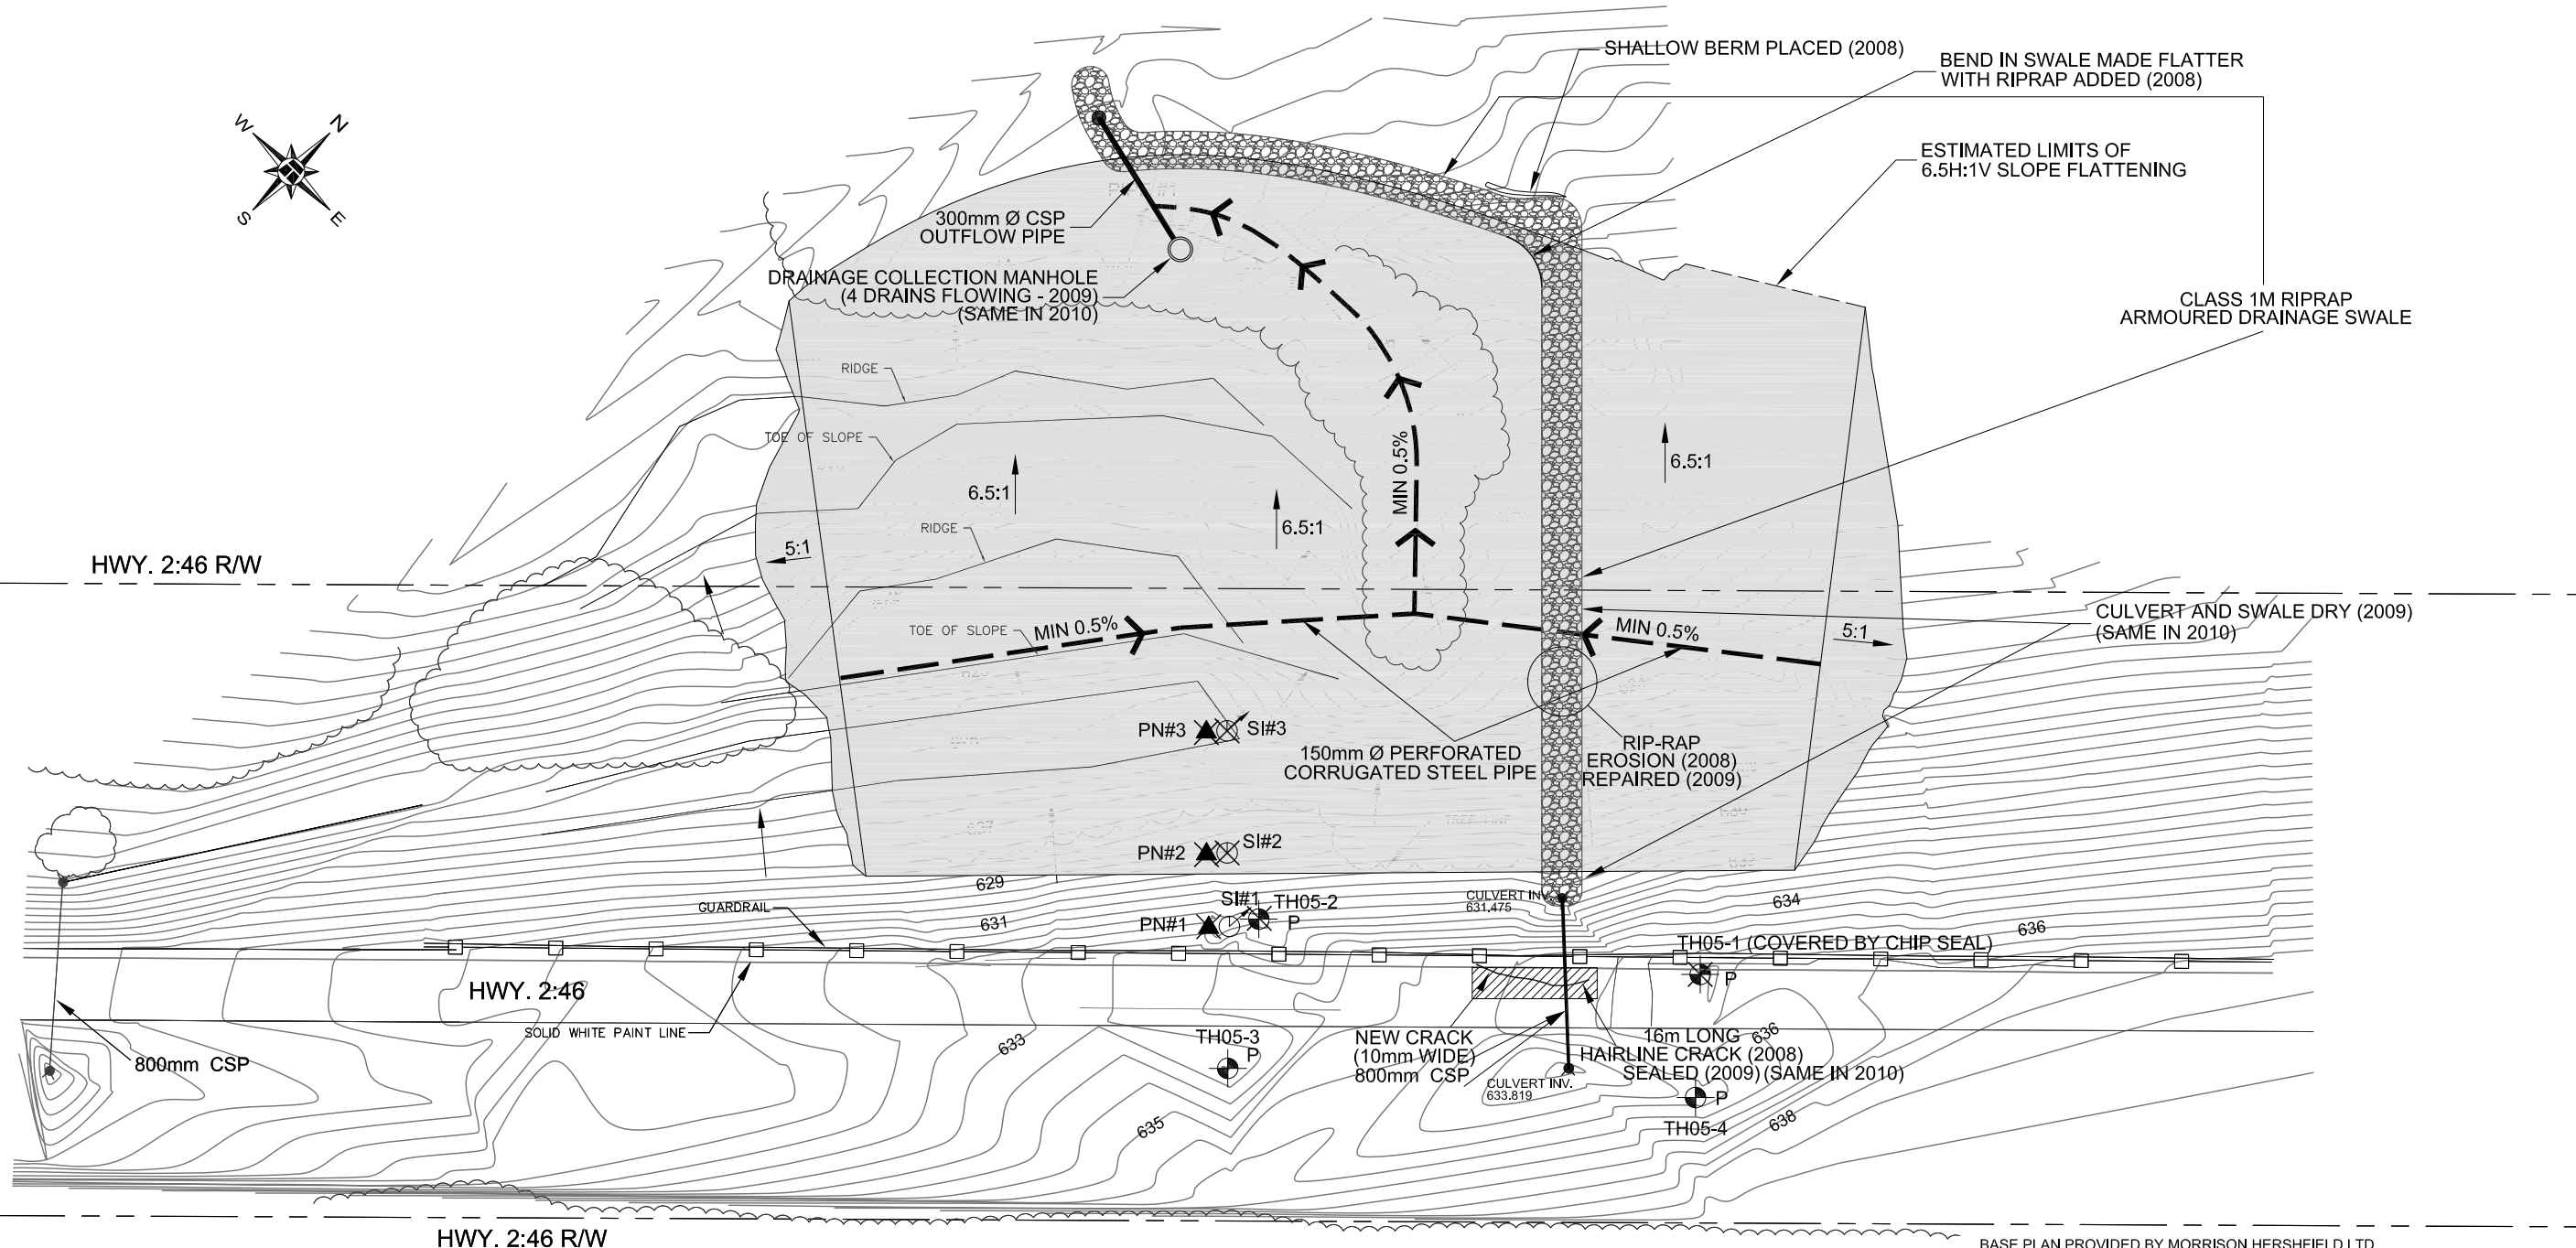
DWG No. 13357-NC006-1

Drawing 13357-NC006-1 in section D provides a sketch of the approximate location of the monitoring instrumentation for this site.
