**ALBERTA TRANSPORTATION AND
ECONOMIC CORRIDORS GRMP
NORTH CENTRAL (ATHABASCA AND FORT
McMURRAY DISTRICTS)
INSTRUMENTATION MONITORING- FALL 2024**

Site Number	Location	Name	Hwy	km
NC006	HWY 2:46 C1 47.6	Mitsue Lake Recreation Area	2:46	km 47.6
Legal Description: 9-12-72-5 W5		UTM Co-ordinates		
		11U E 651534	N	6122185

Current Monitoring:	18-Sep-2024	Previous Monitoring	14-Jun-2024
Instruments Read By:	Mr. Niraj Regmi, G.I.T and Mr. Nixson Mationg, of Thurber

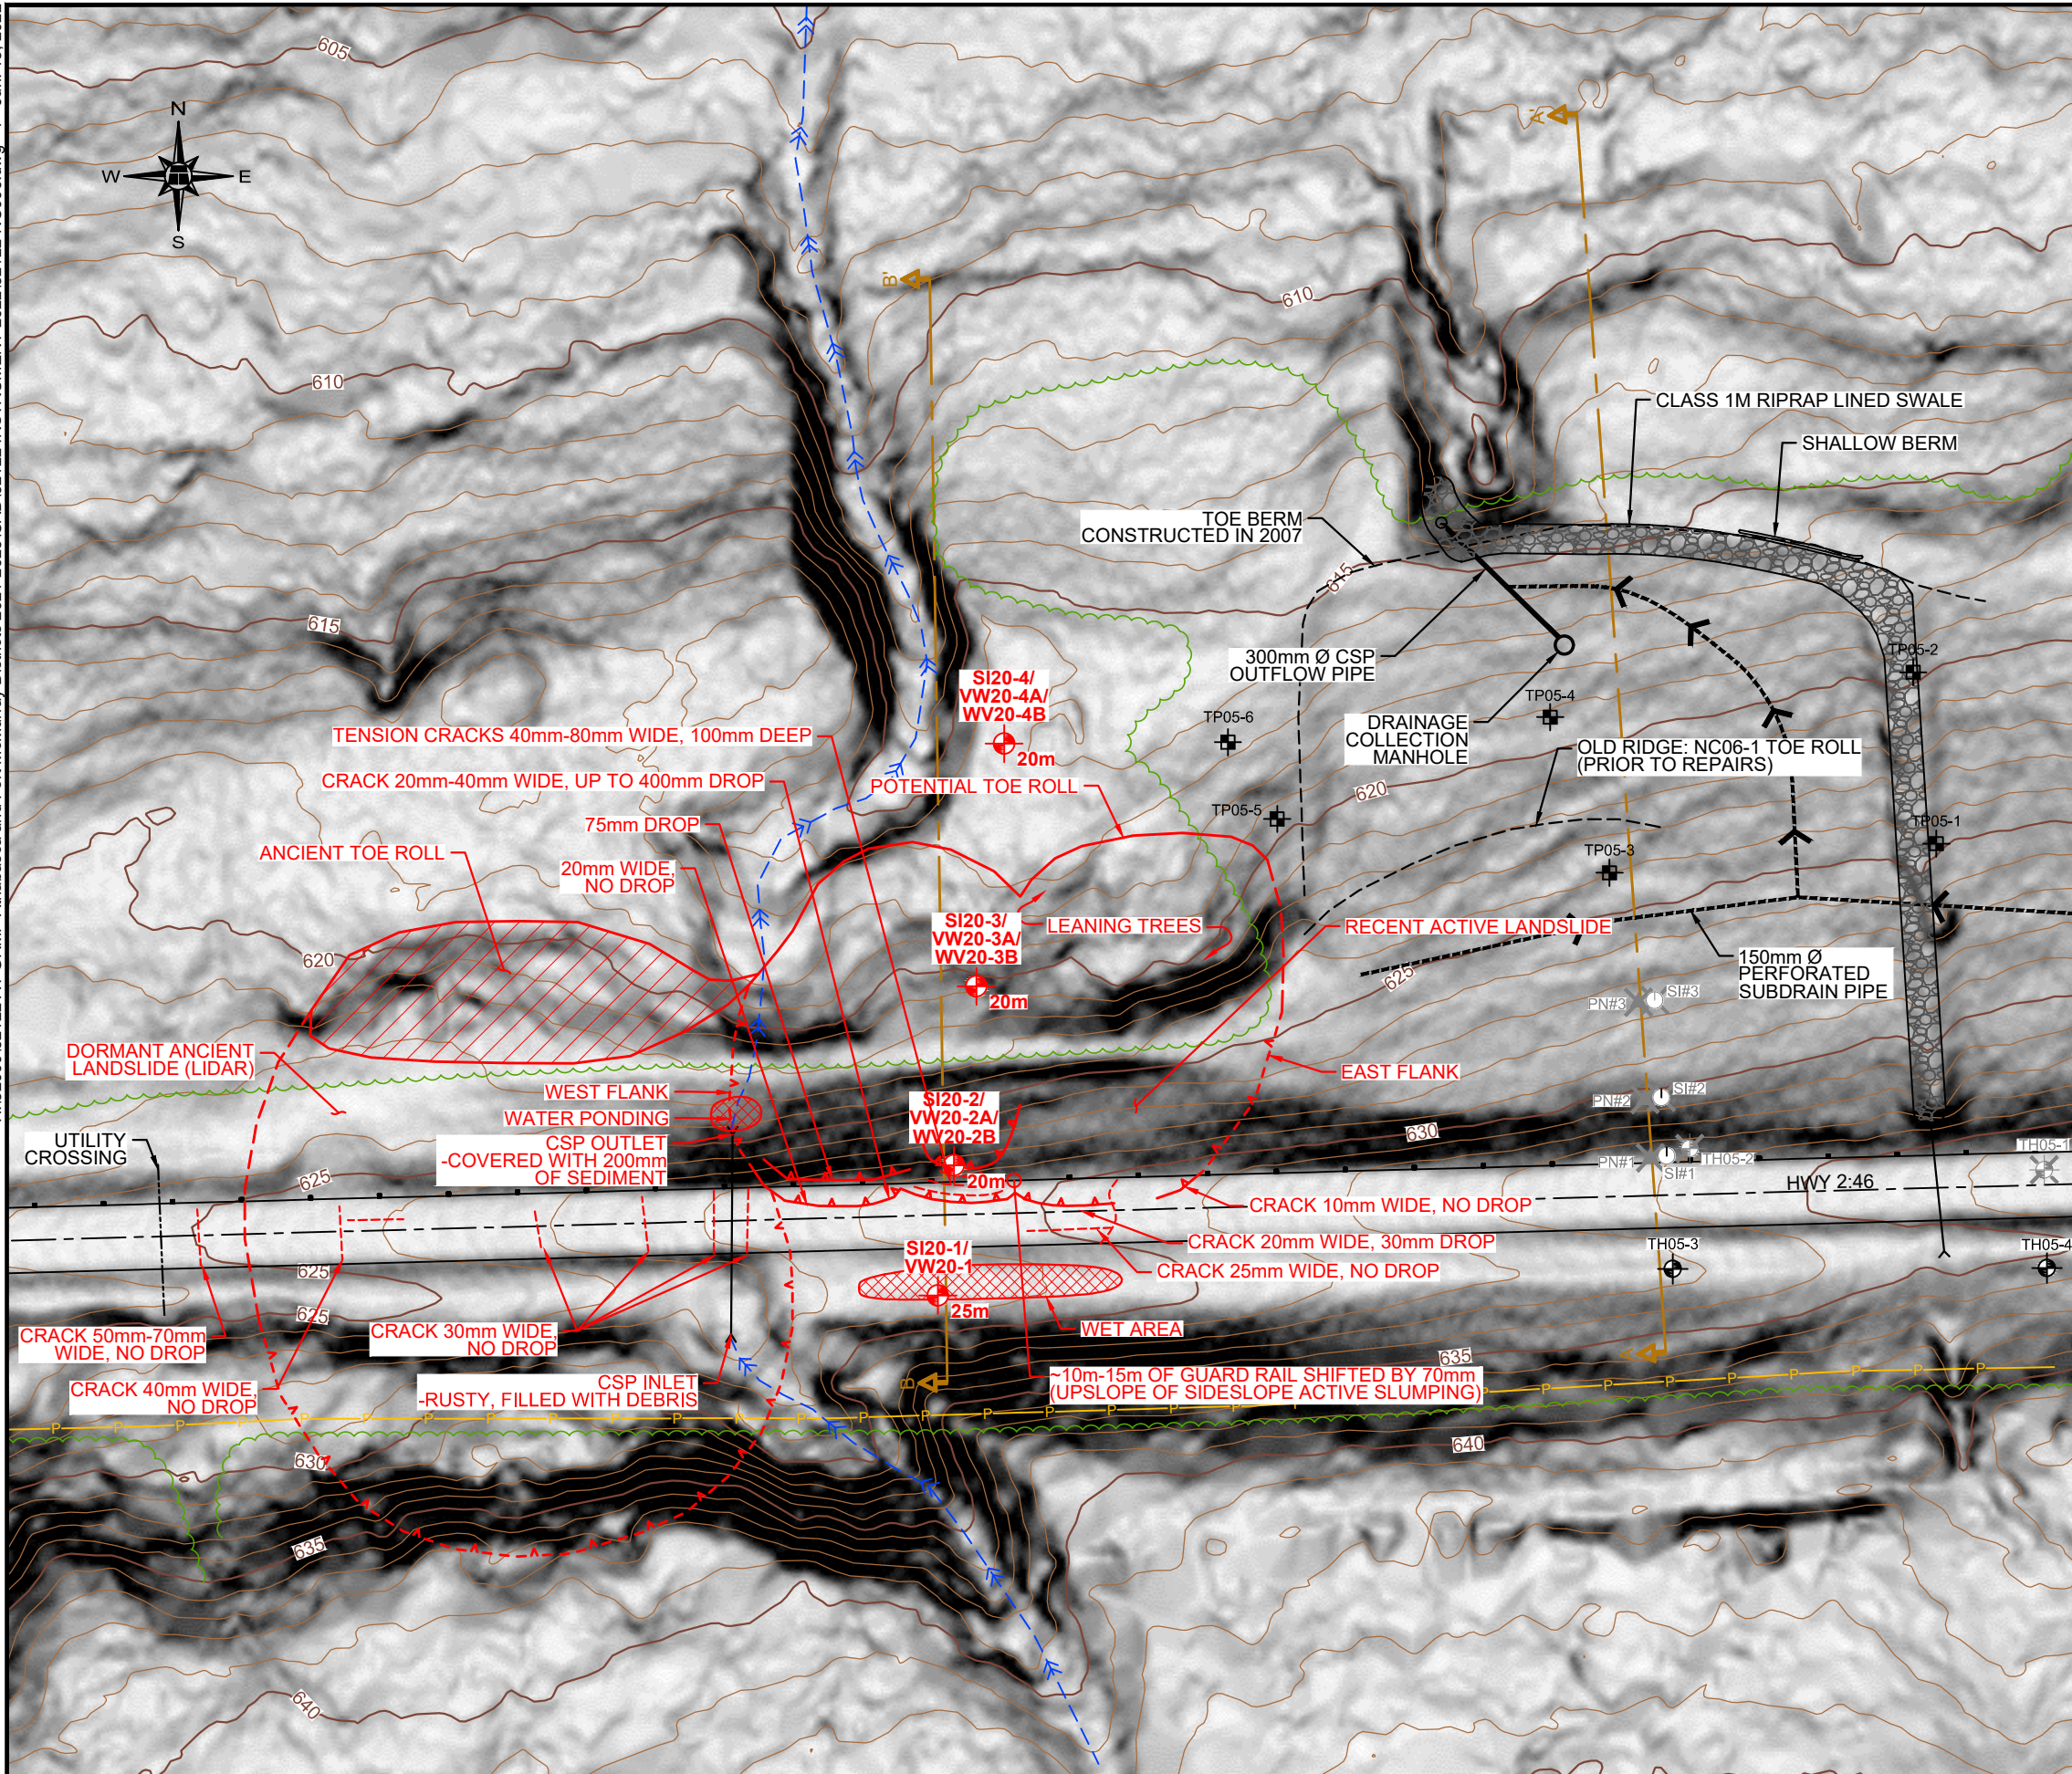
DWG No. 32122-NC006

**NC006 HWY 2:46 MITSUE LAKE (KM 47.6)
SITE PLAN SHOWING APPROXIMATE
INSTRUMENT LOCATIONS**

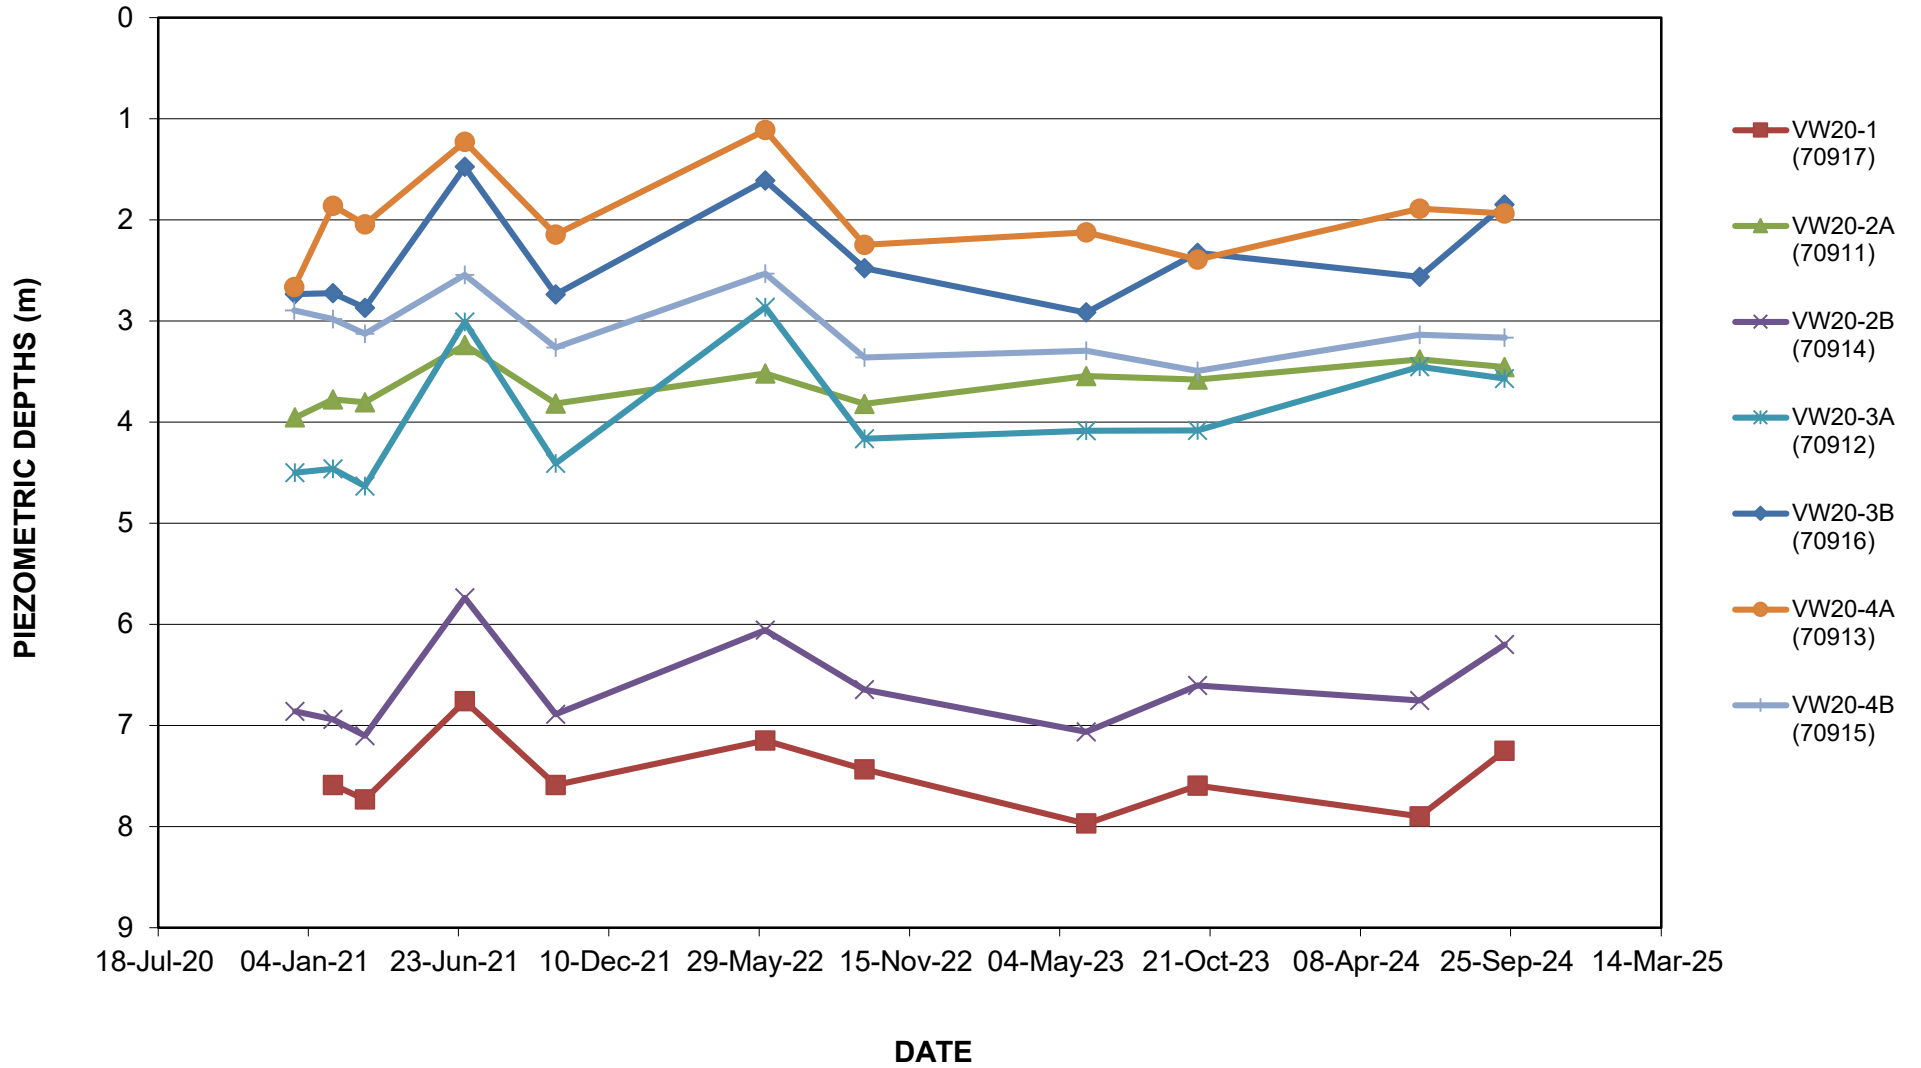
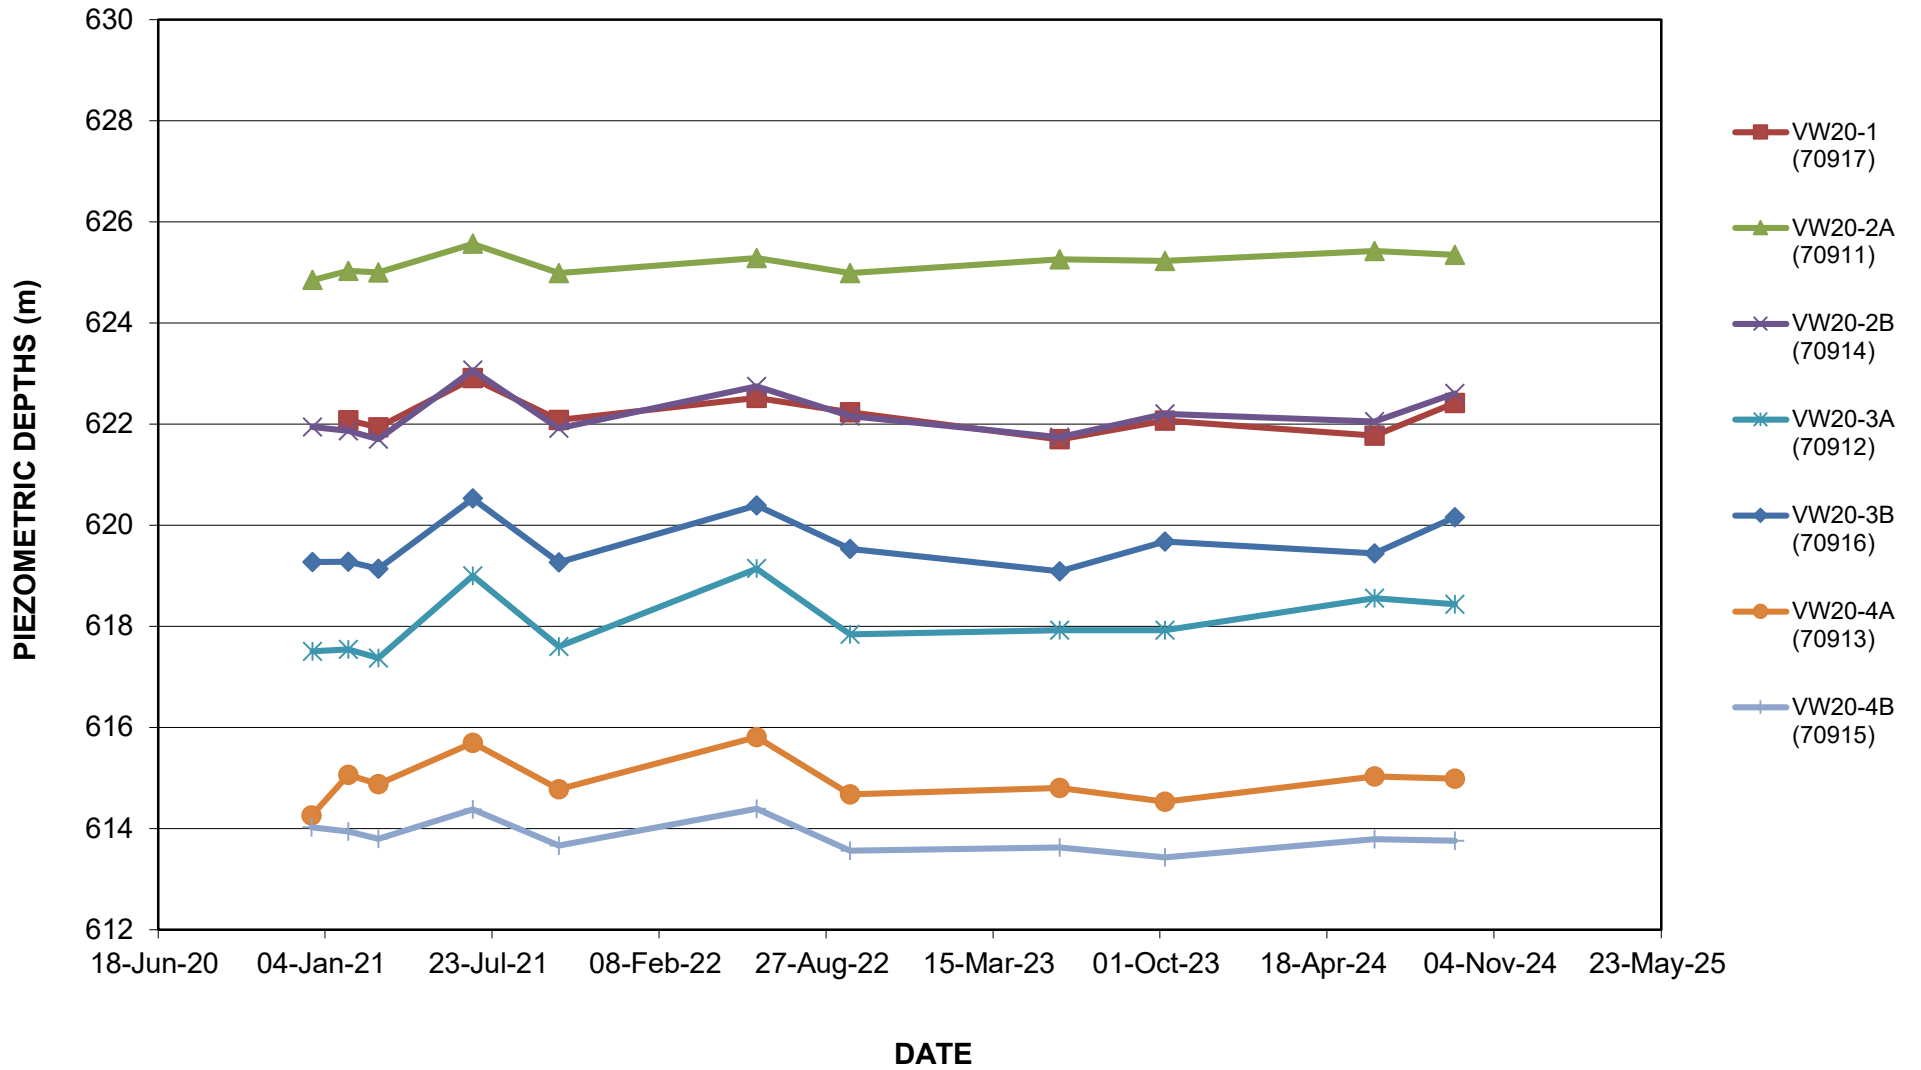
**FIGURE NC006-1
HWY 2:46 MITSUE LAKE SLIDE (KM 47.6)
VIBRATING WIRE PIEZOMETER DATA**

Overall, the measured groundwater levels are within the historically measured groundwater levels for the site.
Future Work:	The instruments should be read again in the spring of 2025.
Instrumentation Repairs:	No instrument repairs are required at this time.
Additional Comments:
