GEOHAZARD ASSESSMENT PROGRAM
NORTH CENTRAL REGION – ATHABASCA
2012 INSPECTION

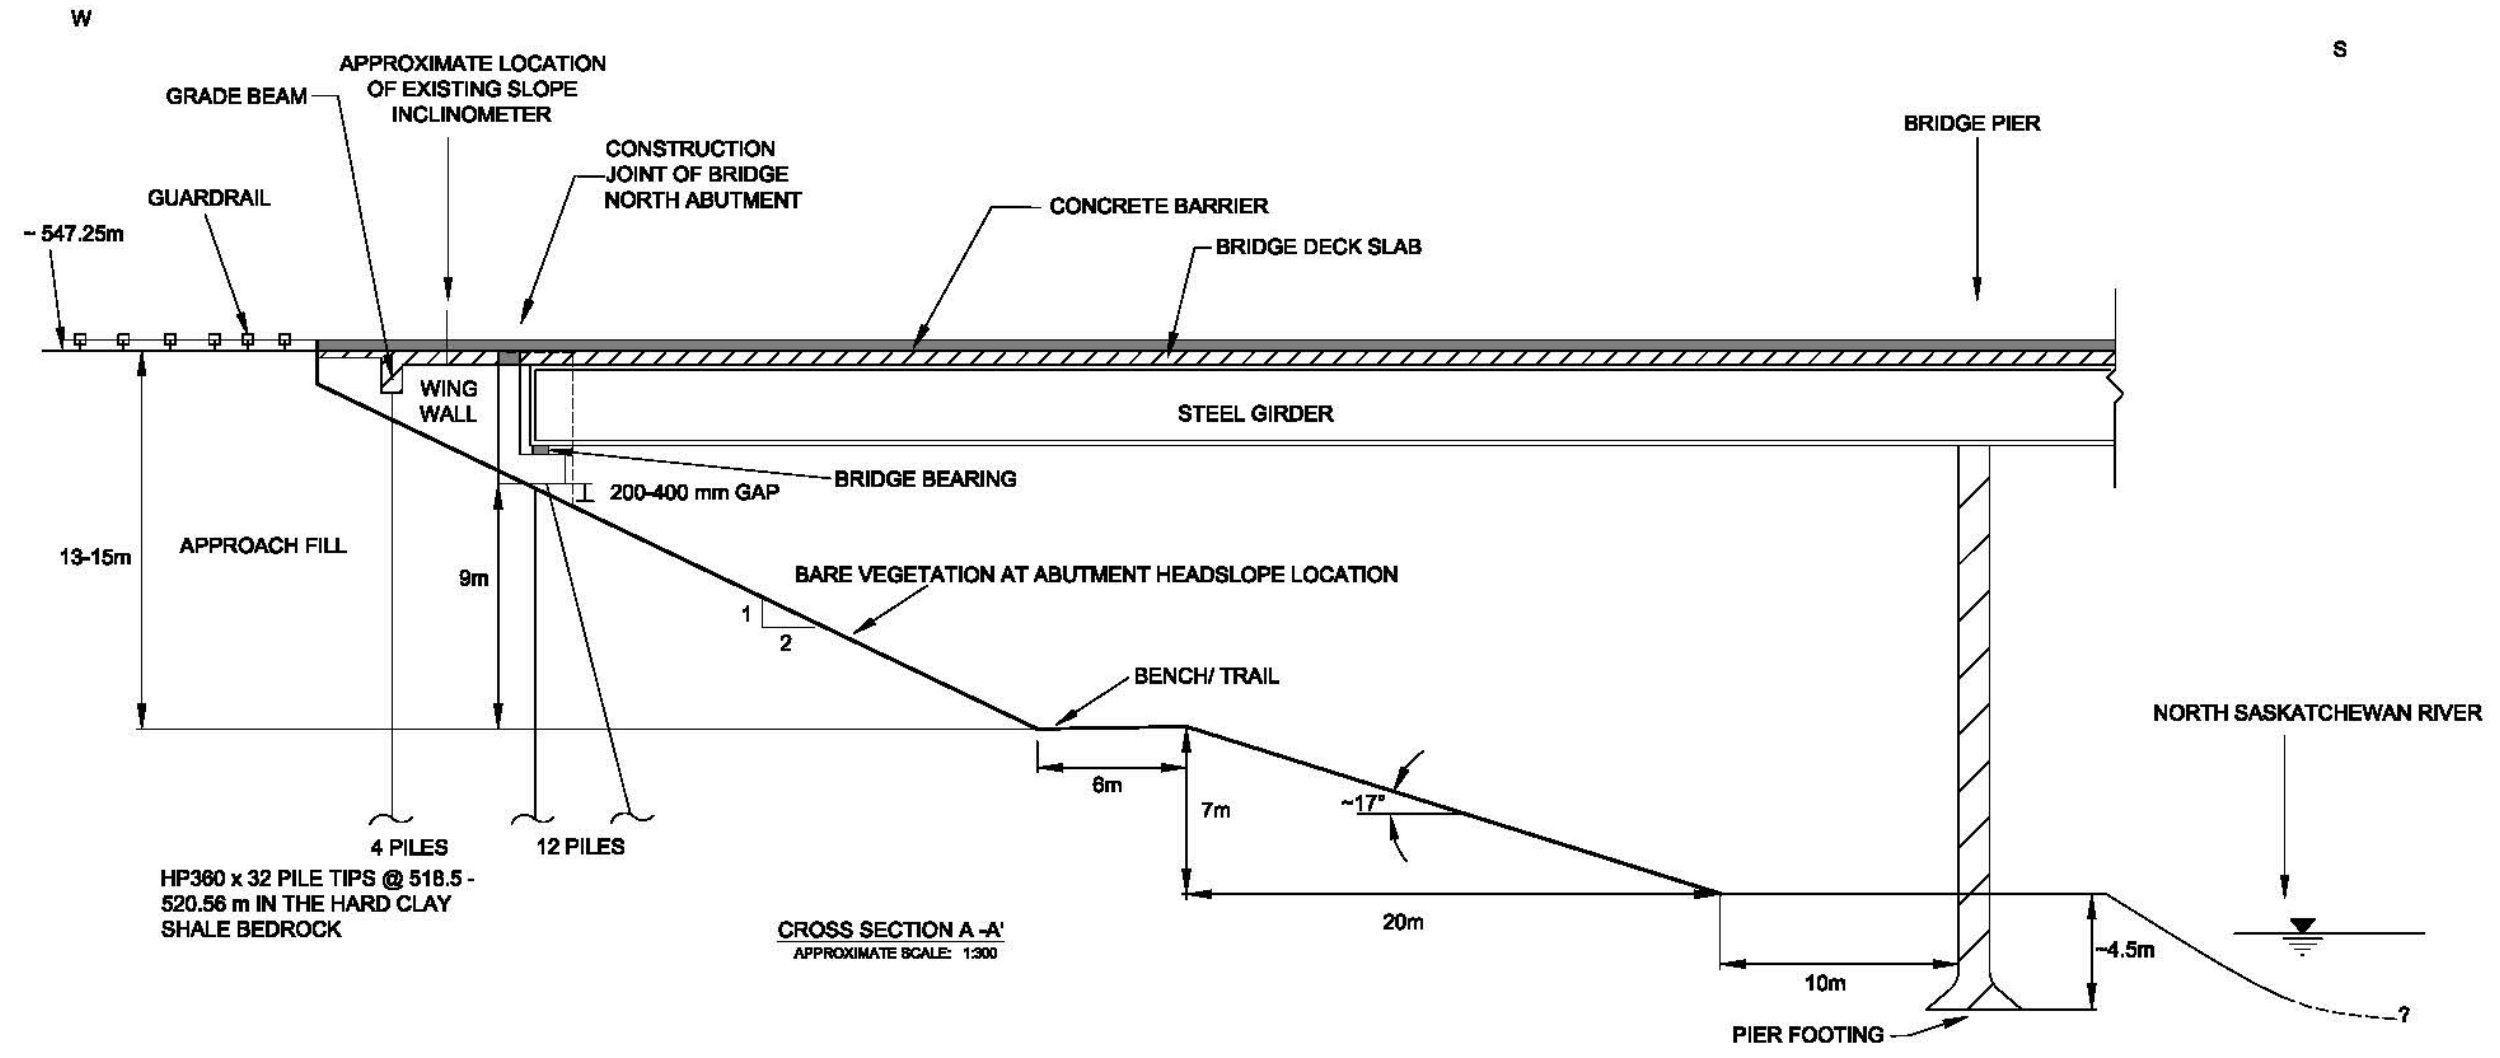
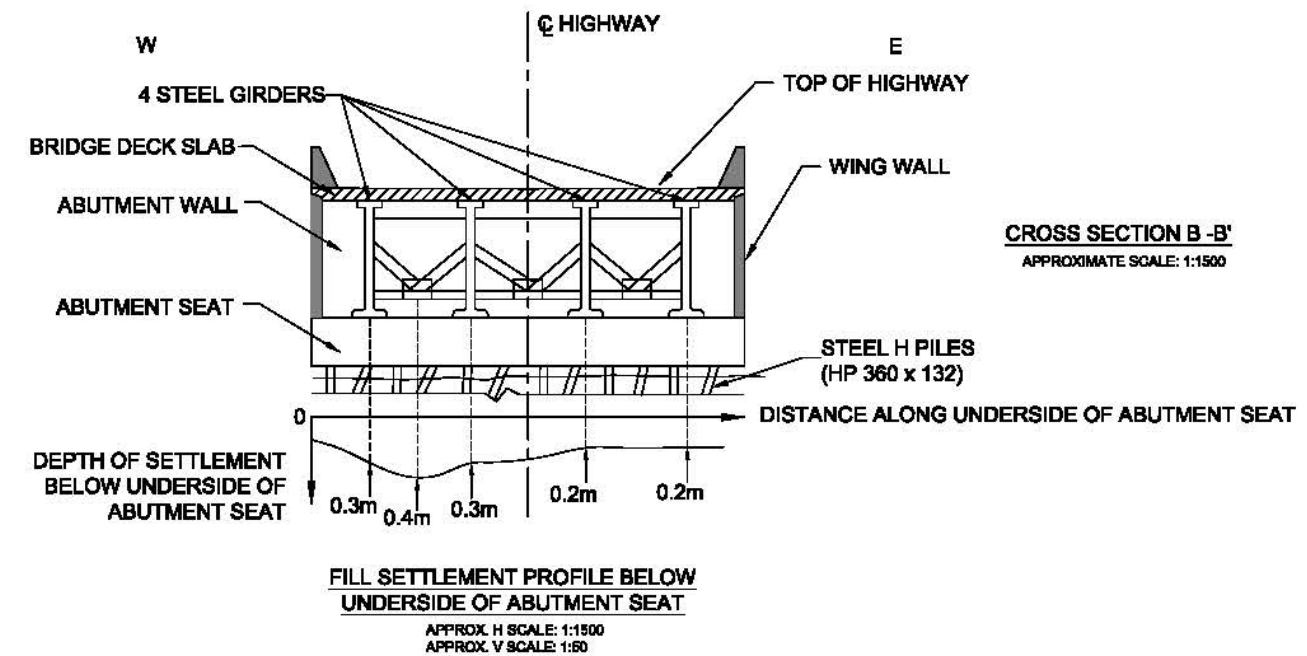
Recommendations:		
This site should be visited again next year to confirm the site observations. If the site condition remains unchanged next year, the subsequent site inspection visit could be deferred for a few years.

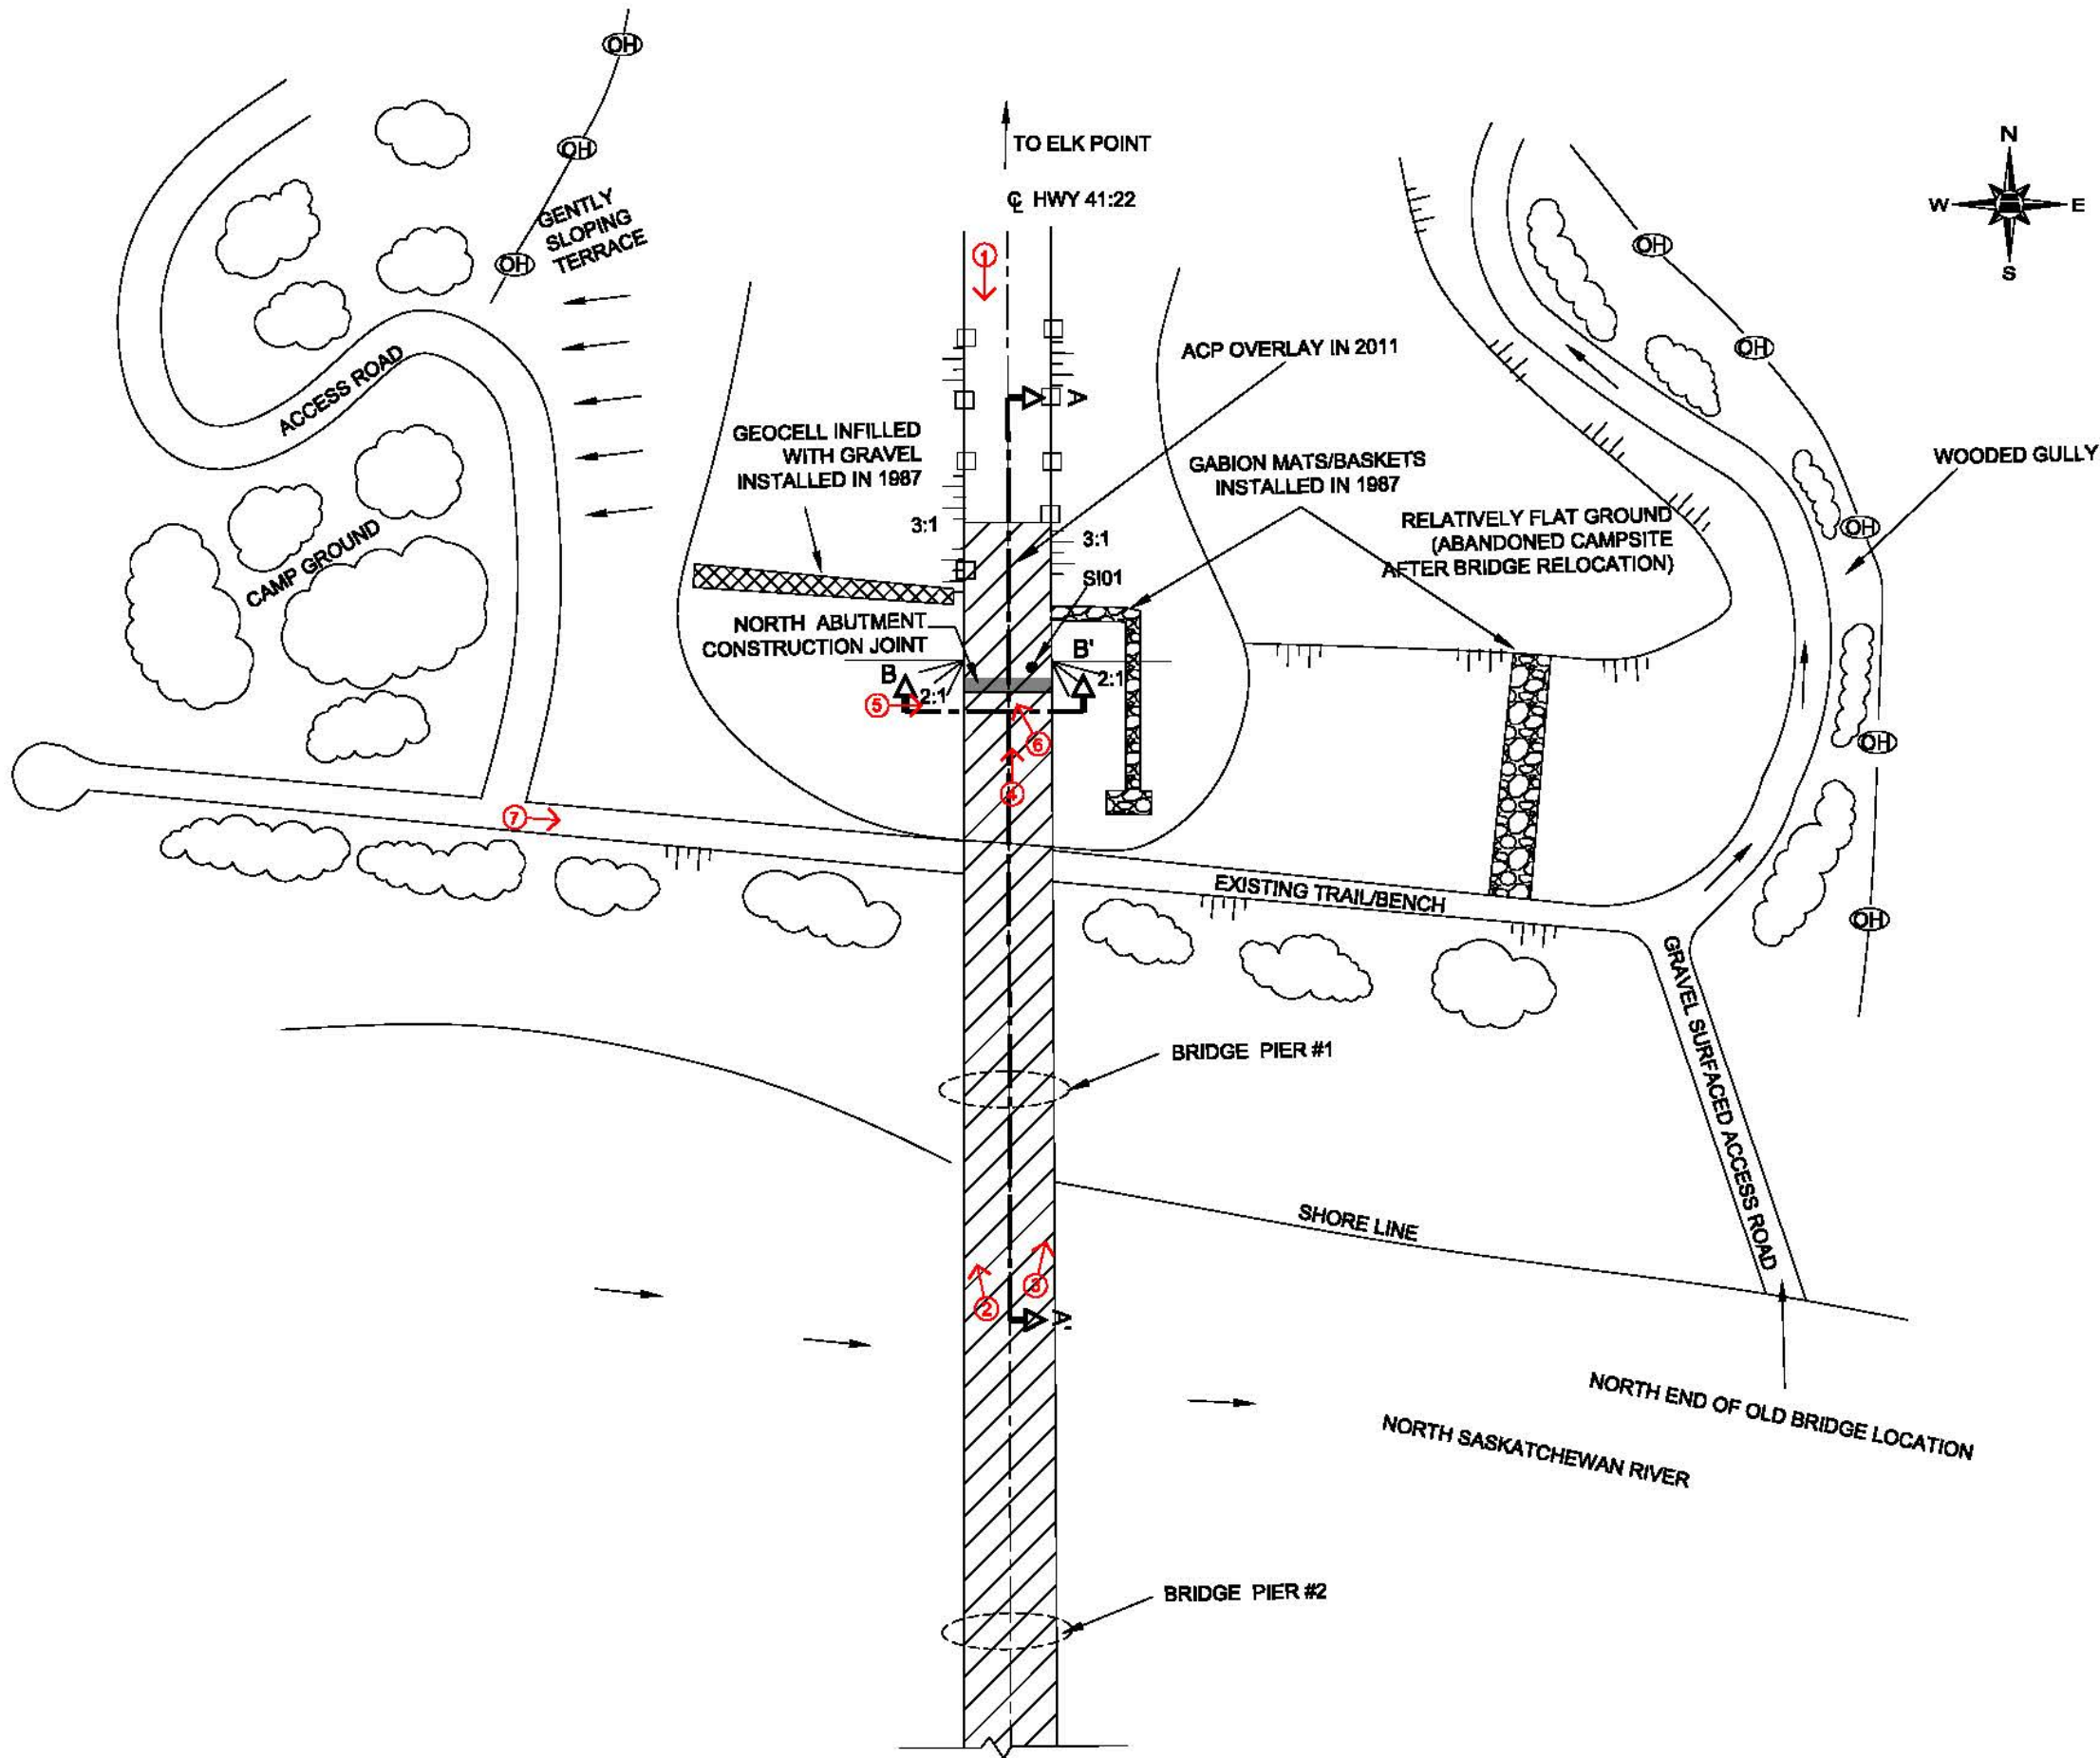
- LEGEND**
- ① PHOTOGRAPH NUMBER, AND APPROXIMATE DIRECTION AND LOCATION (JUNE 13, 2012)
 - ACP OVERLAY
 - TREES
 - OH OVERHEAD POWERLINE
