**GEOHAZARD ASSESSMENT PROGRAM**  
**NORTH CENTRAL REGION – ATHABASCA**

**2010 INSPECTION**

Site Number	Location	Name	Hwy	km
NC 24	8 km north of Hwy 29 (north of Elk Point)	<b>KEHIWIN LAKE</b>	41:23(previously 28:16)	8.0
Legal Description		UTM Co-ordinates (NAD 83)		
NW-27-56-5-W4M		12 N 5988511	E	506780.8

**FIGURE NC24-1 SITE PLAN  
NC24 - HWY 41:23 (PREVIOUSLY 28:16) Km 8 KEHIWIN LAKE  
NE 25-58-7 W4M**

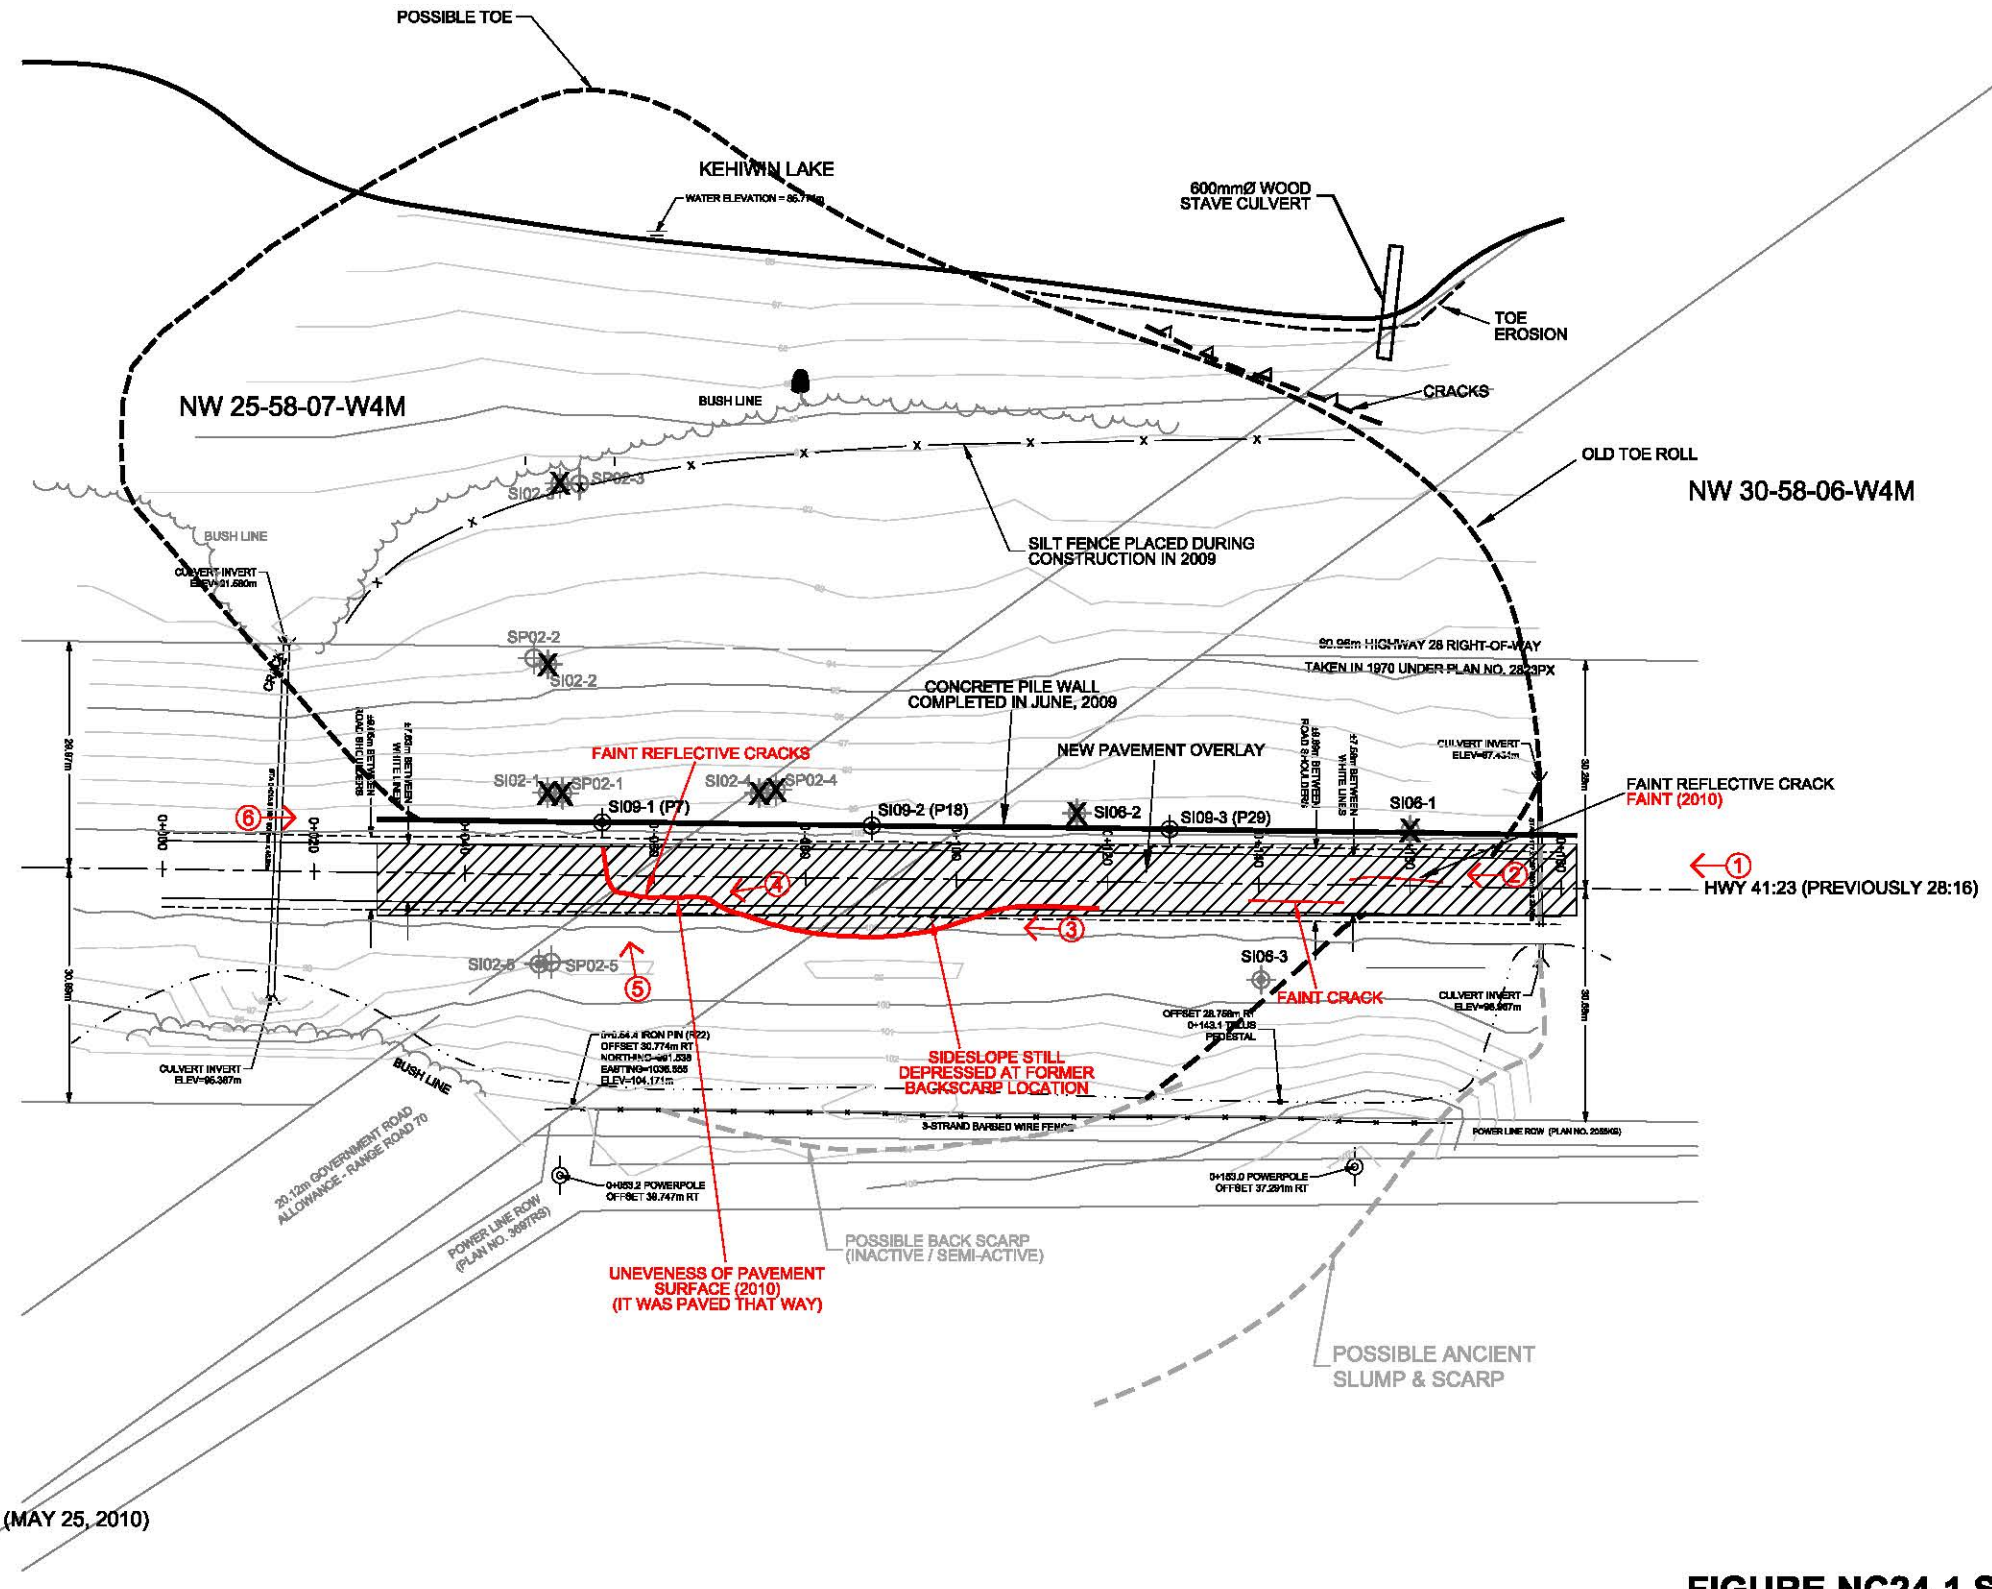
The reflective slide cracks noted on the highway surface are consistent with the downslope wall movement. The top of the wall moved by about 2 mm between September 2009 and May 2010. The downslope wall movement is expected to continue until the pile wall mobilizes the total force required to stabilize the slide mass upslope of the wall. Until the wall mobilizes the stabilizing force, more reflective cracks and/or minor depressions are anticipated to appear on the highway surface.

There was no evidence of ongoing slide movement downslope of the wall.

As discussed on site, this site will be removed from the Geo-hazard visual assessment program. However, semi-annual instrumentation monitoring will be continued to appraise the effectiveness of the remedial measure. The local MCI should continue to monitor and record the development of open cracks/depressions on the highway paved surface.

Open cracks should be sealed to prevent the infiltration of surface water into the slide mass. The NBL surface could be milled where roughness was detected to provide a smooth ride to travellers. A pavement overlay may be required in the future (probably within the next 2 to 3 years) to enhance the quality of ride.

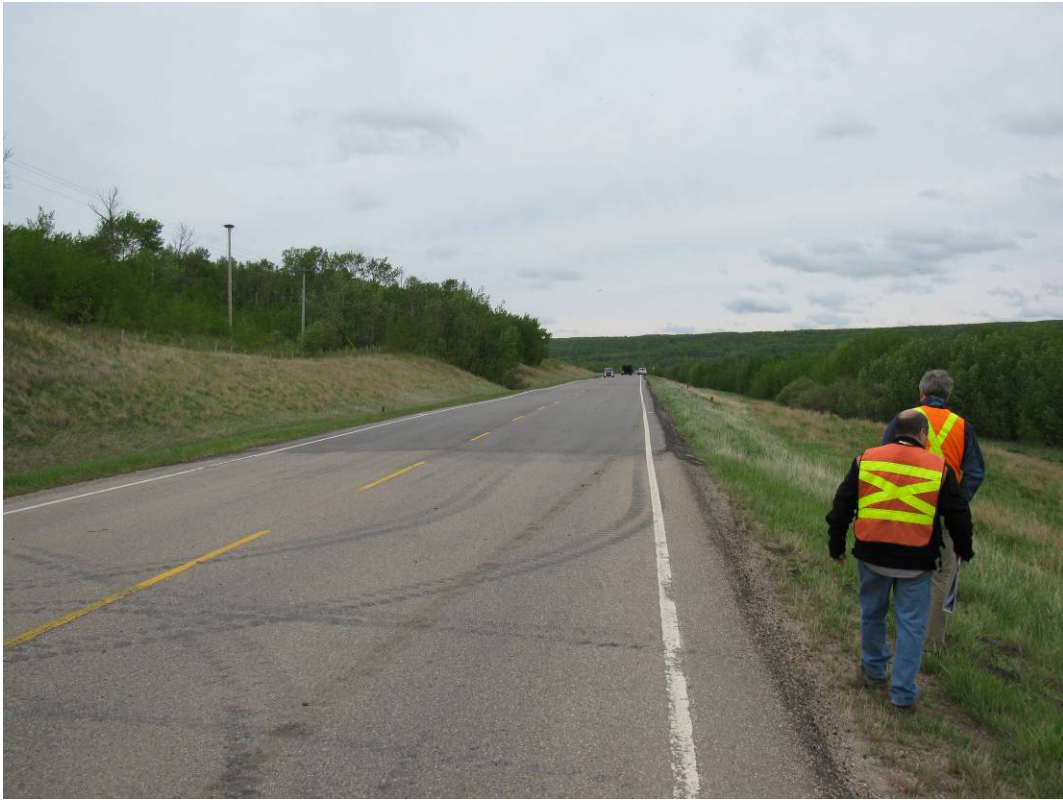
**Photo #1** General view of highway surface at the slide repair location (looking south)

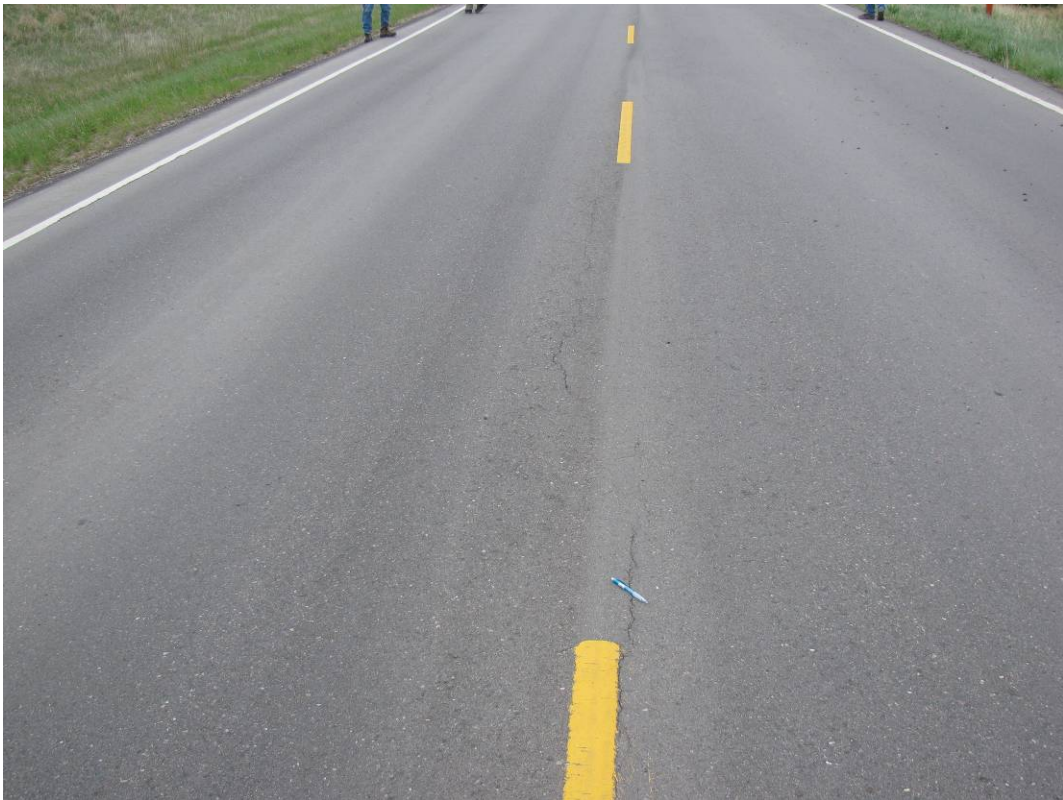
**Photo #2** Looking south towards a reflective faint crack on the highway surface

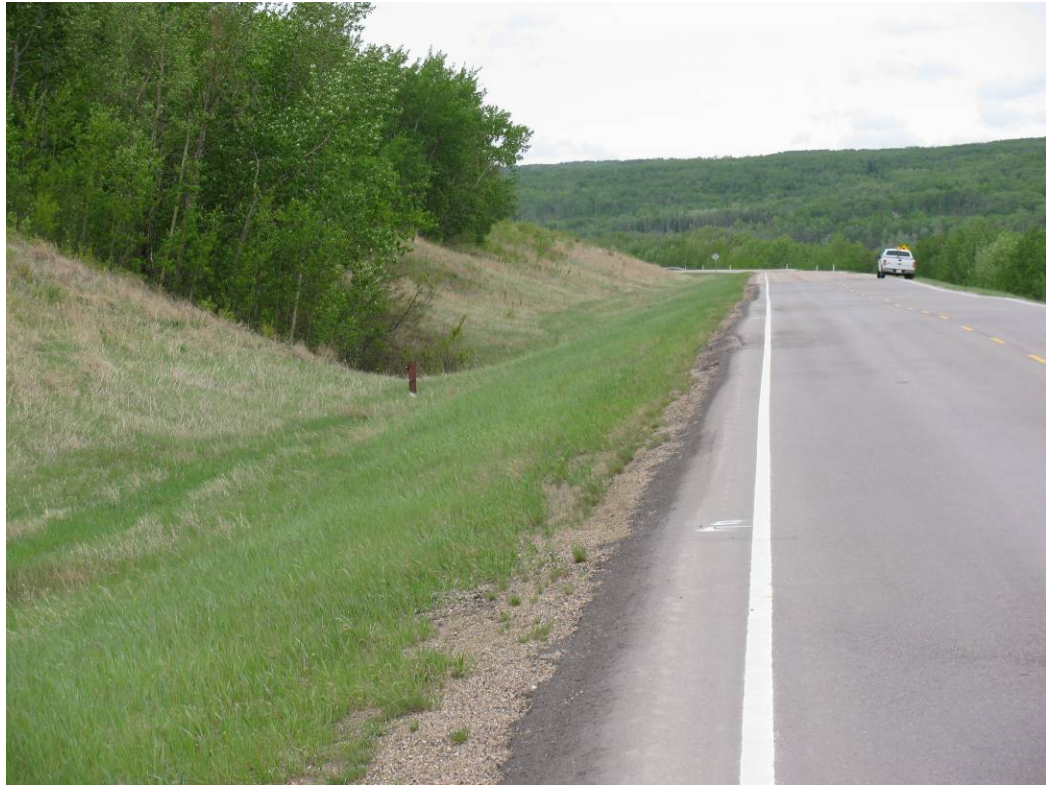
**Photo #3** Looking south. There is a depression area along the former back scarp of the slide

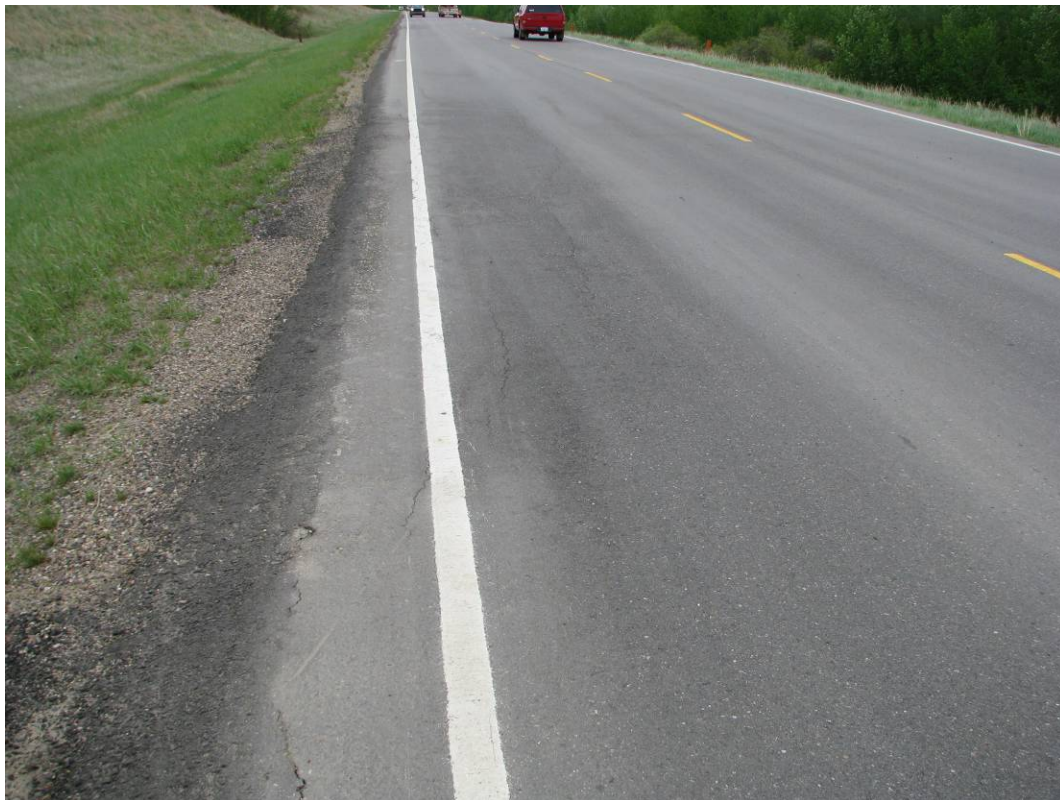
**Photo #4** Looking south at reflective faint cracks on the highway NBL surface. The feathered end of the recent pavement patch is rough at this location

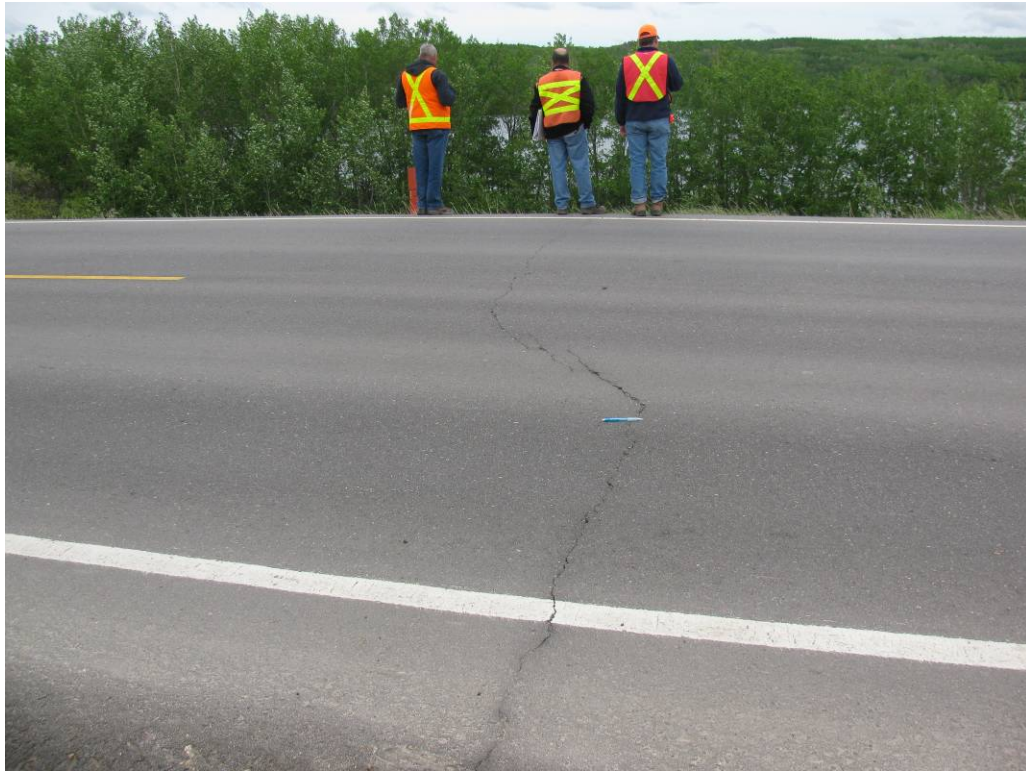
**Photo #5** Transverse reflective crack at the southern limit of the slide area (looking west)

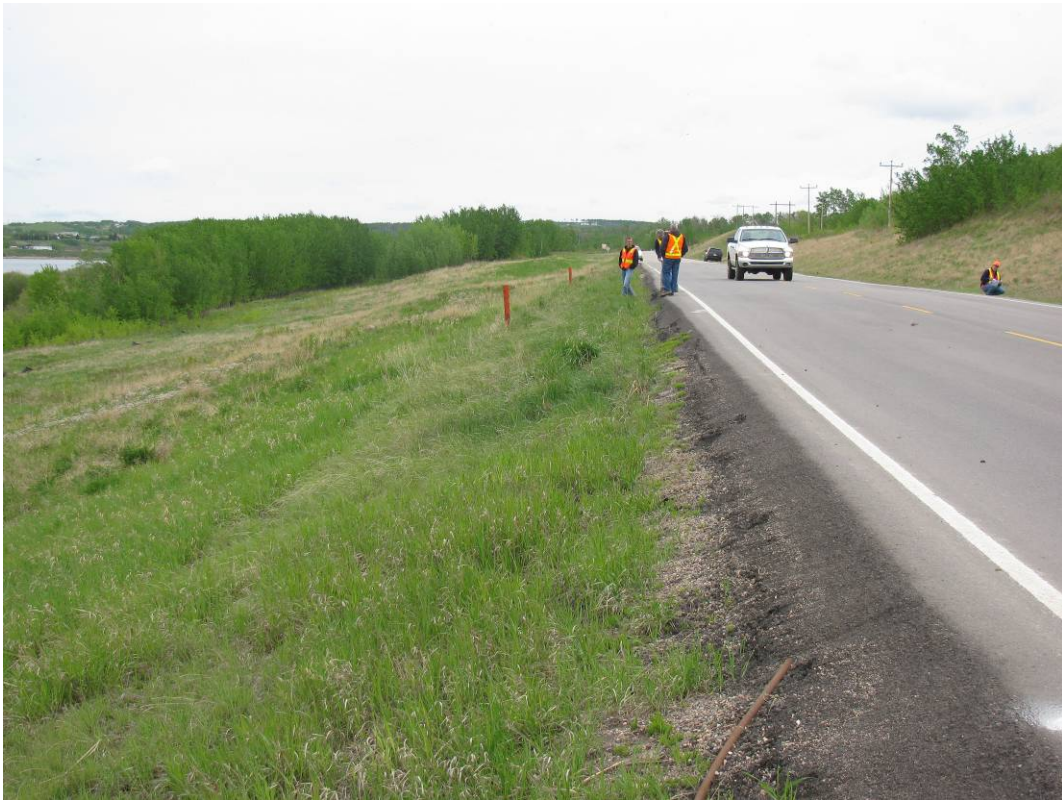
**Photo #6** Looking at the highway side slope where the wall was constructed; note the growth of vegetation on the highway side slope (looking north)
