July 5, 2022

**ALBERTA TRANSPORTATION GRMP (CON0022163)  
NORTH CENTRAL (ATHABASCA AND FORT McMURRAY DISTRICTS)  
INSTRUMENTATION MONITORING RESULTS – SPRING 2022**

**SITE NC024: HWY 41:23 KEHIWIN LAKE (km 7.9)**

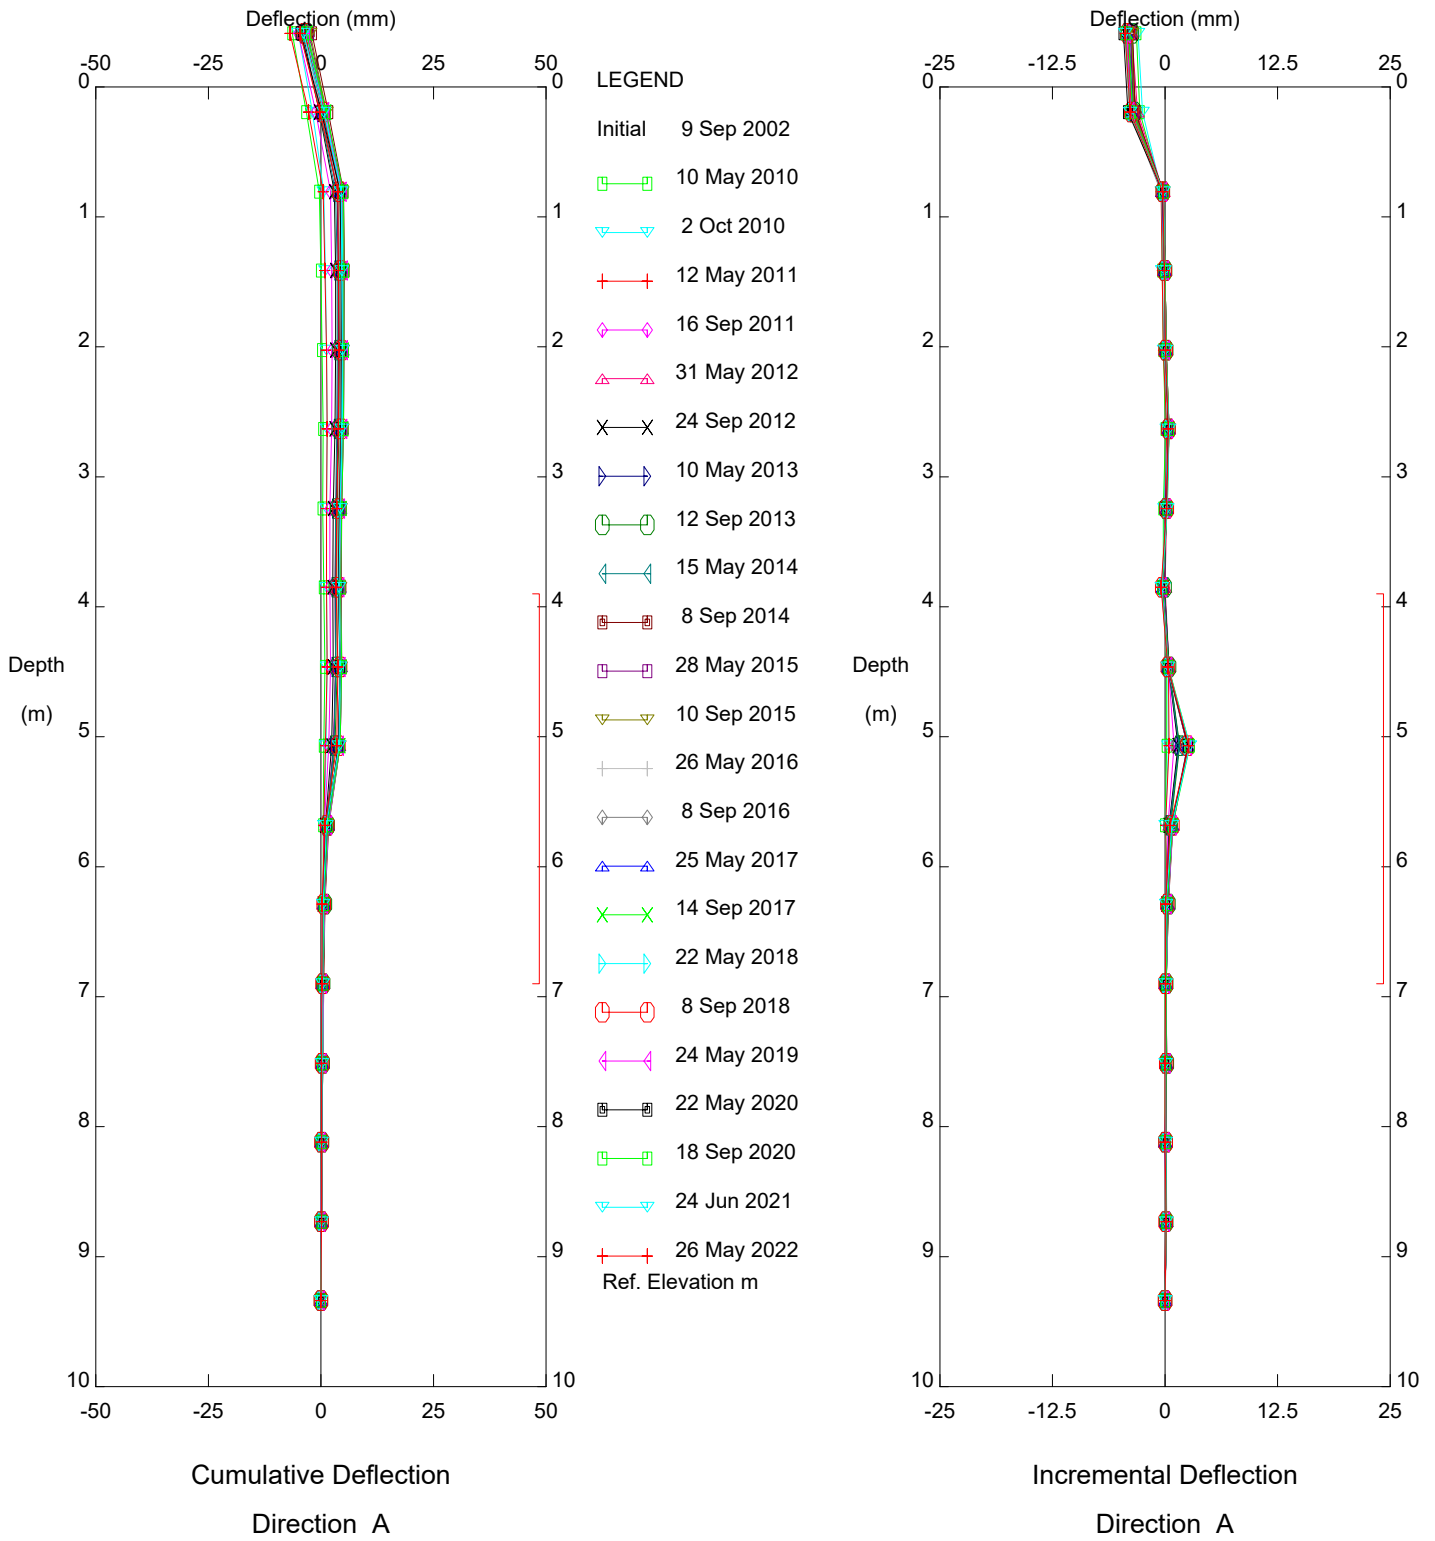
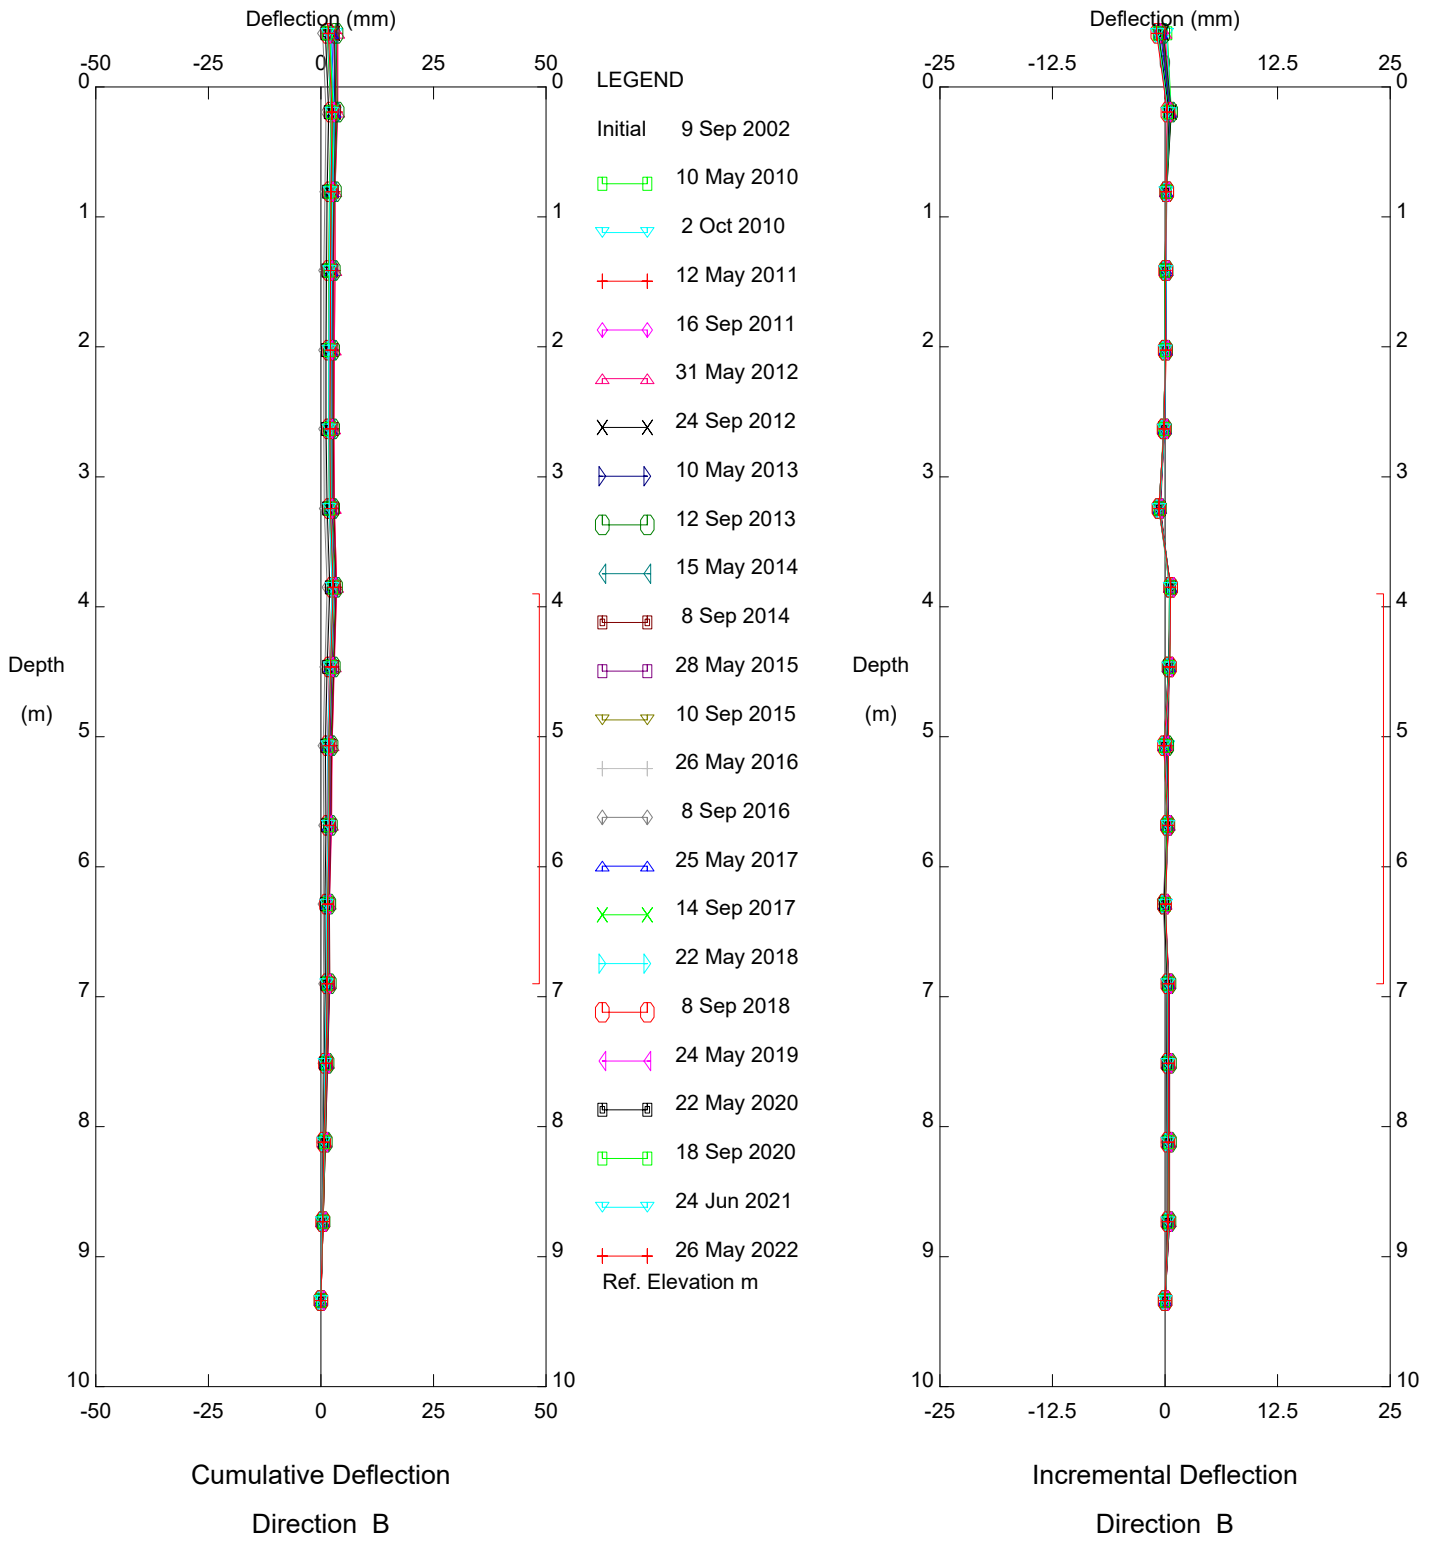
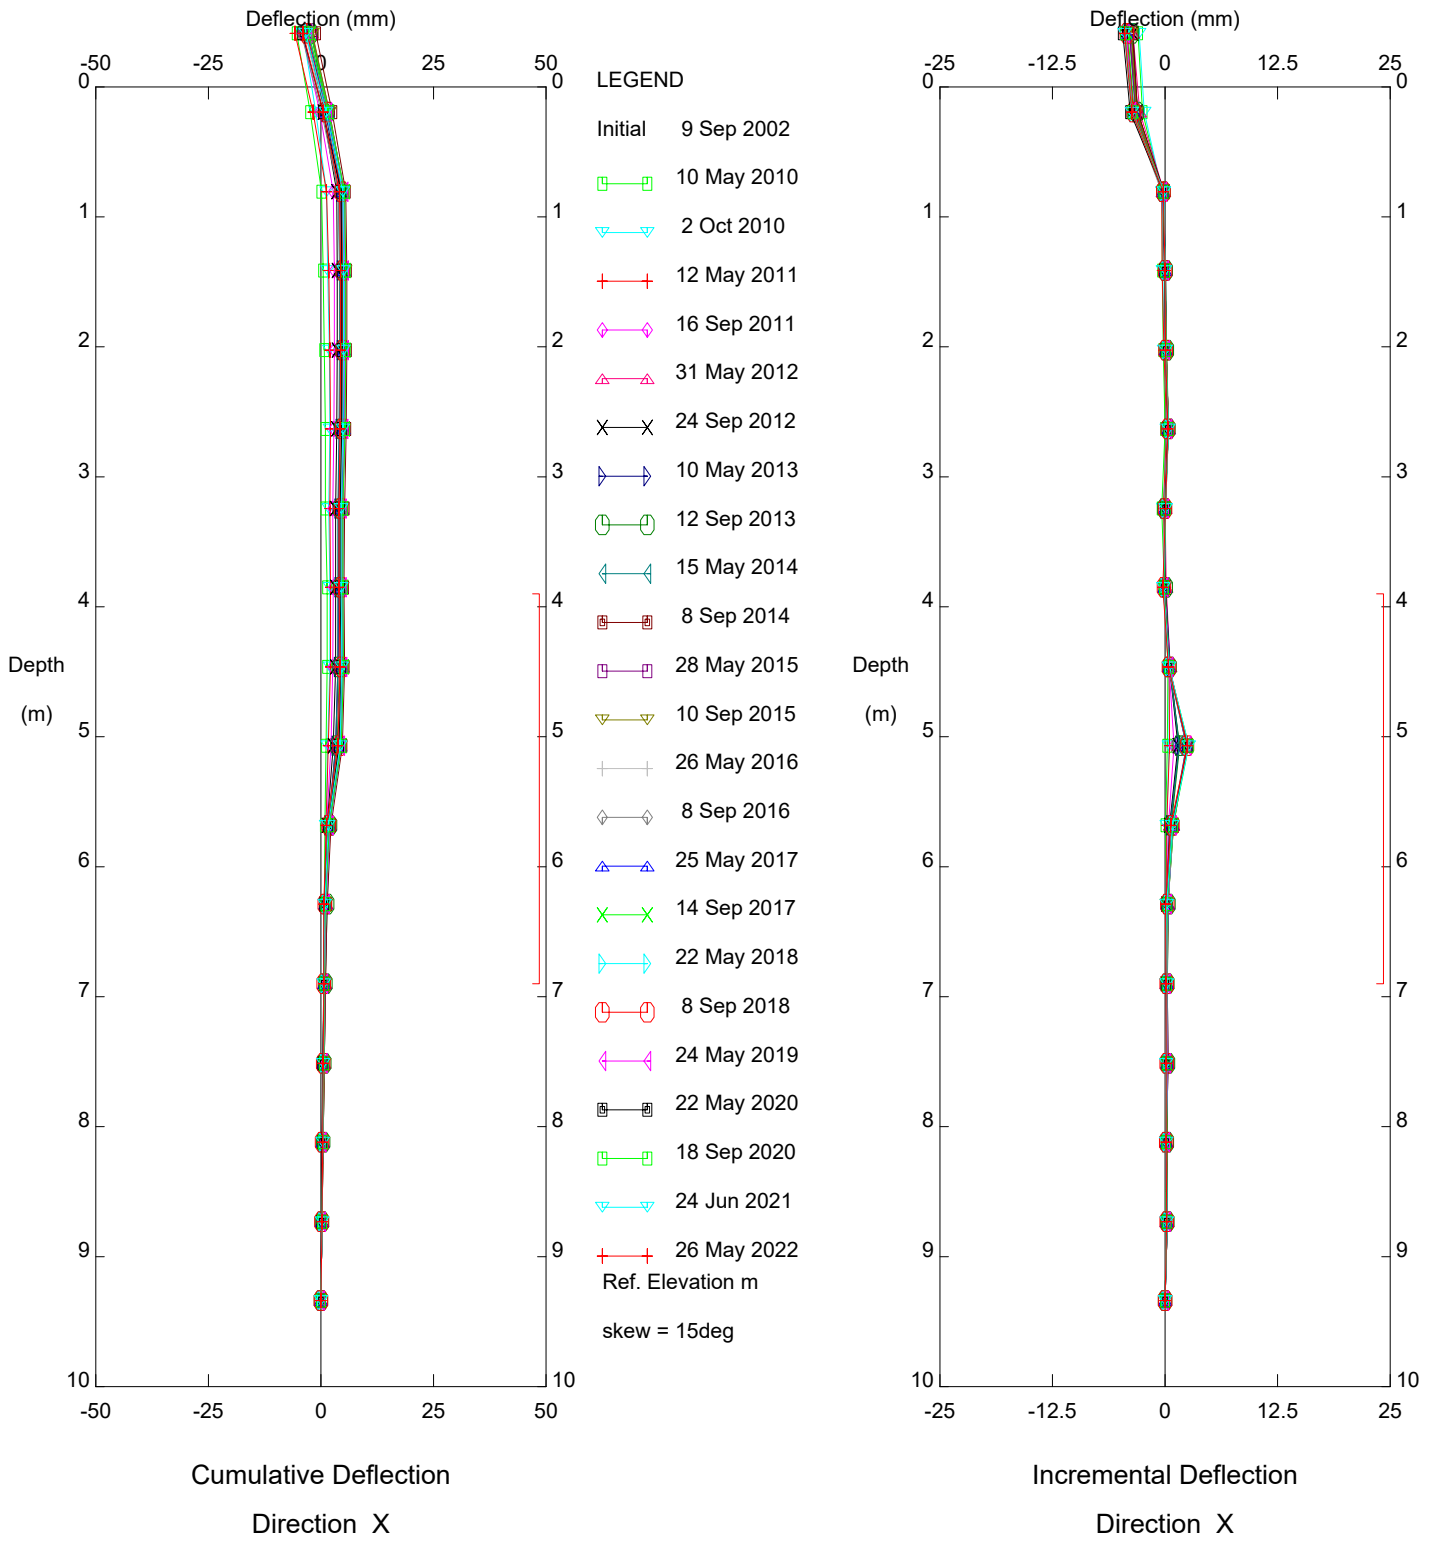
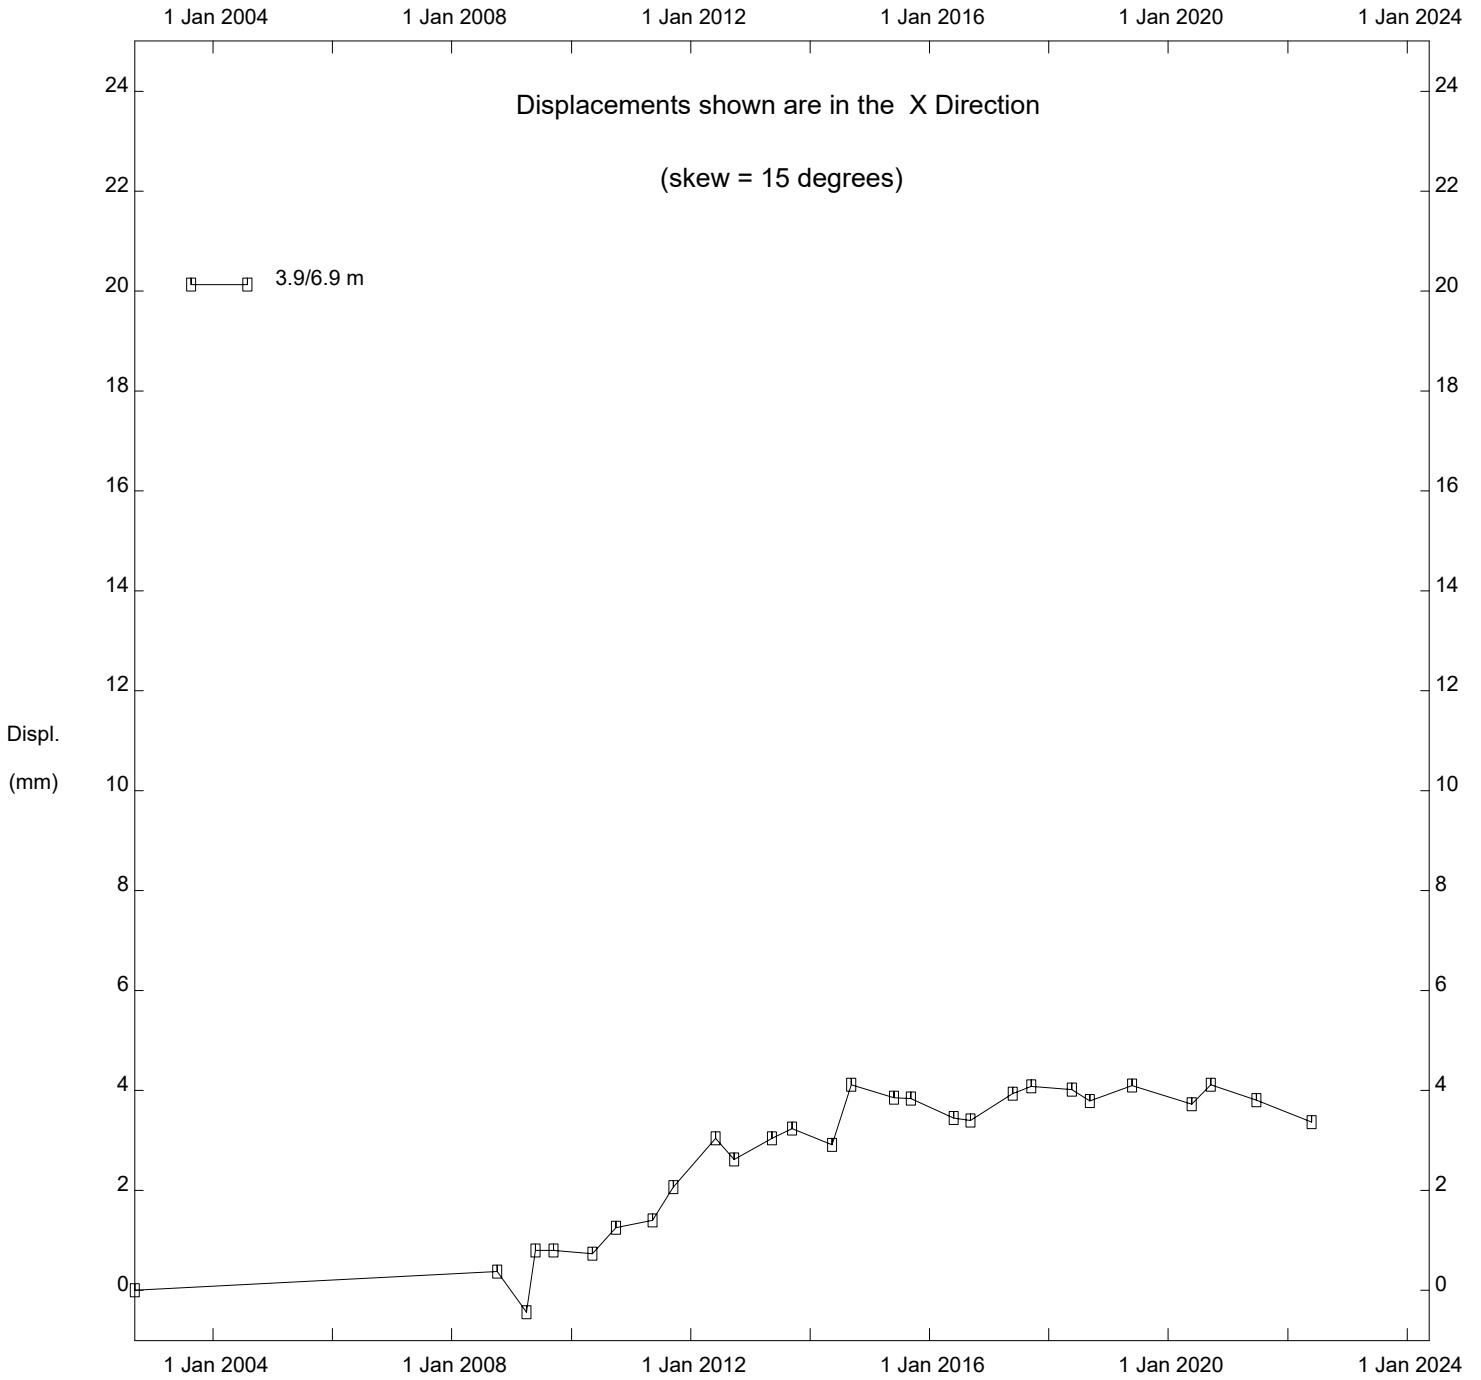
Hwy 41:23 Kehiwin Lake (NC024), Inclinometer SI02-5

SI02-5, installed in the east ditch of the highway, showed no discernible movement since the spring of 2021 readings.

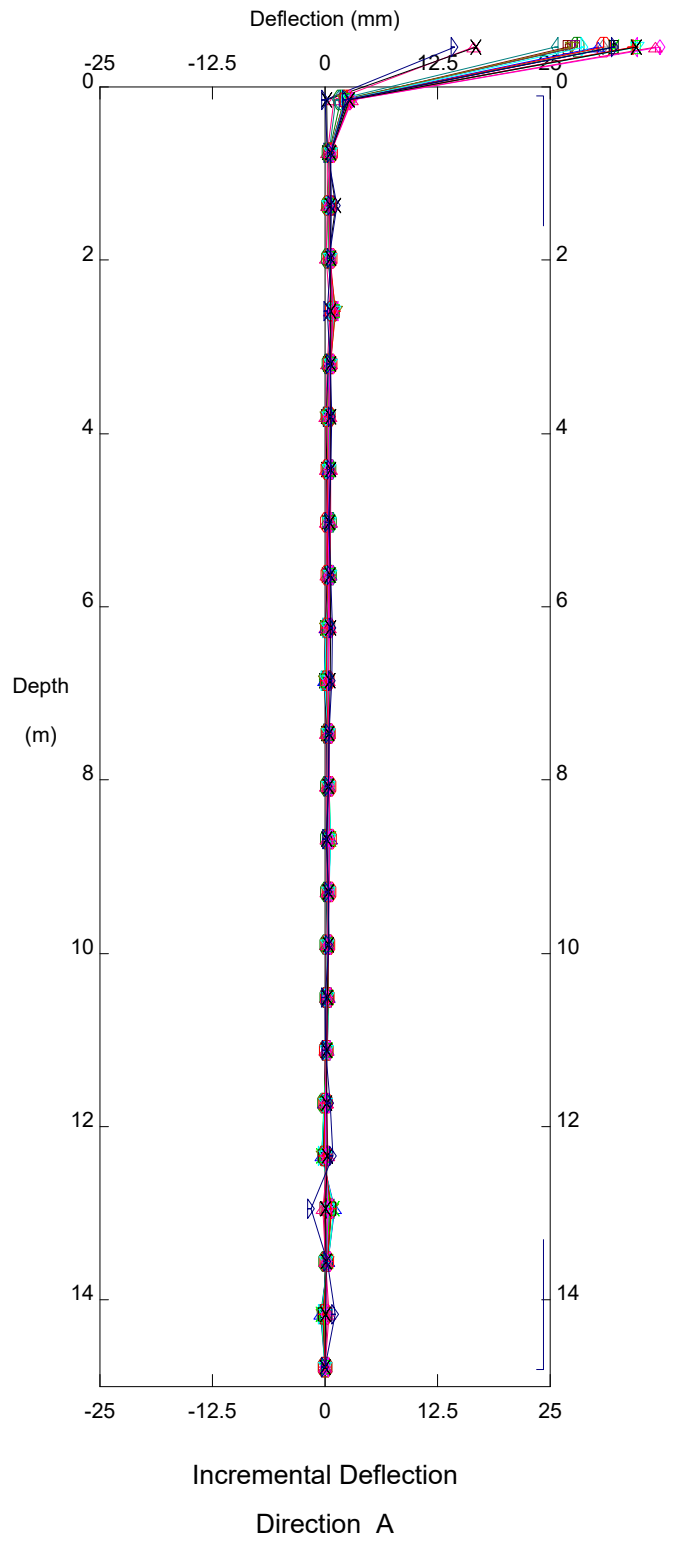
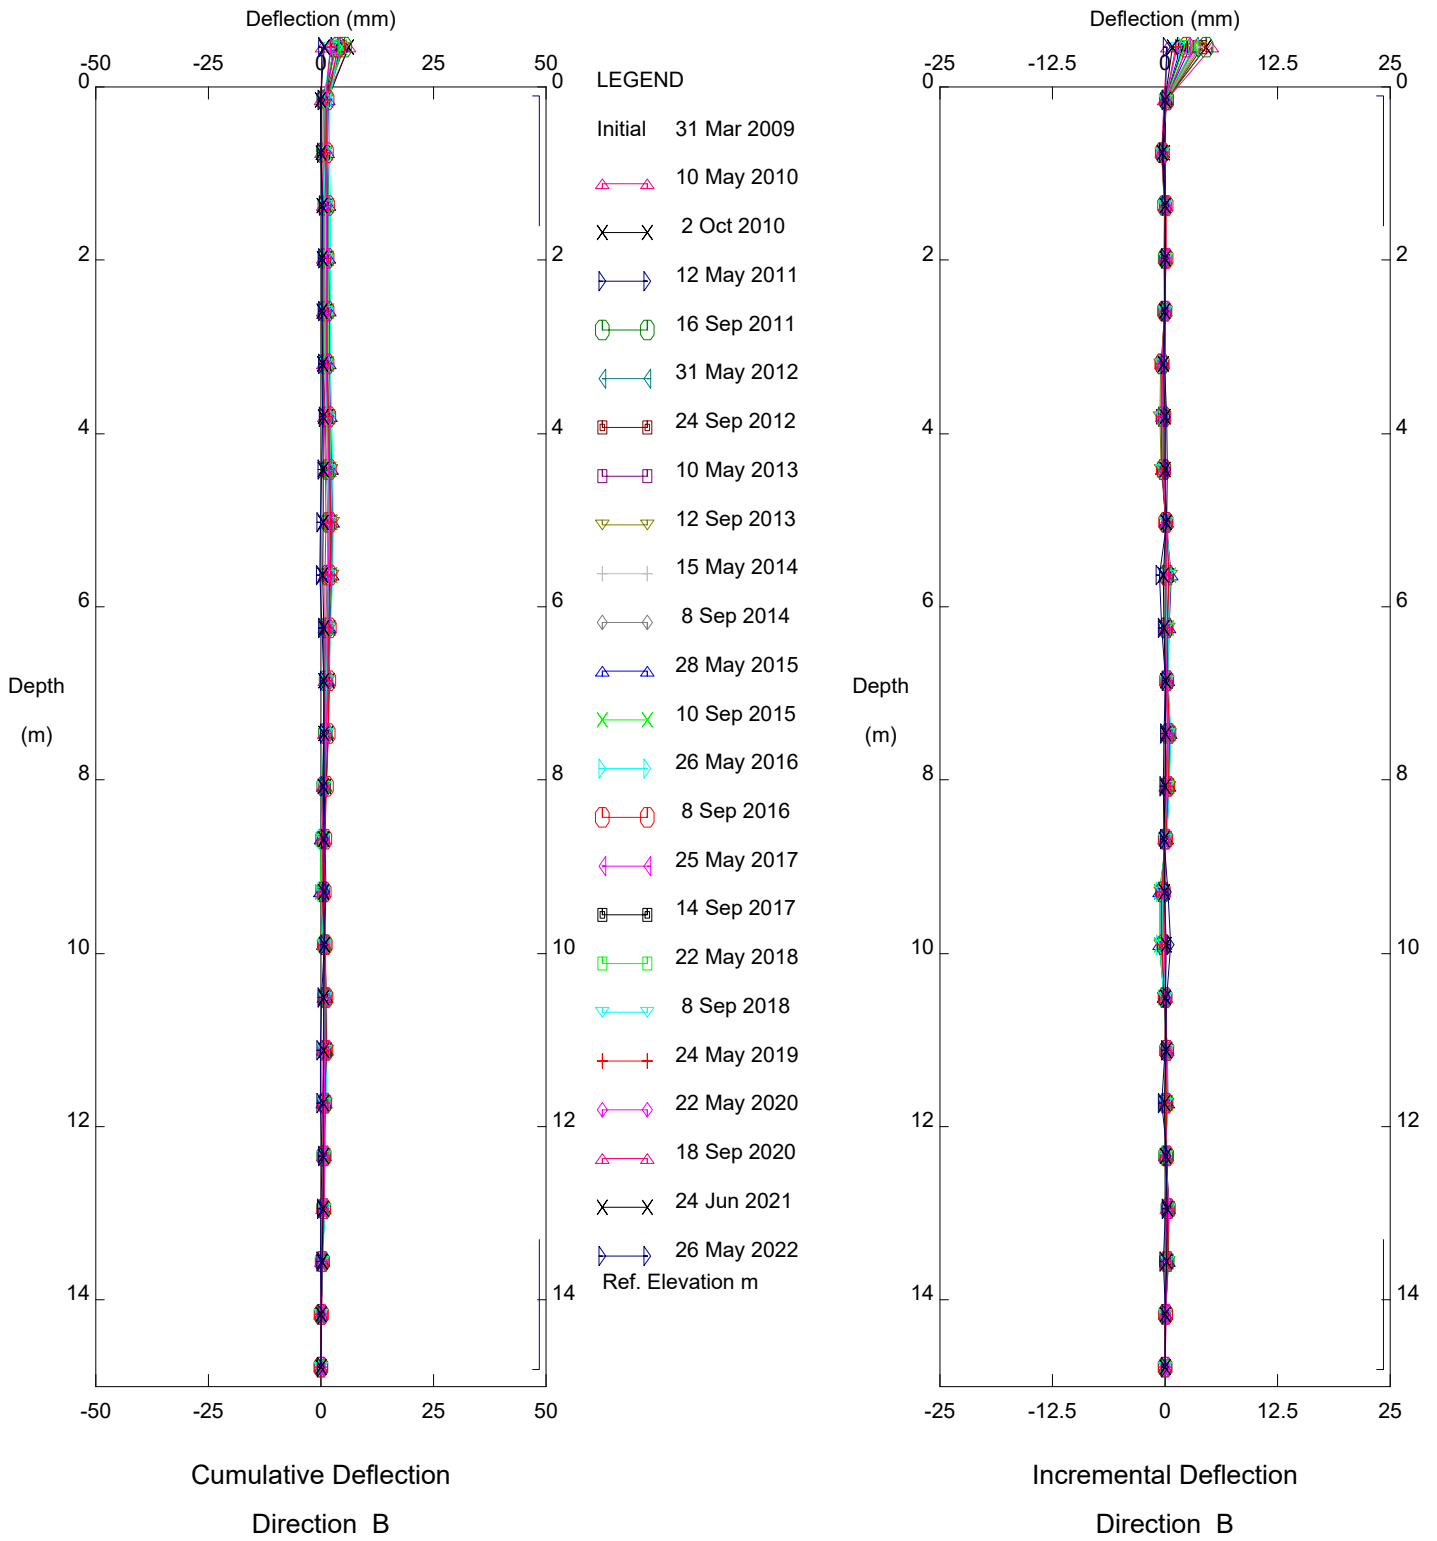
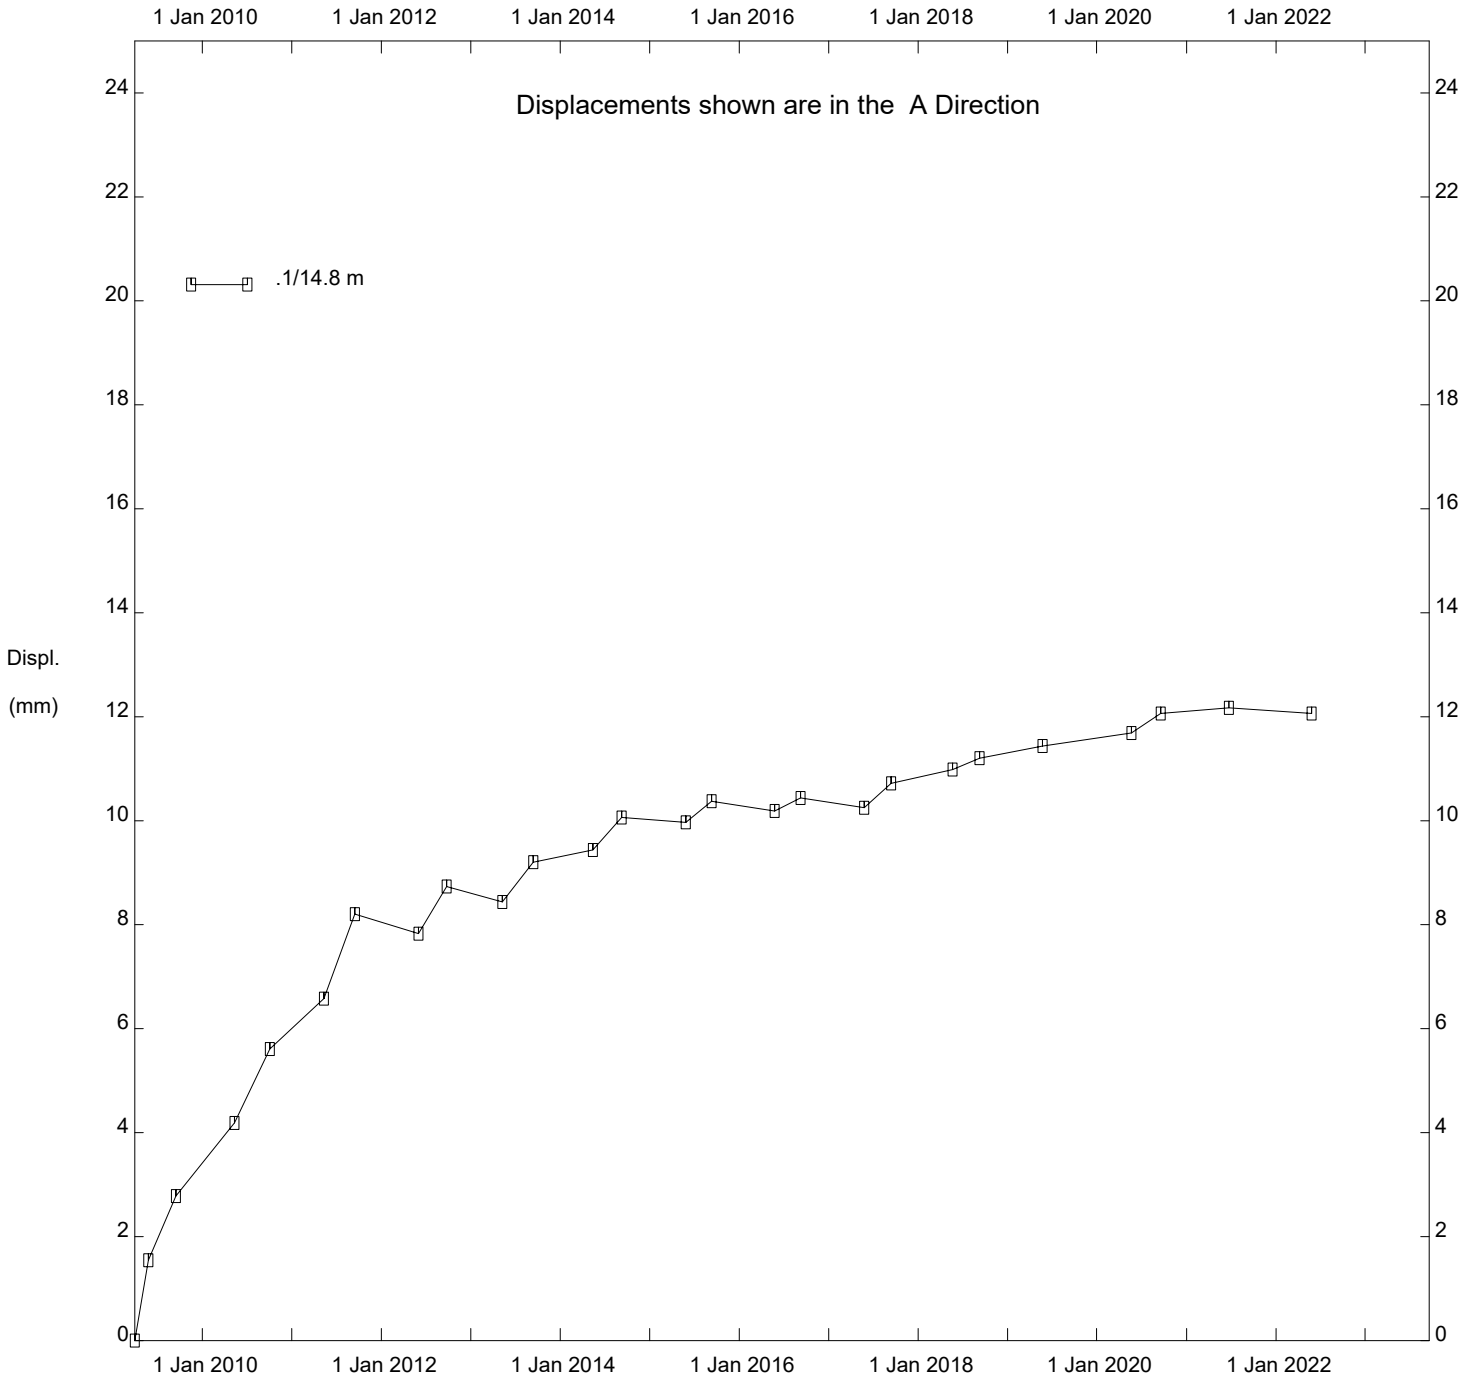
Hwy 41:23 Kehiwin Lake (NC024), Inclinator SI09-1

SI09-1 showed no discernible movement since the readings in spring 2021. SI09-1 has shown a total pile head movement of 12.1 mm to date.

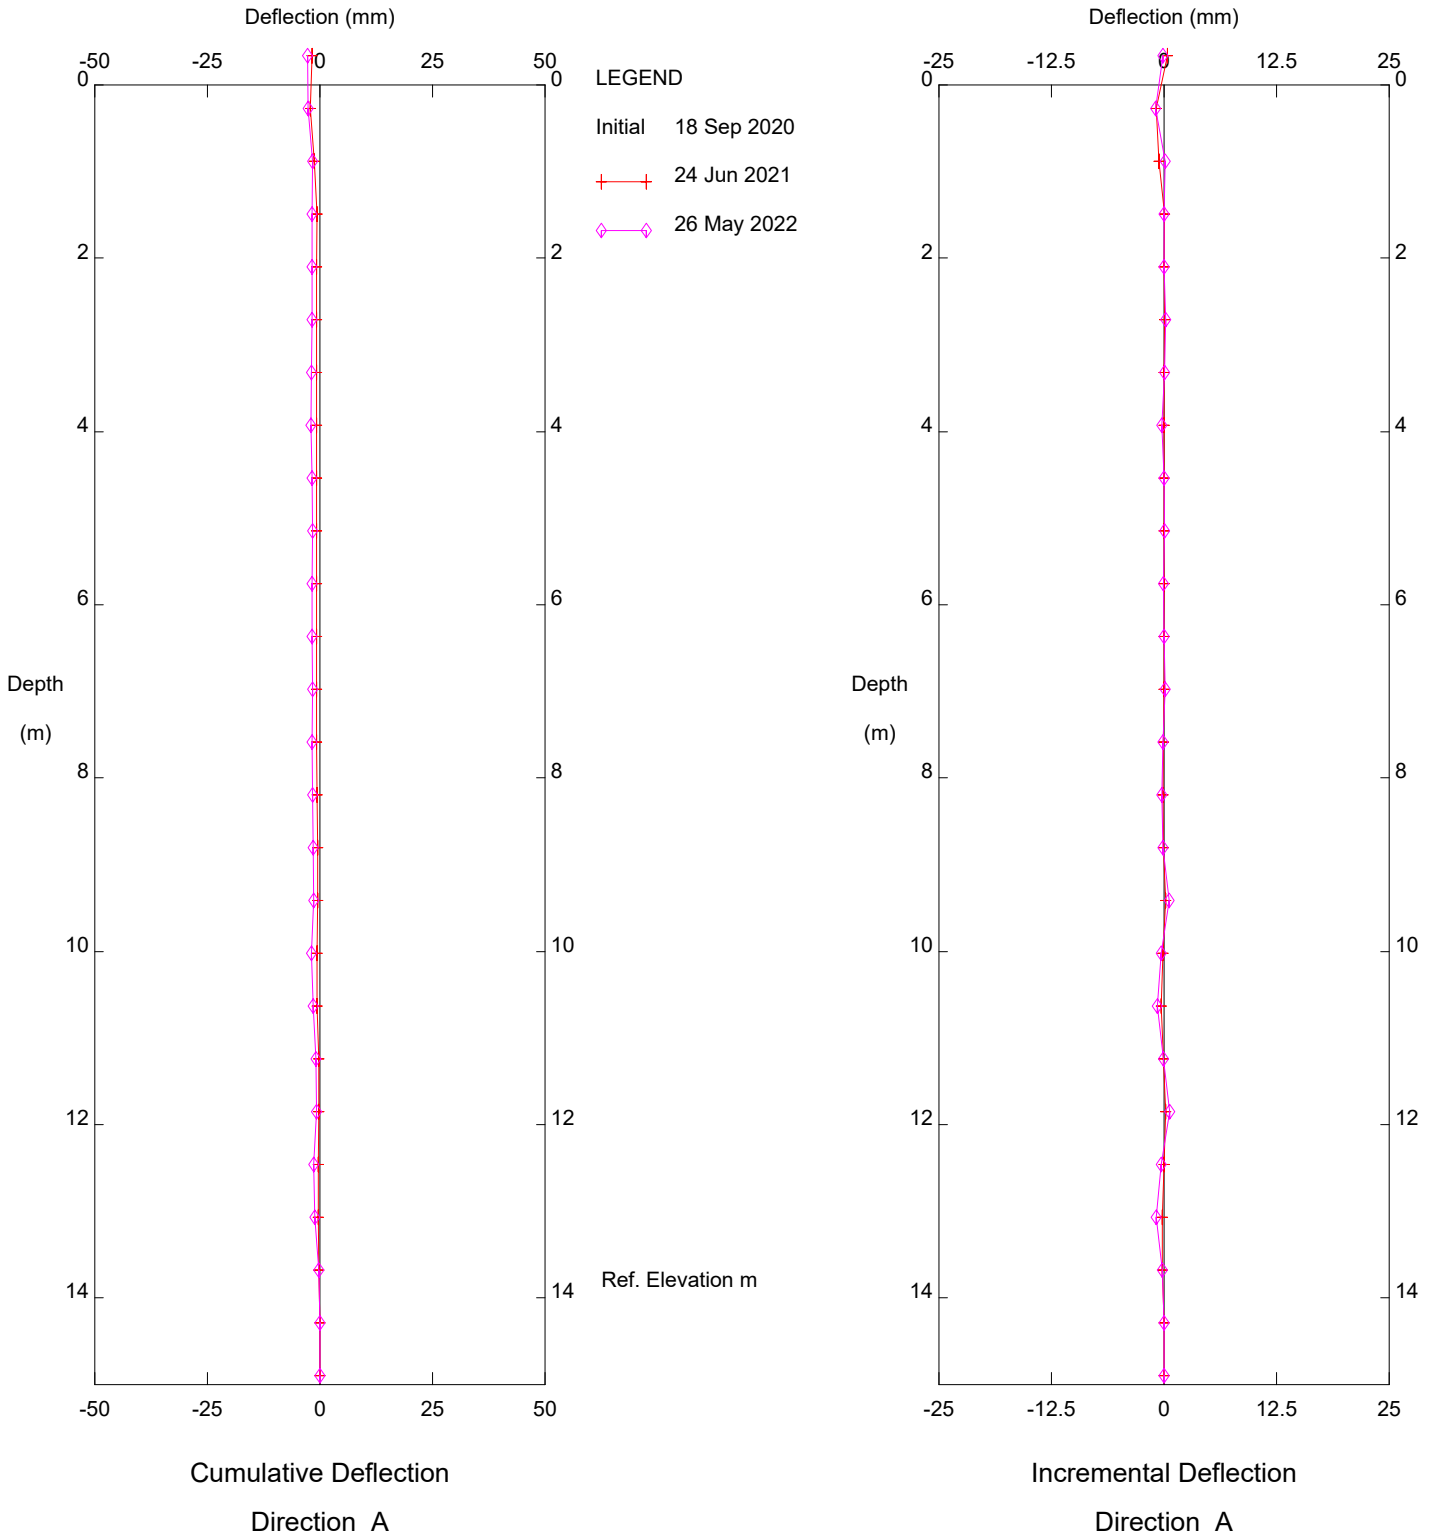
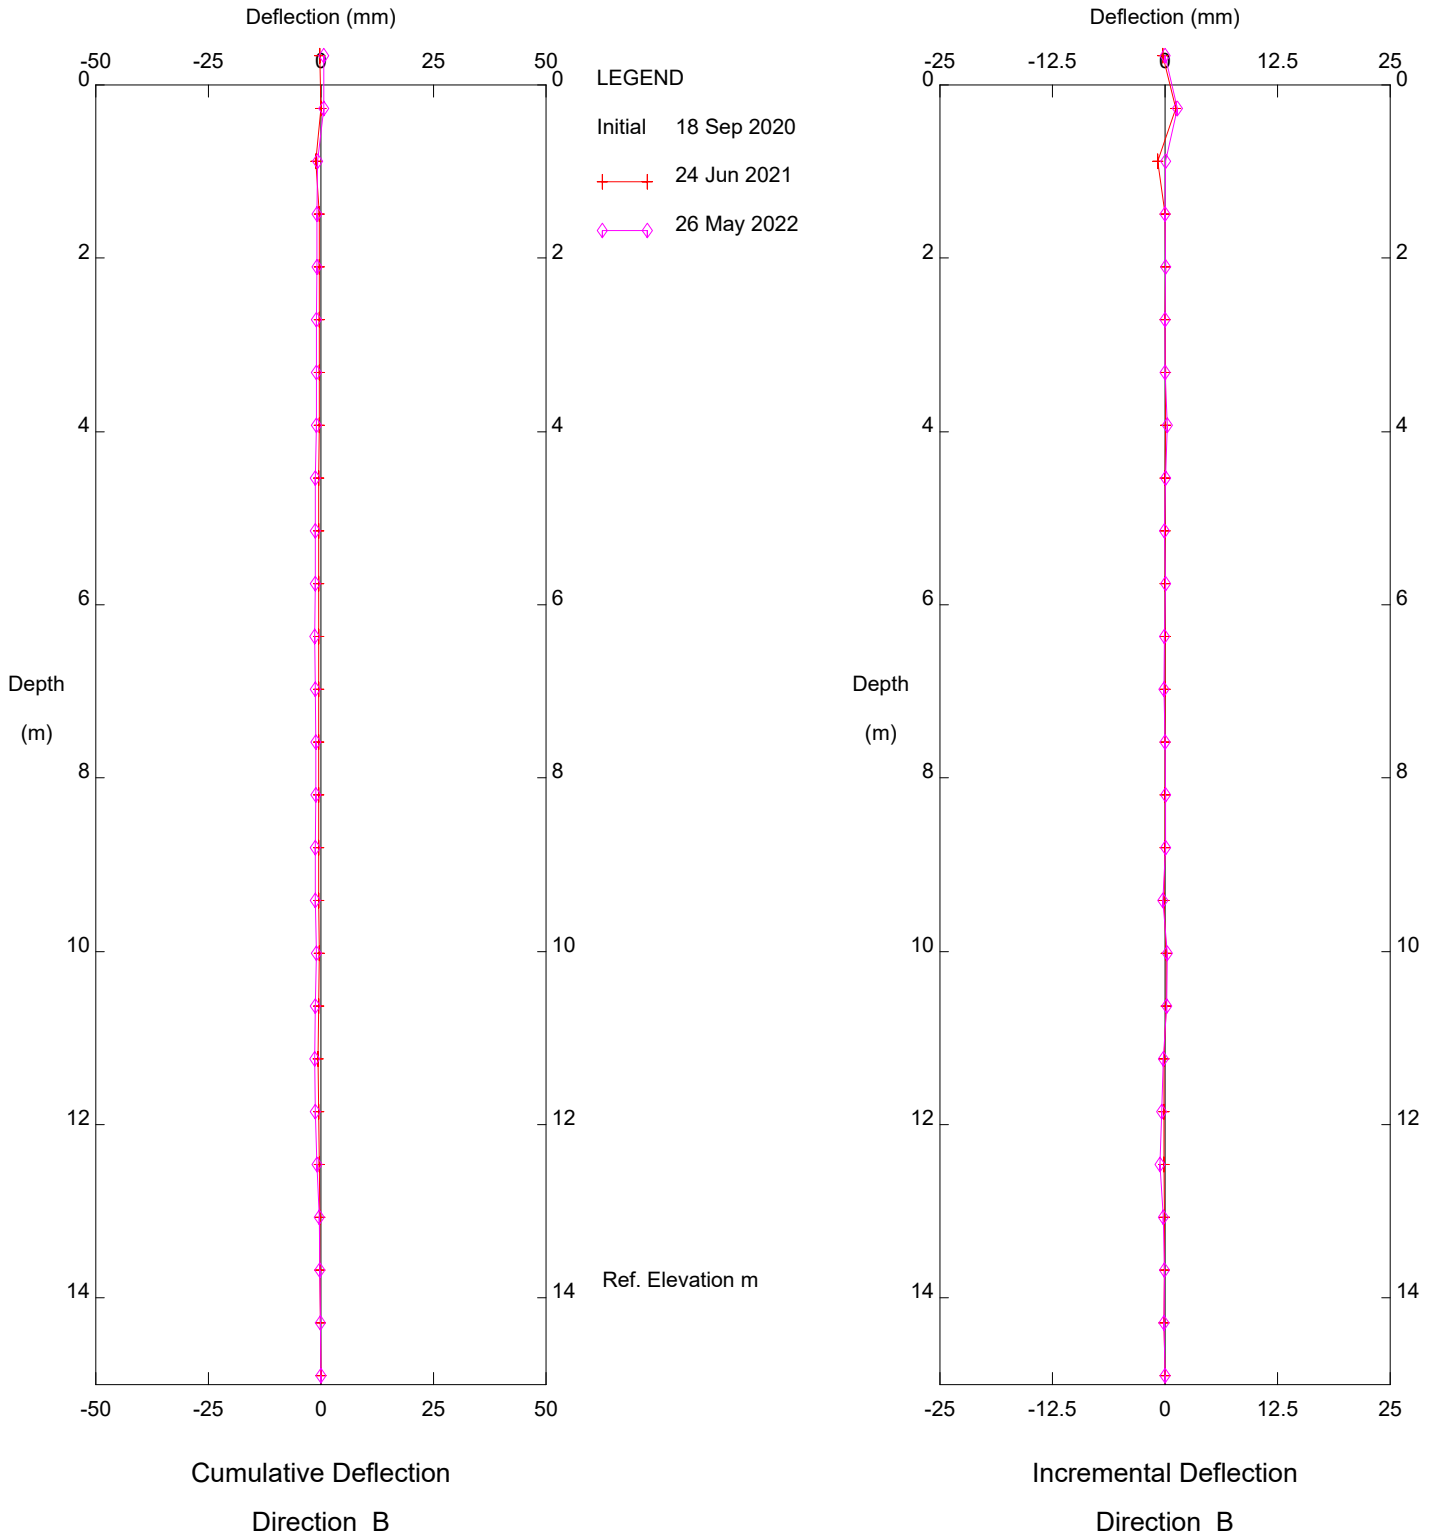
Hwy 41:23 Kehiwin Lake (NC024), Inclinometer SI09-2

SI09-2 and SI09-3 were previously damaged; however, they were repaired prior to the fall of 2020 readings. When the readings from the repaired instruments were compared to previous data for the SIs, the data could not be matched, hence both SI09-2 and SI09-3 were reinitialized for the fall of 2020 readings. SI09-2 and SI09-3 showed no discernible movement since the reinitialization.

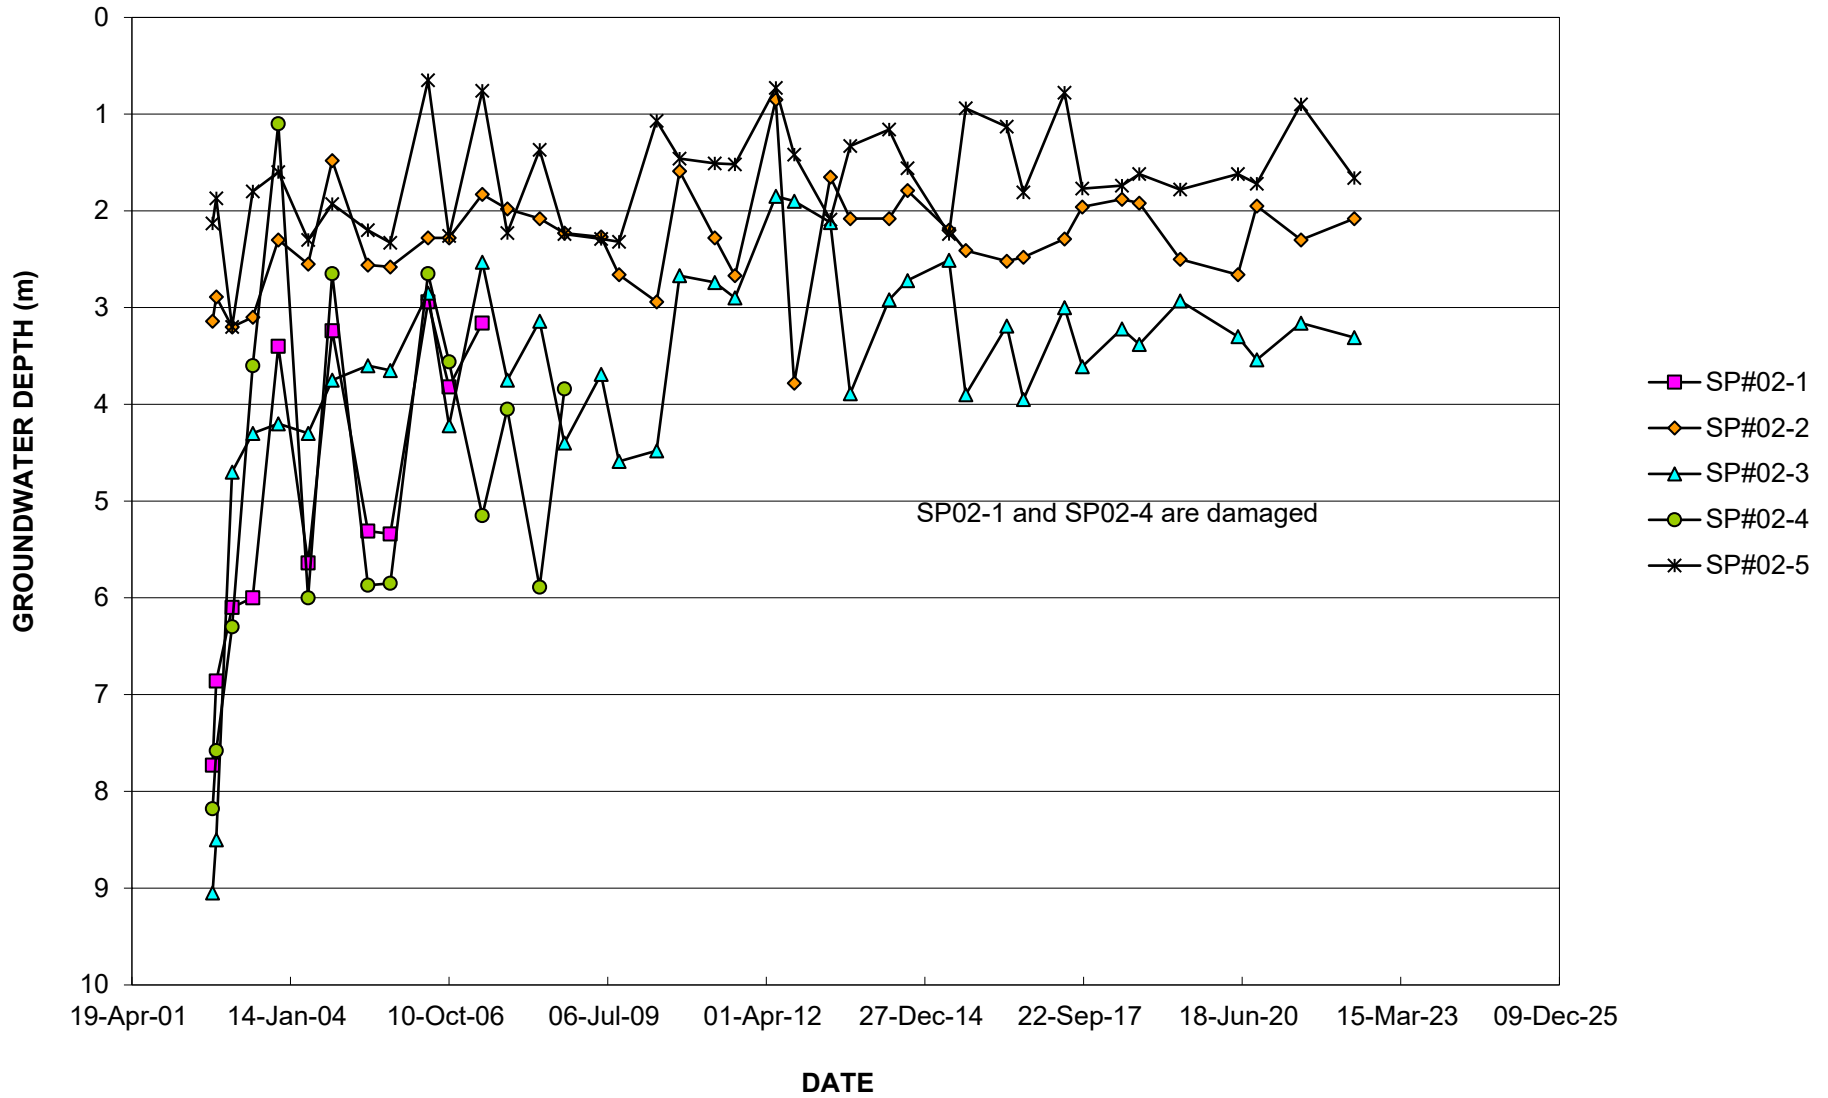
**FIGURE NC024-1  
STANDPIPE PIEZOMETER DATA FOR NC024 KEHIWIN LAKE**

The groundwater level increased by 0.22 m in SP02-2 since the spring of 2021 readings. The groundwater level decreased in SP02-3 and SP02-5 by 0.15 m and 0.76 m, respectively, since the spring of 2021 readings. The standpipe piezometer readings are plotted on Figure NC024-1 in Appendix A.
