November 10, 2022

**ALBERTA TRANSPORTATION GRMP (CON0022163)  
NORTH CENTRAL (ATHABASCA AND FORT McMURRAY DISTRICTS)  
INSTRUMENTATION MONITORING RESULTS – FALL 2022**

**SITE NC106: HWY 63:08 km 27.9 PAVEMENT DISTRESS**

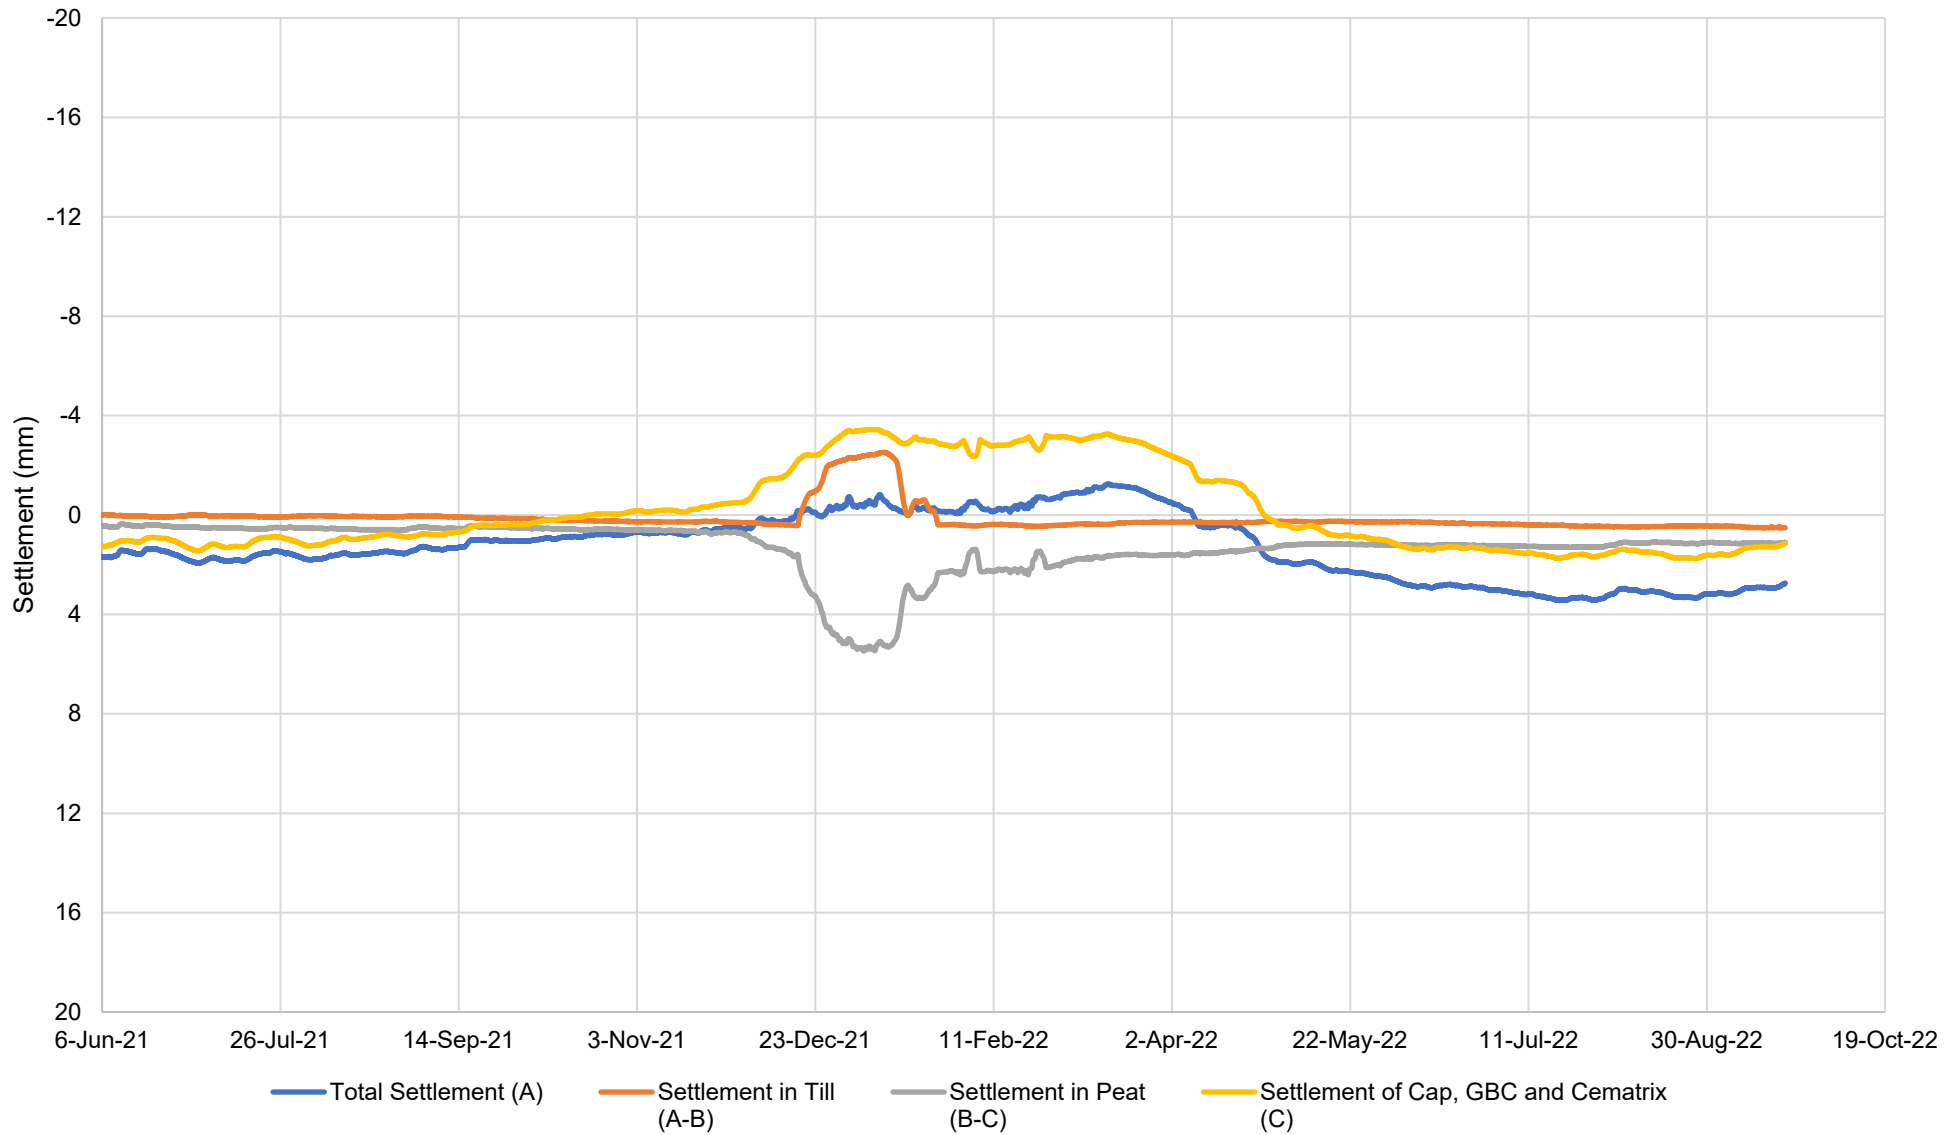
**Figure NC106-1**  
**Highway 63:08 km 27.9 Pavement Distress Near Wandering River, Alberta**  
**EXT21-1 - Displacement**

Extensometer EXT21-1, installed towards the southern end of the Cematrix repair section, shows a current total settlement of 2.7 mm, and is showing equal amounts of settlement between the peat layer and the Cematrix, clay cap and GBC layer. EXT21-1 had shown a total settlement of 2.5 mm on May 28, 2022. EXT21-2, installed towards the northern end of the Cematrix repair section, shows a current total settlement of 13.6 mm, which corresponds to an overall increase in settlement of 2.5 mm since it was previously read on May 28, 2022. As shown on Drawing 32122-NC106-2, the peat layer is thicker at EXT21-2 location, and this explains the higher amount of the overall settlement observed in EXT21-2.

Both EXT21-1 and EXT21-2 previously showed a pattern of heave over the winter months between December 2021 and April 2022, followed by a pattern of increased settlement after spring thaw. The heave was primarily observed in the clay cap, GBC and Cematrix layer closest to the ground surface, and corresponds to the freezing temperatures observed in the uppermost nodes of their respective thermistor string during those months. The next reading in the spring of 2023 will determine if a similar heave pattern is observed this coming winter.

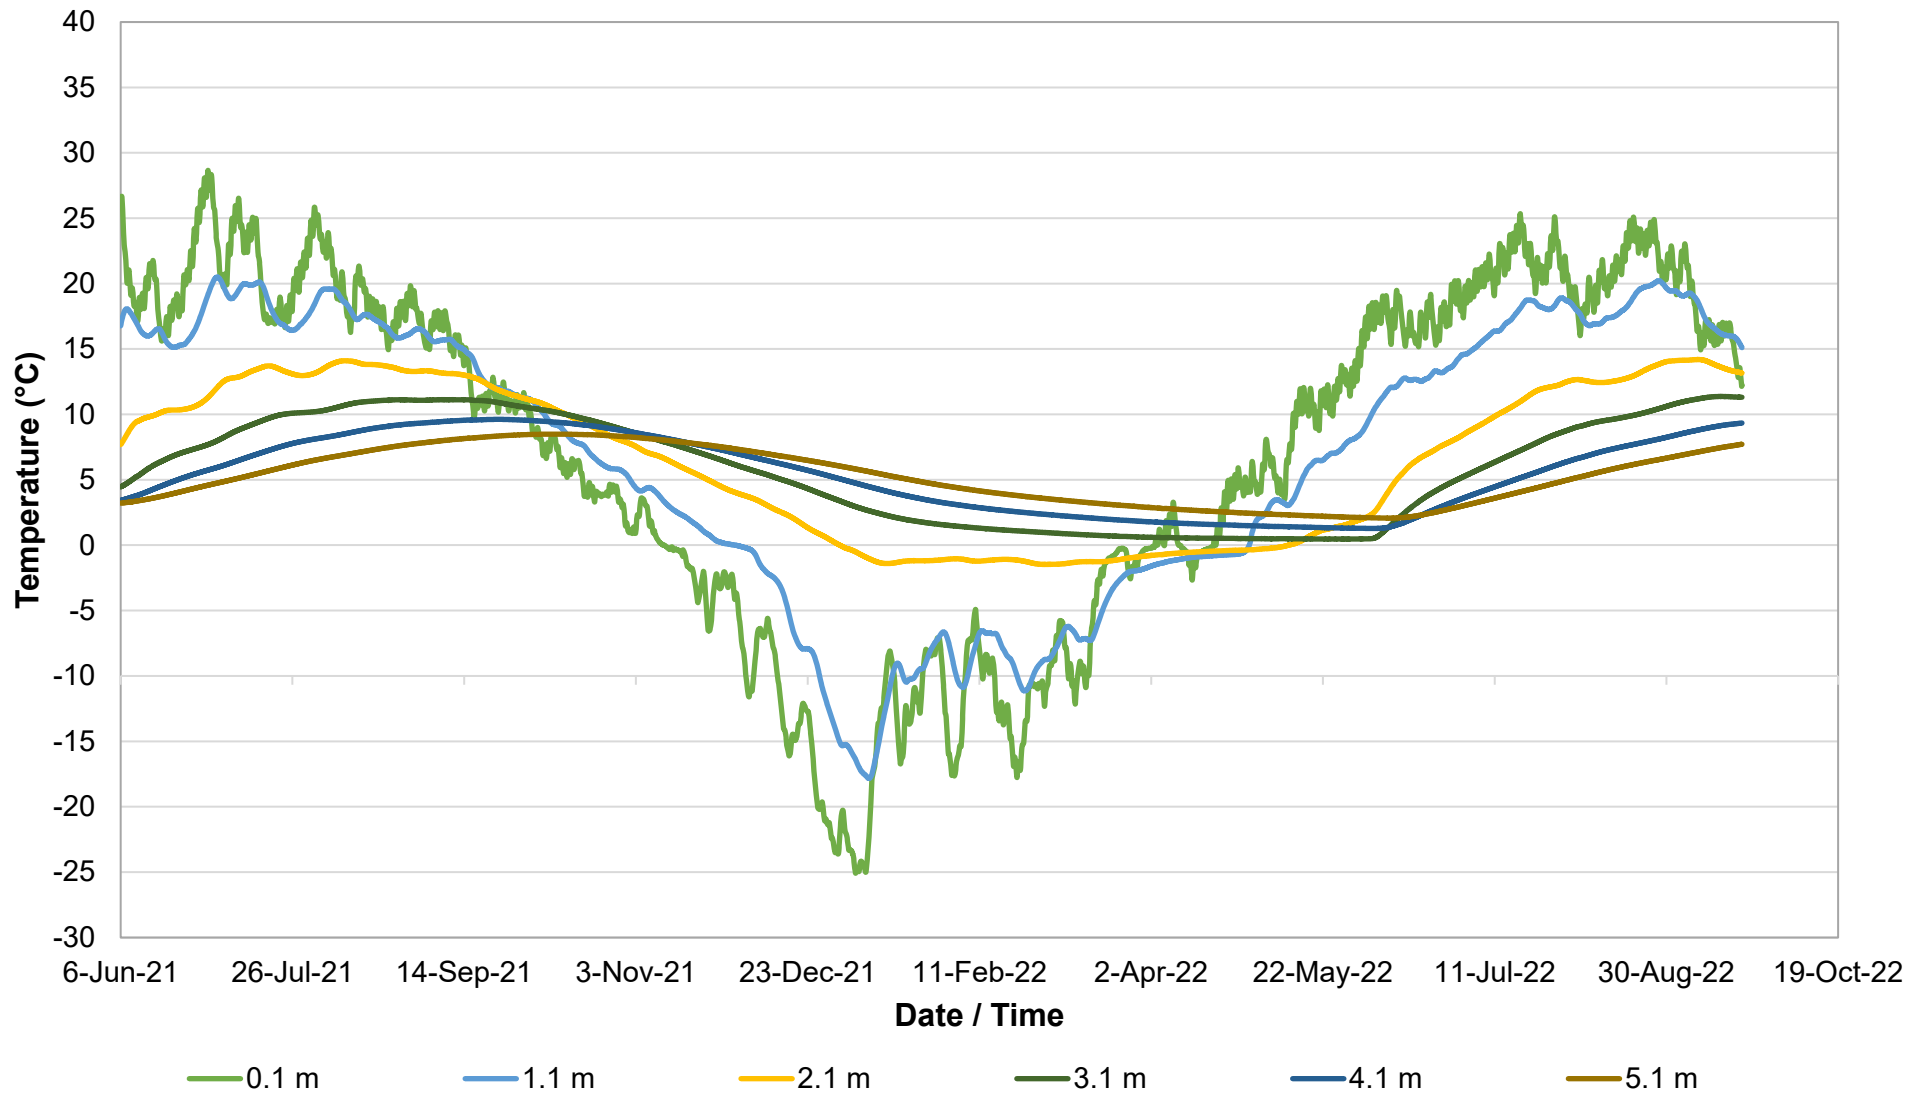
**Figure NC106-3**  
**Highway 63:08 km 27.9 Pavement Distress Near Wandering River, Alberta**  
**THERM21-1 (Pavement Control)**

Thermistor array THERM 21-1 (Figure NC106-3), installed south of the Cematrix repair zone, shows highly variable temperature readings within its shallowest thermistor node (0.1 m depth) reflecting changes in air temperature, which was somewhat muted in the next thermistor node at 1.1 m depth. The thermistor nodes at 2.1 m and 3.1 m depth have been showing a trend of steadily increasing temperatures since the spring. The lowest nodes at 4.1 m and 5.1 m show a trend of slowly decreasing temperatures until the beginning of the summer, after which they have showed a trend of gradually increasing temperatures.

The data for THERM21-1 indicates that the maximum frost penetration for this instrument was between 2.1 m and 3.1 m during the winter of 2021-2022.

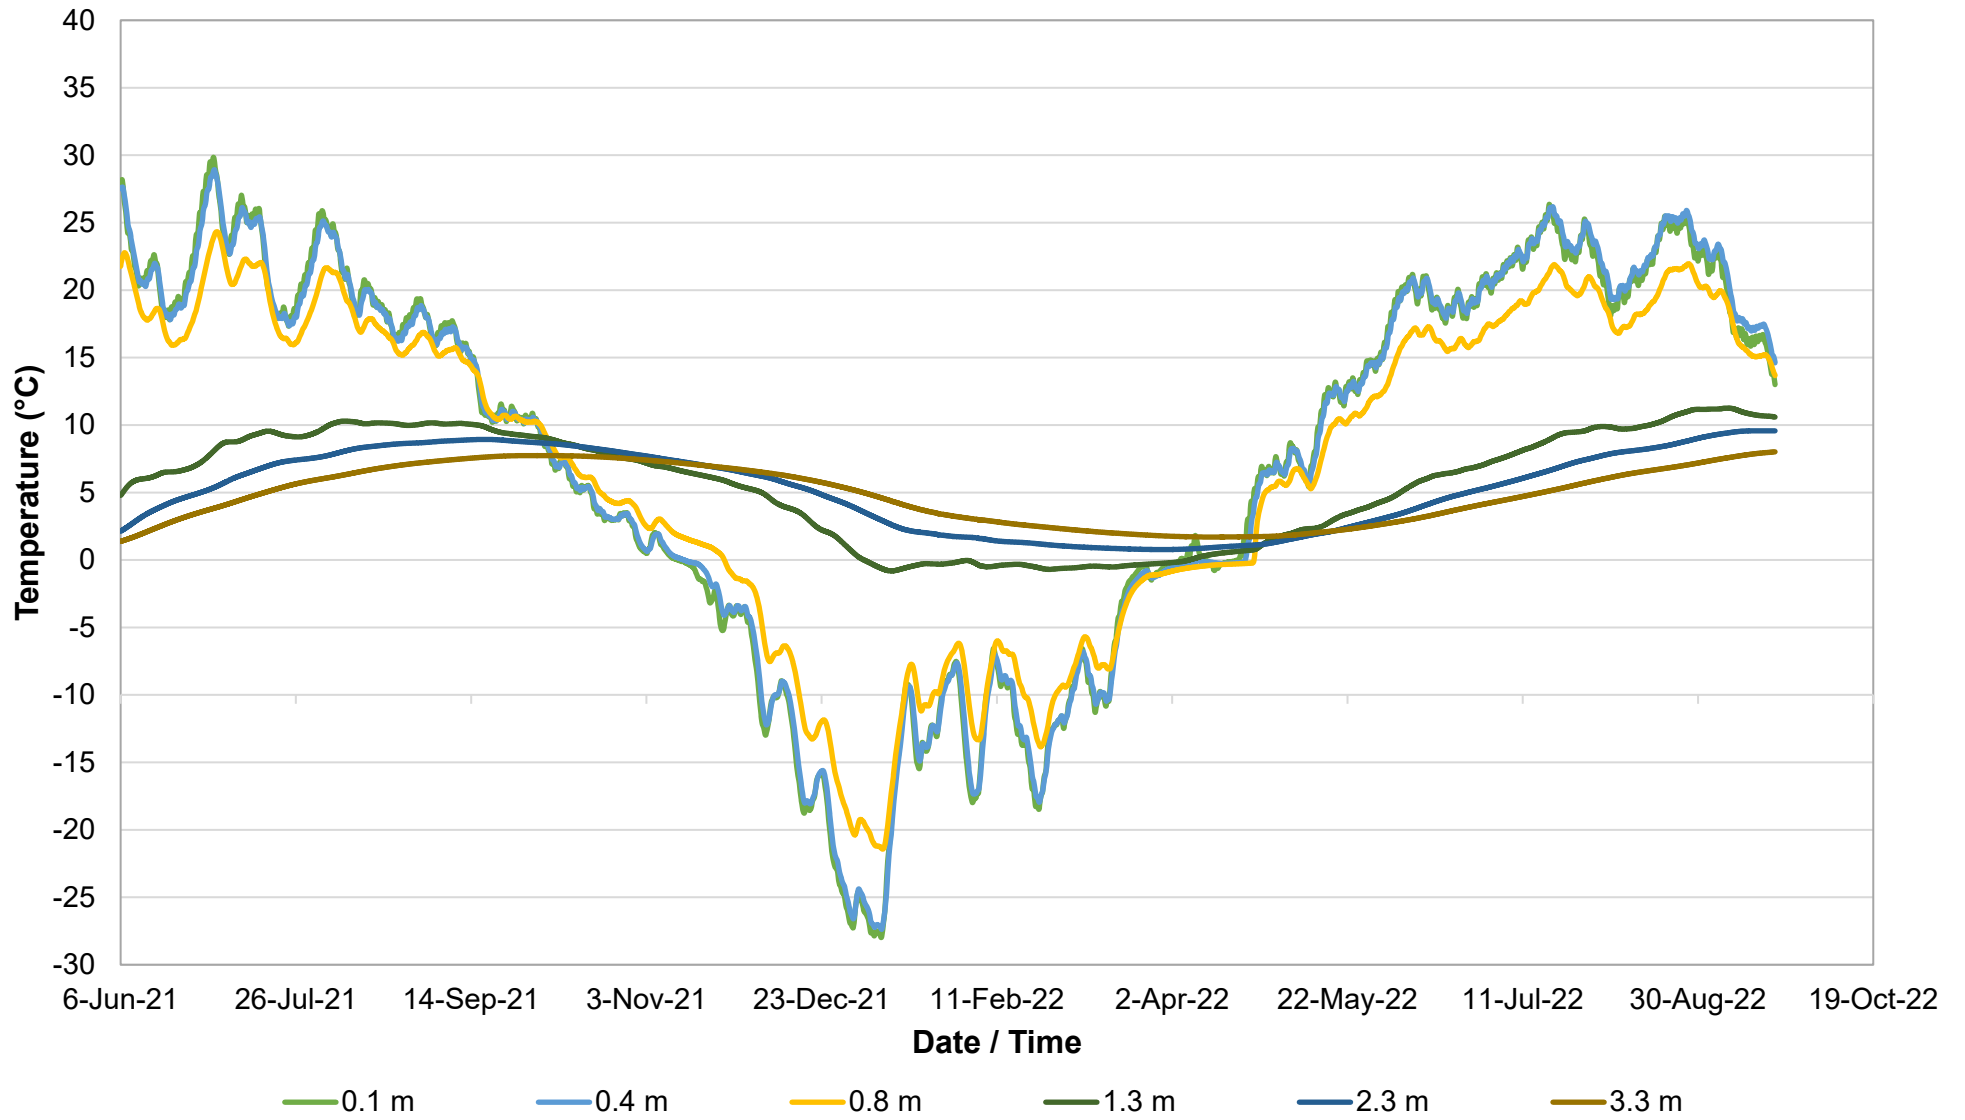
**Figure NC106-4**  
**Highway 63:08 km 27.9 Pavement Distress Near Wandering River, Alberta**  
**THERM21-2 (Pavement Test)**

In THERM21-2 and THERM21-3 (Figures NC106-4 and -5, respectively), installed within the Cematrix repair section, the thermistor nodes within the combined Cematrix, clay cap and GBC layer (thermistors installed within the upper 1 m) show a similar trend to those observed in the shallow thermistors in THERM21-1, where the temperatures follow a pattern of highly variable temperatures corresponding to increasing ambient temperatures. The temperature trend of the thermistor nodes between 1 m and 3.3 m depth shows a more muted response of slowly increasing temperatures since approximately late May 2022. The deeper thermistor nodes in THERM21-3 at 4.3 m and 5.3 m depth show an overall pattern of stable to slowly increasing temperatures over the monitoring period. It should be noted that there was significant noise in the

The data from THERM21-2 indicates that the maximum frost penetration at this location was between 1.3 m and 2.3 m during the previous winter, which when compared to the pavement control section, demonstrates that the Cematrix had an insulating effect for the instrument at this location. The data from THERM21-3 shows that the maximum frost penetration was between 2.3 m and 3.3 m depth, which is similar to what was observed in the pavement control section.

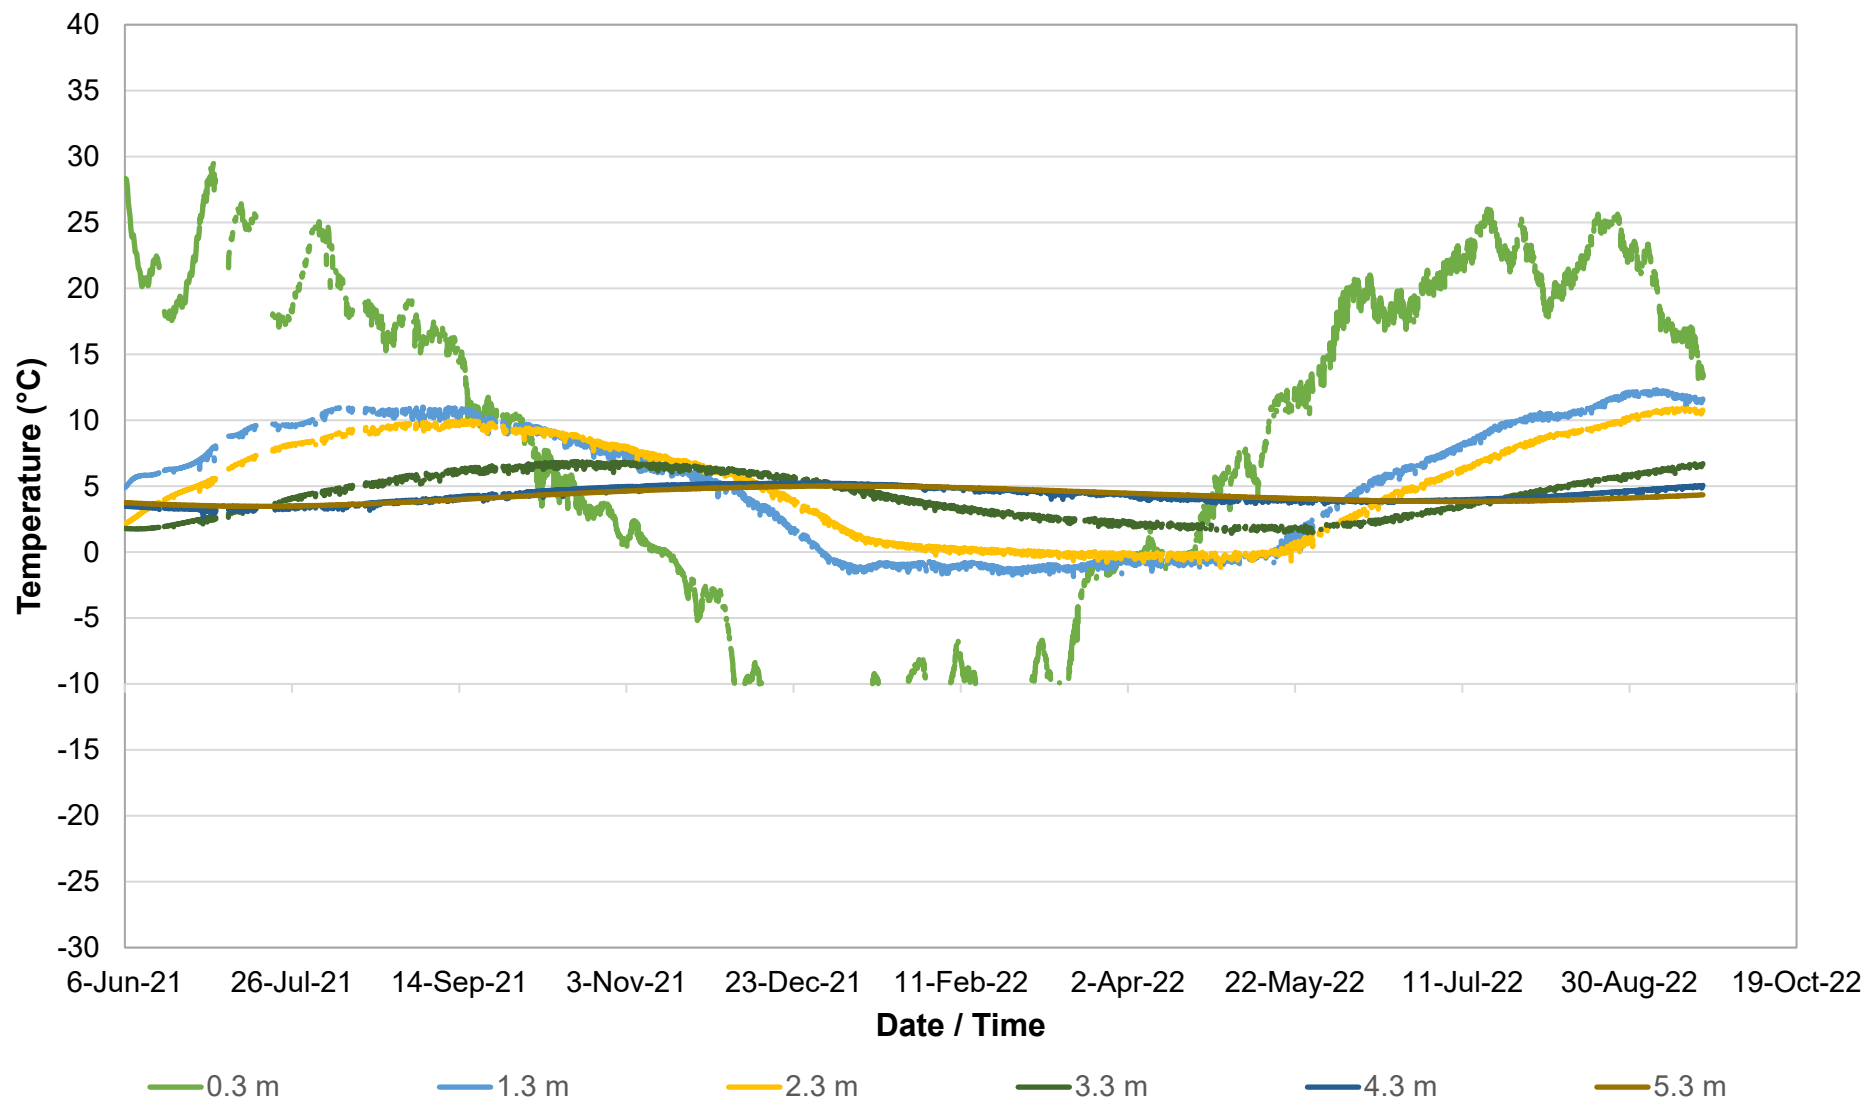
**Figure NC106-5**  
**Highway 63:08 km 27.9 Pavement Distress Near Wandering River, Alberta**  
**THERM21-3 (Pavement Test)**

signals from THERM21-3 and erroneous readings have been removed, resulting in the gaps in the data., particularly during the coldest portion of the winter from December 2021 to January 2022.

During the spring of 2022 site visit, it was confirmed that THERM 21-3 is wired properly, and the erratic data is due to a malfunction of the instrument itself. For future readings, the data will need to be filtered to remove the erratic readings from this instrument.

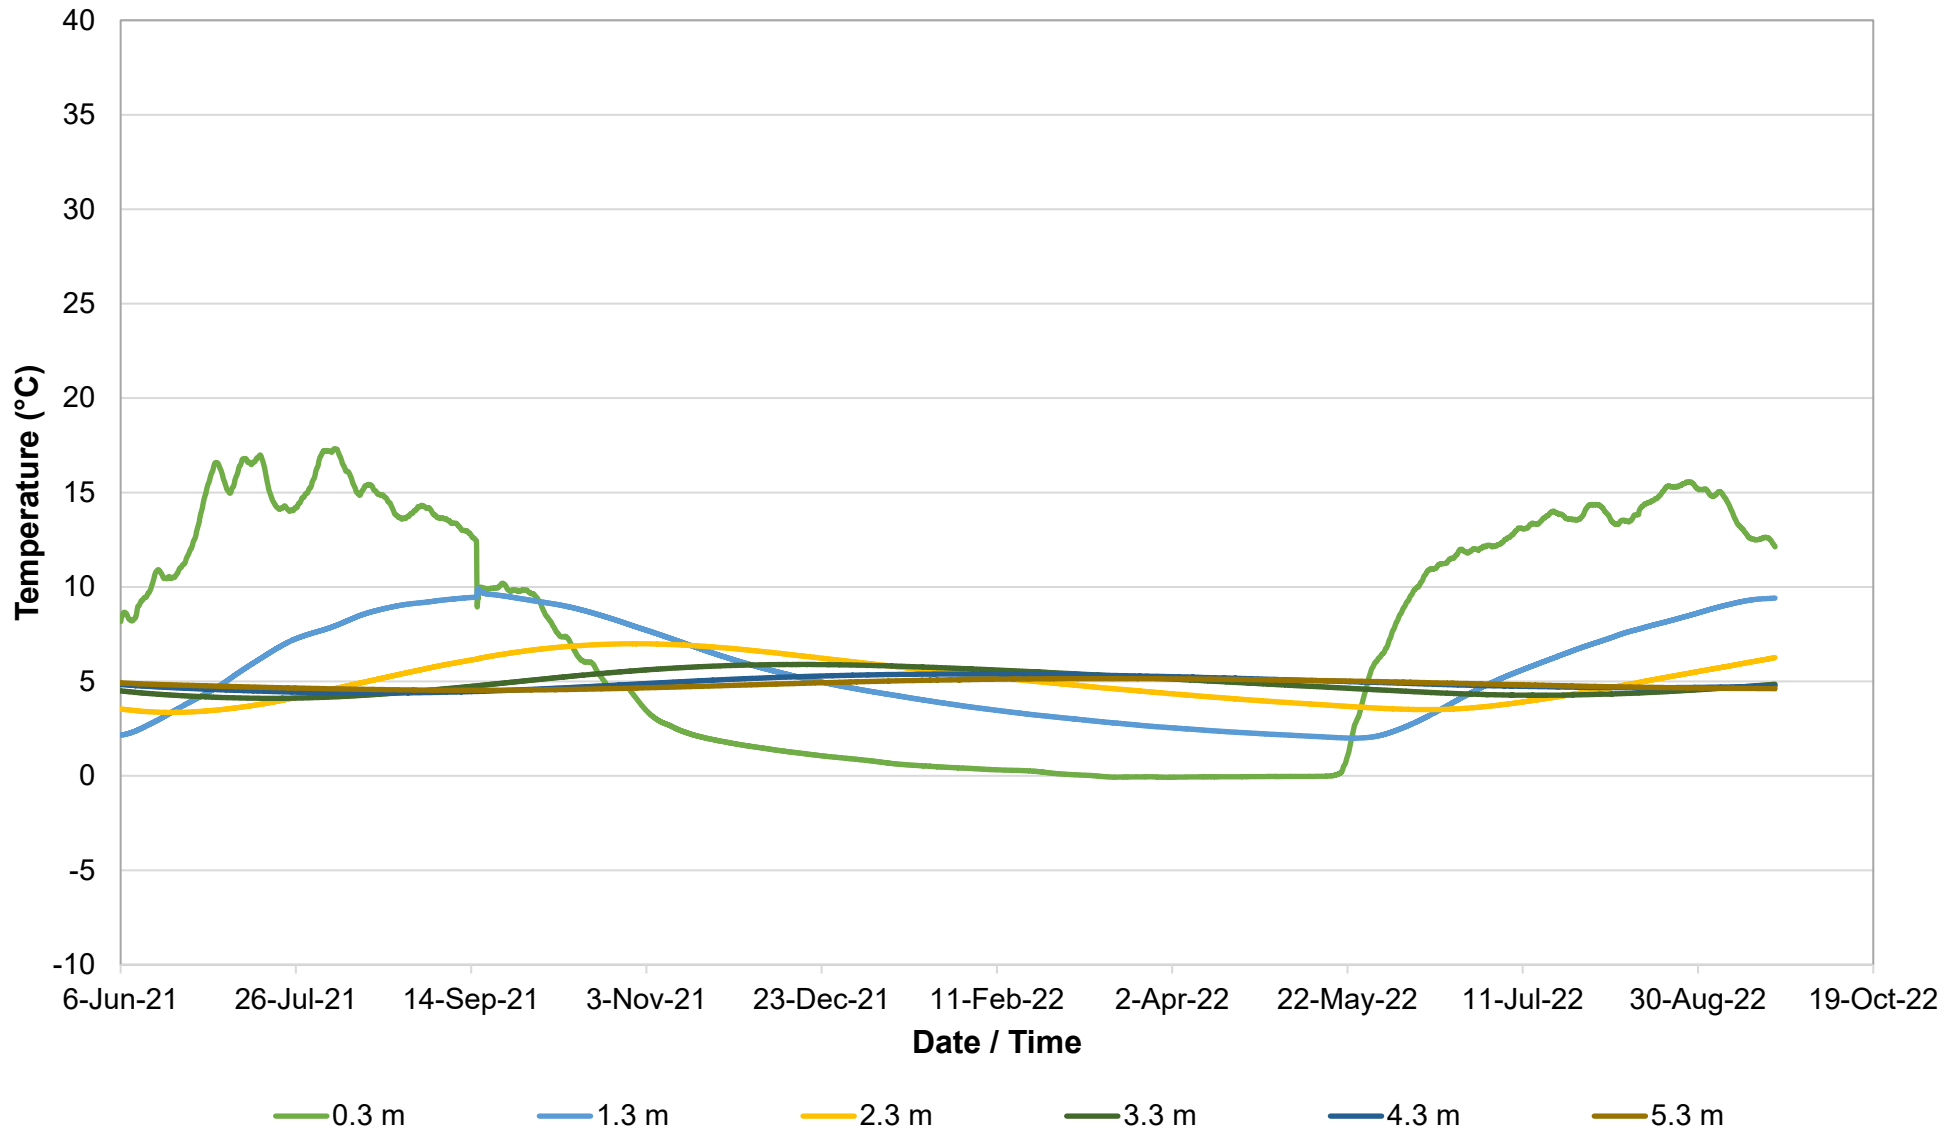
**Figure NC106-6**  
**Highway 63:08 km 27.9 Pavement Distress Near Wandering River, Alberta**  
**THERM21-4 (Control Grassed)**

THERM21-4 (Figure NC106-6) was installed in the grass-covered highway ditch west of the southbound highway lanes. Compared to the other thermistor arrays installed within the pavement, the shallow thermistor node at 0.3 m shows a much more muted response to changes in temperature, presumably due to the vegetative, rather than asphalt surface. The shallow node at this instrument showed a much slower trend of decreasing temperature starting in November 2021 before a sharp increase in temperature starting in May 2022. The behavior of this instrument can likely be attributed due to the insulating effect of the snow cover at its location. The thermistor nodes at 1.3 m and 2.3 m depth shows a trend of slowly increasing temperatures since the previous monitoring period, while the deepest two notes at 4.3 m and 5.3 m depth show an overall stable temperature trend during this time.

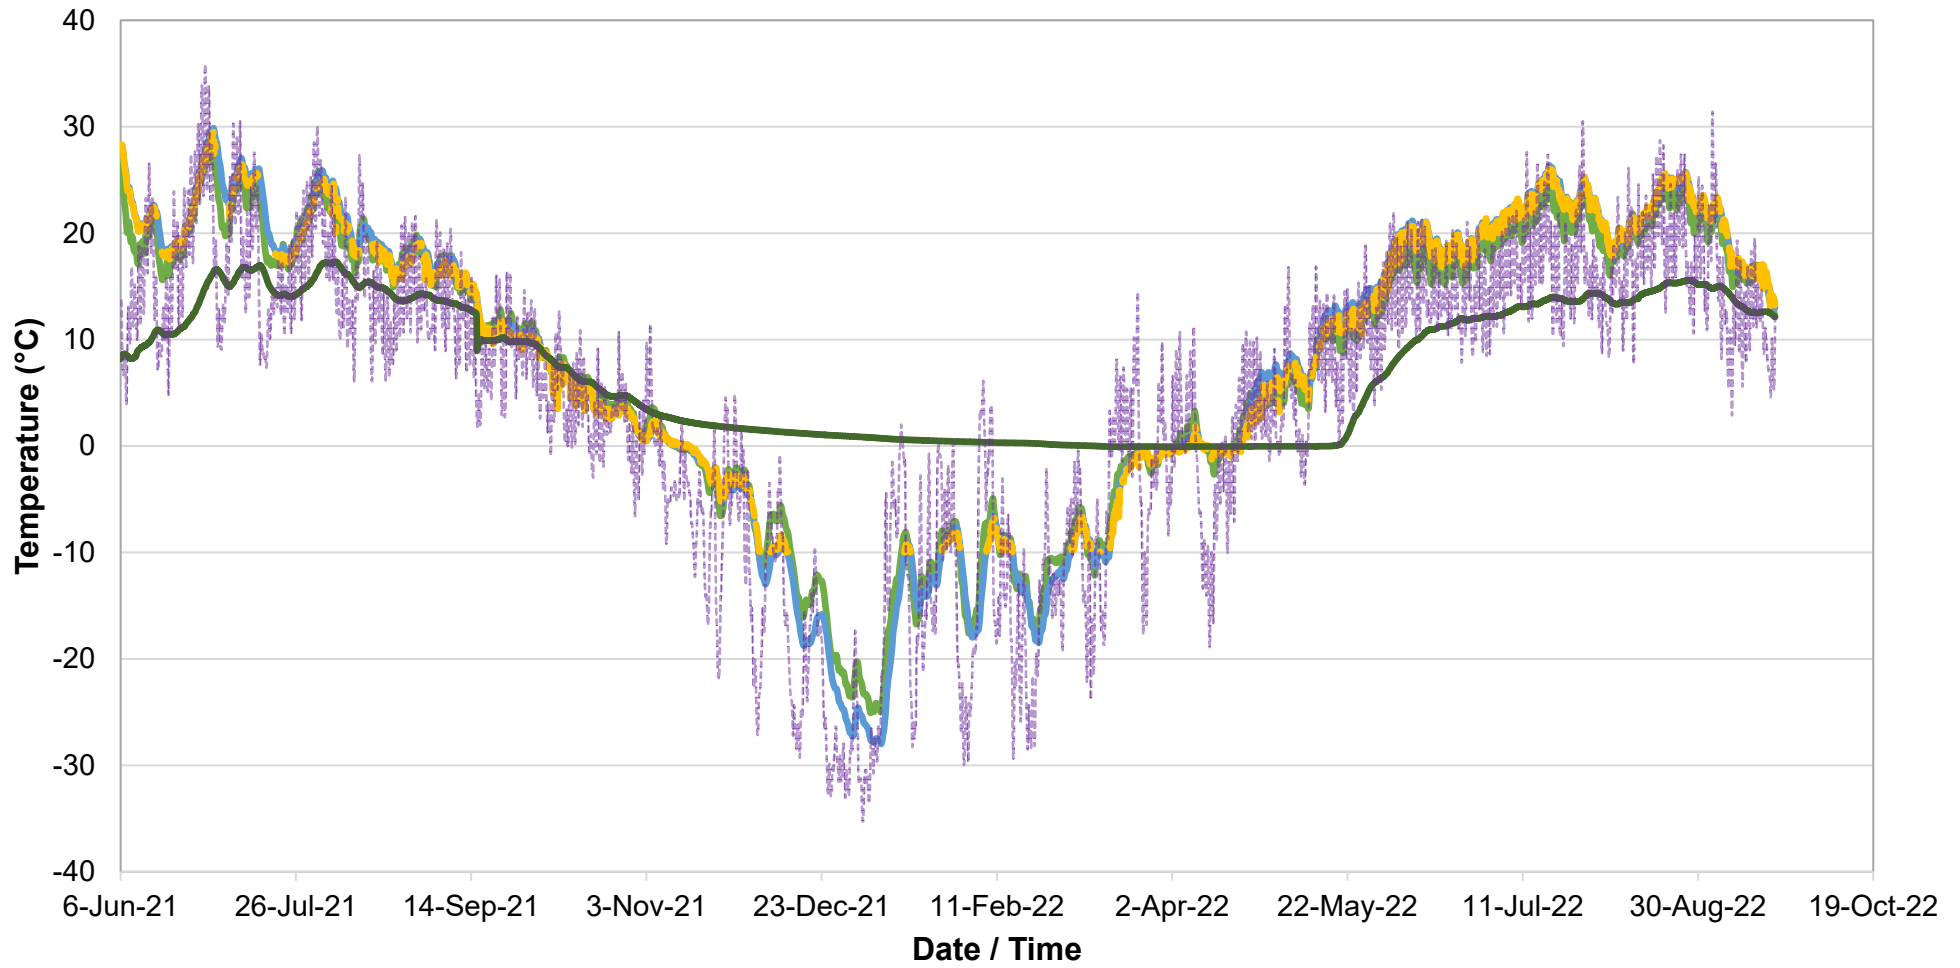
**Figure NC106-7**  
**Highway 63:08 km 27.9 Pavement Distress Near Wandering River, Alberta**  
**Surface Thermistors and Weather Data**

The near-surface temperature nodes from each thermistor array, compared to the ambient temperature are plotted in Figure NC106-7 in Appendix A. From this figure, it can be seen that the near-surface temperature nodes in the highway closely follow the ambient air temperatures, while the shallow thermistor in THERM21-4 remains much more stable.

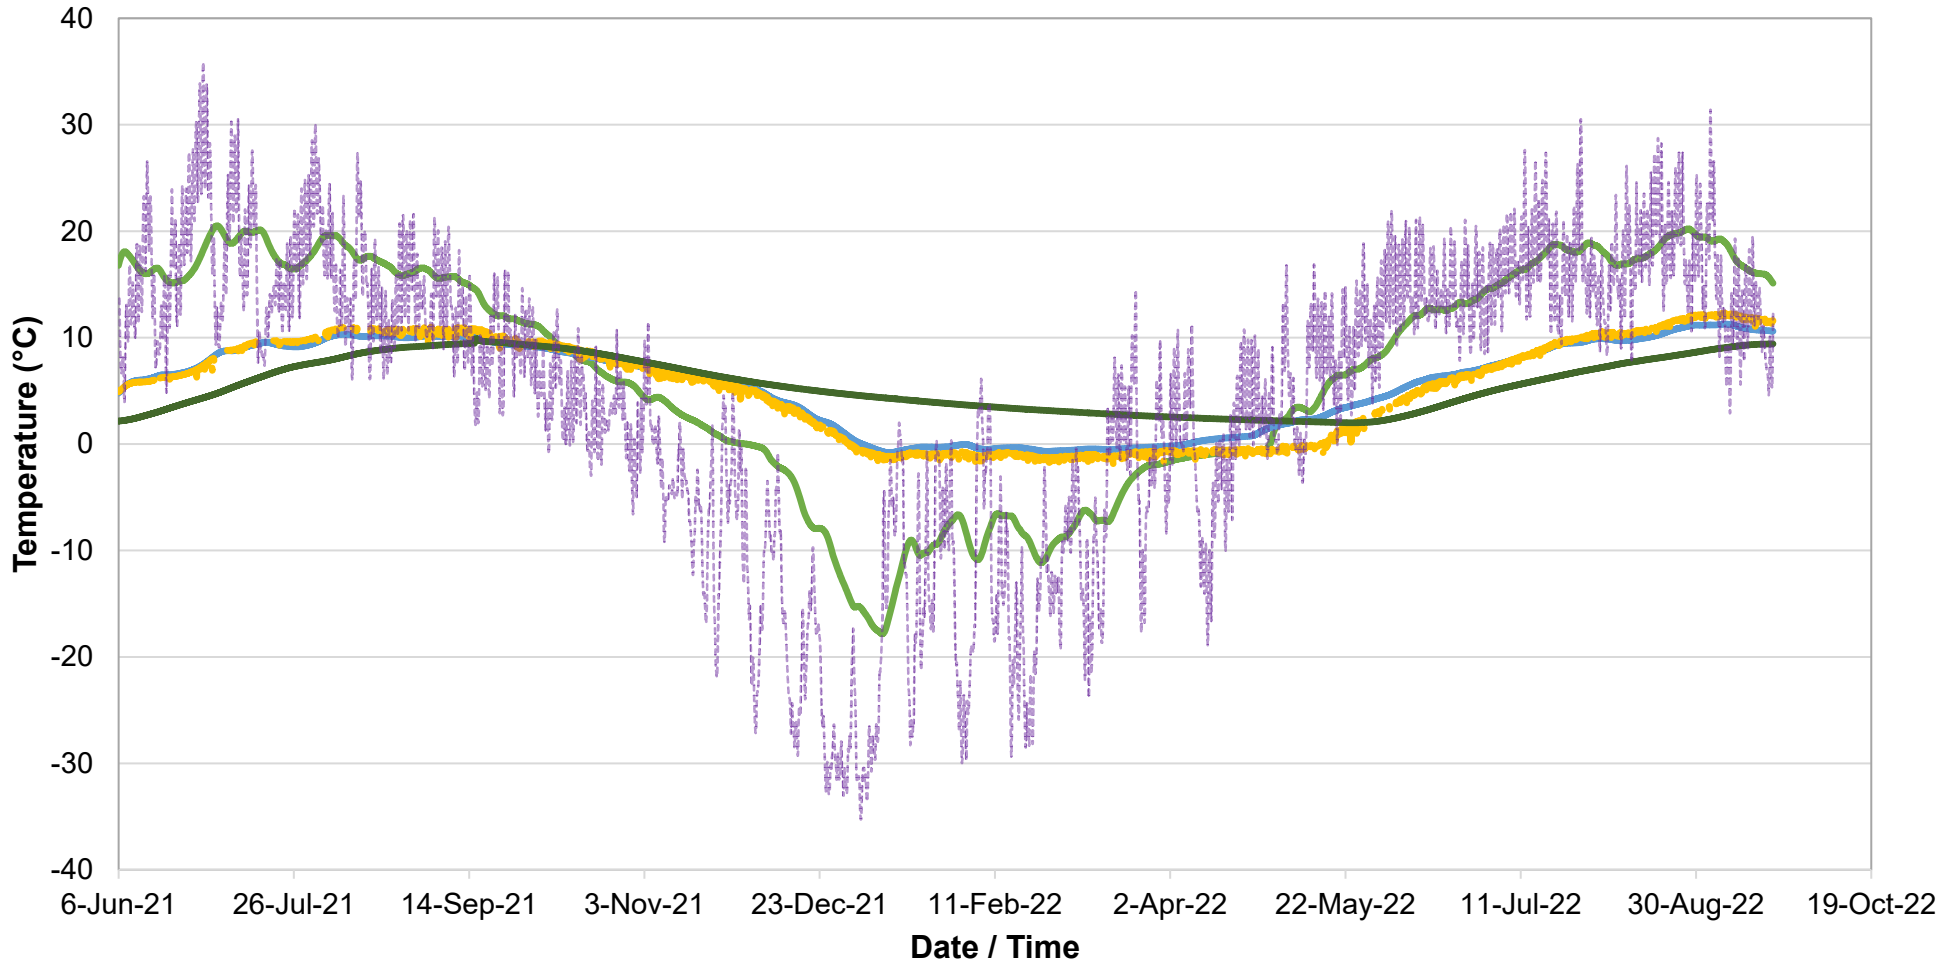
**Figure NC106-8**  
**Highway 63:08 km 27.9 Pavement Distress Near Wandering River, Alberta**  
**1.1 m - 1.3 m Depth Thermistors and Weather Data**

To compare the influence of the Cematrix on temperatures at depth, the 1.1 m – 1.3 m thermistor readings from all four locations are plotted in Figure NC106-8. From this figure, it can be observed that the thermistors in the Cematrix section were less affected by the changes in temperature compared to the pavement control section, which demonstrates the insulating properties of the Cematrix.
