File No.: 32122

**ALBERTA TRANSPORTATION GRMP (CON0022163)
NORTH CENTRAL (ATHABASCA AND FORT McMURRAY DISTRICTS)
INSTRUMENTATION MONITORING RESULTS – FALL 2022**

SITE NC099: HWY 63:10 HANGINGSTONE RIVER BRIDGE

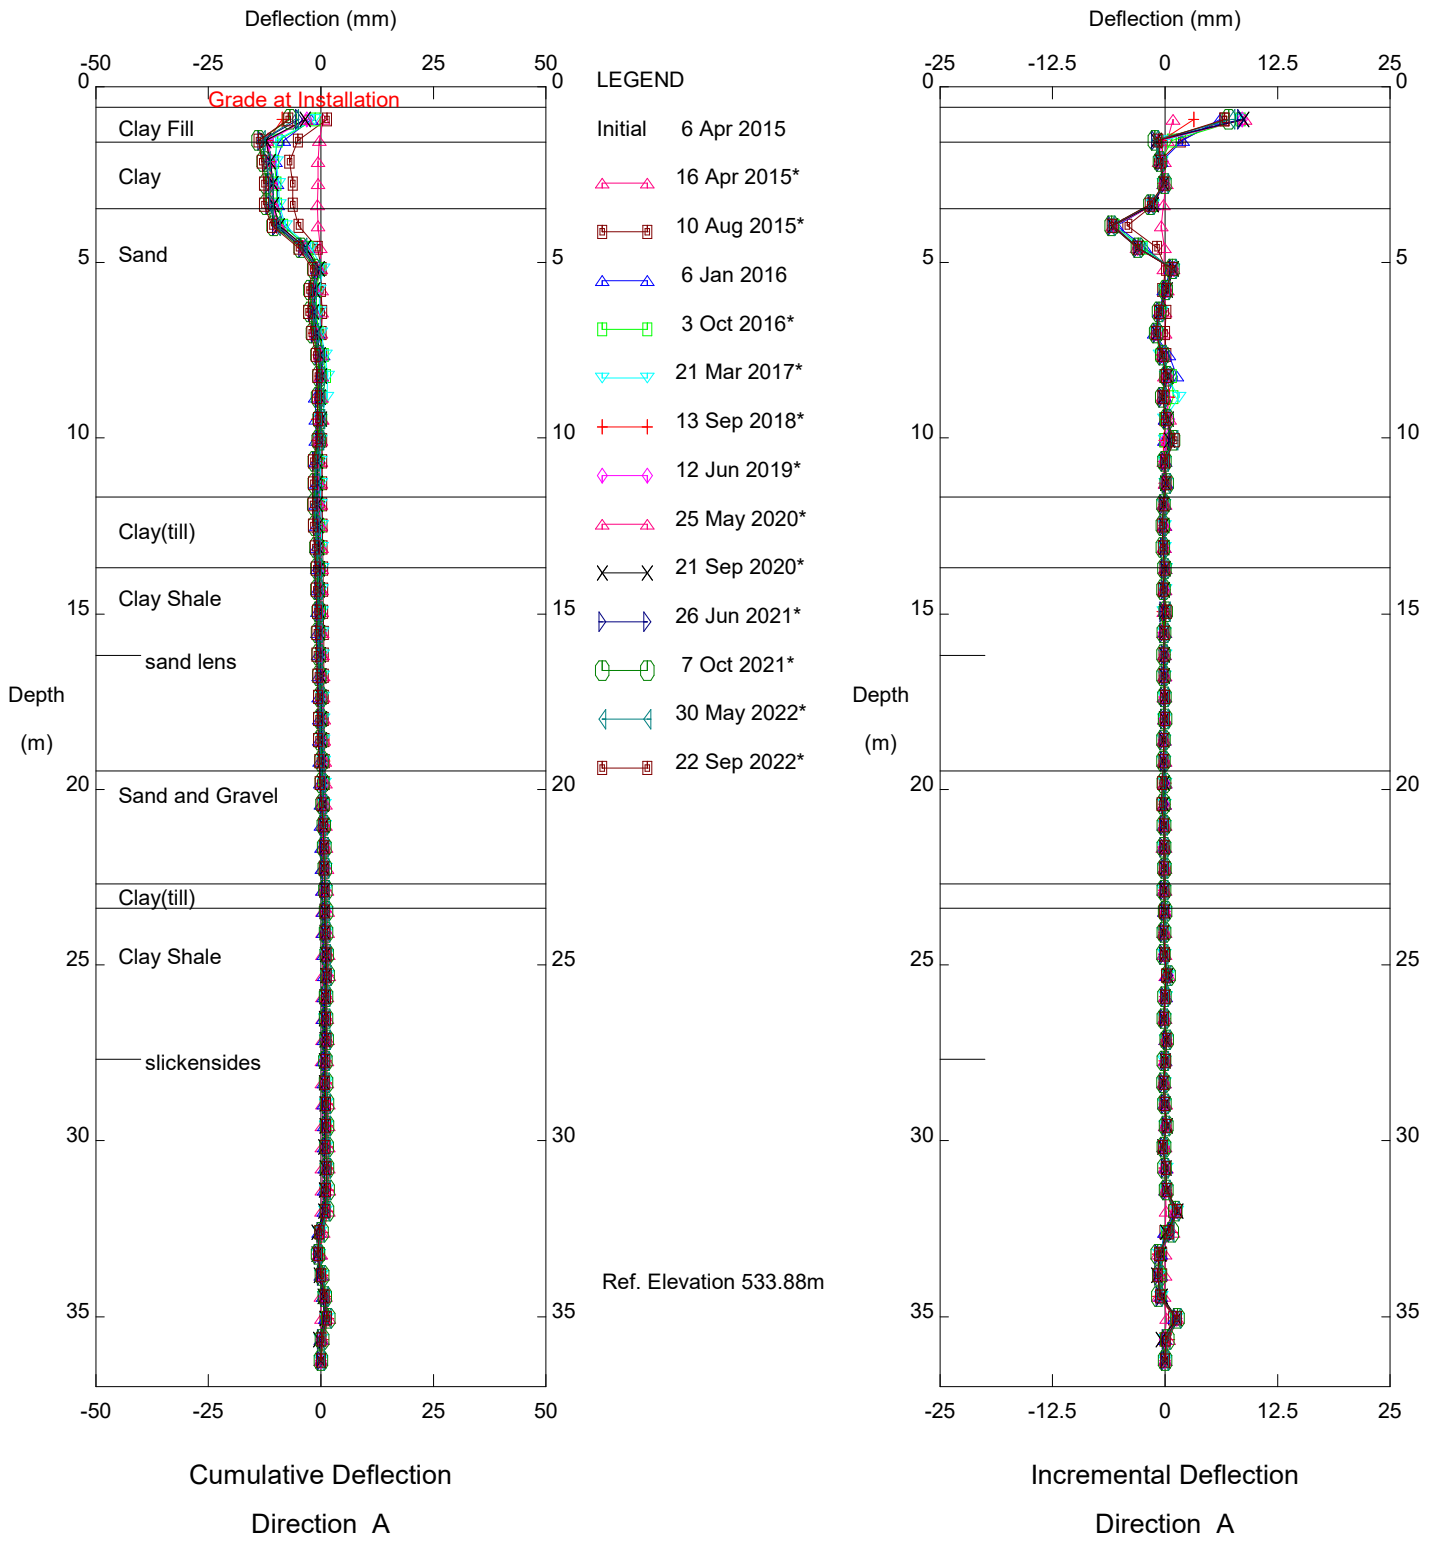
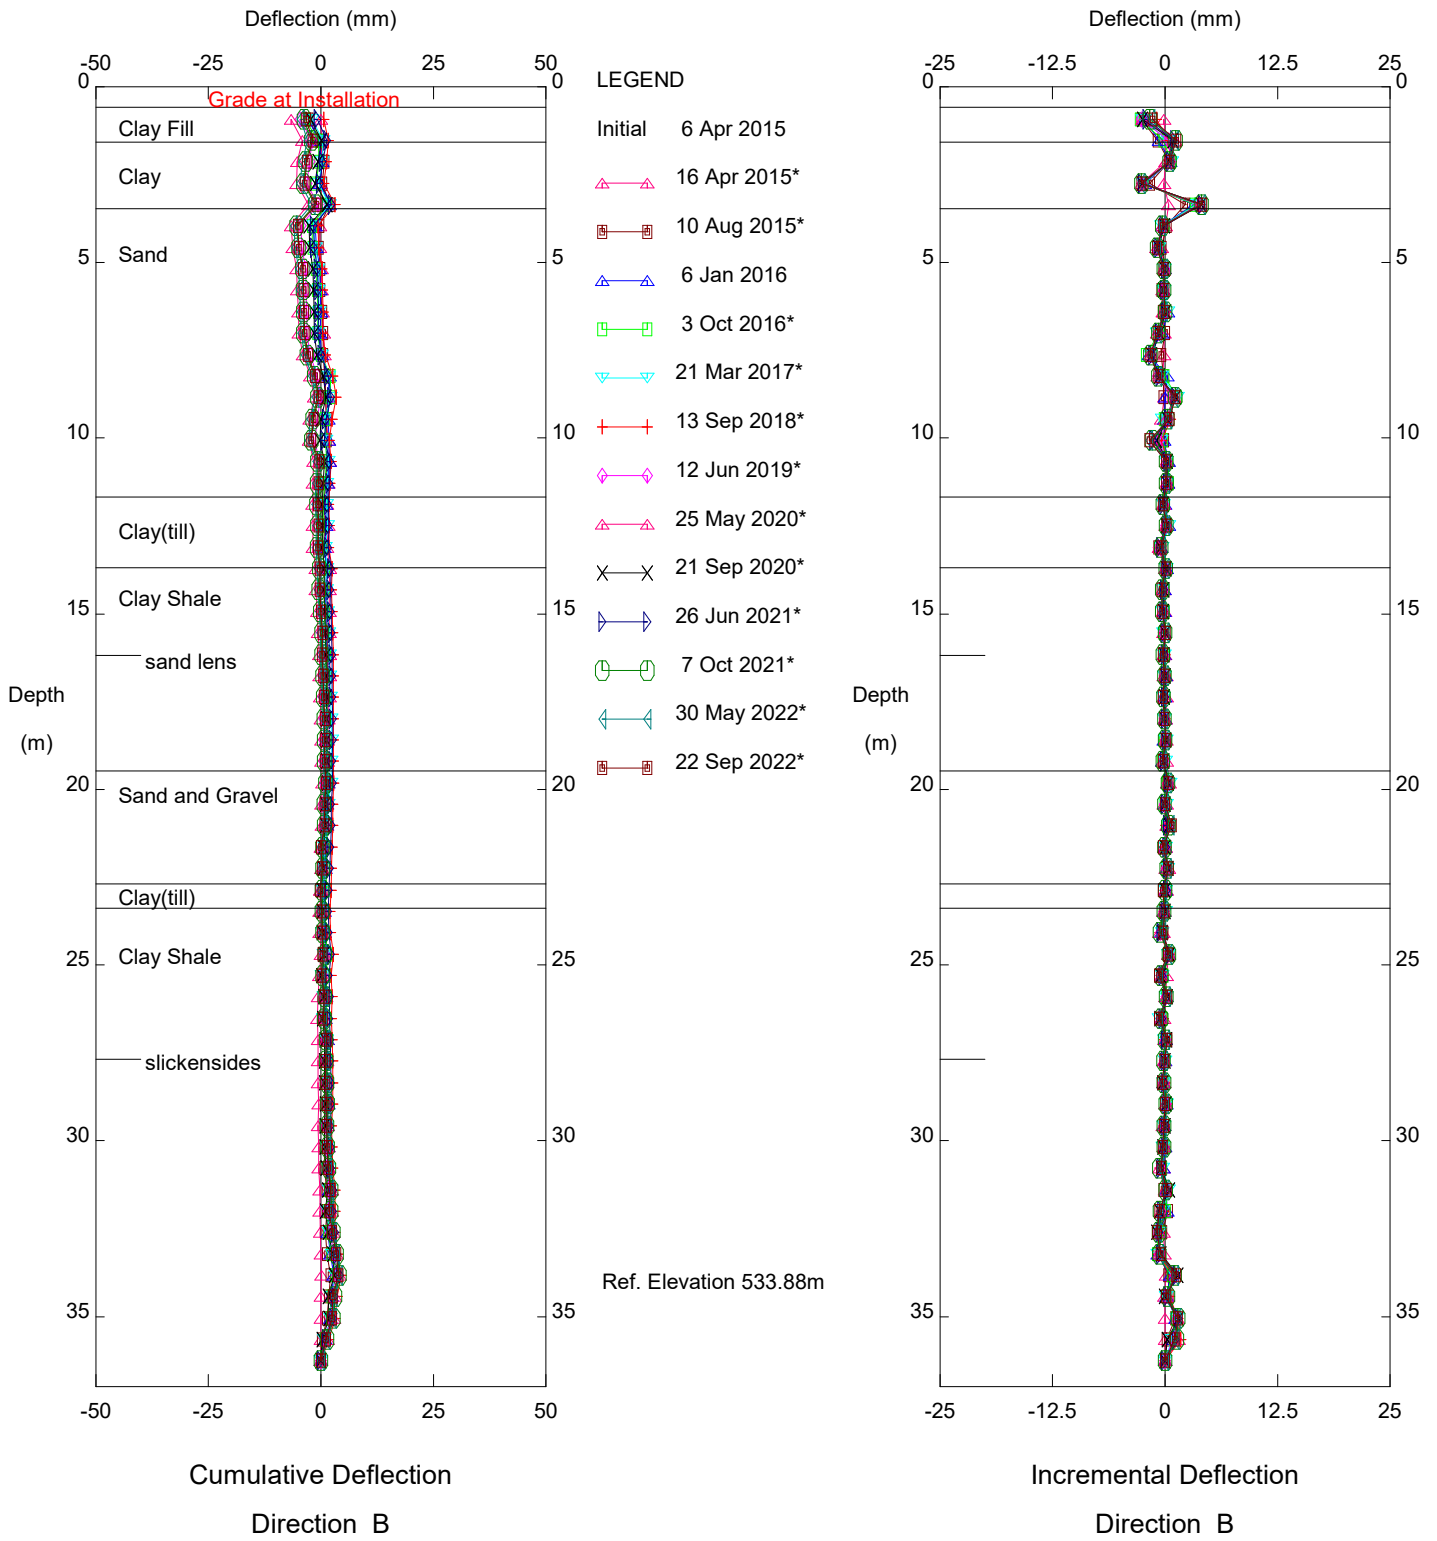
NC099 Cut Slope - Crest, Inclinometer 15-05

Slope inclinometers SI15-05 through SI15-08 have shown no discernible movement since initialization.

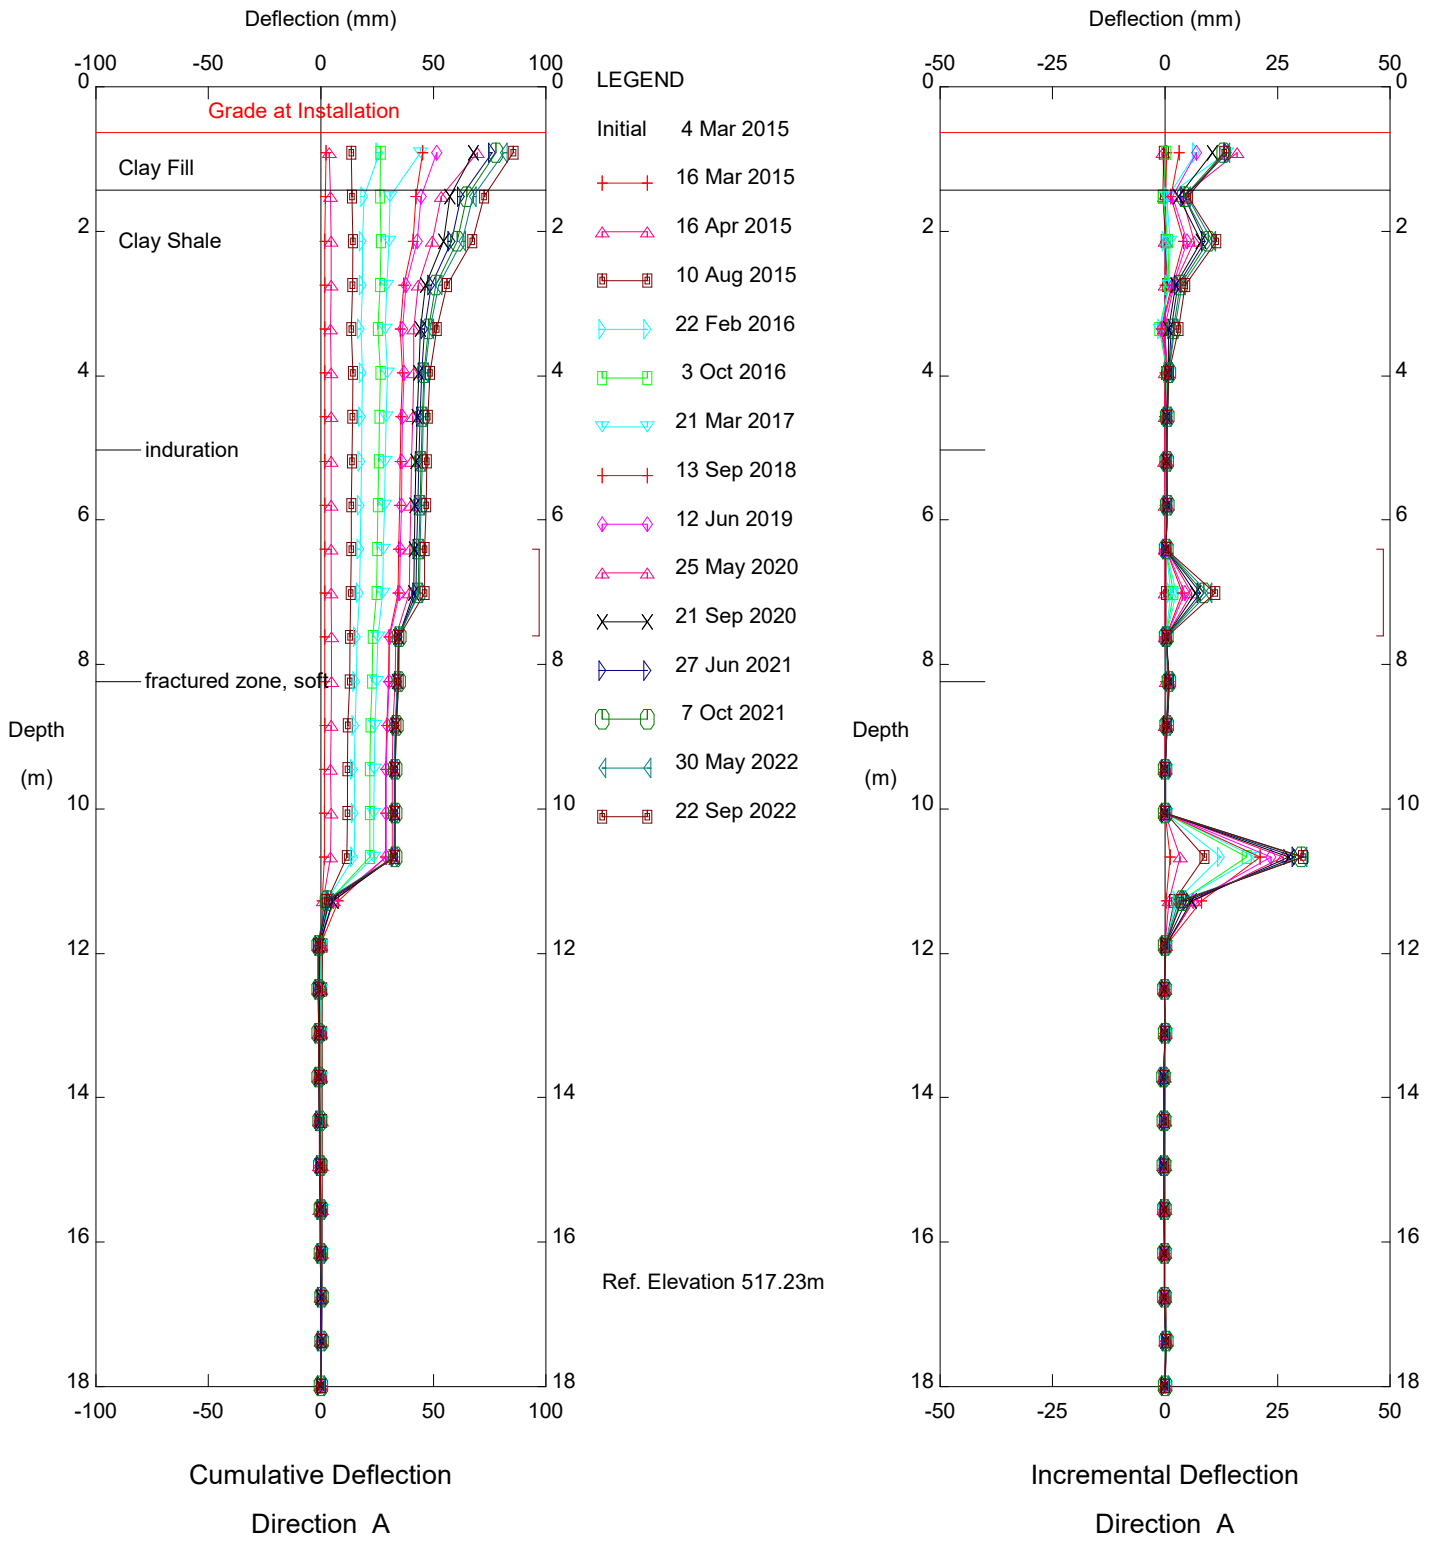
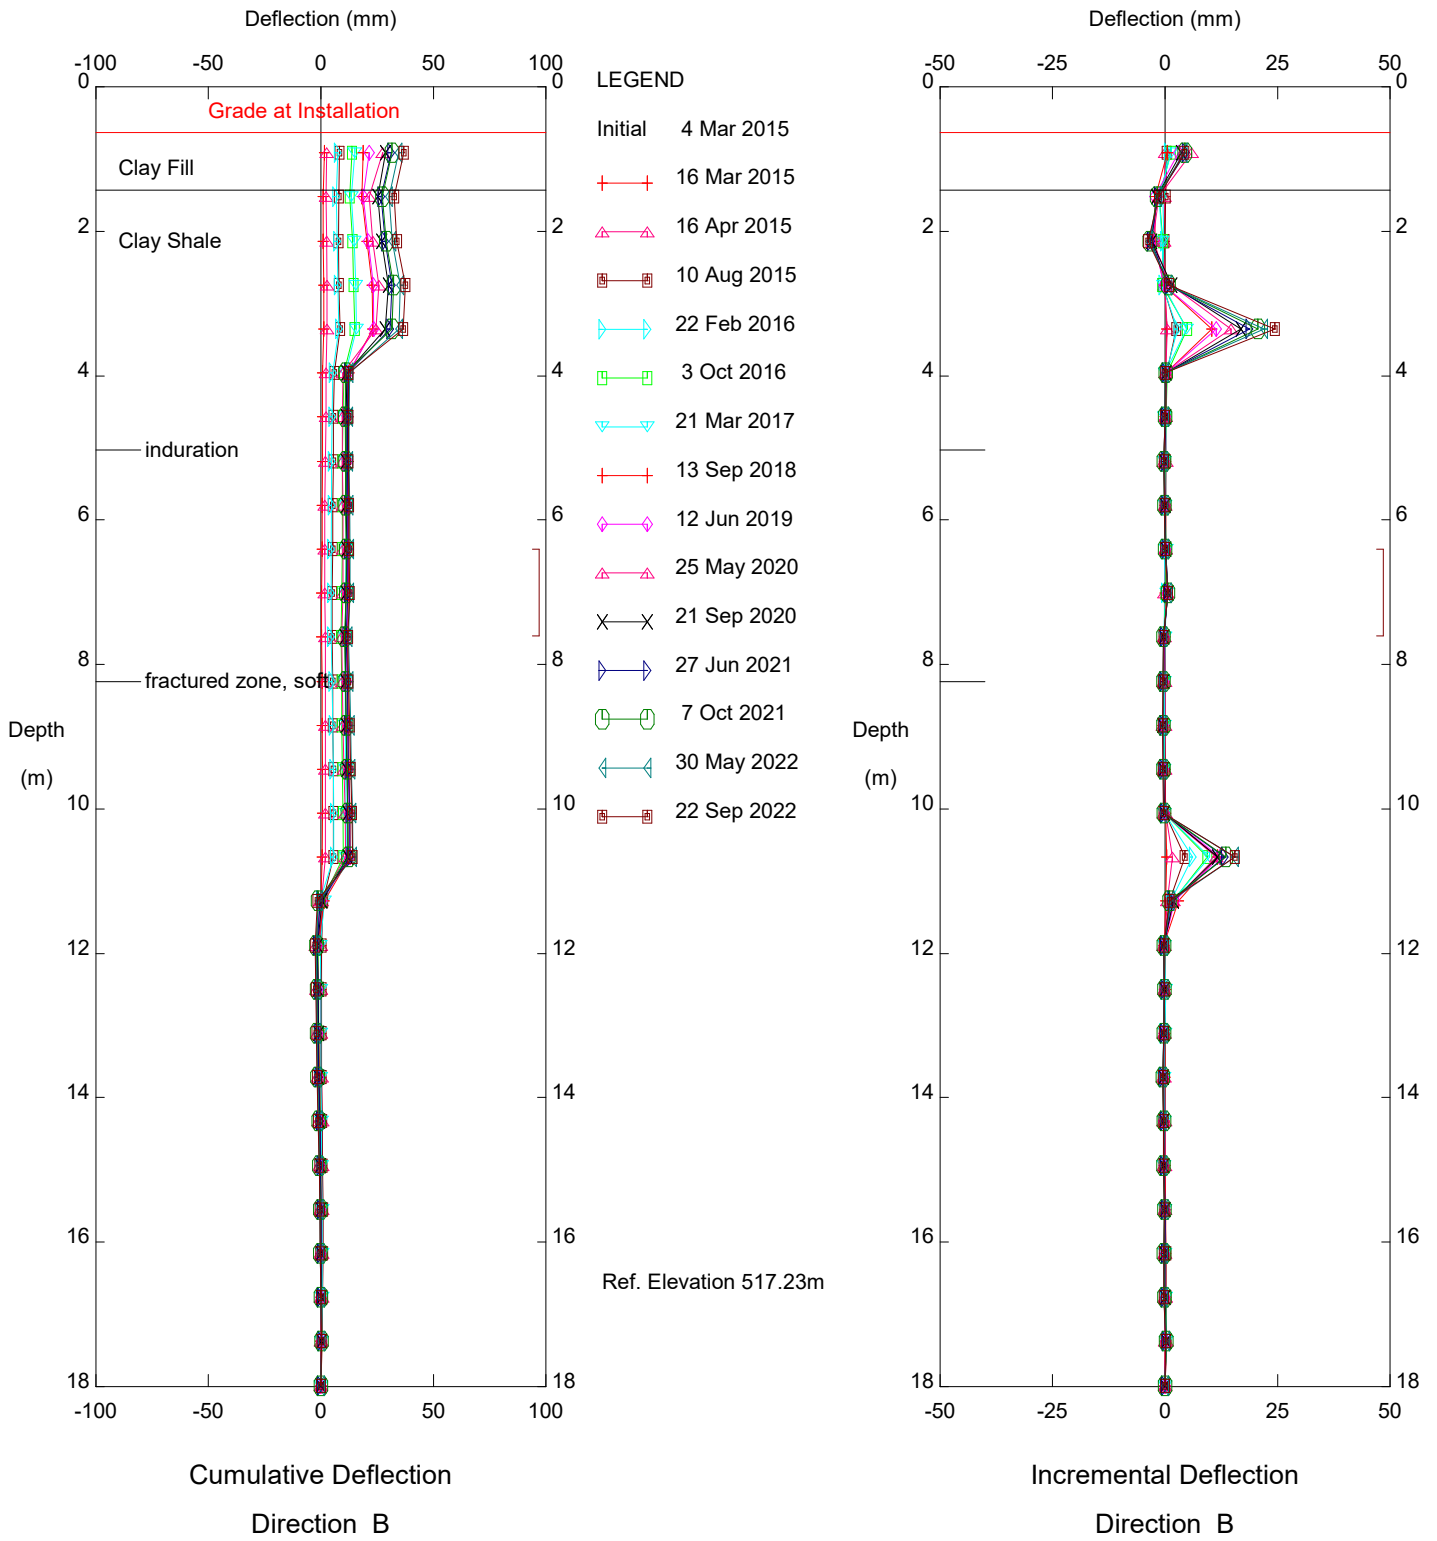
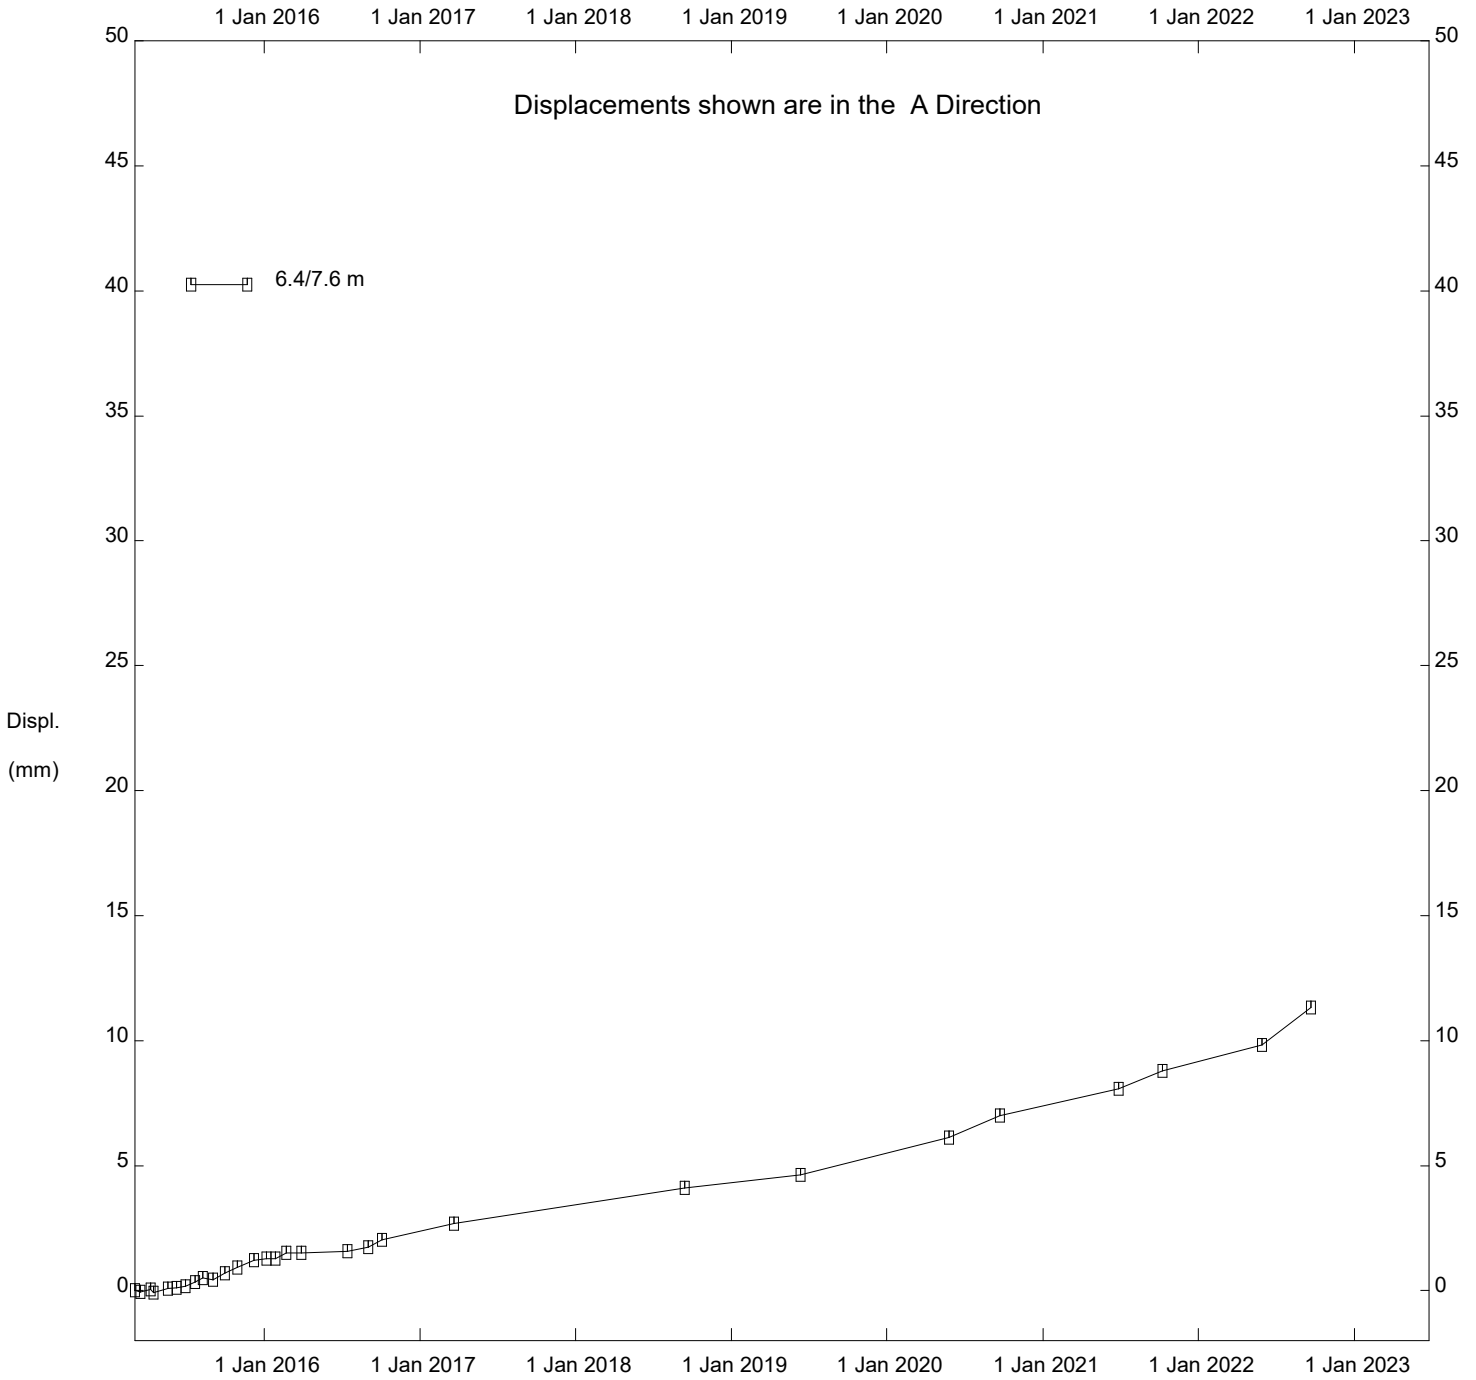
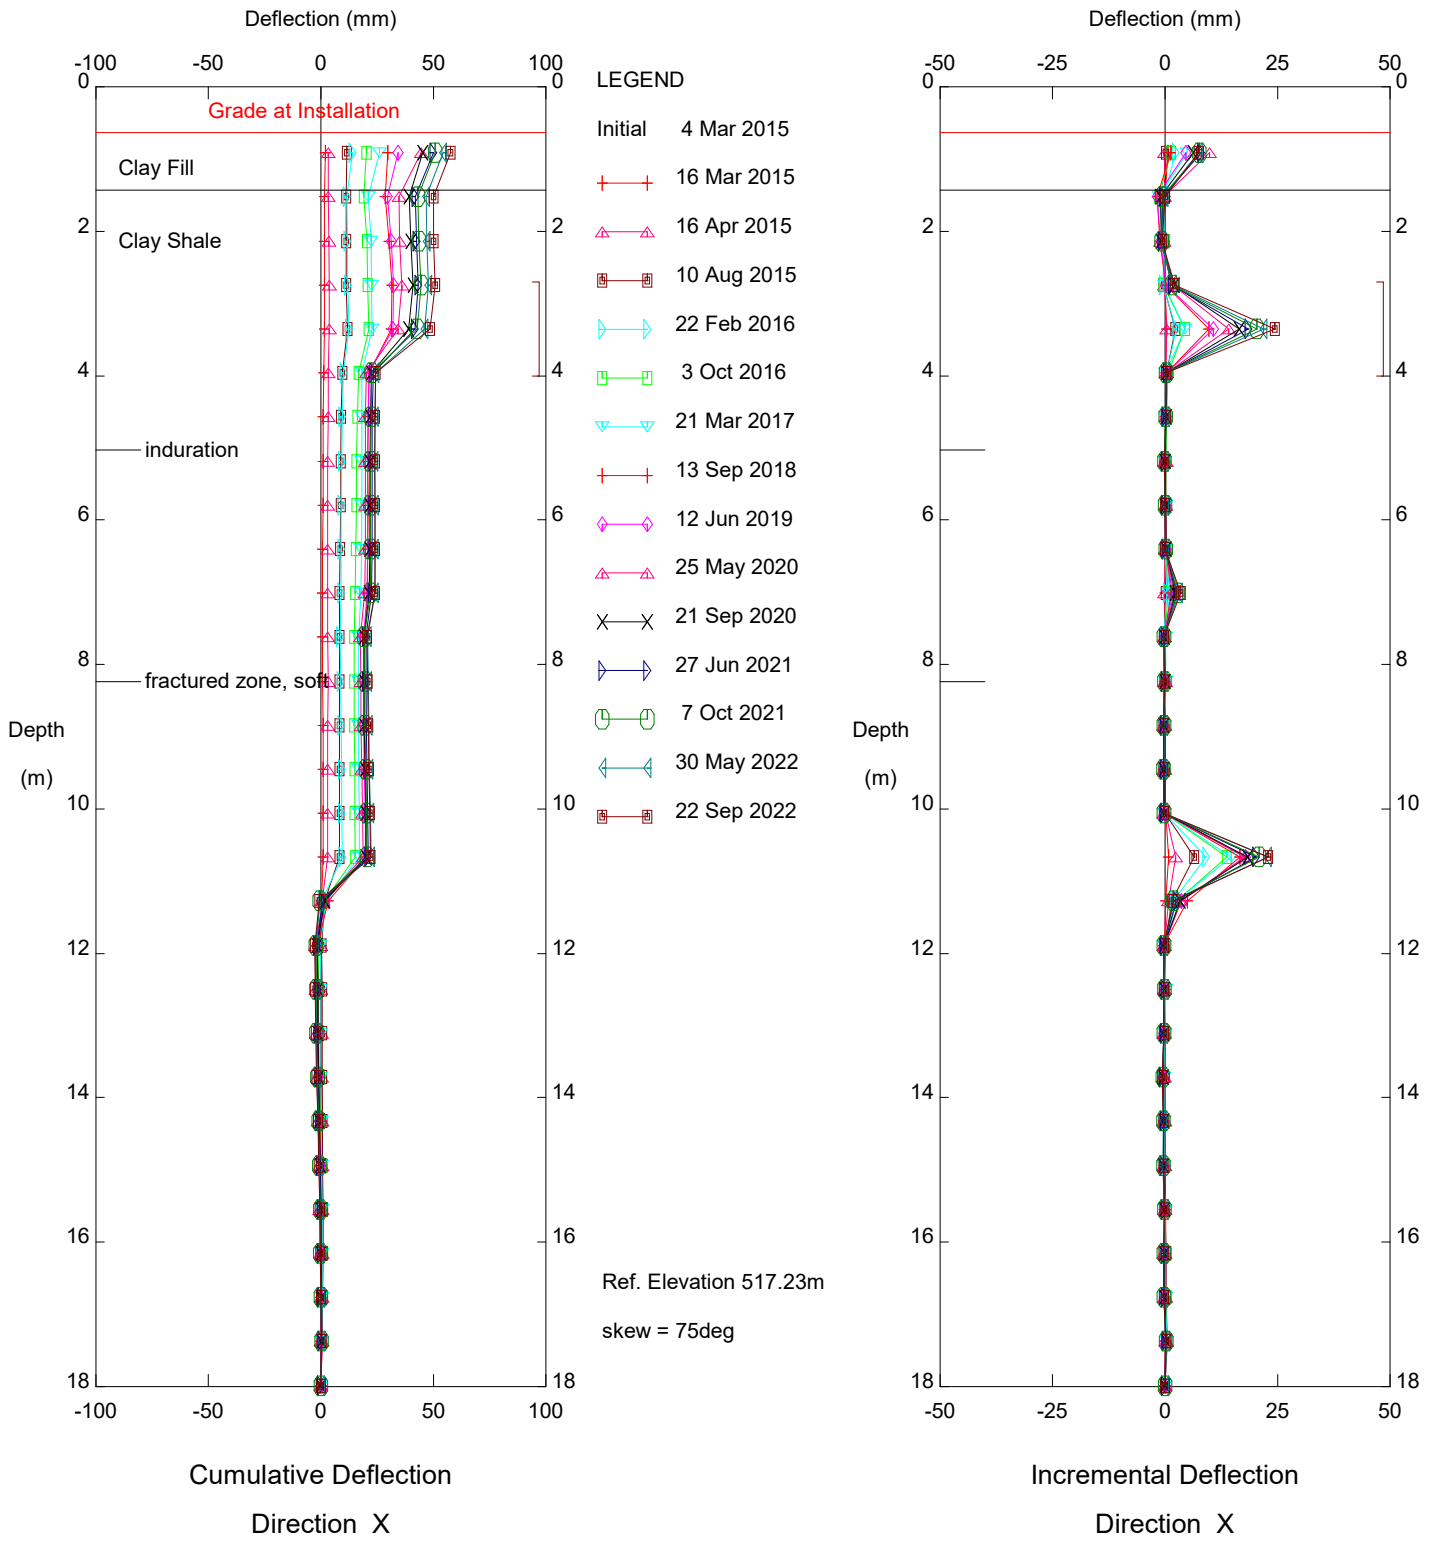
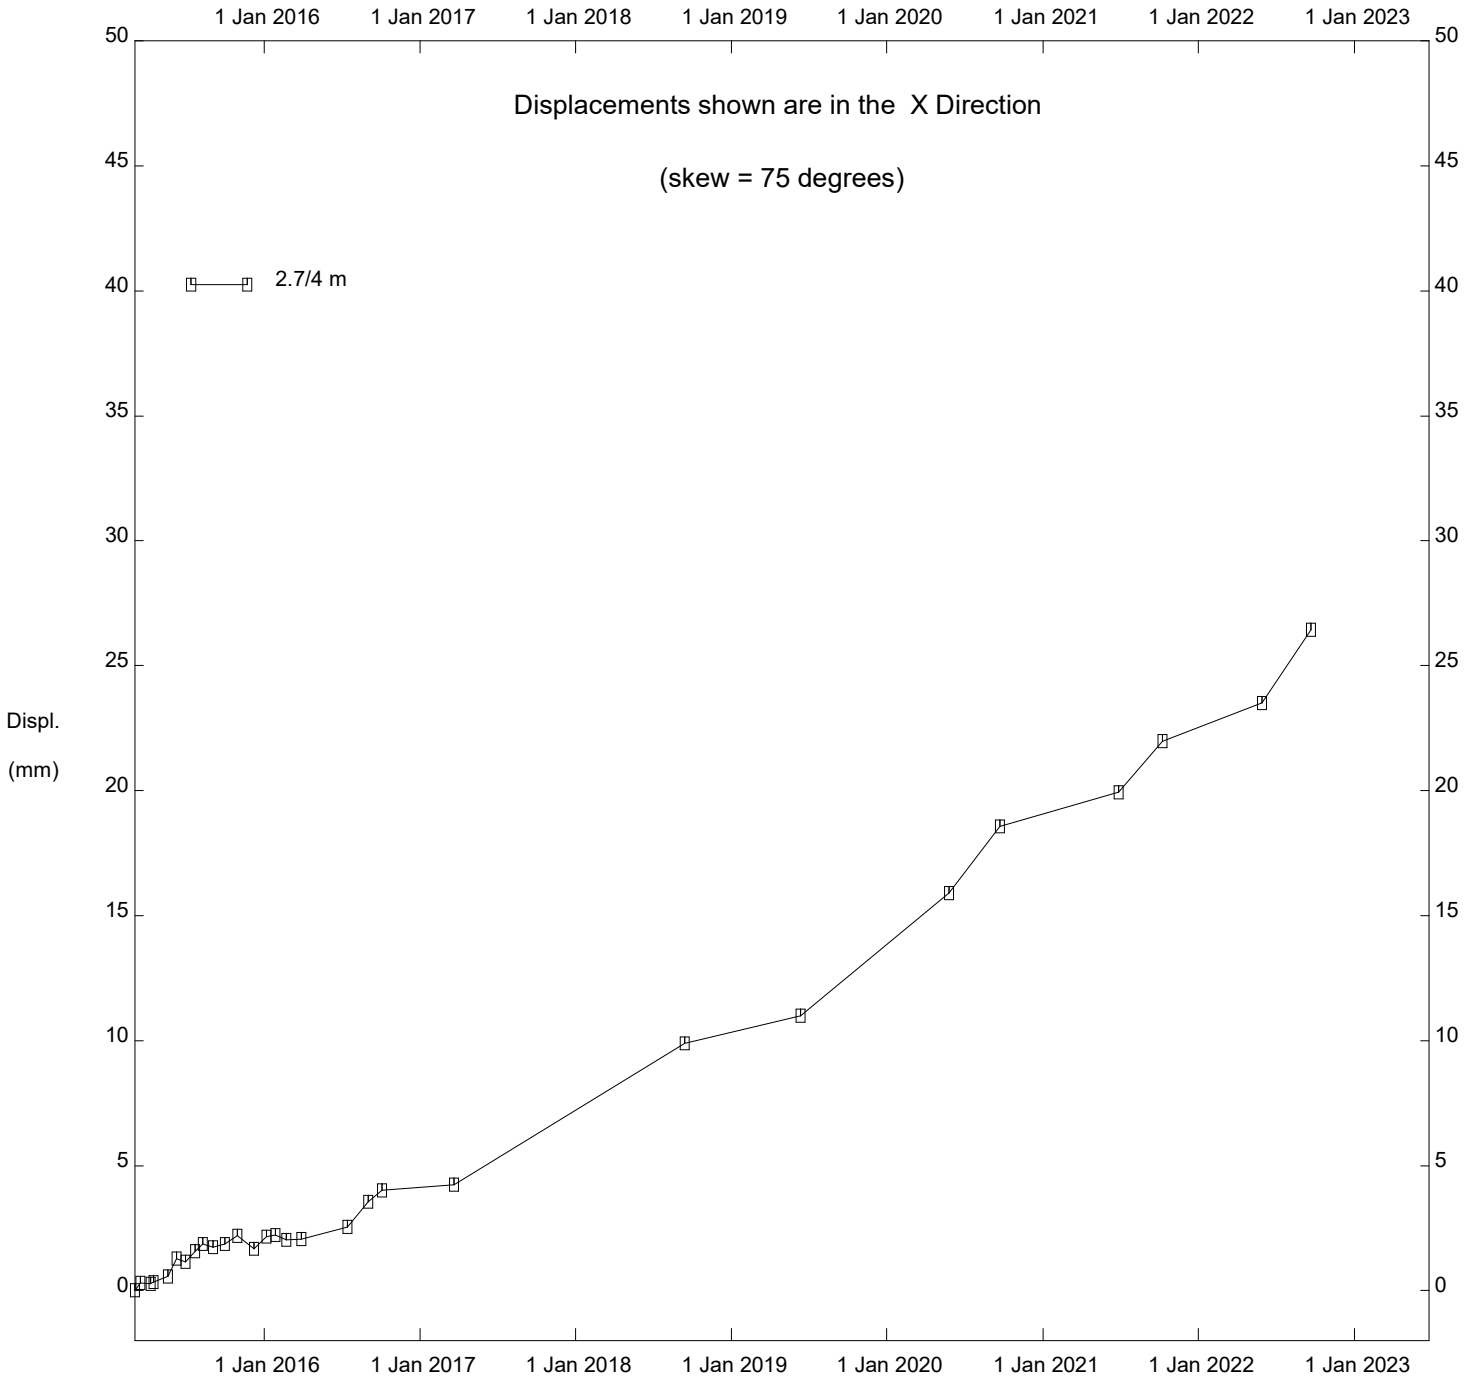
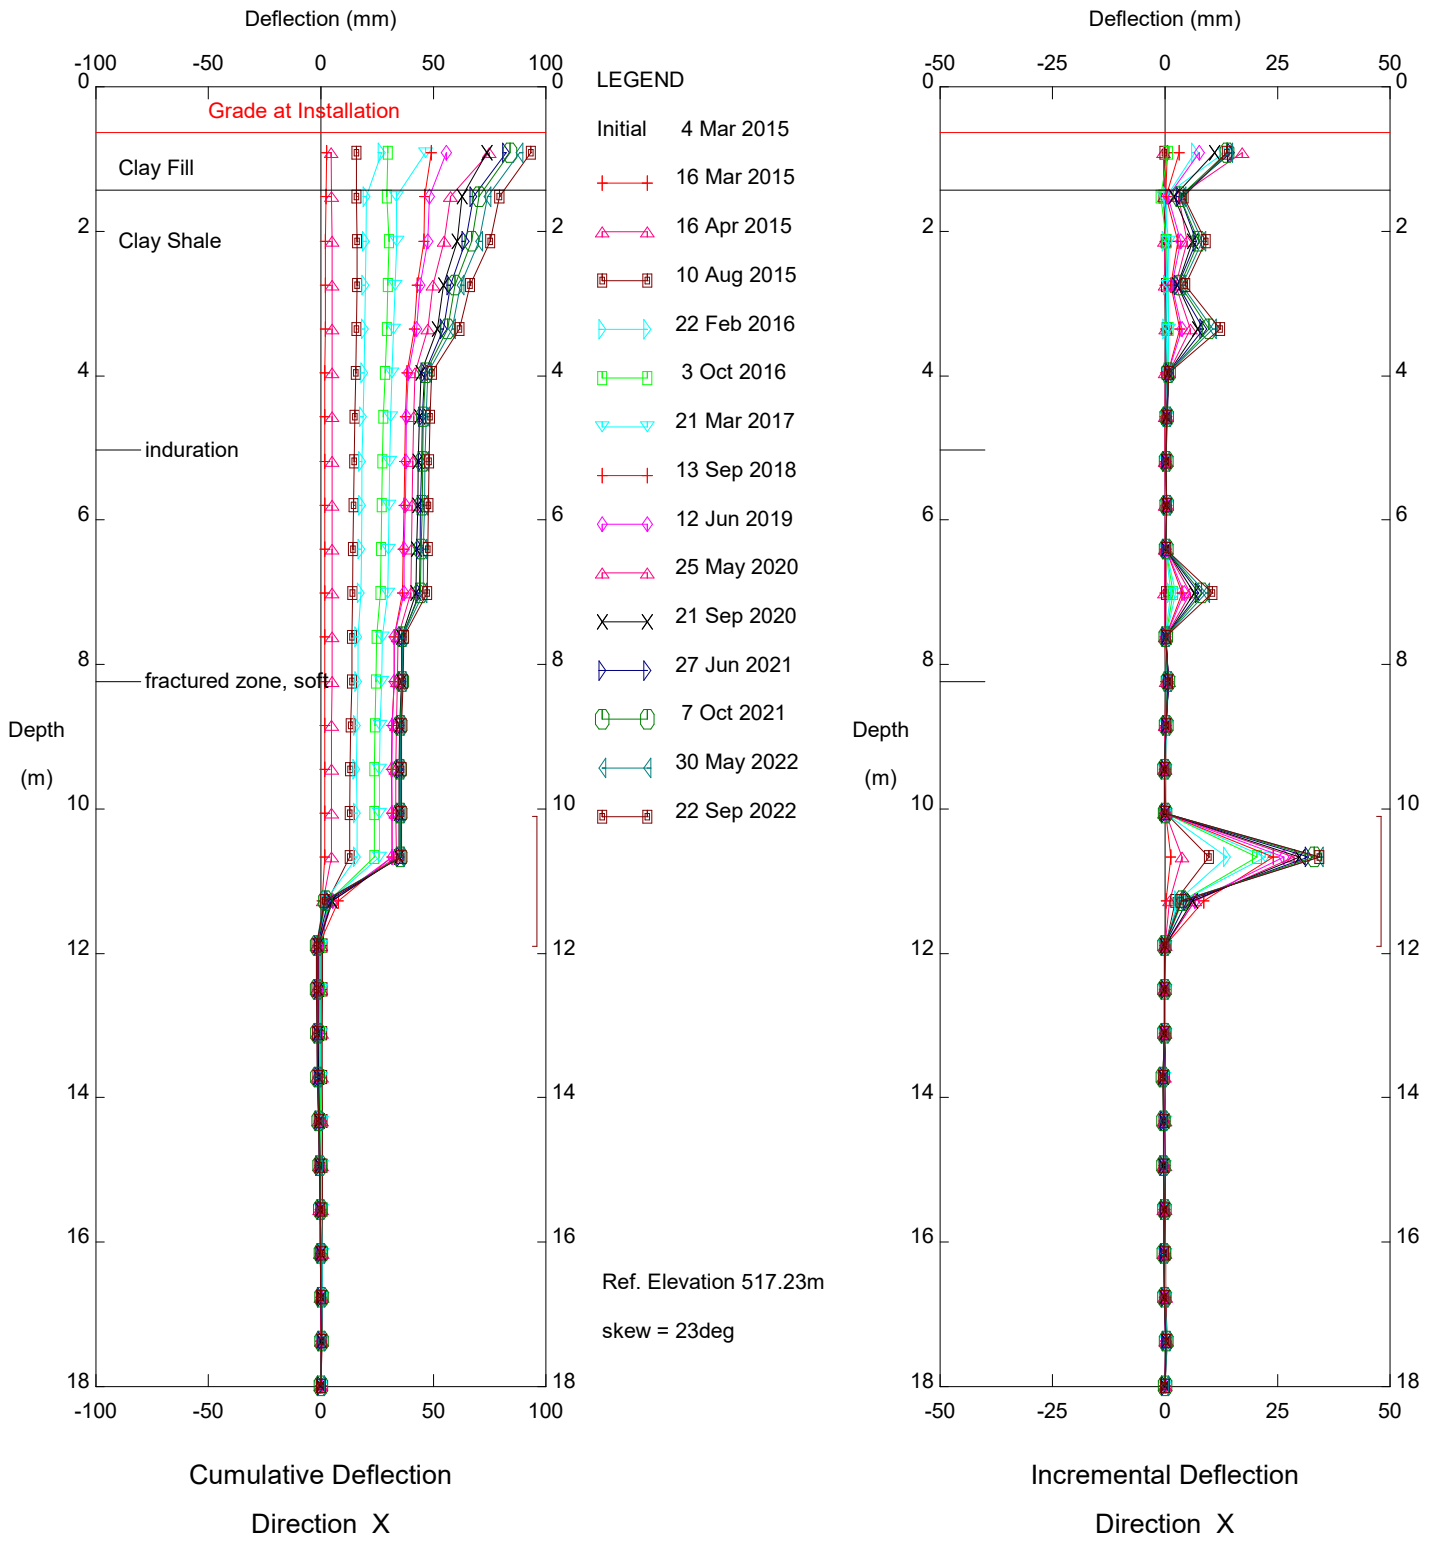
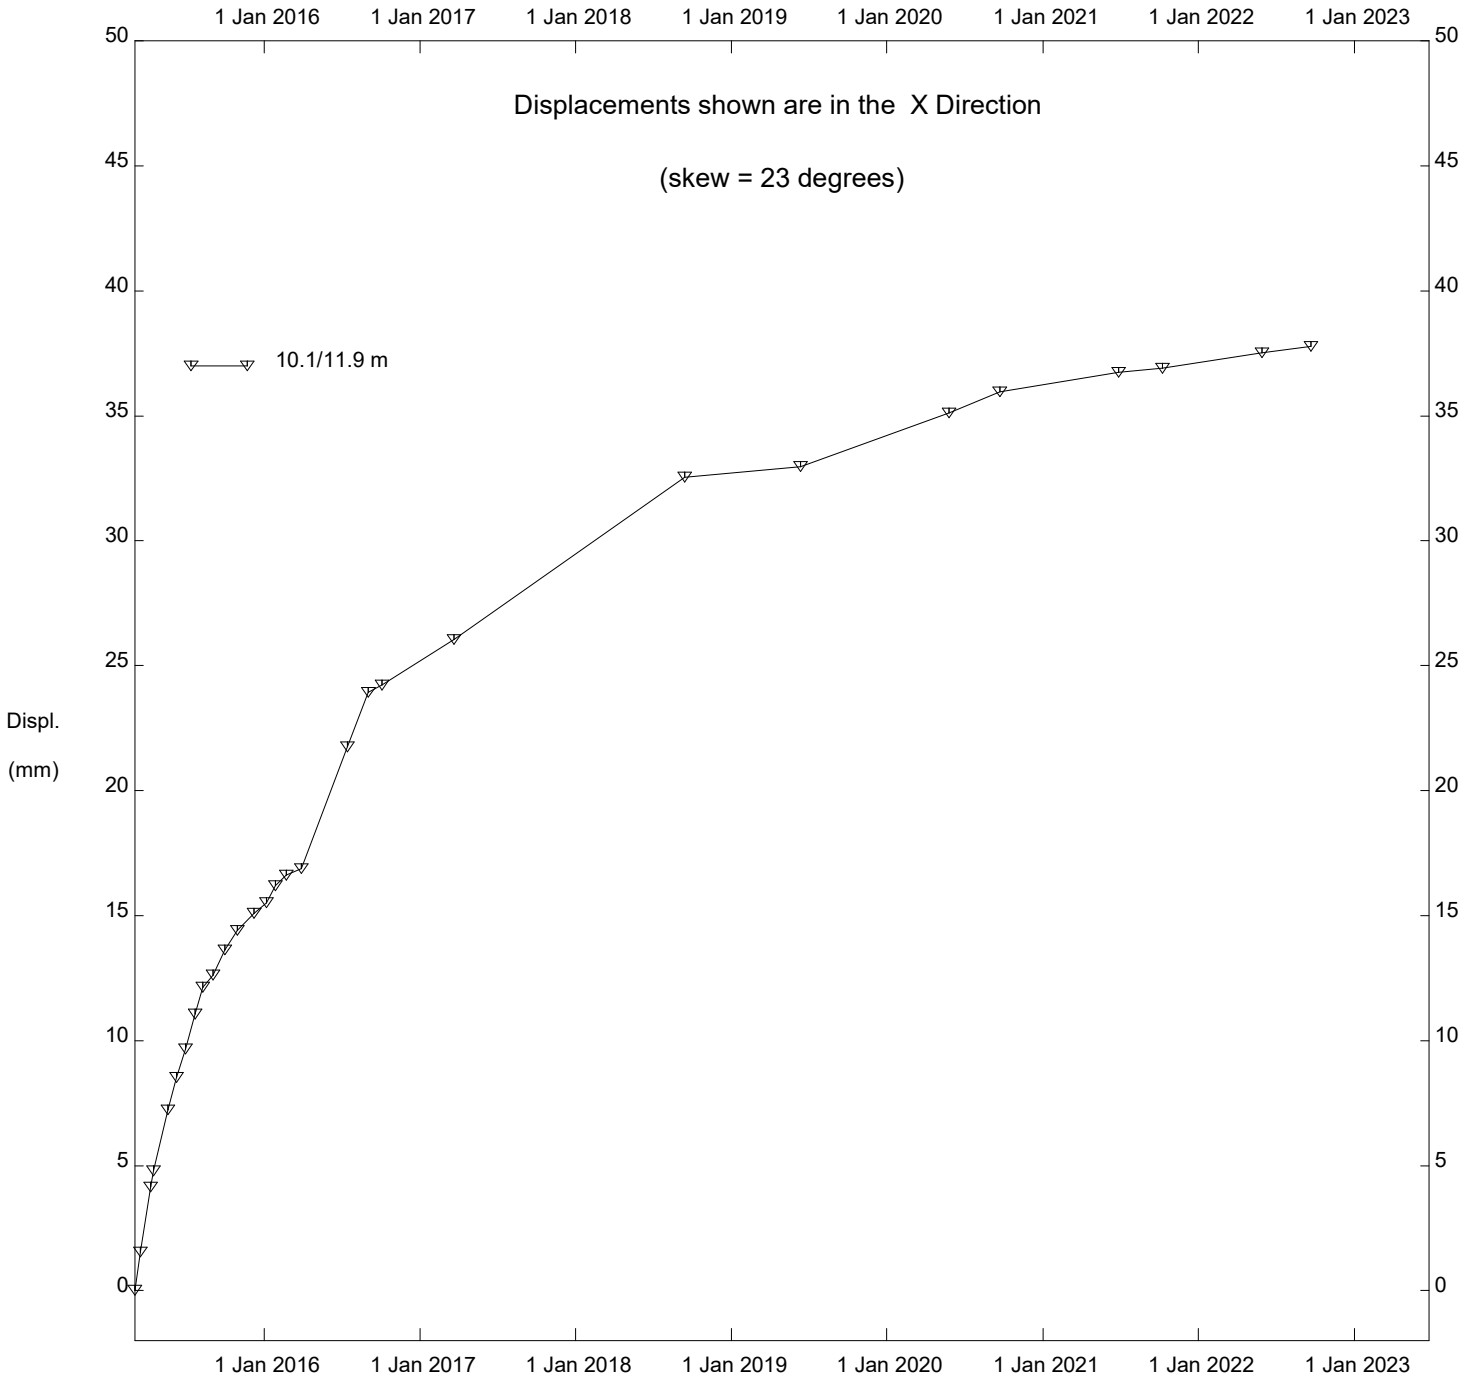
NC099 Cut Slope - Bench 1, Inclinometer 15-09

Slope inclinometer SI15-09 shows current rates of movement of 9.3 mm/yr, 4.9 mm/yr and 0.9 mm/yr over 2.7 m to 4.0 m depth, 6.4 m to 7.6 m depth and 10.1 m to 11.9 m depth, respectively, since the spring of 2022 readings. The current rate of movement over the 2.7 m to 4.0 m depth zone is the highest rate ever recorded within this zone in SI15-09. SI15-10 showed a rate of movement of 0.6 mm/yr over 11.9 m to 13.1 m depth and 0.8 mm/yr over 16.2 m to 17.4 m depth since the spring of 2022 readings.
