File No.: 32122

**ALBERTA TRANSPORTATION GRMP (CON0022163)
NORTH CENTRAL (ATHABASCA AND FORT McMURRAY DISTRICTS)
INSTRUMENTATION MONITORING RESULTS – FALL 2022**

SITE NC099: HWY 63:10 HANGINGSTONE RIVER BRIDGE

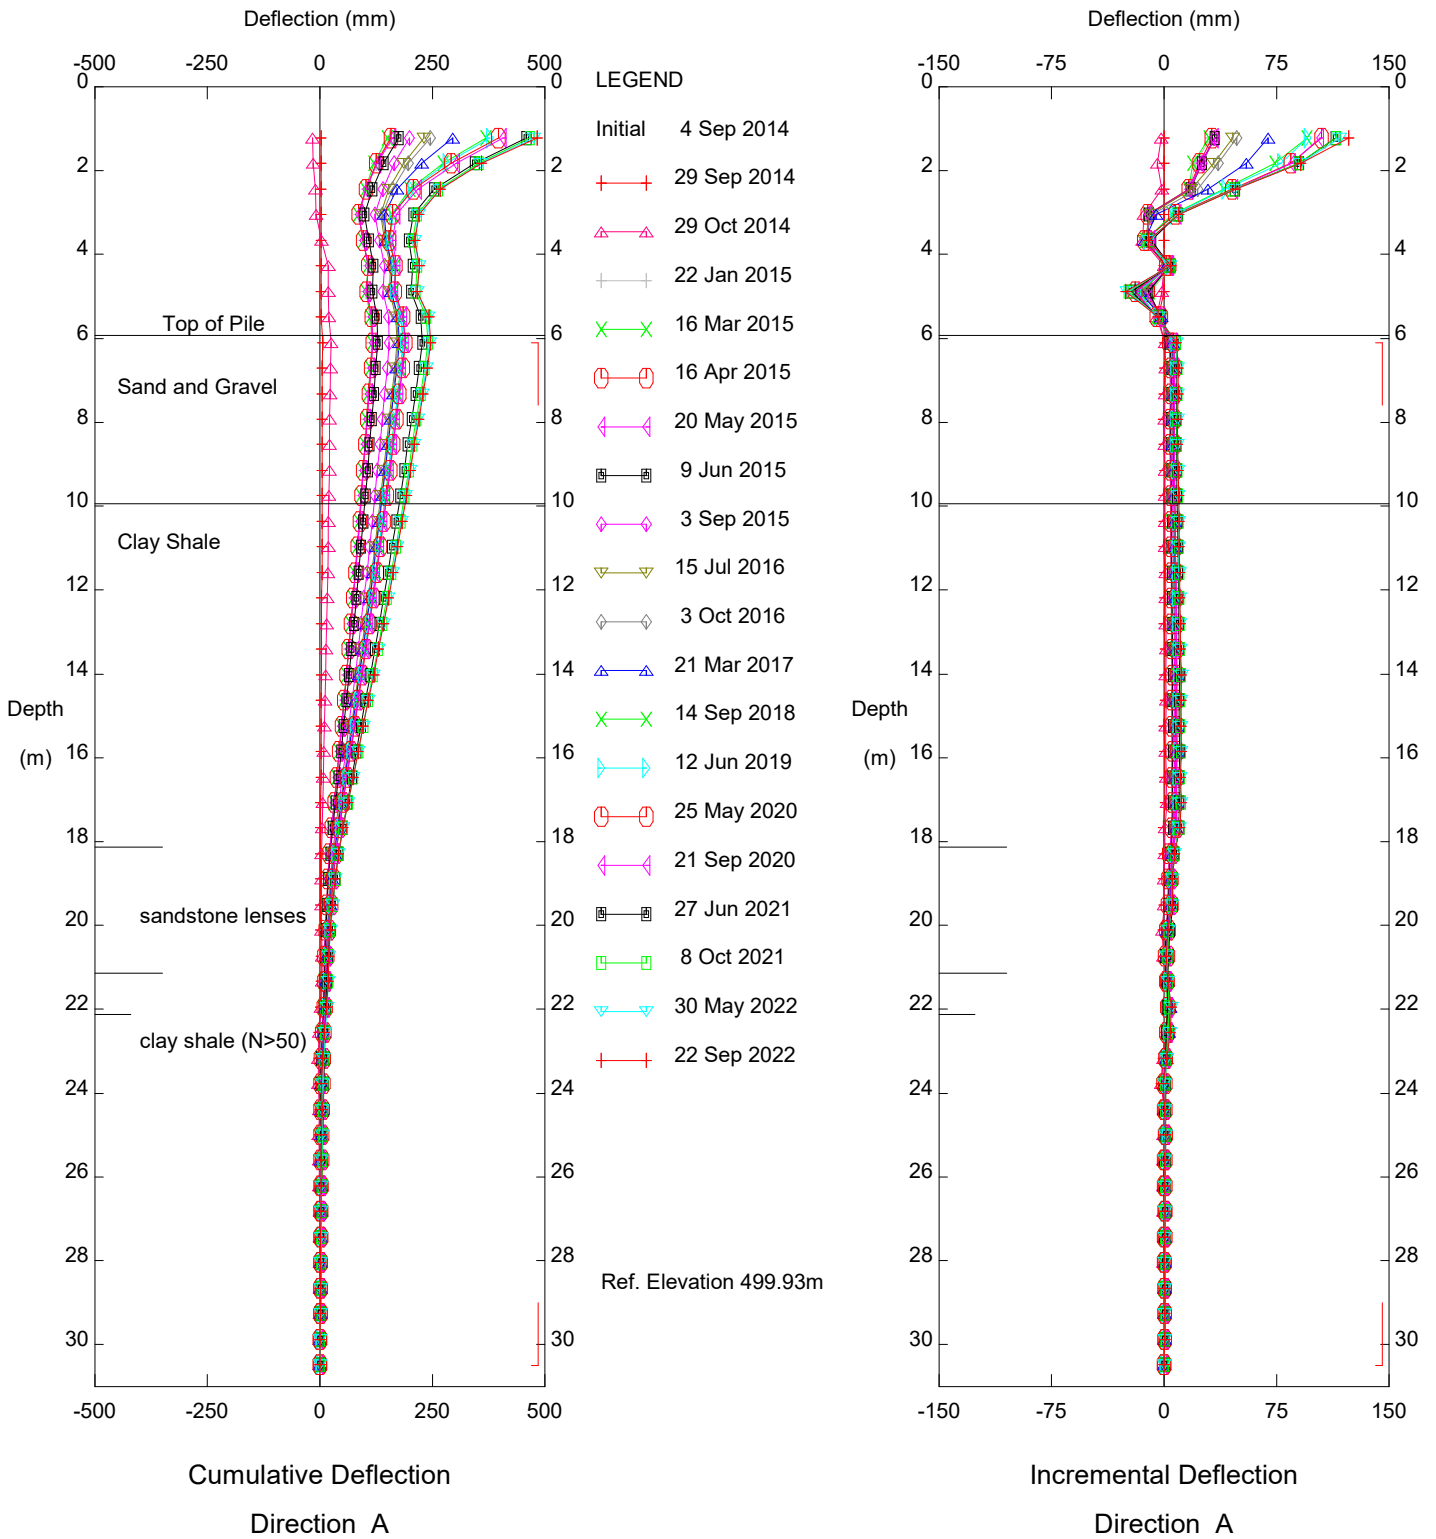
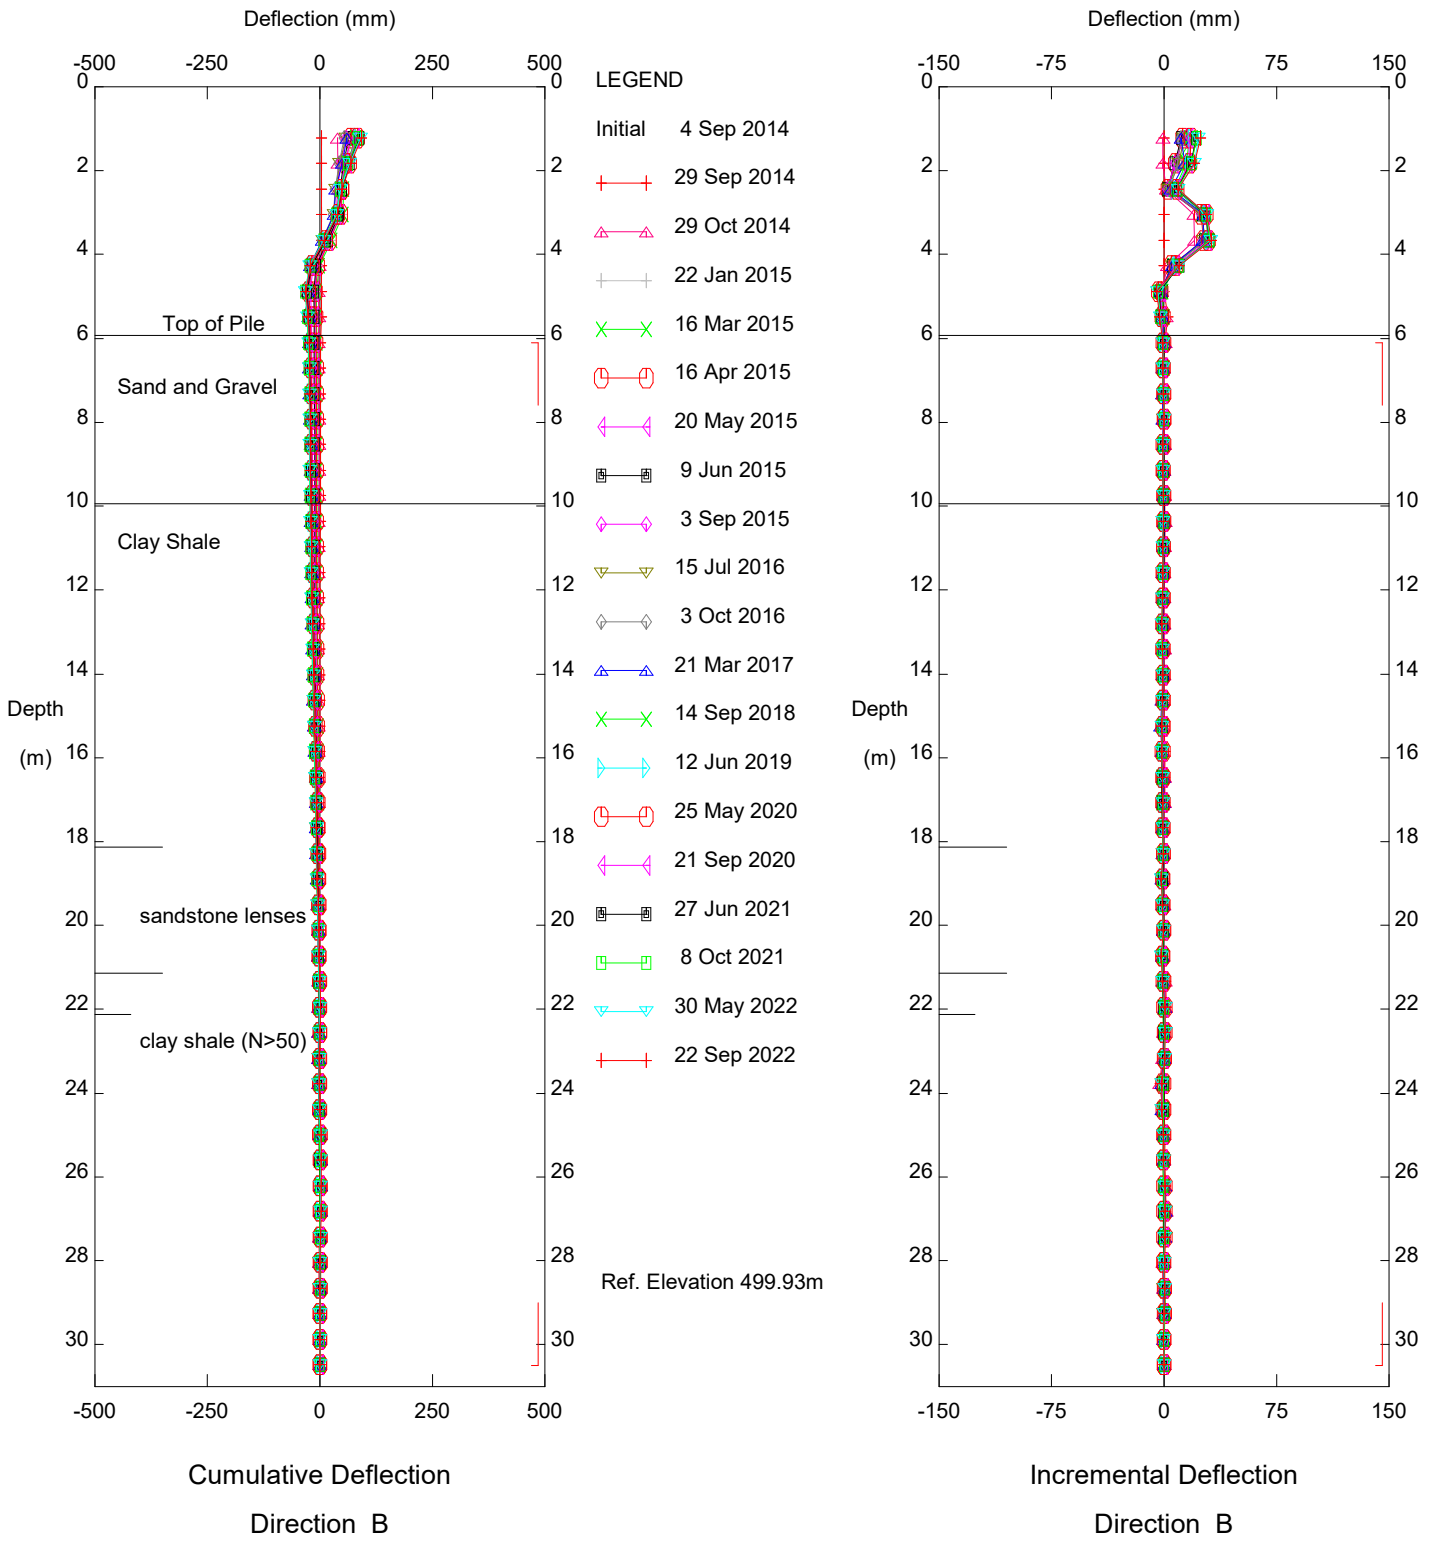
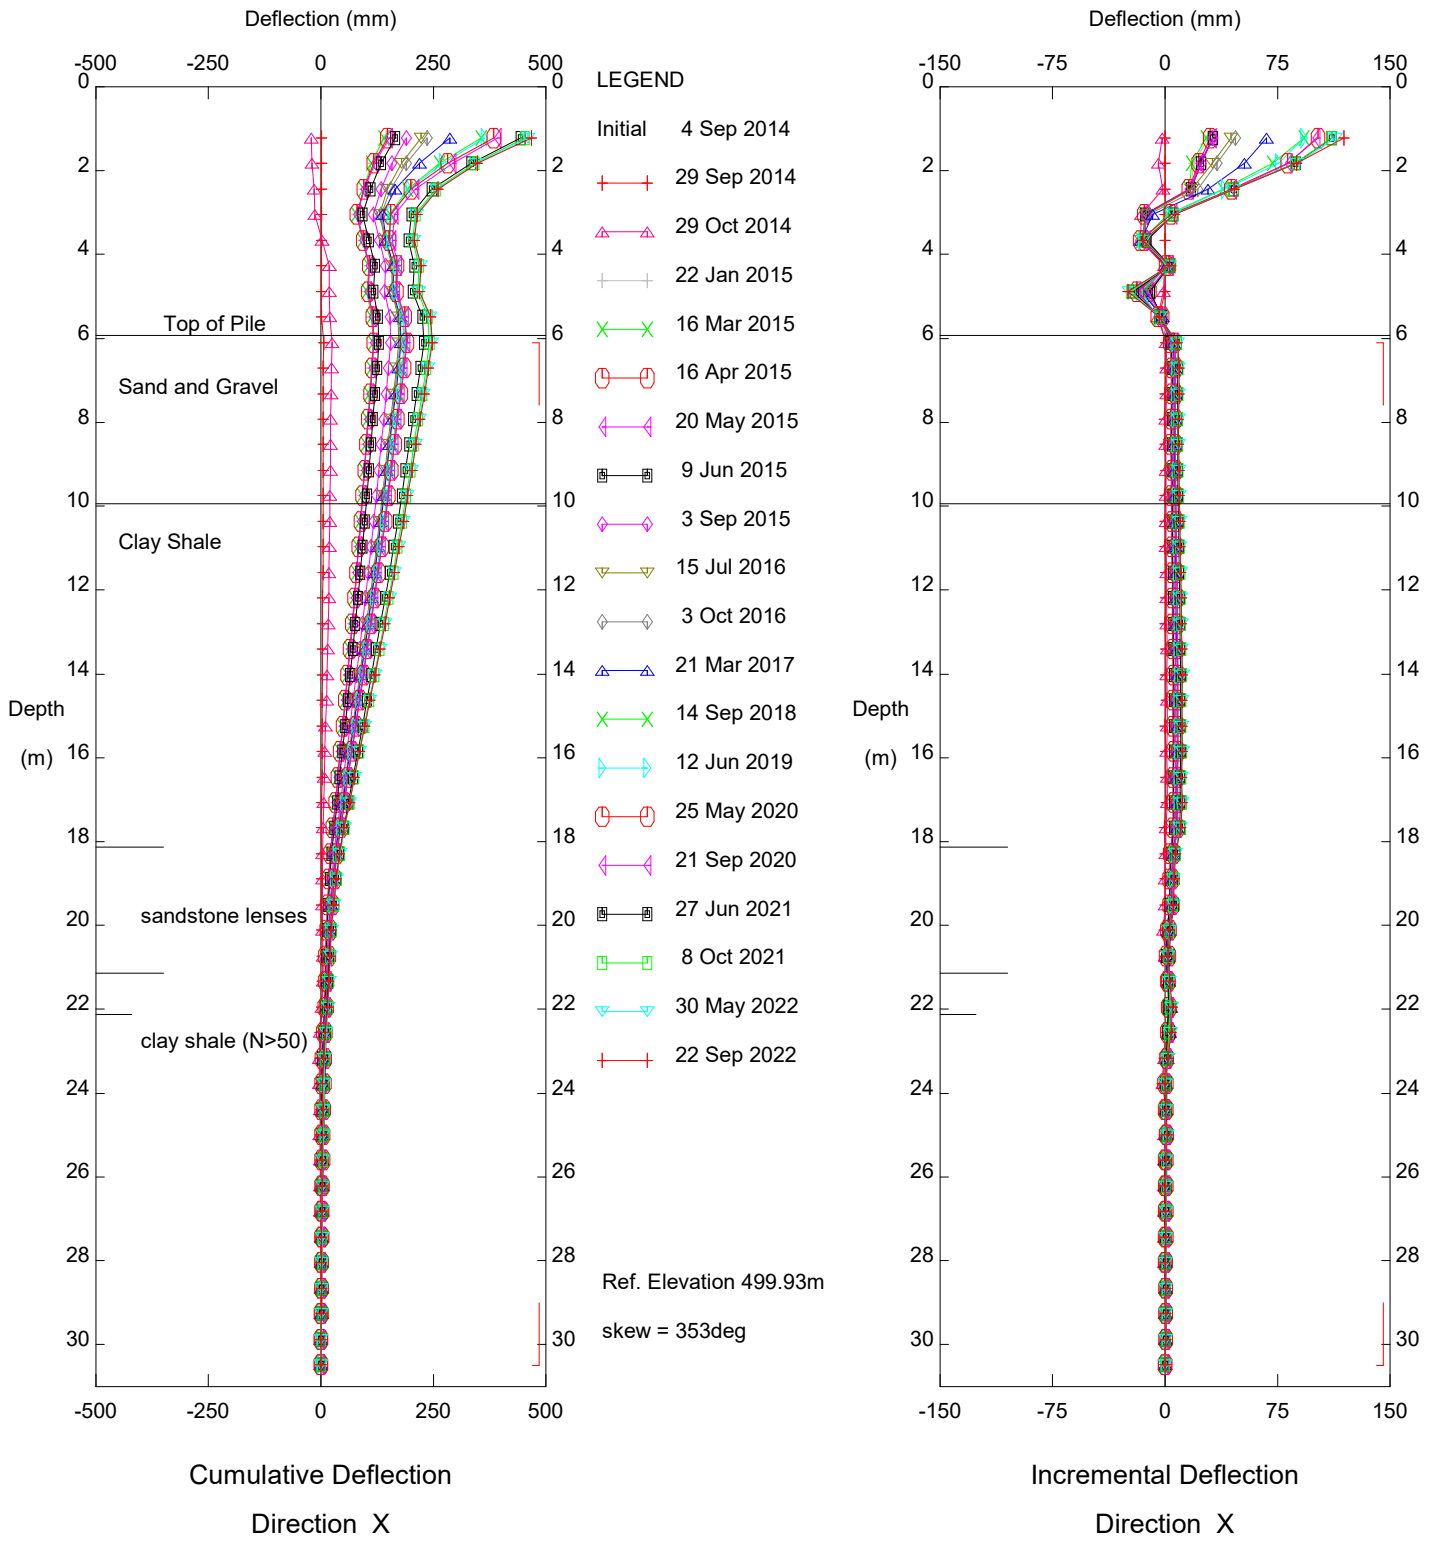
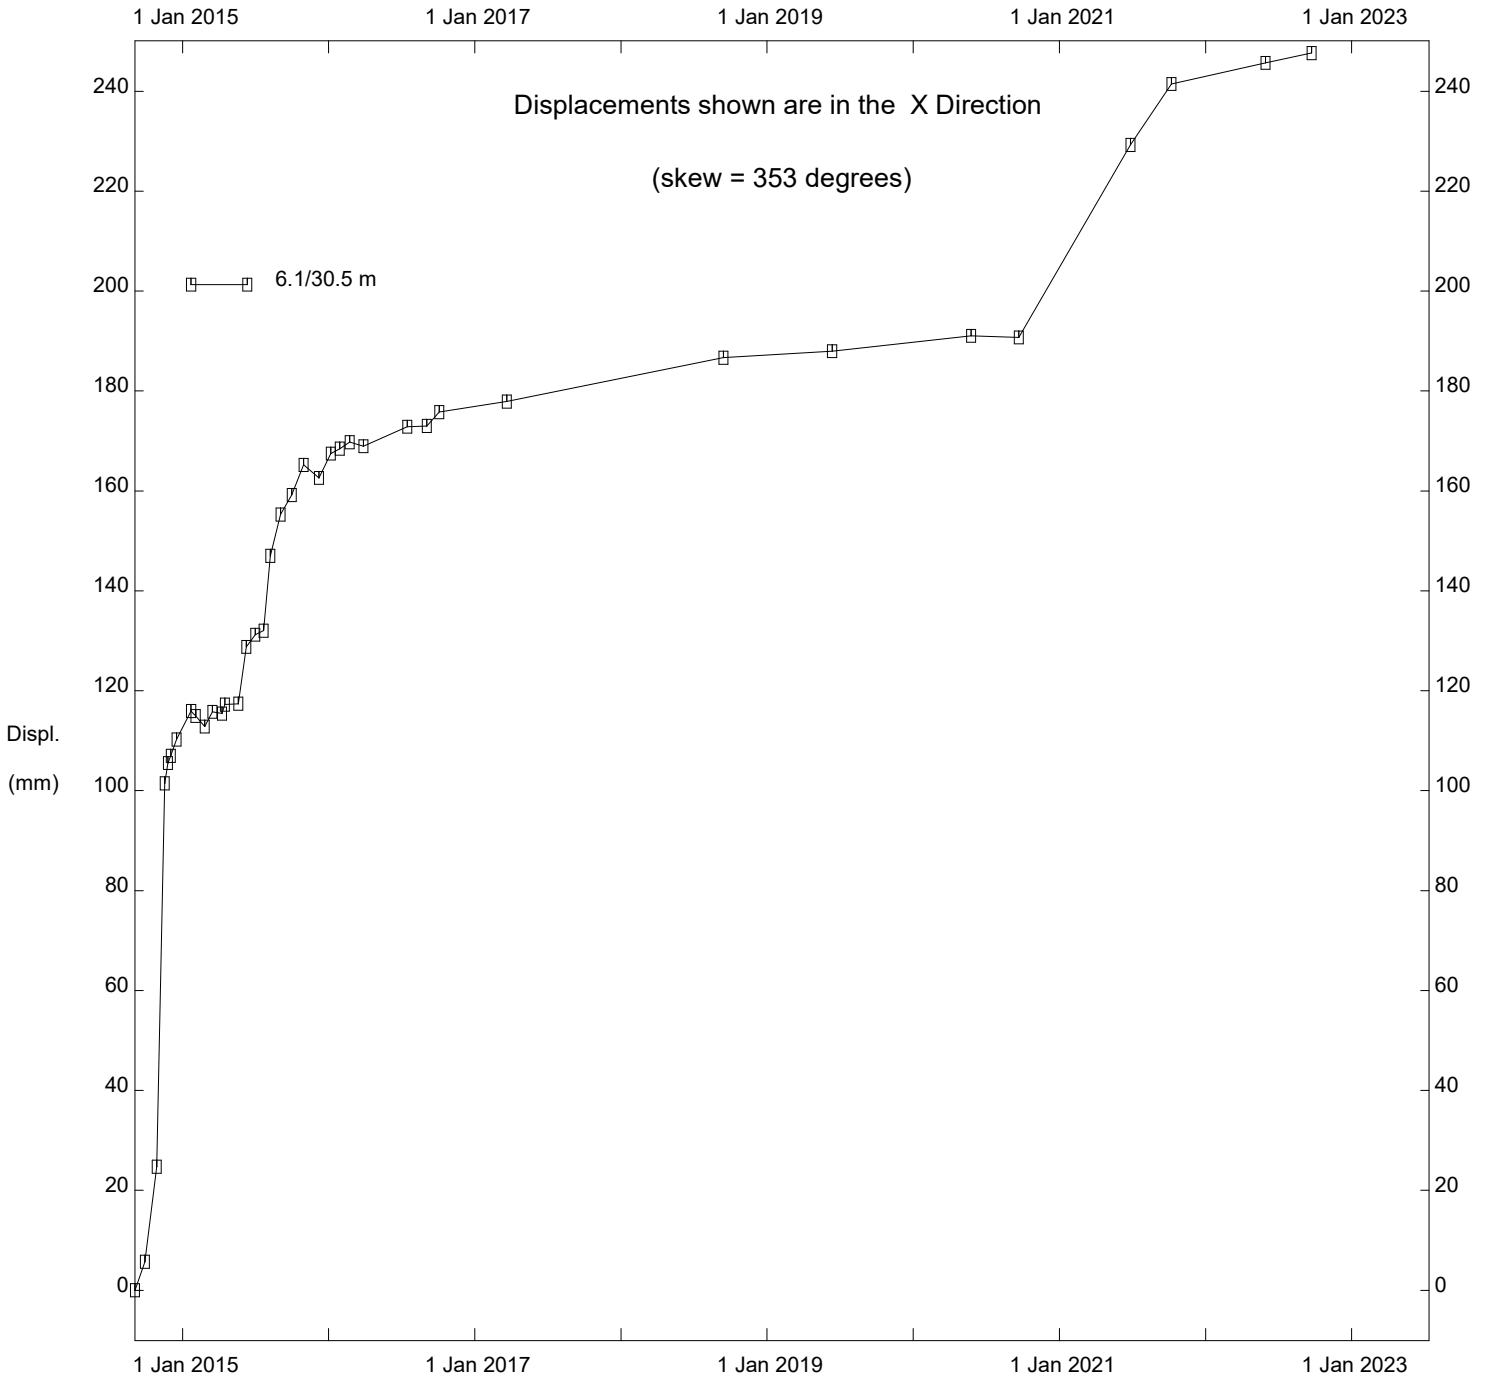
NC099 North Slope Stability Pile Wall, Inclinometer 14-01

SI14-01, located in the pile wall of the bridge north approach fill, showed a rate of movement of 6.4 mm/yr over the length of the pile from 6.1 m to 30.5 m depth, corresponding to an incremental movement of 2 mm since the spring of 2022 readings. SI14-02, located in the pile wall of the bridge south approach fill, shows a current rate of movement of 5.6 mm/yr over the length of the pile from 5.5 m to 31.7 m depth. Overall, SI14-01 and SI14-02 appear to be slowing from the relatively high movement rates observed over the past several readings cycles. The current pile head movement in SI14-01 and SI14-02 is 247.6 mm and 158.1 mm, respectively.

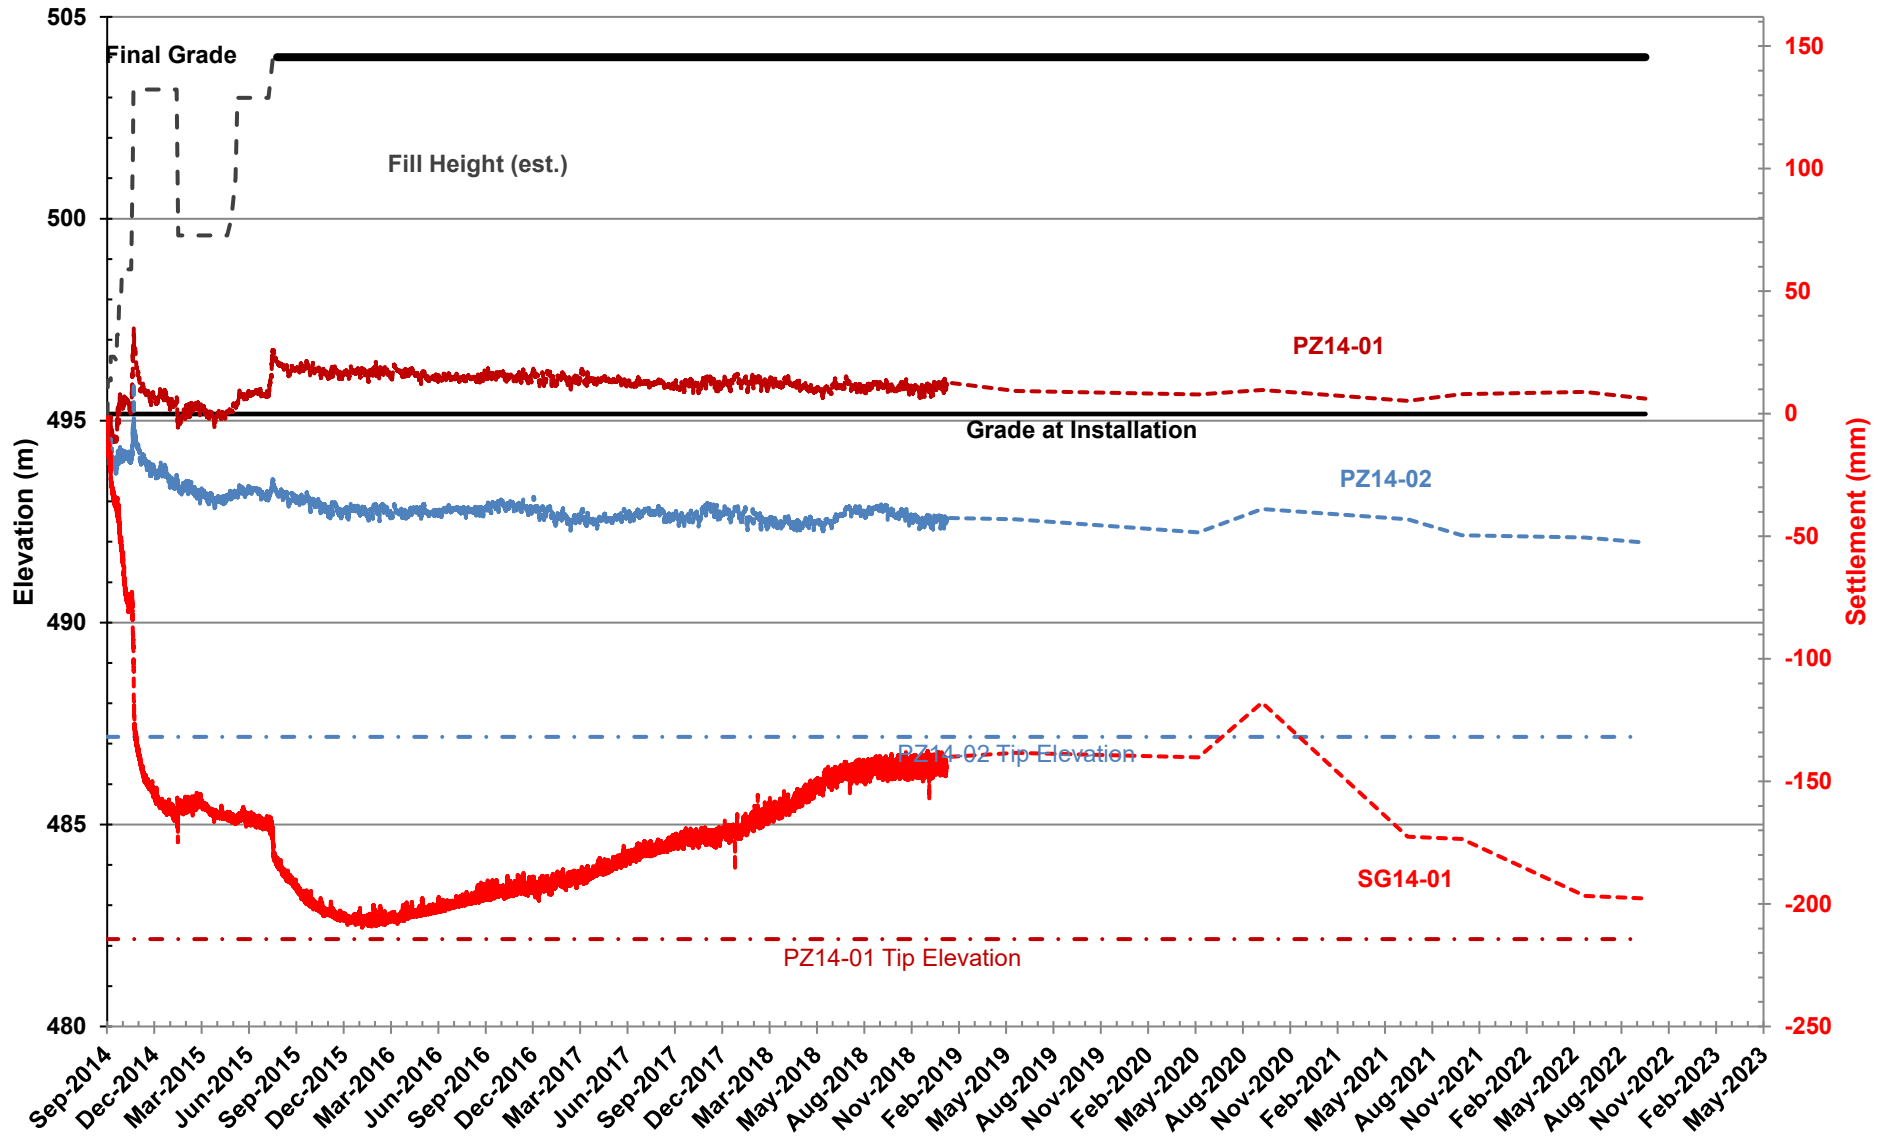
Figure NC099-9

SG14-01 and SG14-02 showed increases in ground settlement of 1.01 mm and 4.42 mm, respectively, since the spring of 2022 readings. The settlement gauge readings are summarized in Table NC099-3.
