December 21, 2007

File: 15-85-66

**NORTH CENTRAL REGION (ATHABASCA AREA)
GEOHAZARD ASSESSMENT
NC 17B – HWY 63:12 SUPERTEST HILL
2007 ANNUAL INSPECTION REPORT**

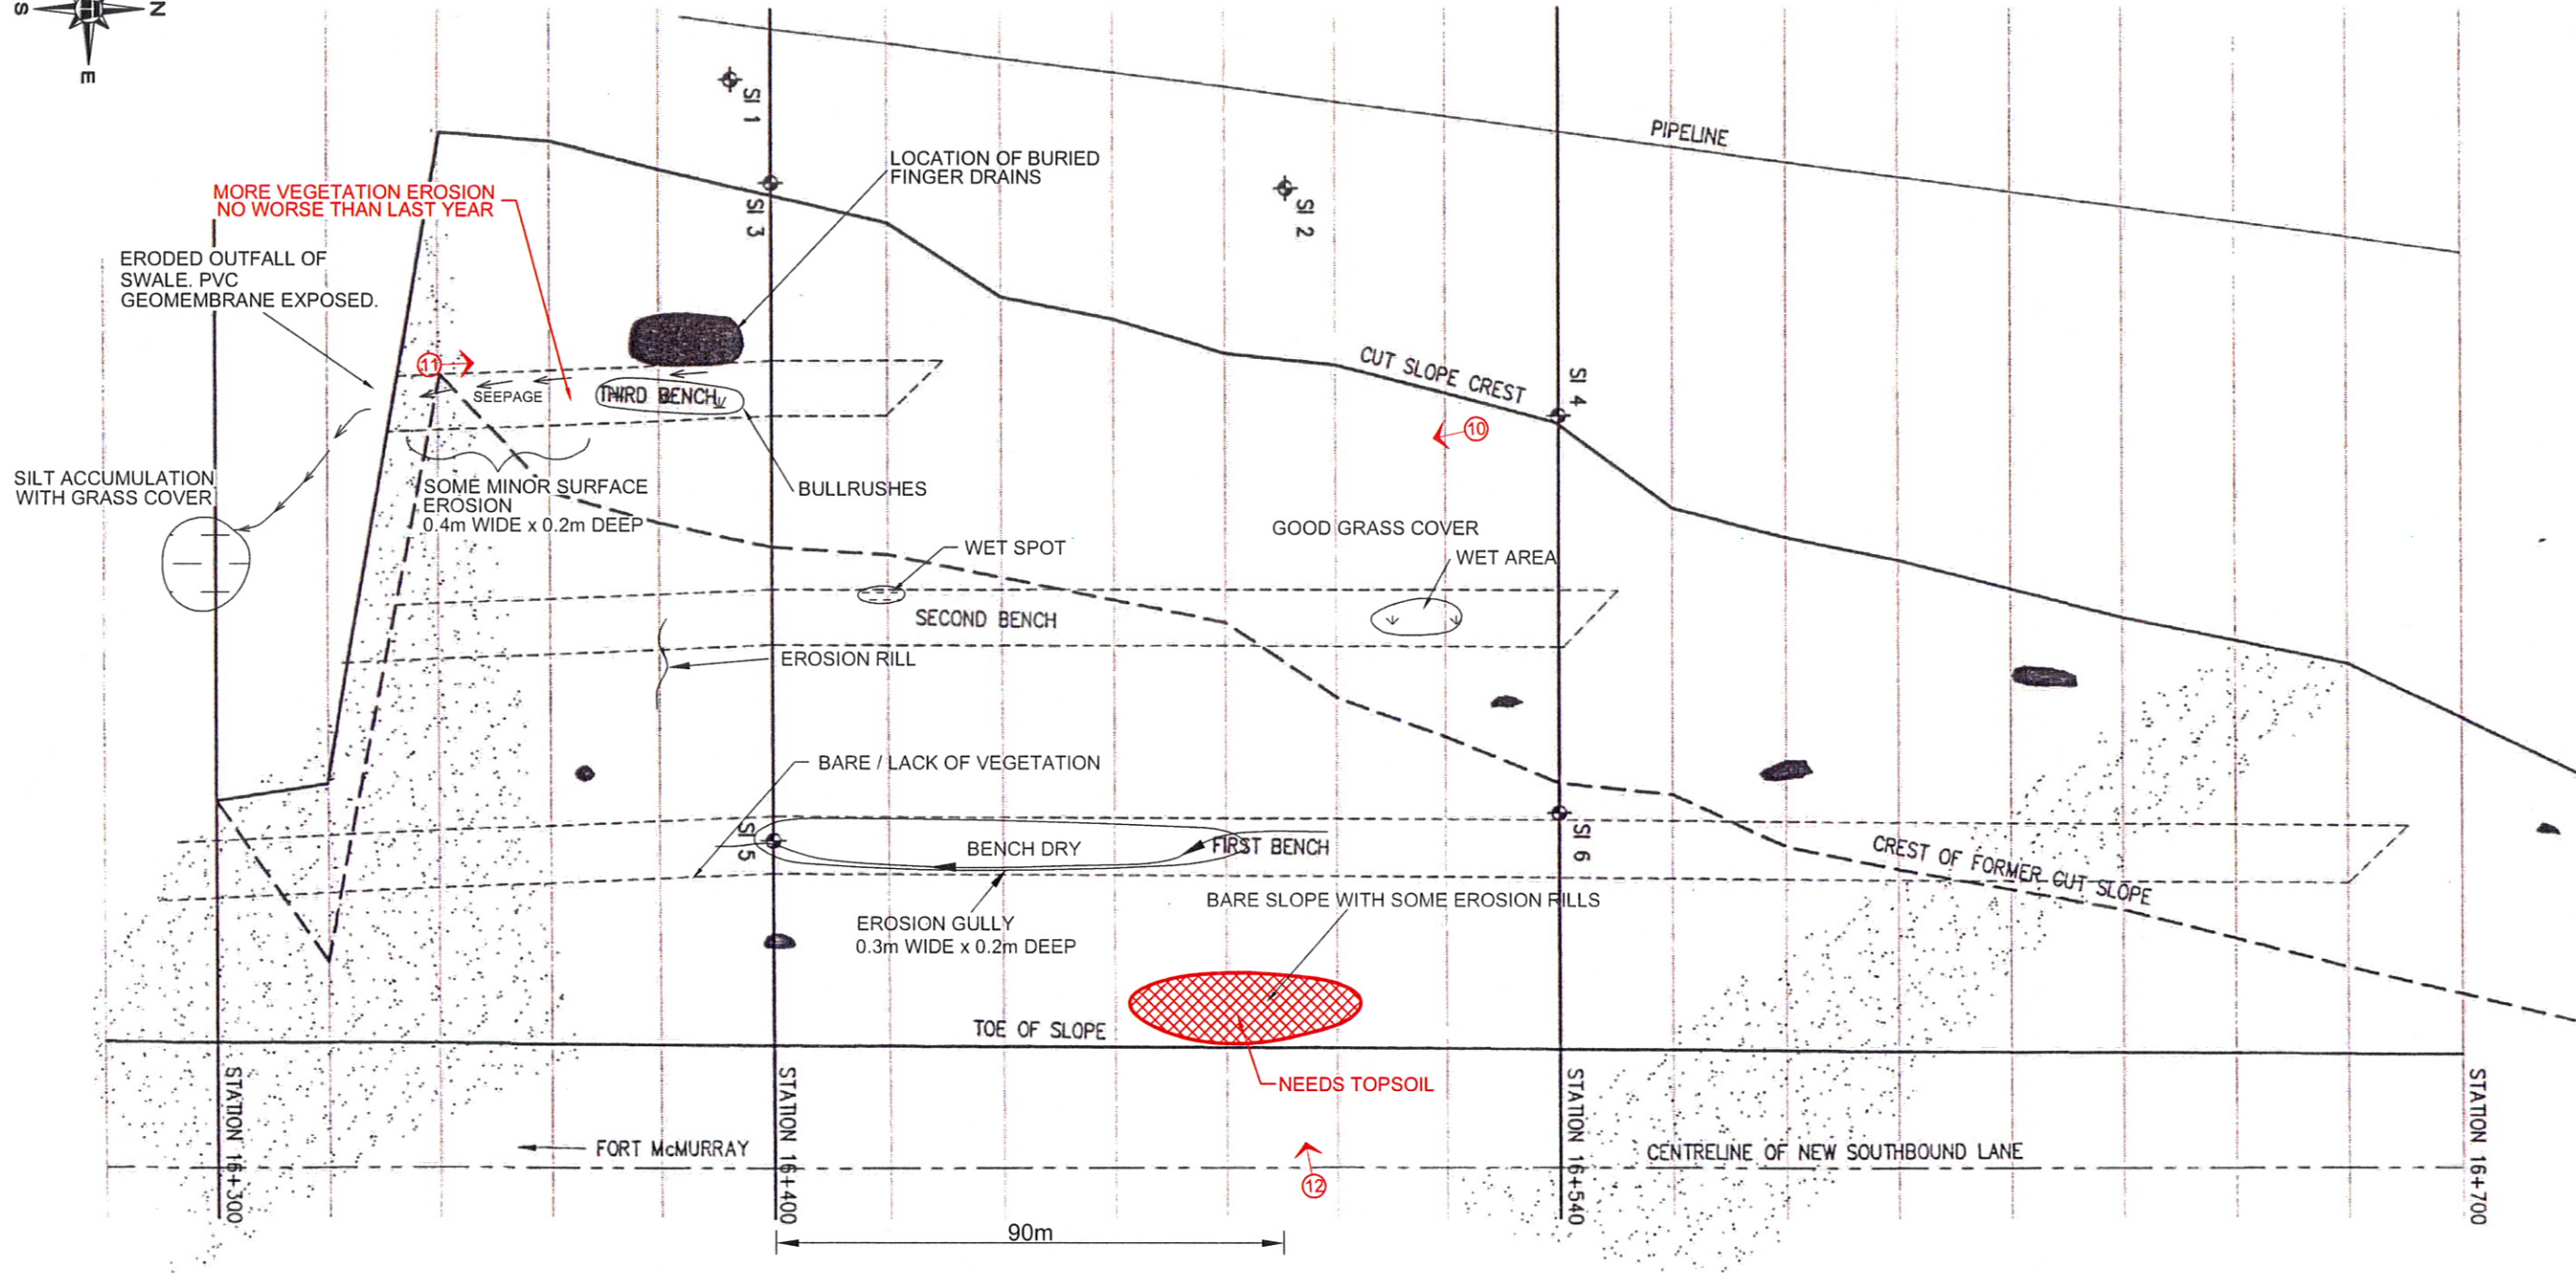
HWY 63:12 Km 15.45 TO 16.8 TWINNING AT SUPERTEST HILL (NC17B)
 NE 25 - 91 - 10 - W4M
 FIGURE NC17B-12 UPDATED SITE PLAN (JULY 17, 2007)

- The overall condition of the high backslope (Figure NC17B-12) was good. There were no visual indications of slope movement. The slope generally had good grass cover except for a portion of the first bench and a section along the toe of the slope;

The high backslope appears to be performing well to date. Although there were no visible signs of slope movement, some small movements in the clay layer were noted during construction and the Fall 2007 readings show continuing small creep movements along this layer in SI3 and SI5R at a rate of 3 to 4 mm/yr. Hence it will be important to continue to closely monitor the instruments to warn of the development of any potential larger scale slope movements in view of the major pipeline located within 30 m of the crest of the backslope.

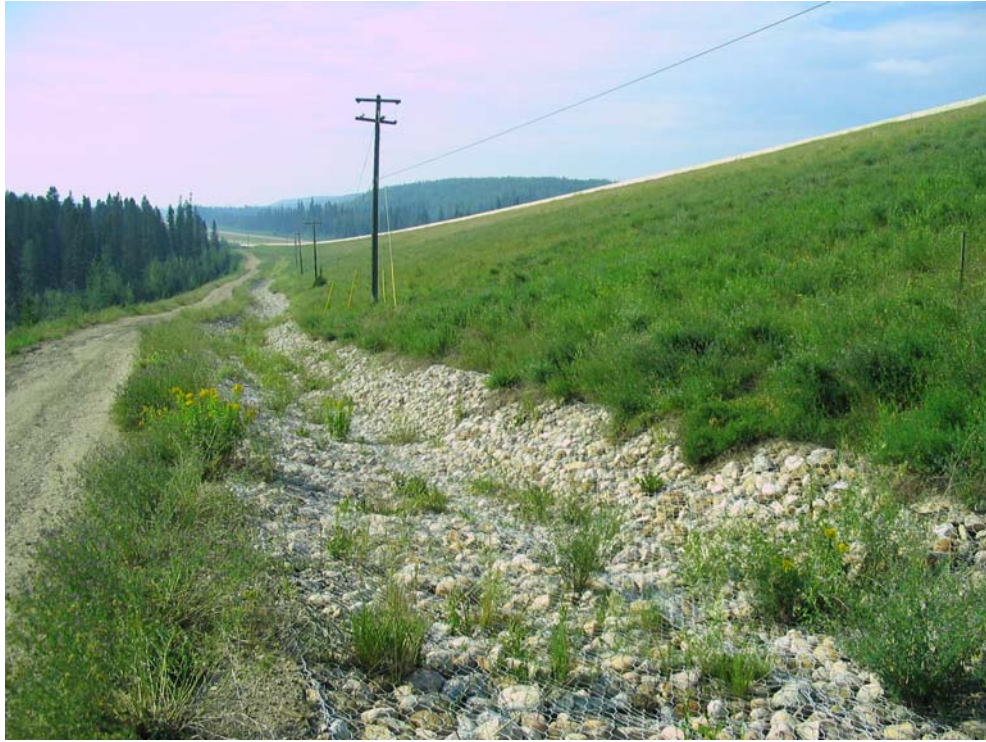
- The east sideslope of the highway embankment, berm surface and berm sideslope appeared in good condition. The few localized spots on the sideslope where small erosion rills have started to develop did not appear to have changed in size since the last visit; and

Photo 1 - Upper Part of East Sideslope.

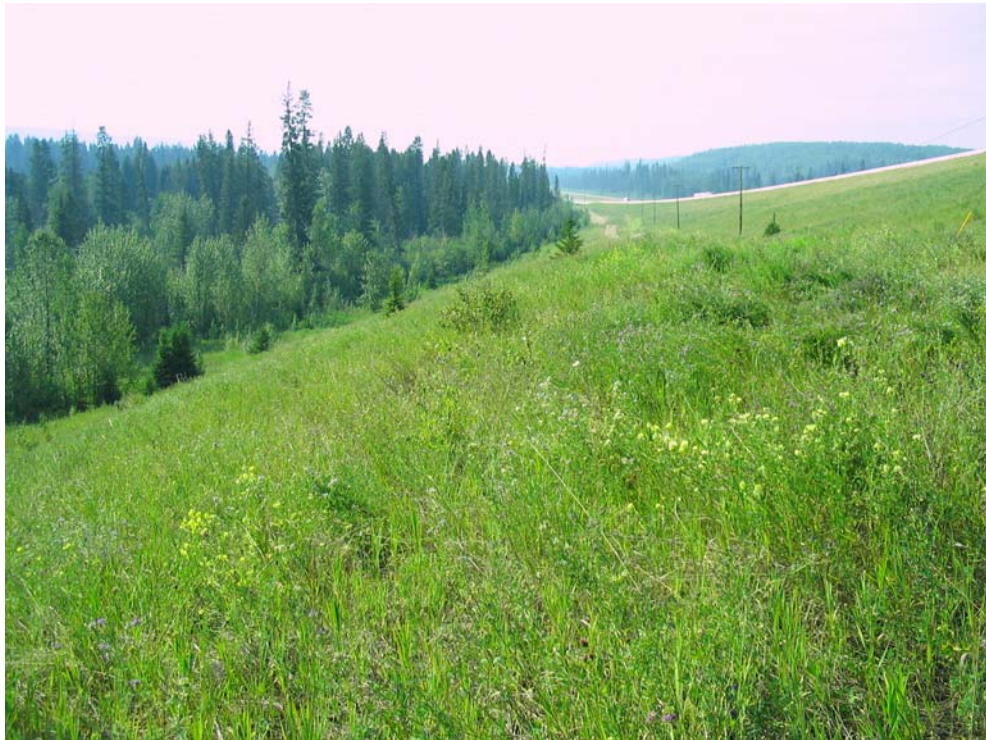
Photo 2 - Lower Part of East Sideslope.

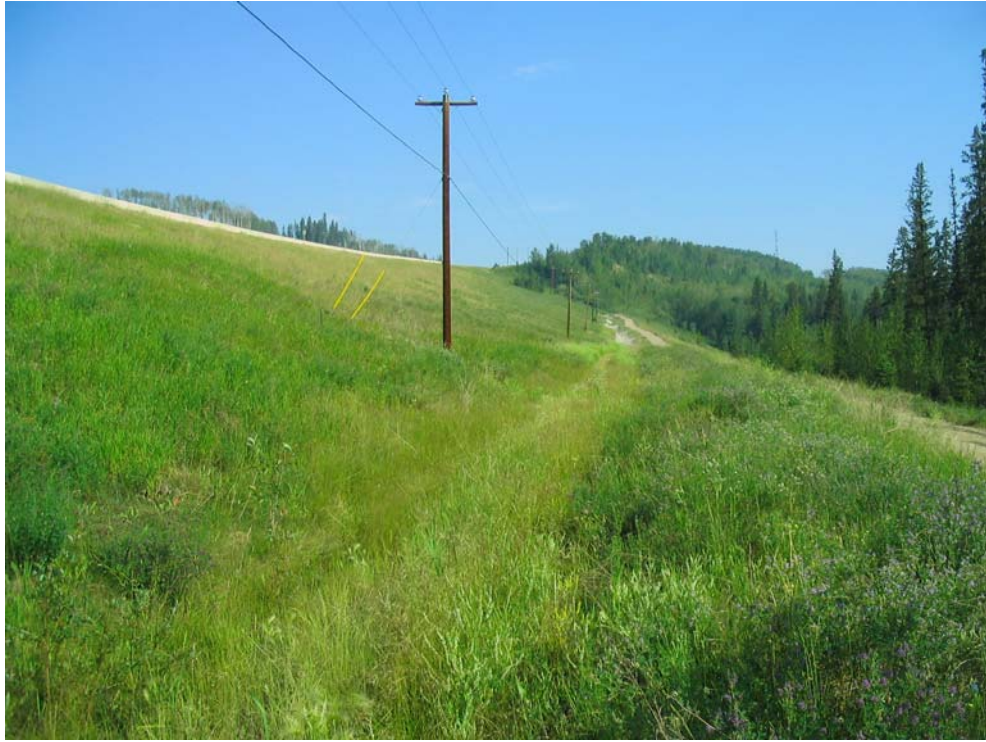
Photo 3 - South End of East Sideslope.

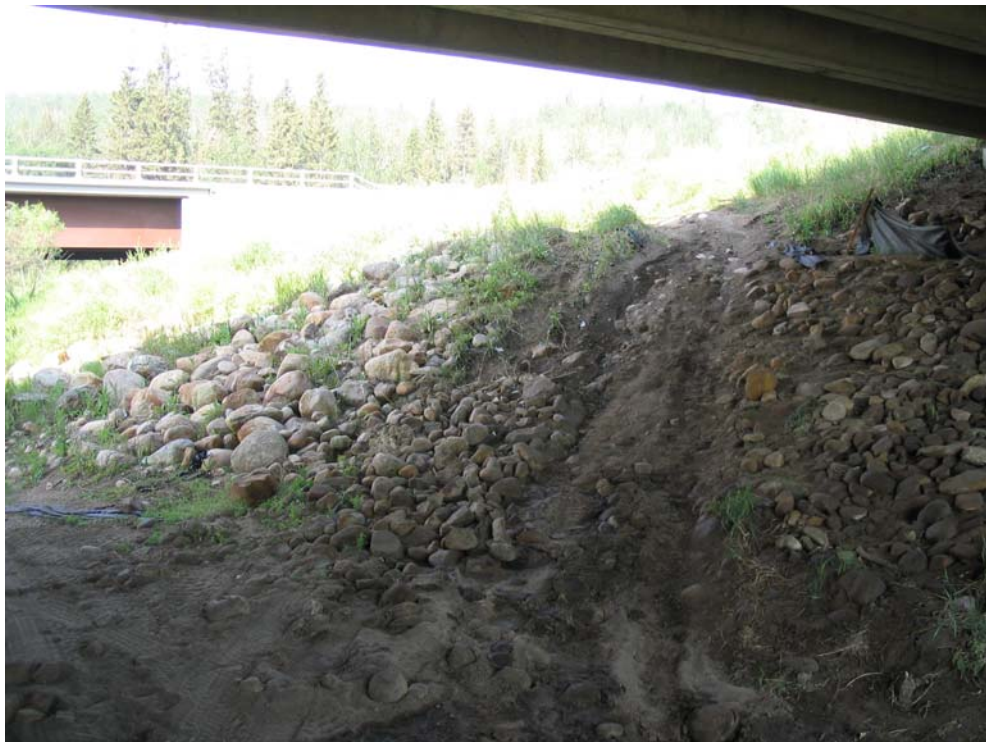
- There was still a section of the median sideslope where grass had not grown yet;
- Quads running under the bridges continue to create a preferential runoff path that is causing some erosion near the headslope area;

Photo 4 - Erosion Along a Quad Trail Under the Northbound Bridge.

- Build up the east median sideslope along the edge of the gabion mat dissipater fan with topsoil and line the border along the fan with riprap salvaged from the old rock check berms in the median to prevent any further flow around the east edge of the fan;
- The quad trail under the bridges could be formalized with interlocking turf stones to keep traffic on a designated path and reduce damage to vegetation off of the path. Alternatively, it is understood that Mr. Behr is considering to block off the southeast quad access with a guardrail and sign access to the river from the north side of the bridge;
- Mr. Behr indicated that the guardrail along the west ditch near Station 16+280 should be extended to provide better protection for motorists from the sudden drop off into the rectangular gabion lined ditch channel; and
- Trash should be removed from the bubble grate over the drop pipe.

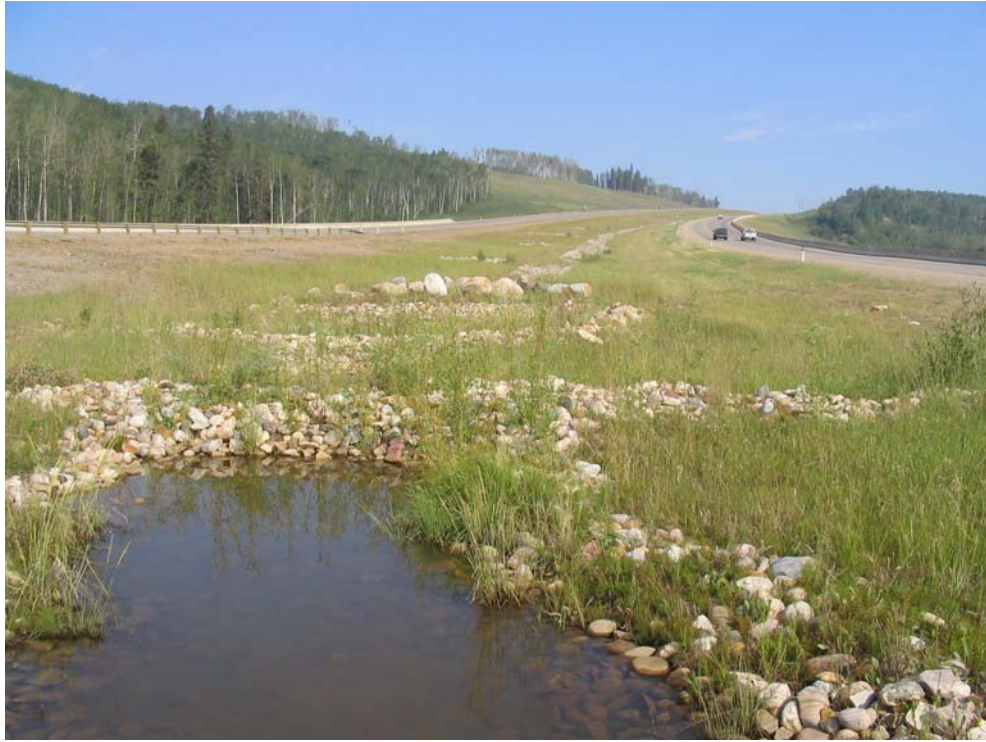
- The median ditch looked good. Grass is starting to grow up through the gabion lining. Trash has started to accumulate on the bubble grate over the drop pipe;

Photo 5 - Looking North Along Median Ditch.

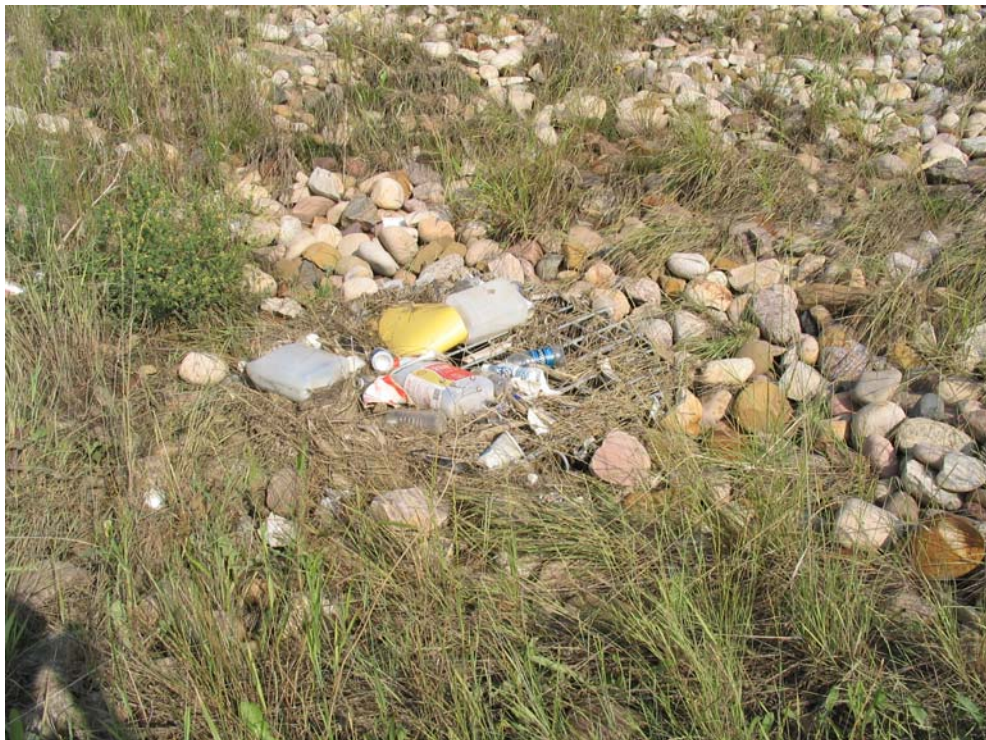
Photo 6 Drop Pipe Grate Needs to be Cleaned.

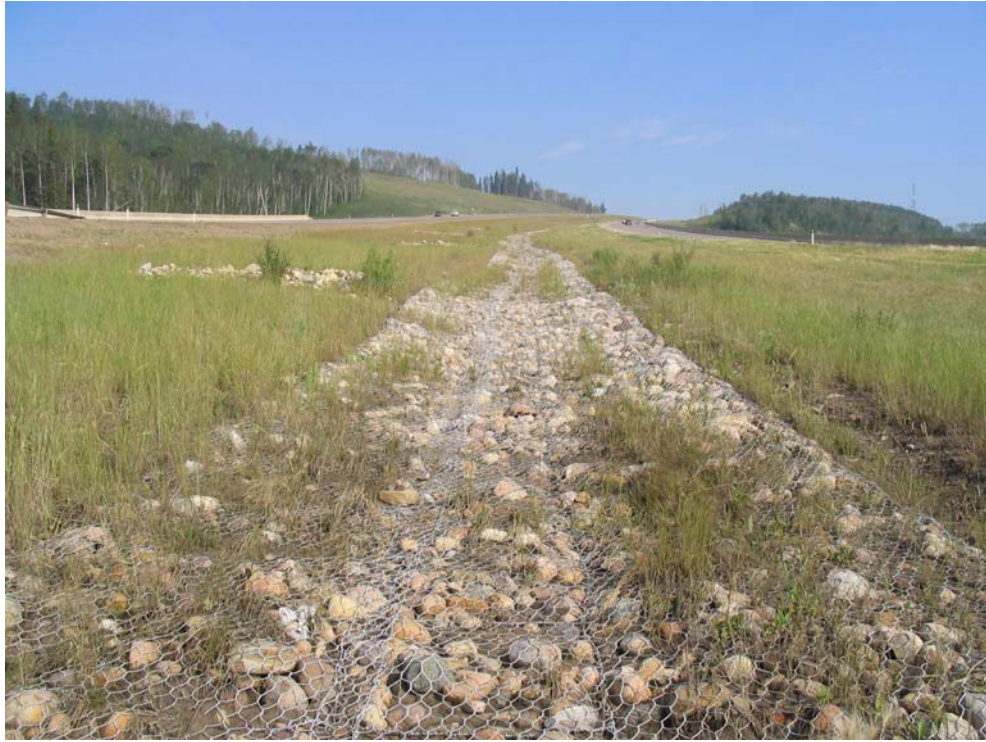
Photo 7 - Gabions in Median Ditch.

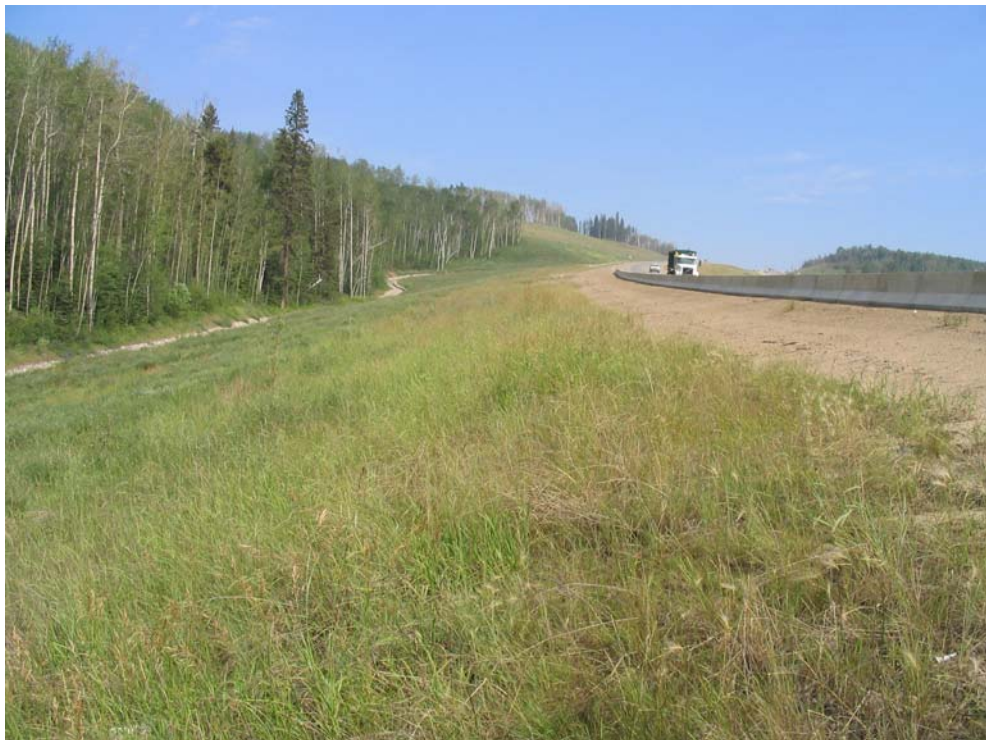
- The west sideslope of the highway embankment also had a good grass cover except for localized areas north of the stilling pond, along the top edge of the slope and near the start of the rectangular drainage section.

Photo 8 - Looking North along West Sideslope from South End.

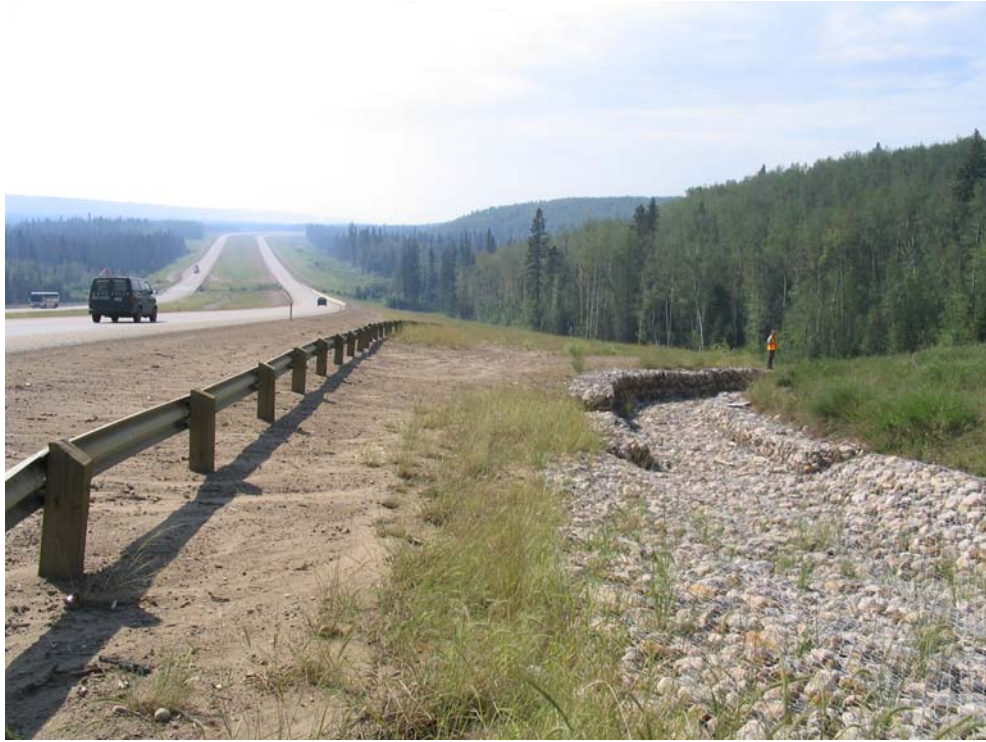
Photo 9 - Looking South along West Sideslope from North End.

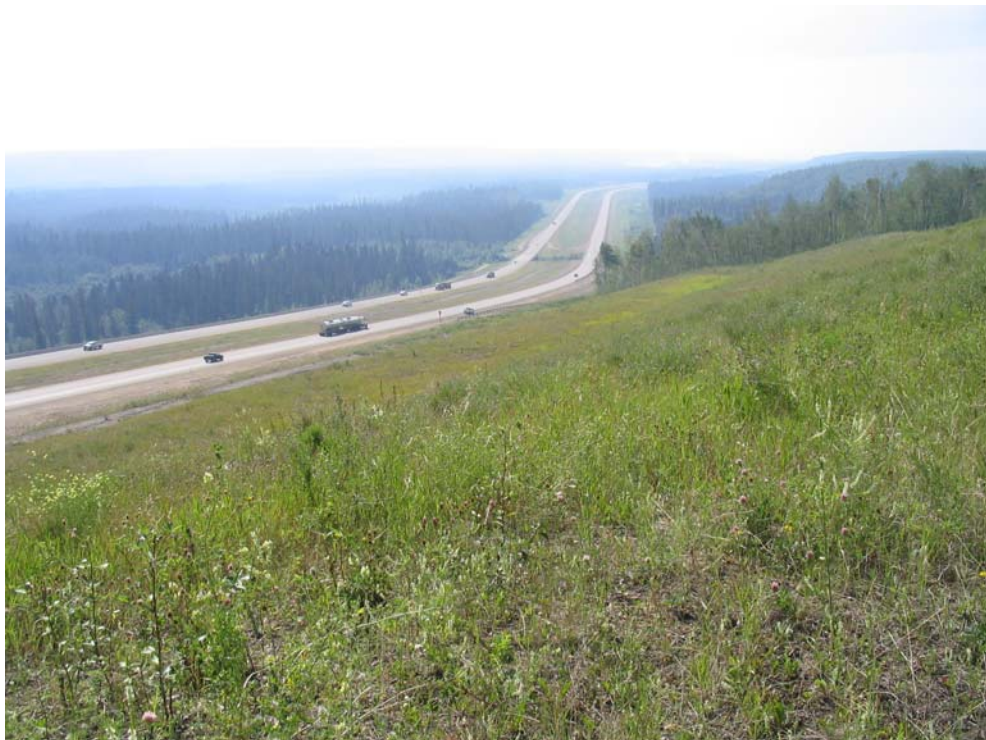
Photo 10 - Looking South along High Backslope.

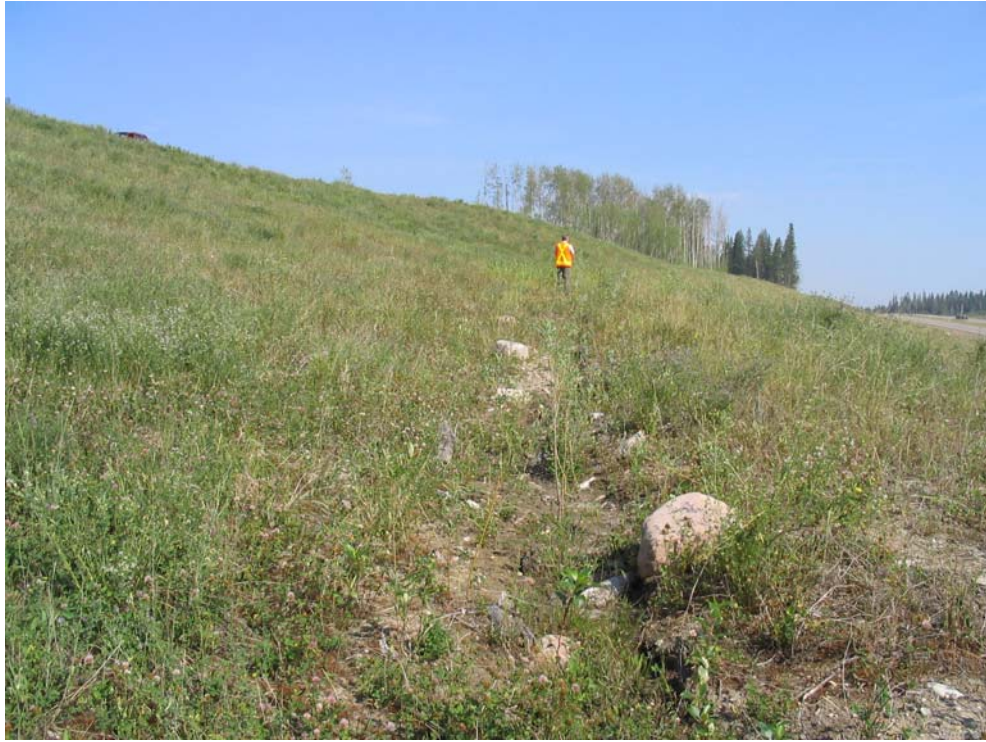
Photo 11 -Third Bench of High Backslope.

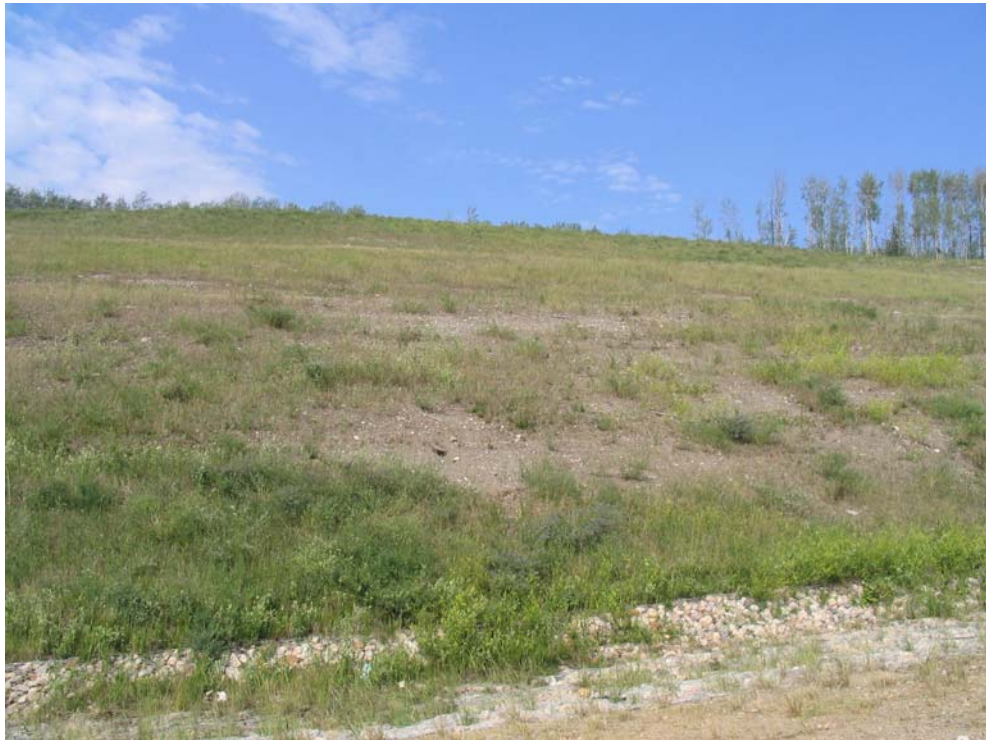
Photo 12 - Bare Area on Lower Part of Backslope.

- Topsoil and seed all of the bare areas shown on the attached drawings where vegetation has not caught. Hydroseeding may also be considered. Prior to spreading topsoil, any rilled slope areas should be smoothed and track-packed in an up and down slope direction. After topsoil spreading and seeding any sloped areas should be covered with low flow soil covering. A shallow topsoil berm or Filtrexx Sock should be placed diagonally across the west sideslope near Station 16+220 to intercept flow down the slope and direct it back into the gabion lined left ditch. Salt resistant seed mix should be used to revegetate the upper bare side slope

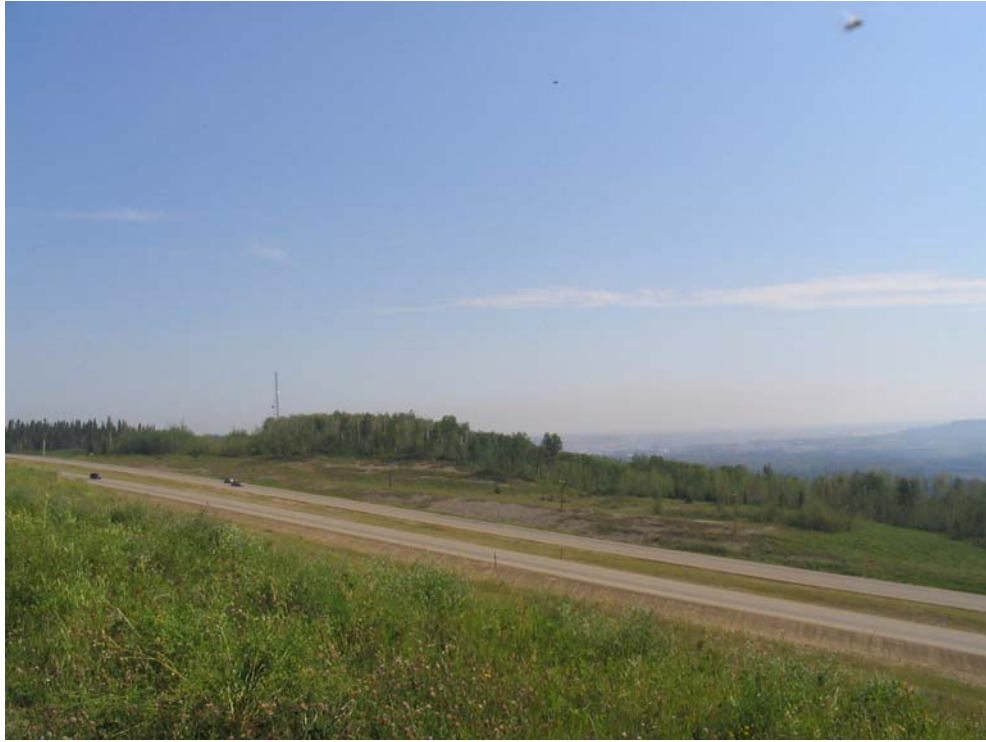
- There was still a bare backslope on the east side of the highway near Station 16+650 that was not included in the erosion repair works. This section continues to develop erosion rills due to the lack of topsoil and vegetation.

Photo 13 - Bare Backslope on East Side of Highway at North End of Site.
