GEOHAZARD ASSESSMENT PROGRAM

NORTH CENTRAL REGION – ATHABASCA

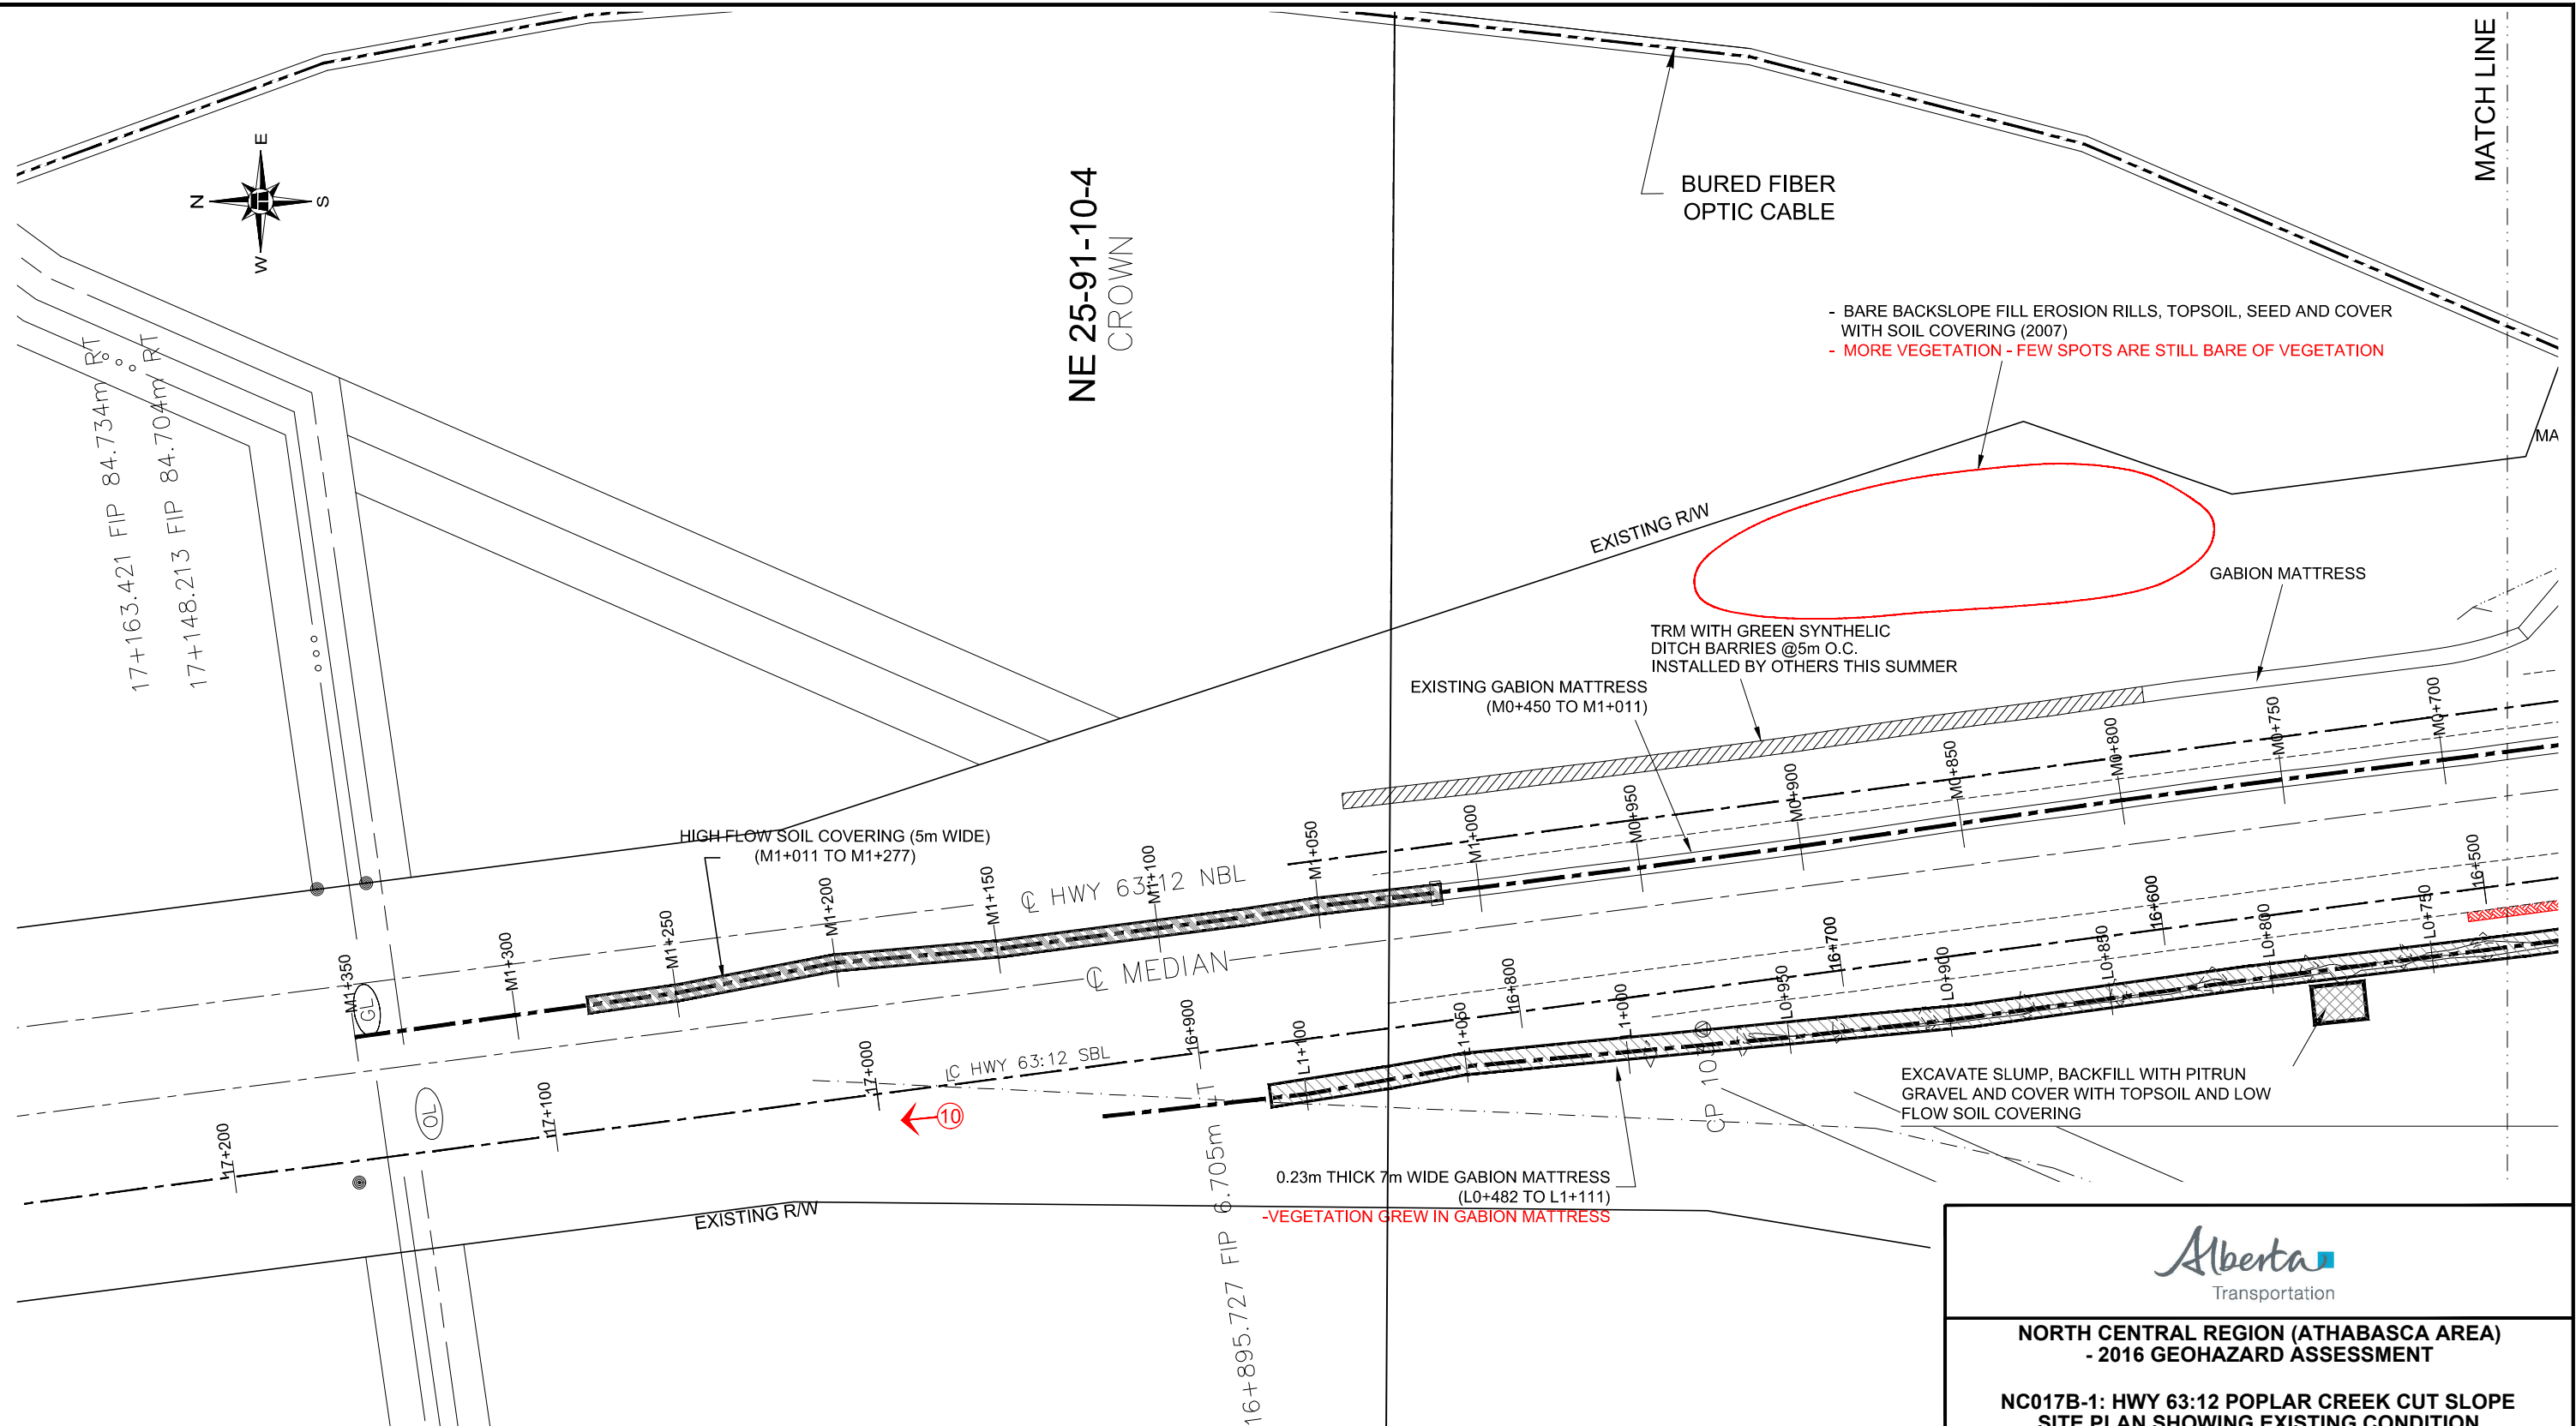
Trash should always be removed from above and around the median ditch bubble grate over the drop pipe.

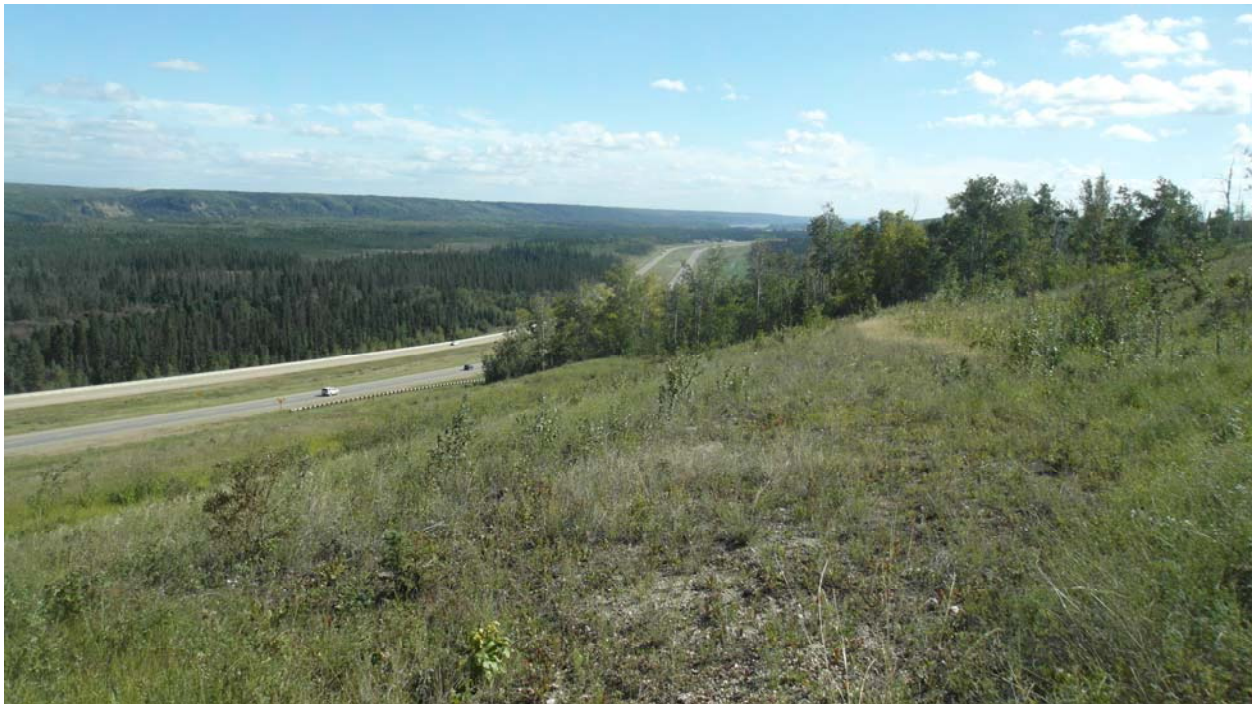
Photo #13A - Looking north at the third bench of the west back slope; seepage was noted within the northern limit of the bench.

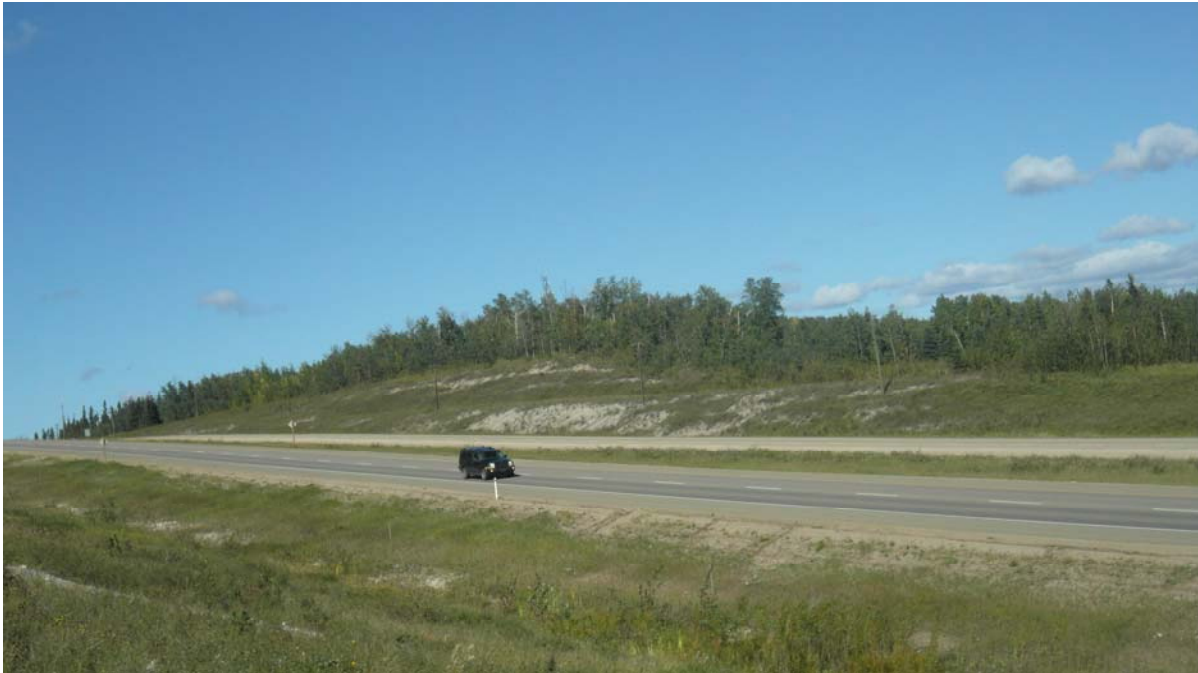
Photo #14 - Looking northeast from the first bench of the west back slope at spots bare of vegetation within the highway east back slope.
