August 19, 2021

File No.: 32122, Task C

# ALBERTA TRANSPORTATION GRMP (CON0022163) NORTH CENTRAL (ATHABASCA AND FORT McMURRAY DISTRICTS) INSTRUMENTATION MONITORING RESULTS – SPRING 2021

# SITE NC017B: HWY 63:12 SUPERTEST HILL

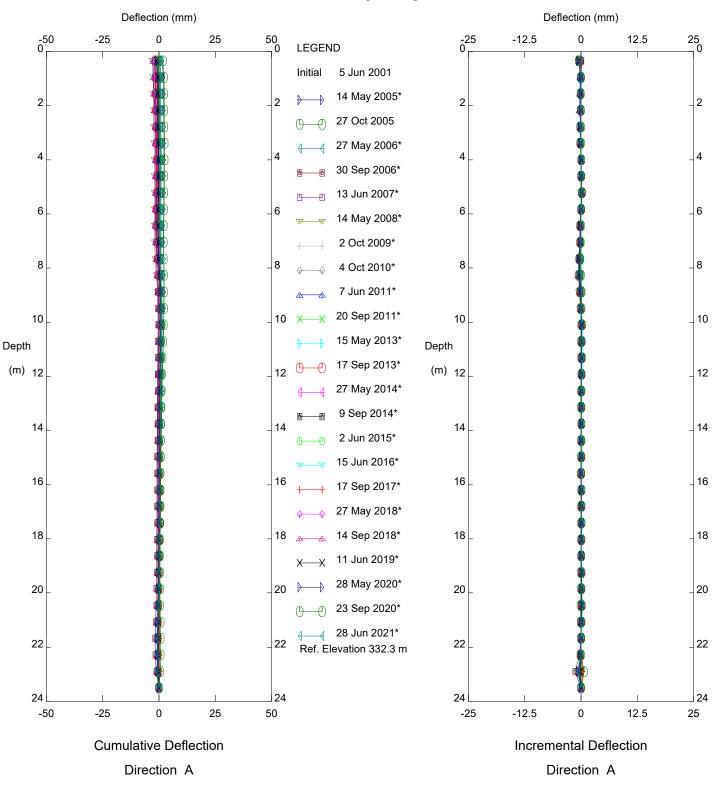
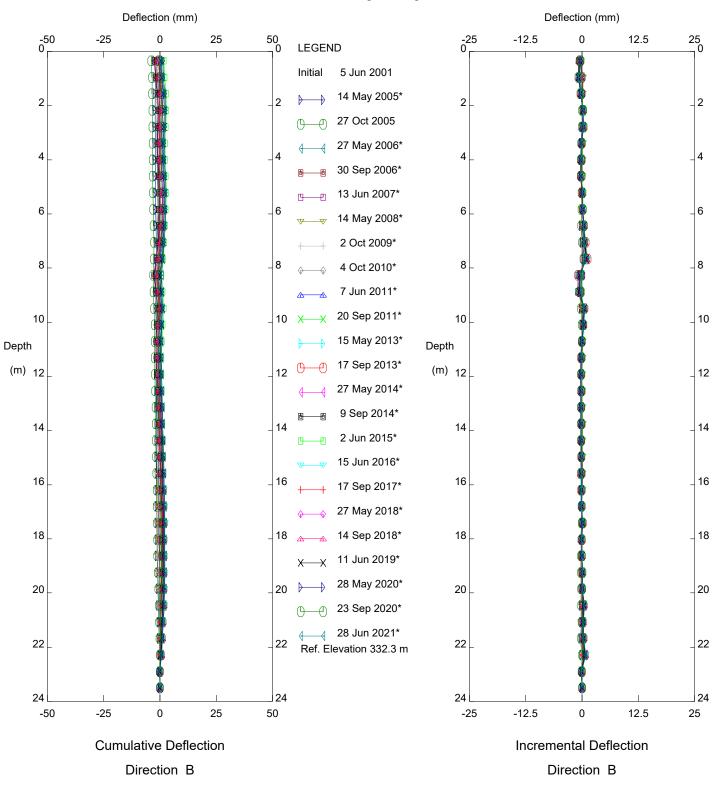
Hwy 63:12 Supertest Hill (NC017B-1), Inclinometer SI-1

Slope inclinometers SI-1 and SI-2 continued to show no discernible movement. SI-3 showed a rate of movement of 1.5 mm/yr over 42.5 m to 46.2 m depth since the fall of 2020 readings. SI-4 showed a rate of movement of 1.1 mm/yr over 37.6 m to 41.3 depth since the fall of 2020 readings.
