GEOHAZARD ASSESSMENT PROGRAM
NORTH CENTRAL REGION – ATHABASCA
2009 INSPECTION

Site Number	Location	Name	Hwy	km
NC 25	16 km east of Hwy 41:22 near the Town of Lindbergh	WEST LINDBERGH HILL	646:04	16
Legal Description		UTM Co-ordinates (NAD 83)		
NW-27-56-5-W4M		12 N 5969352.8	E 522398.9

Date	PF	CF	Total
Previous Inspection:	June 6, 2008	9	2	18
Current Inspection:	June 22, 2009	9	2	18
Road AADT:	1280	Year:		2008
Inspected By:	Tarek Abdelaziz, Don Proudfoot (Thurber) Roger Skirrow, Calvin Kissel (TRANS)			
Report Attachments:	<input checked="" type="checkbox"/> Photographs <input checked="" type="checkbox"/> Plans <input type="checkbox"/> Maintenance Items

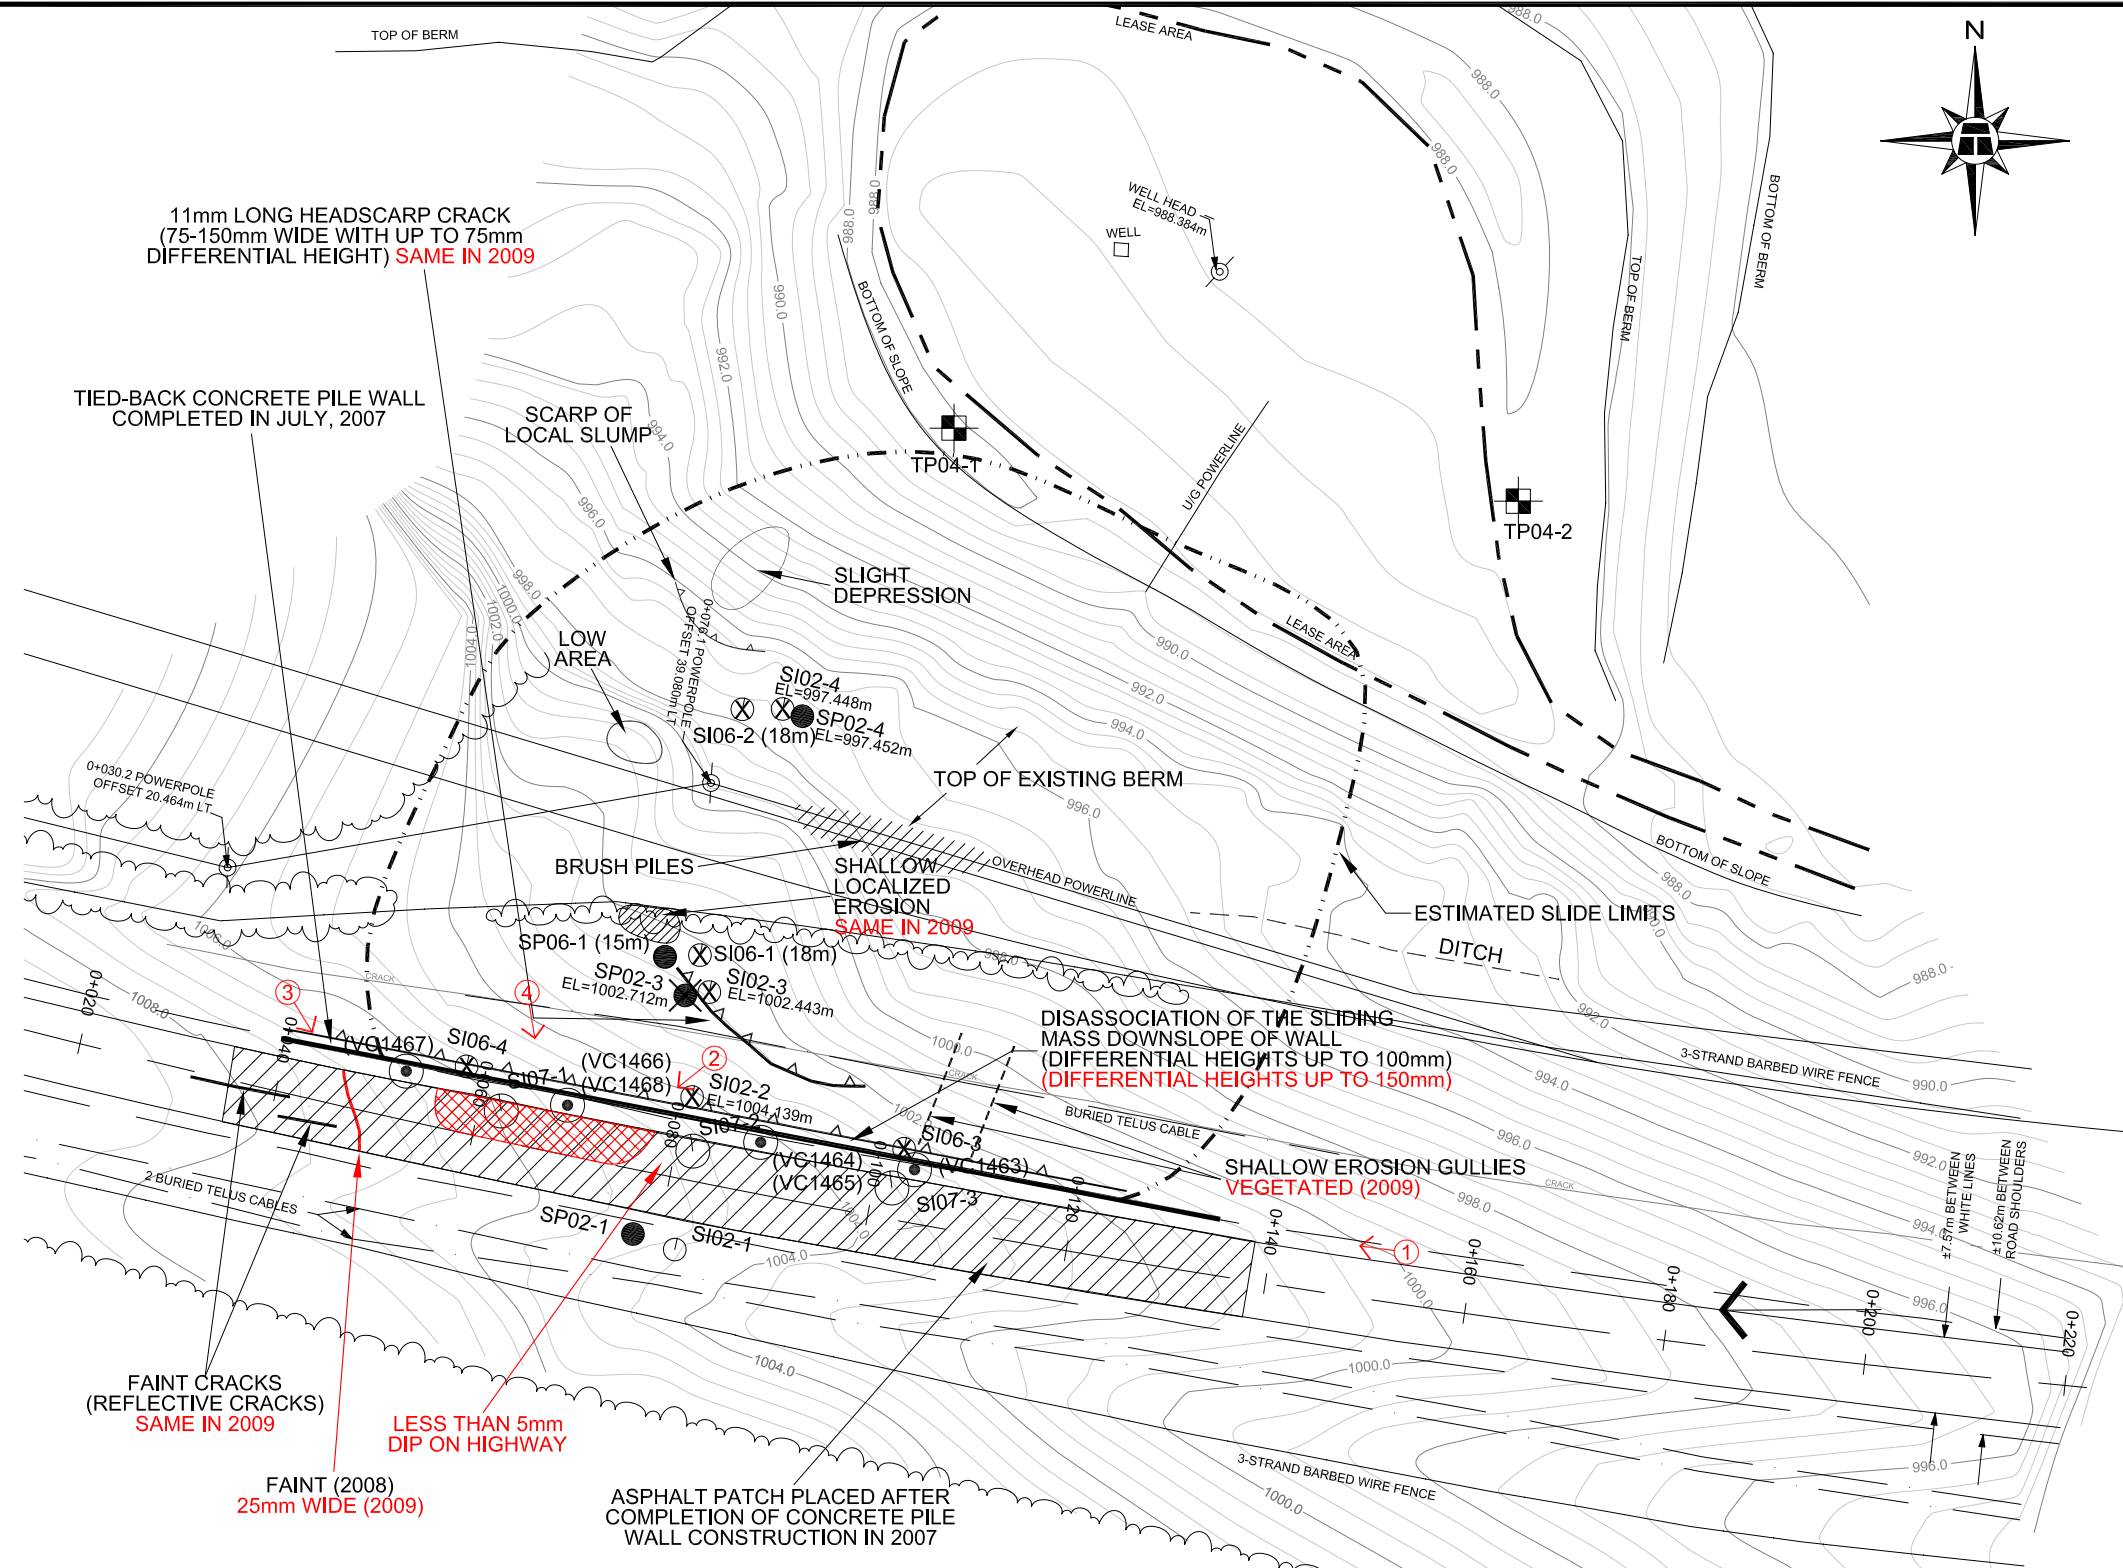
ALBERTA TRANSPORTATION	
NC25 - HWY 646:04 km 16 WEST LINDBERGH HILL SLIDE INSTRUMENT LOCATIONS AND SITE FEATURES (JUNE, 2009)	
LINDBERGH, AB	NE 27-56-5-W4M

Primary Site Issue:	Active slide movement on the north side slope causing pavement distress of the highway roadway surface along the east and west bound lanes.	
Dimensions:	About 75 m along the highway and 80 m wide perpendicular to north edge of highway.	
Date of any remediation:	Construction of a tied-back concrete wall to retain slide mass along with minor earthwork (completed in July 2007). Highway was overlaid in late 2007.	
Maintenance:	None since construction completion in 2007	
Observations:	Description	Worse?
<input checked="" type="checkbox"/> Pavement Distress	Dip on the WBL by 5 mm along the western portion of the slide. 25 mm wide diagonal reflective crack at the west limit of the slide	<input checked="" type="checkbox"/>
<input checked="" type="checkbox"/> Slope Movement	Settlement of soil in contact with the wall at the downslope side by 150 mm	<input checked="" type="checkbox"/>

The site observations and the instrument readings indicated that the pile wall has been effective in retaining the portion of the slide mass along the highway. The slide mass has crept a bit above the wall and more noticeably along the west side of the old slide as revealed from the dip on the highway, the open diagonal crack, and the instrument readings. The lateral thrust of the slide mass on the wall resulted in slight downslope movement of the wall and accordingly an increase in the anchor loads.

The slide mass downslope of the wall has been very active and the scarp crack developed along the wall face dropped by 50 mm since last site visit in 2008.

In the short term, open cracks on the highway surface should be sealed to prevent the built up of excess pore water pressure on the wall. The scarp cracks immediately downslope of the pile wall should be regraded and filled. Gravel may be temporarily used to smooth the side slope at the contact between the wall and the downslope slide mass to protect runaway cars from a sharp drop along the face of the wall. In the long term, it will be required to install a guardrail along the shoulder of the highway; otherwise a toe berm will be required to stabilize the downslope slide mass.

As discussed on site, this site will be removed from the Geohazard Assessment Program. However, semi-annual instrumentation monitoring will be continued to appraise the ongoing effectiveness of the remedial measure. The local MCI should continue to monitor and record the development of any new cracks/depression on the highway paved surface.

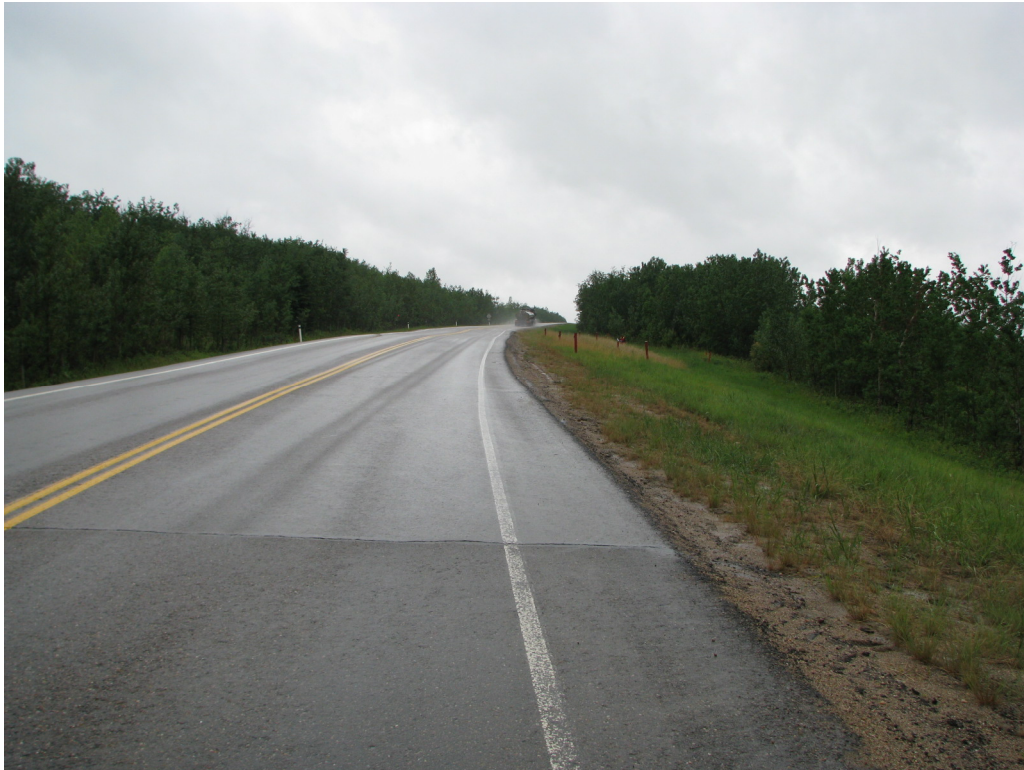
Photo #1 General view of highway surface at slide location, looking west

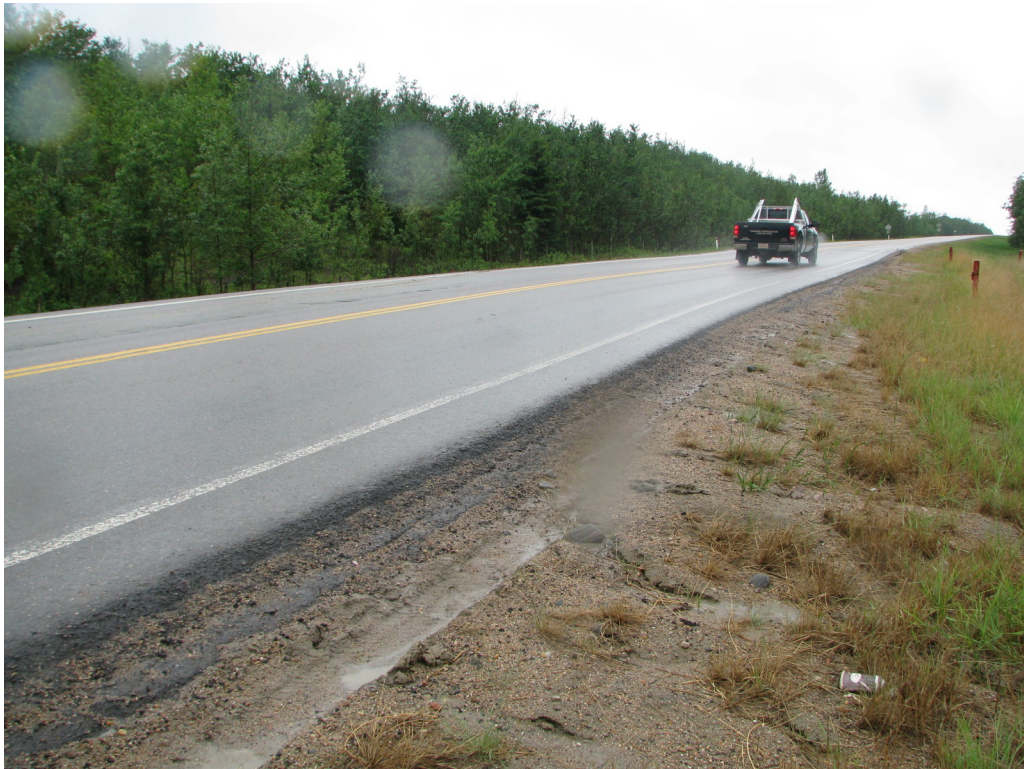
Photo #2 Looking southwest at the slight dip on the highway WBL, note the dip below the passing vehicle

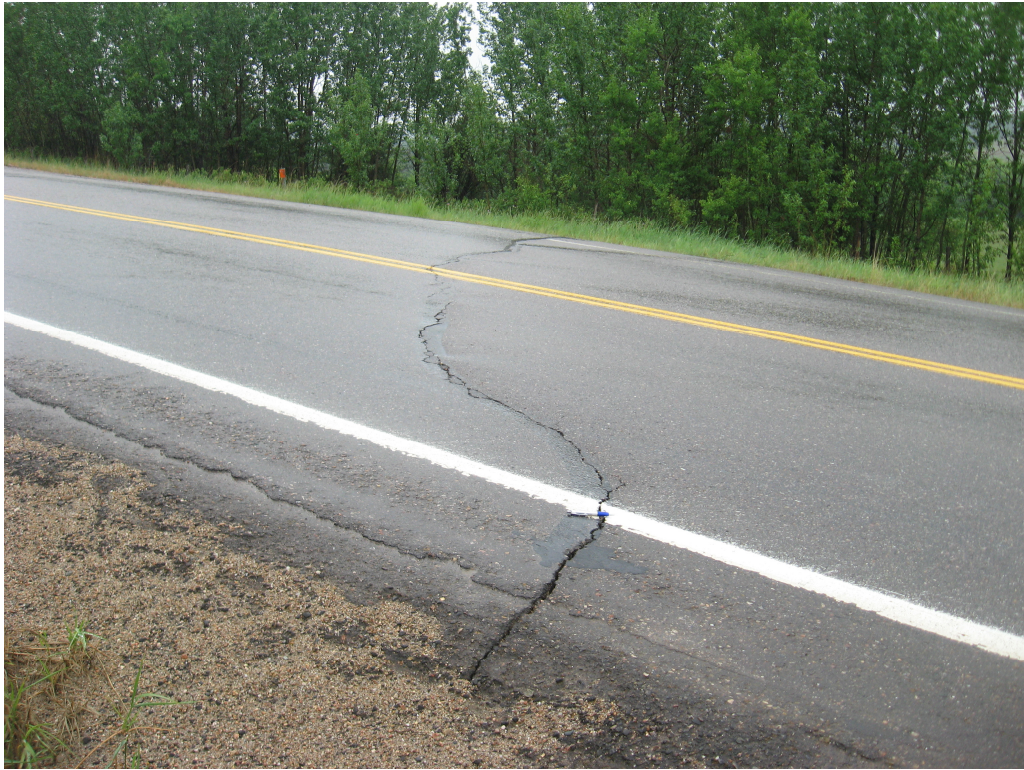
Photo #3 Open arc-shaped crack at the western limit of the slide, looking east

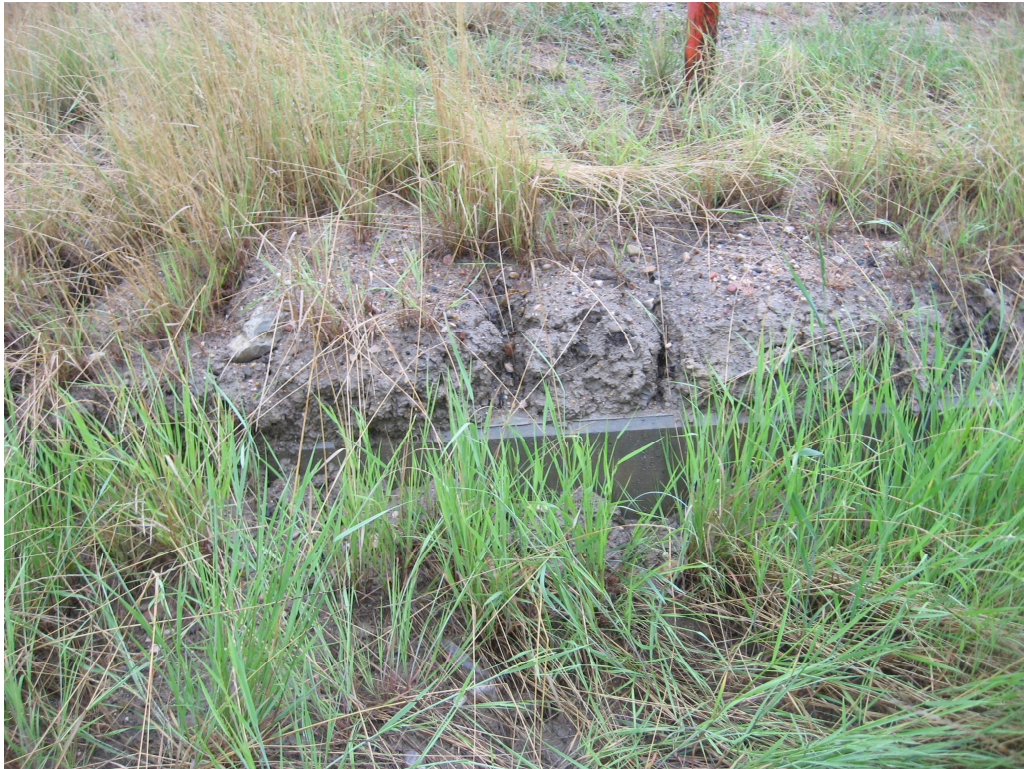
Photo #4 Existing crack along the downslope face of the wall, looking south
