**GEOHAZARD ASSESSMENT PROGRAM**  
**NORTH CENTRAL REGION – ATHABASCA**

**2010 INSPECTION**

Site Number	Location	Name	Hwy	km
NC 25	16 km east of Hwy 41:22 near the Town of Lindbergh	<b>WEST LINDBERGH HILL SLIDE</b>	646:04	16
Legal Description		UTM Co-ordinates (NAD 83)		
NW-27-56-5-W4M		12 N	5969352.8 E	522398.9

**NC25 - HWY 646:04 km 16  
WEST LINDBERGH HILL SLIDE  
INSTRUMENT LOCATIONS AND  
SITE FEATURES (MAY 25, 2010)**

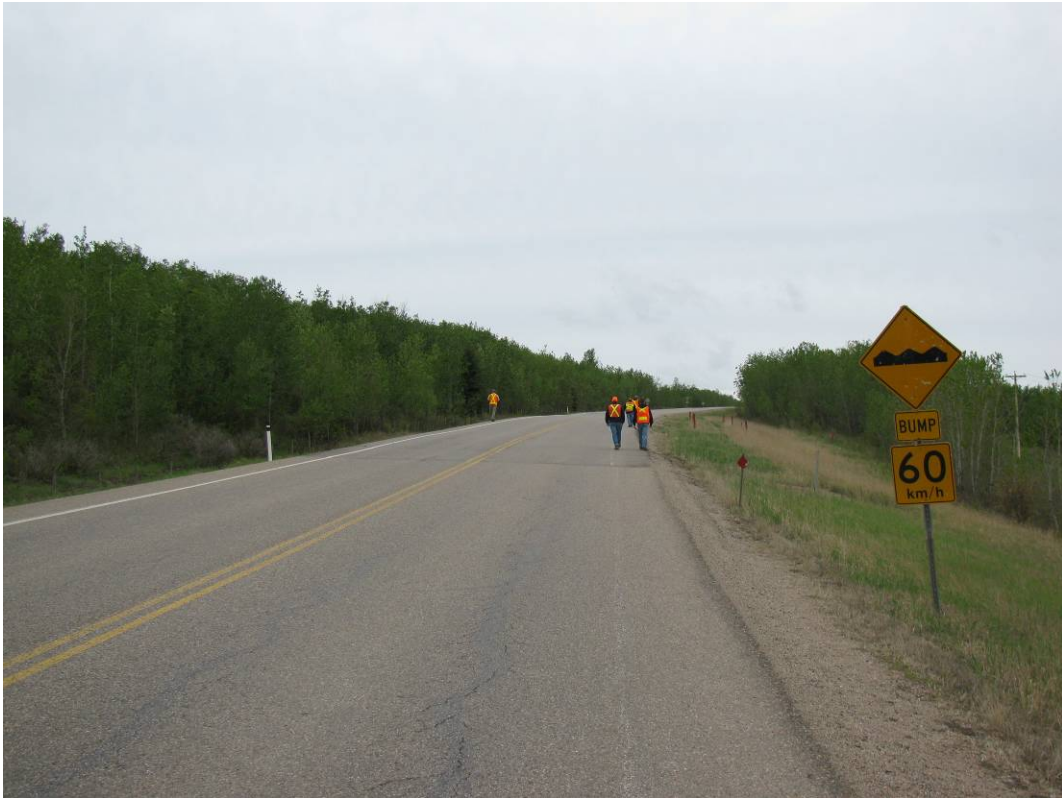
**Photo #1** General view of highway surface at slide location, looking west

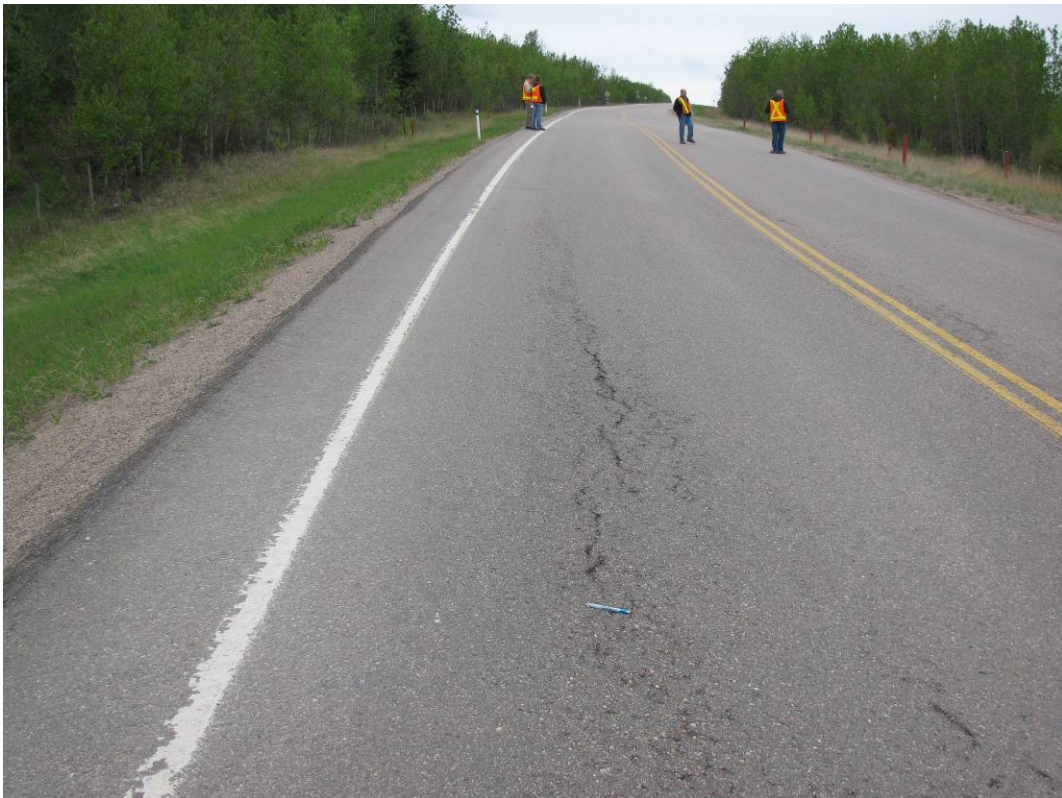
**Photo #2** 10-15 mm wide reflective crack on the highway EBL, looking west

In the short term, open cracks on the highway surface should be sealed to prevent the built up of excess pore water pressure on the wall. As a temporary measure, gravel may be used again to smooth the side slope at the contact between the wall and the downslope slide mass to protect potential runaway cars from the sharp drop along the face of the wall. In the longer term, and as previously recommended in the 2009 inspection report, a permanent solution would be to install a guardrail along the shoulder of the highway or construct a toe berm on the well pad to stabilize the downslope slide mass.

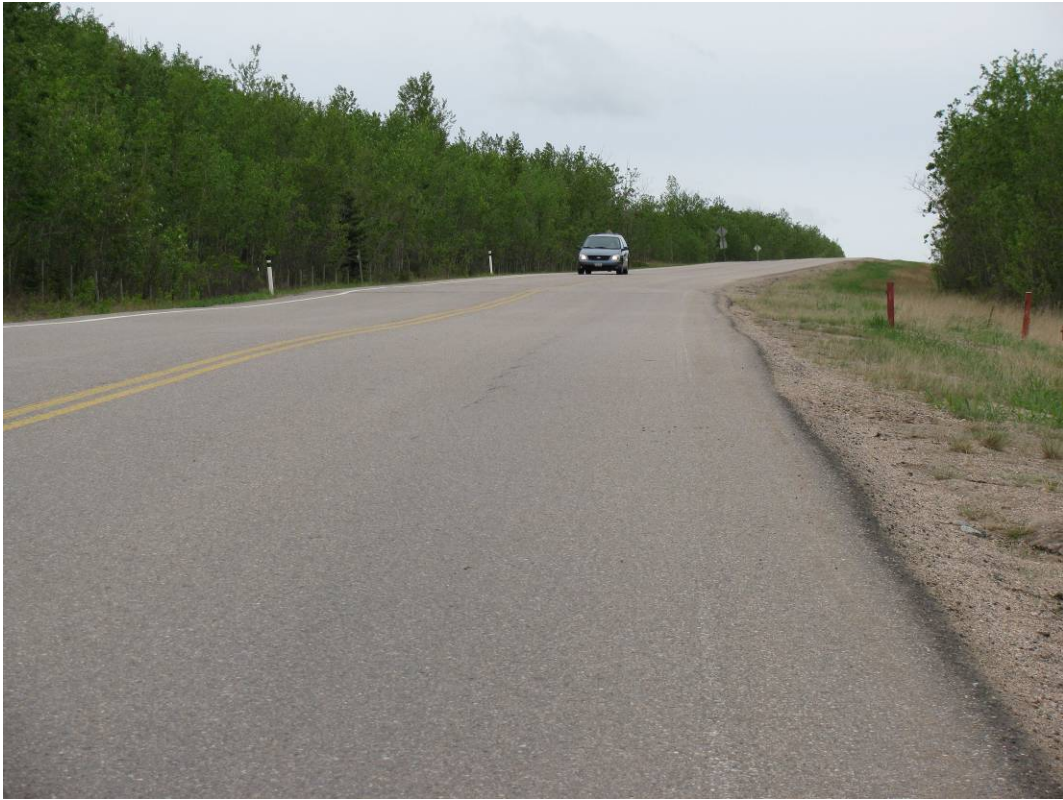
**Photo #3** Looking west at the dip on the highway surface

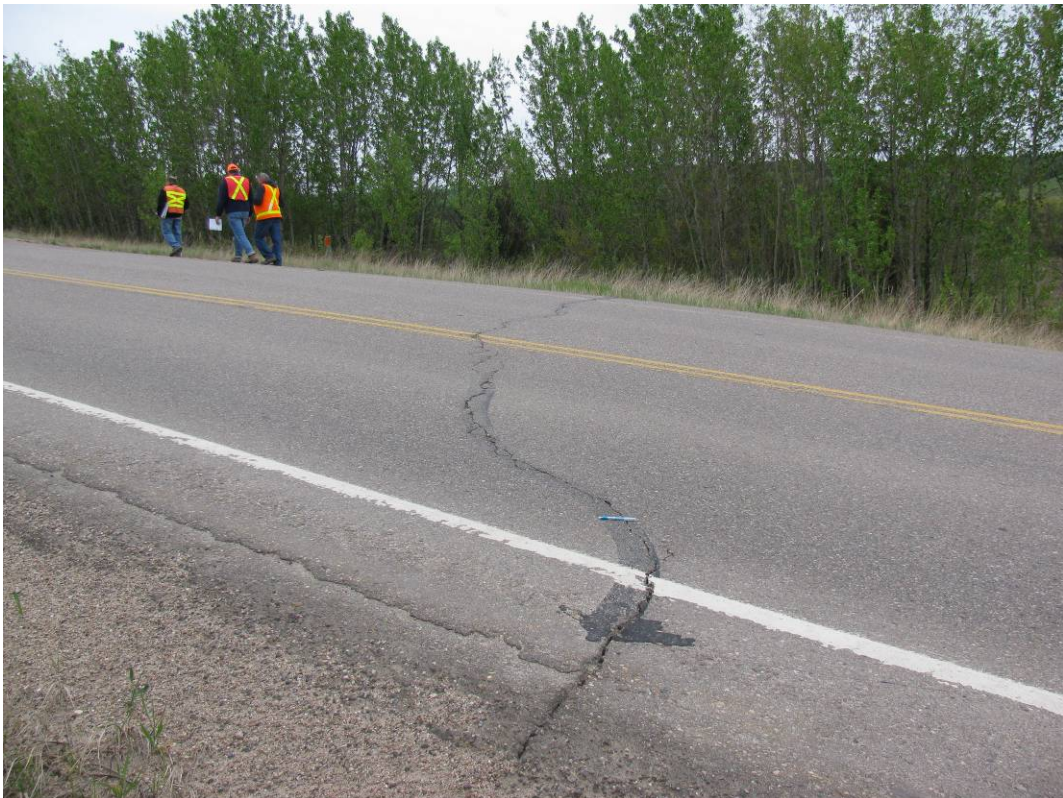
**Photo #4** 10-25 mm wide open arc-shaped crack at the western limit of the slide, looking north

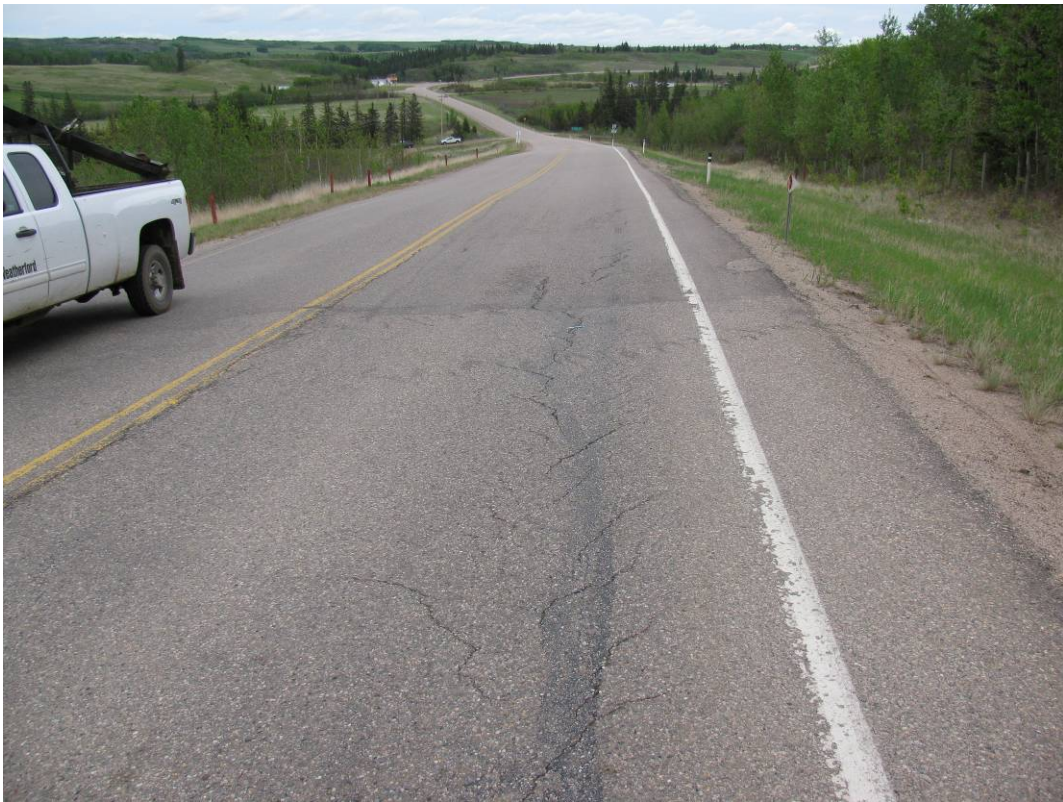
The cracks noted outside the western edge of the patched area are likely not slide-related cracks and are probably reflecting sub-grade or pavement structure issues.

**Photo #5** 5-10mm wide open cracks outside the western limit of the patched area, looking east

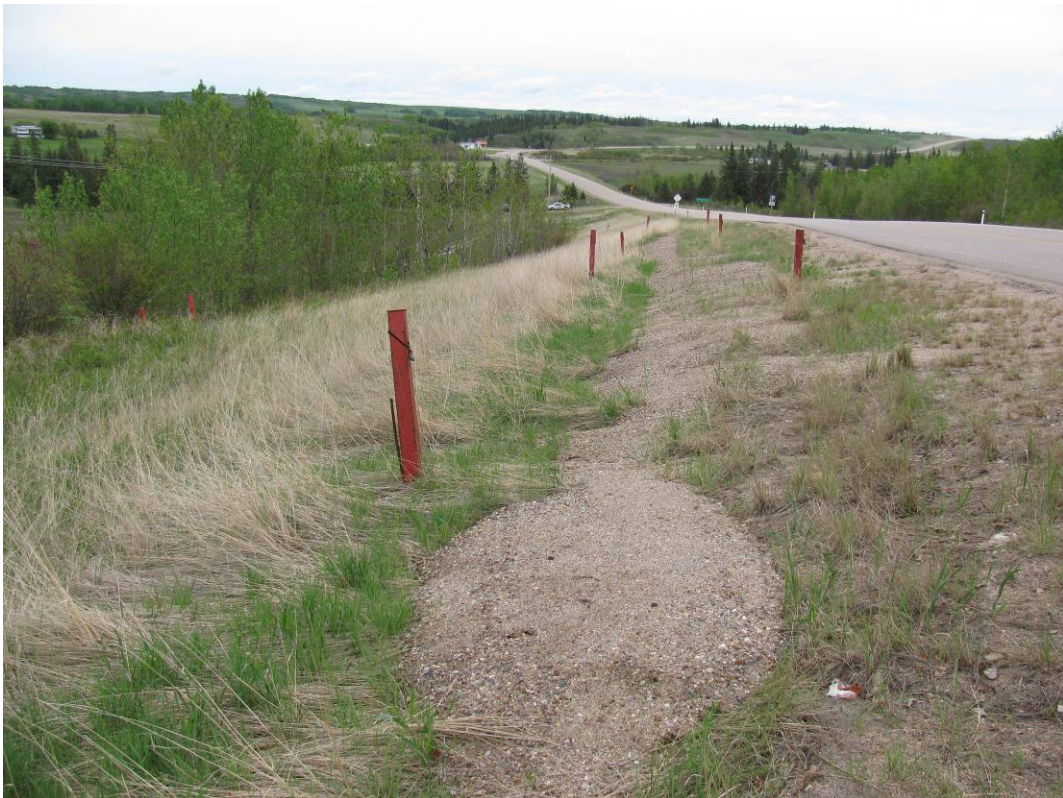
**Photo #6** Gravel fill placed along the wall face in late 2009, looking west

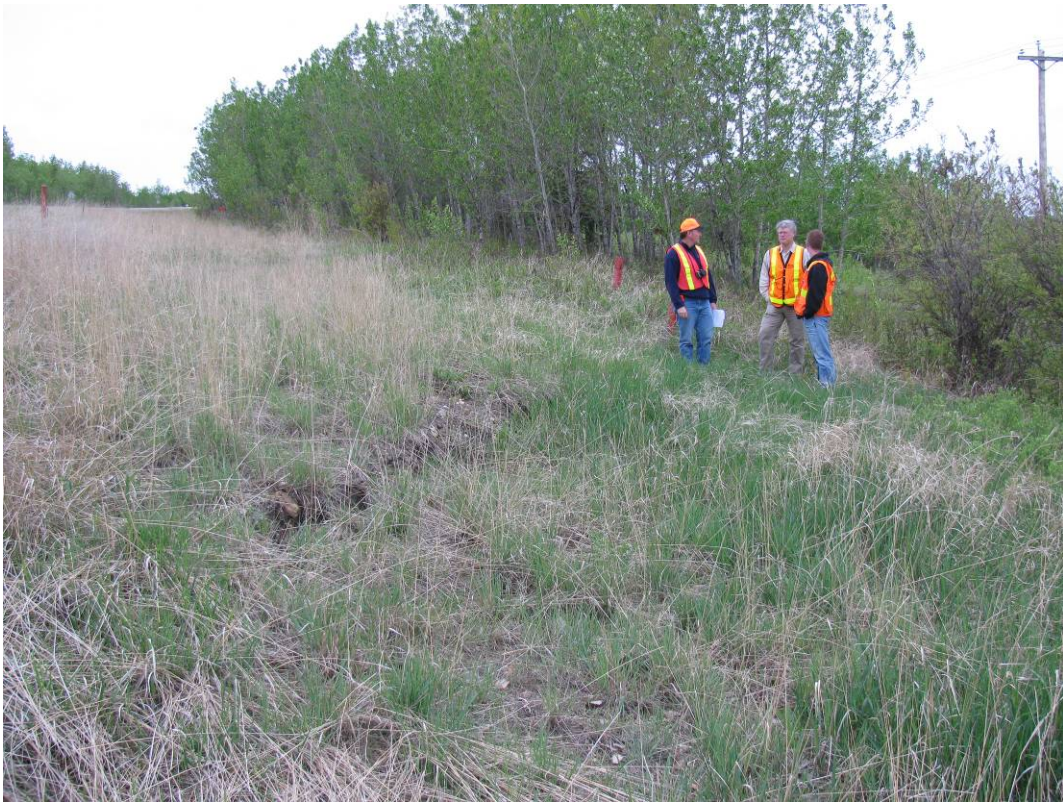
The fresh cracks along the wall face and downslope of the wall location suggest that the slide mass downslope of the wall has been active. The slide mass downslope of the wall will probably continue to move, and again will create a drop off at the wall face.

**Photo #7** Active scarp crack downslope of the wall, looking west

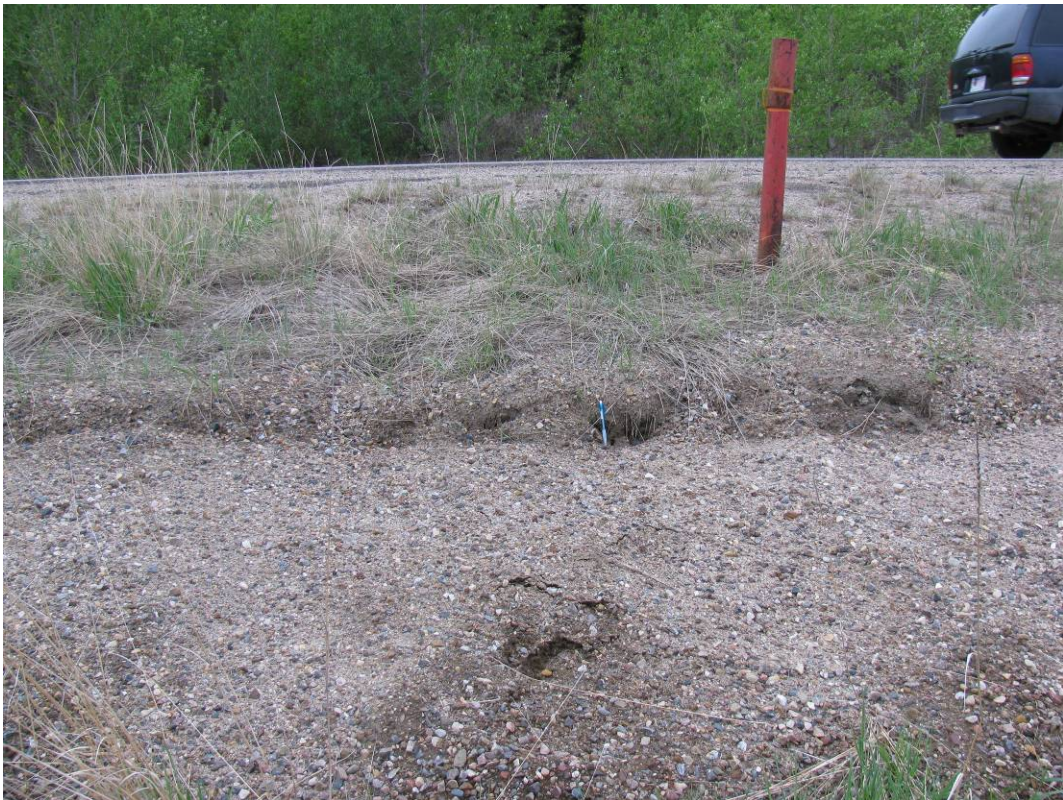
**Photo #8** Settlement of gravel in contact with the wall downslope face by up to 150 mm, looking south
