<b>SITE NUMBER AND NAME:</b> C047 Hwy 27 Ditch Erosion		<b>HIGHWAY &amp; KM:</b> 27:10, 22.762 to 25.496	<b>PREVIOUS INSPECTION DATE:</b> N/A	<b>INSPECTION DATE:</b> <b>June 19, 2024</b>
<b>LEGAL DESCRIPTION:</b> 03-15-31-21-W4	<b>NAD 83 COORDINATES:</b> UTM    Northing    Easting 12       5723911    368294		<b>RISK ASSESSMENT:</b> PF: 3    CF: 2    TOTAL: 6	
<b>AVERAGE ANNUAL DAILY TRAFFIC (AADT):</b> 1650 (east) & 1680 (west) (Ref No. 106260 & 108260)			<b>CONTRACT MAINTENANCE AREA (CMA):</b> 517

<b>SUMMARY OF SITE INSTRUMENTATION:</b>  There is no instrumentation at the C047 site.  LAST READING DATE: N/A	<b>INSPECTED BY:</b> Chris Gräpel (KCB) James Lyons (KCB) Tony Penney (TEC) Rocky Wang (TEC)
<b>PRIMARY SITE ISSUE:</b> Ditch erosion, exacerbated by dispersive soil, in the south (eastbound) ditch east of the Morrin Bridge.	
<b>APPROXIMATE DIMENSIONS:</b> The overall length of the site is approximately 2.5 km.	
<b>DATE OF ANY REMEDIAL ACTION:</b> As part of the Morrin Bridge replacement project in the early 2020s, the erosion gullies in the south ditch (west of the Morrin Bridge) and in the north and south ditches (east of the Morrin Bridge) were repaired using a combination o

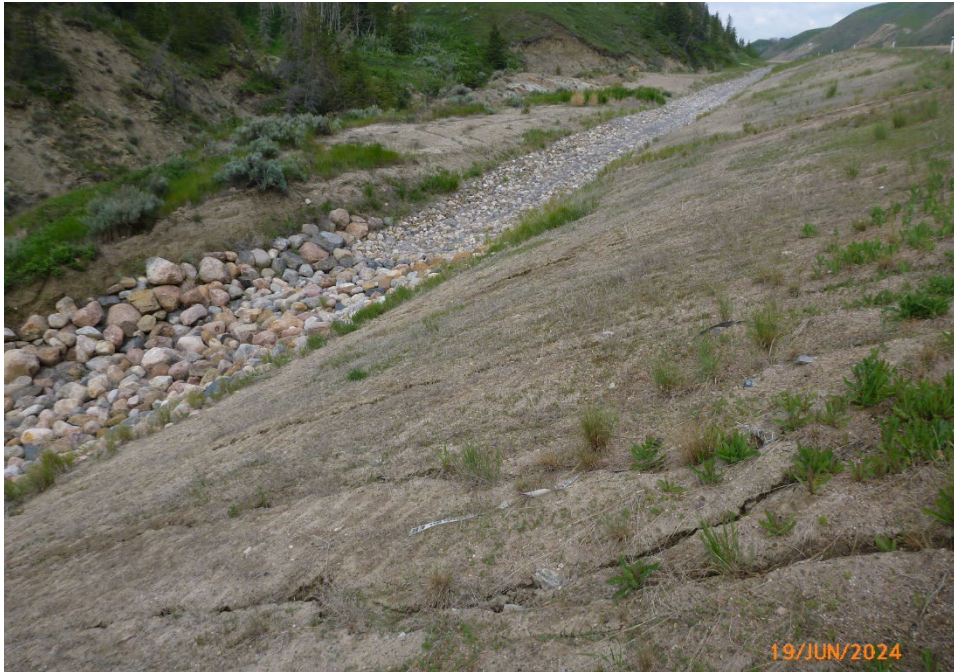
- The gabion baskets installed along the south (eastbound) ditch appear to be in good condition (Photo 1). The gabion baskets were installed in a channel shape and are performing well (Photo 2).
- There were sandstone particles observed in the gabion baskets, but KCB estimates they only make up around 5% of the riprap particles within the gabions (Photo 3).
- The riprap armouring downstream (south) of the gabion baskets shown in Photo 1 and 2 is in good condition and appears to be performing well (Photo 4 and 7).
- Minor rill erosion was observed along the west (eastbound) highway embankment slope (Photo 5).
- Minor erosion was observed in the east (westbound) highway ditch (Photo 6). It appears as though the ditch may have previously been repaired with a rolled erosion control product (RECP), and the recent erosion has exposed the RECP.

**Photo 1** Gabion baskets installed along the west (eastbound) ditch west of the Morrin Bridge.  
Photo taken June 19, 2024, facing north.

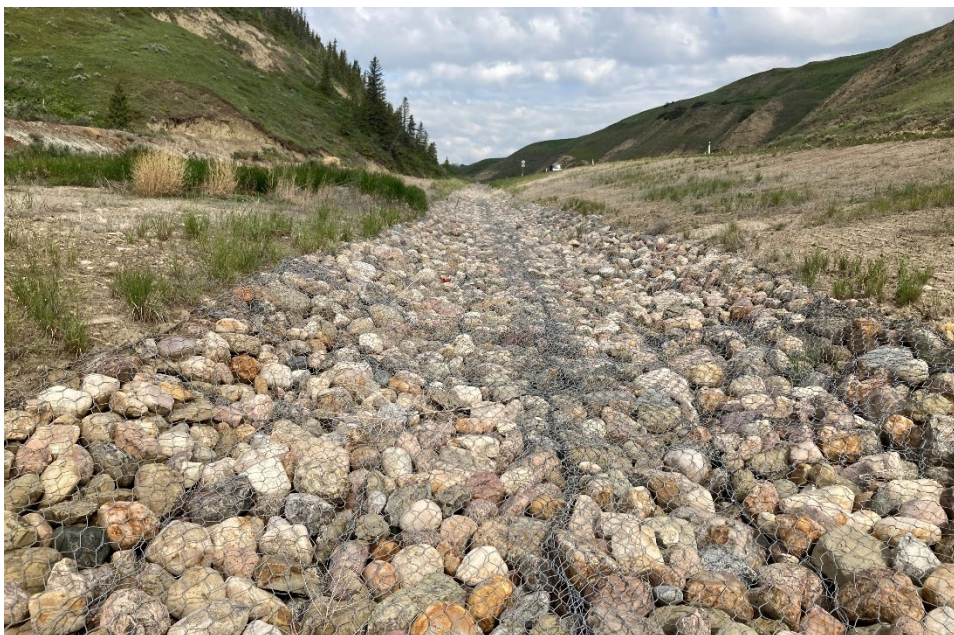
**Photo 2** Gabion baskets were installed to achieve a channel shape and are performing well.  
Photo taken June 19, 2024, facing north.

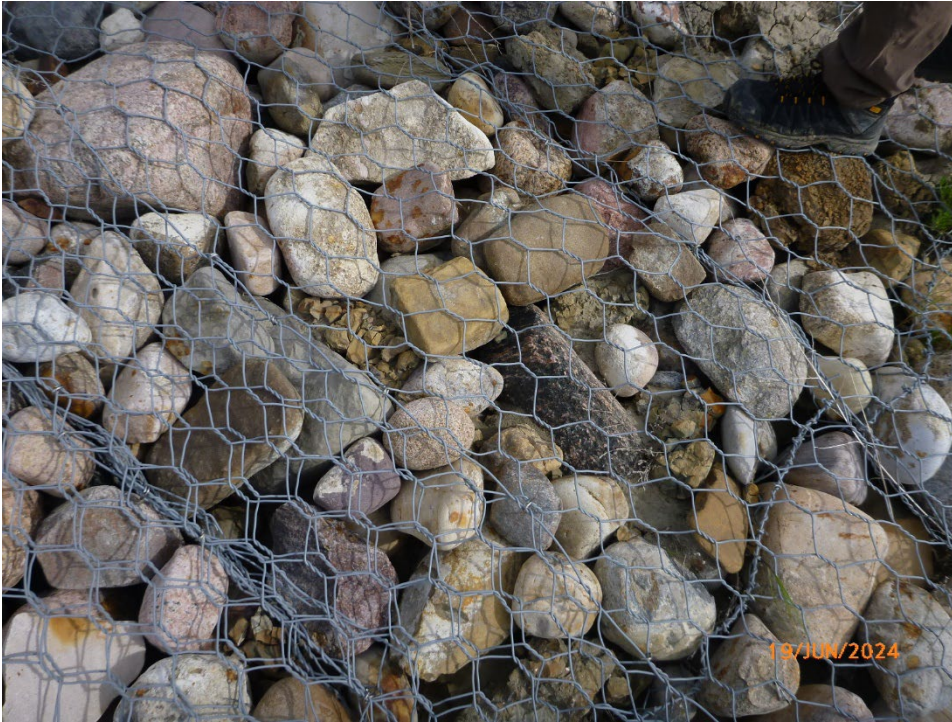
**Photo 3** Sandstone riprap particles were observed throughout the riprap gabion baskets along the length of the repair. Photo taken June 19, 2024.

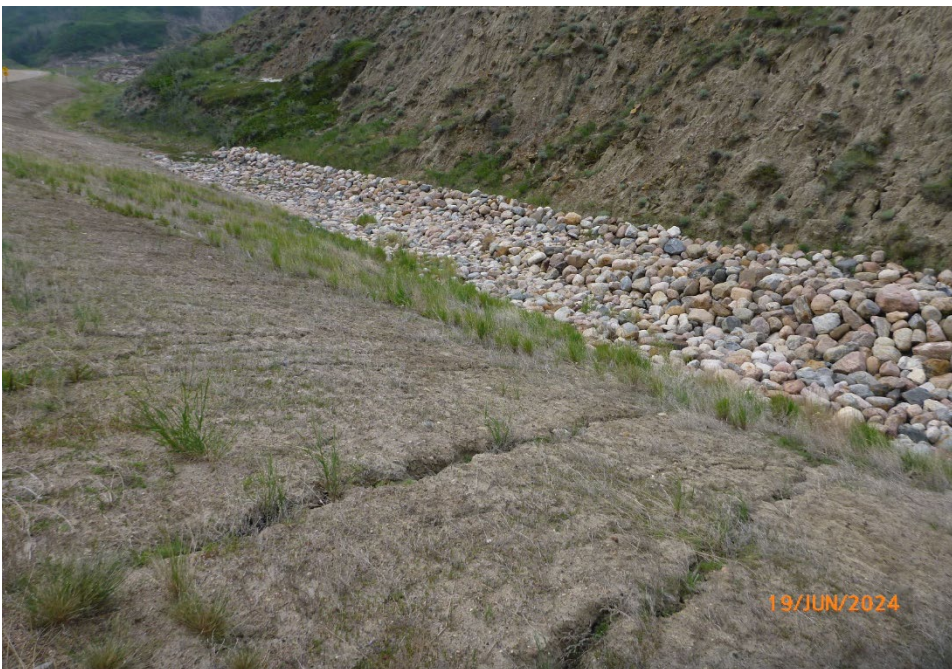
**Photo 4** Riprap armouring downstream (south) of the gabion baskets. Photo taken June 19, 2024, facing south.

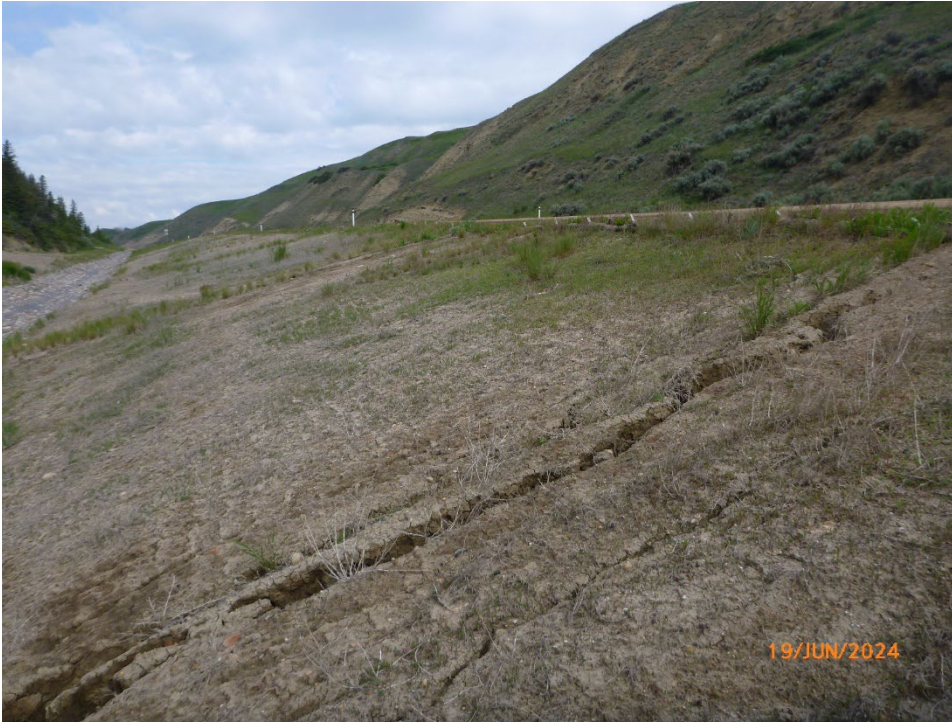
**Photo 5** Rill erosion observed along the west highway embankment slope. Photo taken June 19, 2024, facing north.

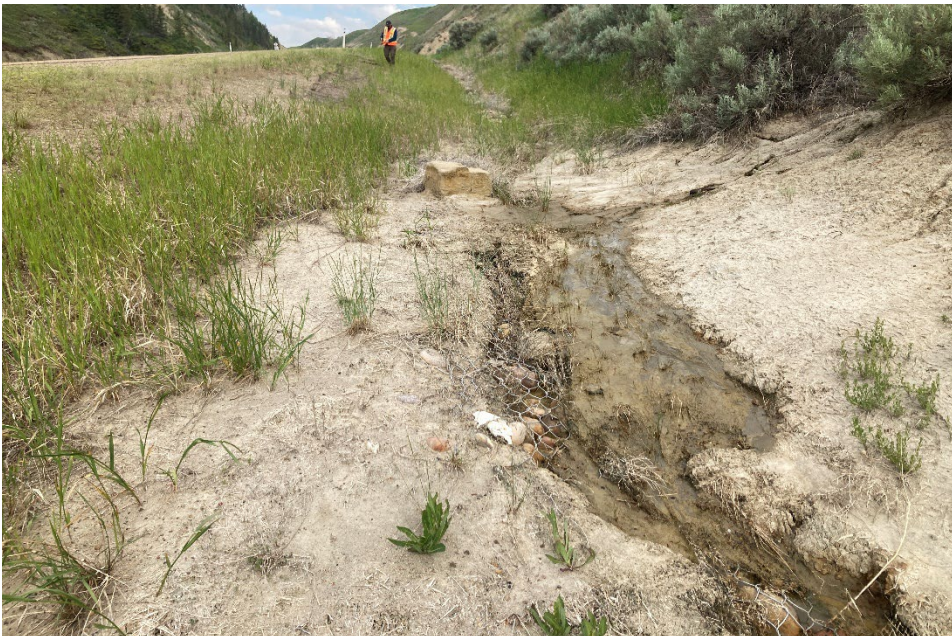
**Photo 6** Minor erosion observed in the east (westbound) highway ditch. It appears as though the ditch was previously repaired with a rolled erosion control product. Photo taken June 19, 2024, facing north.

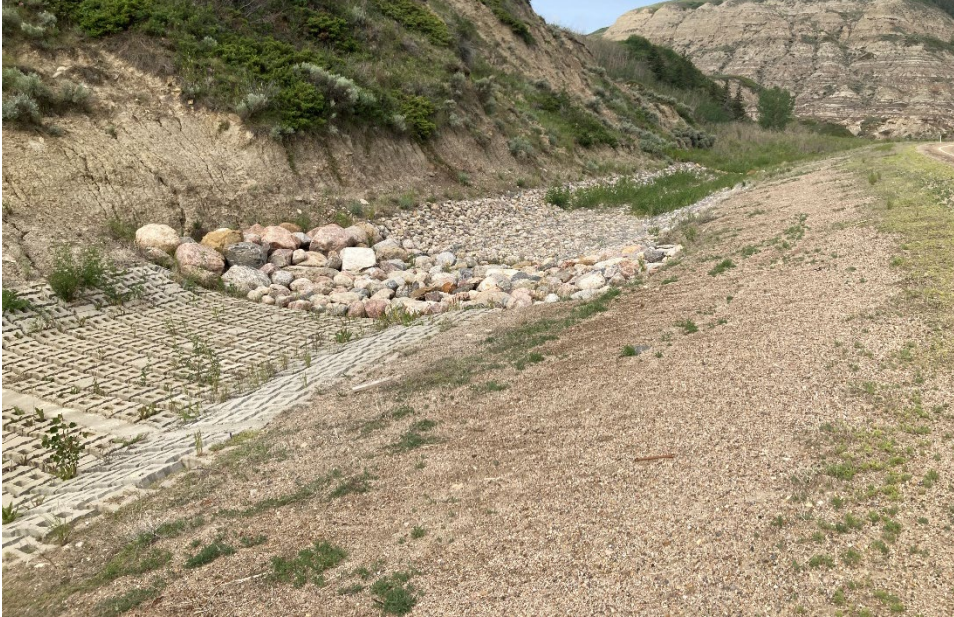
**Photo 7** Transition from riprap armouring to articulated concrete blocks along the west (eastbound) ditch near the east extent of the repair. Photo taken June 19, 2024, facing west.

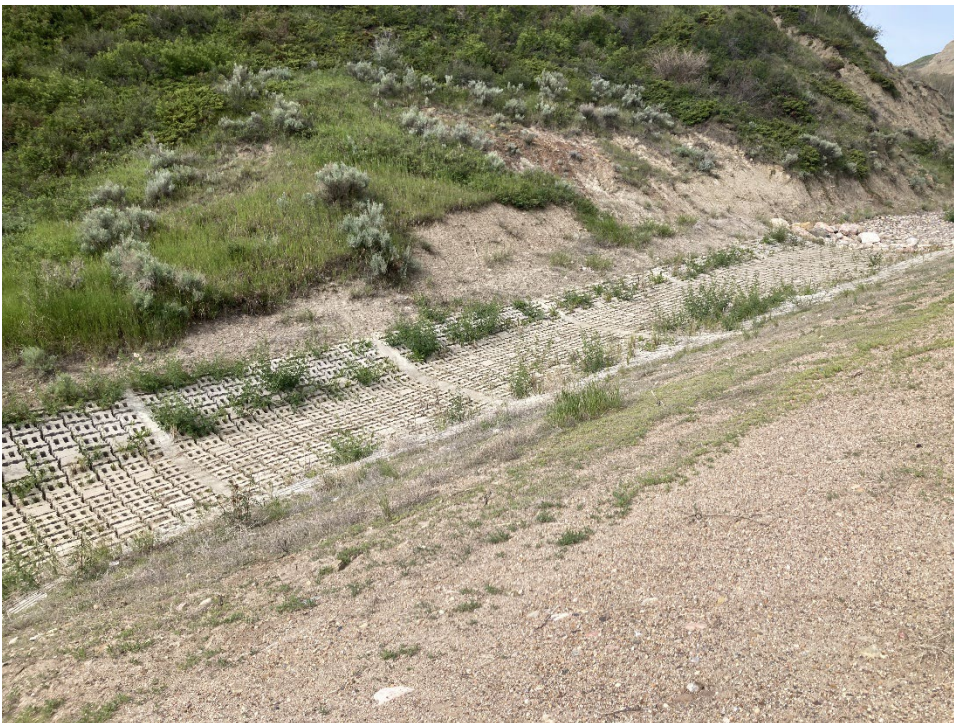
- The articulated concrete blocks installed at the downstream extent of the repair are in good condition and are performing well (Photo 8). Grass was observed growing between the concrete block during the inspection.
- The riprap energy dissipated structure appears to be in good condition. The riprap is rounded fieldstone and KCB estimates it is Class 3 riprap (Photo 9).

**Photo 8** Length of ditch repaired using articulated concrete blocks. Photo taken June 19, 2024, facing southwest.

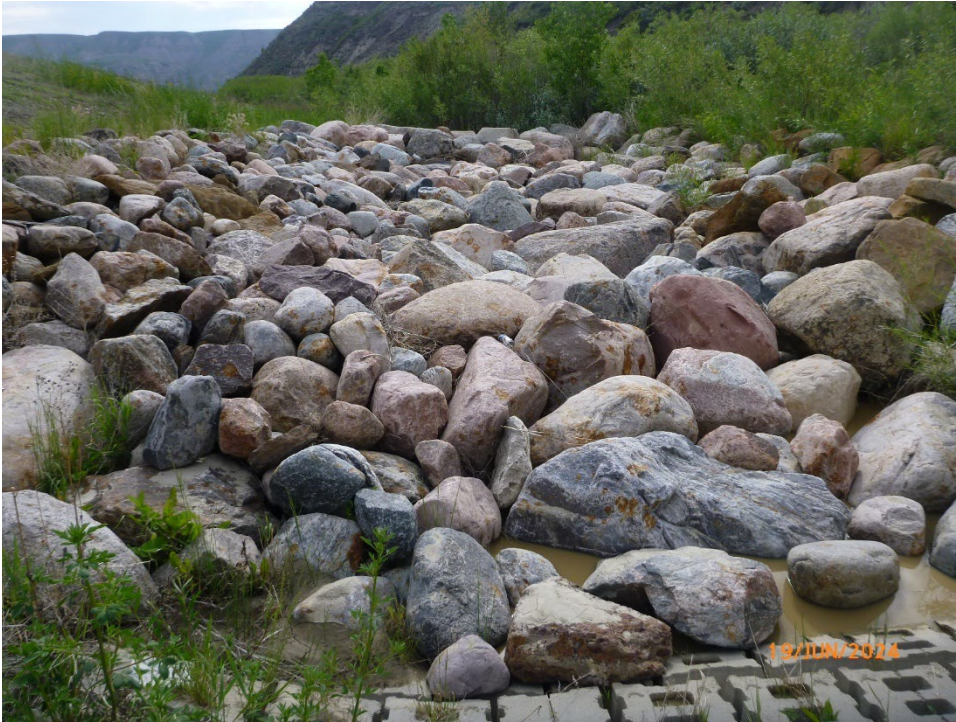
**Photo 9** Riprap energy dissipation structure consisting of Class 3 riprap at the east extent of the south (eastbound) ditch repair. Photo taken June 19, 2024, facing southeast.

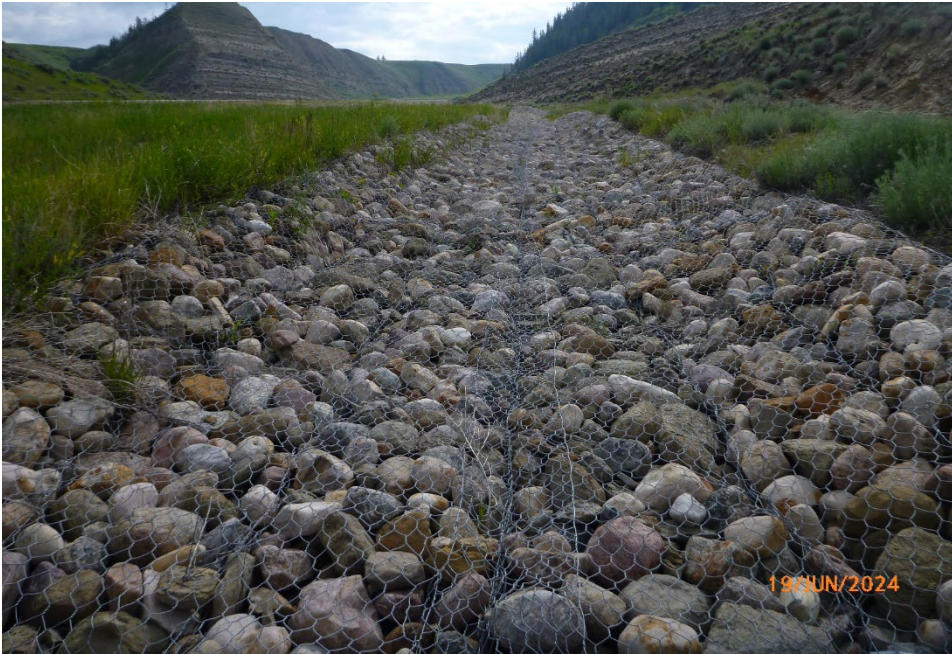
- The gabion baskets in the south (eastbound) ditch (approximately 350 m long) east of the bridge are in good condition and appear to be performing well (Photo 10 and 11). The gabion baskets were installed in a channel shape and grass was observed to be growing on the ditch slide slopes.
- Riprap armouring in the north (westbound) ditch (approximately 1.2 km long) is in good condition and appears to be performing well (Photo 12).

**Photo 10** Gabions baskets installed in the south (eastbound) ditch east of the Morrin Bridge.  
Photo taken June 19, 2024, facing east.

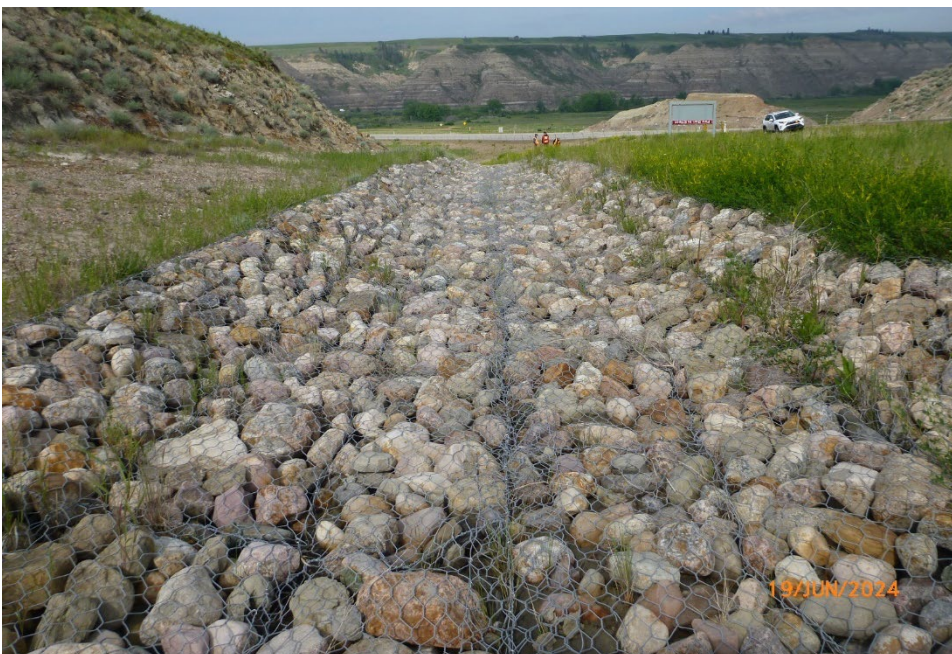
**Photo 11** Gabions baskets installed in the south (eastbound) ditch east of the Morrin Bridge.  
Photo taken June 19, 2024, facing northwest.

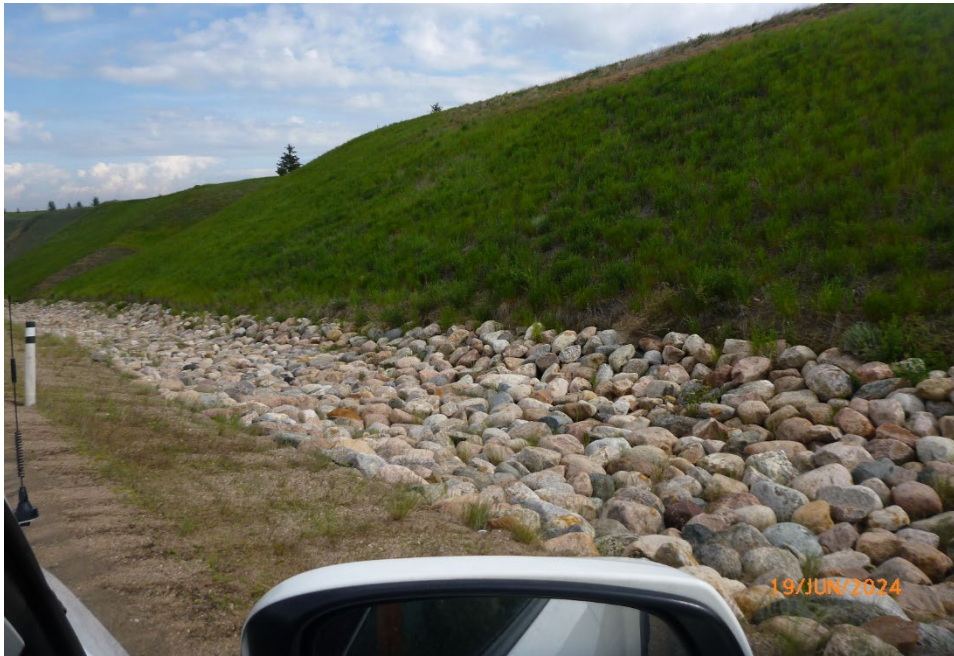
**Photo 12**      **Riprap armoring in the north (westbound) ditch east of the Morrin Bridge. Photo taken June 19, 2024, facing north.**
