**Narrow Riverbank Repair:**

ALBERTA INFRASTRUCTURE & TRANSPORTATION CENTRAL REGION  
Geohazard Assessment Site C18  
H837:02 Riverbank Erosion

Wide Riverbank Section

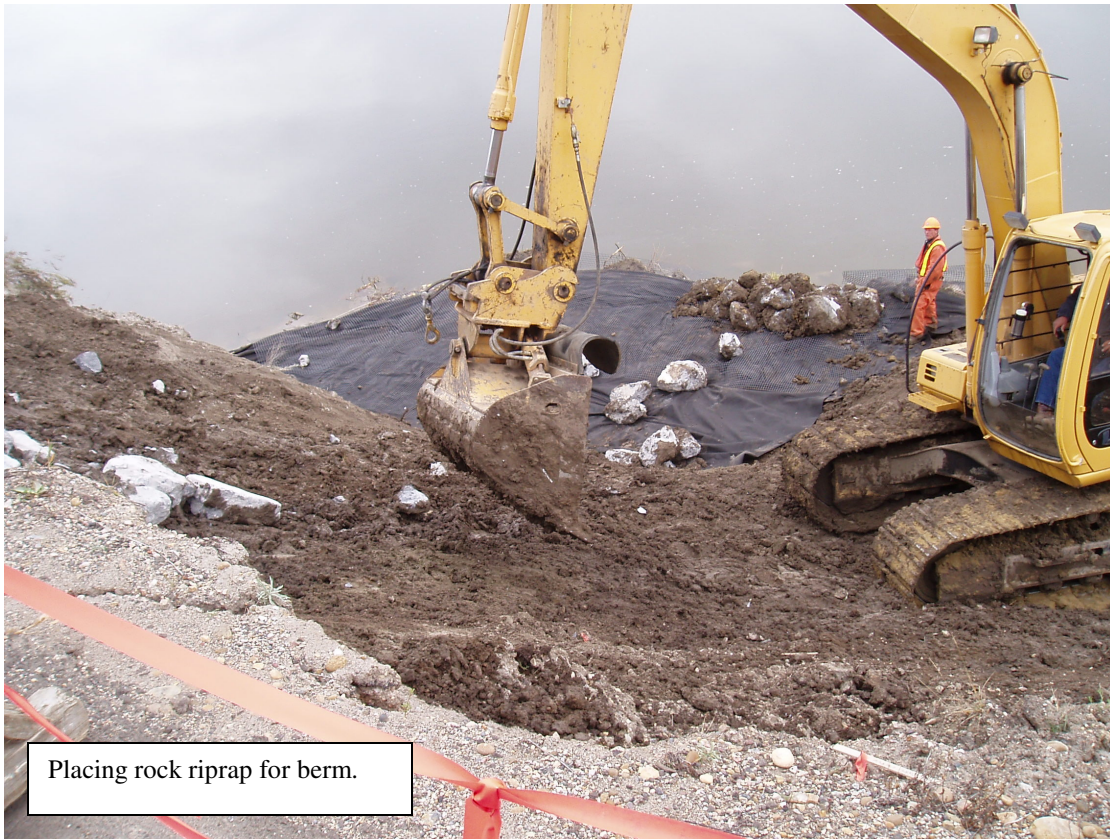
Placing rock riprap for berm.

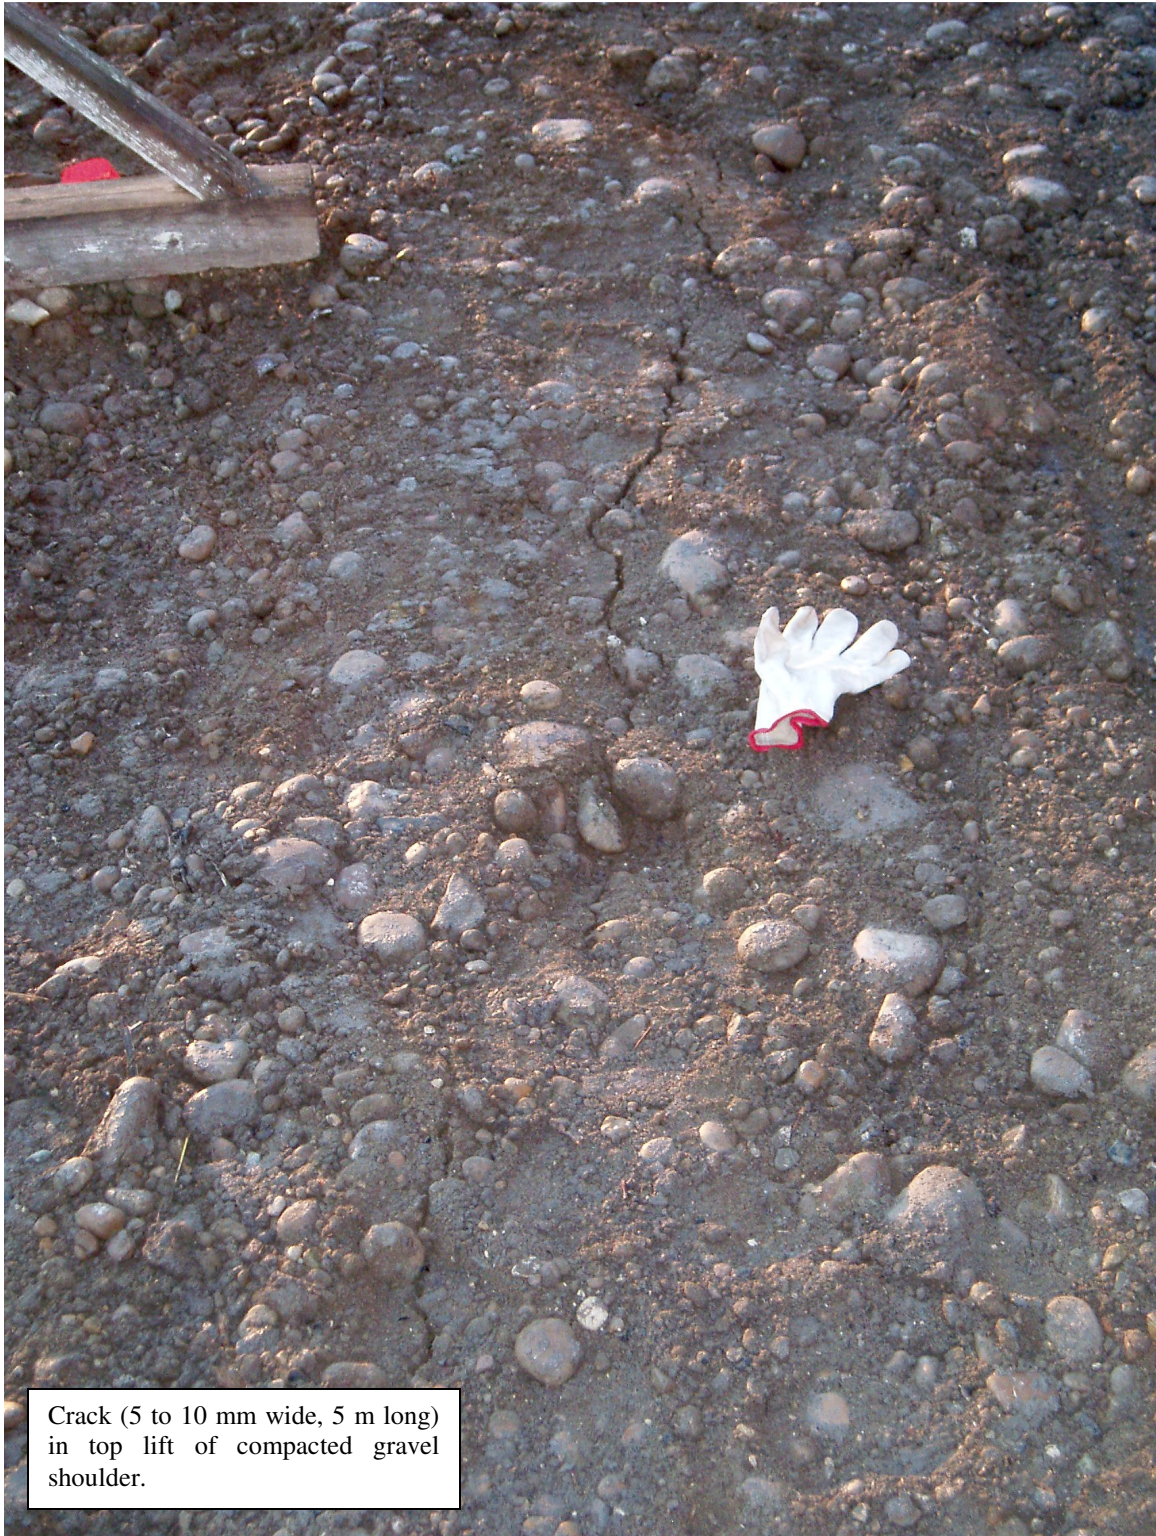
Crack (5 to 10 mm wide, 5 m long)  
in top lift of compacted gravel  
shoulder.

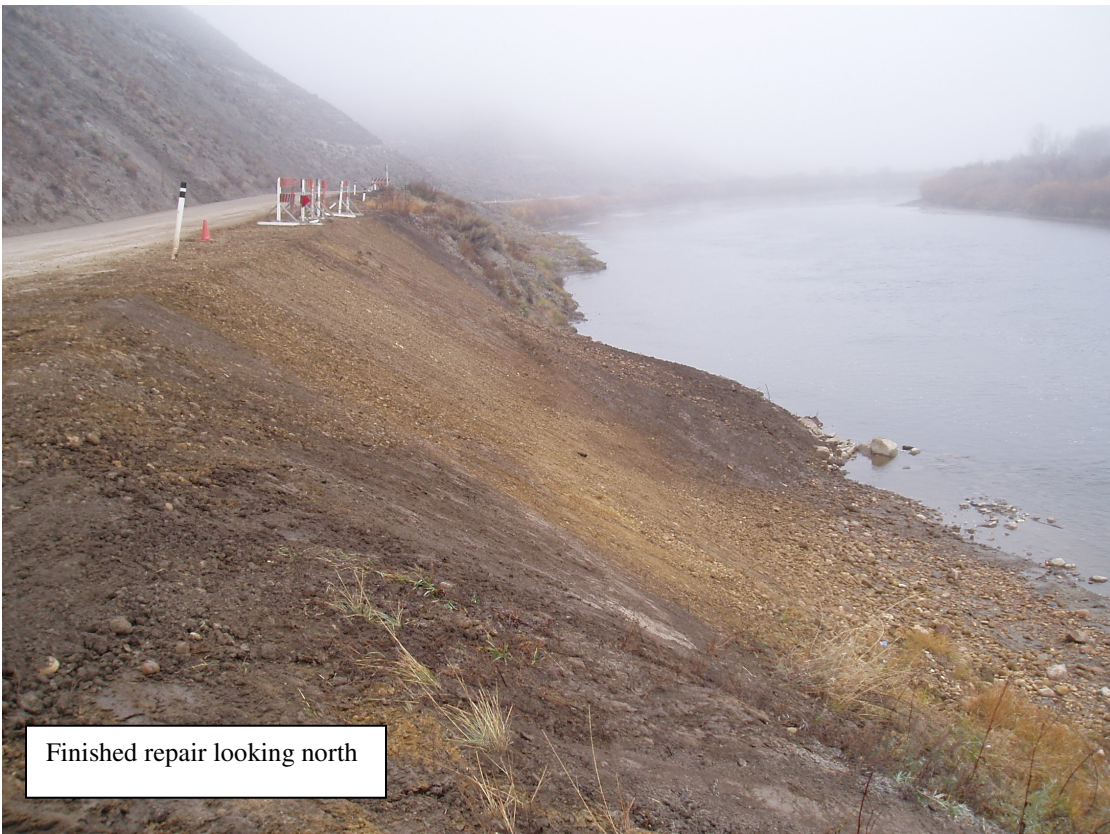
Finished repair looking north

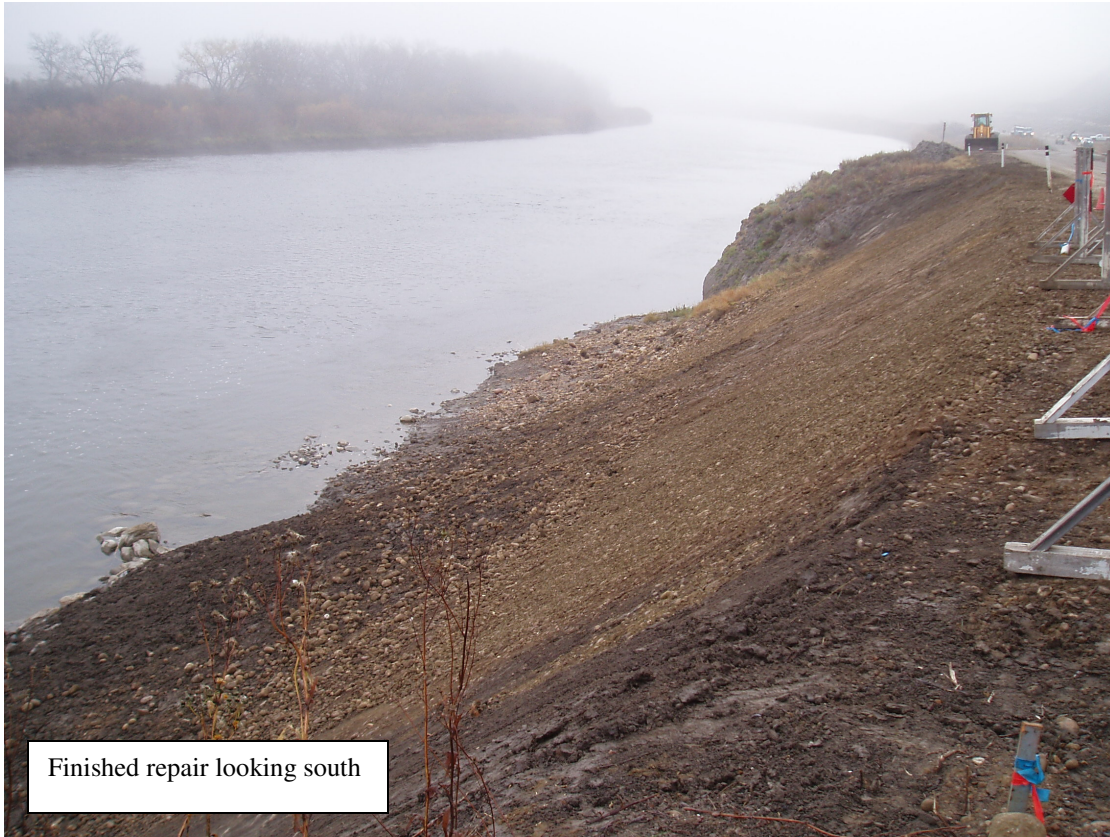
Finished repair looking south

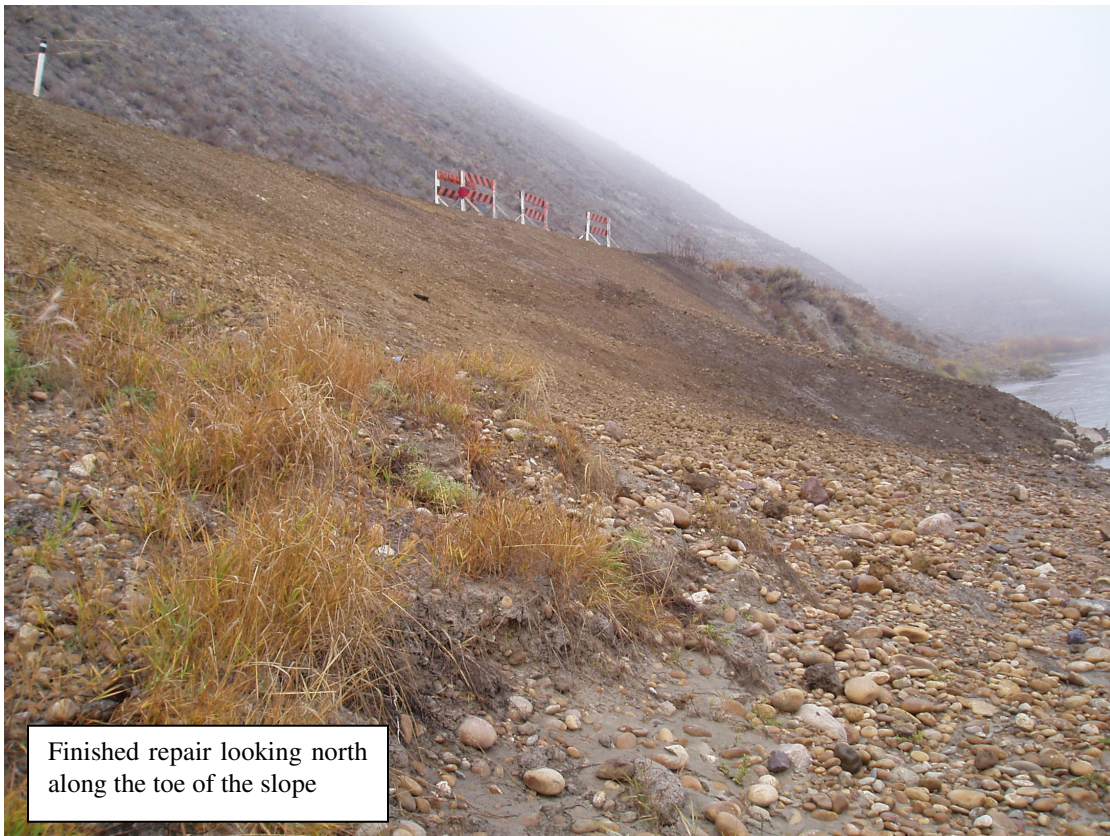
Finished repair looking north along the toe of the slope

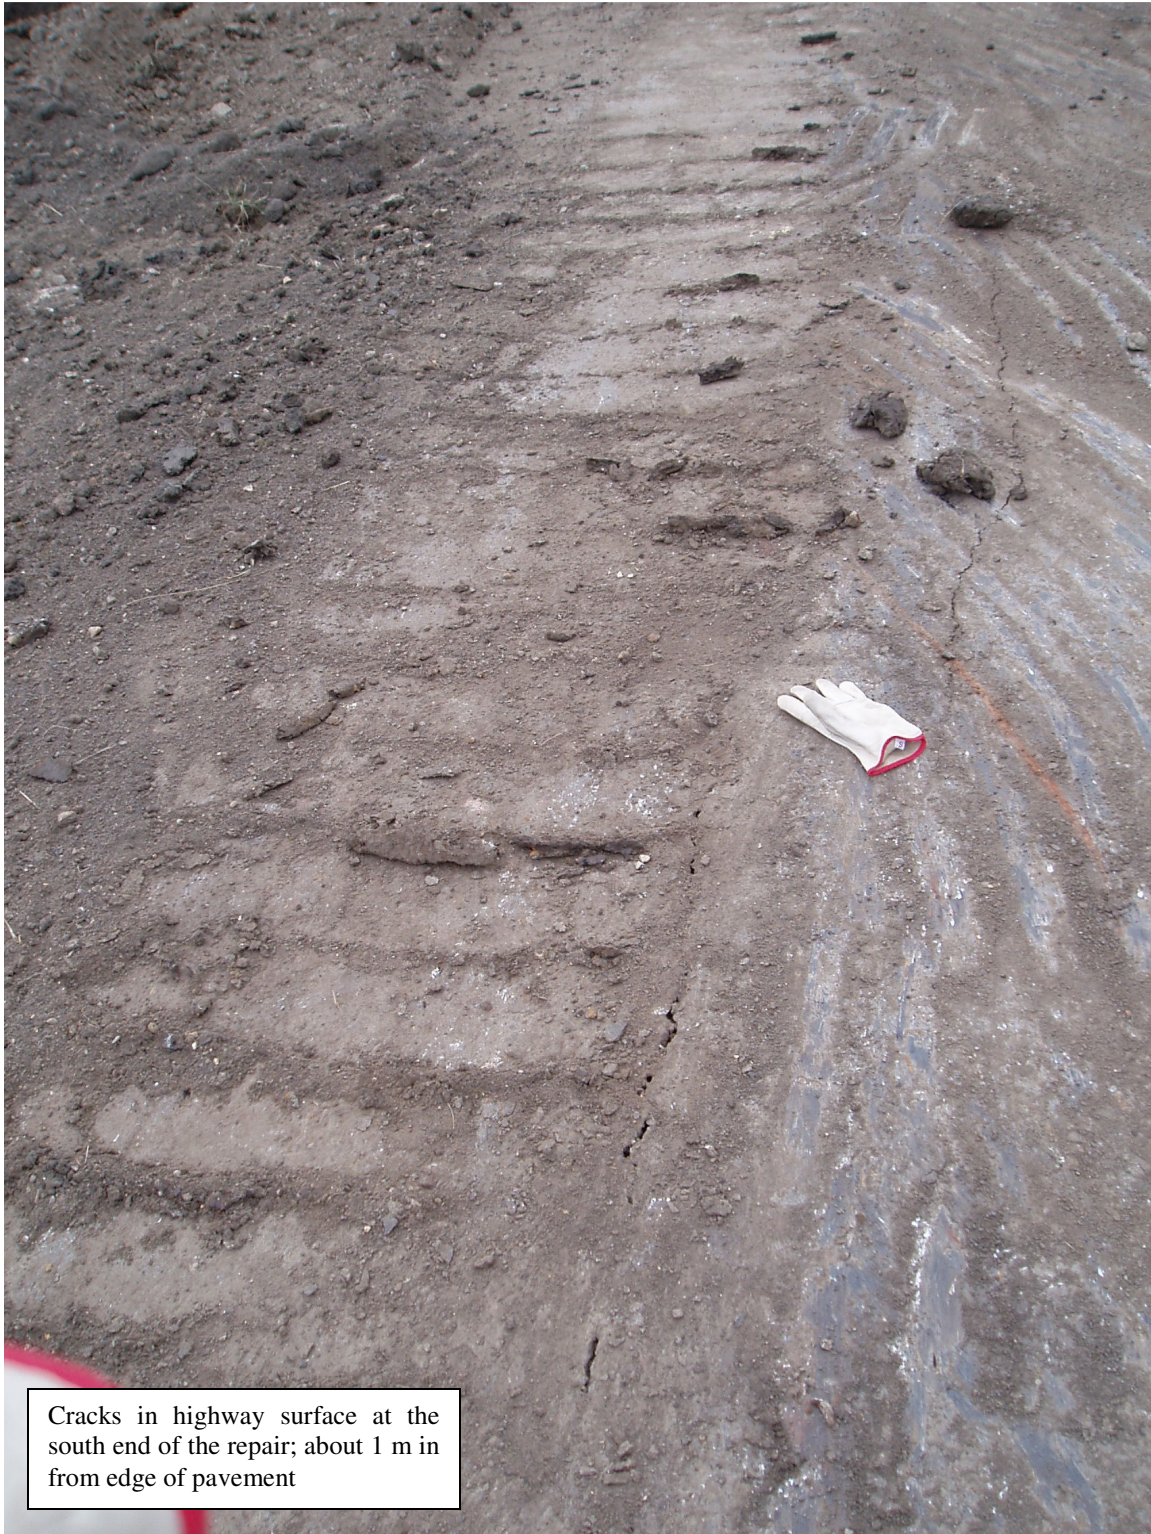
Cracks in highway surface at the south end of the repair; about 1 m in from edge of pavement

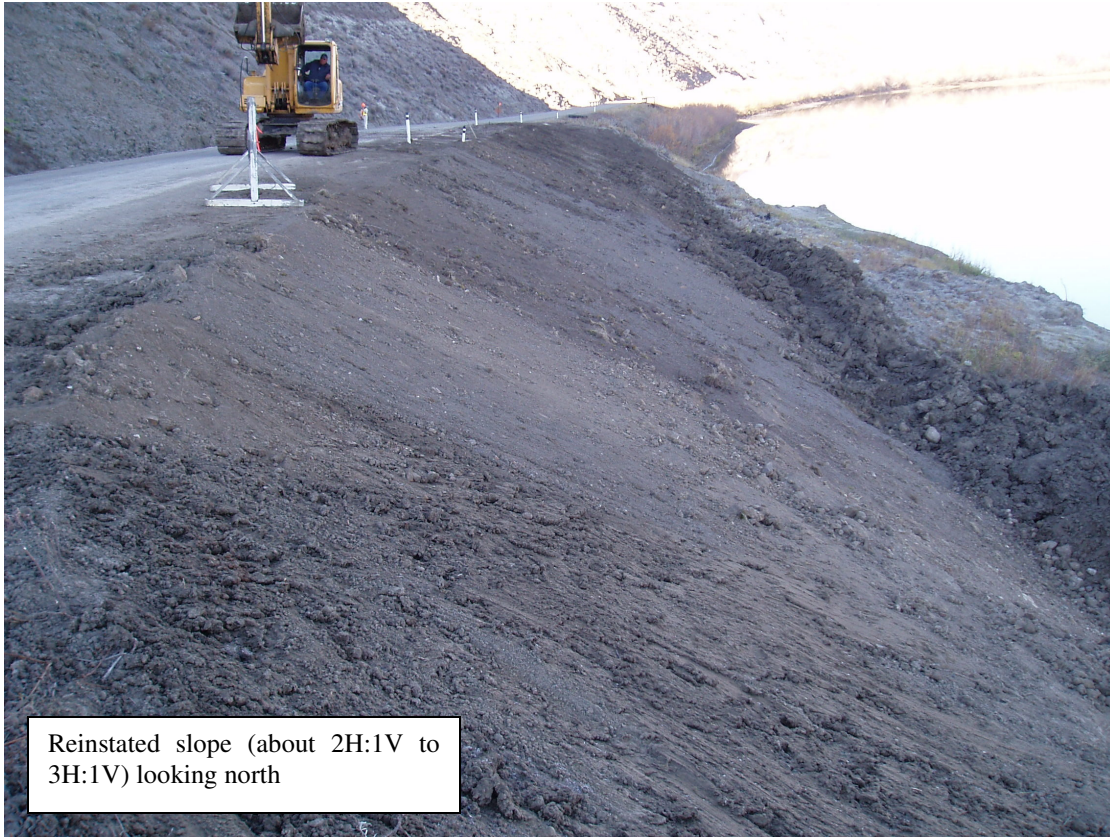
Reinstated slope (about 2H:1V to 3H:1V) looking north

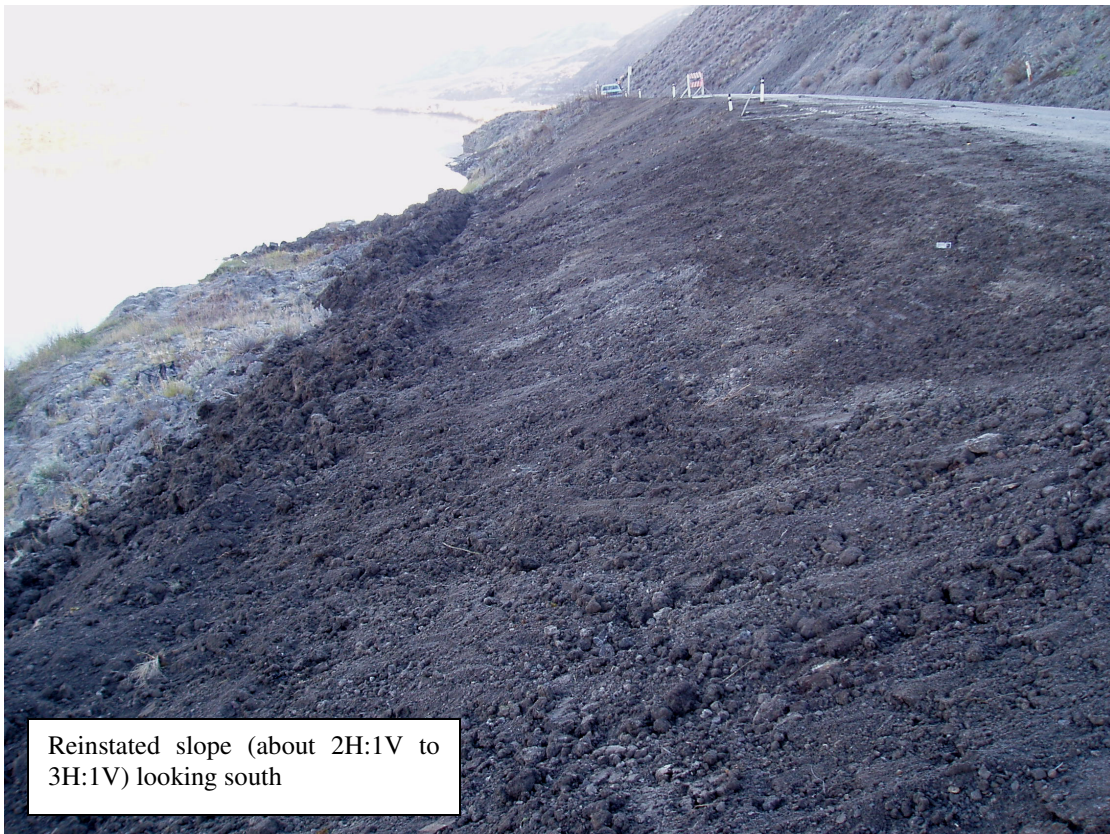
Reinstated slope (about 2H:1V to 3H:1V) looking south

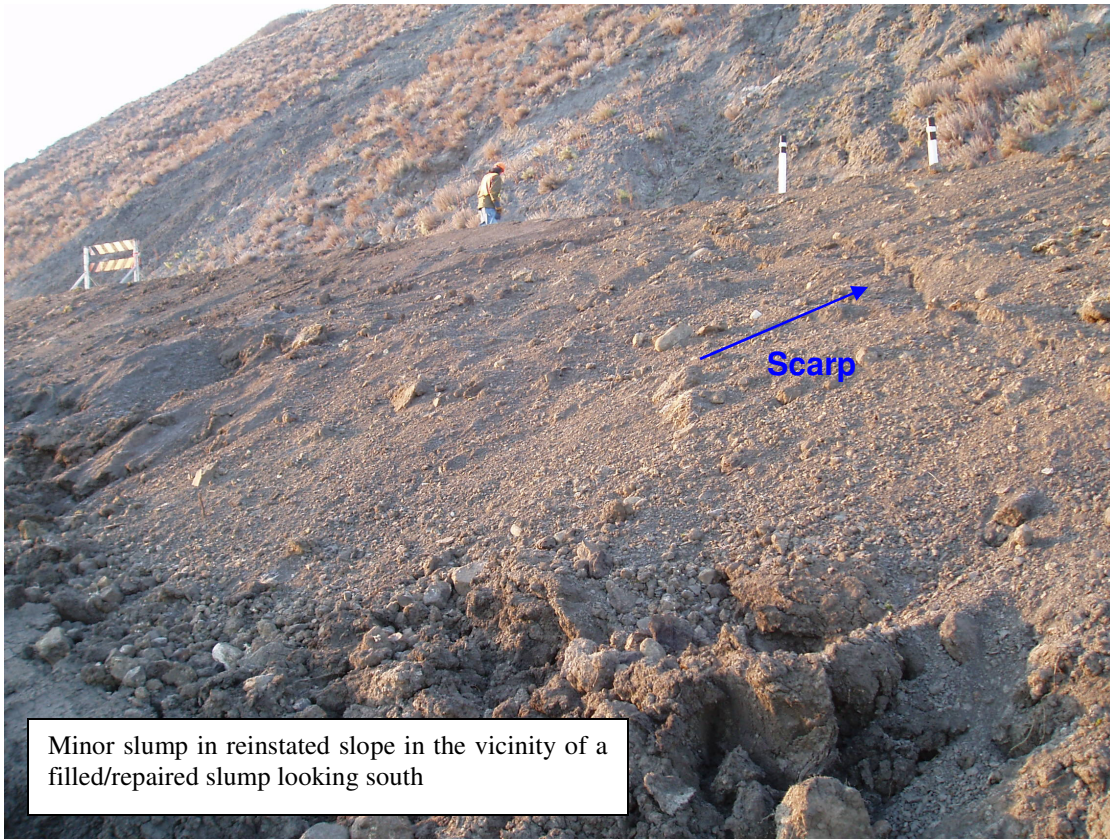
Minor slump in reinstated slope in the vicinity of a filled/repared slump looking south

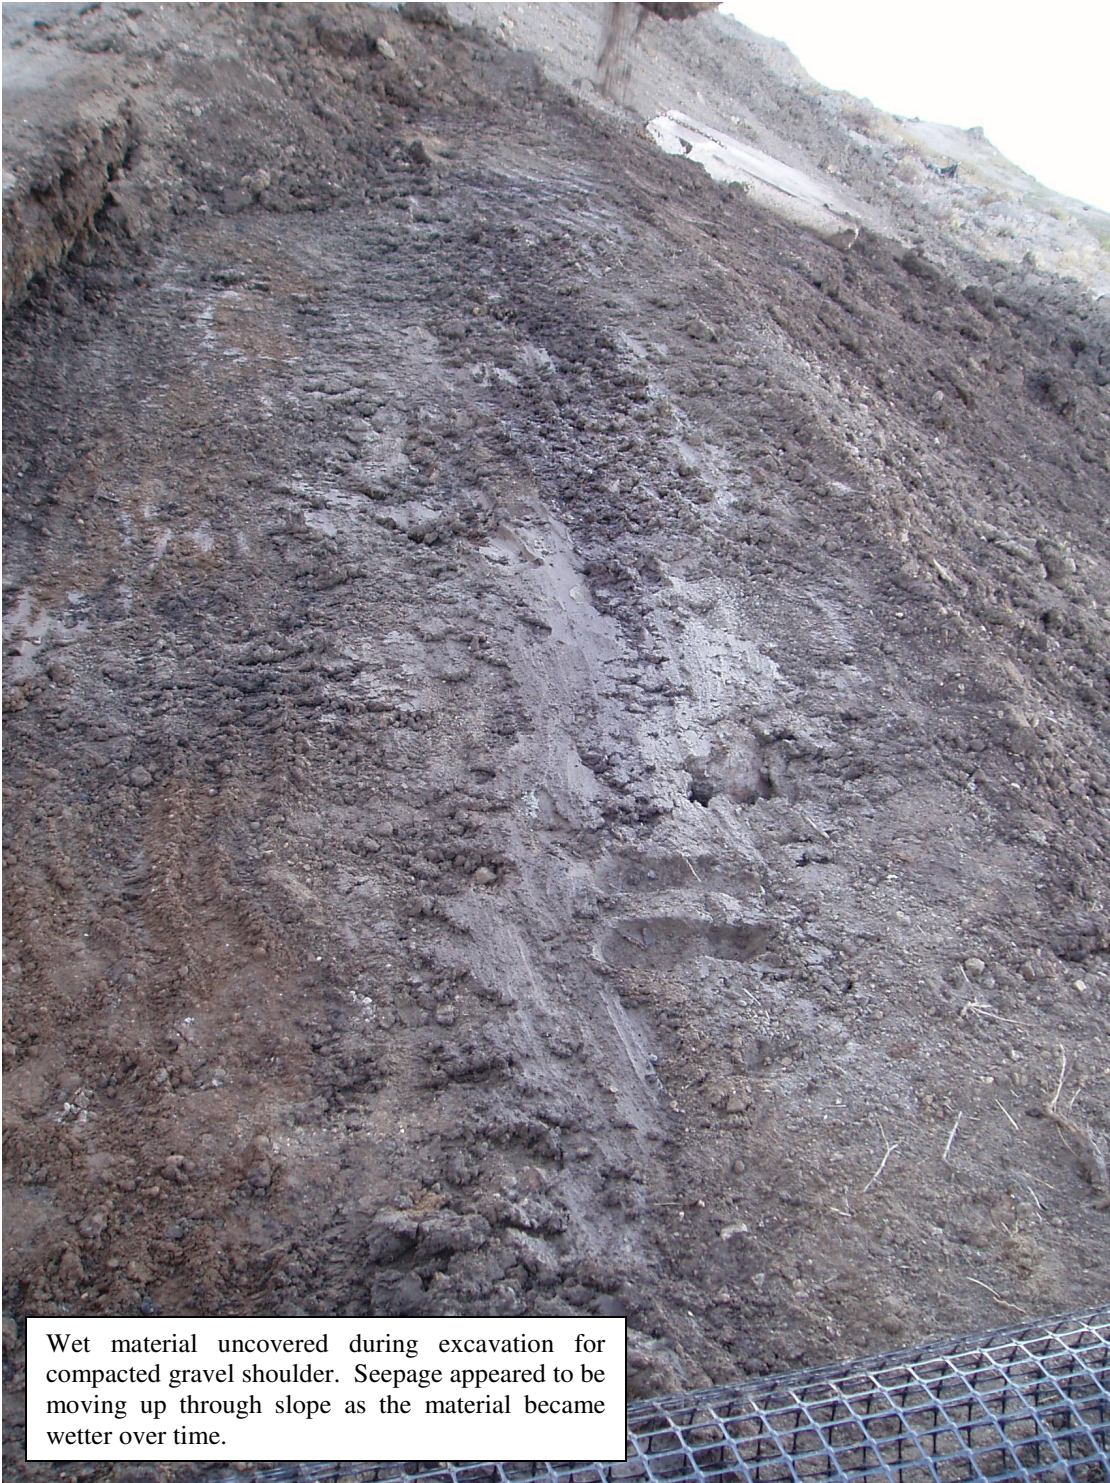
Wet material uncovered during excavation for compacted gravel shoulder. Seepage appeared to be moving up through slope as the material became wetter over time.

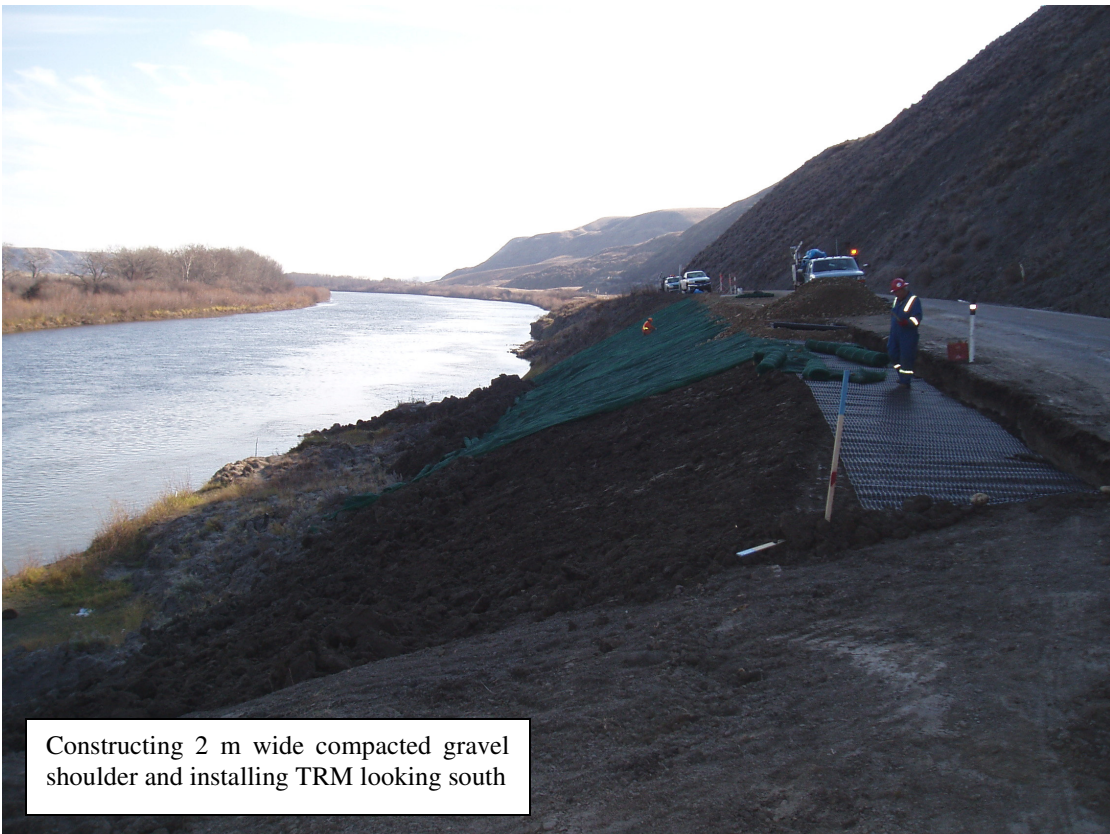
Constructing 2 m wide compacted gravel shoulder and installing TRM looking south

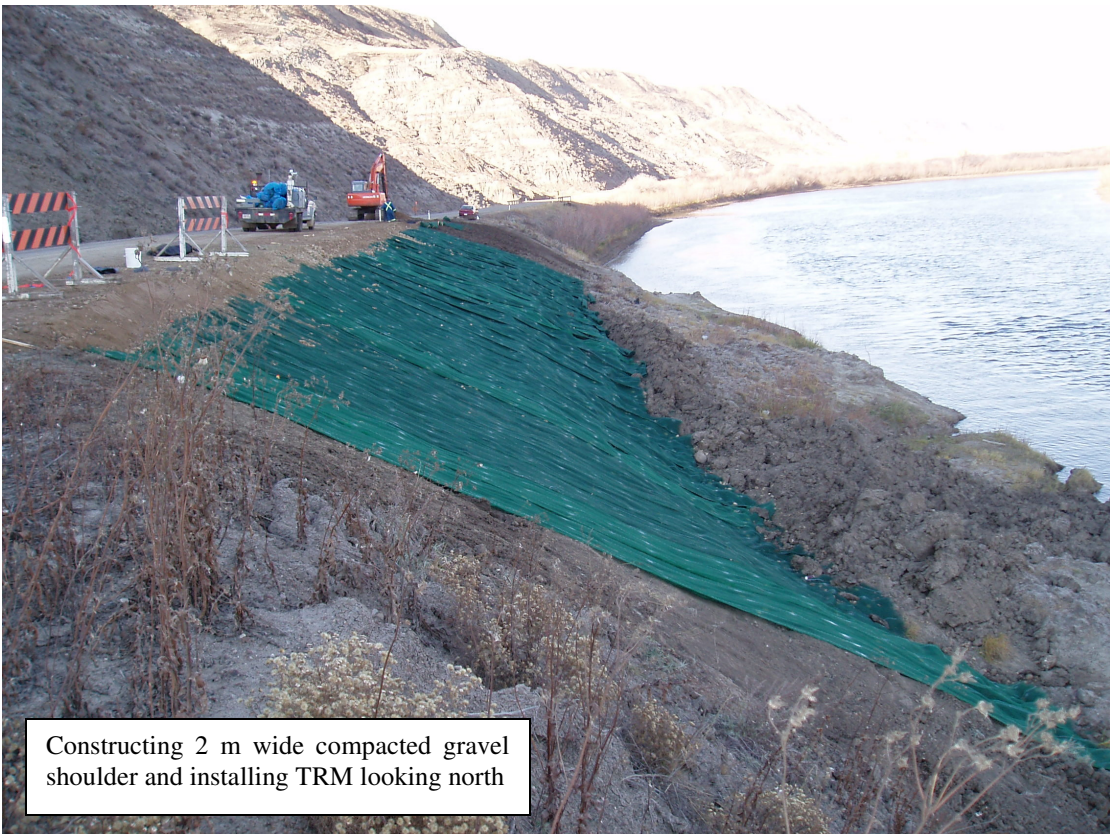
Constructing 2 m wide compacted gravel shoulder and installing TRM looking north

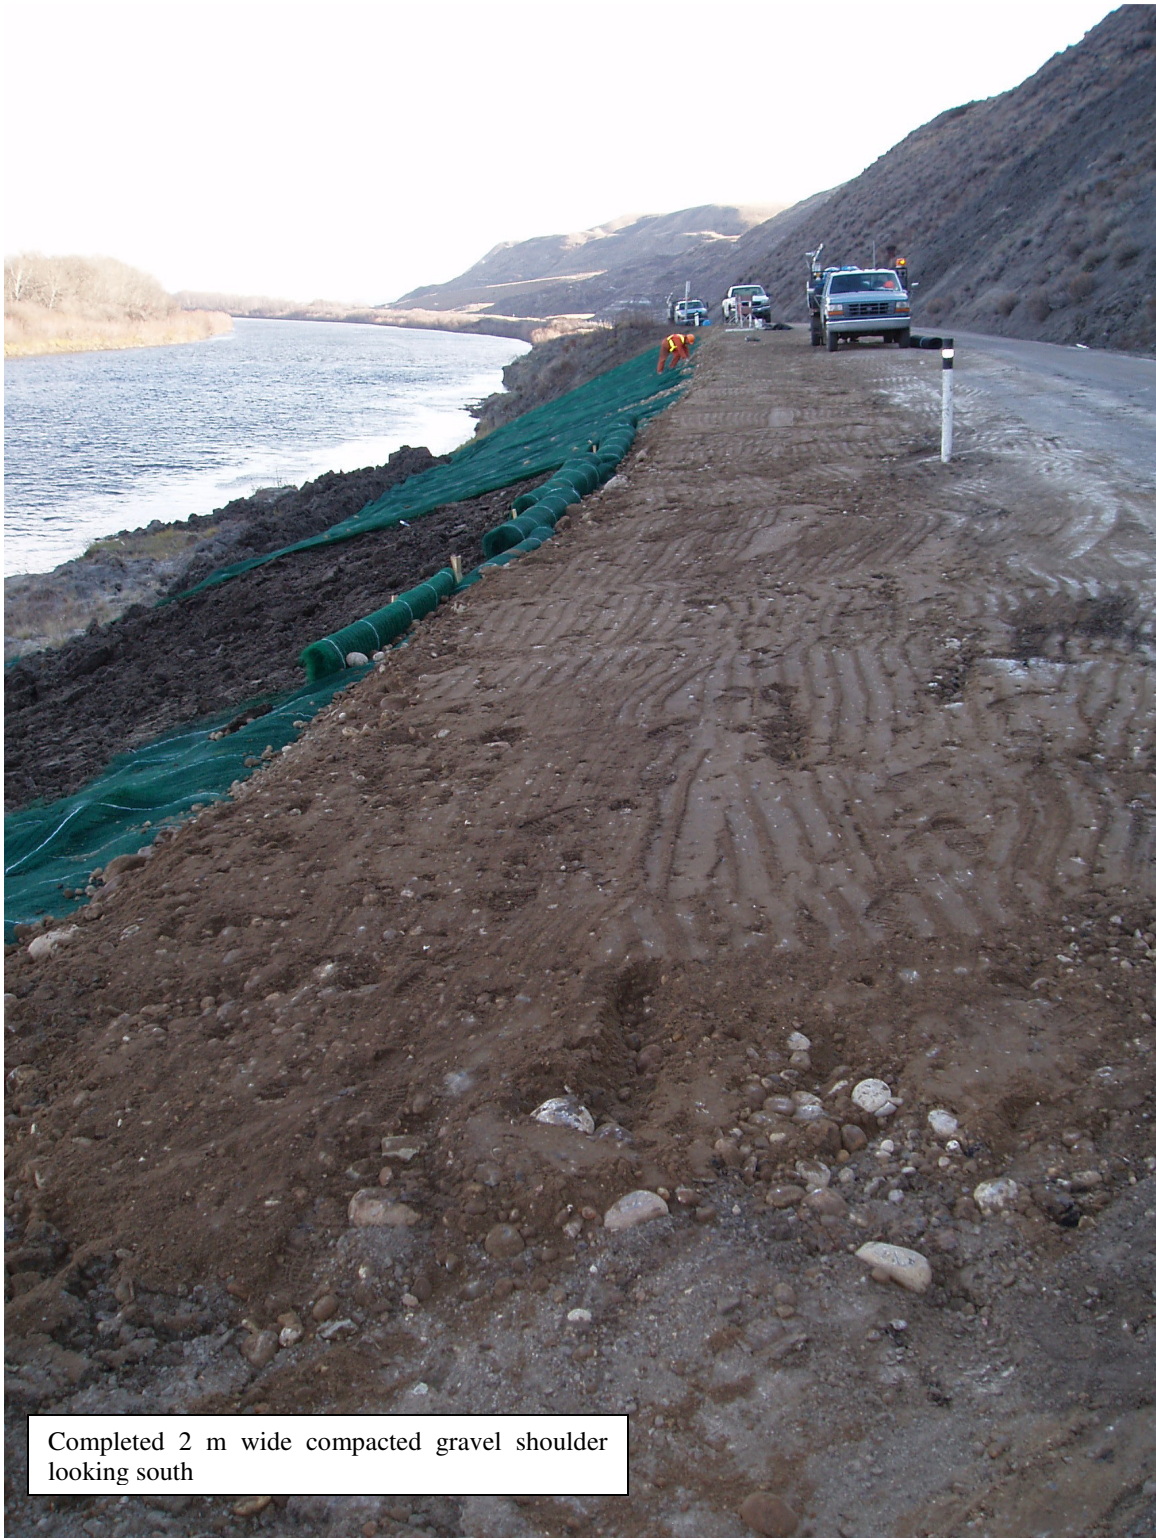
Completed 2 m wide compacted gravel shoulder  
looking south

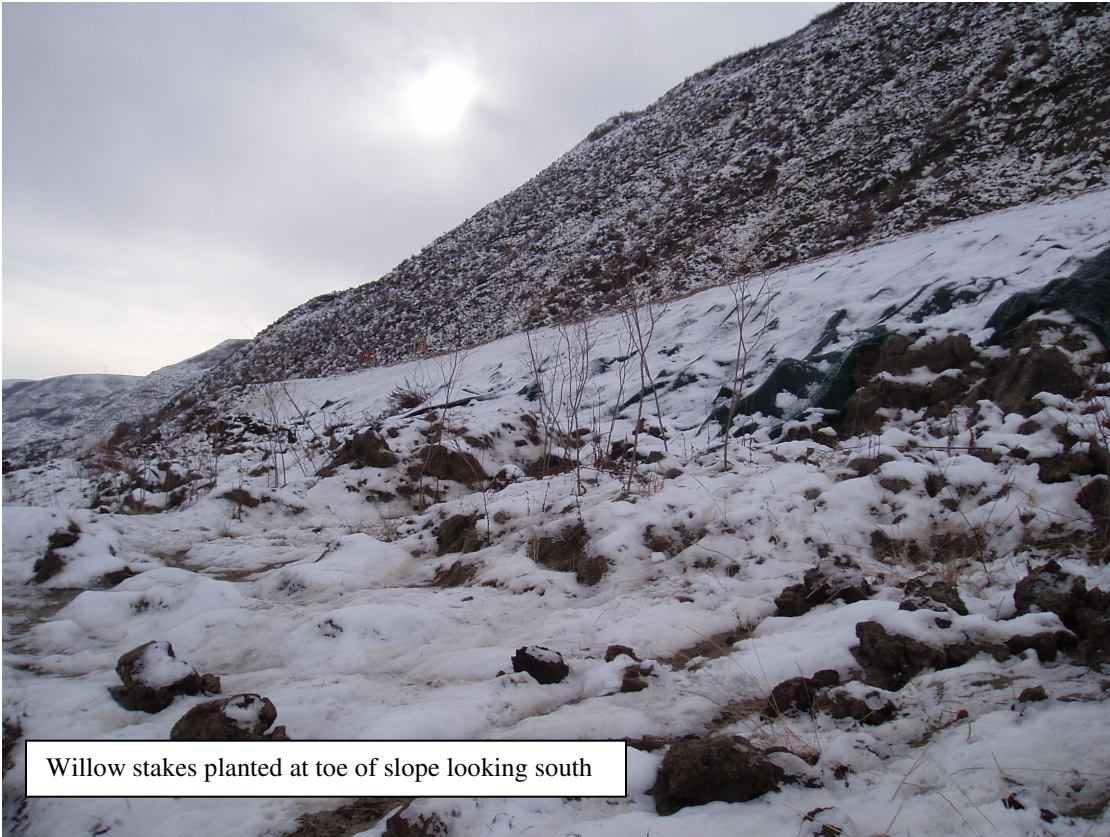
Willow stakes planted at toe of slope looking south

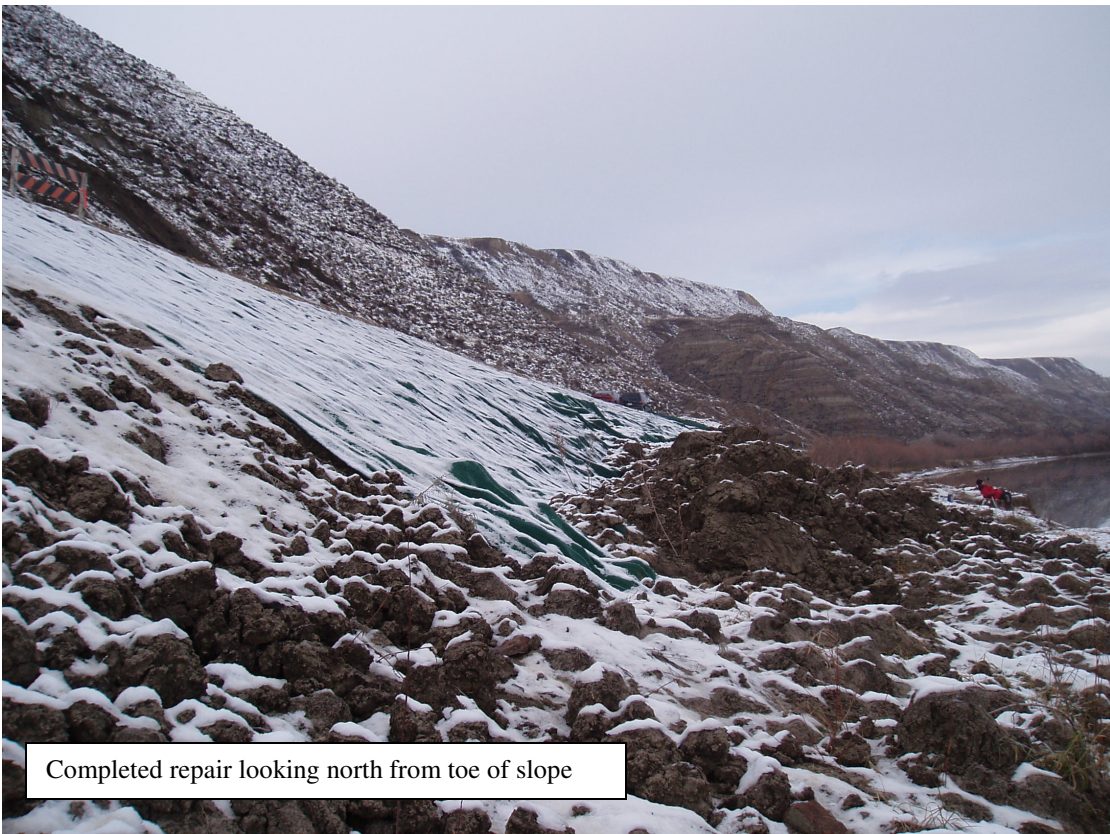
Completed repair looking north from toe of slope

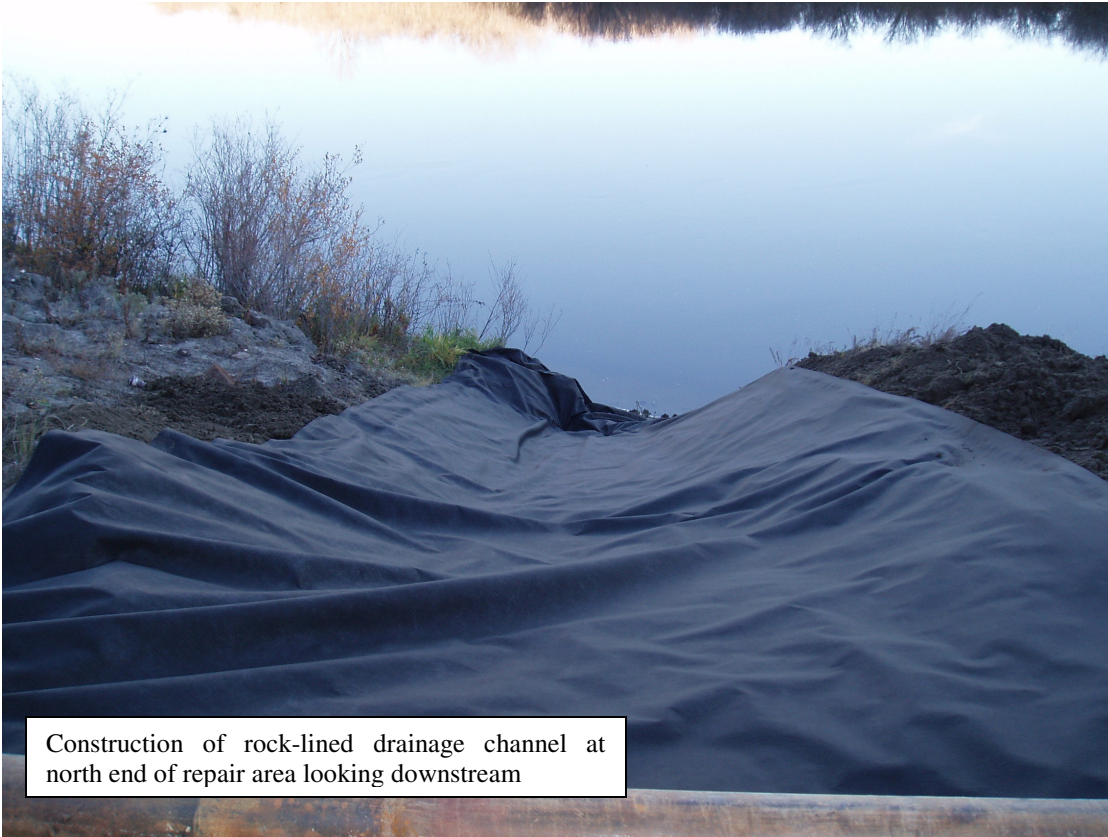
Construction of rock-lined drainage channel at north end of repair area looking downstream

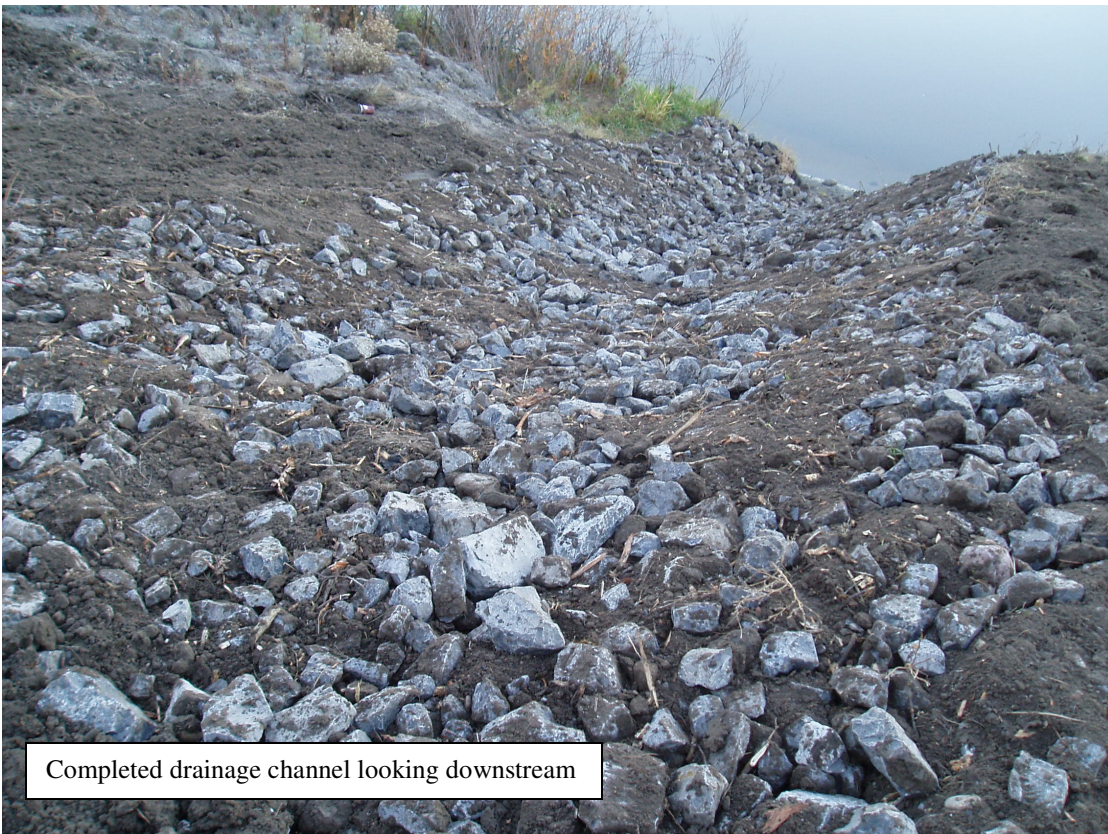
Completed drainage channel looking downstream

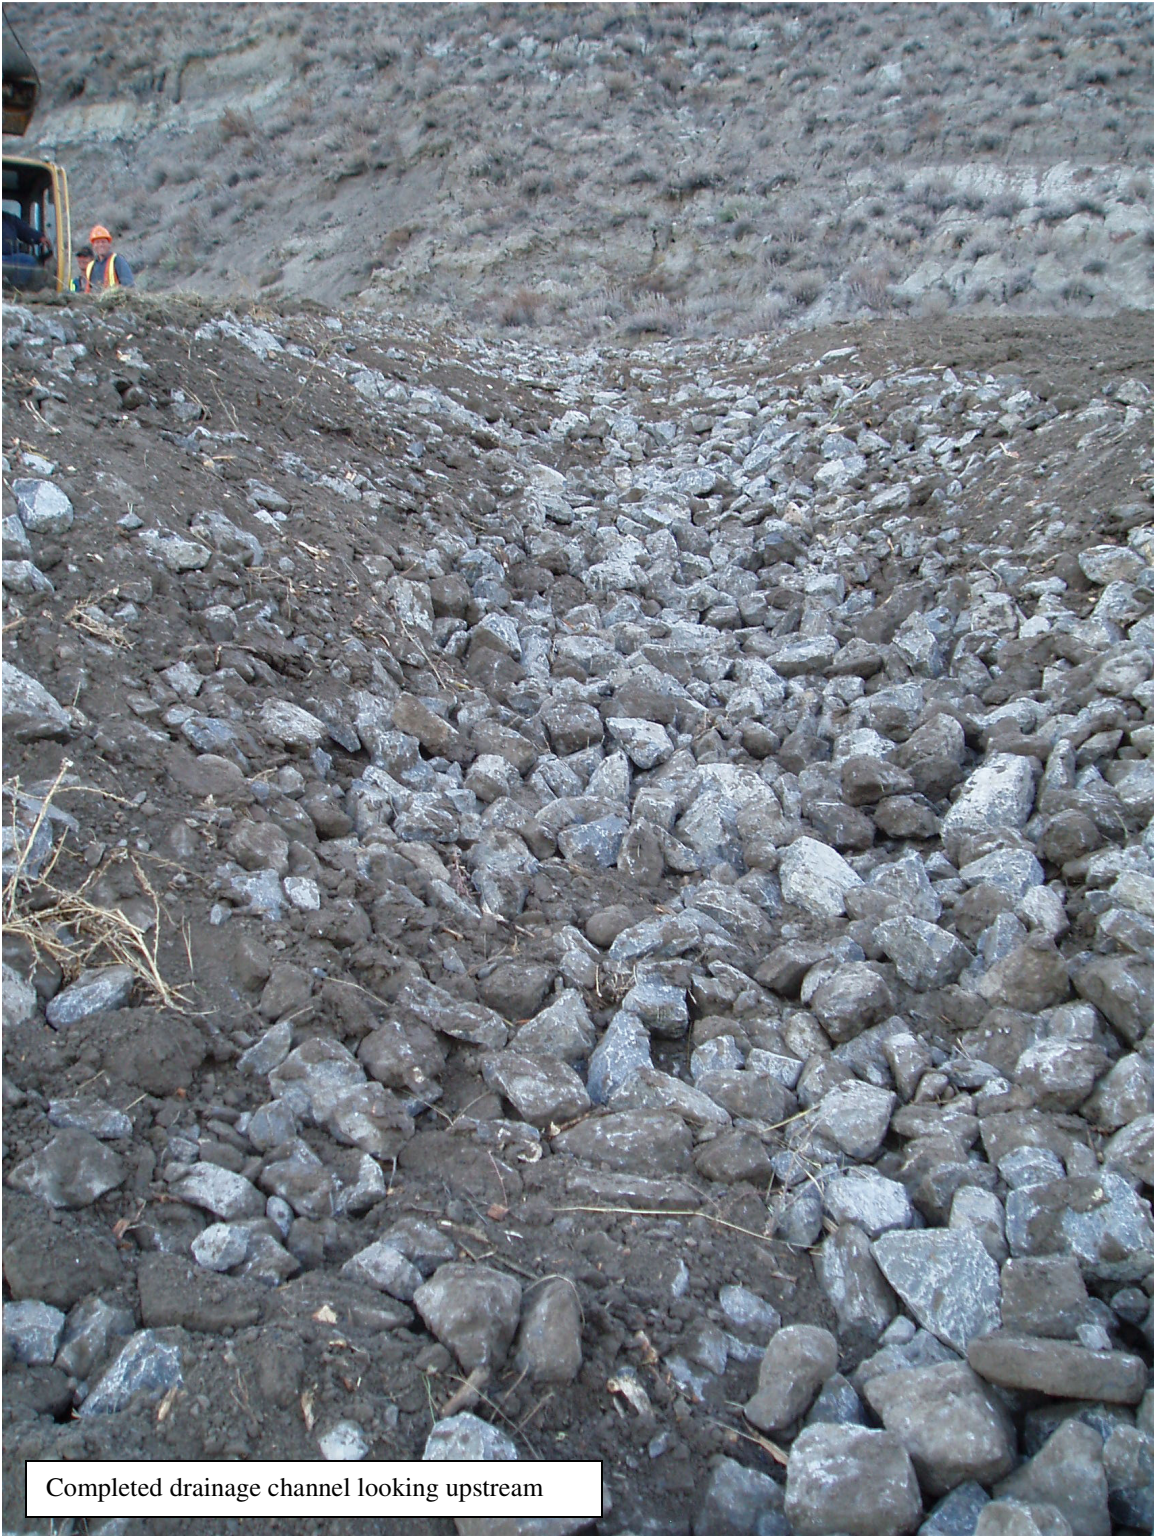
Completed drainage channel looking upstream
