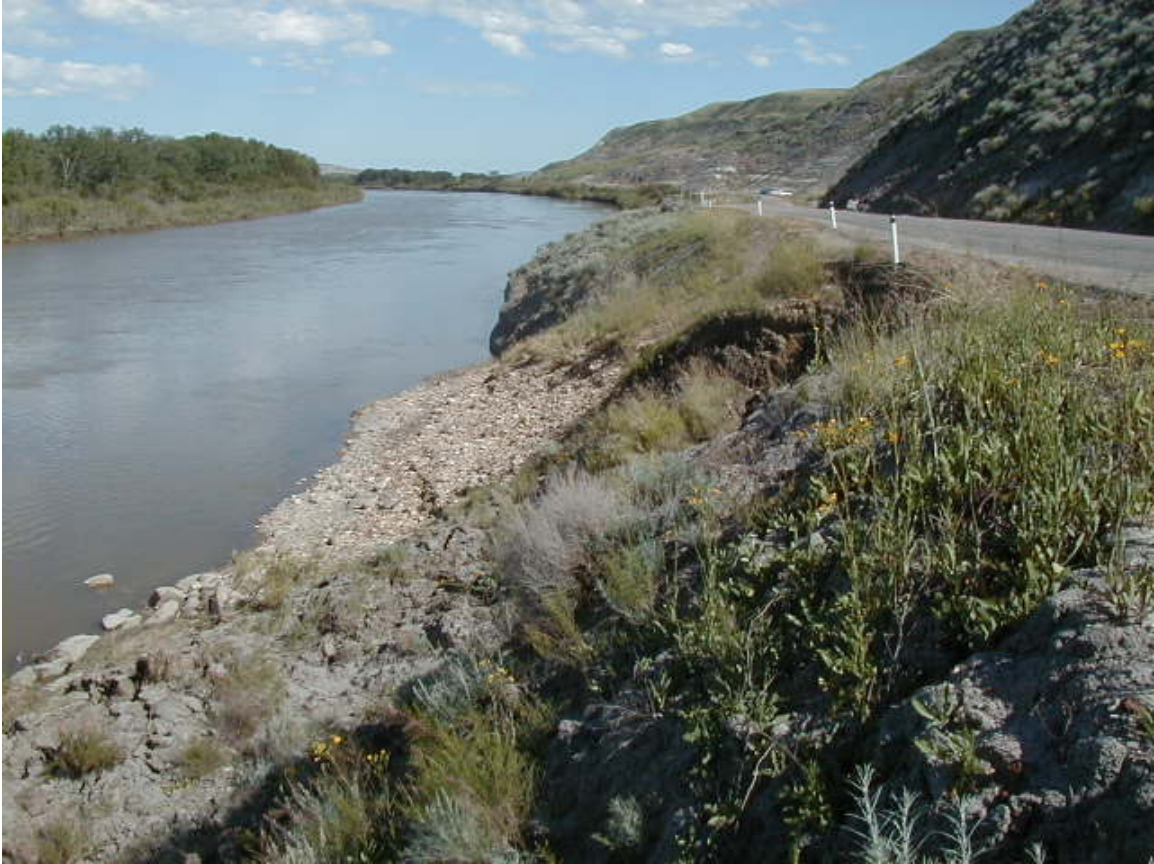
View of new slump section at north end of gravel berm due to June 2005 flooding.
Width is about 13 m.

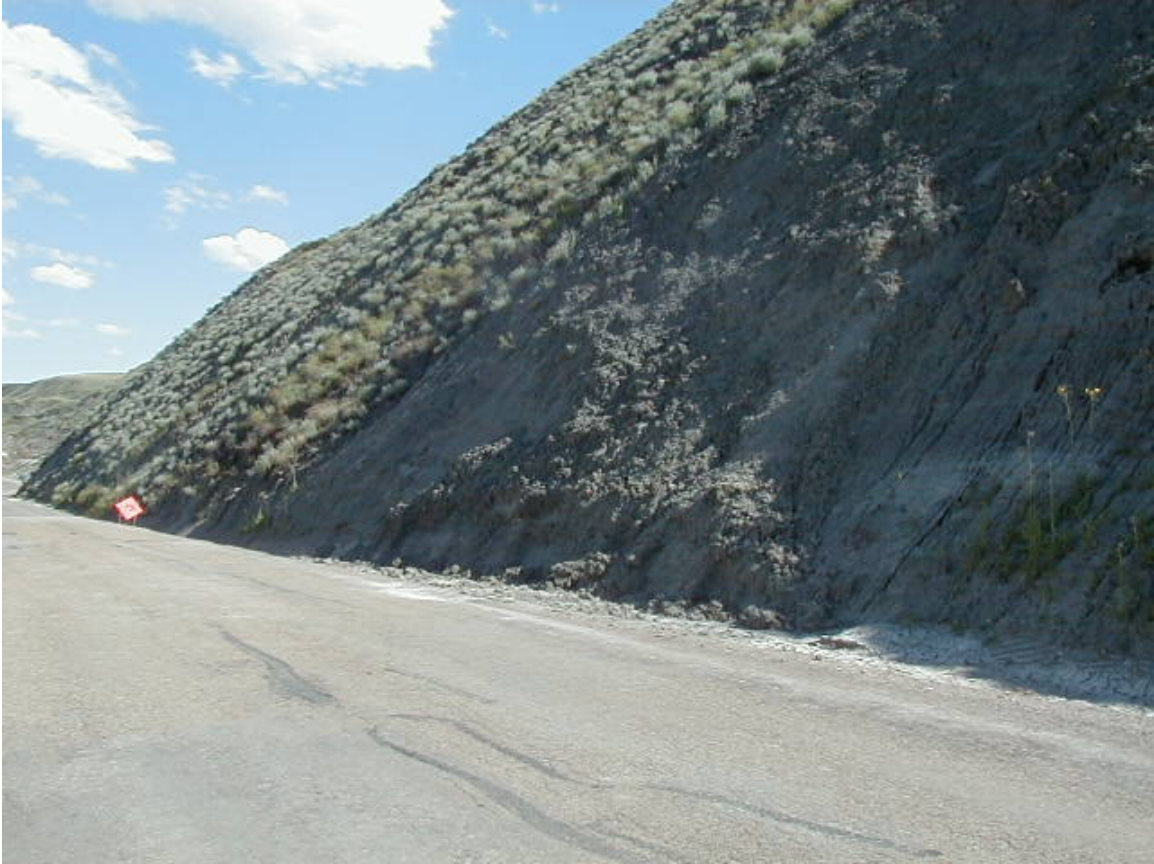
Backslope Erosion
