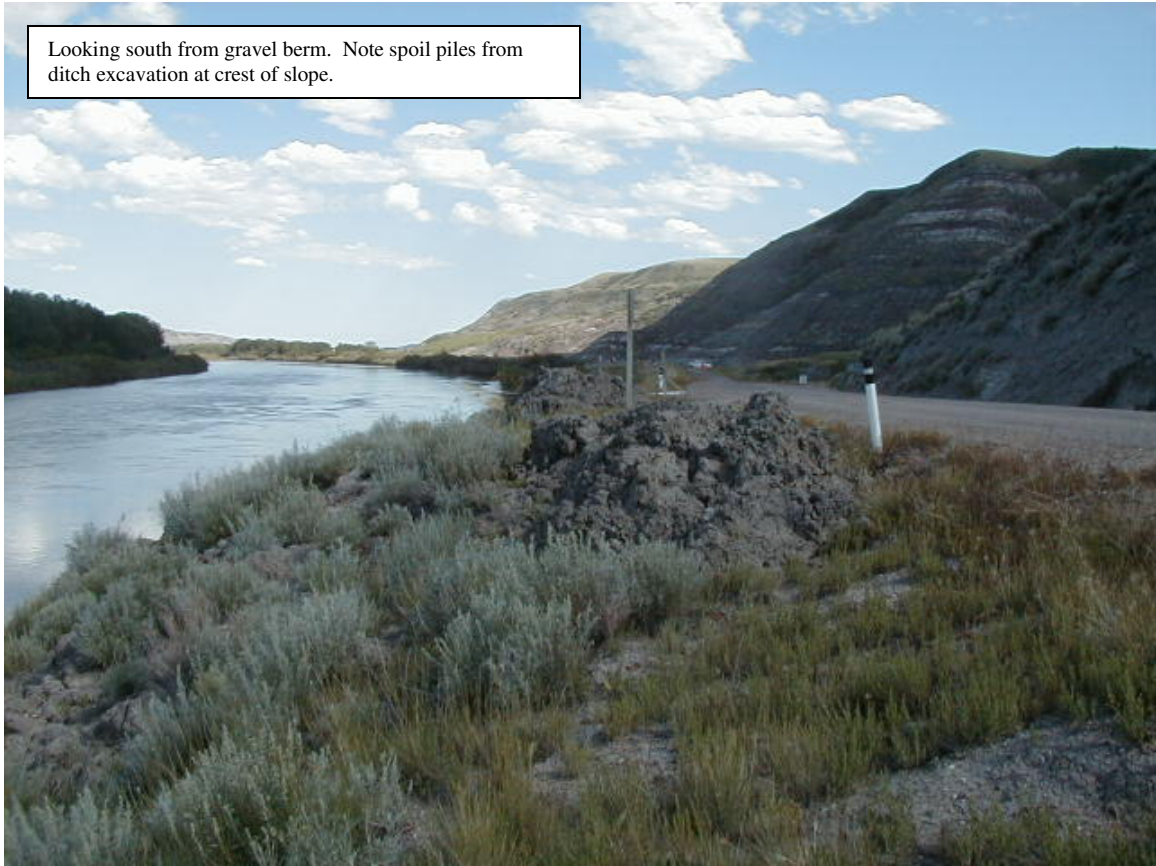
Looking south from gravel berm. Note spoil piles from ditch excavation at crest of slope.

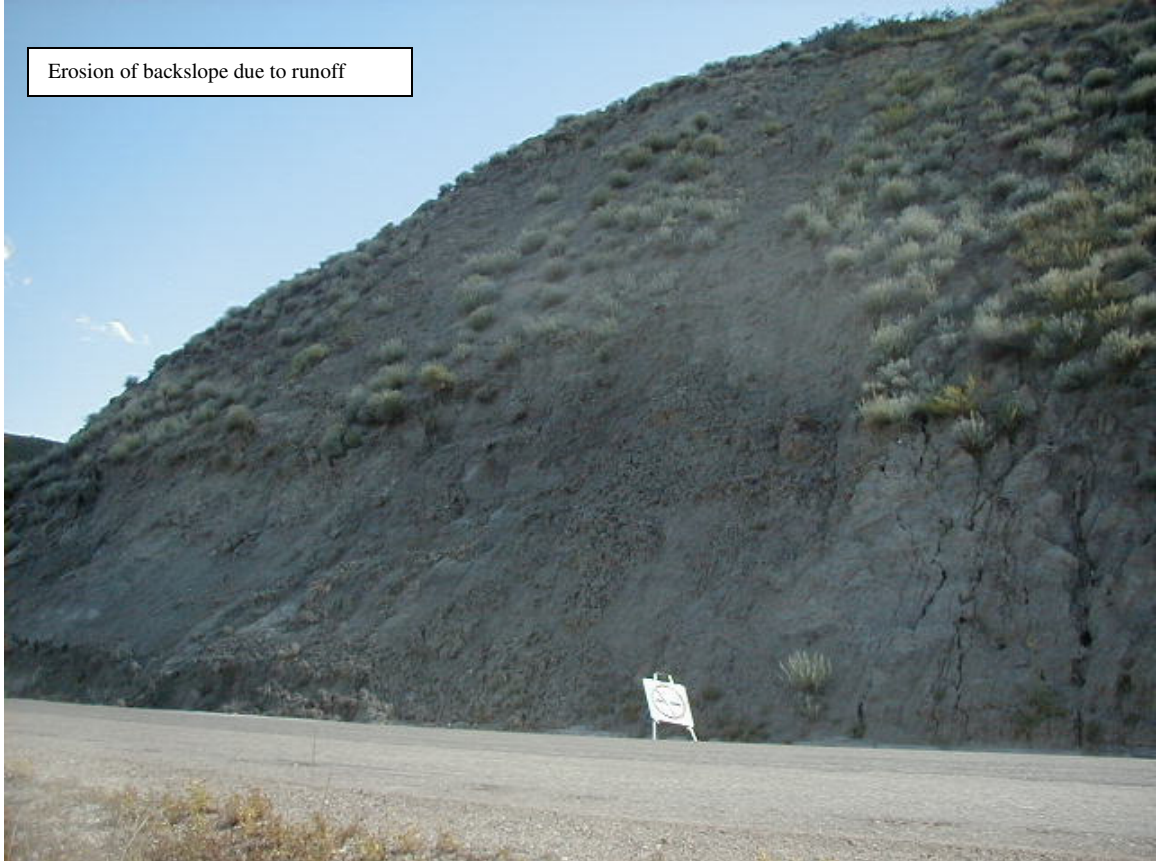
Erosion of backslope due to runoff

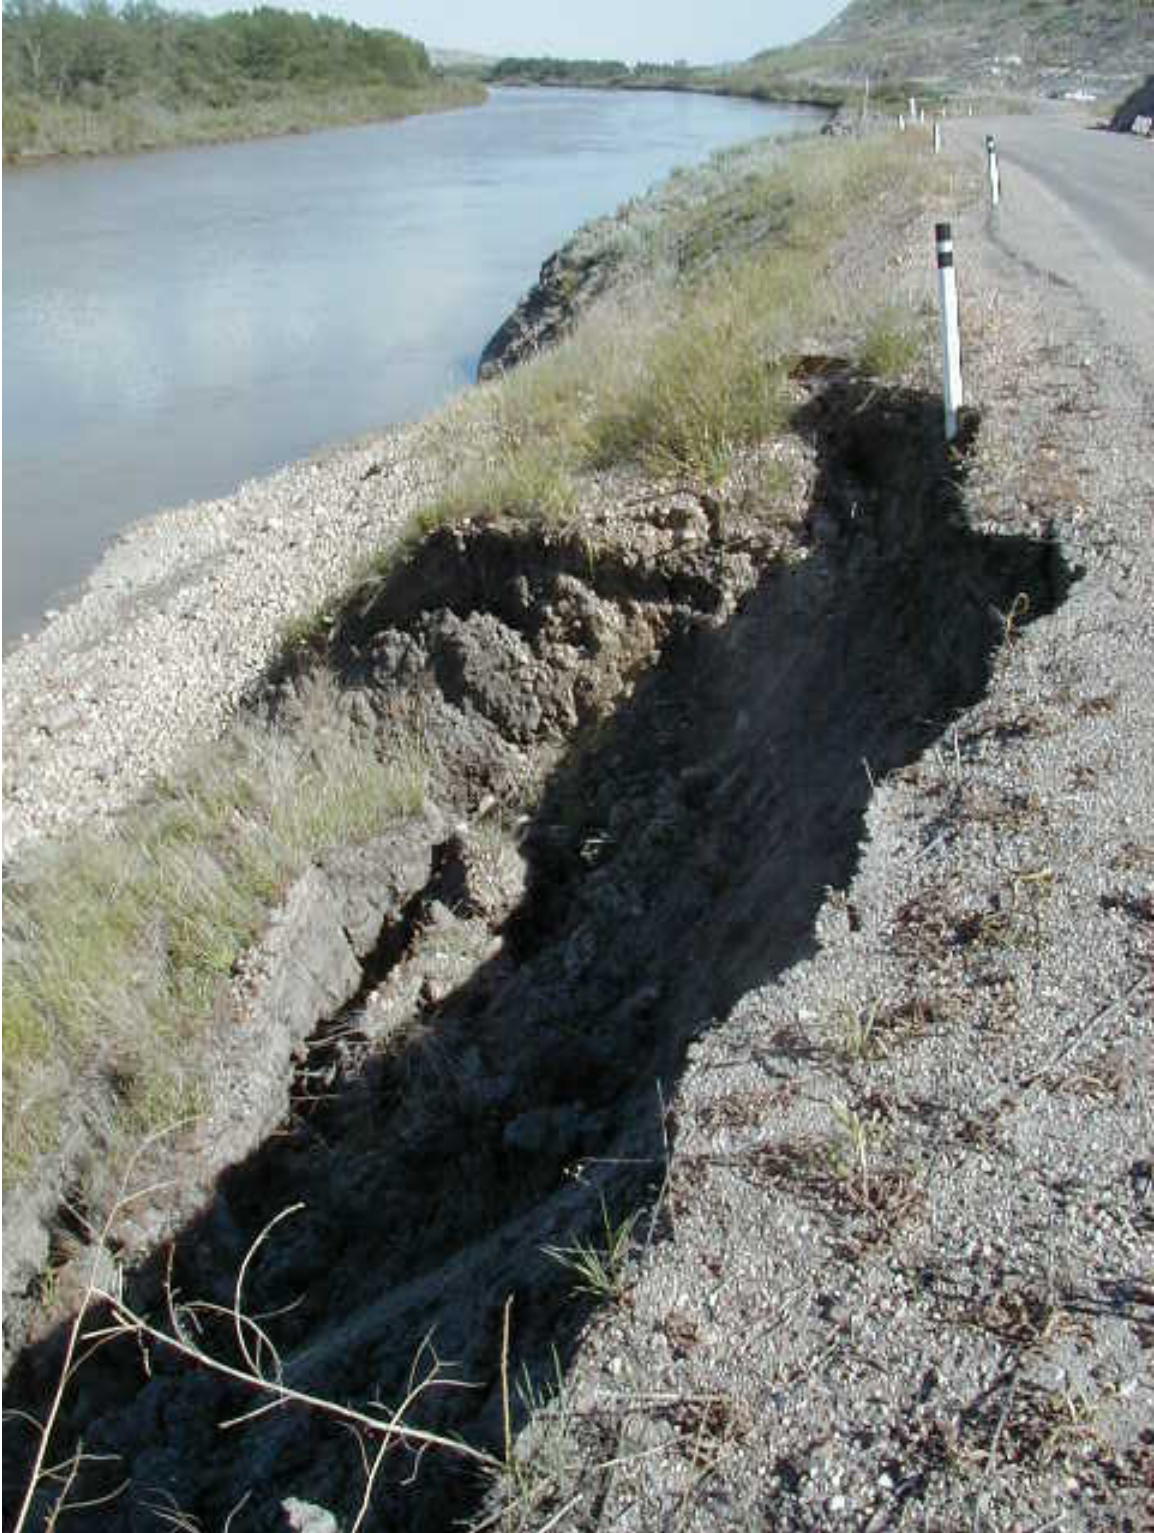
View of new slump section at north end of gravel berm due to June 2005 flooding.
Width is about 13 m.

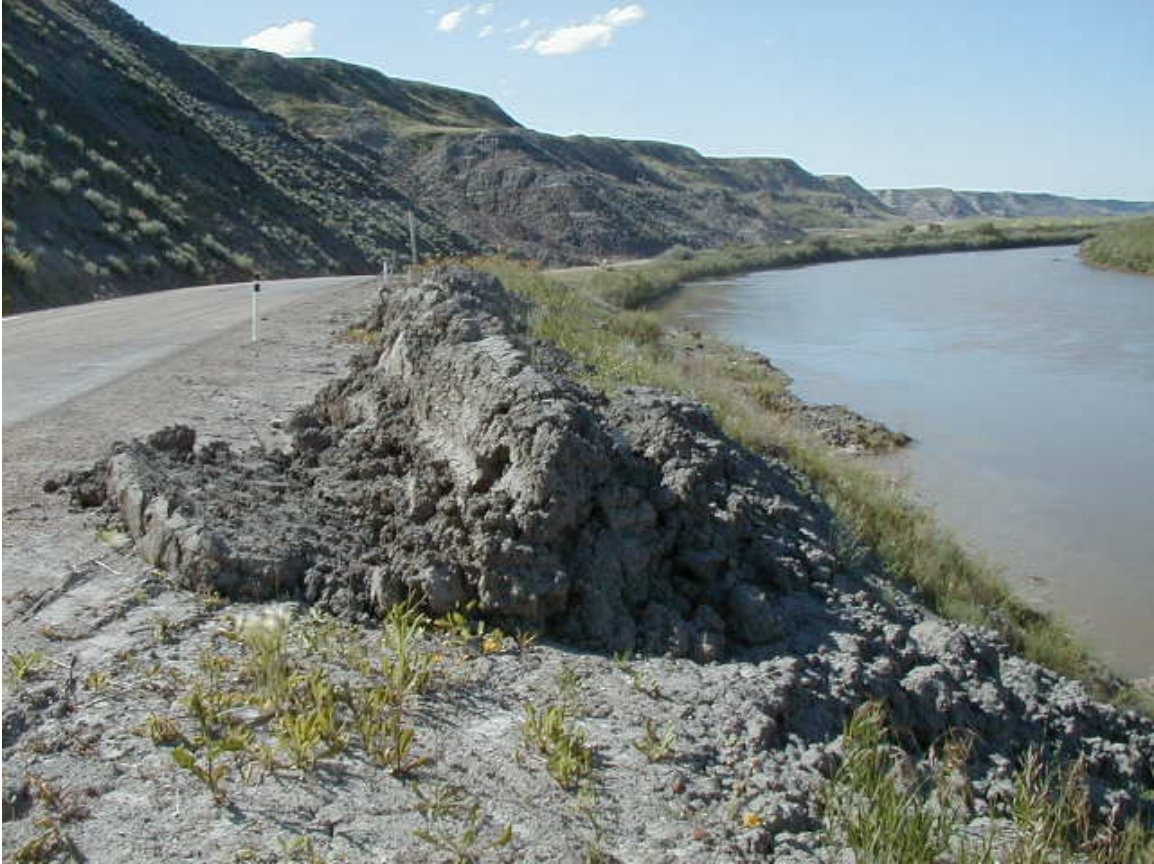
Ditch spoil pile placed at crest of slope

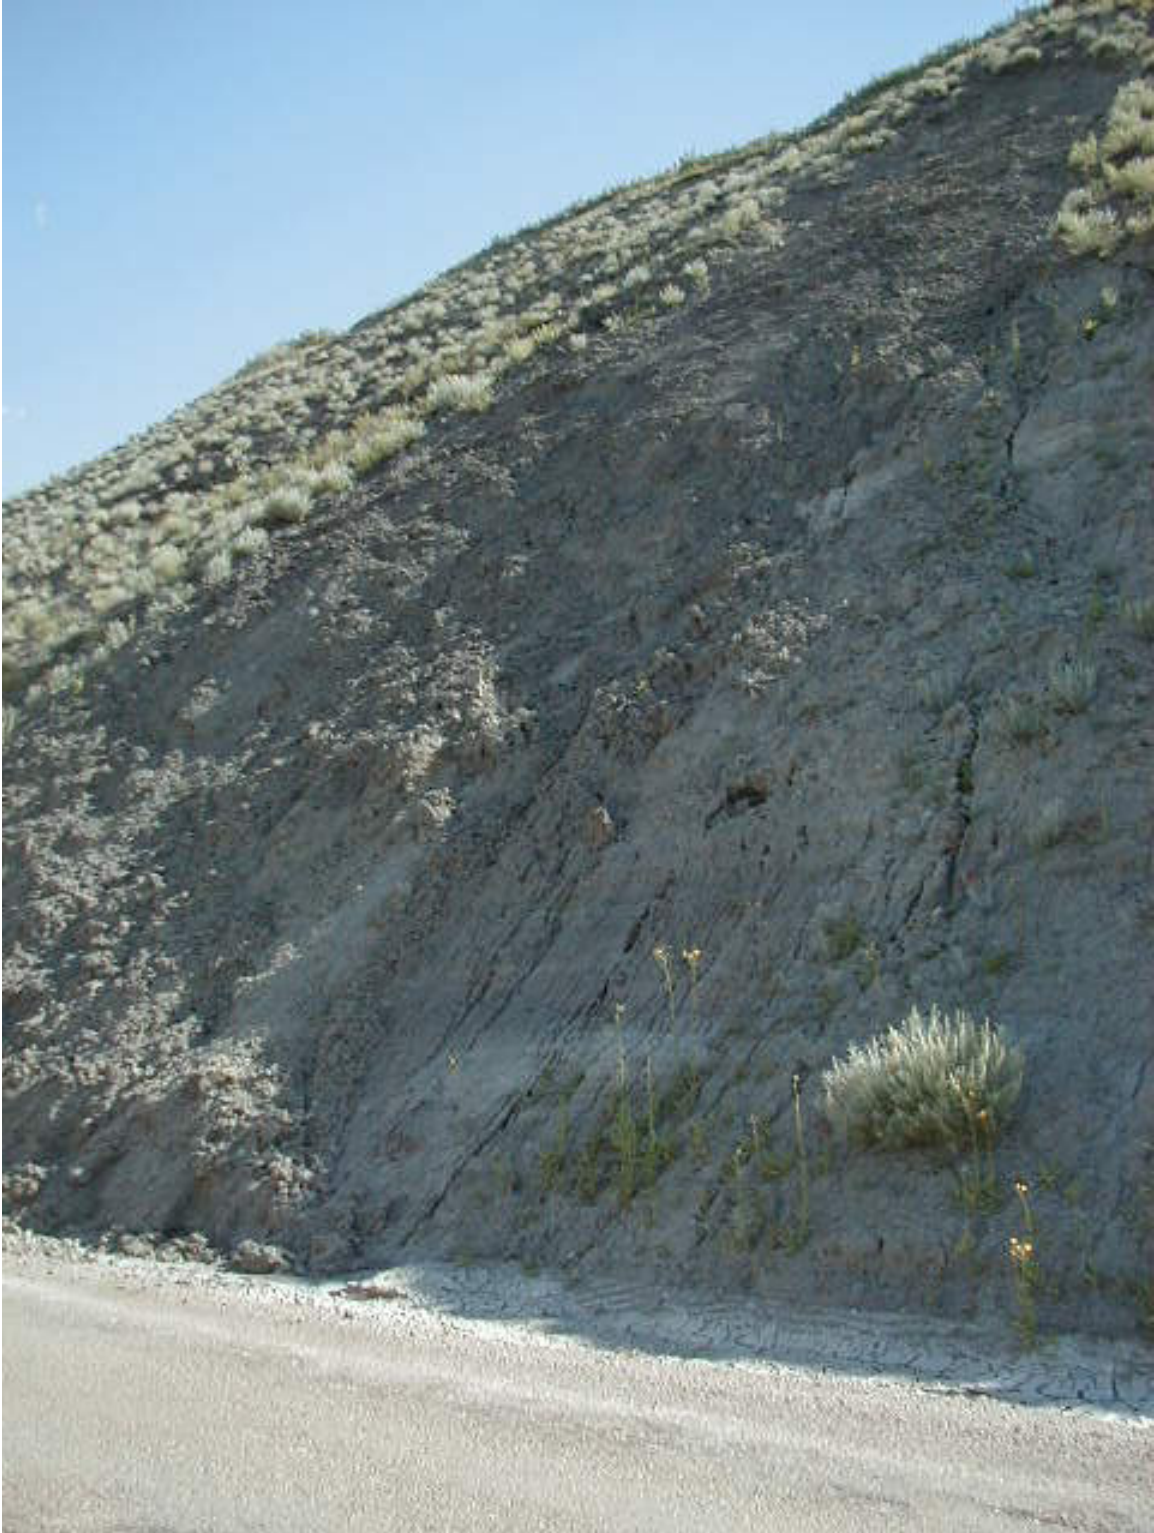
Backslope Erosion

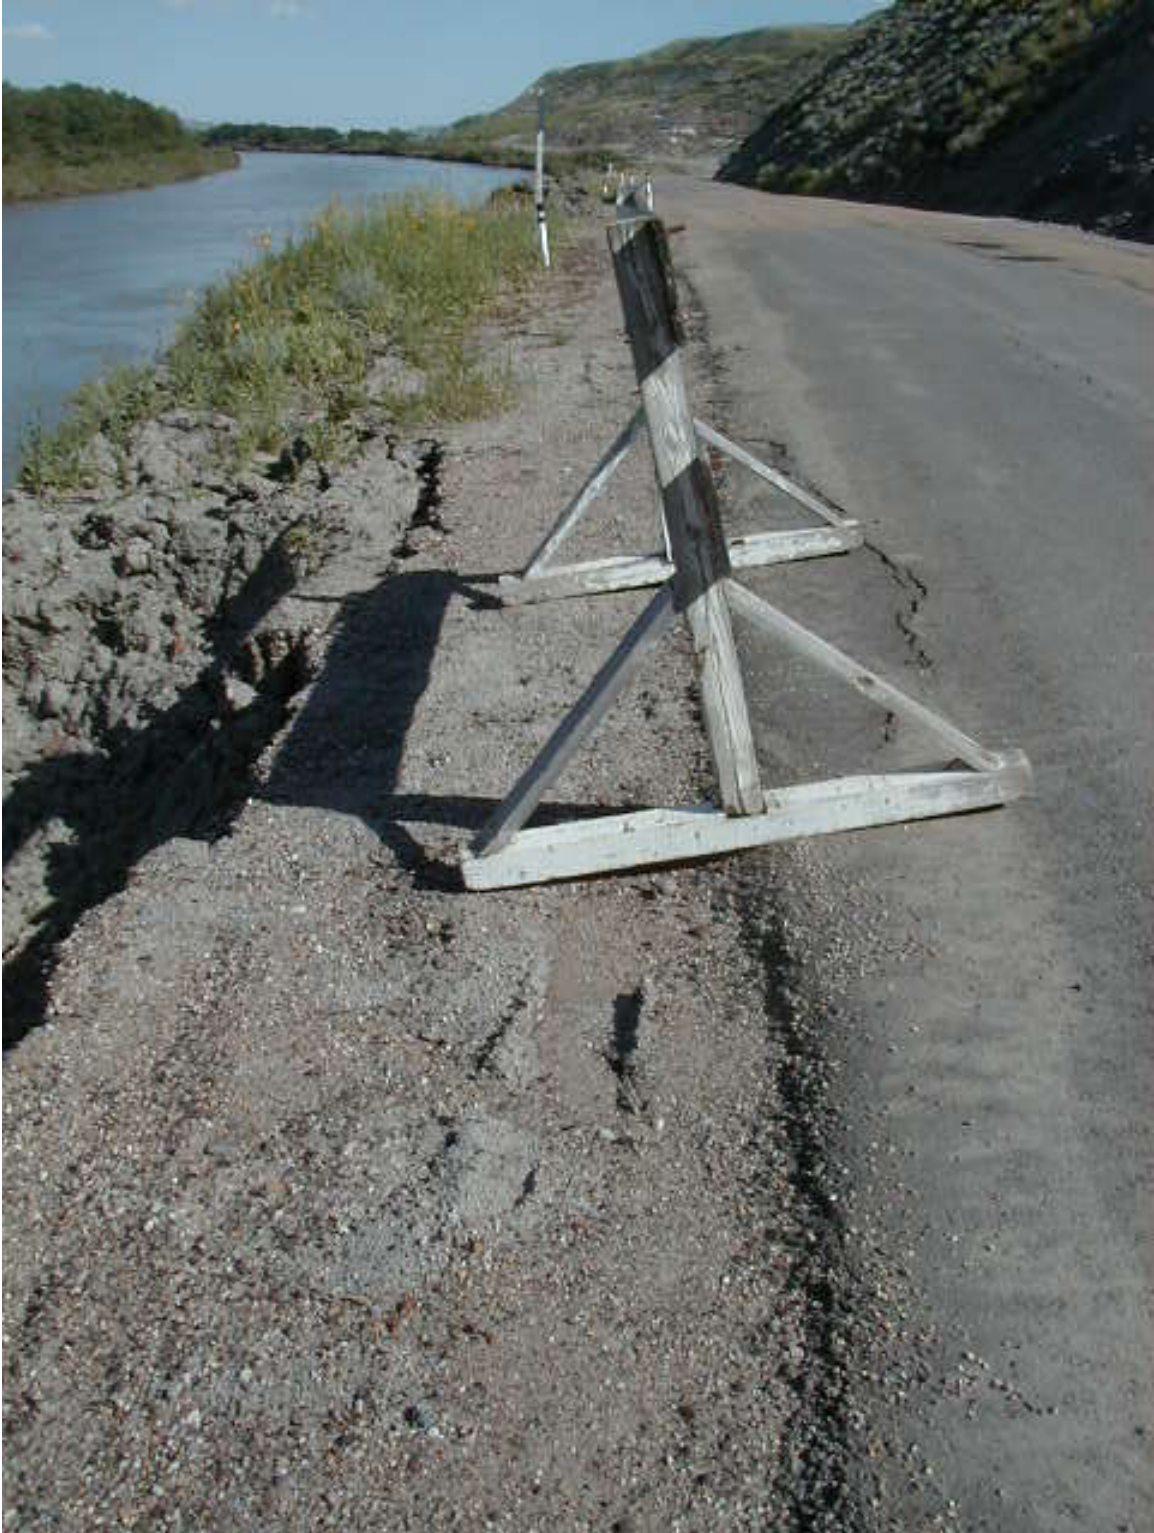
Observed cracking in pavement
