| SITE NUMBER AND NAME: C018-1 and -2 | | HIGHWAY & KM: 837:02, 2.1 | PREVIOUS INSPECTION DATE: June 26, 2023 | INSPECTION DATE: June 18, 2024 |

PRIMARY SITE ISSUE: Natural slope instability along a section of the west valley slope along Hwy 837 (C018-2) and highway embankment instability (C018-1). On May 22, 2018, an earthflow slide deposited approximately 500 m³ of material on the highway. Ongoing sliding and expansion of the 2018 slide area has occurred since 2018, and new slides on the highway embankment have developed since 2021.

| TITLE Site Plan C018 - Red Deer Riverbank Slide Hwy 837:02, km 2.100 | | |

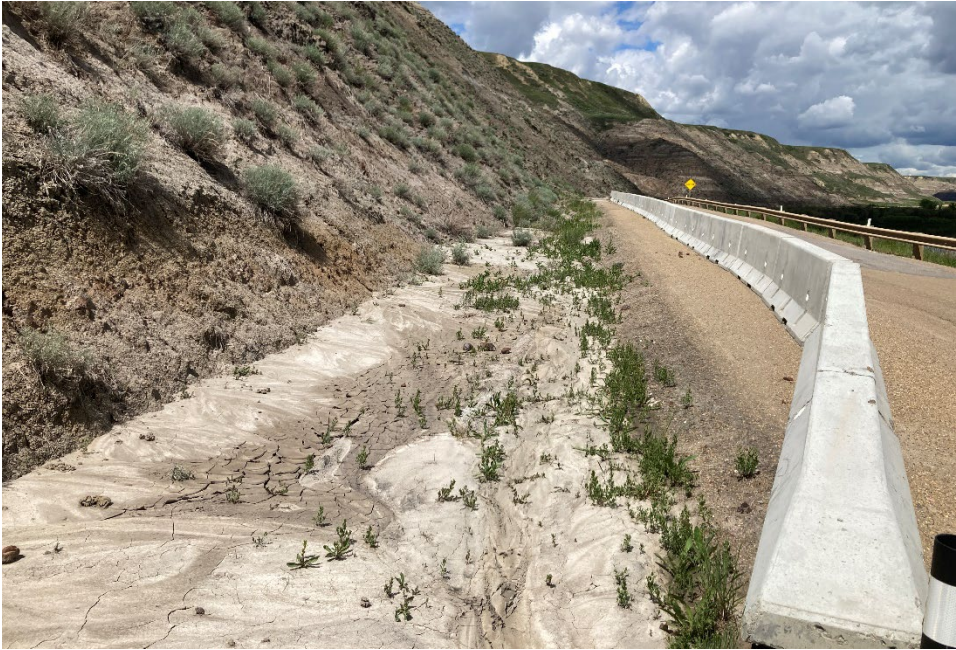
- In general, there was less material deposited behind the jersey barriers than previous years inspections, particularly along the southeast portion of the site (Photo 1).

Photo 1 Southeast extent of where the jersey barriers are installed along the C018-2 site. Photo taken June 17, 2024, facing northwest.

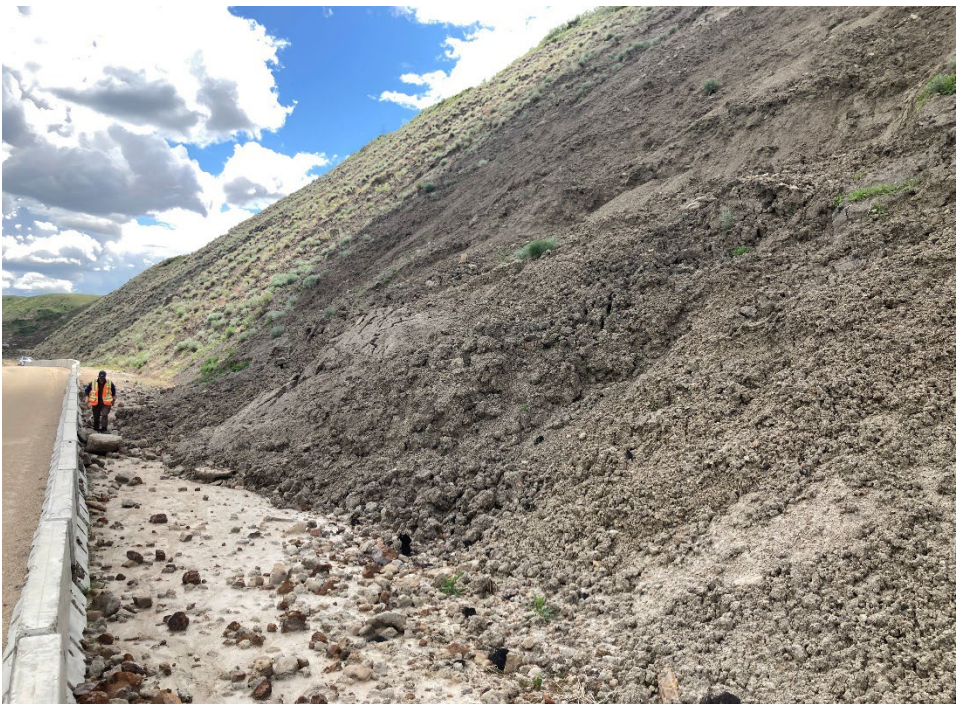
- Near the middle of the site, failed material has been deposited into the west (southbound) lane between the 2023 and 2024 inspections (Photo 2). The material was deposited approximately 35 m along the base of the slope and the area of instability extends approximately a quarter of the way up the slope.

Photo 2 Failed material deposited into the west lane behind the jersey barriers, near the middle of the site, between the 2023 and 2024 inspections. Photo taken June 17, 2024, facing southeast.

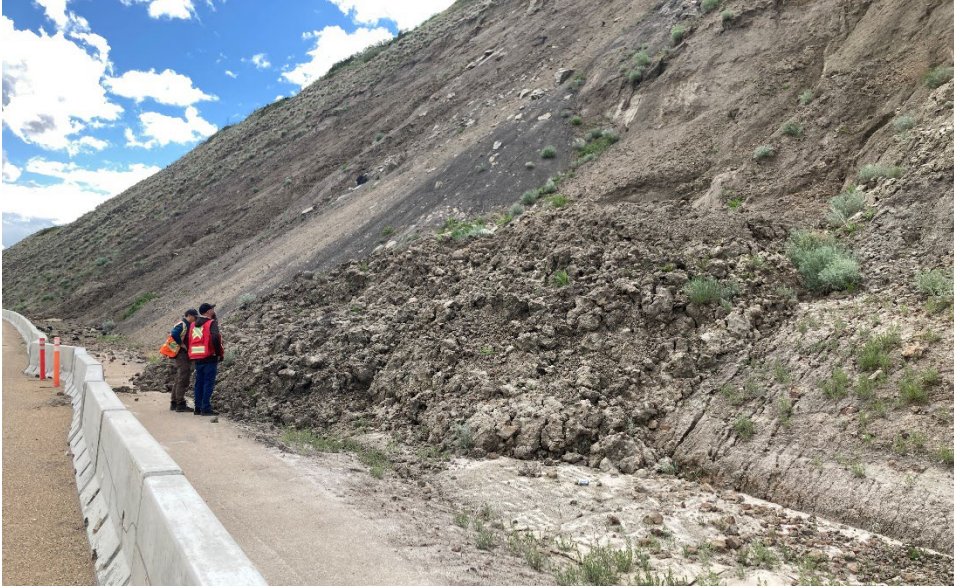
- Near the north extent of the site, failed material has been deposited into the ditch and west (northbound) lane between the 2023 and 2024 inspections (Photo 3). The volume of failed material was approximately 480 cubic meters (15 m long, 8 m deep, and 4 m tall). The area of instability extends approximately one third of the way up the slope.

Photo 3 Failed material deposited into the west lane behind the jersey barriers, near the northwest extent of the site, between the 2023 and 2024 inspections. Photo taken June 17, 2024, facing southeast.

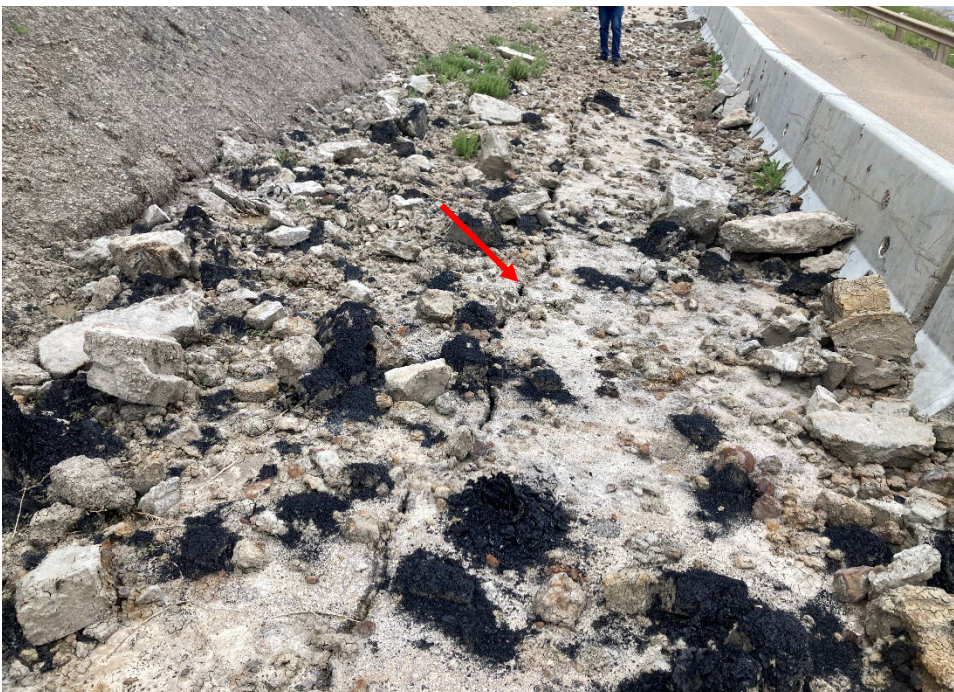
- A new pavement crack (approximately 25 mm to 50 mm wide and 20 m long) was observed in the west (southbound) lane behind the jersey barriers at the north extent of C018-2 (Photo 4 and 5). The crack extends across both lanes (Photo 5). The crack was near the north extent of the previous riverbank repair completed in the early 2000s and could indicate movement is outflanking the previous repair and the rate of movement has increased between the 2023 and 2024 inspections.

Photo 4 New pavement crack (approximately 25 mm wide and 20 m long, indicated by red arrow) that extends across both lanes near the northwest extent of the C018-2 site (northwest of the previous riverbank slide repair). Photo taken June 17, 2024, facing northwest.

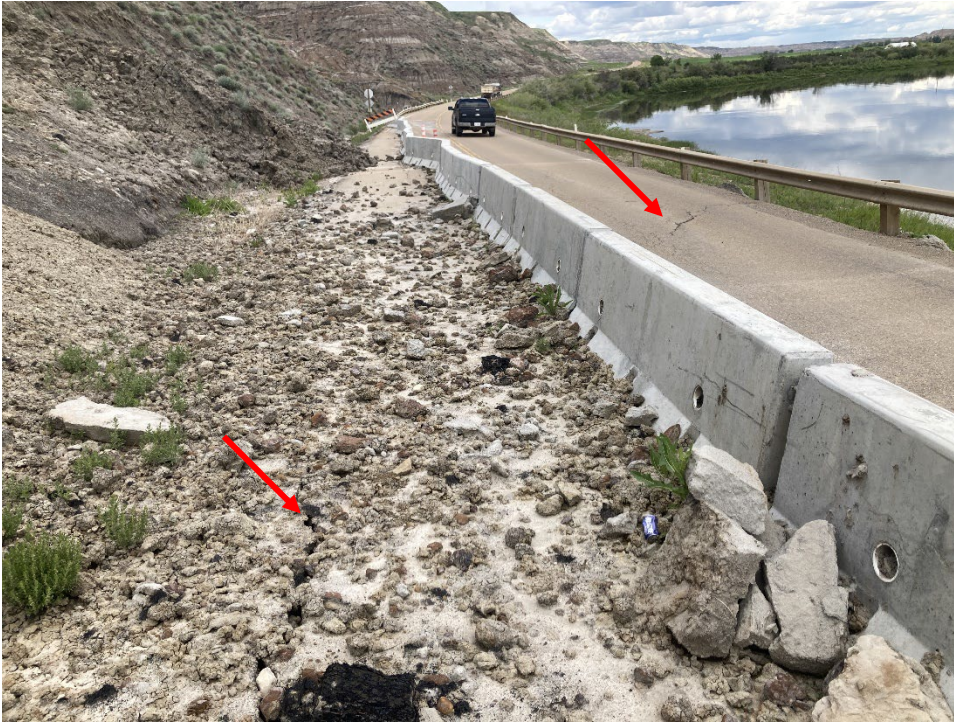
Photo 5 New pavement crack extending across the east and west lanes (indicated by red arrows). Photo taken June 18, 2024, facing northwest.

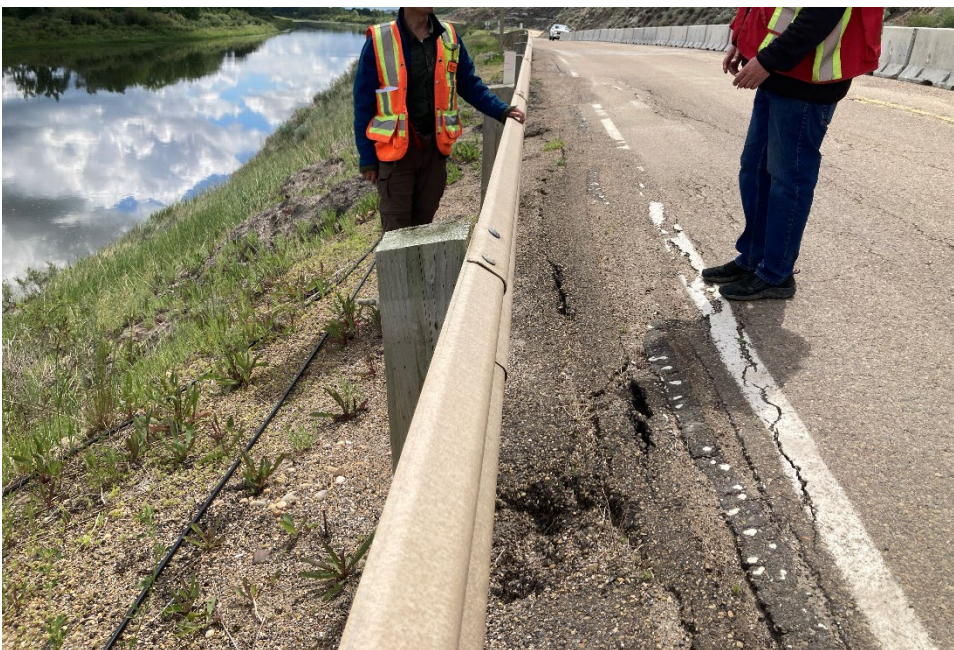
- Longitudinal pavement cracking north of the C018-1 slide was observed in the shoulder of the east (northbound) lane (Photo 6). Longitudinal pavement cracking has been regularly and is the most severe upslope of the slide failures near the south extent of the site. Increased traffic loading on the east (northbound) lane due to jersey barriers in the west (southbound) lane along C018-2 may be attributing to slope movements that are impacting the pavement surface (i.e., pavement settlement and cracking). Ground cracks were also observed further north, closer to the length of riverbank repaired in the early 2000s (Photo 7).

Photo 6 Pavement cracking at the edge of the east lane northwest of the C018-1 slide. Photo taken June 18, 2024 facing southeast.

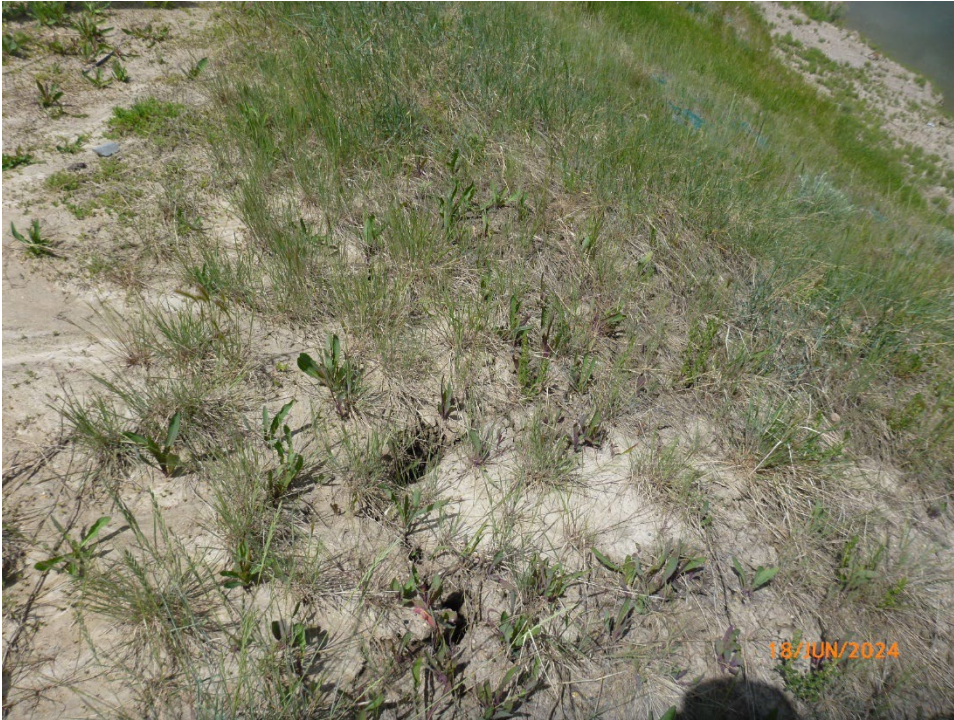
Photo 7 Ground cracking observed just southeast of the previous riverbank slide repair completed in the early 2000s. Photo taken June 18, 2024, facing northwest.

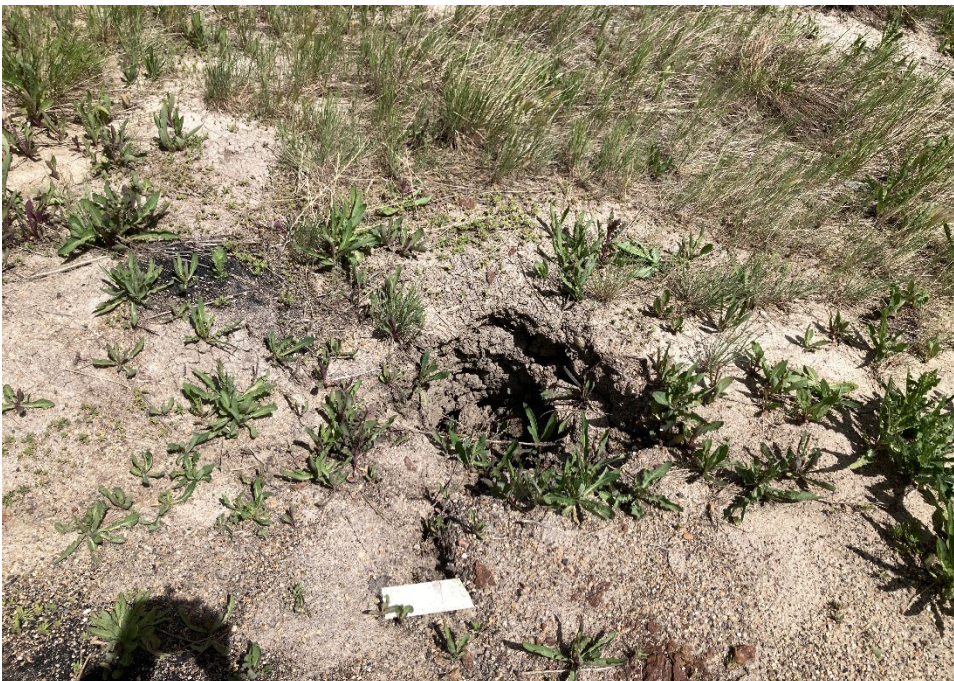
- Dispersive soil voids were observed on the east side of the highway along the length of the site (Photos 8 through 10). The sinkholes were concentrated near the left (northwest) and right (southeast) extent of the previous riverbank repair. Between 5-10 voids were observed during the 2024 inspection.

Photo 8 Sinkhole observed in the highway embankment slope downslope of C018-2. Photo taken June 18, 2024, facing north.

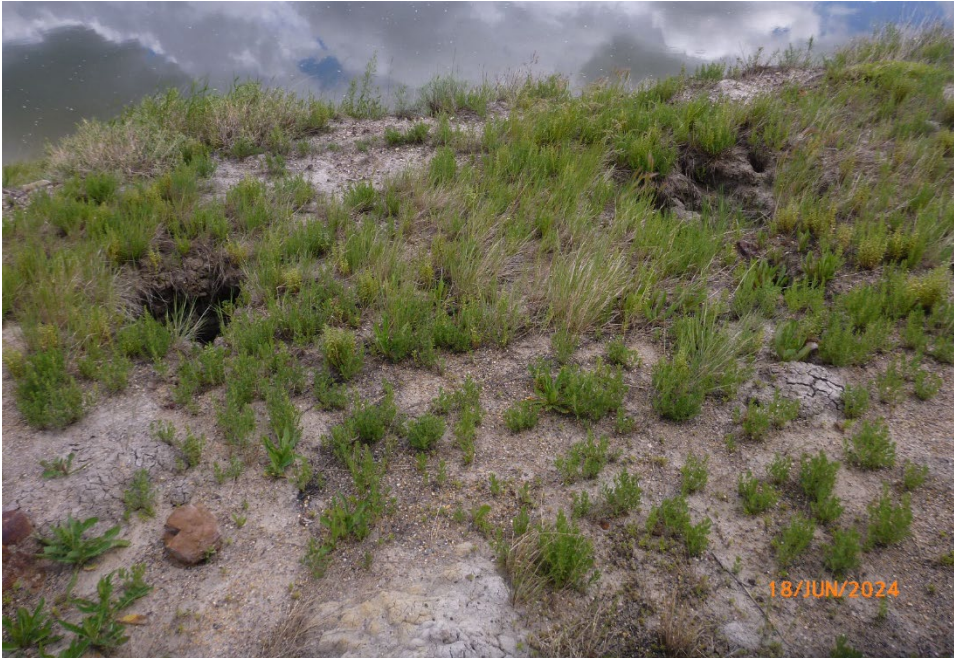
Photo 9 Sinkholes observed in the highway embankment slope downslope of C018-2.
Photo taken June 18,2024, facing north.

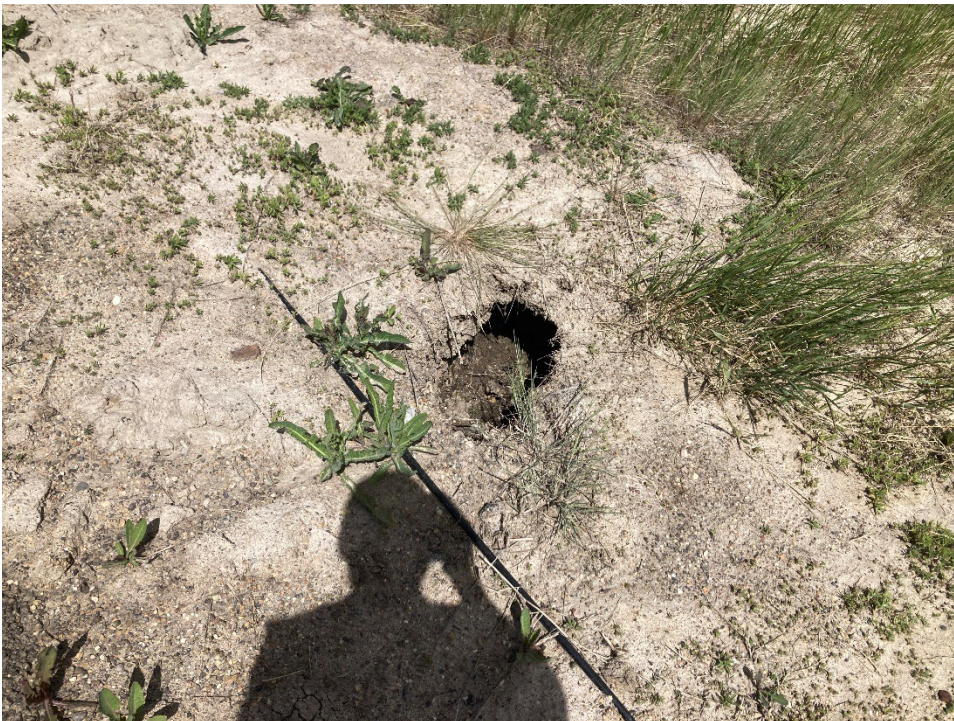
Photo 10 Sinkhole observed in the highway embankment slope downslope of C018-2.
Photo taken June 18,2024, facing north.

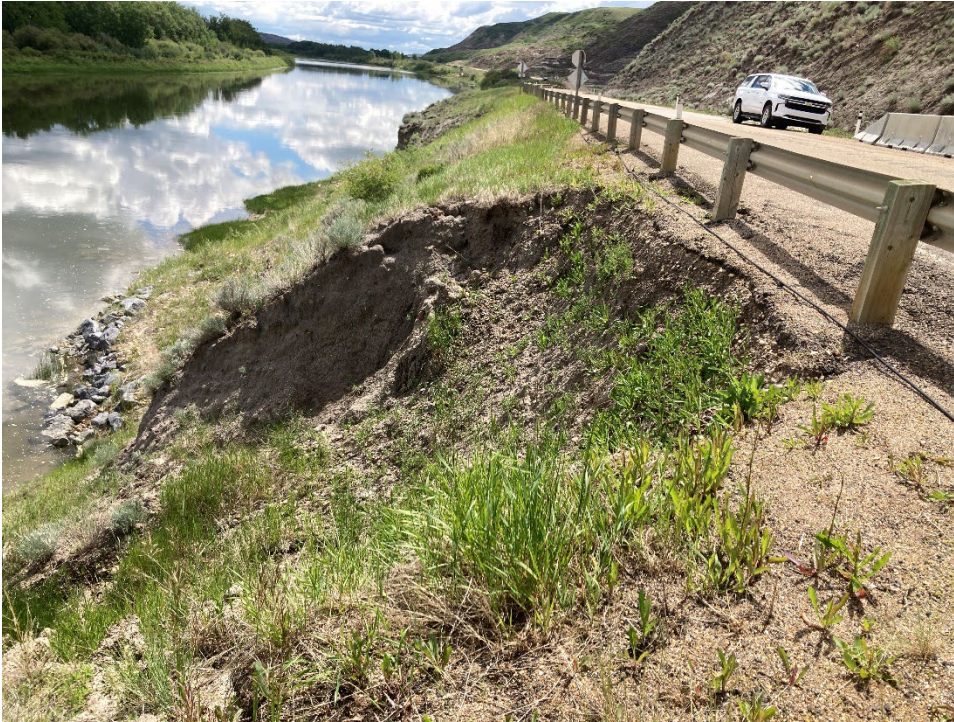
- Waypoint 380 and 381: Two sinkholes up to approximately 0.7 m in diameter and 1 m deep.
- Between 2023 and 2024, no significant change to the slope failure on the east (northbound) highway embankment slope (first observed during the 2021 inspection) was observed (Photo 11). KCB and TEC believe that the failure occurred in spring 2021. The failure expanded between the 2022 and 2023 inspections (likely due to wet weather) and is approximately 20 m wide and 3 m high, with ground cracks observed approximately 5 m to 10 m on either side of the failure.

Photo 11 No significant changes were observed at the C018-1 slide between the 2023 and 2024 inspections. Photo taken June 18, 2024, facing southeast.

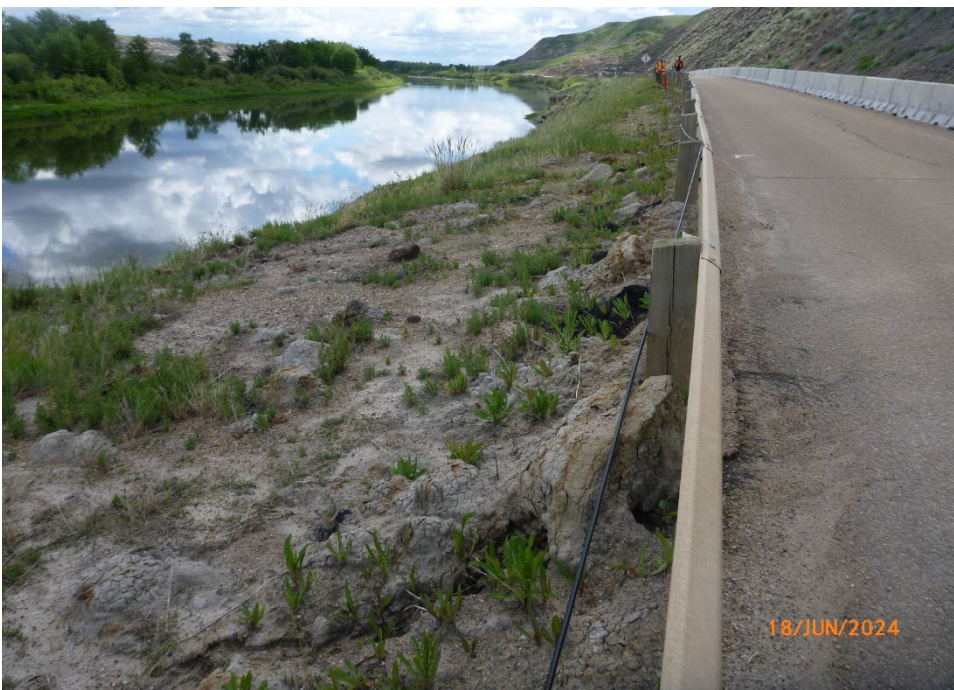
- Material (soil and coal fragments) from the C018-2 site was observed on the east side of the guardrail, indicating that material falling down the slope is not being completely contained with the concrete jersey barriers (Photo 12). The larger blocks deposited behind the guardrail appear older (weathered) and were generally less than approximately 0.5 m x 0.5 m x 0.5 m.

Photo 12 Material (soil and coal fragments) have been deposited across the highway surface. Photo taken June 18, 2024, facing southeast.
