SITE NUMBER AND NAME: C034-2 Abraham Lake Erosion		HIGHWAY & KM: 11:04, 11.056	PREVIOUS INSPECTION DATE: July 9, 2019	INSPECTION DATE: June 27, 2023
LEGAL DESCRIPTION: 07-07-38-17 W5M	NAD 83 COORDINATES: UTM Northing Easting 11 5789173 539996		RISK ASSESSMENT: PF: 13 CF: 6 TOTAL: 78	
AVERAGE ANNUAL DAILY TRAFFIC (AADT): 395 (west) & 375 (east) (Ref No. 50110250)			CONTRACT MAINTENANCE AREA (CMA): 514

PRIMARY SITE ISSUE: Erosion and retrogression of a slope along the south (eastbound lane of H11:04 on the west side of Abraham Lake (a reservoir created by the Bighorn Dam (owned and operated by TransAlta Generation Partnership) on the North Saskatchewan River). The erosion is caused by precipitation, surface water runoff from the highway surface, and wave action when the reservoir level is high.

Inspection Photographs

PROJECT	CENTRAL REGION GEOHAZARD RISK MANAGEMENT PROGRAM	
TITLE	Site Plan C034-II - Abraham Lake Hwy 11:02, km 11.056	
SCALE	PROJECT No.	FIG No.
1:3,000	A05116A02	1

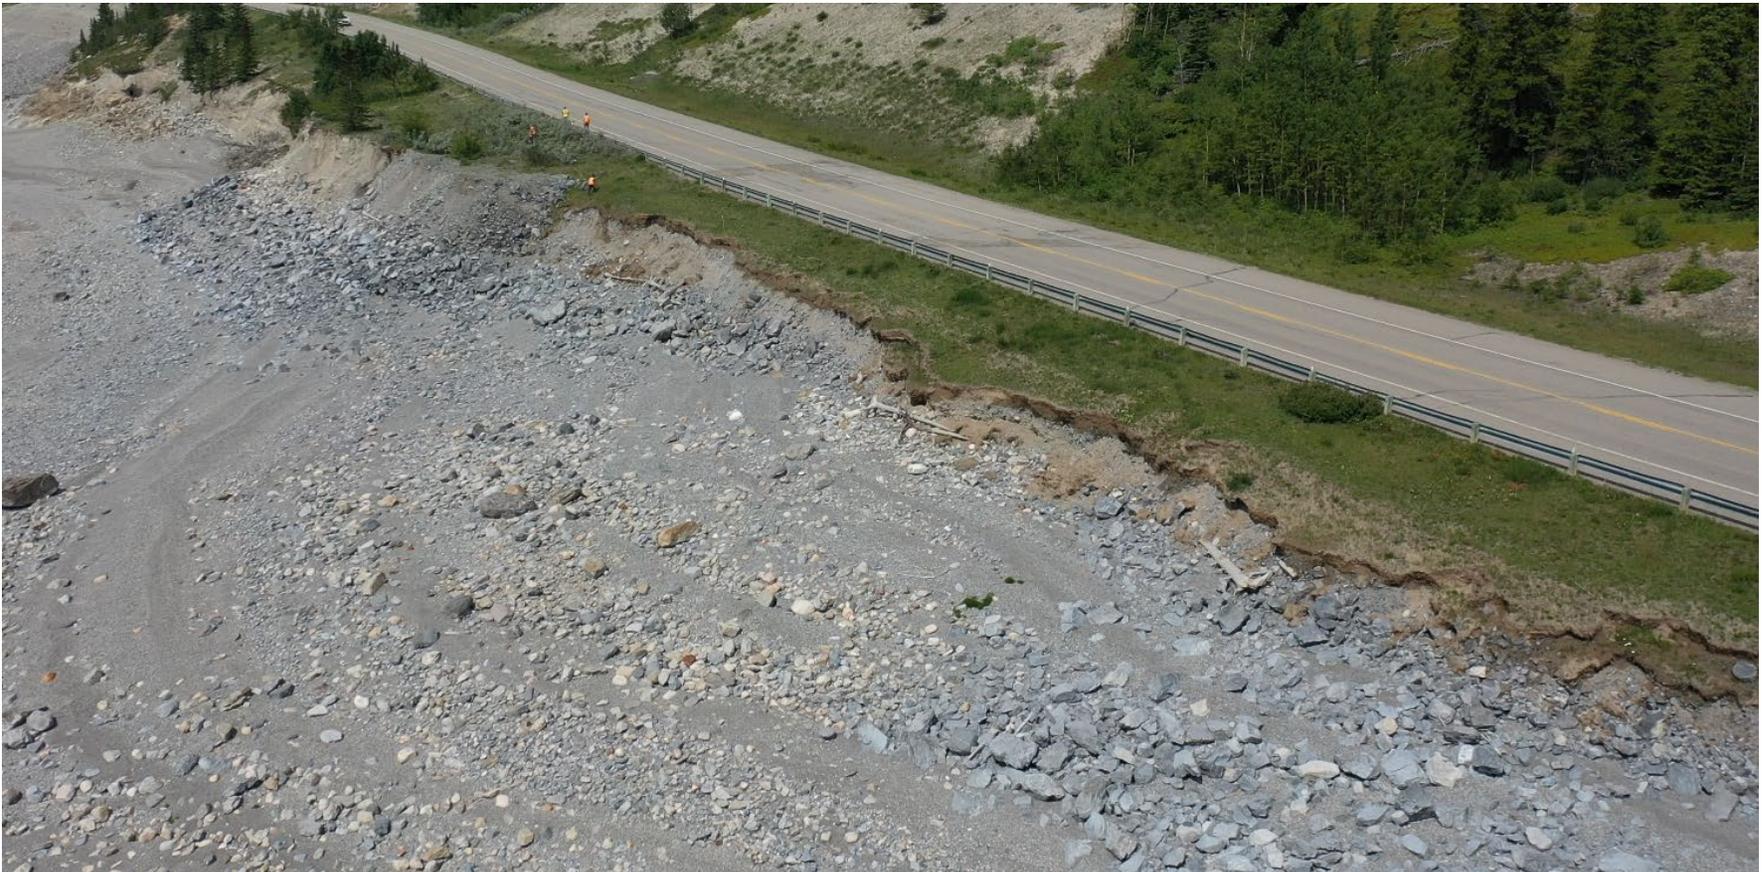
Fine-grained material is being eroding from the upper portion of the erosion scarp and being deposited further down the slope (Photos 1, 2, and 3). The erosion appears to be more severe than during the 2022 test pitting program. The exposed material on the slope is sand and gravel with some cobbles.
Vegetation (i.e., trees and shrubs) on the slope near the west (right) flank of the eroding slope are failing into Abraham Lake due to ongoing erosion (Photo 5).
In 2022, KCB submitted a proposal to TEC in May 2022 for engineering work to complete a repair design for the C034-2 site. The proposal was approved and in July 2022, a test pitting program to support design work (i.e., assessing ground conditions and ground water level) was completed. The program included six (6) test pits along the toe of the embankment slope. In August 2022, a site visit was also to support an environmental and regulatory work. The design work (including engineering and environmental work) was completed in 2022. However, the project was temporarily put on hold due to insufficient funding. In 2023, KCB was authorized by TEC to restart work and to prepare a tender and complete environmental work (i.e., regulatory and permitting).

Photo 1 An aerial photo of the C034-2 site. The site is approximately 250 m to 300 m in length and up to 6 m to 7 m in height. The erosion scarp along the site varies from approximately 2 m to 3 m in height and within 3 m to 6 m of the south (eastbound) guardrail. Photo taken June 27, 2023, facing northwest.

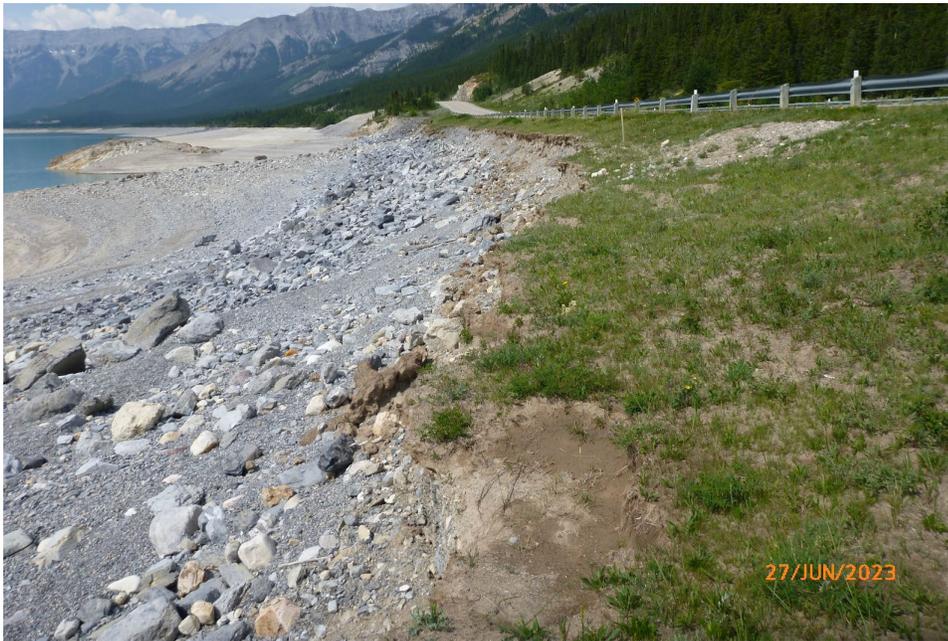
Photo 2 The erosion scarp near the east (left) flank of the C034-2 site. The erosion scarps are approximately 2 m to 3 m in height. Photo taken June 27, 2023, facing west.

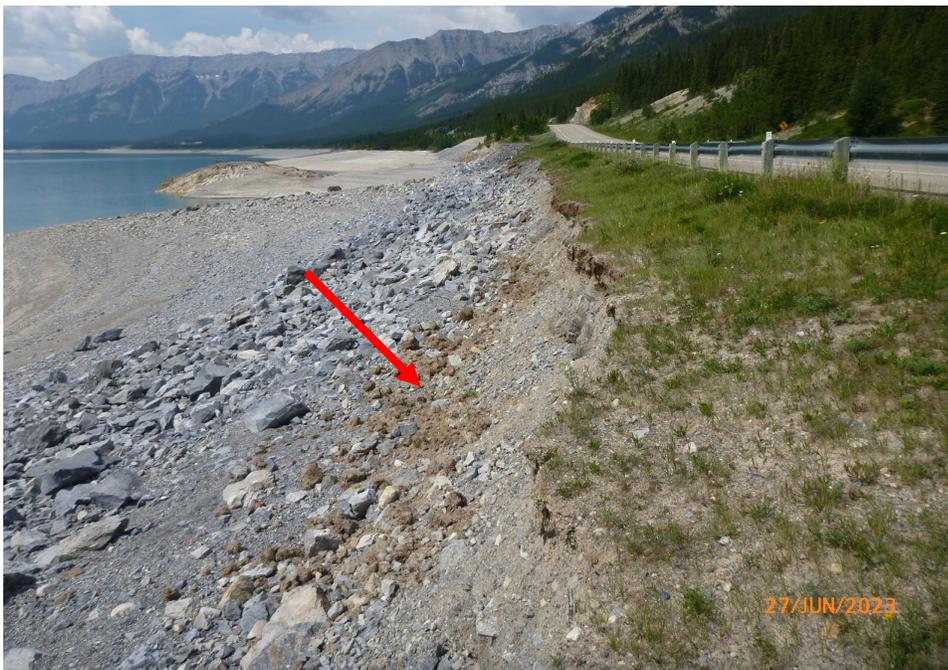
Photo 3 The erosion scarp near the east (left) flank of the C034-2 site. Material has been eroded and deposited downslope (indicated by red arrow). Photo taken June 27, 2023, facing west.

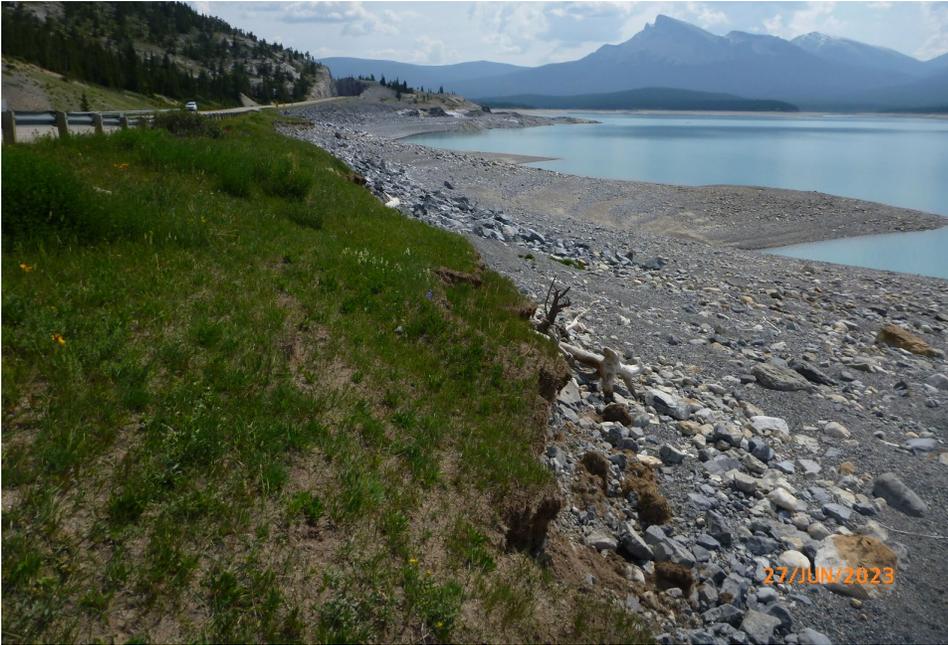
Photo 4 The erosion scarp along the C034-2 site (Waypoint 367). Photo taken June 27, 2023, facing east.

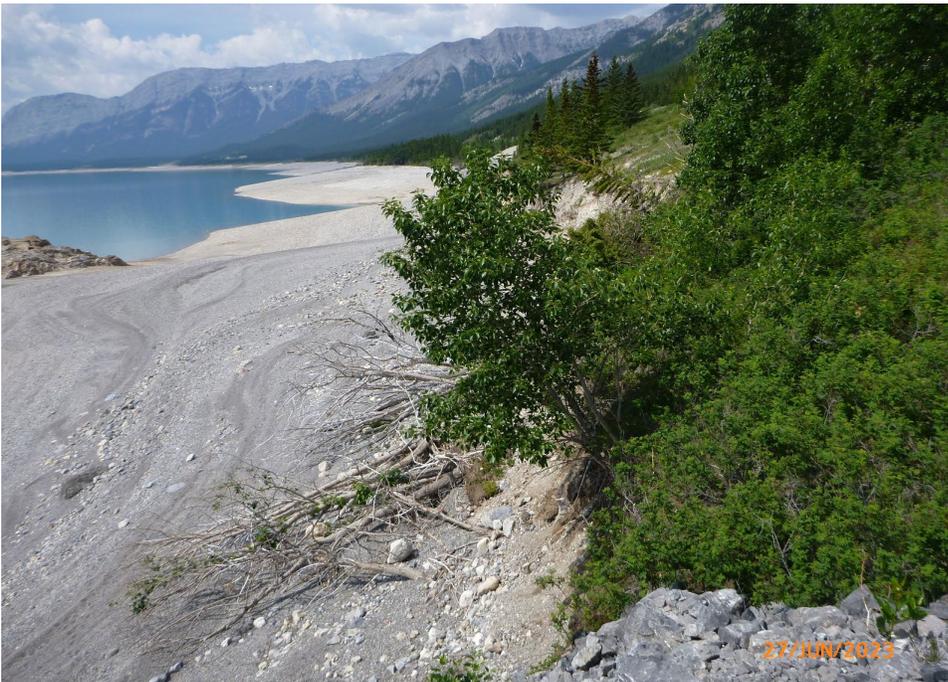
Photo 5 Vegetation (trees and shrubs) located near the right (west) flank of the C034-2 site. The vegetation has begun to fail due to ongoing erosion and trees were observed at the toe of the slope. Photo taken June 27, 2023, facing west.
