SITE NUMBER AND NAME: C007 Kenilworth Lake	HIGHWAY & KM: 16:30, 23.89	PREVIOUS INSPECTION DATE: June 24, 2020	INSPECTION DATE: June 28, 2023
LEGAL DESCRIPTION: 11-27-050-04 W4M	NAD 83 COORDINATES: UTM Northing Easting 12 5910761 532907	RISK ASSESSMENT: PF: 2 CF: 2 TOTAL: 4	
AVERAGE ANNUAL DAILY TRAFFIC (AADT): 7,420 (west) & 7,560 (east) (Ref No. 137470 & 134470)		CONTRACT MAINTENANCE AREA (CMA): 512

Inspection Photographs

PROJECT CENTRAL REGION GEOHAZARD RISK MANAGEMENT PROGRAM		
TITLE Site Plan C007 - Kenilworth Lake Slide Hwy 16:30, km 23.890		
SCALE 1:1,000	PROJECT No. A05116A02	FIG No. 1

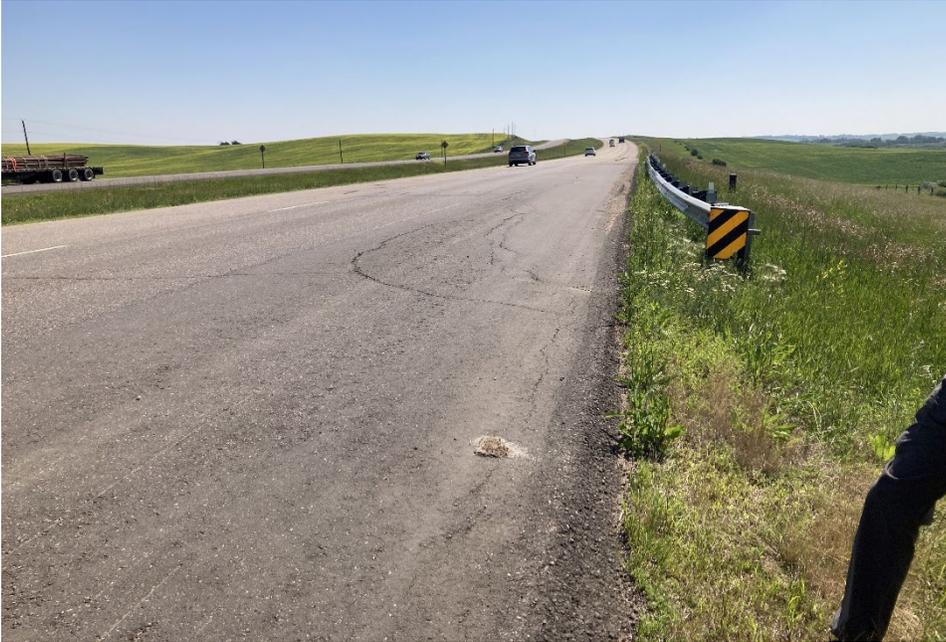
Photo 1 Asphalt cracking observed in the south (eastbound) travel lane and shoulder of Hwy 16:30, upslope of the H-pile wall and guardrail. Photo taken June 28, 2023, facing east.

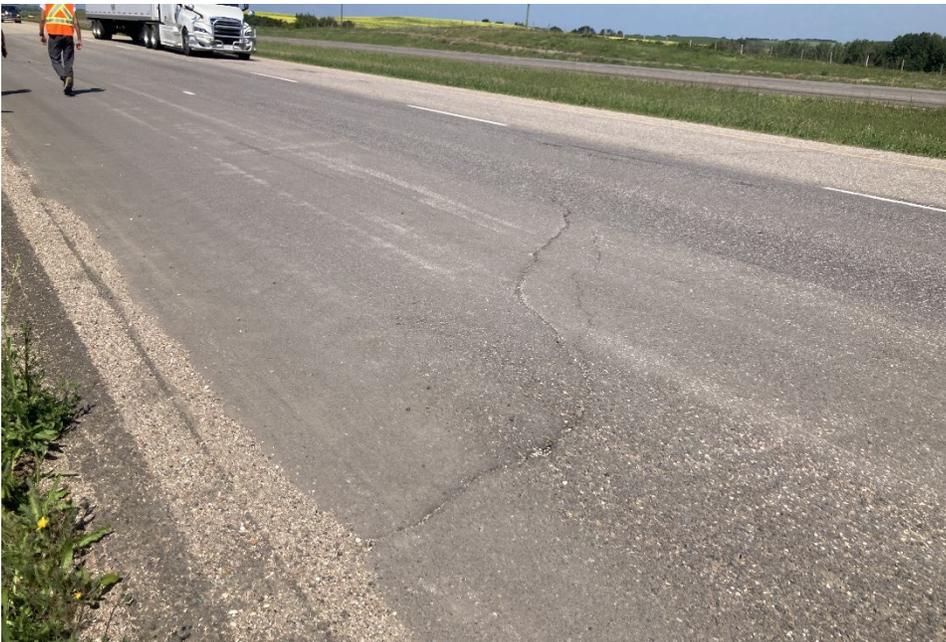
Photo 2 Asphalt cracking and settlement observed in the south (eastbound) lane. Asphalt cracking appears to have extended through a recent asphalt patch between 2020 and 2023. Photo taken June 28, 2023, facing west.

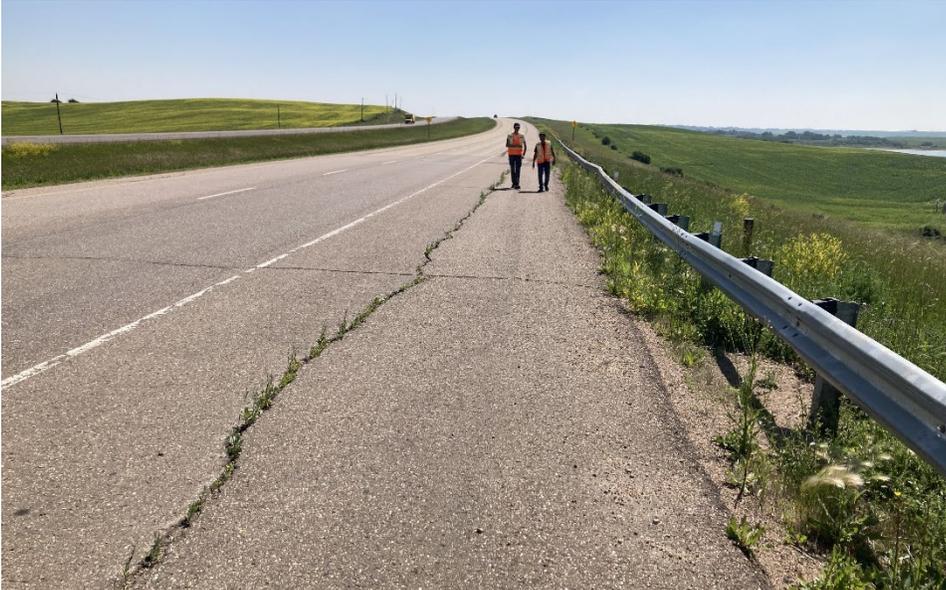
Photo 3 Asphalt cracking in the shoulder of the south (eastbound) lane, east of the pile wall installed in 2015 and upslope of the east H-pile wall extension completed in 2021. Photo taken June 28, 2023, facing east.

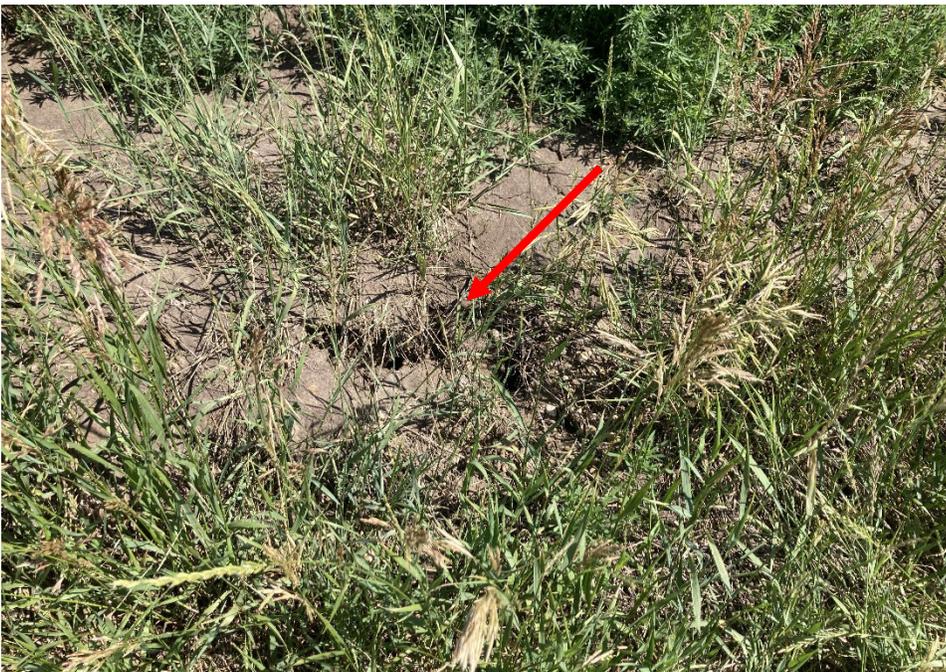
Photo 4 Ground settlement and cracking observed on the upper portion of the highway embankment slope downslope of the h-pile wall (crack indicated by red arrow). Photo taken June 28, 2023, facing north.
