July 15, 2024

Alberta Transportation and Economic Corridors
4th Floor, Provincial Building
4920 51 Street
Red Deer, Alberta
T4N 6K8

**CON0022160 Central Region GRMP Instrumentation Monitoring
Site C007; H16:30, km 23.890 Kenilworth Lake Slide
Section C – 2024 Spring Readings**

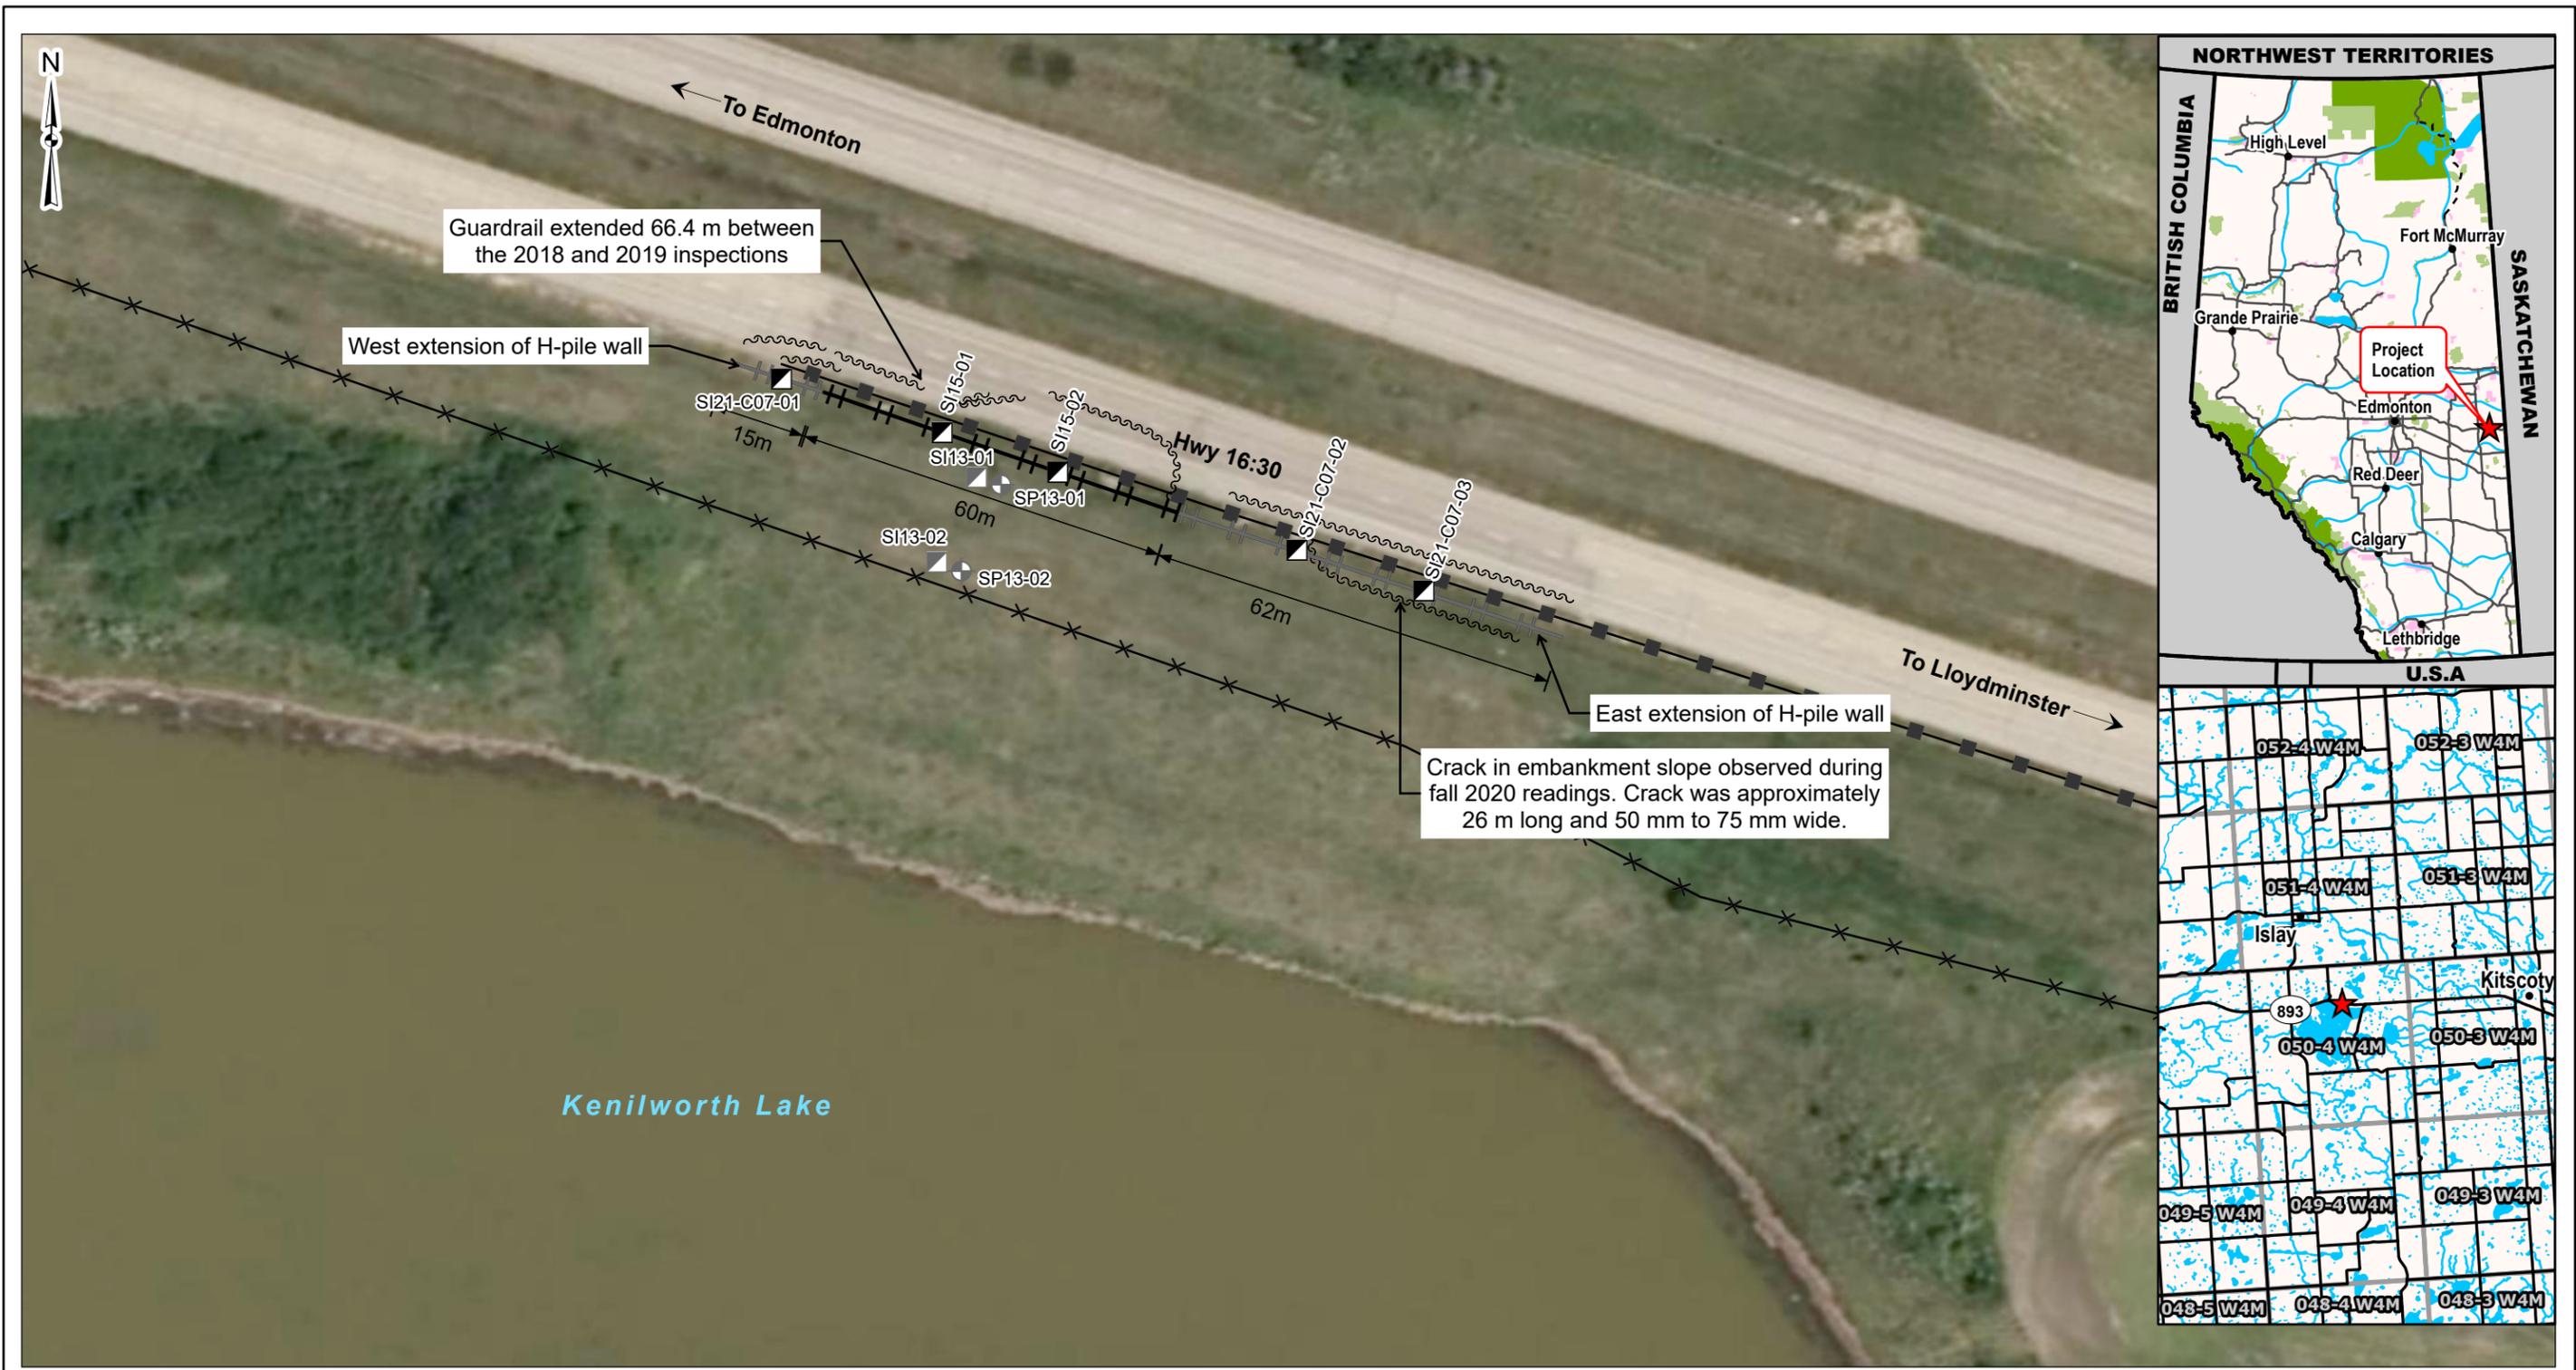
The geohazard at the C007 site consists of a slope failure along the north shore of Kenilworth Lake that impacts the south (eastbound) lanes of Hwy 16:30. The slope failure was first observed in 1977 and appears to be a deep-seated rotational slide. In March 2015, an 18-m-deep, 60-m-long H-pile wall (H360X132) consisting of 80 piles was installed to stabilize the slope, as presented in Figure 1.

In March 2021, the H-pile wall was extended 62 m to the east and 15 m to the west, with 18-m-long H-piles, to address lateral expansion of the slide mass. Previous remedial actions include construction of a granular toe berm in 1980, installation of horizontal drains in 1985 and 1986, construction of a keyed-in granular toe berm in 2011, and regular patching and paving. Twinning of the highway was completed in 1990 or 1991.

Crack in embankment slope observed during fall 2020 readings. Crack was approximately 26 m long and 50 mm to 75 mm wide.

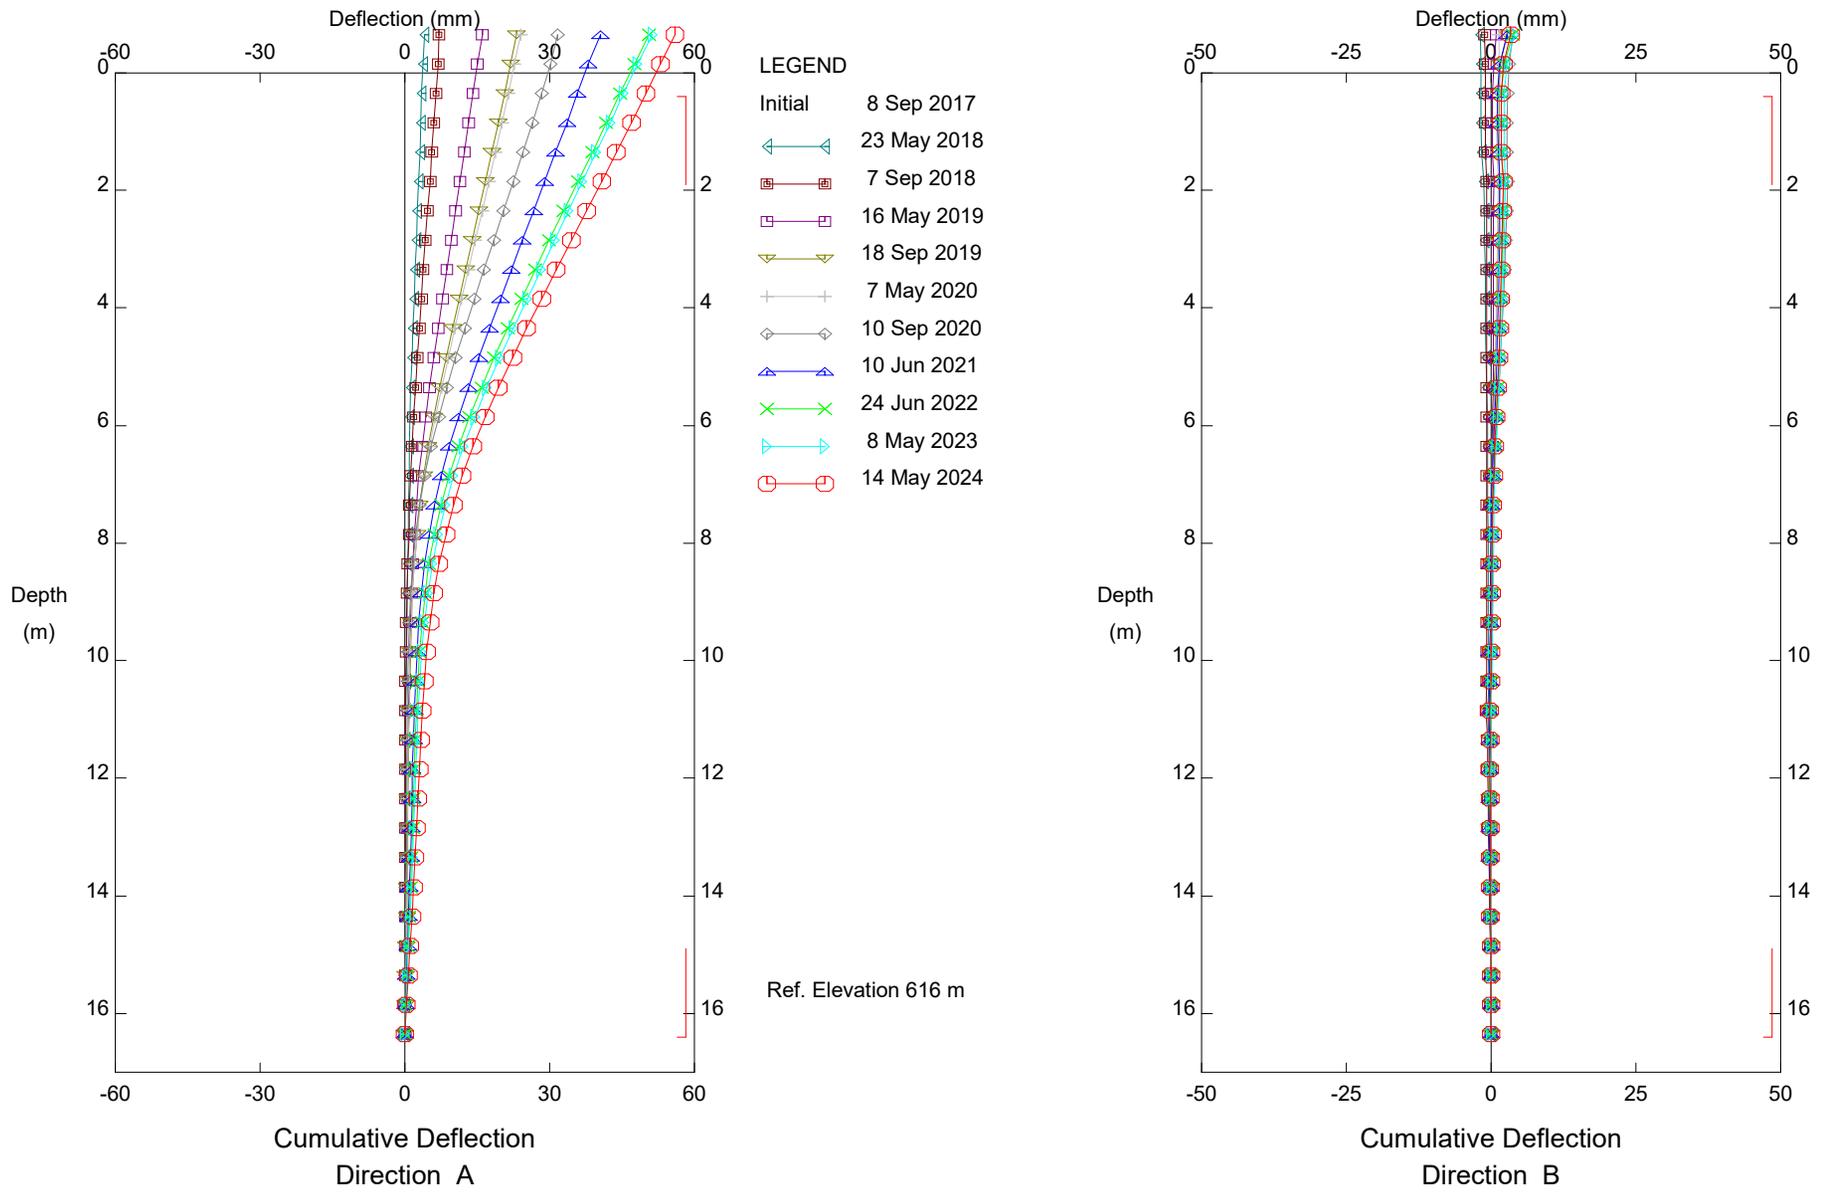
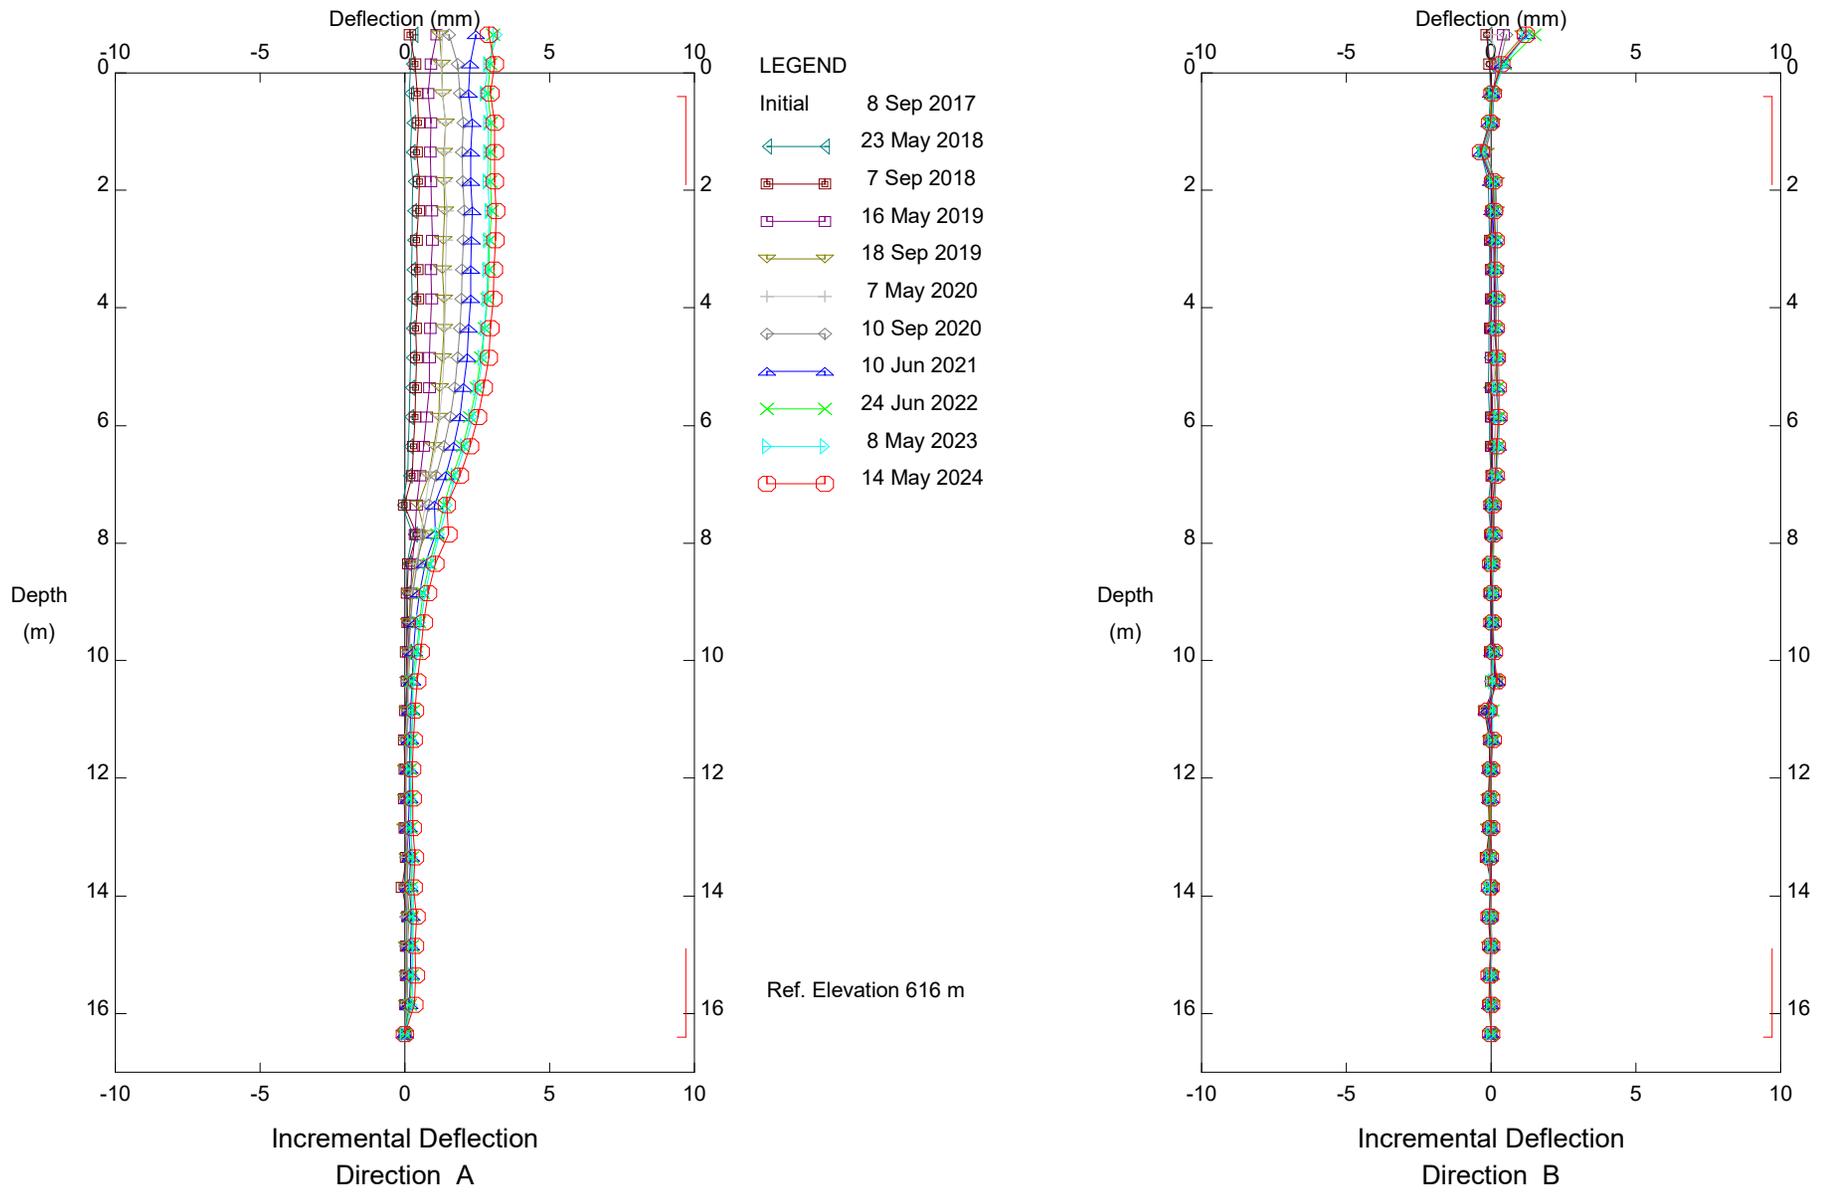
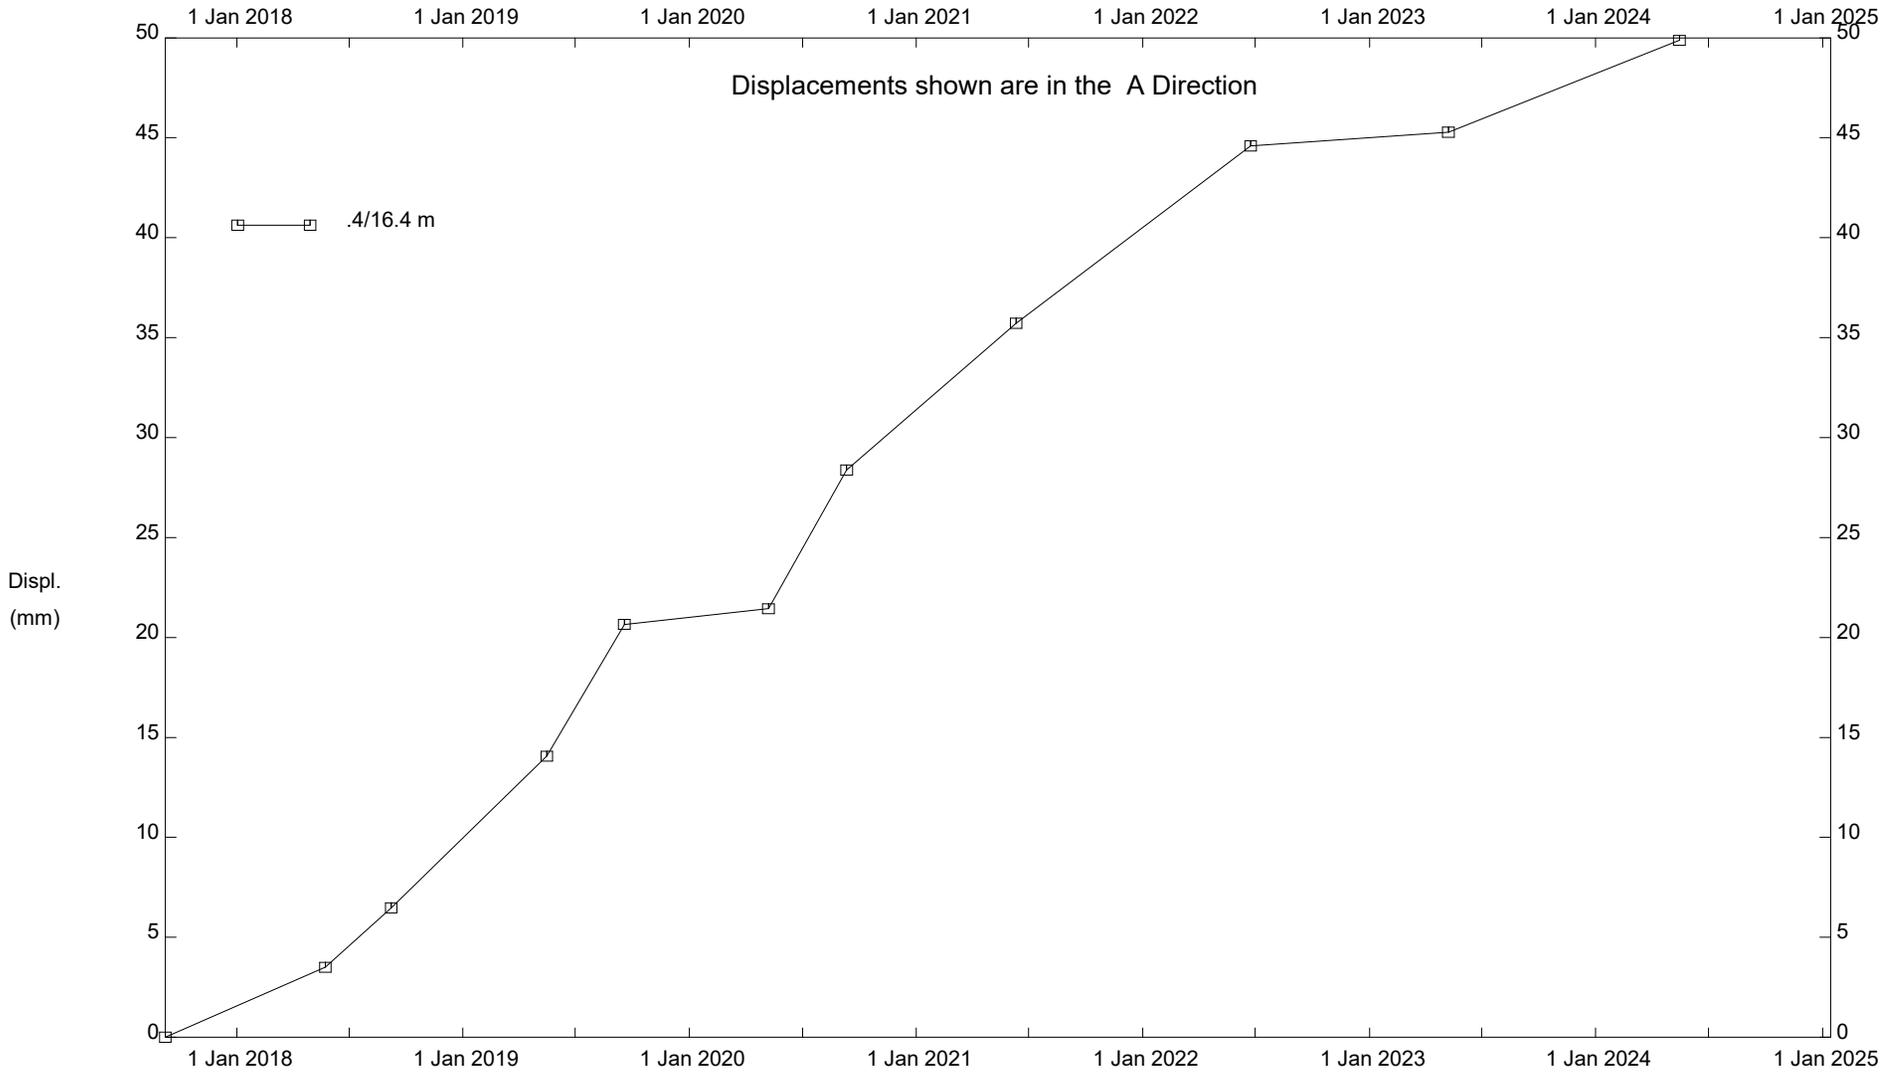
C007; H16:30, Kenilworth Lake Slide, Inclinator SI15-01

The May 2024 data obtained from SI15-01 and SI15-02 indicates that the top of the original H-pile wall has deflected between approximately 172 mm and 138 mm, respectively, since installation, with most of the displacement occurring before June 2015. The maximum rate of movement recorded in SI15-01 and SI15-02 occurred in June 2015, one month after the H-pile wall was installed and was approximately 655 mm/year and 293 mm/year, respectively. The rate of movement has since decreased and is now less than 5 mm/year.

Before SI15-01 was re-initialized in September 2017, approximately 135 mm of distributed movement (i.e., from top to bottom of casing) was recorded in the B-direction. It is unknown if this movement was due to post installation SI casing flexure, shifting in the steel pocket, or twist of the H-piles that occurred when the H-pile wall picked up load while stabilizing the sliding mass. However, movements in the B-direction have attenuated and no additional movement has been recorded in the B-direction of this instrument since it was re-initialized.

Instrument re-initialized in September 2017 when the SI equipment was changed.
