July 15, 2024

Alberta Transportation and Economic Corridors
4th Floor, Provincial Building
4920 51 Street
Red Deer, Alberta
T4N 6K8

**CON0022160 Central Region GRMP Instrumentation Monitoring
Site C007; H16:30, km 23.890 Kenilworth Lake Slide
Section C – 2024 Spring Readings**

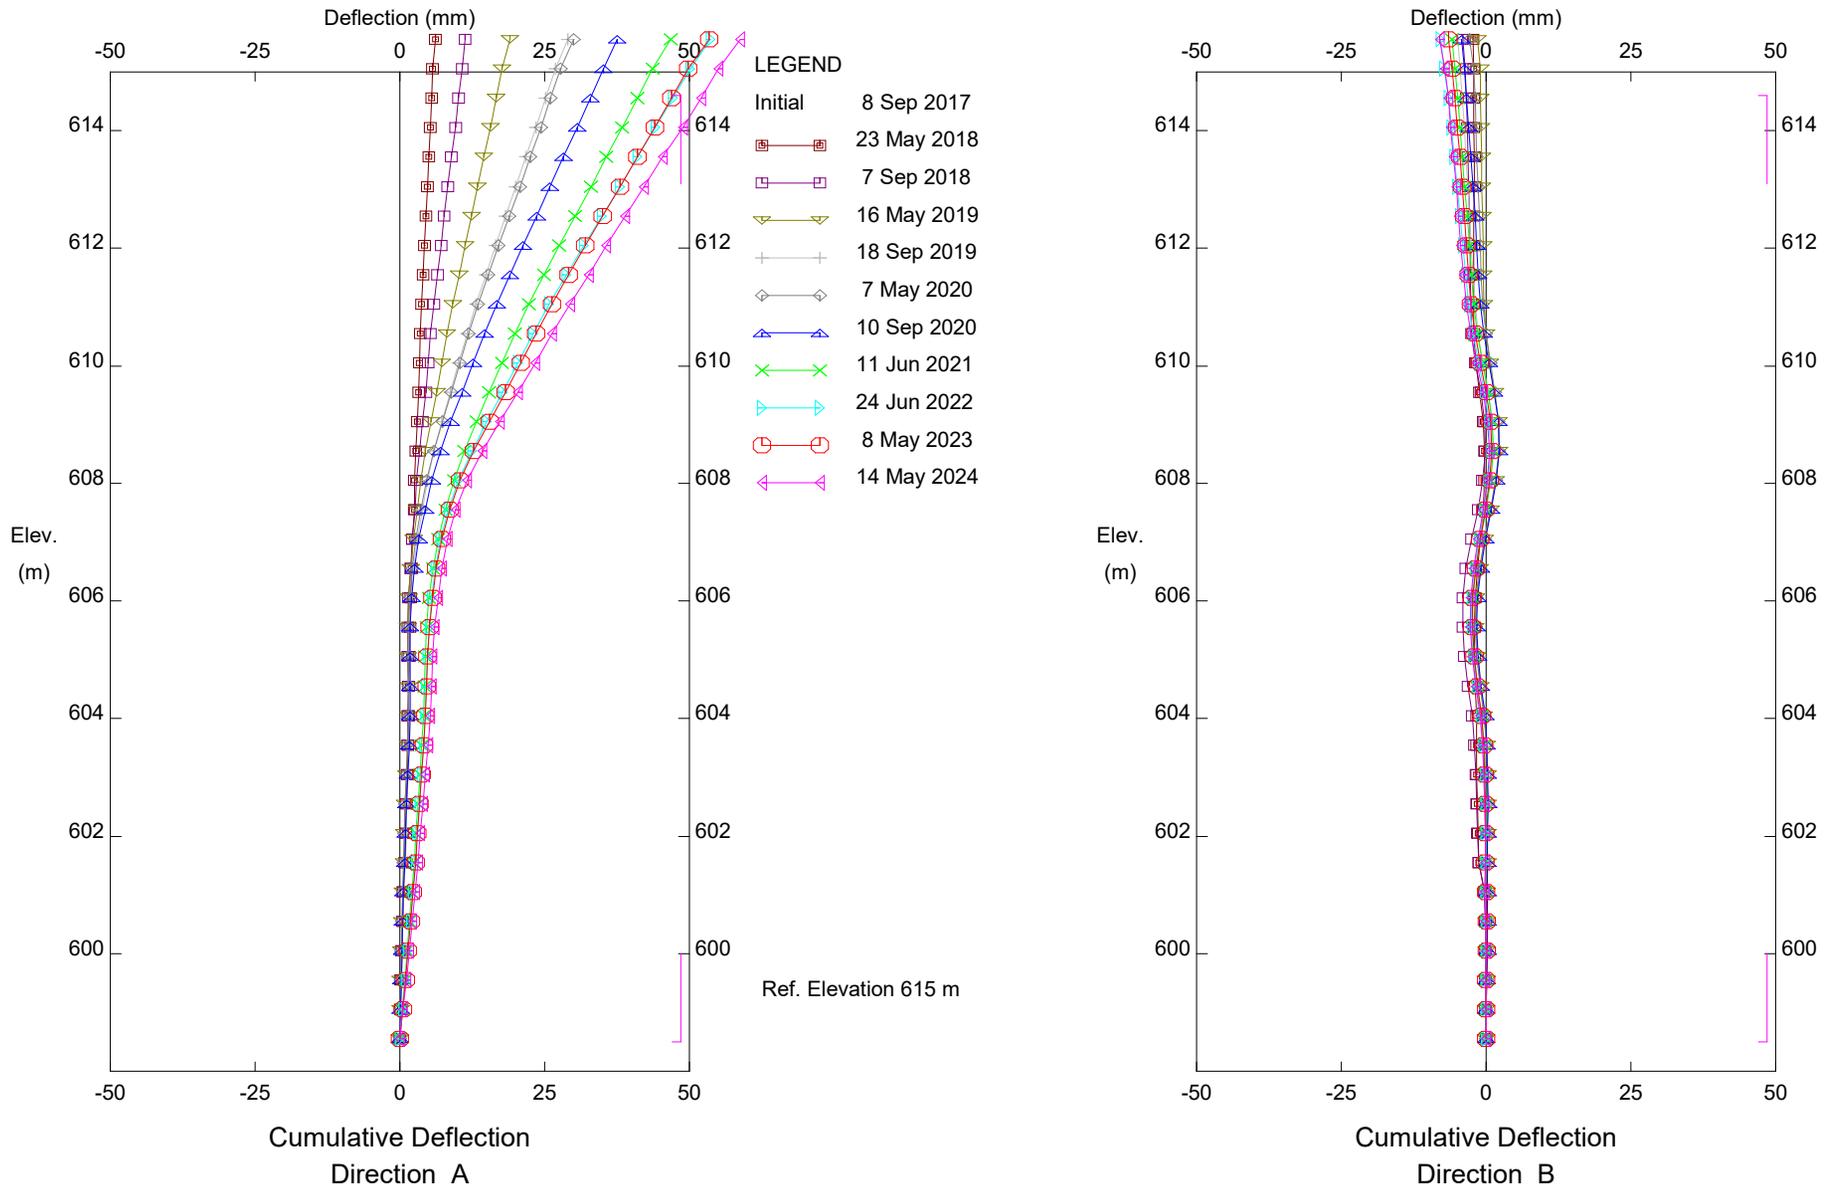
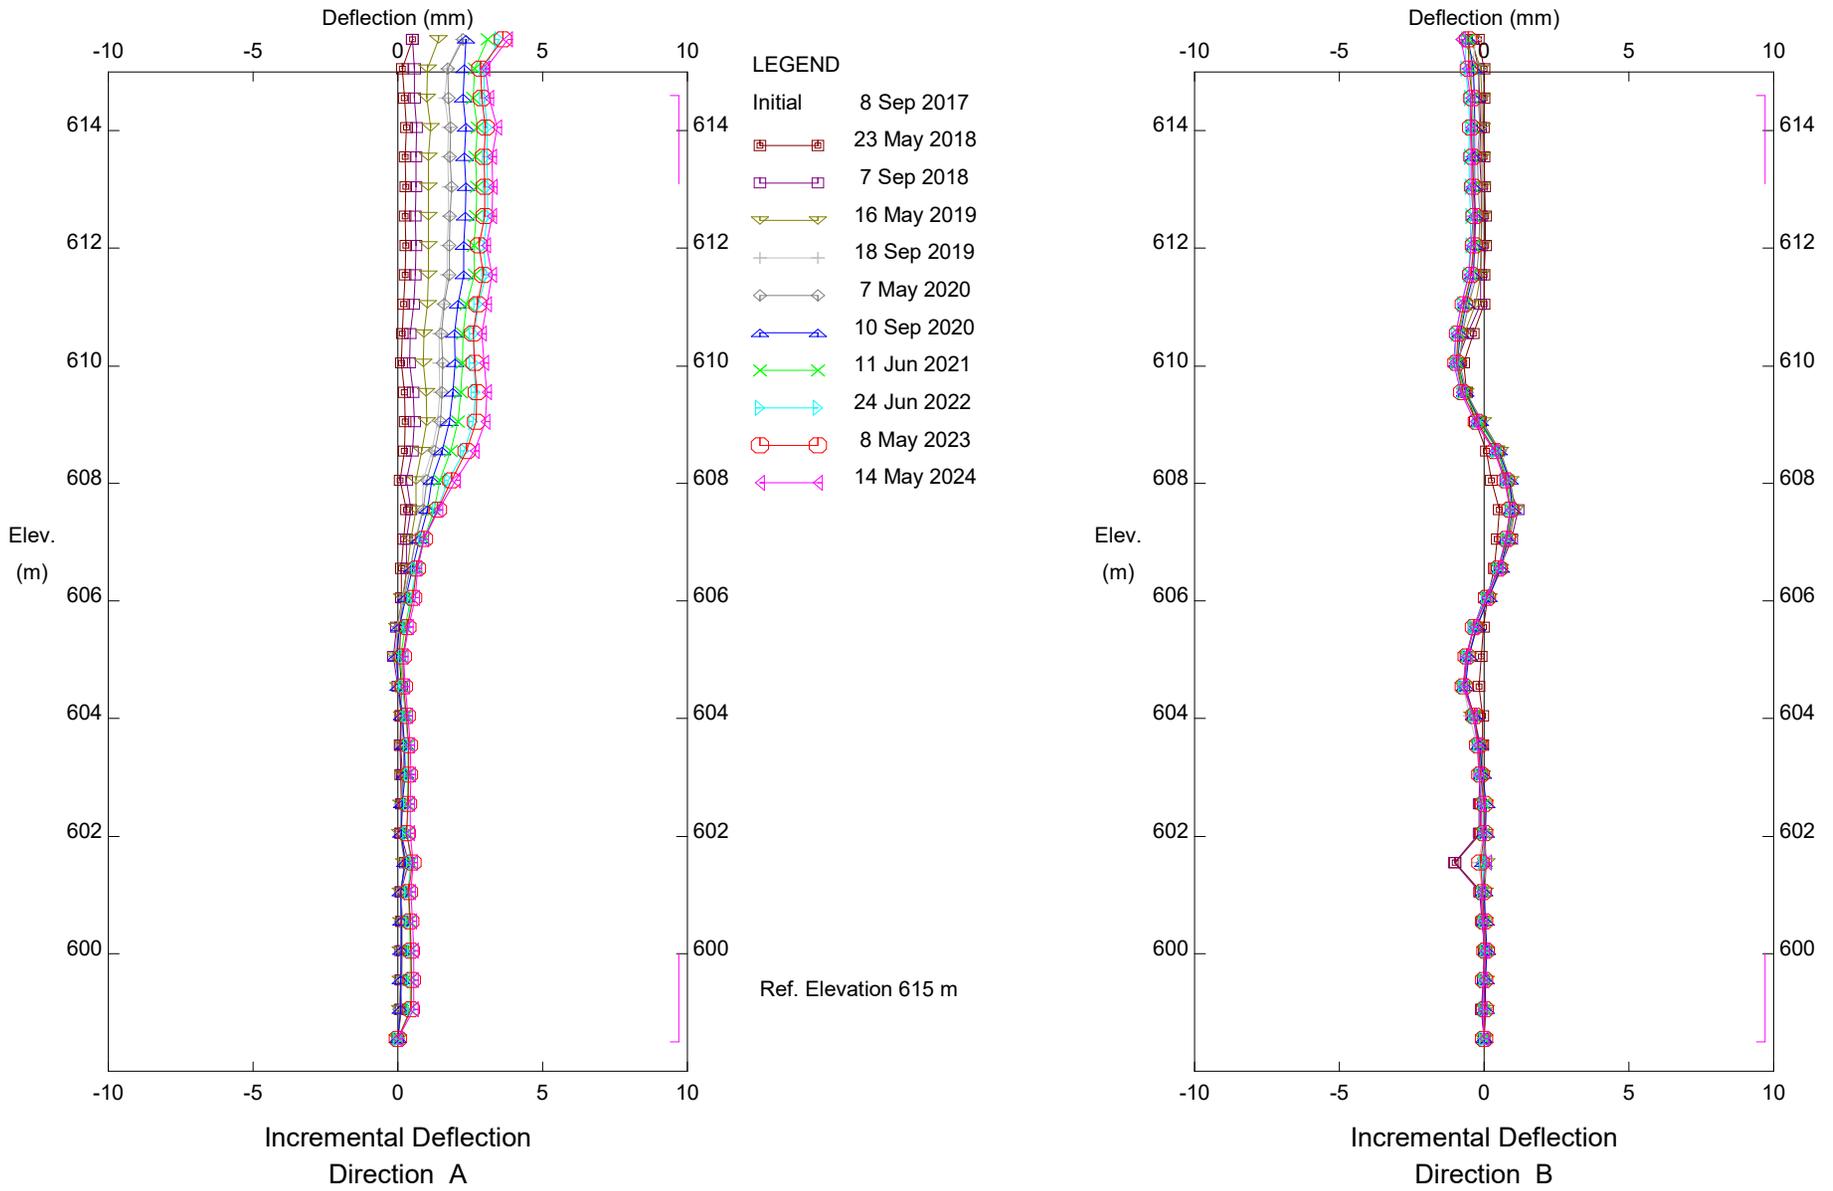
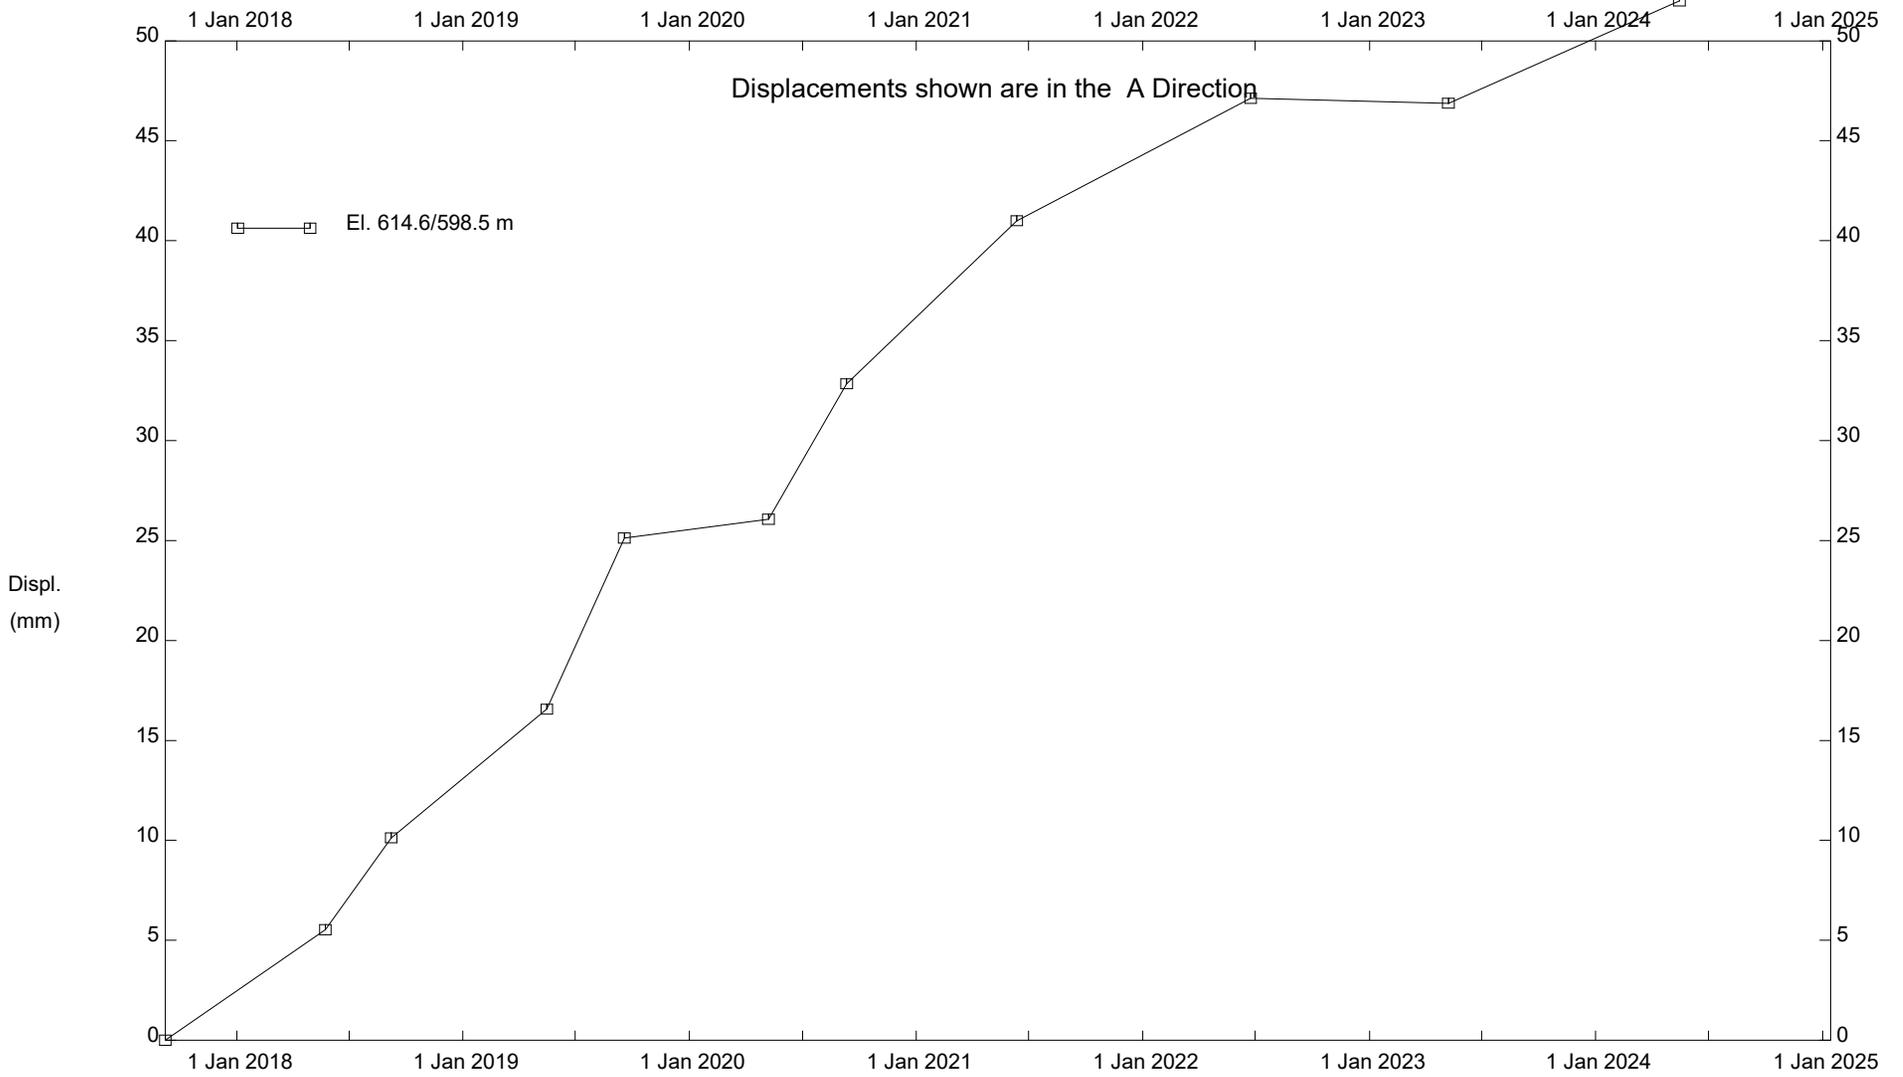
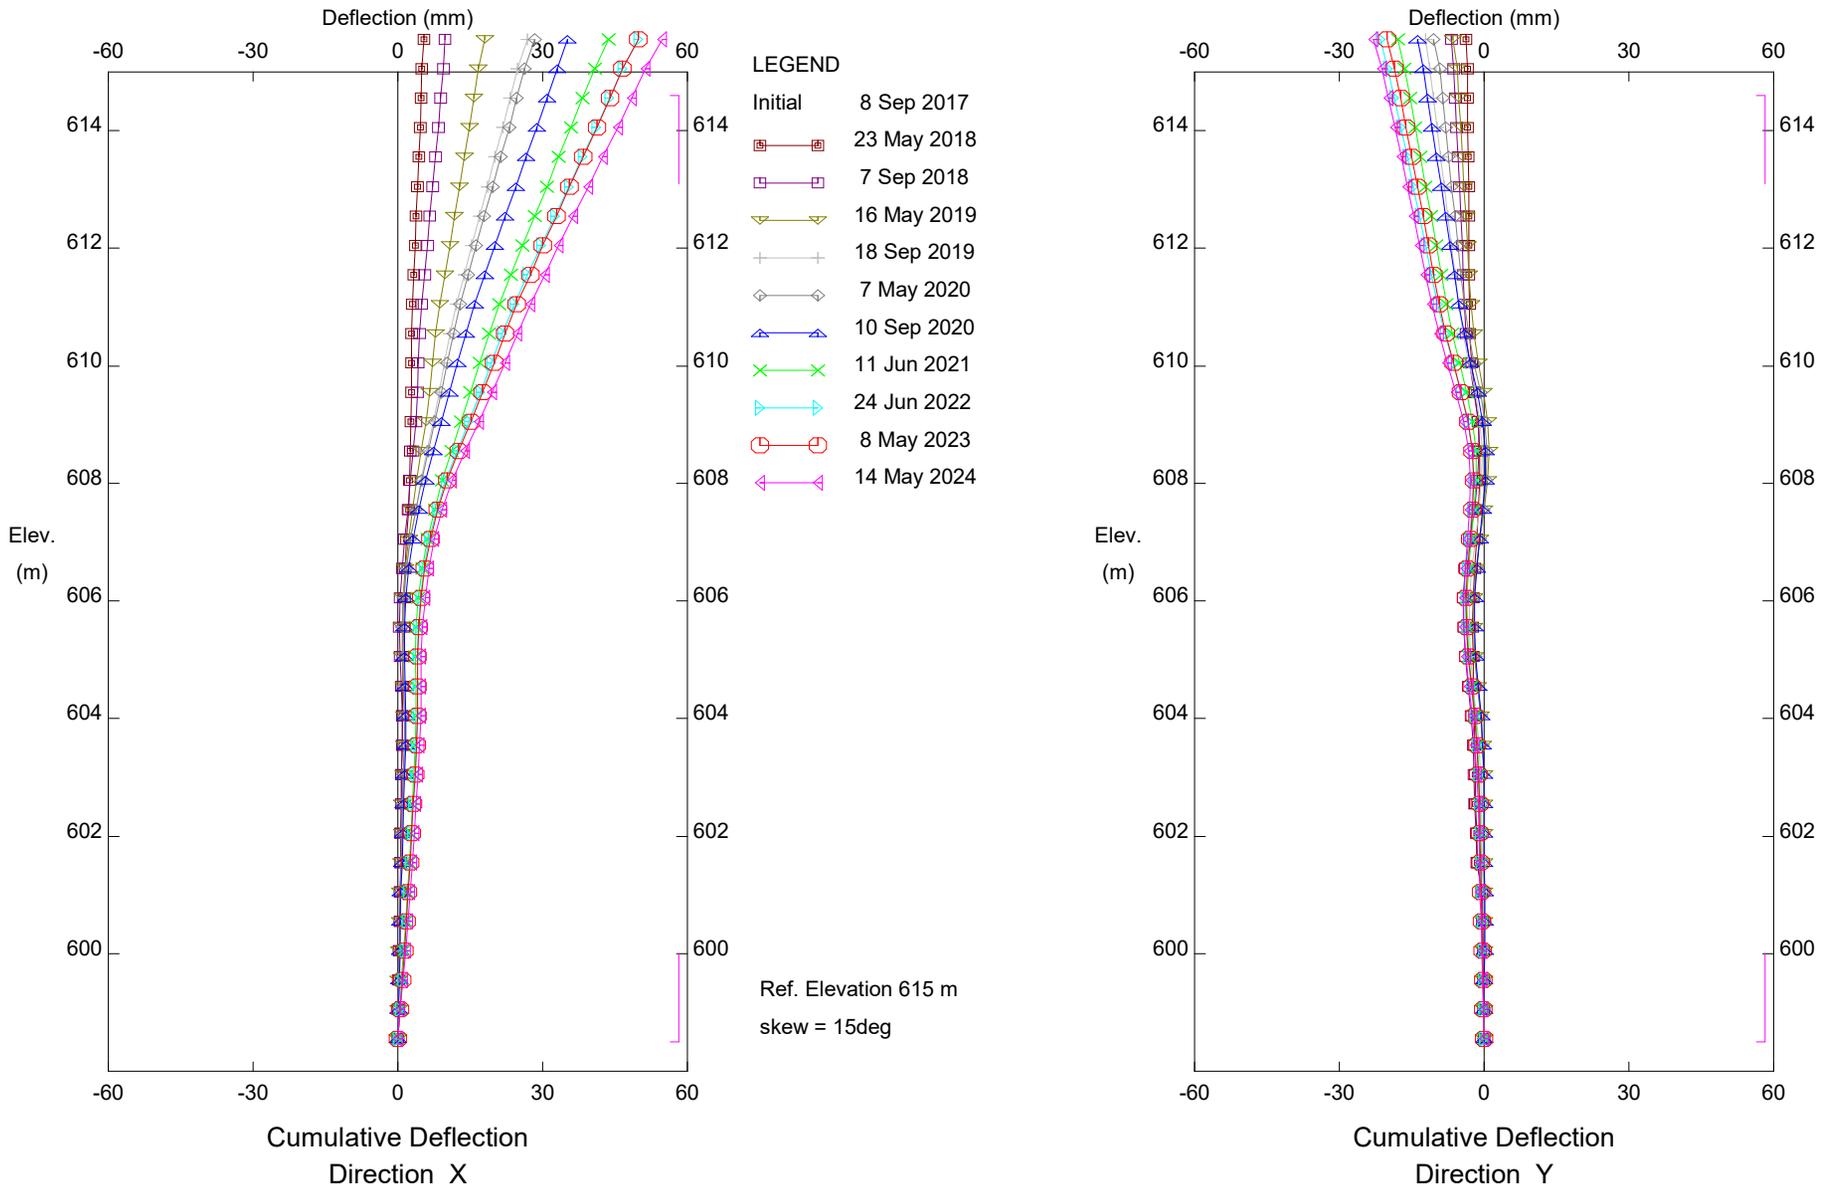
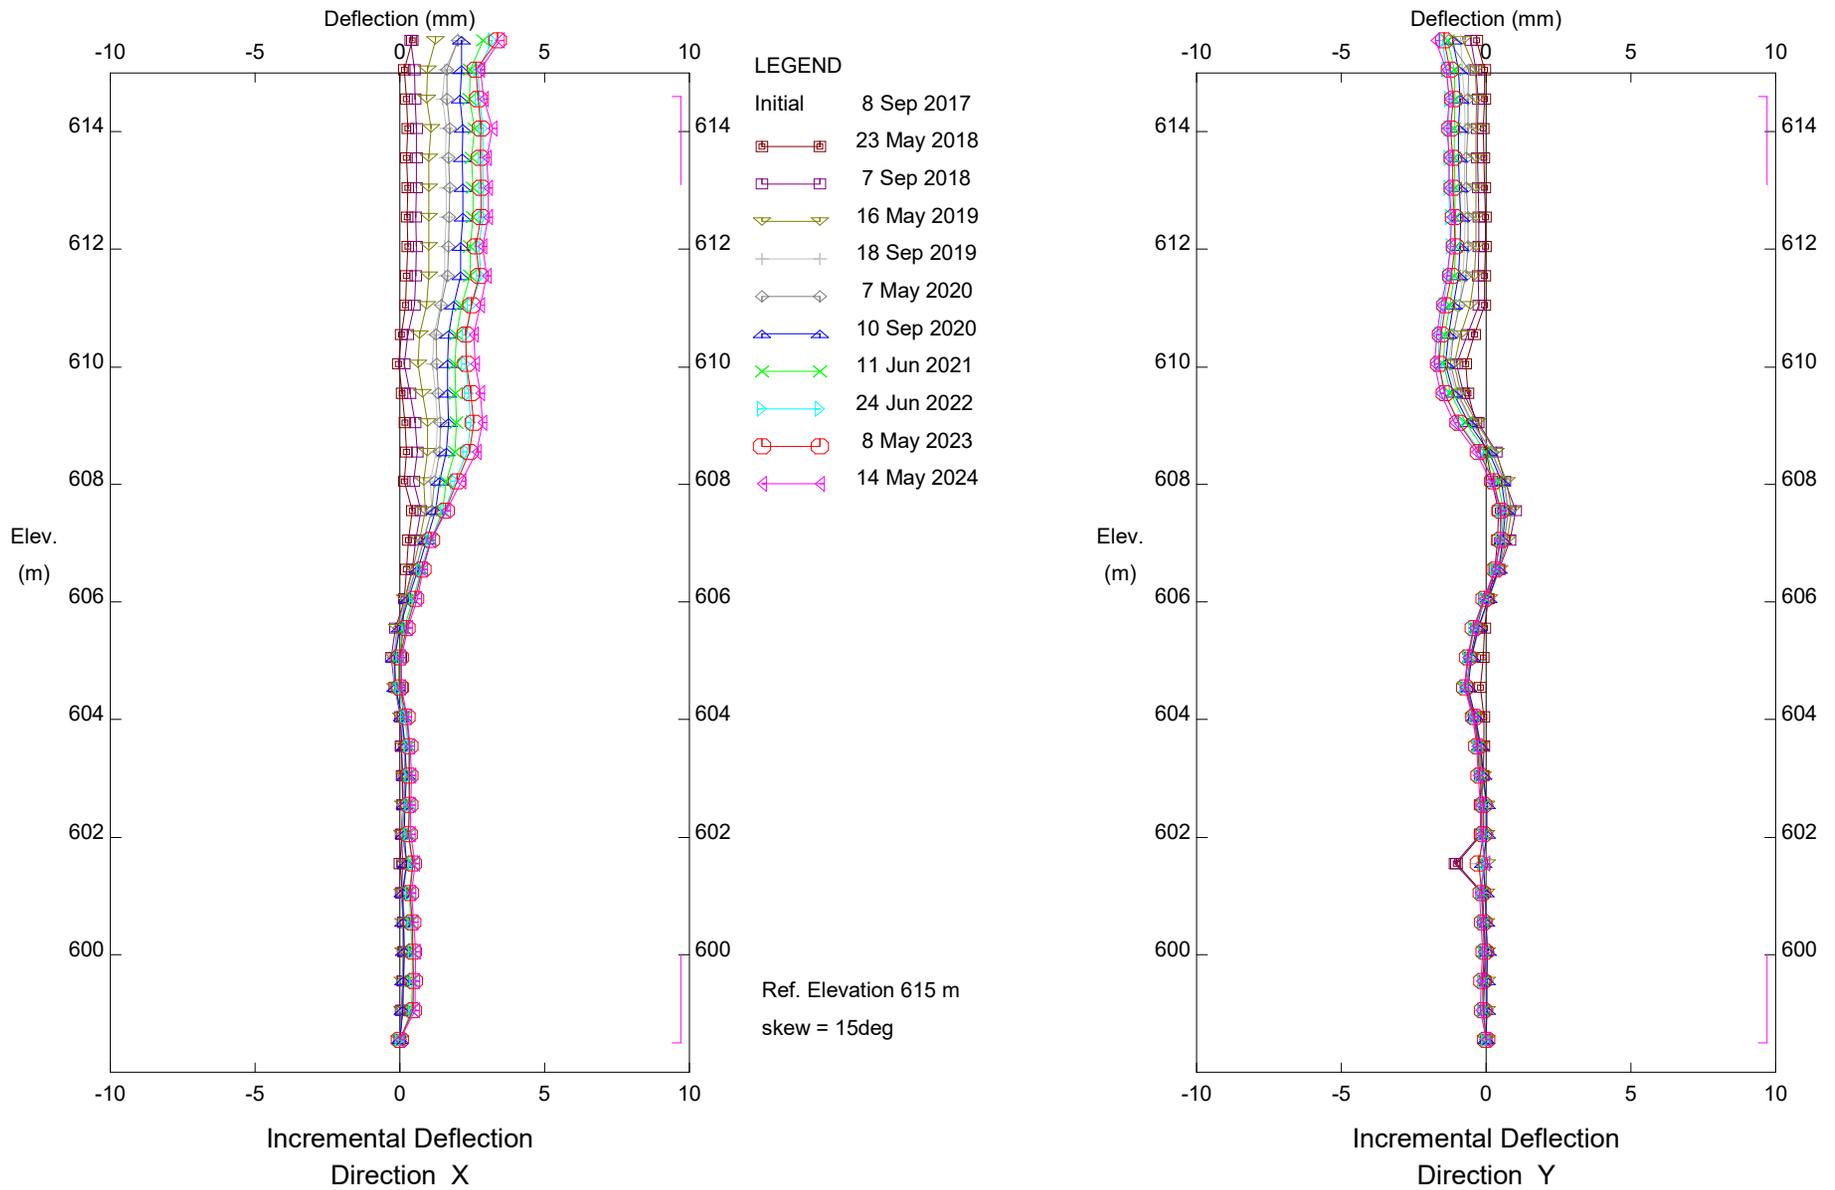
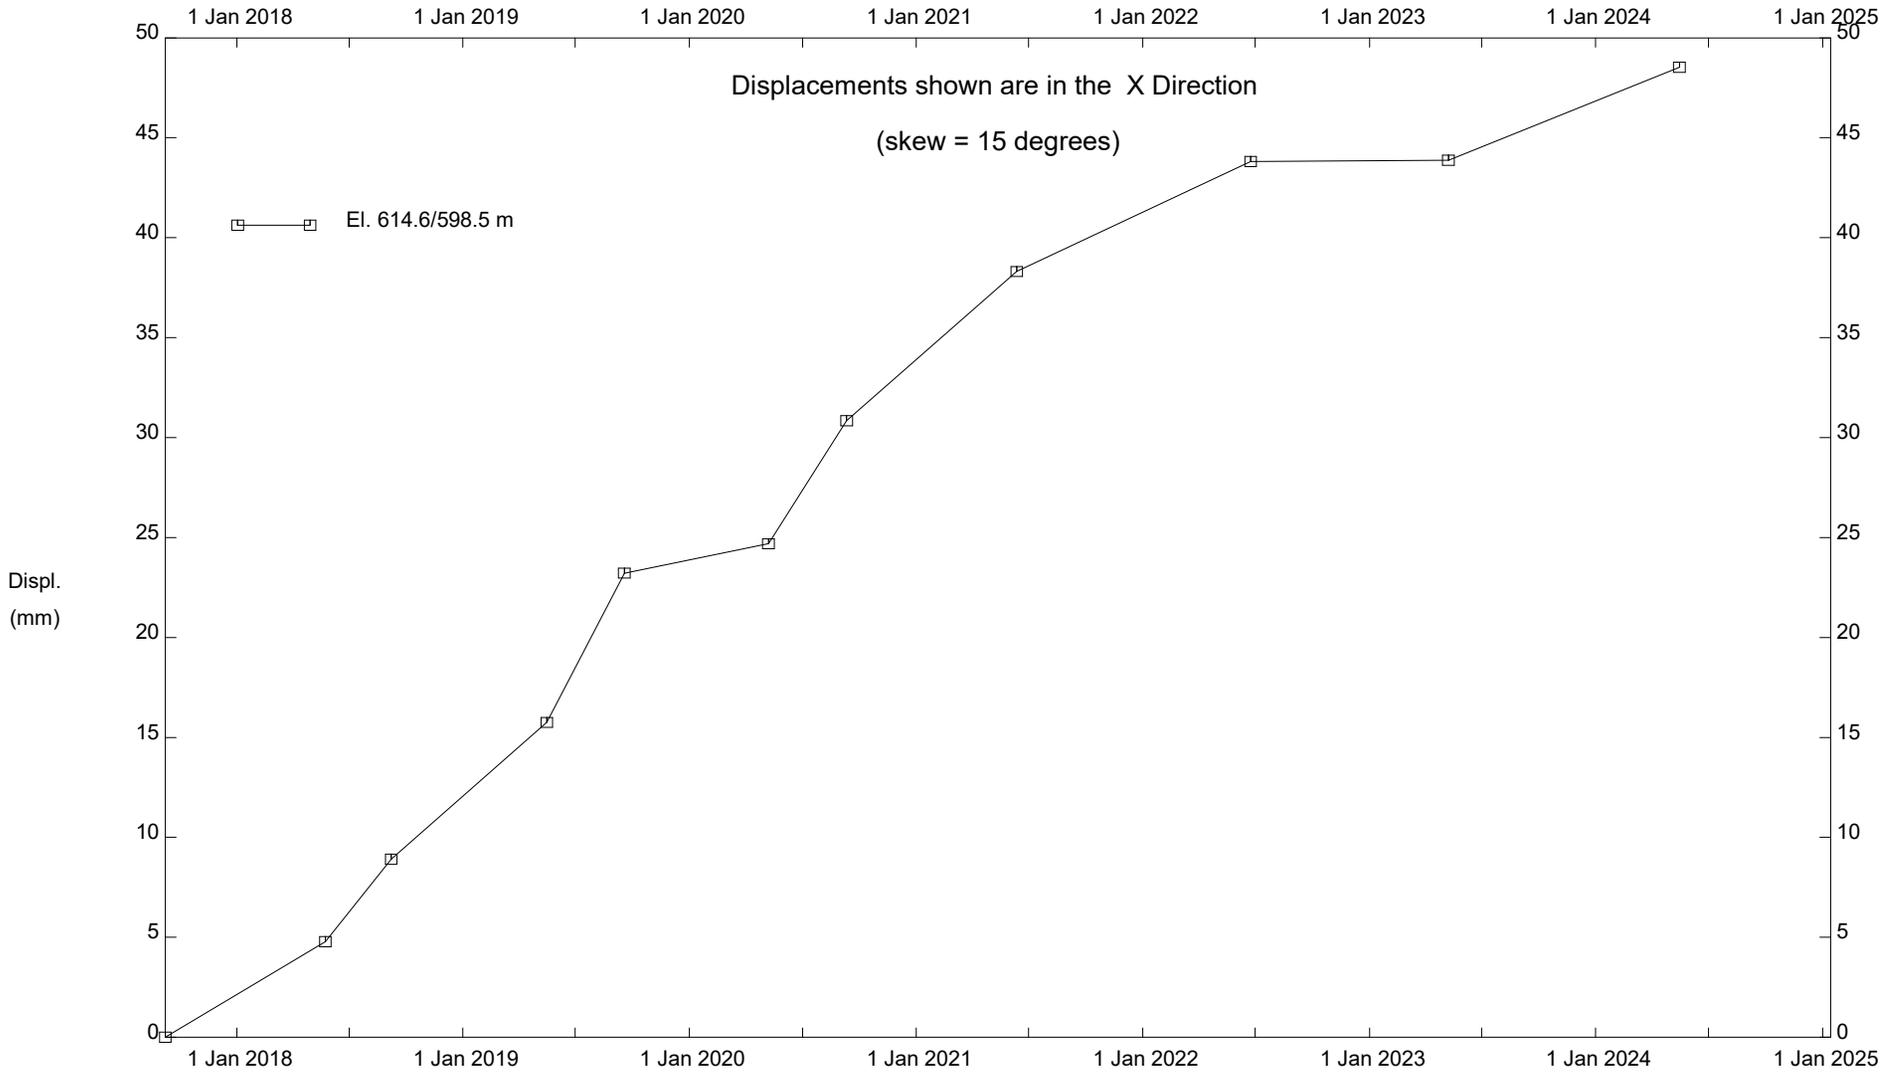
C007; H16:30, Kenilworth Lake Slide, Inclinometer SI15-02

The May 2024 data obtained from SI15-01 and SI15-02 indicates that the top of the original H-pile wall has deflected between approximately 172 mm and 138 mm, respectively, since installation, with most of the displacement occurring before June 2015. The maximum rate of movement recorded in SI15-01 and SI15-02 occurred in June 2015, one month after the H-pile wall was installed and was approximately 655 mm/year and 293 mm/year, respectively. The rate of movement has since decreased and is now less than 5 mm/year.

Instrument re-initialized in September 2017 when the SI equipment was changed.

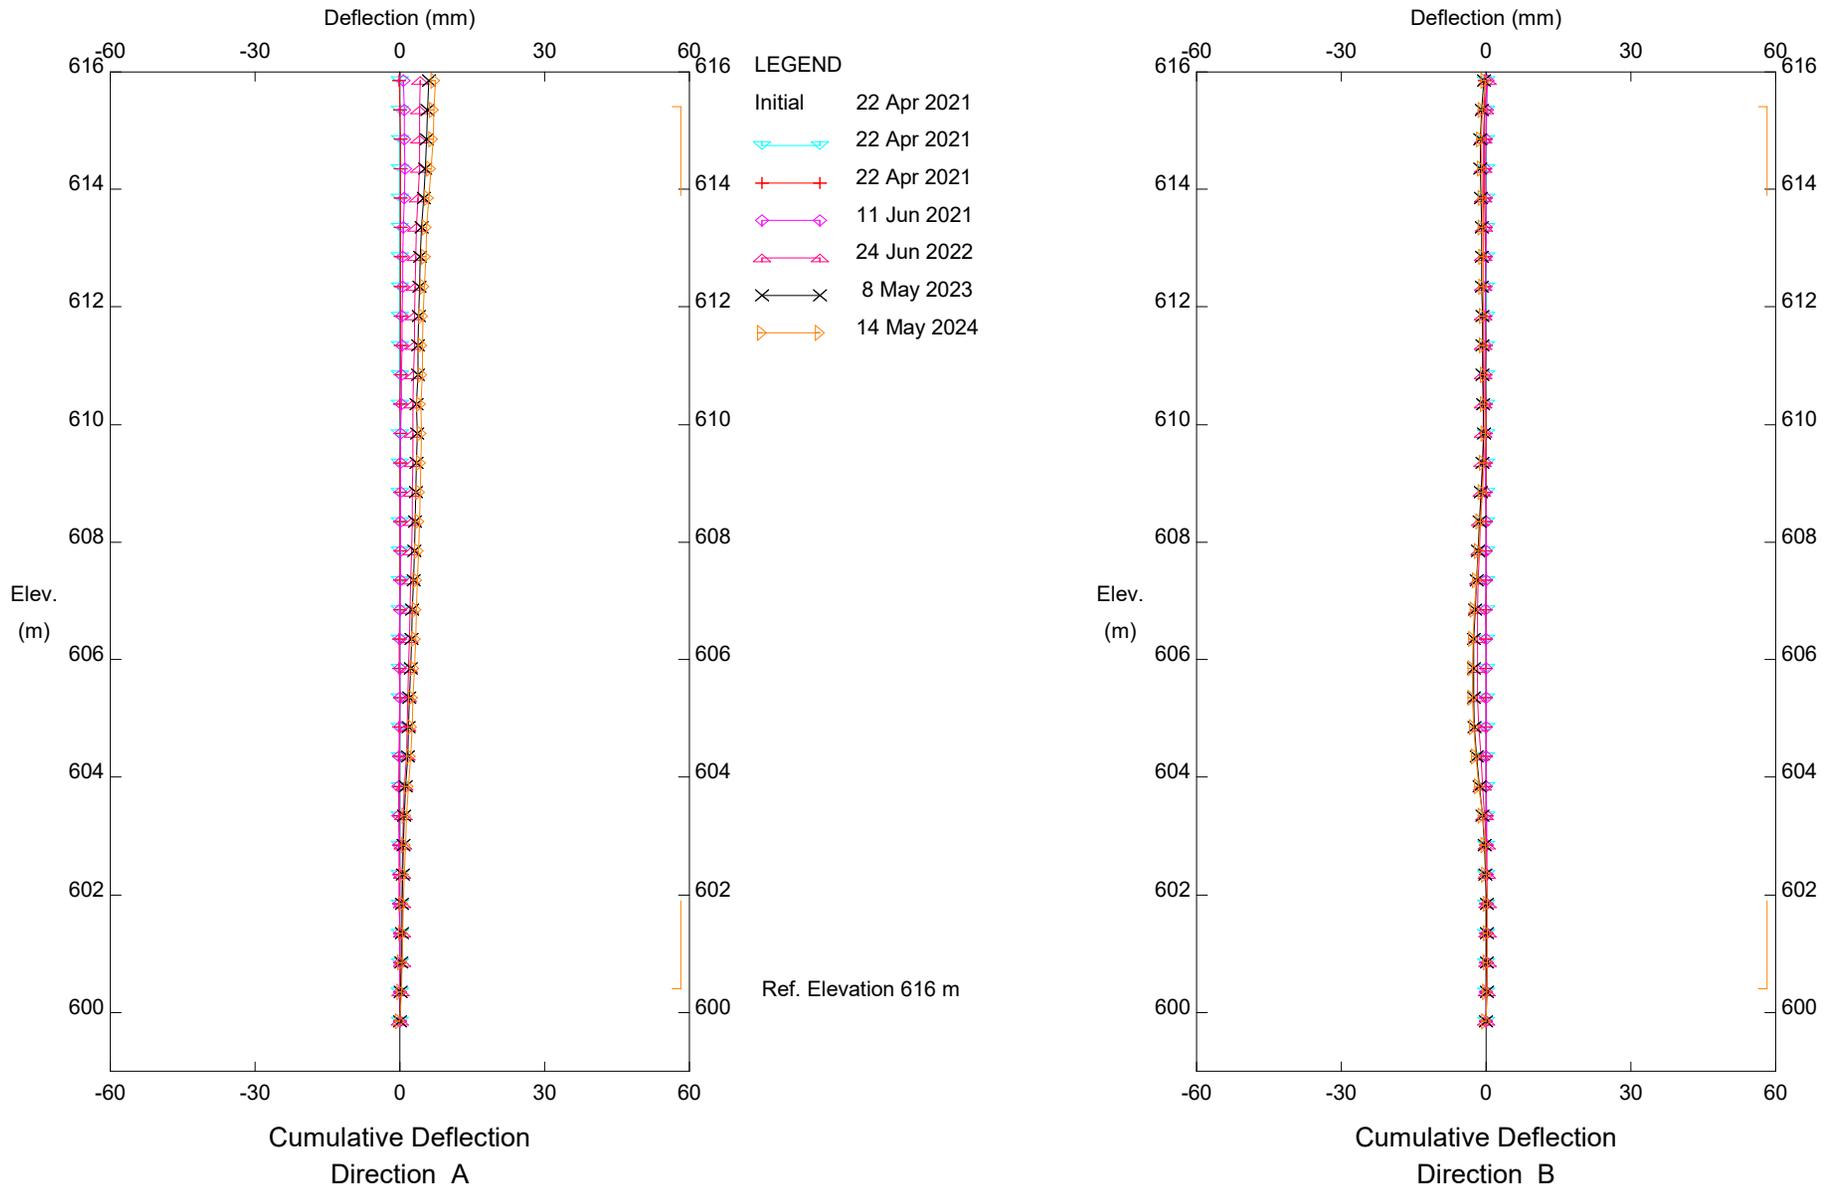
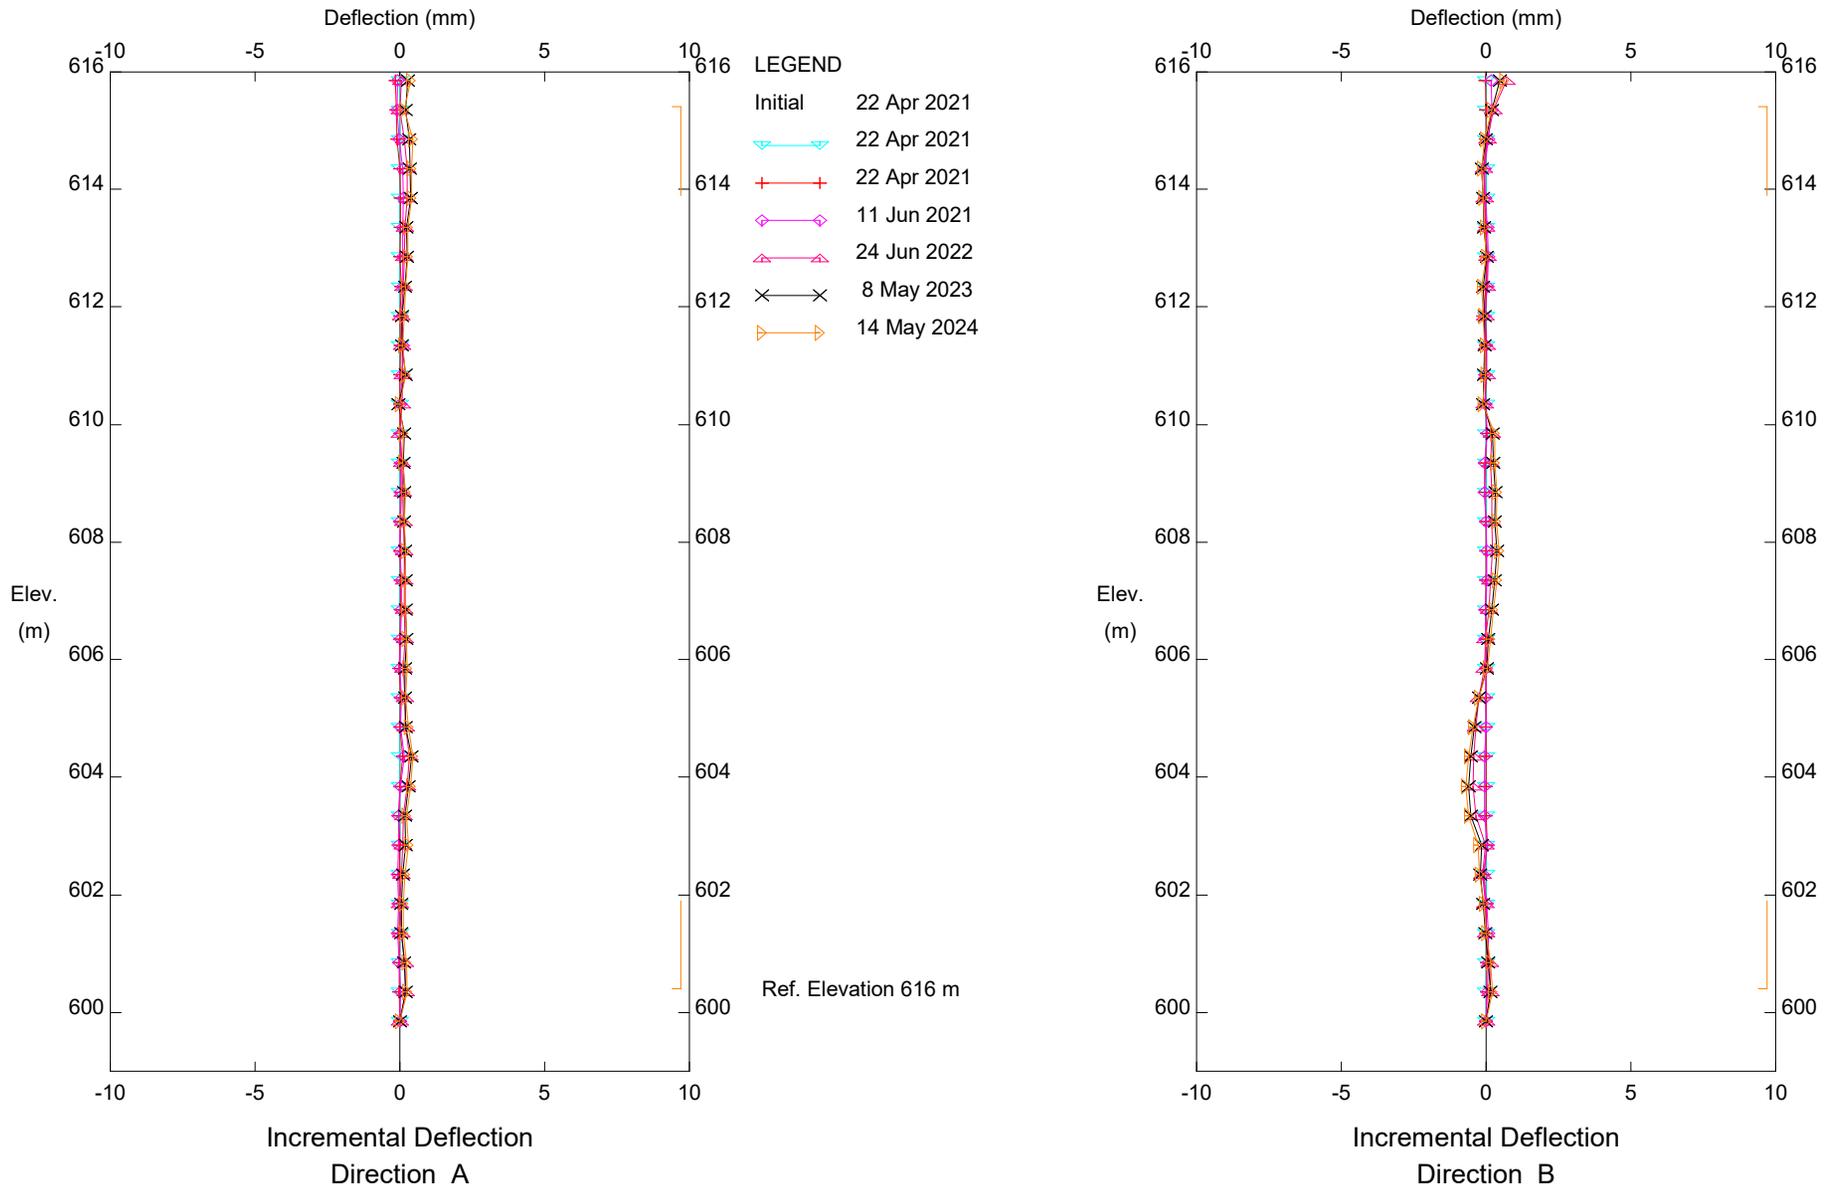
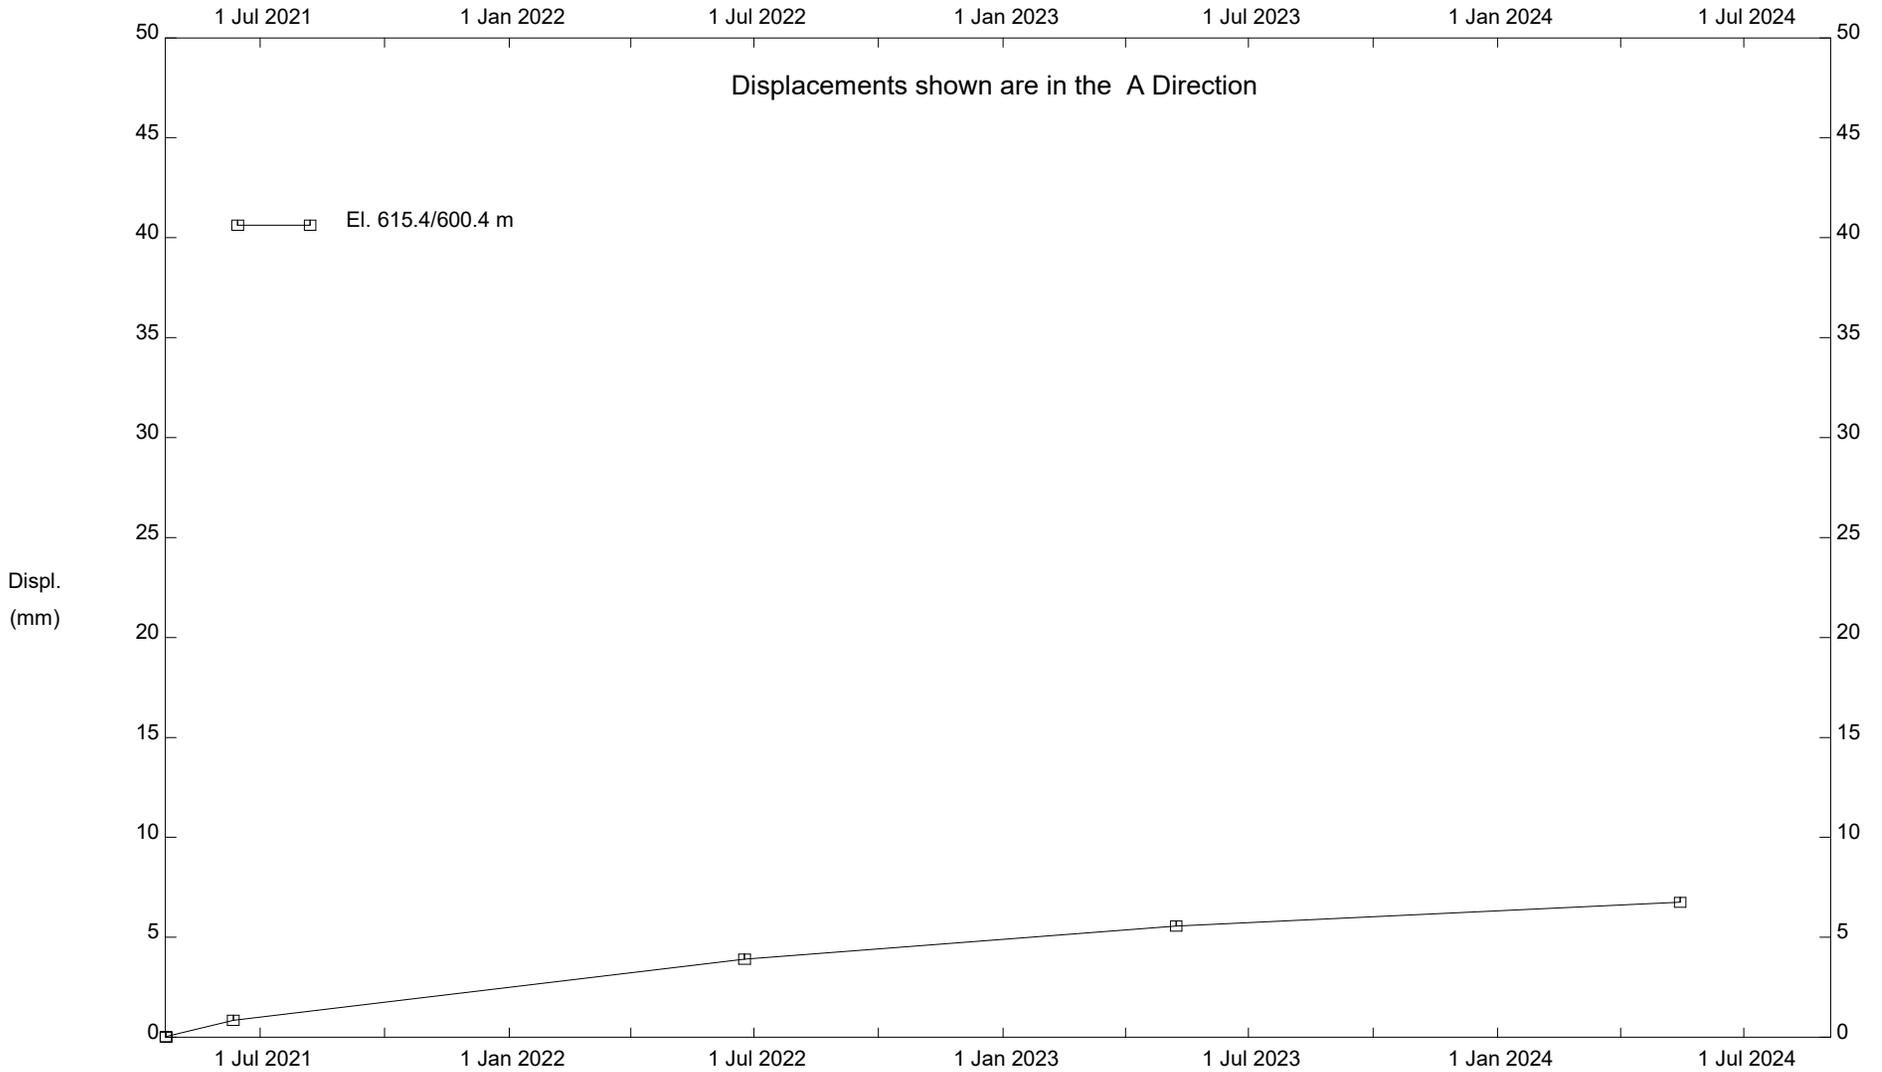
C007; H16:30; Kenilworth Lake Slide, Inclinator SI21-C07-01
 Alberta Transportation

The May 2024 data obtained from SI21-C07-01 through SI21-C07-03 indicates that the top of the west and east H-pile wall extensions have deflected up to approximately 7 mm and 15 mm, respectively, since installation. In the spring of 2021, shortly after construction of the H-pile wall extensions, the maximum rate of movement recorded in these SIs was between approximately 6 mm/year and 40 mm/year. The rate of movement has since decreased and is now less than approximately 3 mm/year. KCB anticipated that the rate of movement shortly after installation would be highest and would decrease as the H-pile wall picked up load stabilizing the sliding mass.
