July 15, 2024

Alberta Transportation and Economic Corridors
4th Floor, Provincial Building
4920 51 Street
Red Deer, Alberta
T4N 6K8

**CON0022160 Central Region GRMP Instrumentation Monitoring
Site C007; H16:30, km 23.890 Kenilworth Lake Slide
Section C – 2024 Spring Readings**

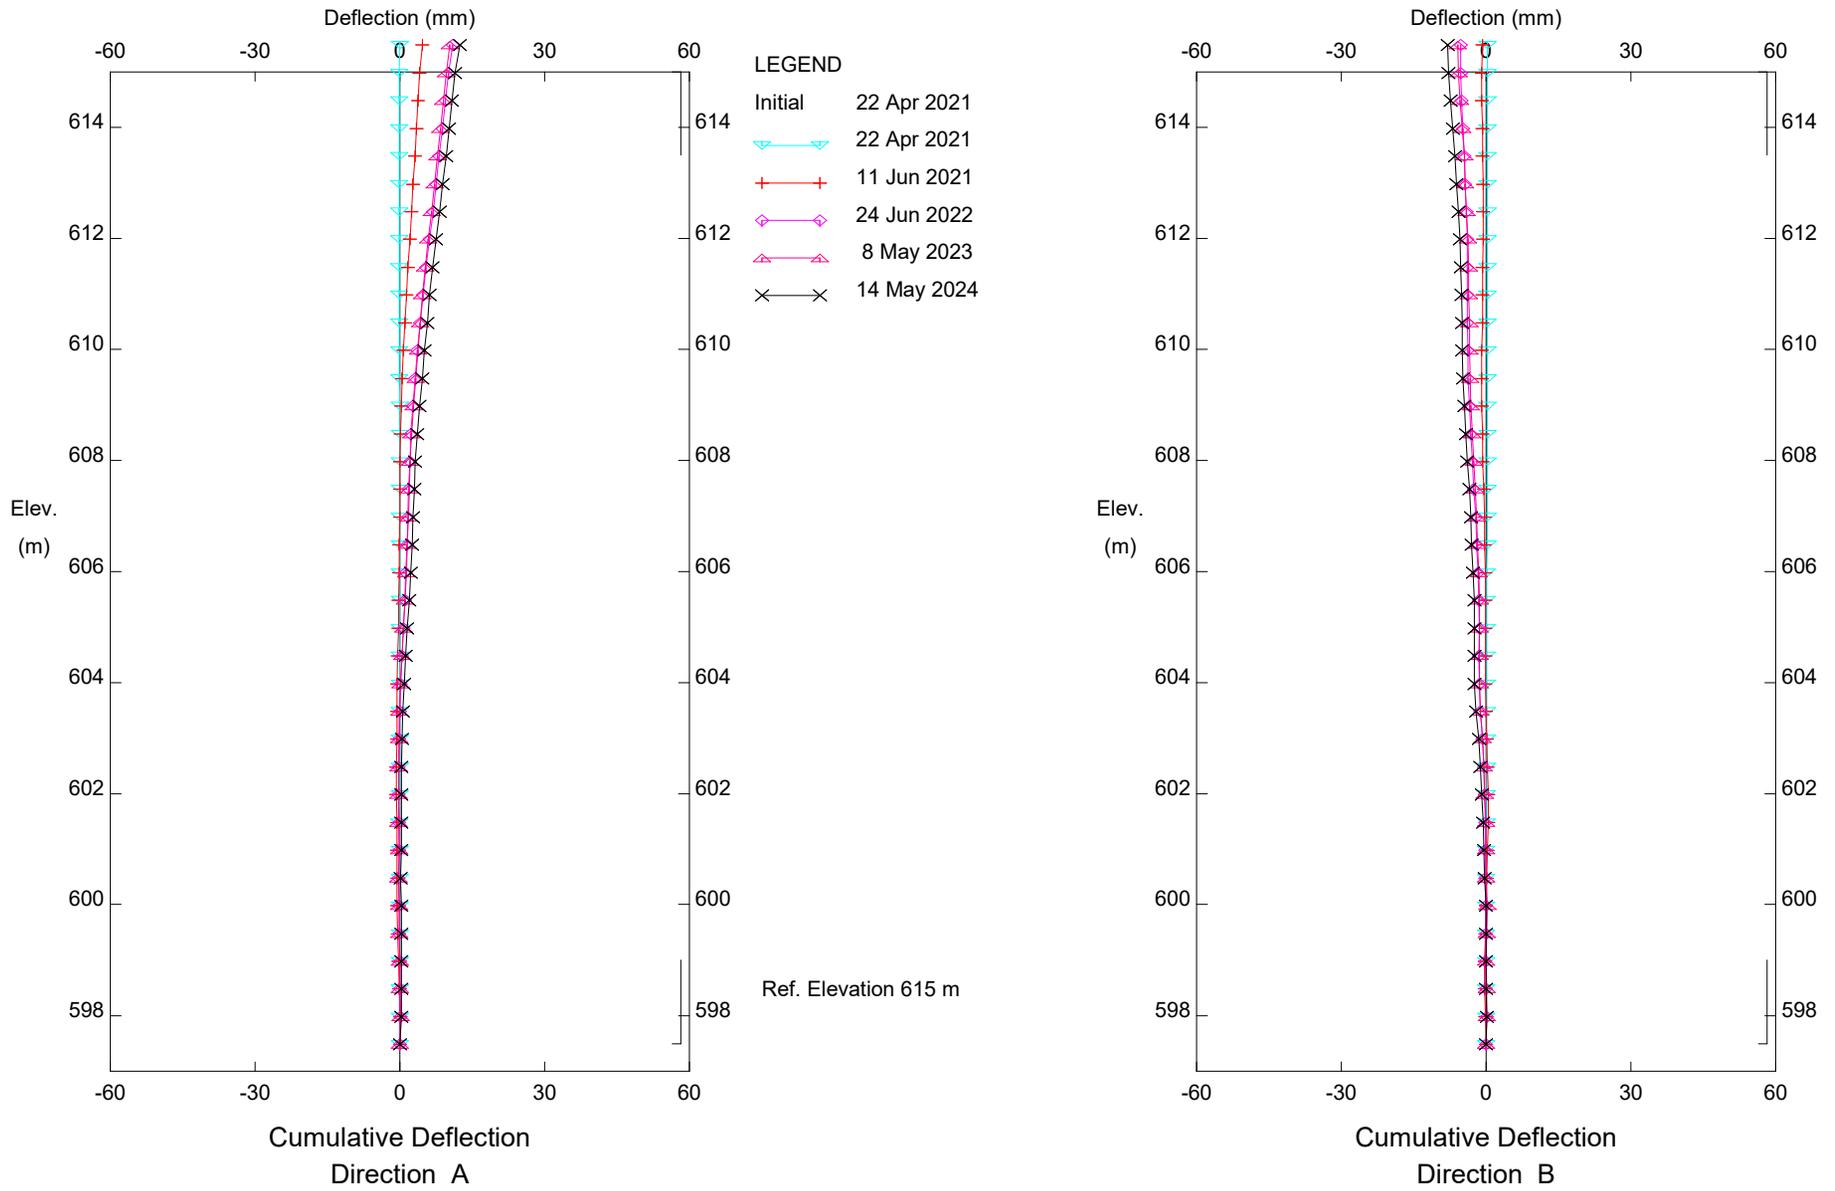
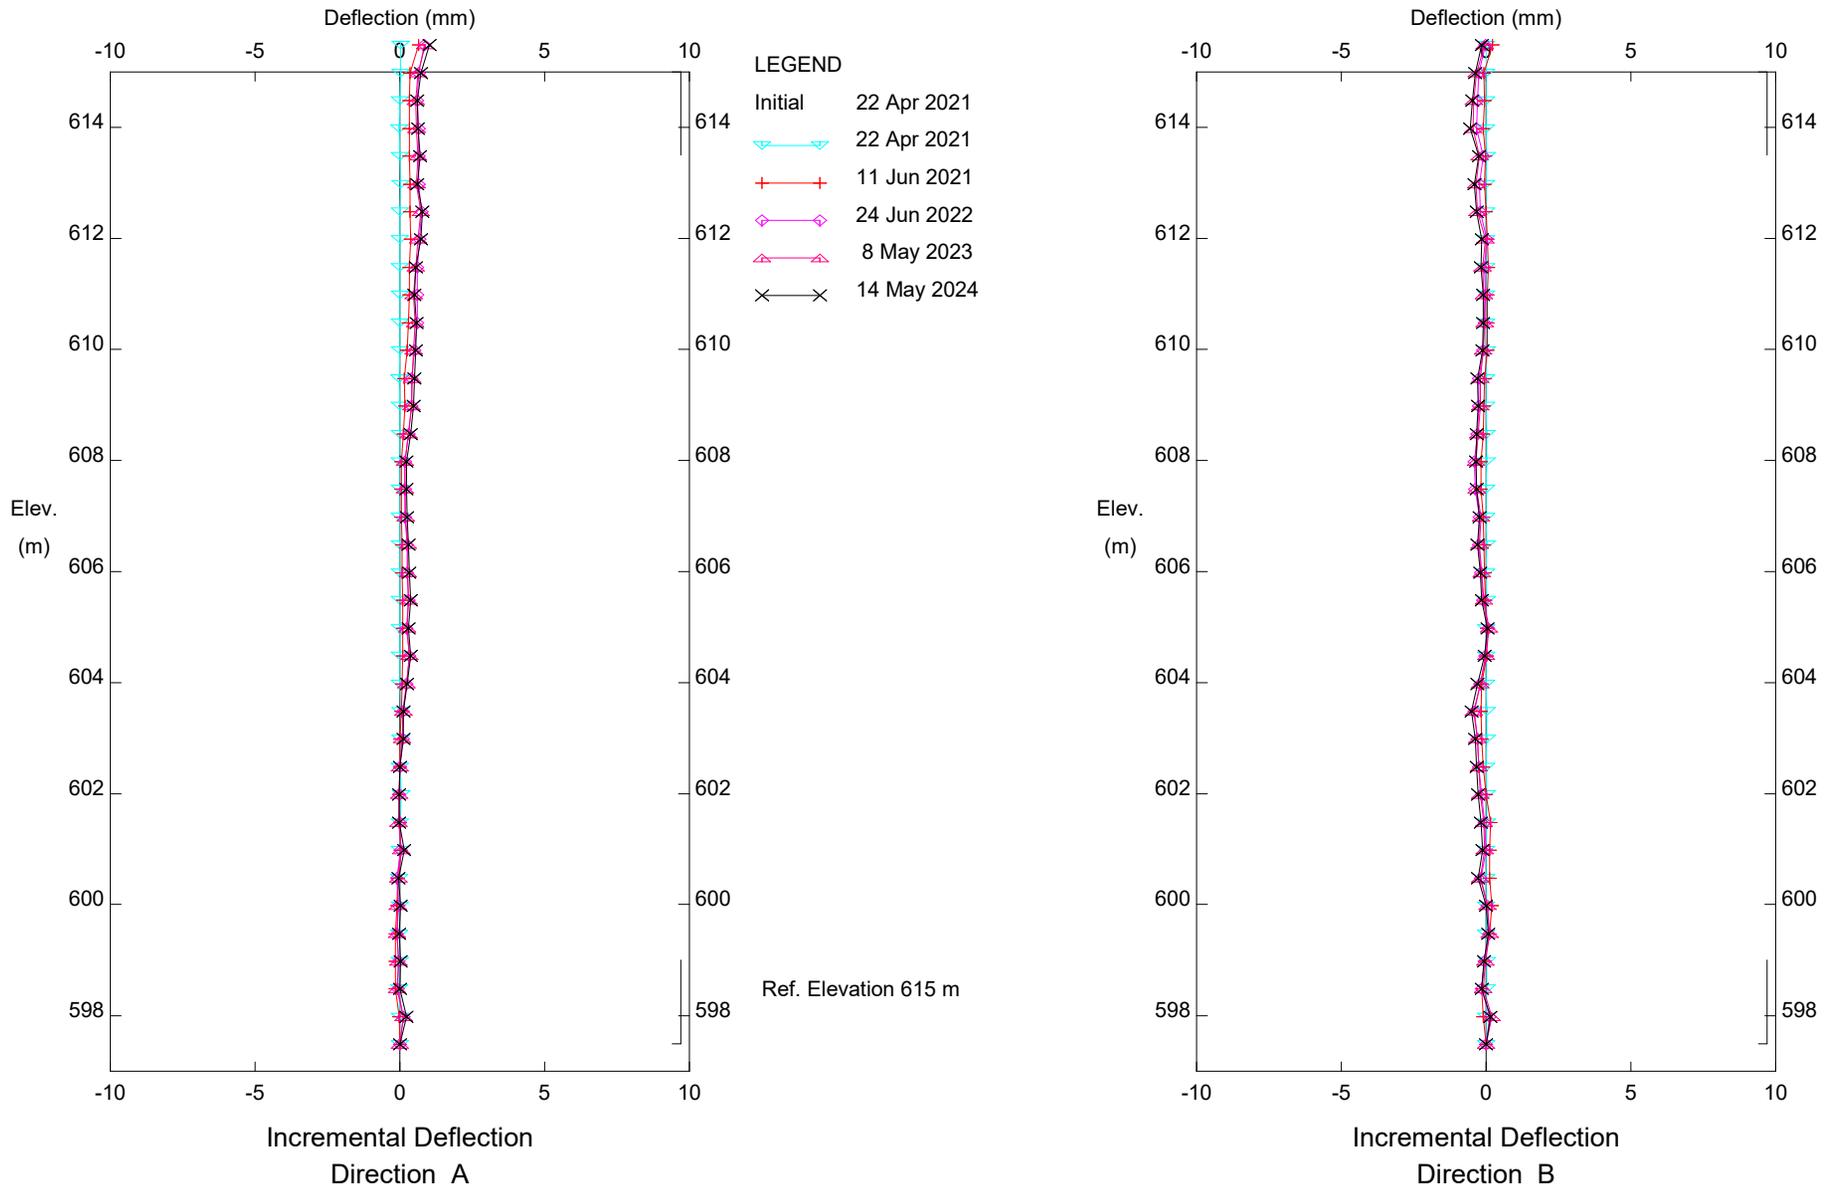
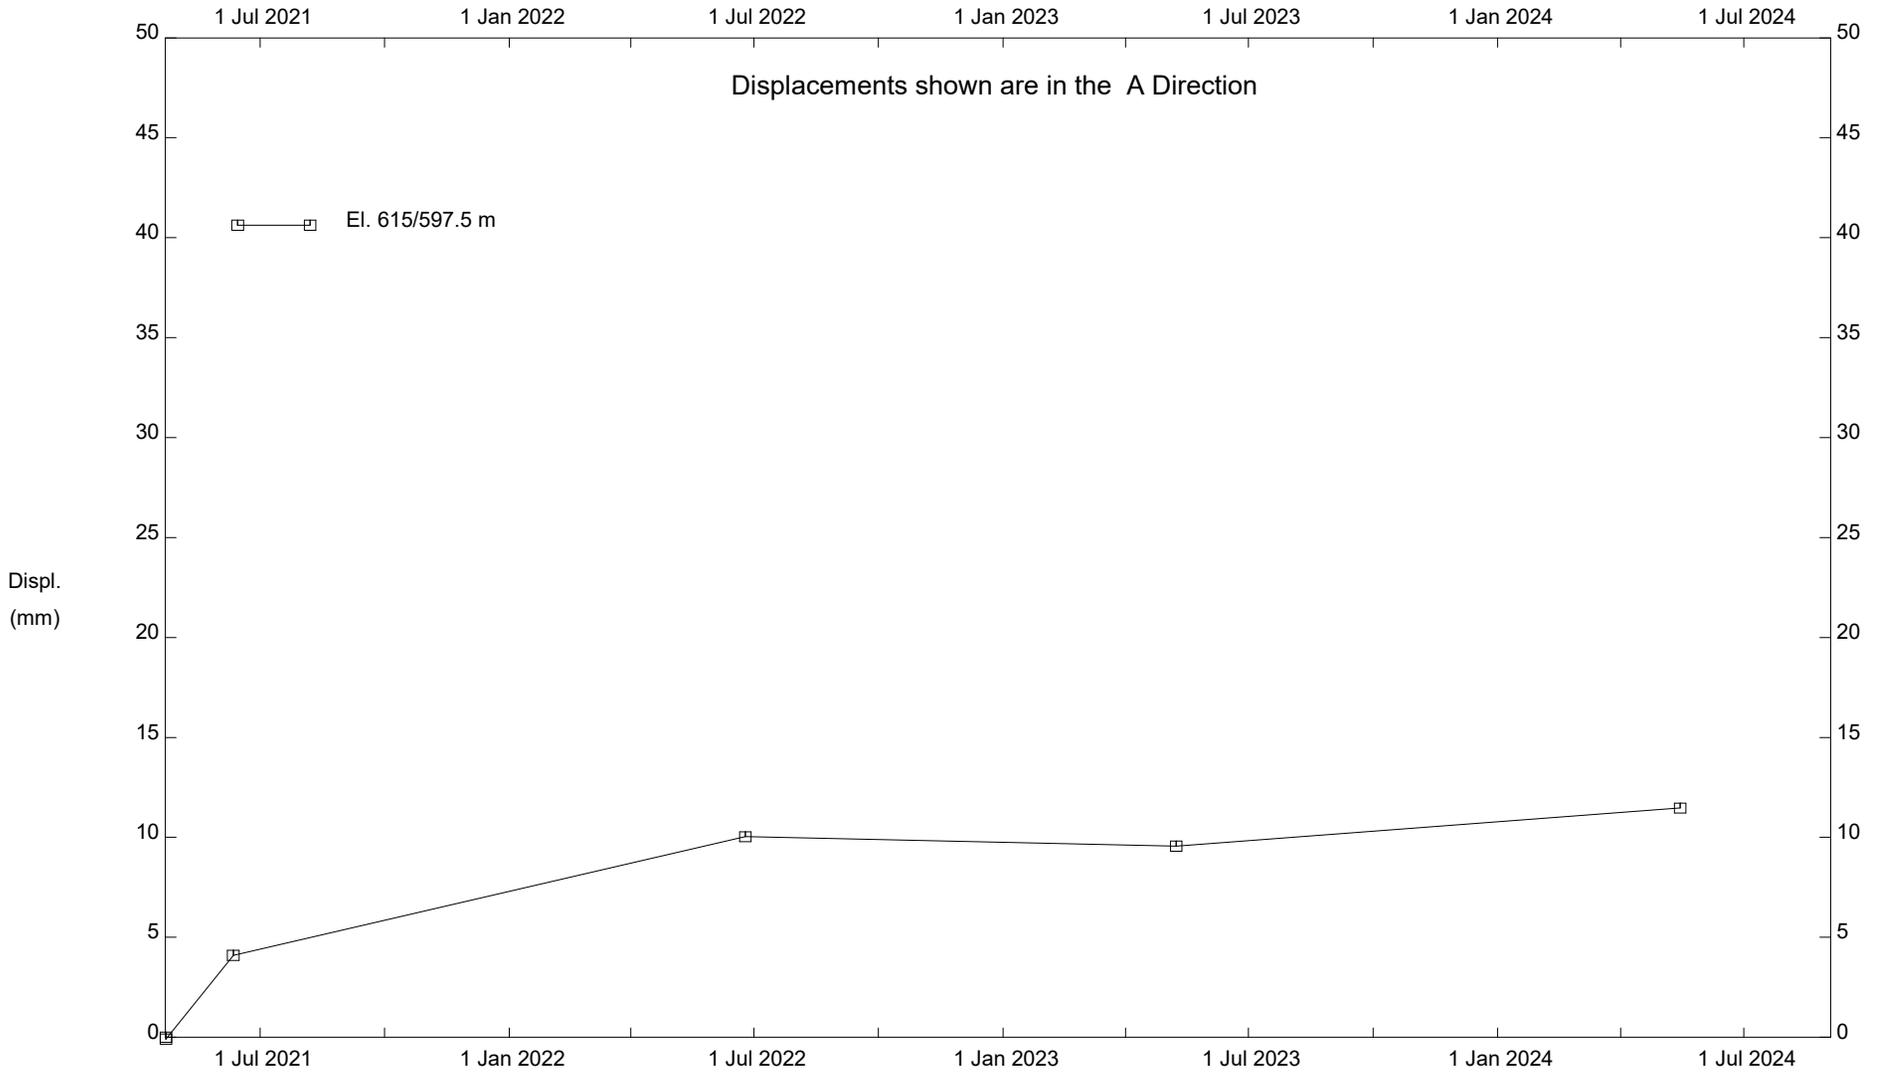
C007; H16:30; Kenilworth Lake Slide, Inclinometer SI21-C07-02
 Alberta Transportation

The May 2024 data obtained from SI21-C07-01 through SI21-C07-03 indicates that the top of the west and east H-pile wall extensions have deflected up to approximately 7 mm and 15 mm, respectively, since installation. In the spring of 2021, shortly after construction of the H-pile wall extensions, the maximum rate of movement recorded in these SIs was between approximately 6 mm/year and 40 mm/year. The rate of movement has since decreased and is now less than approximately 3 mm/year. KCB anticipated that the rate of movement shortly after installation would be highest and would decrease as the H-pile wall picked up load stabilizing the sliding mass.

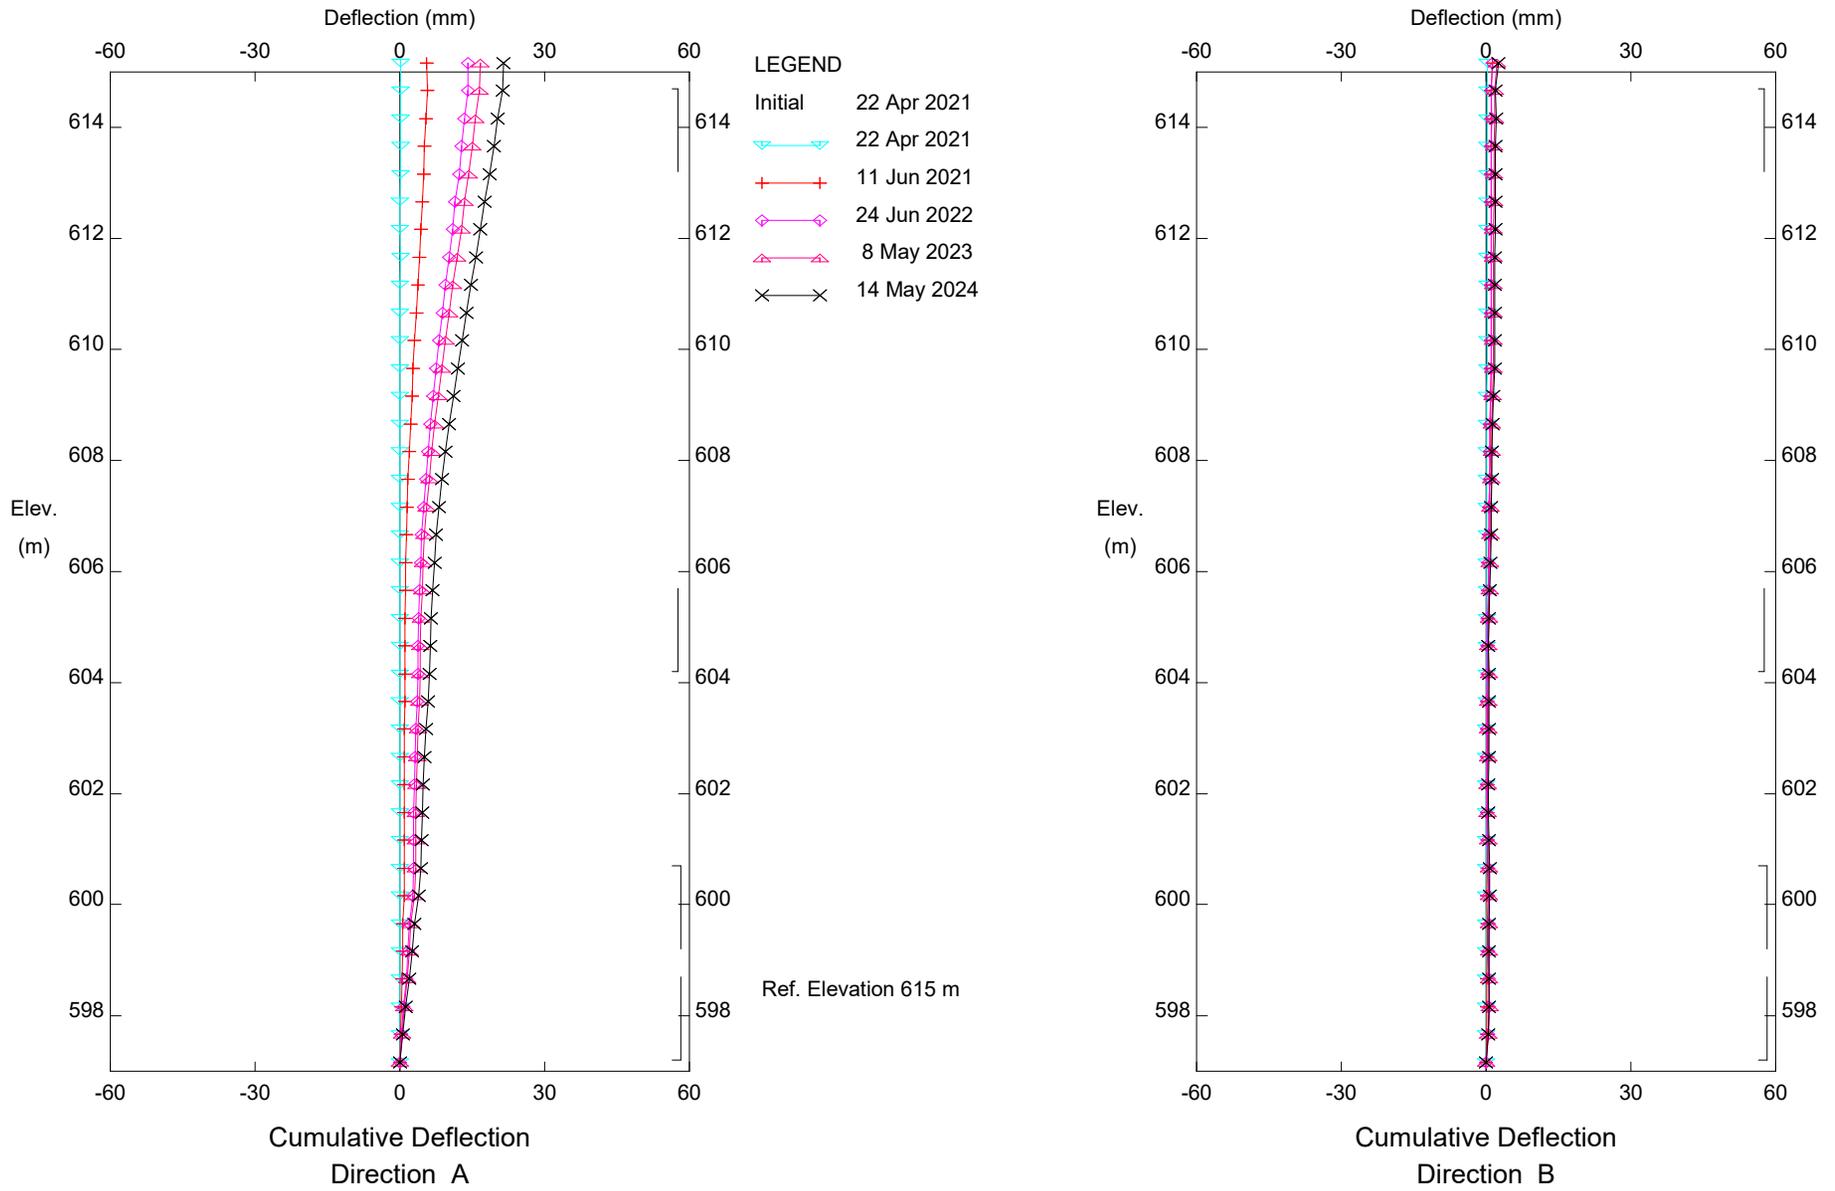
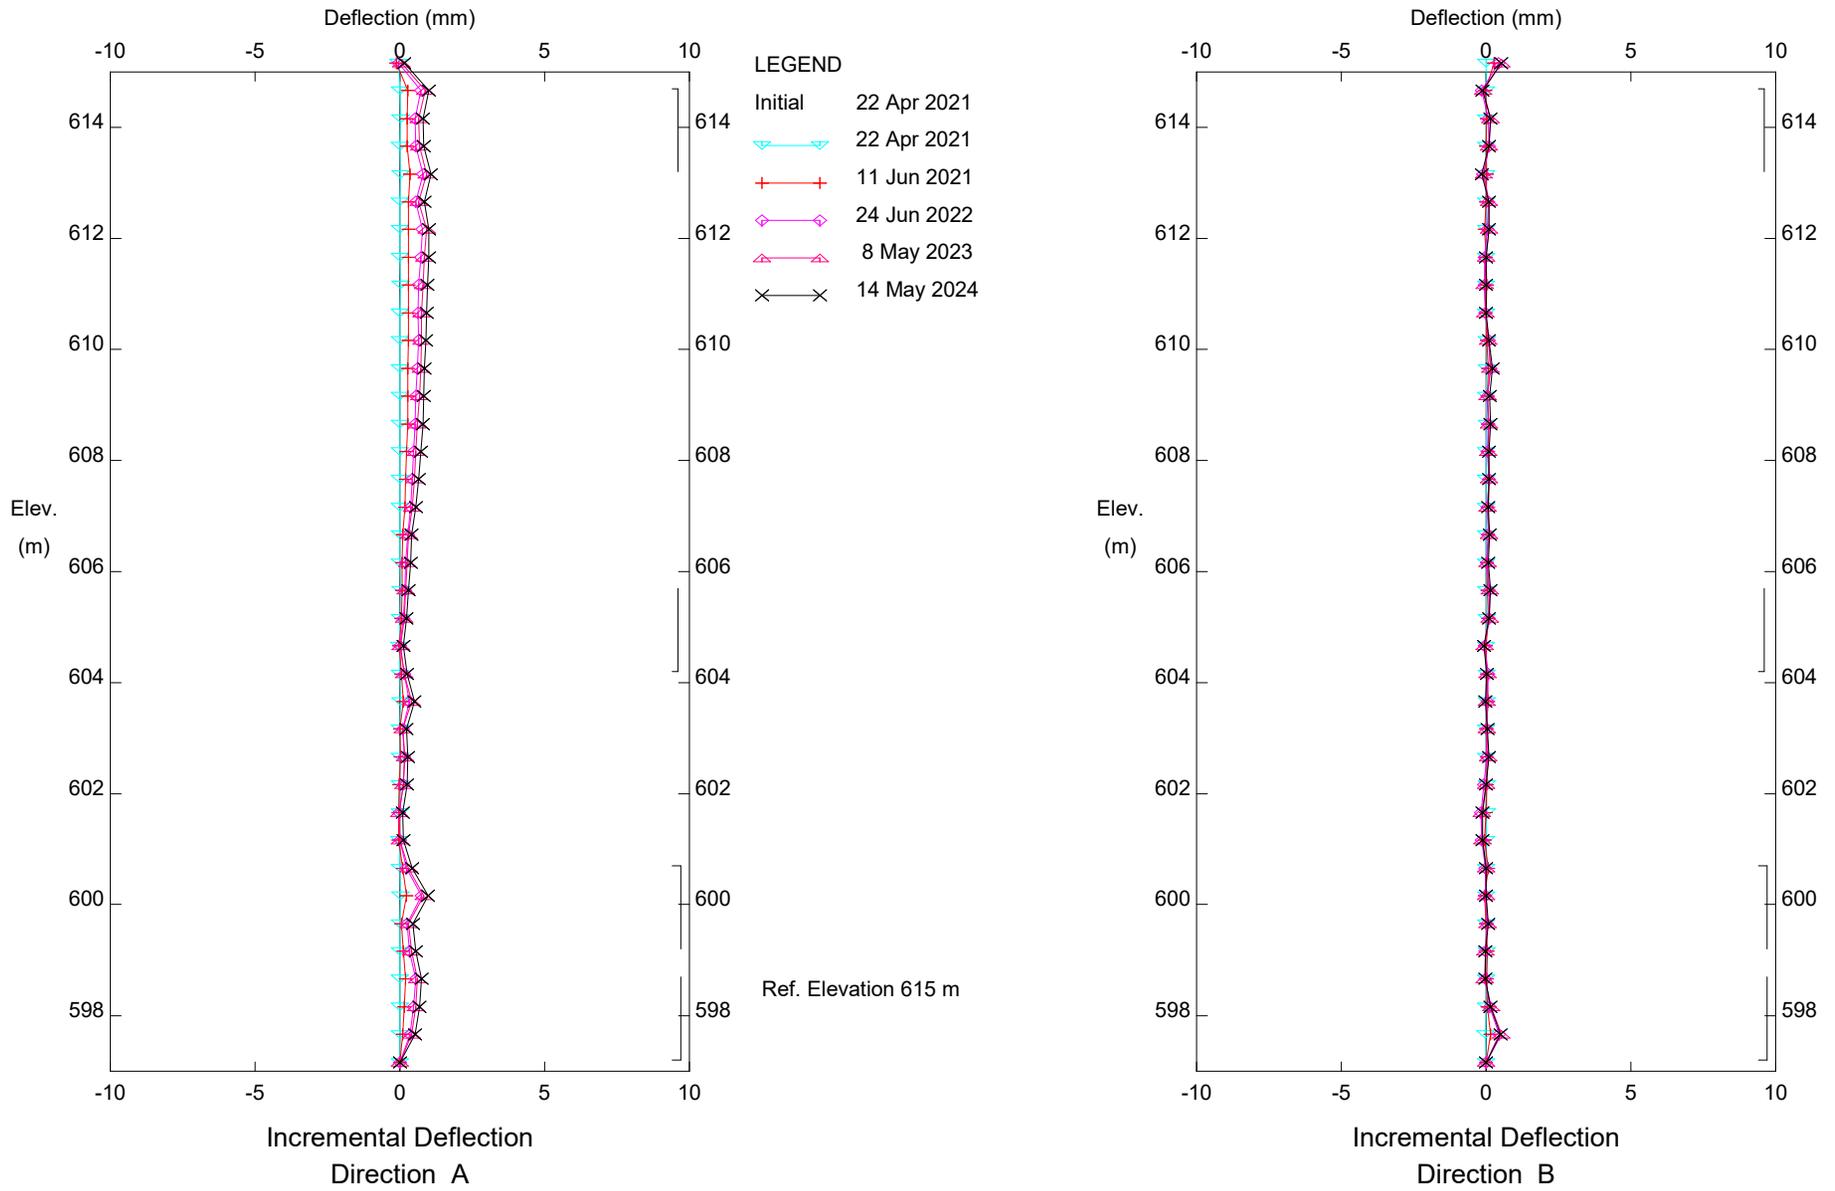
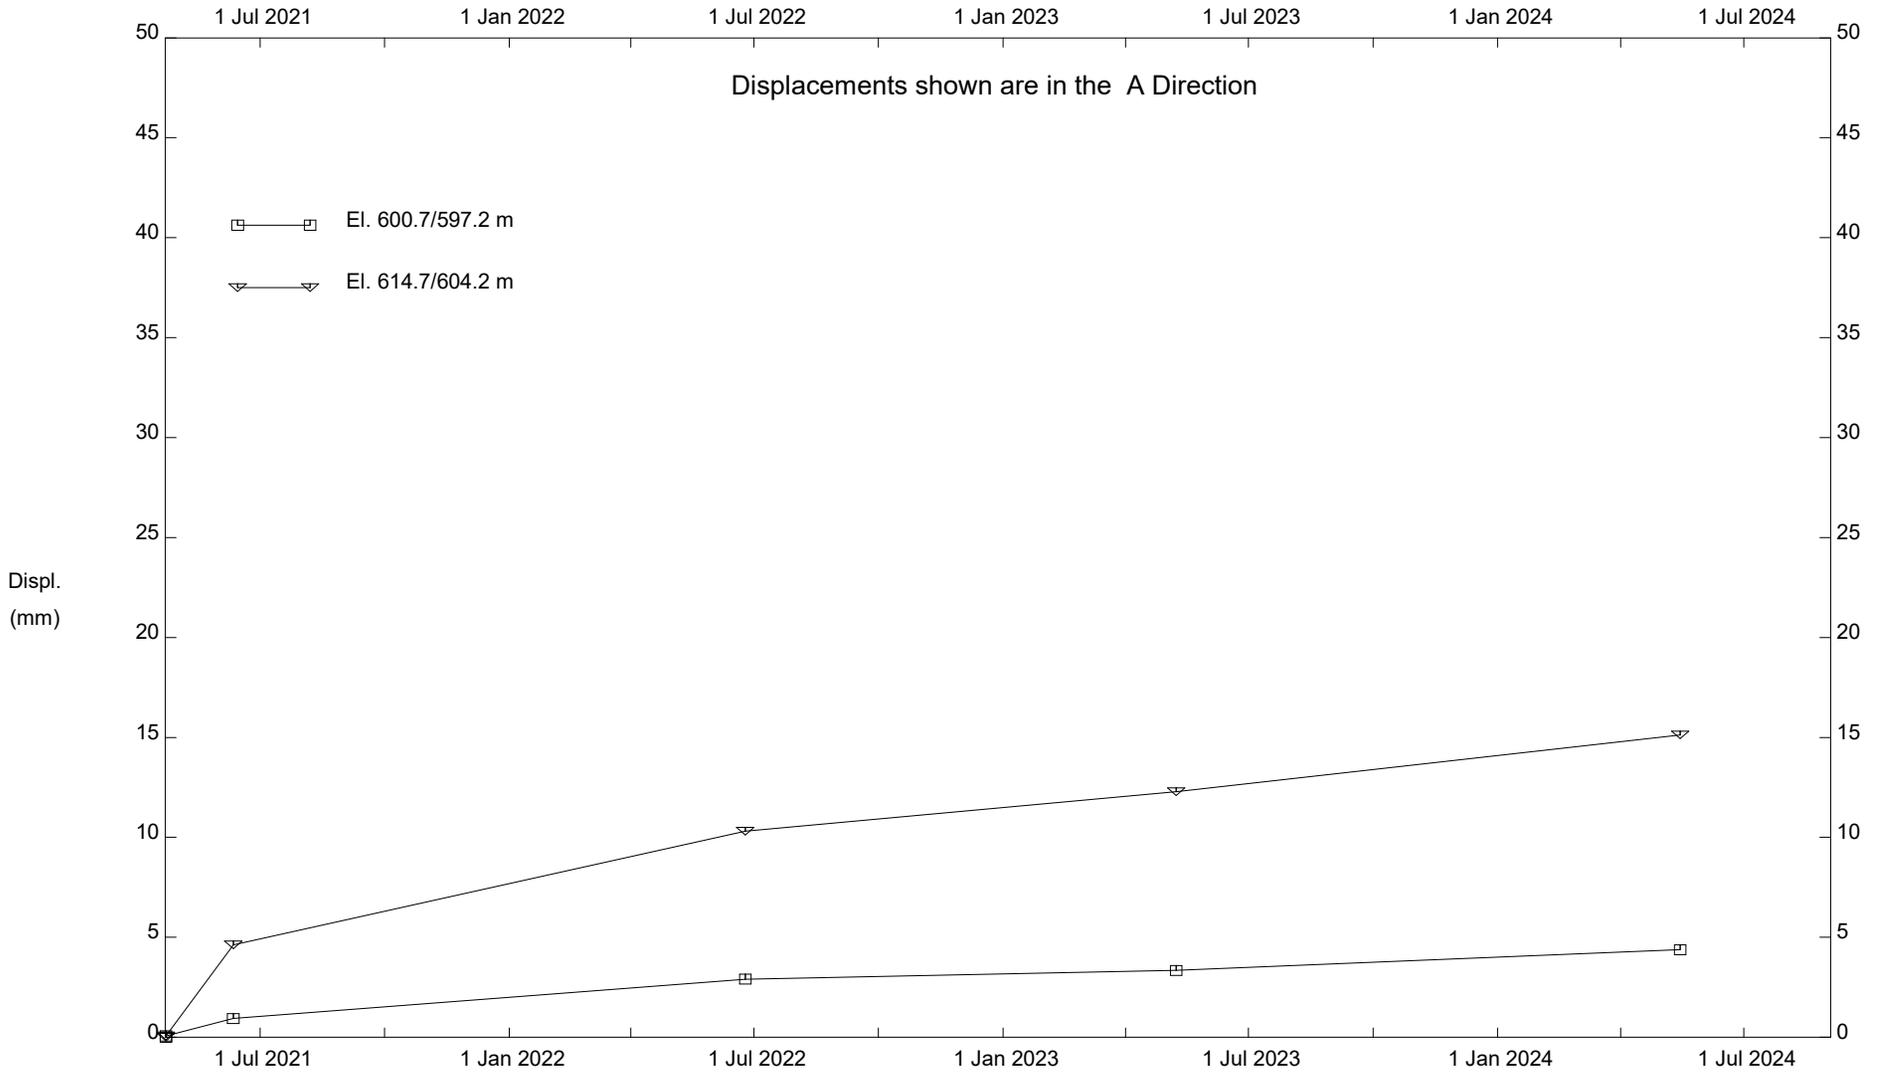
C007; H16:30; Kenilworth Lake Slide, Inclinator SI21-C07-03
Alberta Transportation

The depth of movement being recorded in the pile-wall SIs (excluding SI21-C07-03) appears to be occurring approximately 5 m above the base of the H-pile walls and approximately 3 m below the depth of movement previously recorded in SI13-01 and SI13-02. SI21-C07-03 is also experiencing deeper seated movement approximately 3 m above the base of the H-pile walls. This indicates the H-pile walls have intercepted the failure surface and is continuing to deflect, transferring load to depths below the failure plane as the piles stabilize the slide mass.
