SITE NUMBER AND NAME: C067 Kneehill Creek Slide		HIGHWAY & KM: 21:14, 12.988	PREVIOUS INSPECTION DATE: June 23, 2021	INSPECTION DATE: June 26, 2023
LEGAL DESCRIPTION: 19-29-23-W4M	NAD 83 COORDINATES: UTM Northing Easting 12 5707671 344892		RISK ASSESSMENT: Site A: PF: 5 CF: 3 TOTAL: 15 Site B: PF: 9 CF: 5 TOTAL: 45	
AVERAGE ANNUAL DAILY TRAFFIC (AADT): 867 (south) and 863 (north) (Ref No. 60211450)			CONTRACT MAINTENANCE AREA (CMA): 517

PROJECT
CENTRAL REGION GEOHAZARD RISK MANAGEMENT PROGRAM

TITLE
Site Plan
C067 - Kneehill Creek Slide
Hwy 21:14, km 12.988

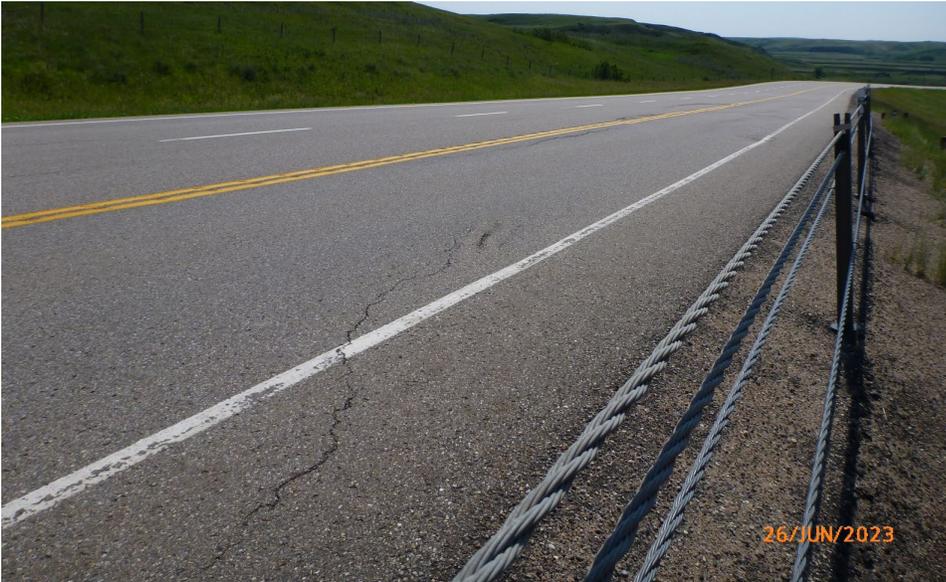
- Pavement cracking was observed in the west (southbound) and extends into the east (northbound) driving lane (Photo 1 and 2). The pavement cracking appears worse than during the 2021 inspection. Pavement cracks were up to 25 mm wide during the 2023 inspection.

- Pavement settlement was observed in west (southbound) lane (Photo 1 and 2). The settlement was between approximately 15 mm to 40 mm and was near the center of the lane, not beneath the wheel path. This may be attributed to a soft spot or less likely, a void in the highway subgrade. Downstream of the pavement settlement, there is a shallow depressed area on the highway embankment slope (Waypoint 344).

- Photo 1** At Site B, pavement distress (cracking and settlement) was observed in the west (southbound) lane, and the pavement cracking extends into the east (northbound) passing lane. The degree of pavement distress appears to have increased since the 2021 inspection. Photo taken June 26, 2023, facing southeast.

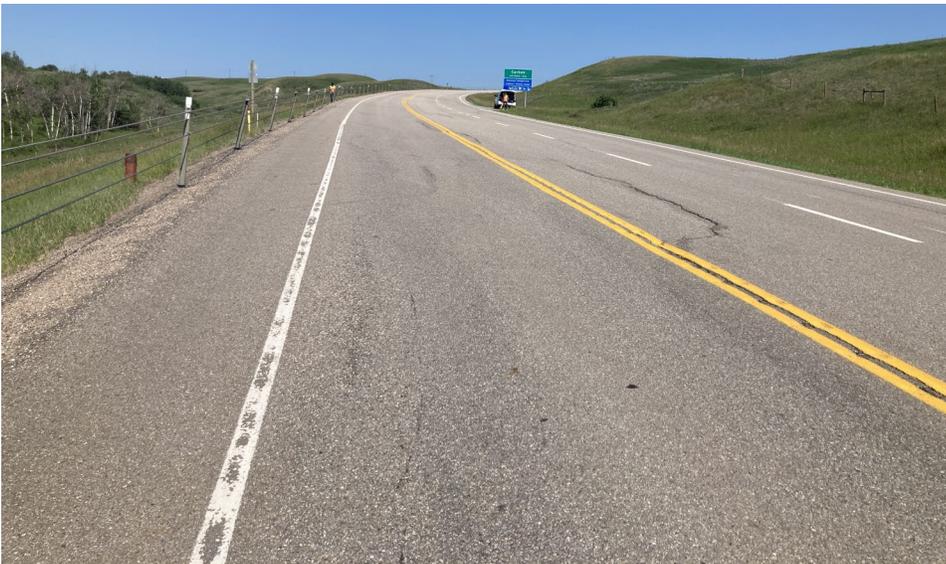
- Photo 2** At Site B, pavement cracking and settlement in the west (southbound) lane and east (northbound) passing lane. Pavement cracks were approximately 15 mm to 30 mm wide and settlement was up to approximately 40 mm. Photo taken June 26, 2023, facing northwest.

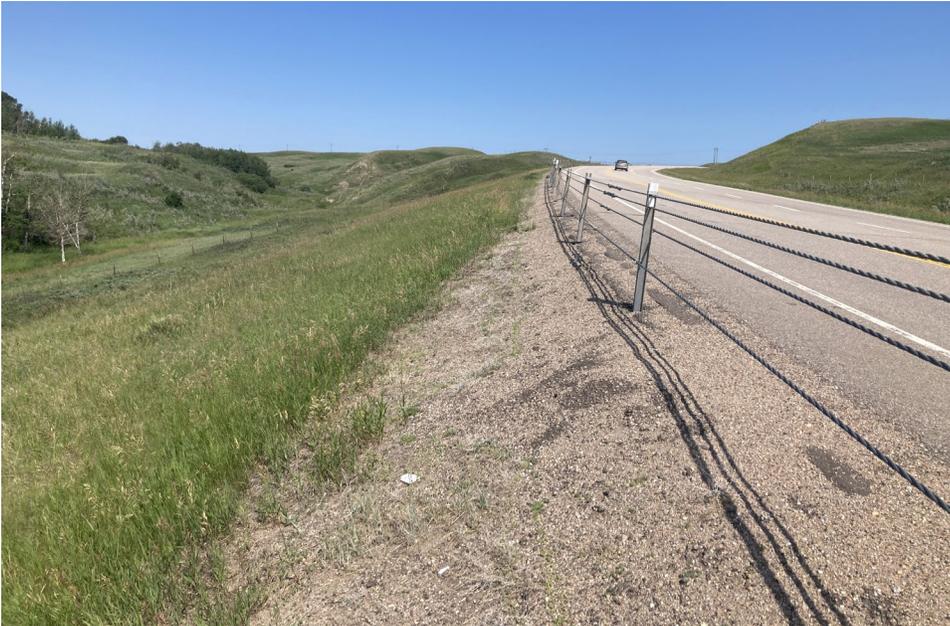
Photo 3 The west (southbound) highway embankment at Site B is well vegetated and appears to be in good condition. Photo taken June 26, 2023, facing northwest.

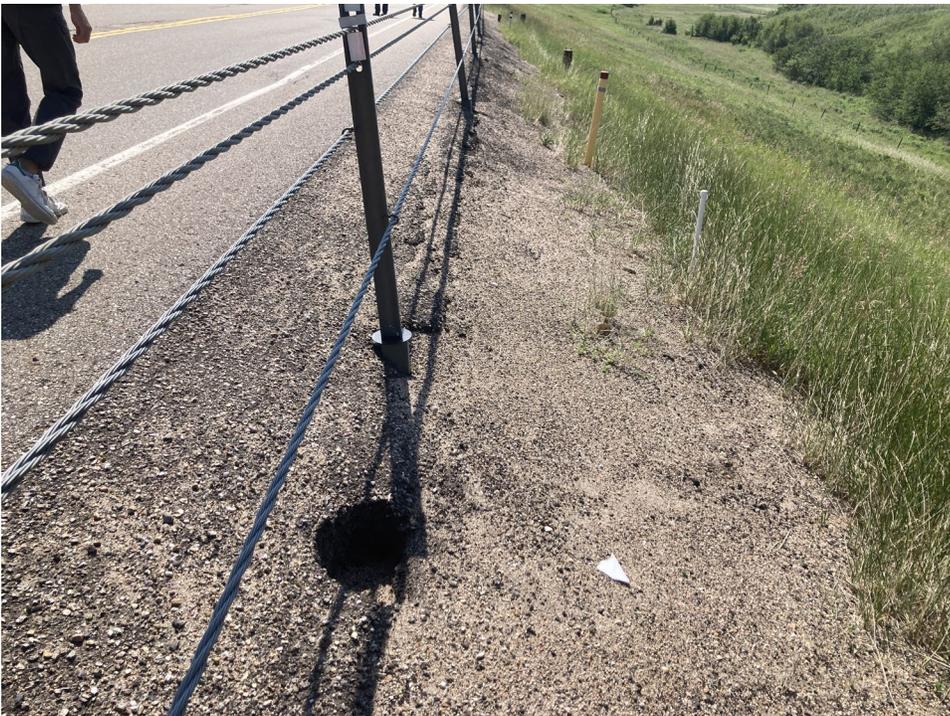
- Two voids (approximately 150 mm in diameter) were observed in the west (southbound) shoulder (Photo 4). TEC and KCB suspect they formed due to guardrail removal during construction. If the voids increase in size, they should be backfilled, as they could impact the shoulder of the highway and become a hazard to highway traffic.

Photo 4 Voids are located along the Site B, most likely from guardrail post replacement during 2017 construction. Photo taken June 26, 2023, facing southeast.

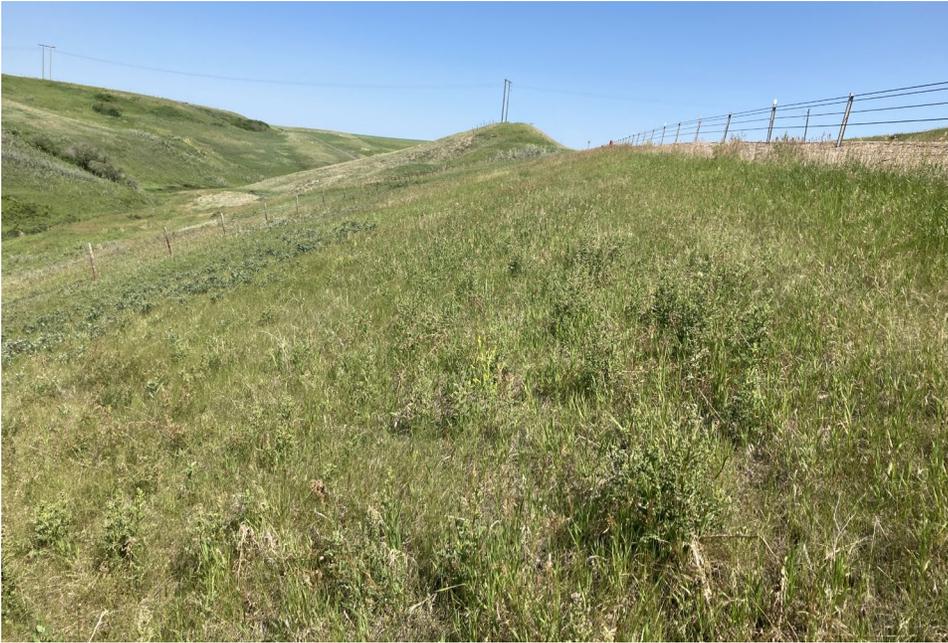
- The west (southbound) highway embankment is well vegetated, and no signs of slope deformation were observed during the 2023 inspection (Photo 5).
- No new pavement distress was observed upslope of the H-pile wall (Photo 6). Overall, there has been approximately 16 mm of movement in the Site A H-pile wall since July 2017, with current movement rates less than 5 mm/year. The relatively slow rate of movement, along with no new pavement distress being observed, indicate the H-pile wall is performing well.
- In 2023, since Site A appears to be performing better than Site B, TEC and KCB decided to assign different risk ranking to each subsite.

Photo 5 **The west (southbound) highway embankment at Site A is well vegetated and appears to be in good condition. Photo taken June 26, 2023. facing north.**

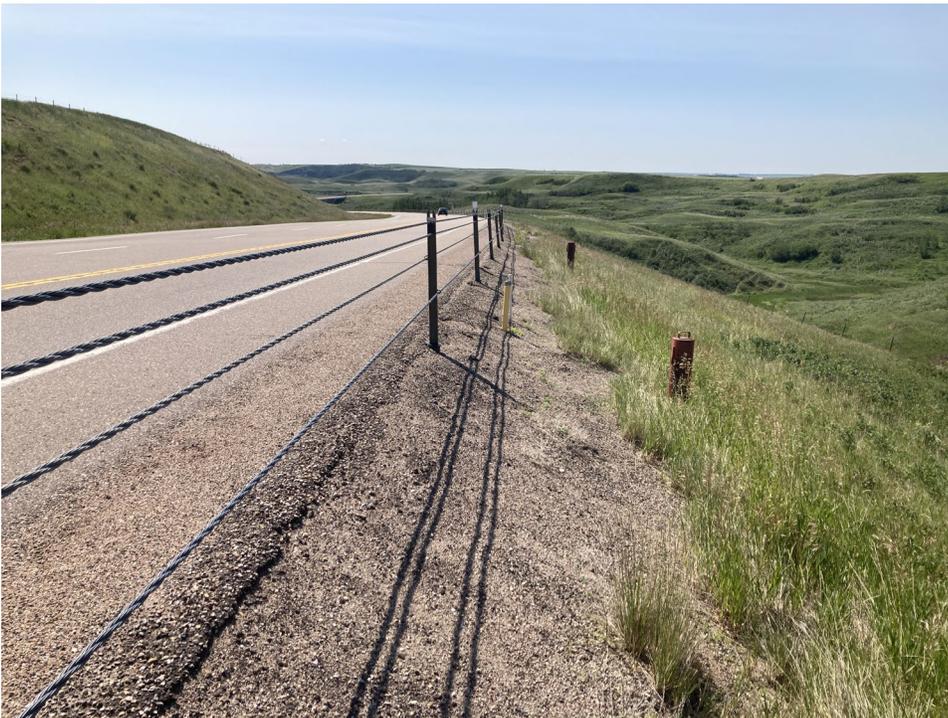
Photo 6 **The pavement and highway embankment slope at Site A appear to be in good condition, indicating the 2017 H-pile wall is performing well. Photo taken June 26, 2023, facing south.**
