November 15, 2024

**CON0022160 Central Region GRMP Instrumentation Monitoring
Site C067; H21:14, km 12.988 Kneehill Creek Slide
Section C – 2024 Fall Readings**

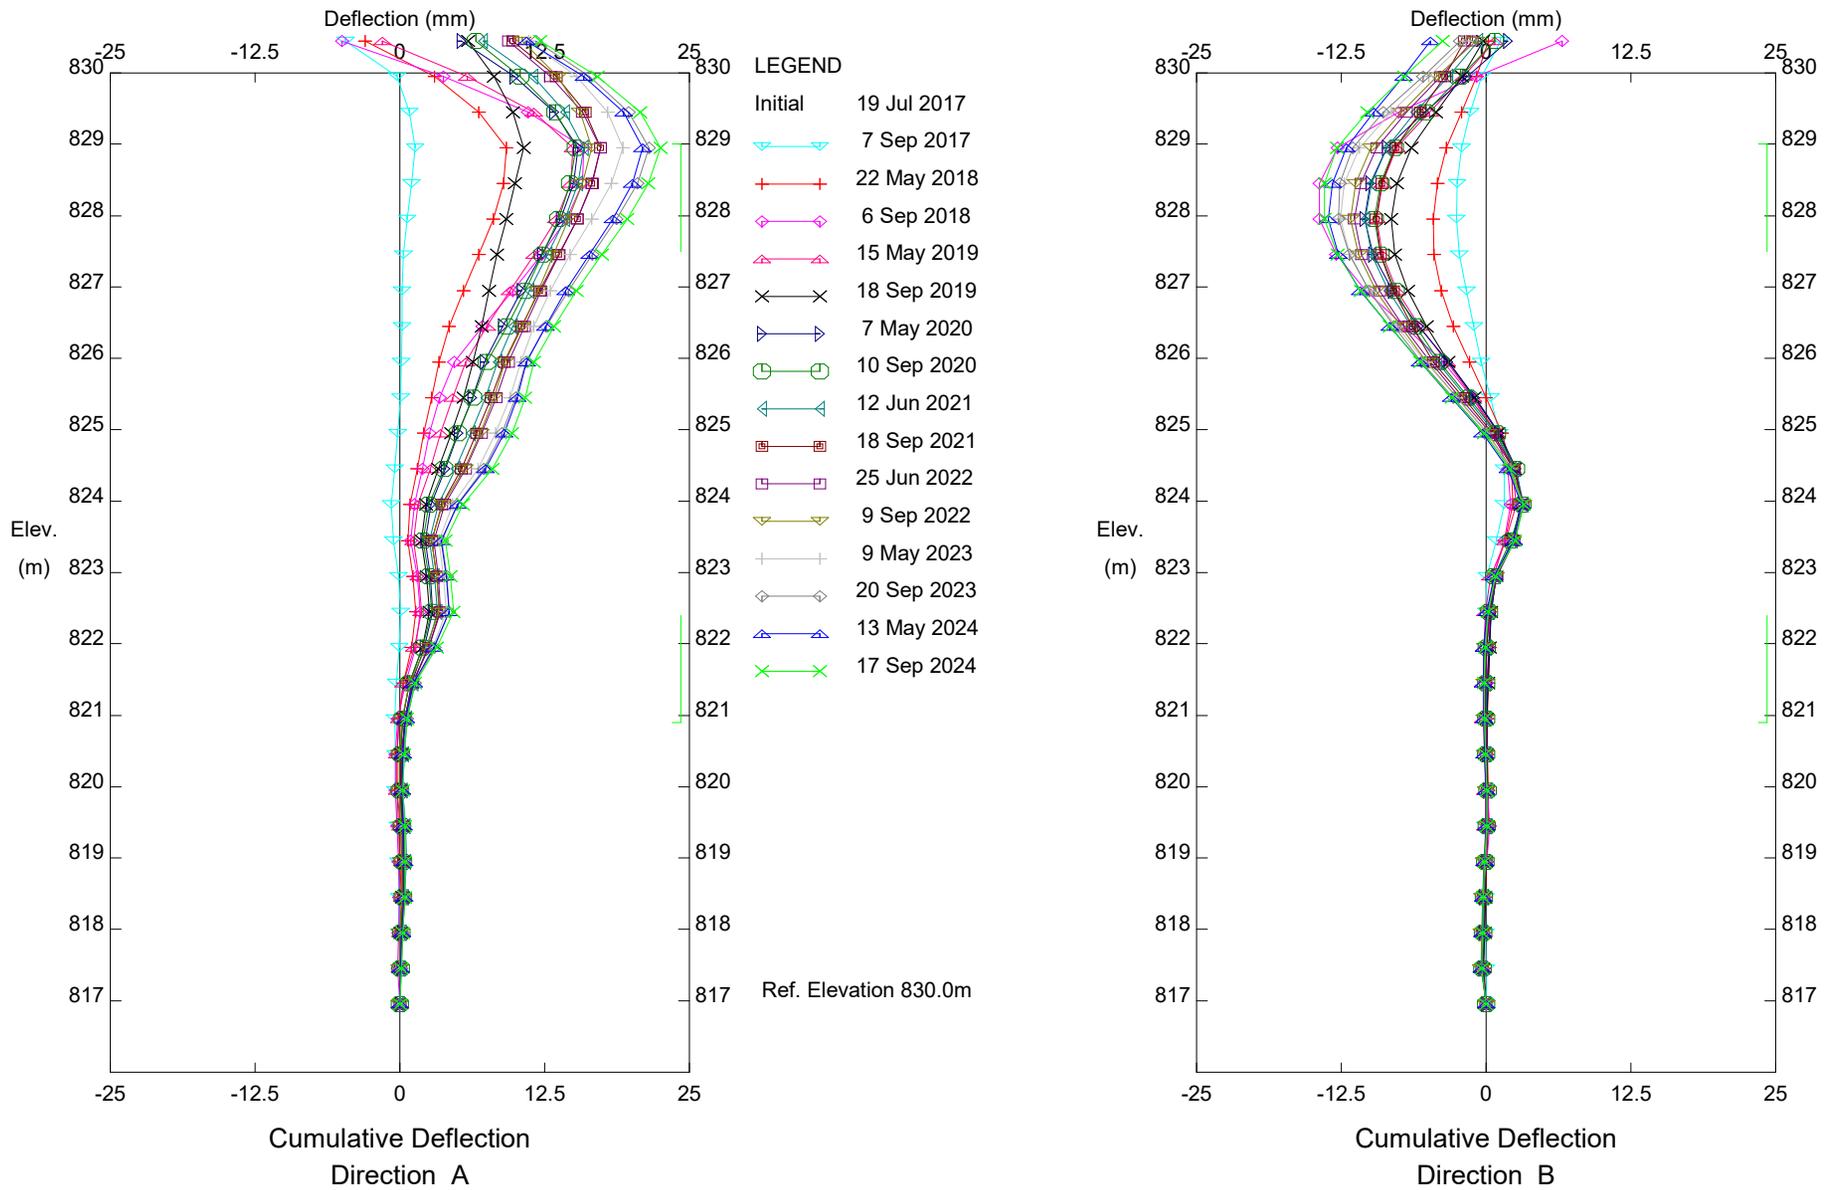
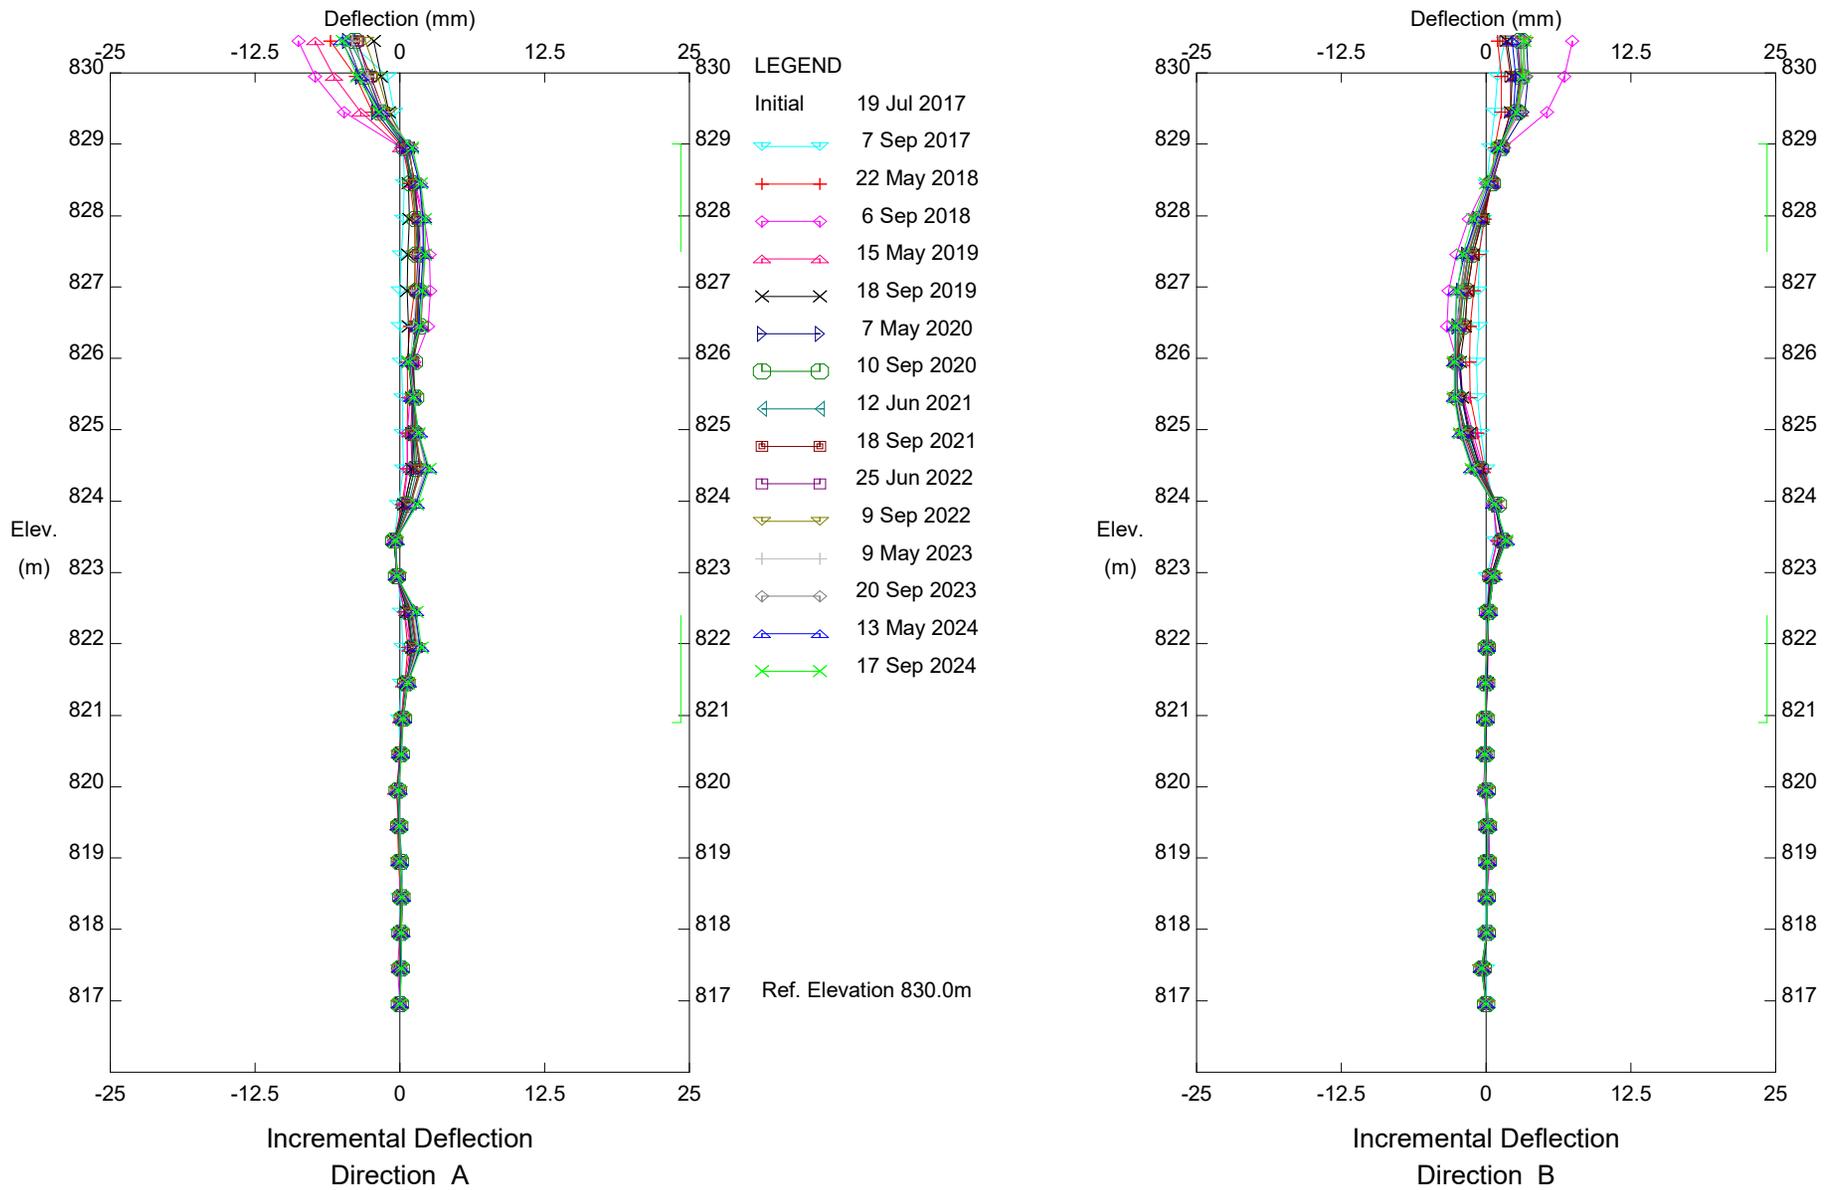
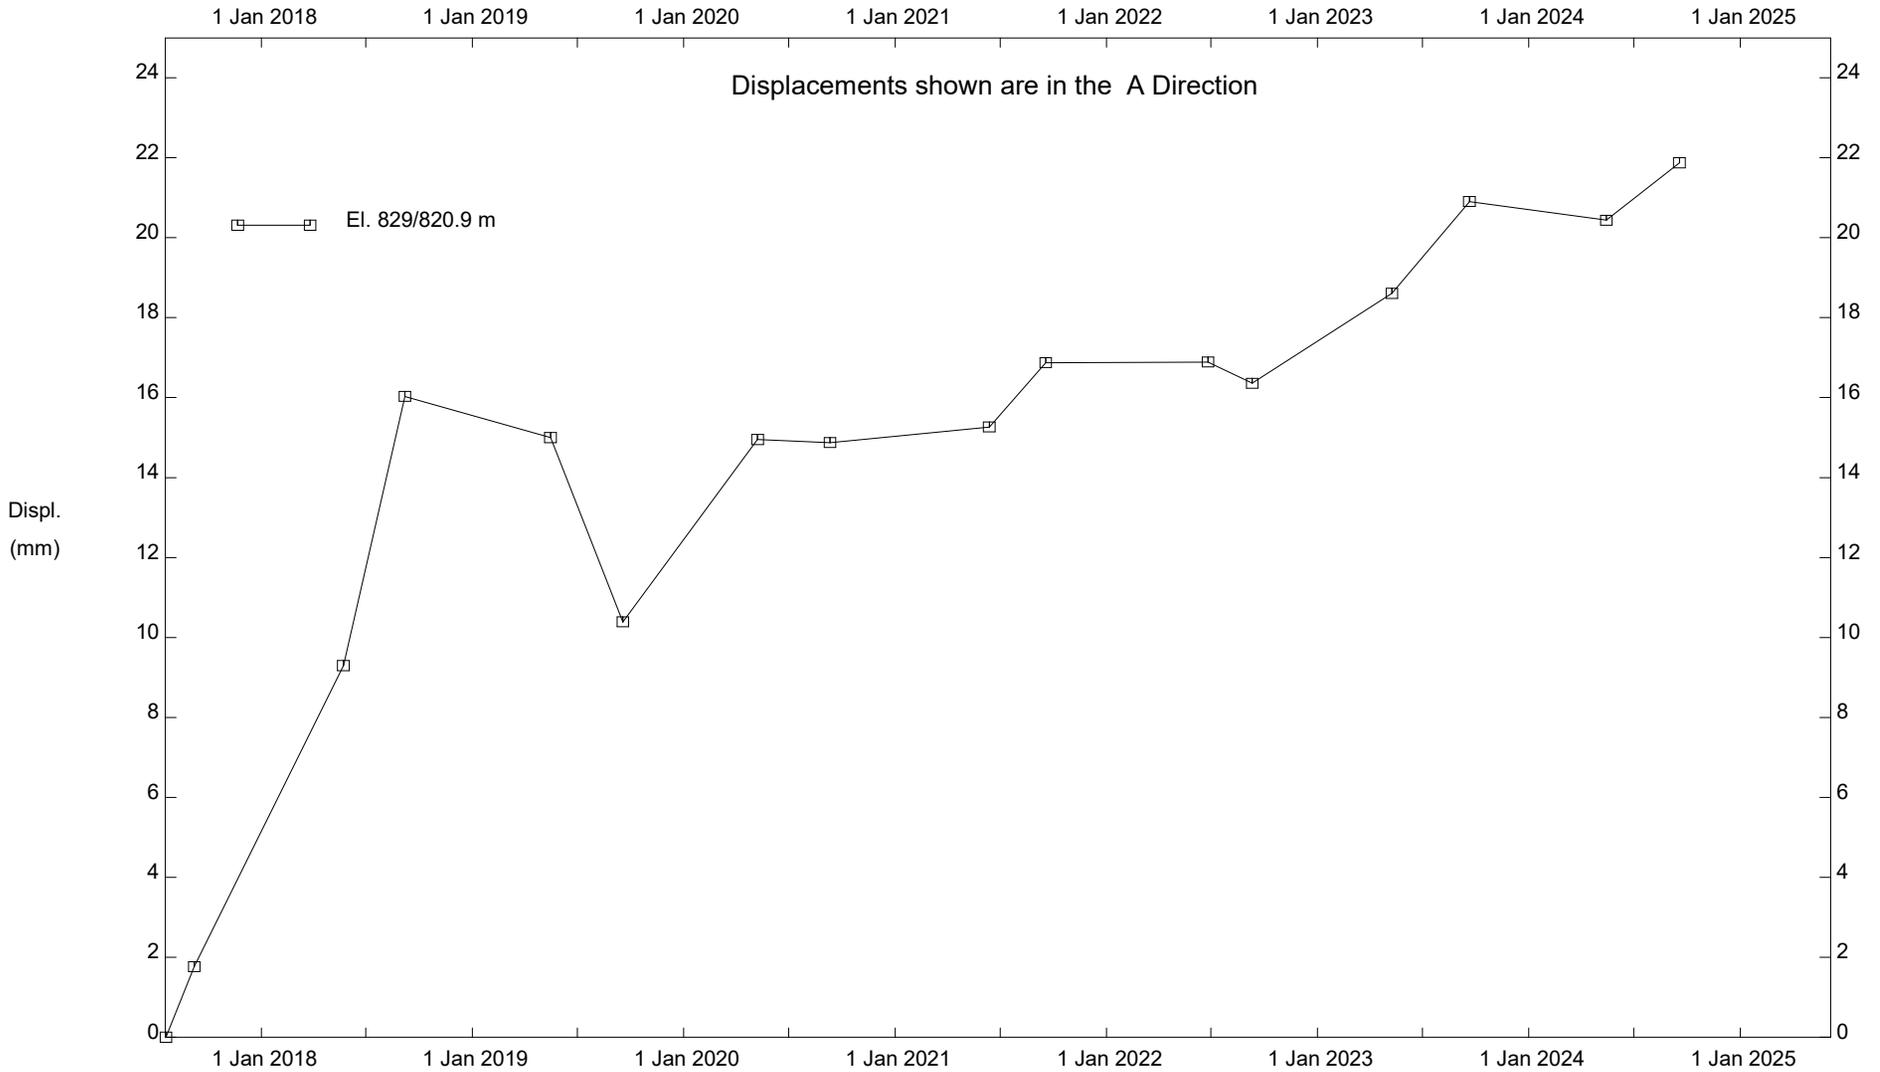
C067; H21:14, Kneehill Creek Slide, Inclinometer SI16-02

Distributed movement is being recorded in SI16-02 (downslope of the Site A H-pile wall) from near ground surface to approximately 9 m below ground surface or approximately 6.5 m above the base of the H-pile wall.

Data obtained from SI16-02 (installed upslope of the H-pile wall) indicates the active block upslope of the H-pile wall continues to creep as the H-pile wall stabilizes the sliding mass. Before the H-pile wall was installed, the maximum rate of movement recorded in SI16-02 was approximately 205 mm/year on February 21, 2017. Between April and May 2017, after installation of the H-pile wall, the rate of movement recorded in SI16-02 increased to approximately 345 mm/year. Since September 2018, the overall rate of movement recorded in this instrument has been relatively steady (less than approximately 7 mm/year).

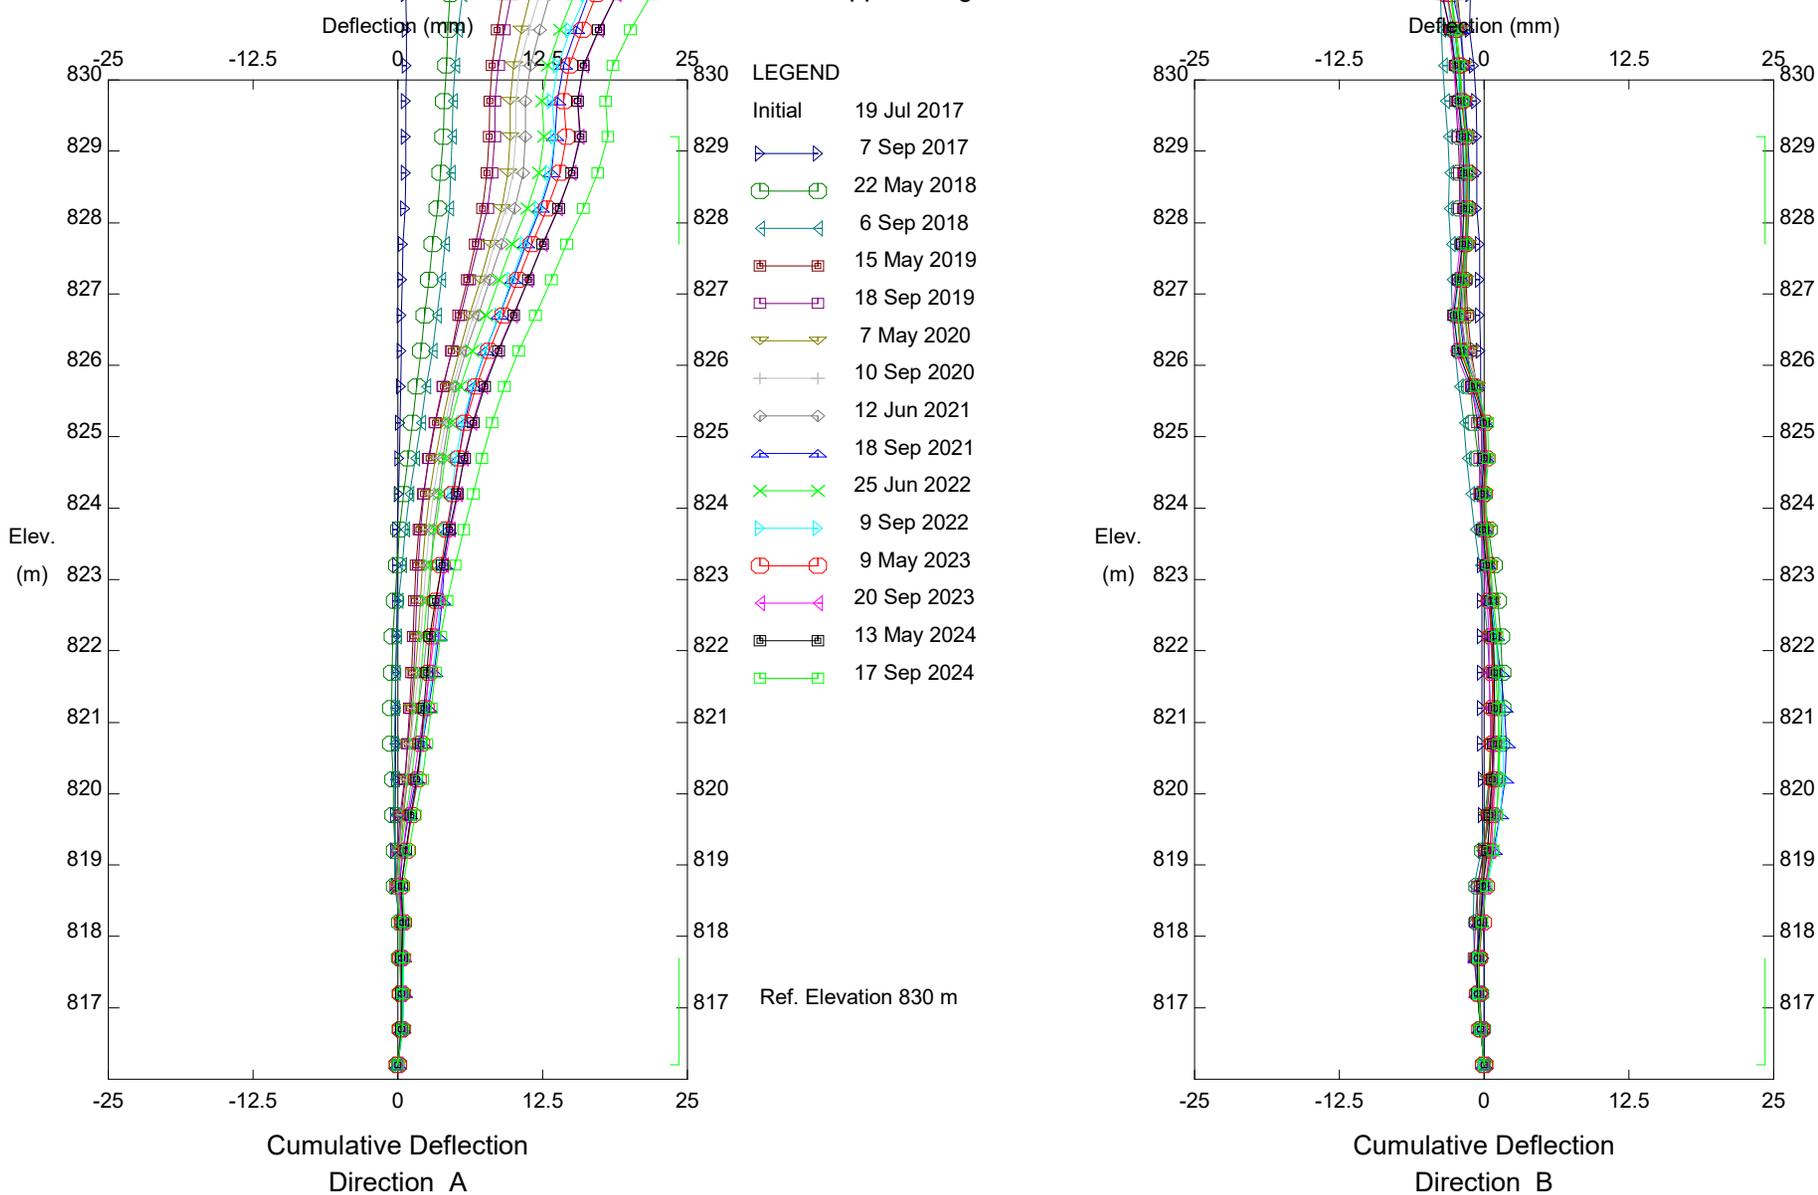
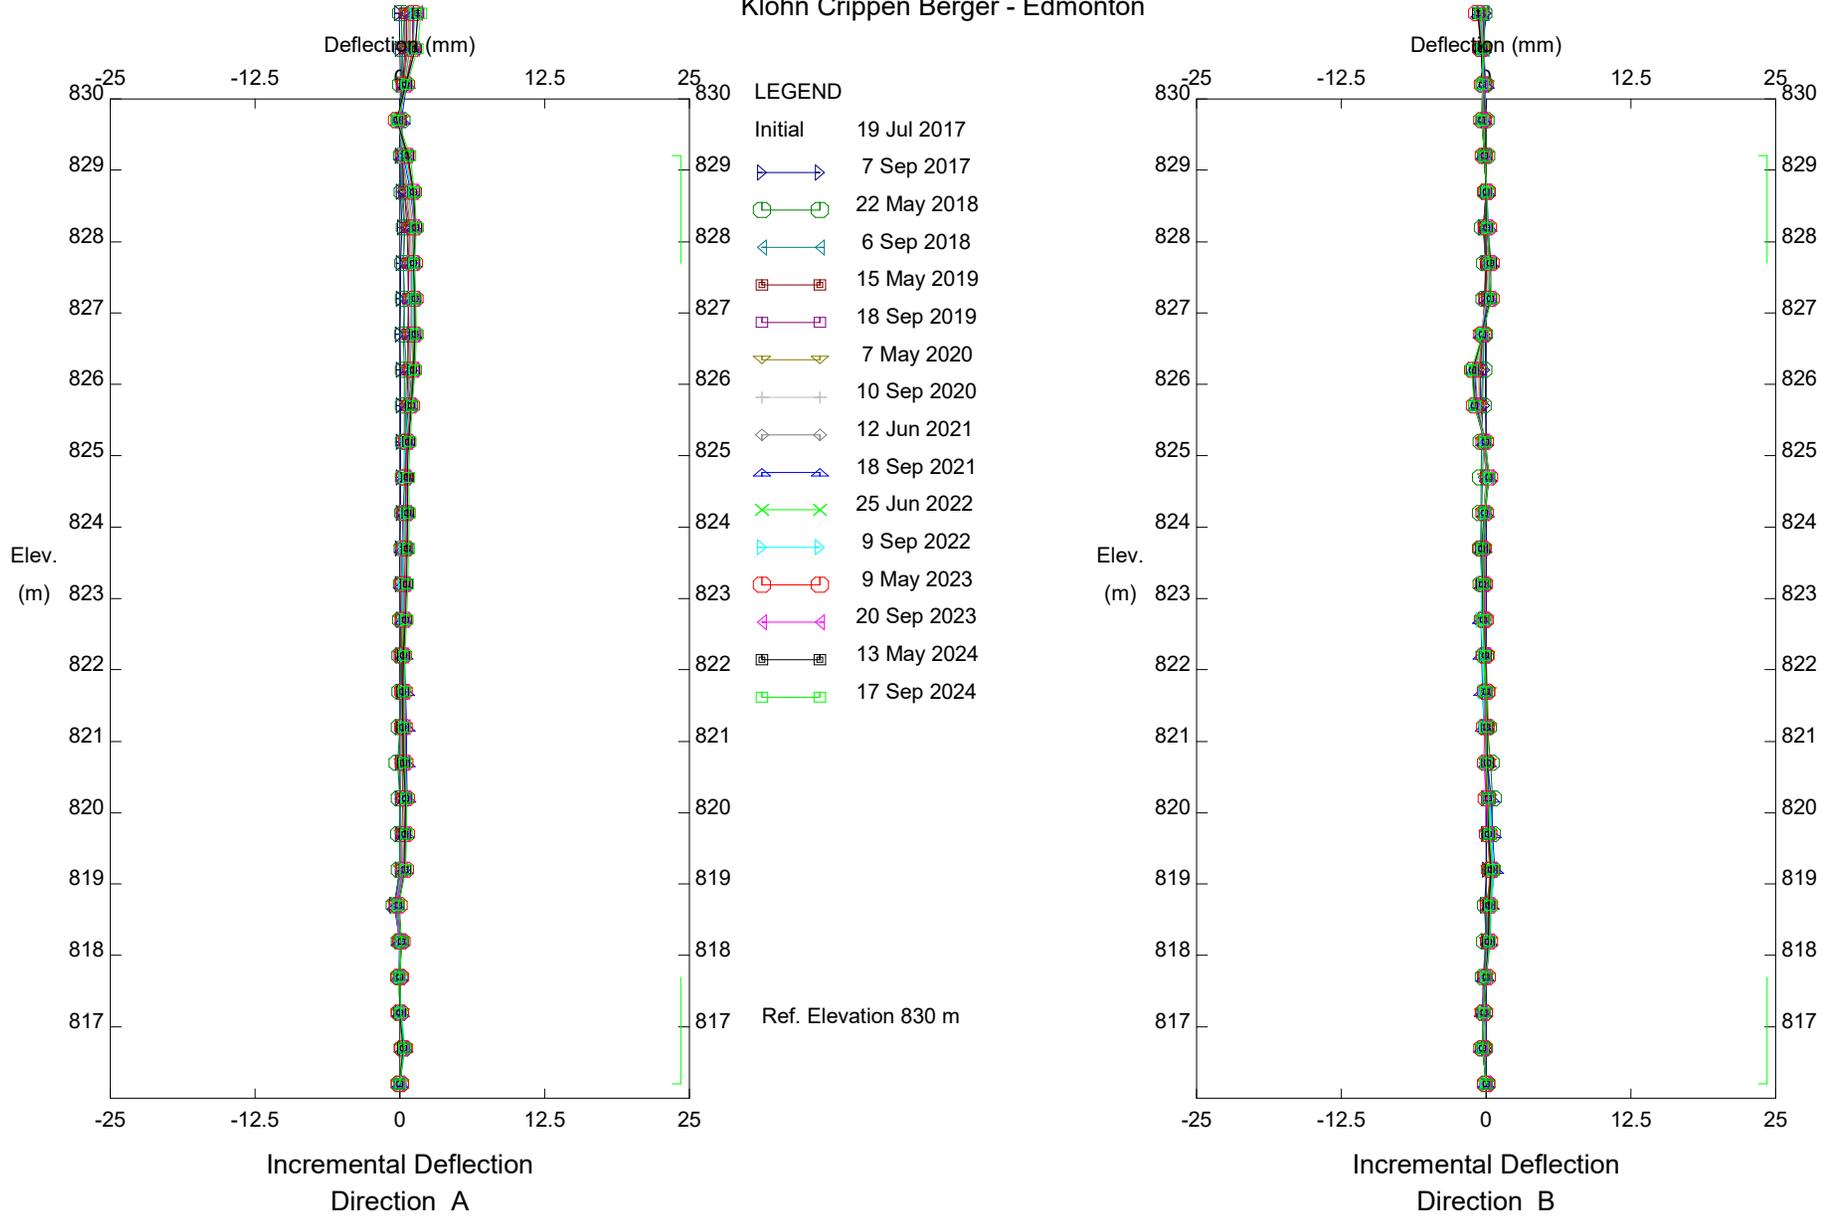
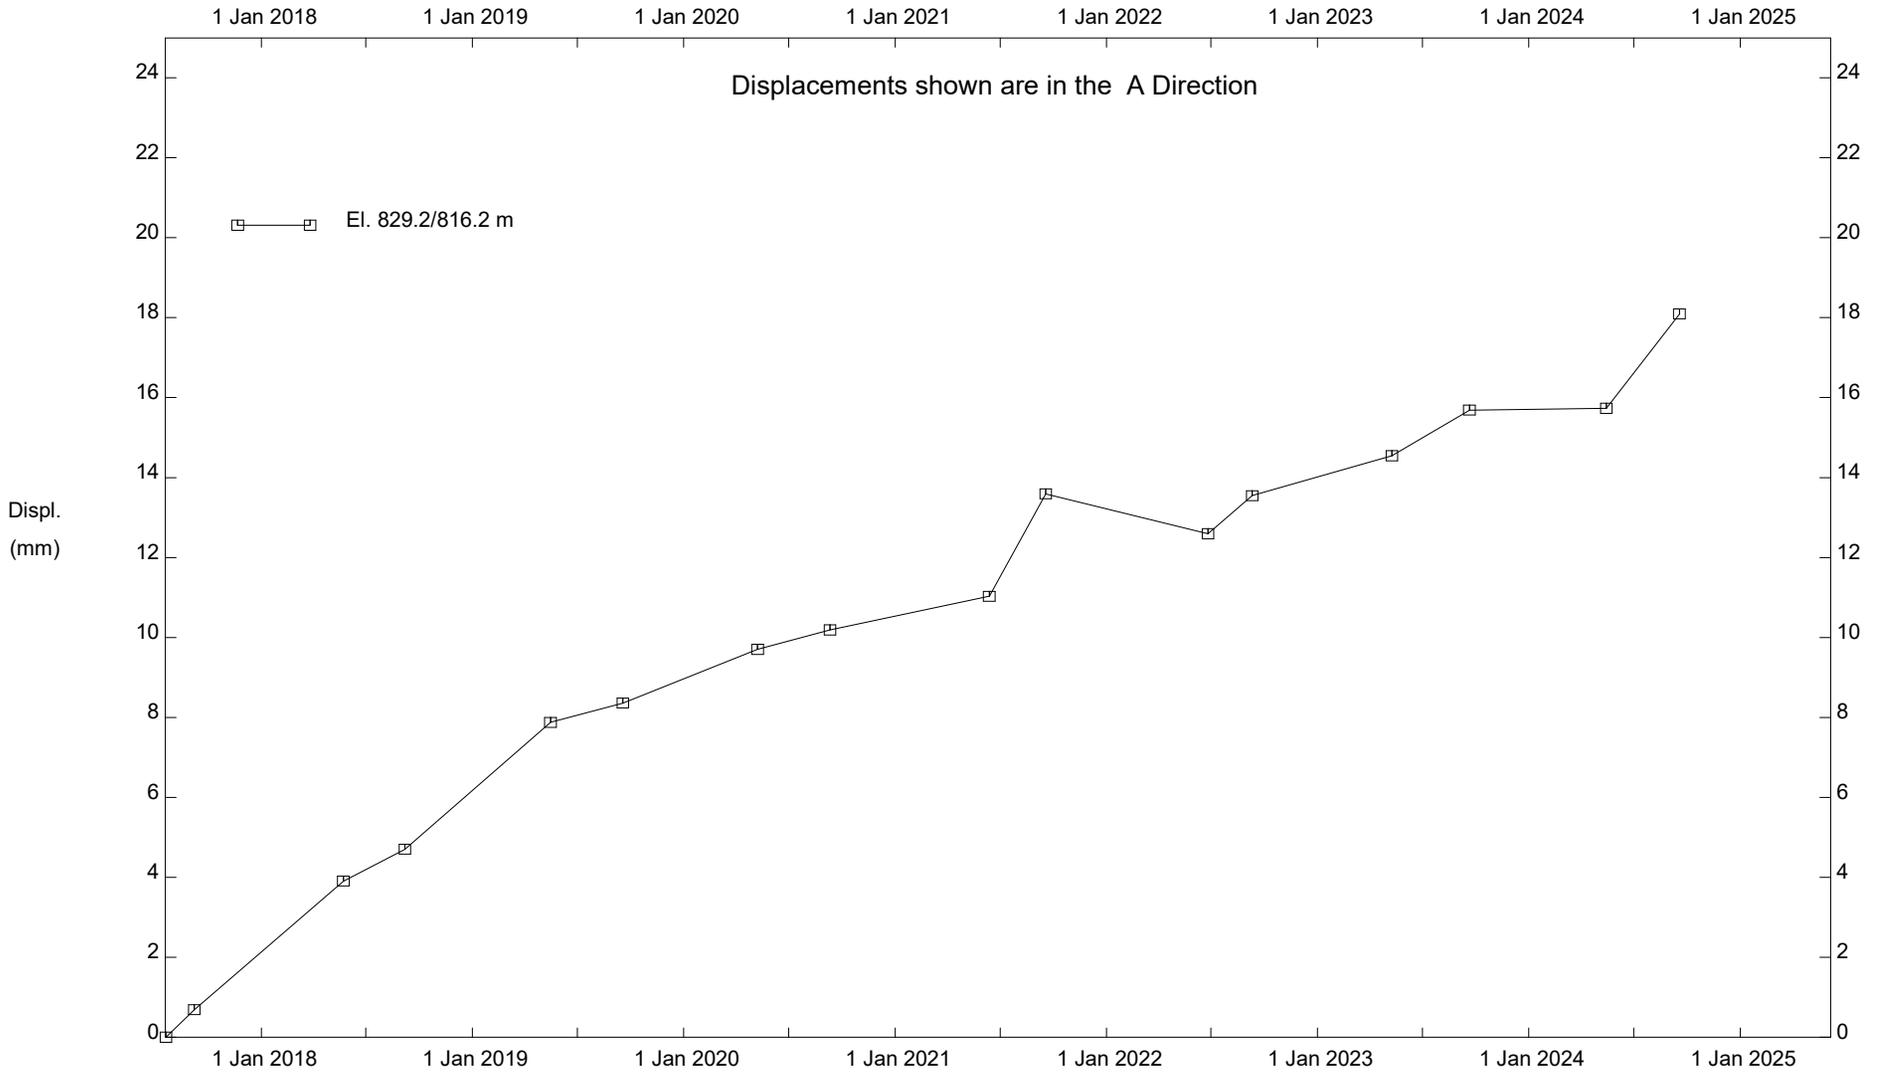
C067; H21:14, Kneehill Creek Slide, Inclinometer SI17-C67-01

Distributed movement is being recorded in the SIs installed in the H-pile wall (SI17-C67-01 and SI17-C67-02) from top of casing to an approximate depth of 11 m below ground surface or approximately 4 m above the base of the H-pile wall.

The deepest zone of movement being recorded in the pile-wall SIs (SI17-C67-01 and SI17-C67-02) appears to be approximately 2 m below the depth of movement recorded in SI16-02. This indicates the H-pile wall has intercepted the failure surface and is continuing to deflect, transferring load to depths below the failure plane as the piles stabilize the sliding mass.

The September 2024 data obtained from SI17-C67-01 and SI17-C67-02 indicates the top of the H-pile wall at Site A has deflected between approximately 19 mm and 24 mm since installation. In May 2017, the maximum rate of movement recorded in SI17-C67-01 and SI17-C67-02 was approximately 45 mm/year, one month after the H-pile wall was installed. The rate of movement has since slowed and is now generally less than 5 mm/year, excluding:

- between June and September 2022, when an increased rate of movement of approximately 4 mm/year and 9 mm/year was recorded in SI17-C67-01 and SI17-C67-02, respectively, likely in response to wet weather in June and July 2022; and
- increased rate of movement was recorded in SI17-C67-01 between May and September 2024 of approximately 7 mm/year. The increased rate of movement may be attributed to construction activities on site (chip sealing along the C067 site was completed in summer 2024) and wet weather in August 2024 (approximately 55 mm precipitation versus the average of 45 mm recorded between 2015 and 2024).

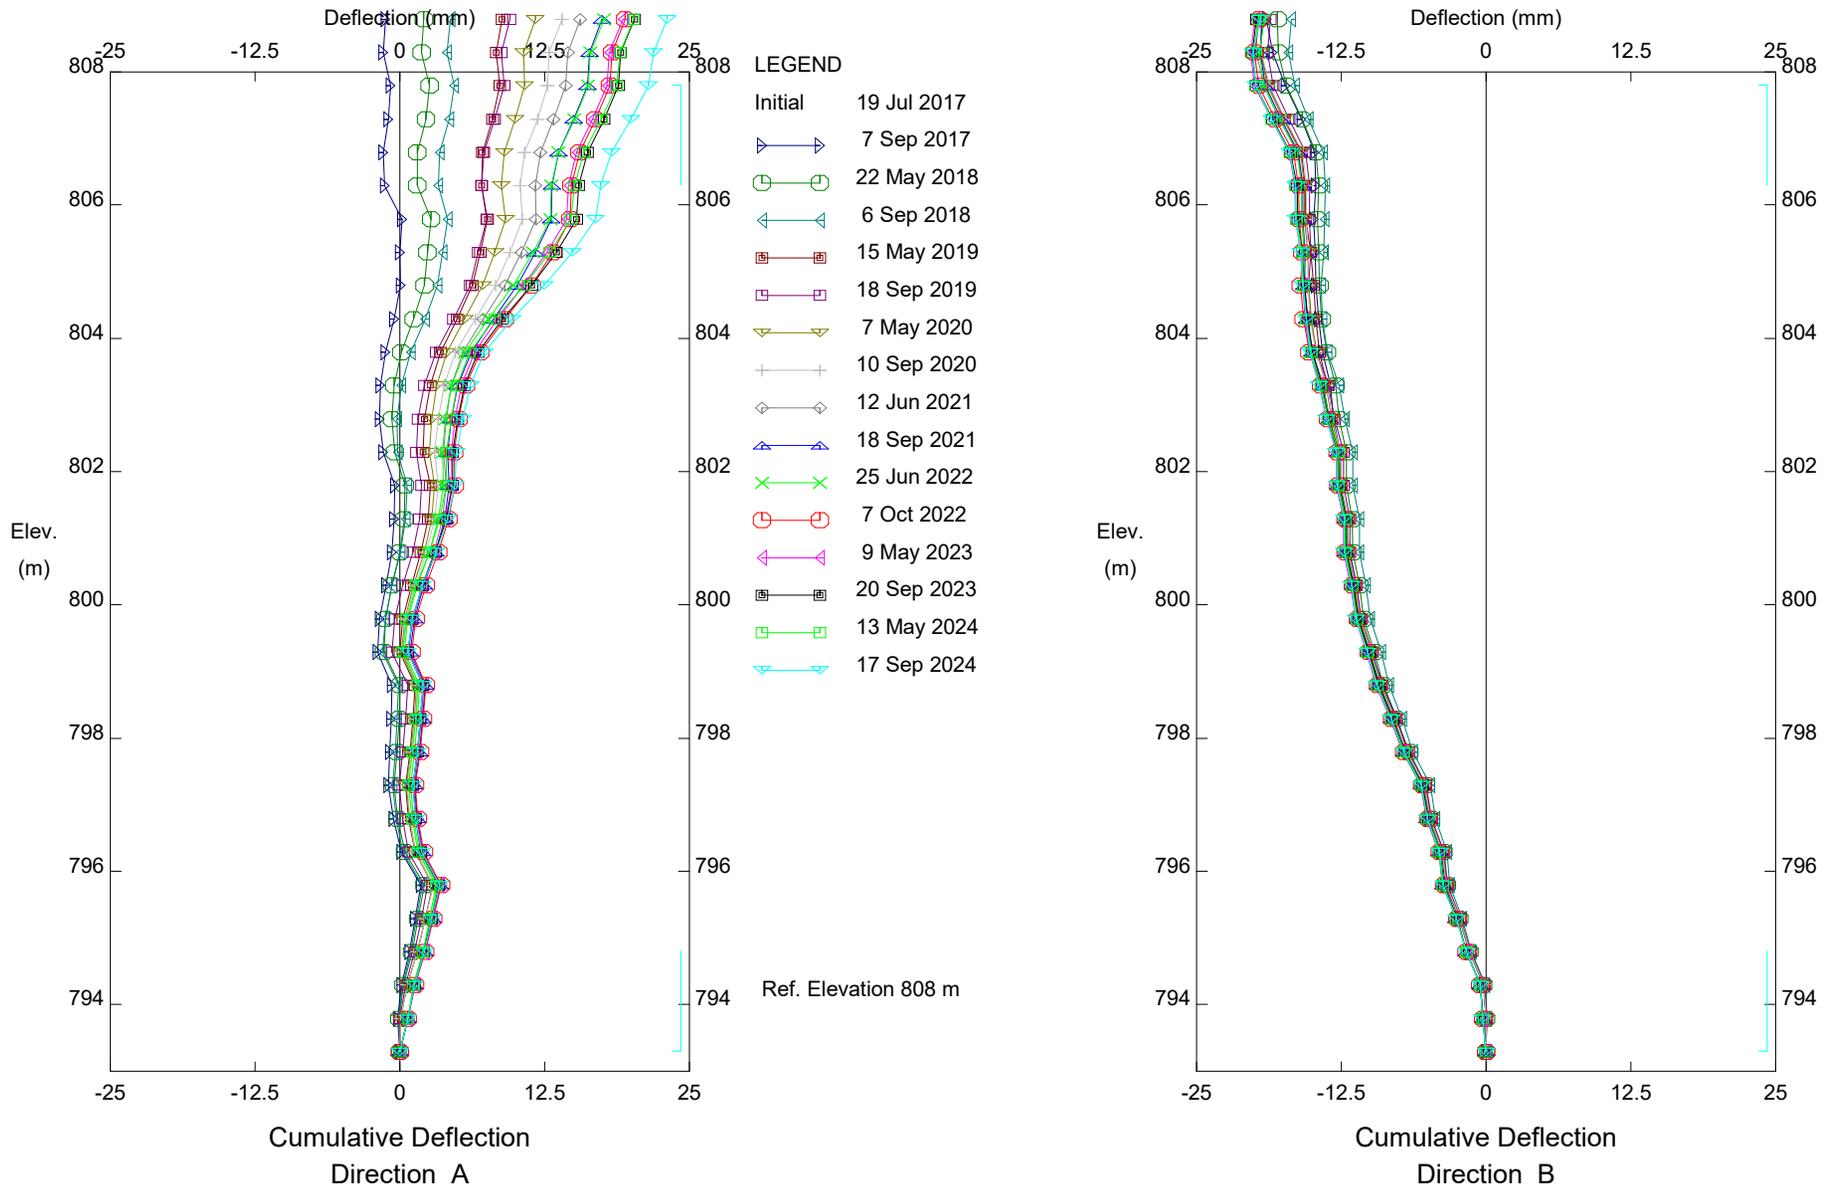
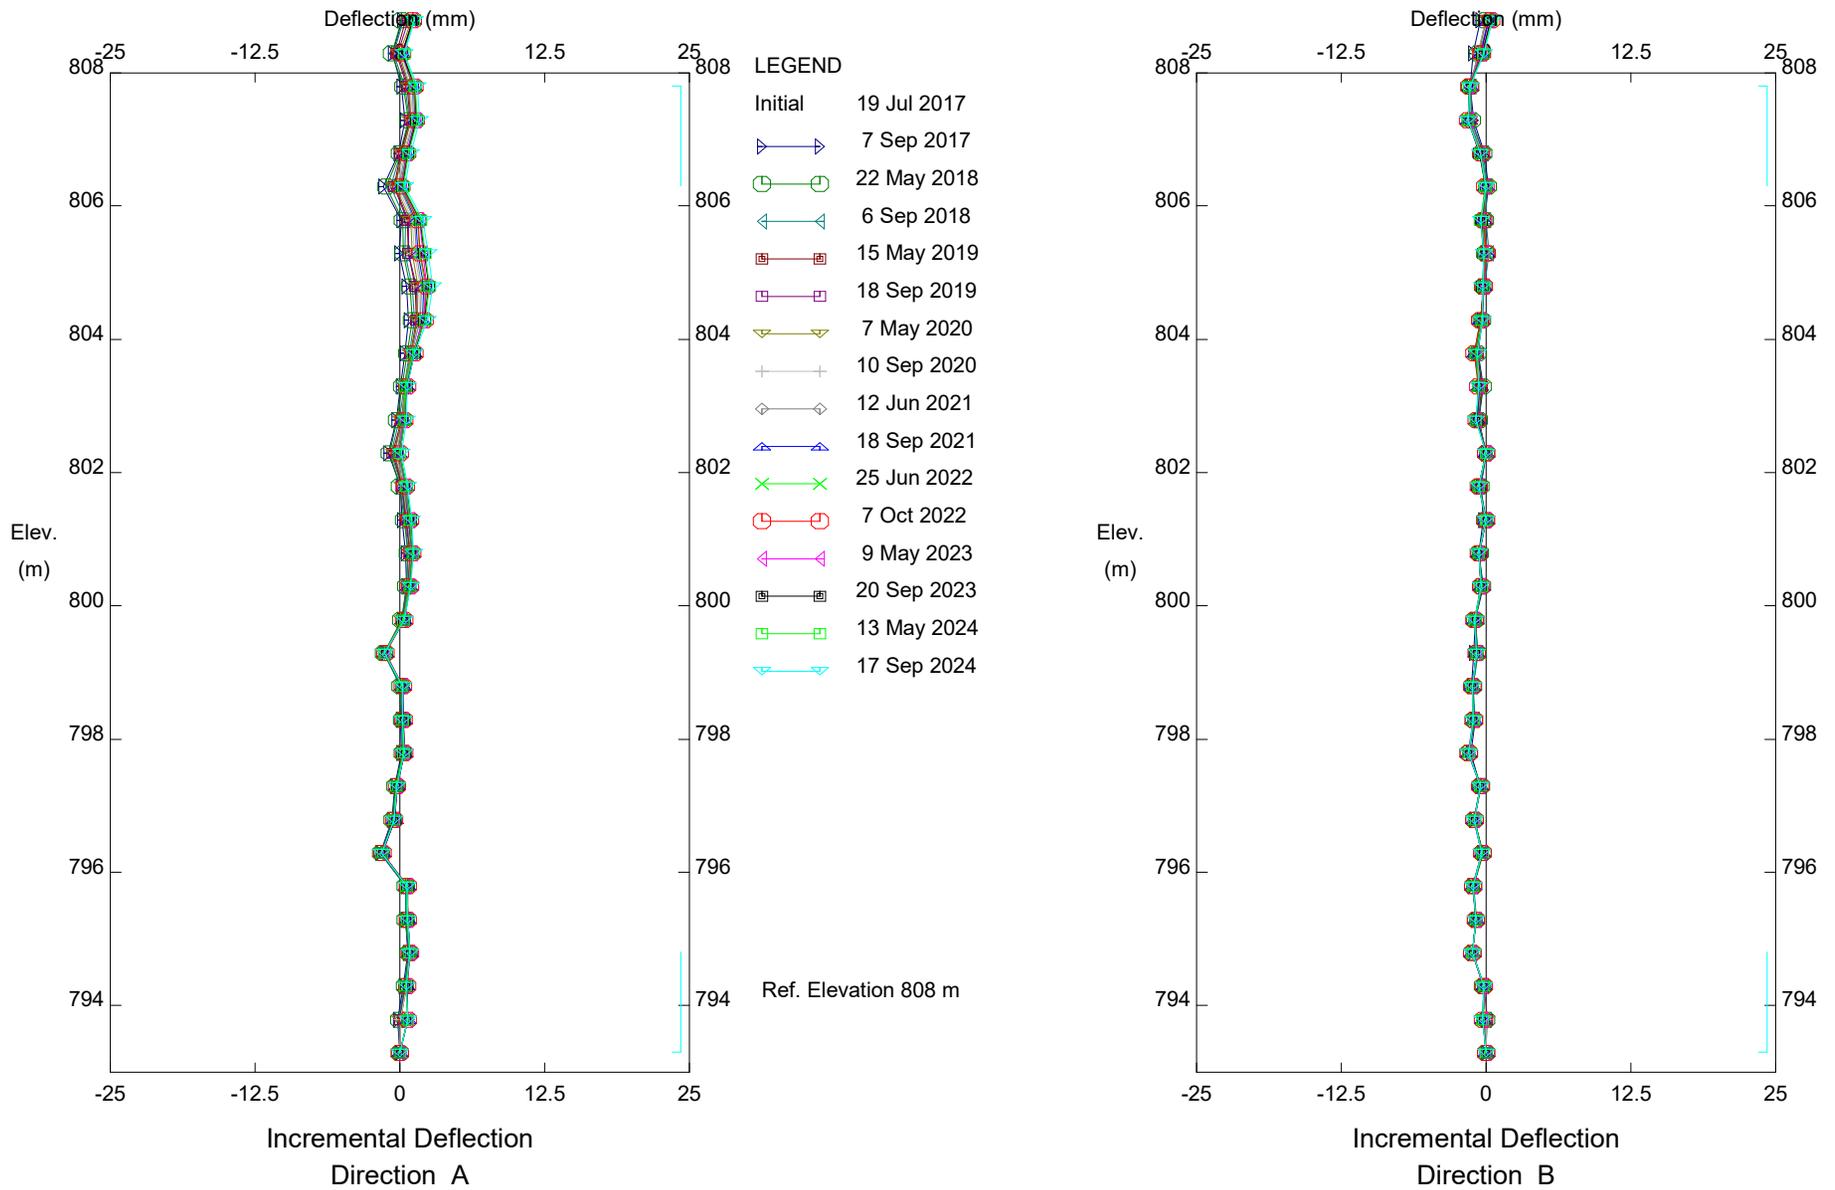
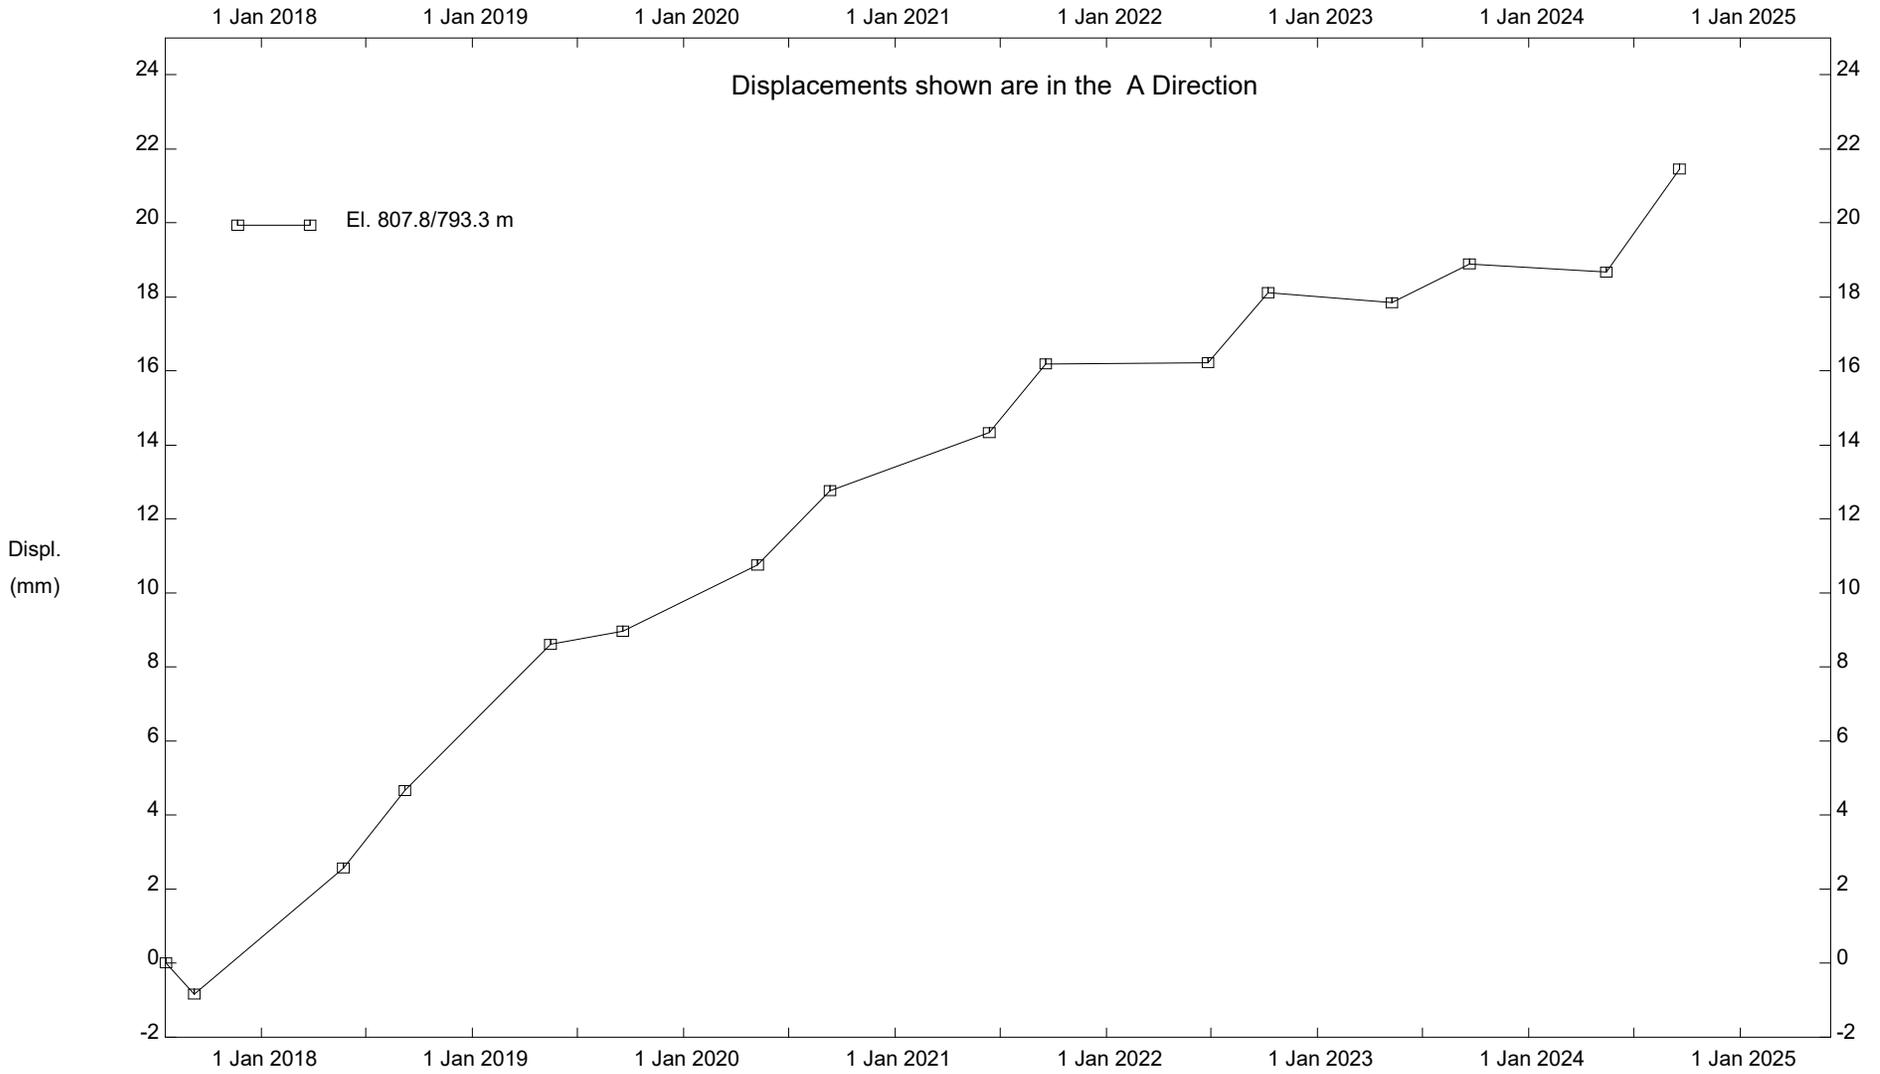
C067; H21:14, Kneehill Creek Slide, Inclinometer SI17-C67-03

Distributed movement is being recorded in the SIs installed in the H-pile wall (SI17-C67-03 though and SI17-C67-05) from top of casing to an approximate depth of 8.7 m, 7.8 m, and 6.5 m, respectively.

The depth of movement being recorded in the pile-wall SIs (SI17-C67-03 through SI17-C67-05) appears to be occurring 2 m to 4 m below the depth of movement previously recorded in SI16-01. This indicates the H-pile wall has intercepted the failure surface and is continuing to deflect, transferring load to depths below the failure plane as the piles stabilize the sliding mass.

The September 2024 data obtained from SI17-C67-03 through SI17-C67-05 indicates the top of the H-pile wall has deflected between approximately 19 mm and 31 mm since installation. The maximum rate of movement recorded in SI17-C67-03 through SI17-C67-05 was approximately 71 mm/year to 115 mm/year in May 2017, one month after the H-pile wall was installed. The rate of movement has since decreased and is now generally less than 3 mm/year, excluding:

- In September 2023, the rate of movement recorded in SI17-C067-03 through -05 increased to up to approximately 7 mm/year. Although the movement recorded in September 2023 was within historical trends for these instruments, evidence of movement (pavement cracking and settlement) primarily in the south (eastbound) lane was observed during the 2023 Section B Inspection. The increased rate of movement recorded may be attributed to settlement of the highway subgrade and fill due to H-pile wall movement between 2017 and 2023.

- In September 2024, the rate of movement recorded in SI17-C67-03 through SI17-C67-05 increased from less than approximately 2 mm/year to up to approximately 8 mm/year. The increased rate of movement may be attributed to construction activities on site (chip sealing along the site was completed in summer 2024) and wet weather in August 2024 (approximately 55 mm precipitation versus the average of 45 mm recorded between 2015 and 2024).
