November 15, 2024

**CON0022160 Central Region GRMP Instrumentation Monitoring
Site C067; H21:14, km 12.988 Kneehill Creek Slide
Section C – 2024 Fall Readings**

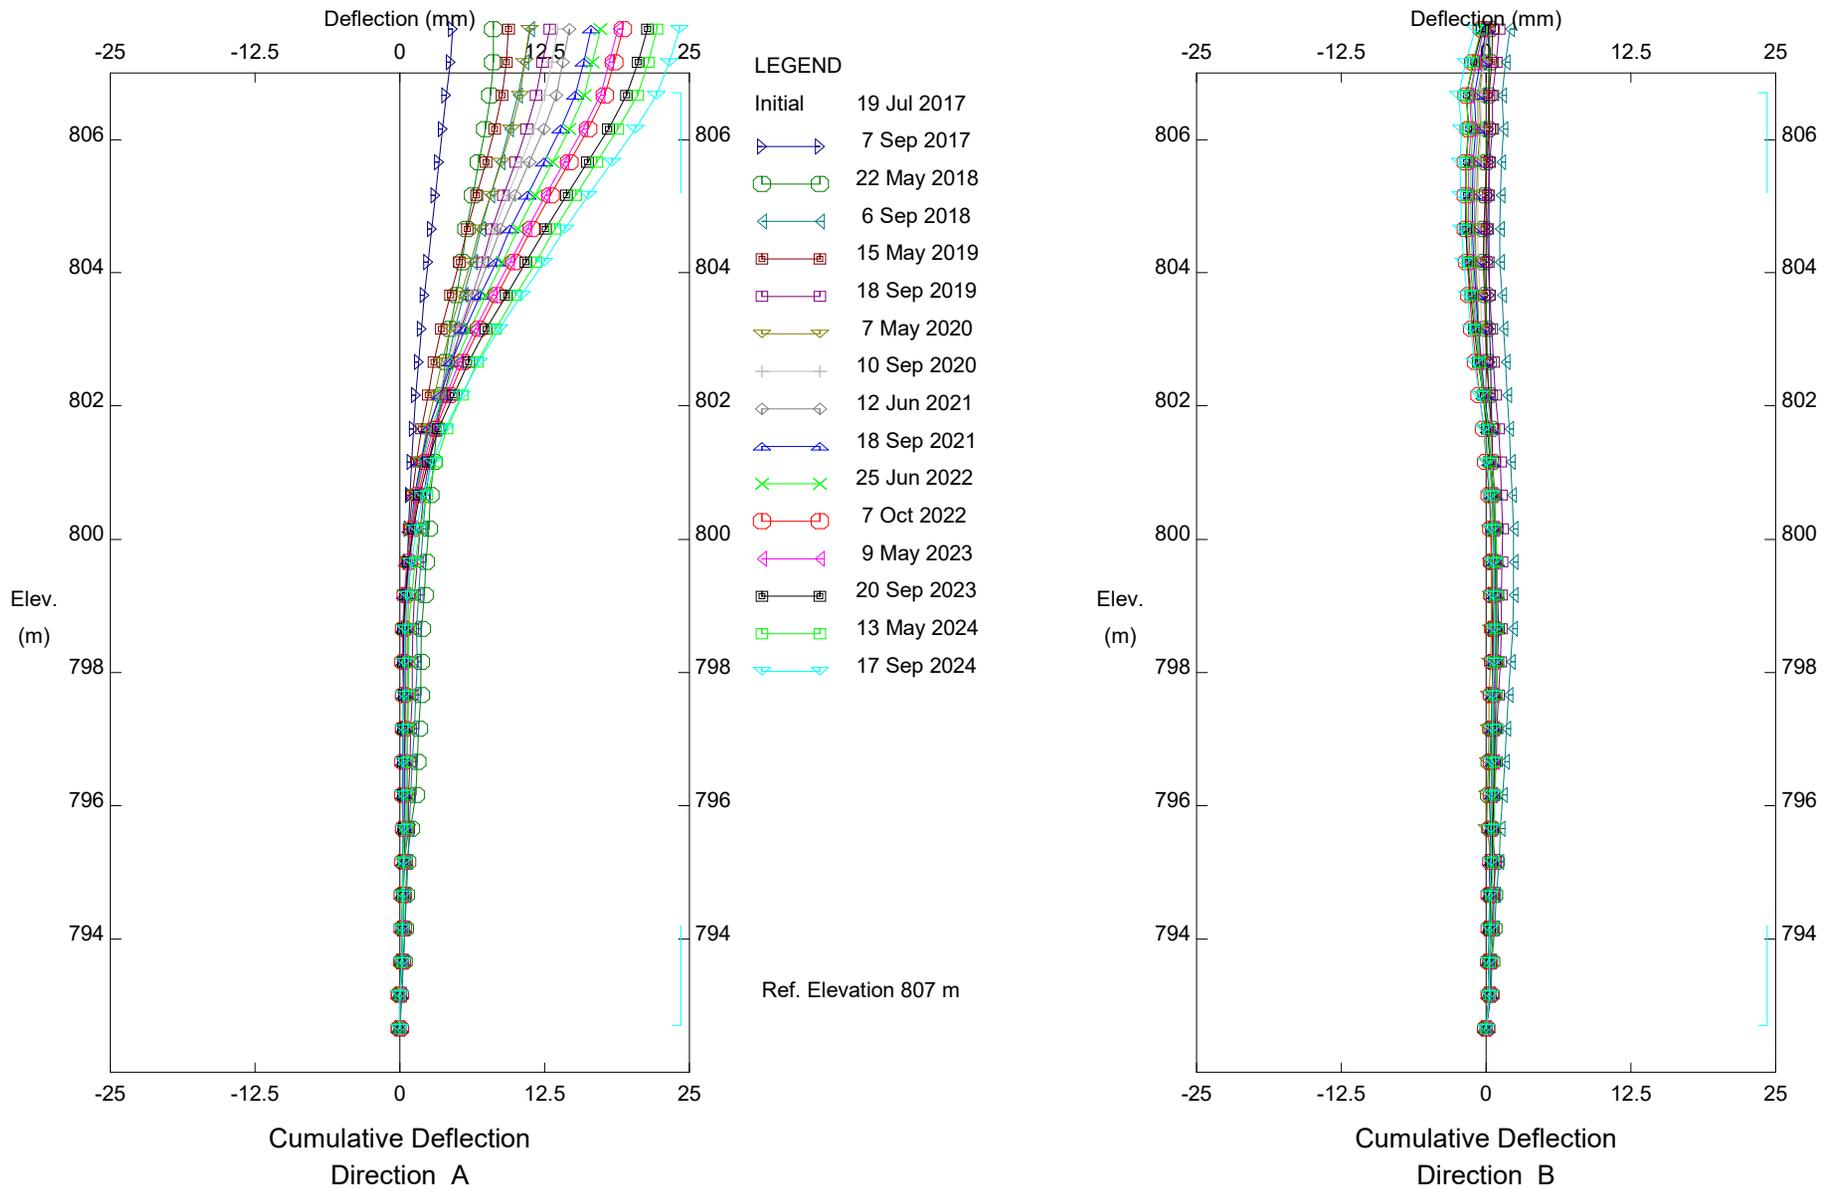
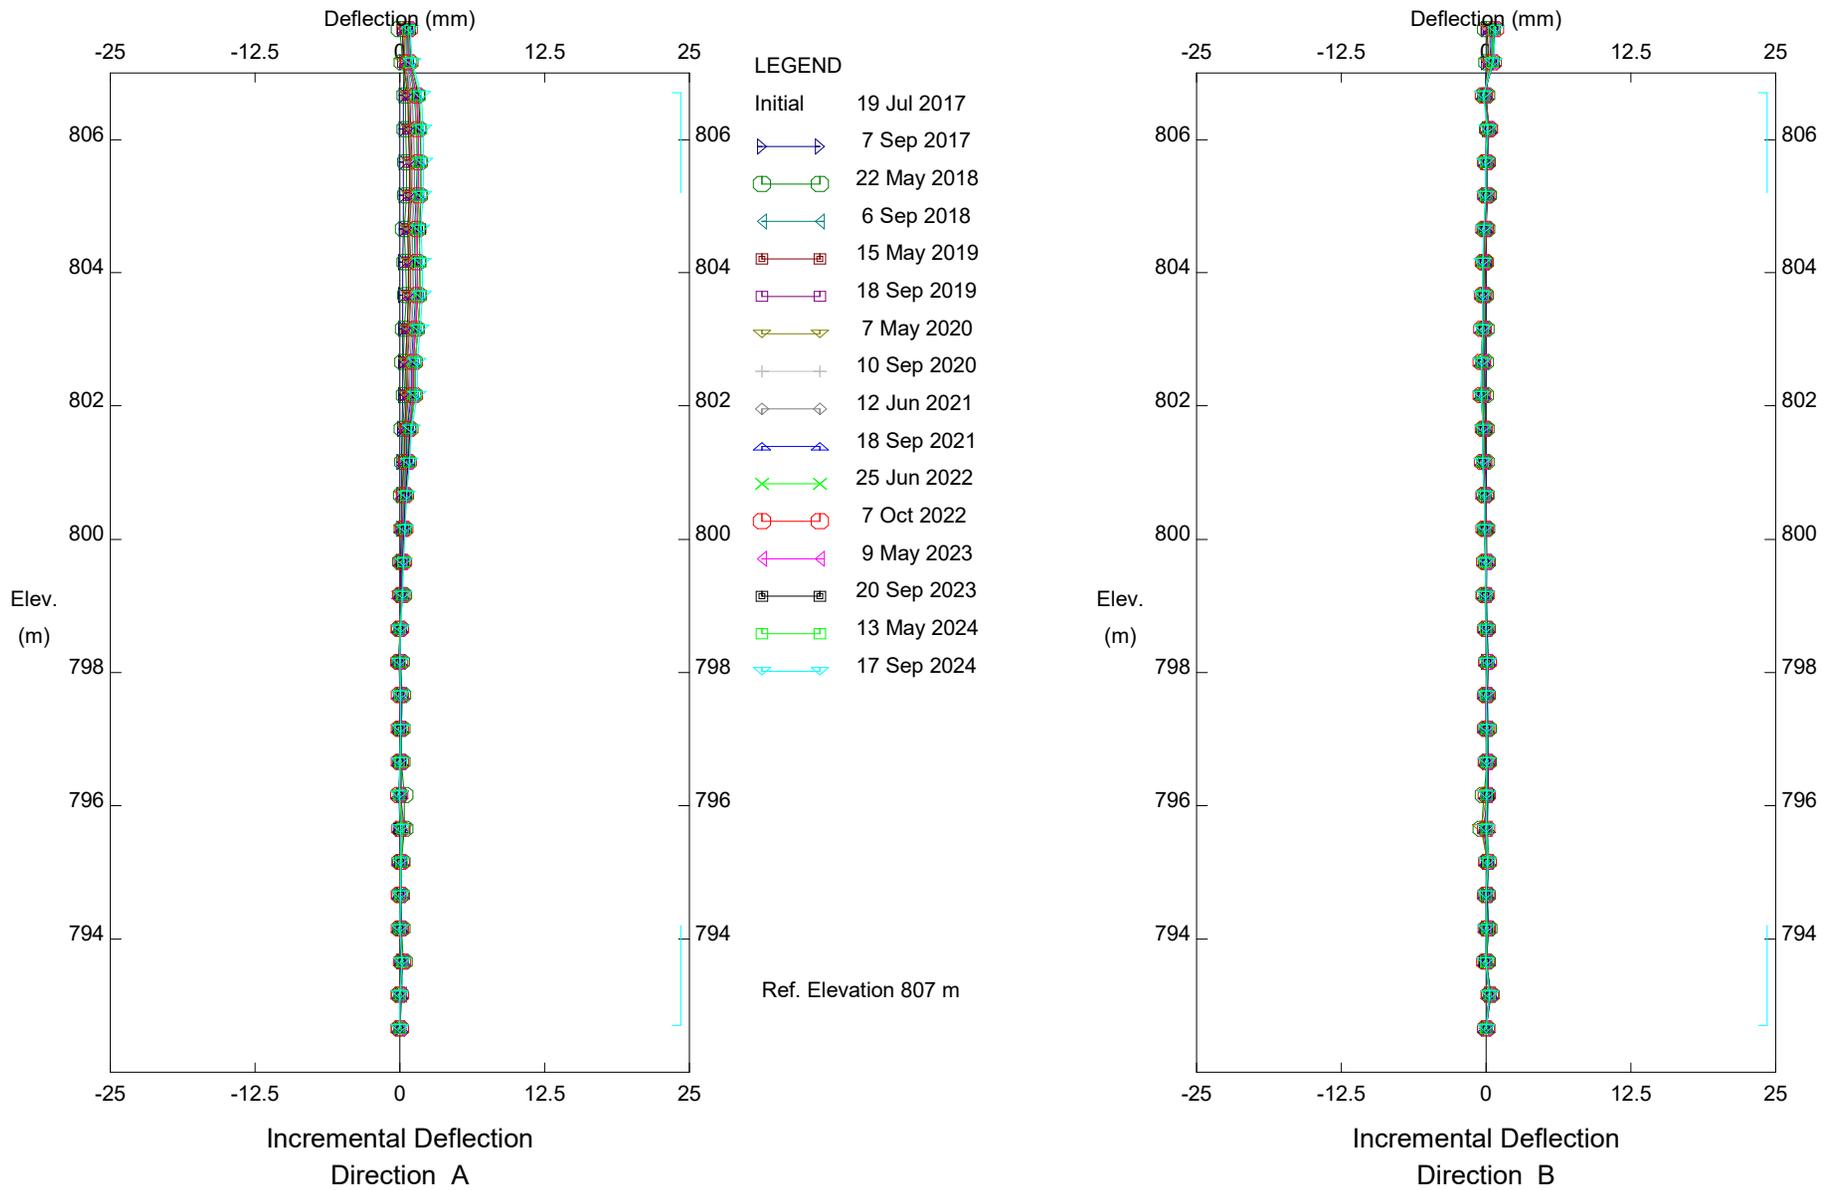
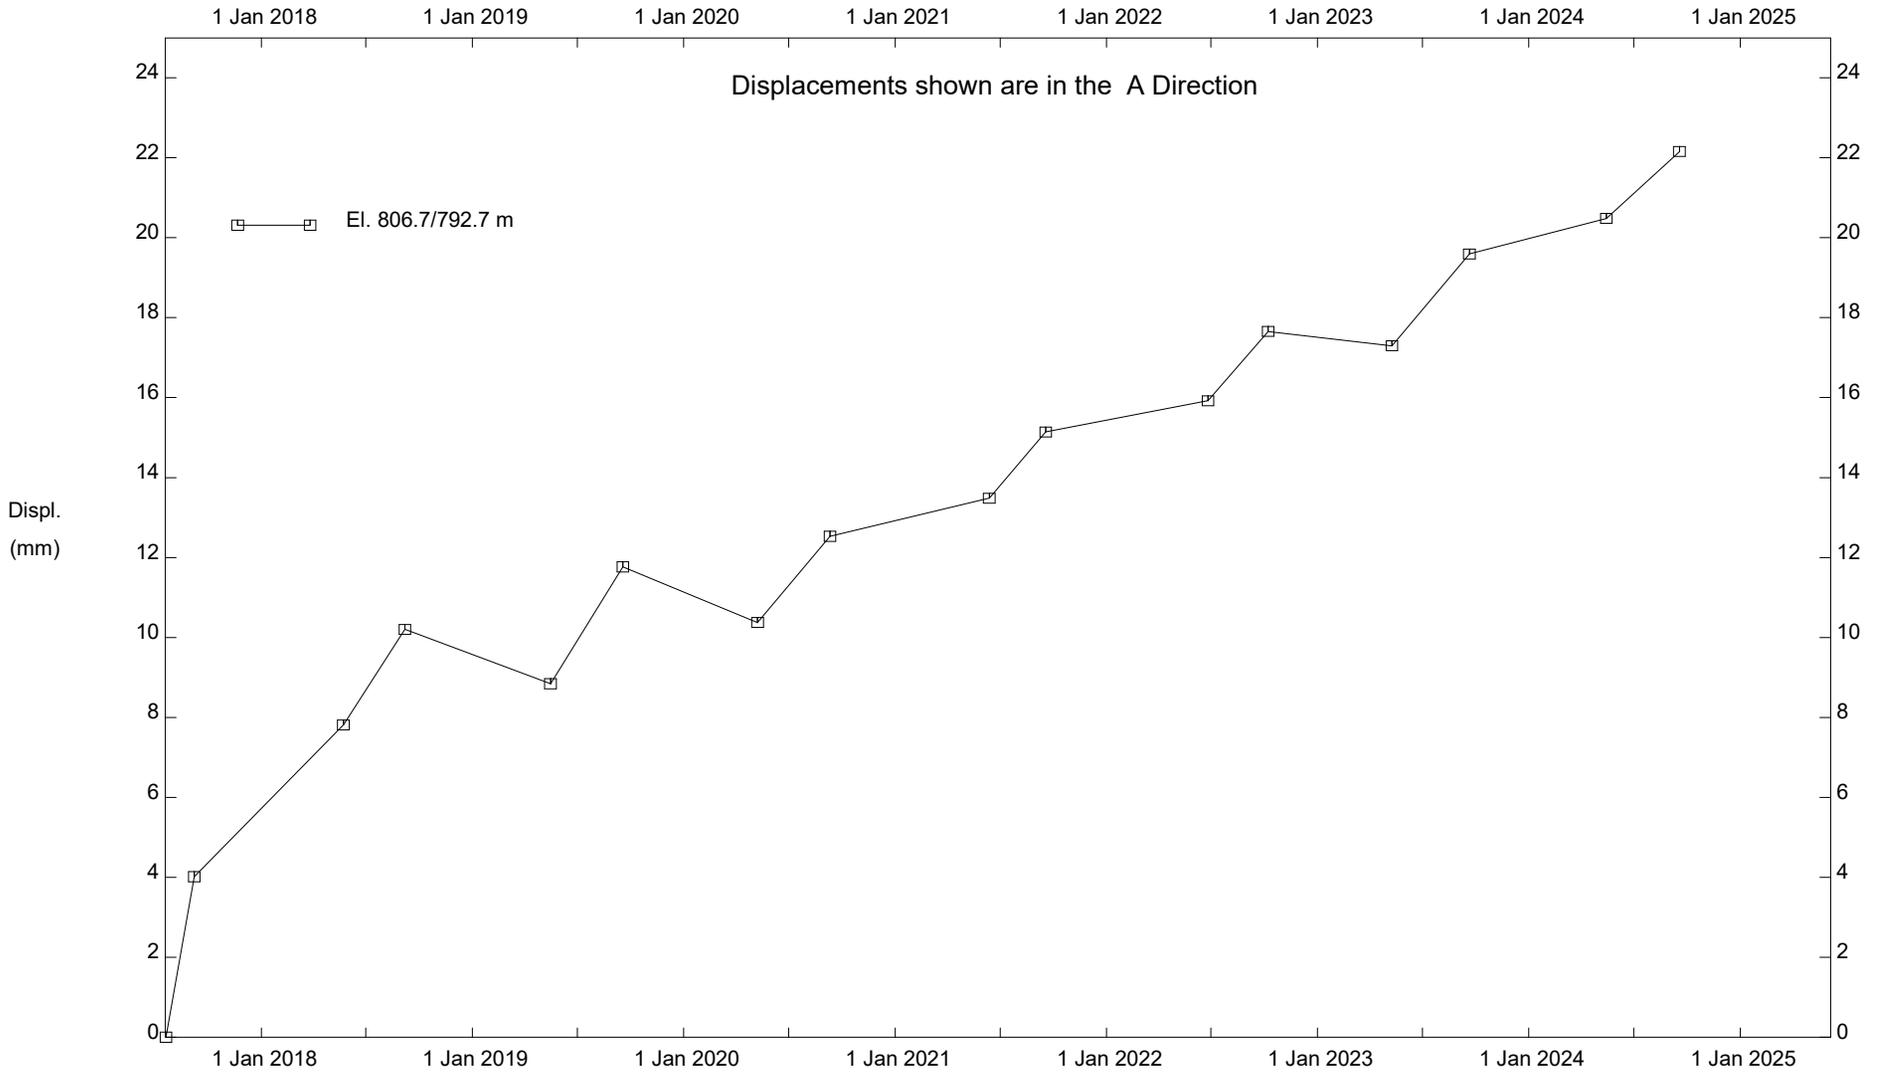
C067; H21:14, Kneehill Creek Slide, Inclinometer SI17-C67-04

Distributed movement is being recorded in the SIs installed in the H-pile wall (SI17-C67-03 though and SI17-C67-05) from top of casing to an approximate depth of 8.7 m, 7.8 m, and 6.5 m, respectively.

The depth of movement being recorded in the pile-wall SIs (SI17-C67-03 through SI17-C67-05) appears to be occurring 2 m to 4 m below the depth of movement previously recorded in SI16-01. This indicates the H-pile wall has intercepted the failure surface and is continuing to deflect, transferring load to depths below the failure plane as the piles stabilize the sliding mass.

The September 2024 data obtained from SI17-C67-03 through SI17-C67-05 indicates the top of the H-pile wall has deflected between approximately 19 mm and 31 mm since installation. The maximum rate of movement recorded in SI17-C67-03 through SI17-C67-05 was approximately 71 mm/year to 115 mm/year in May 2017, one month after the H-pile wall was installed. The rate of movement has since decreased and is now generally less than 3 mm/year, excluding:

- In September 2023, the rate of movement recorded in SI17-C067-03 through -05 increased to up to approximately 7 mm/year. Although the movement recorded in September 2023 was within historical trends for these instruments, evidence of movement (pavement cracking and settlement) primarily in the south (eastbound) lane was observed during the 2023 Section B Inspection. The increased rate of movement recorded may be attributed to settlement of the highway subgrade and fill due to H-pile wall movement between 2017 and 2023.

- In September 2024, the rate of movement recorded in SI17-C67-03 through SI17-C67-05 increased from less than approximately 2 mm/year to up to approximately 8 mm/year. The increased rate of movement may be attributed to construction activities on site (chip sealing along the site was completed in summer 2024) and wet weather in August 2024 (approximately 55 mm precipitation versus the average of 45 mm recorded between 2015 and 2024).

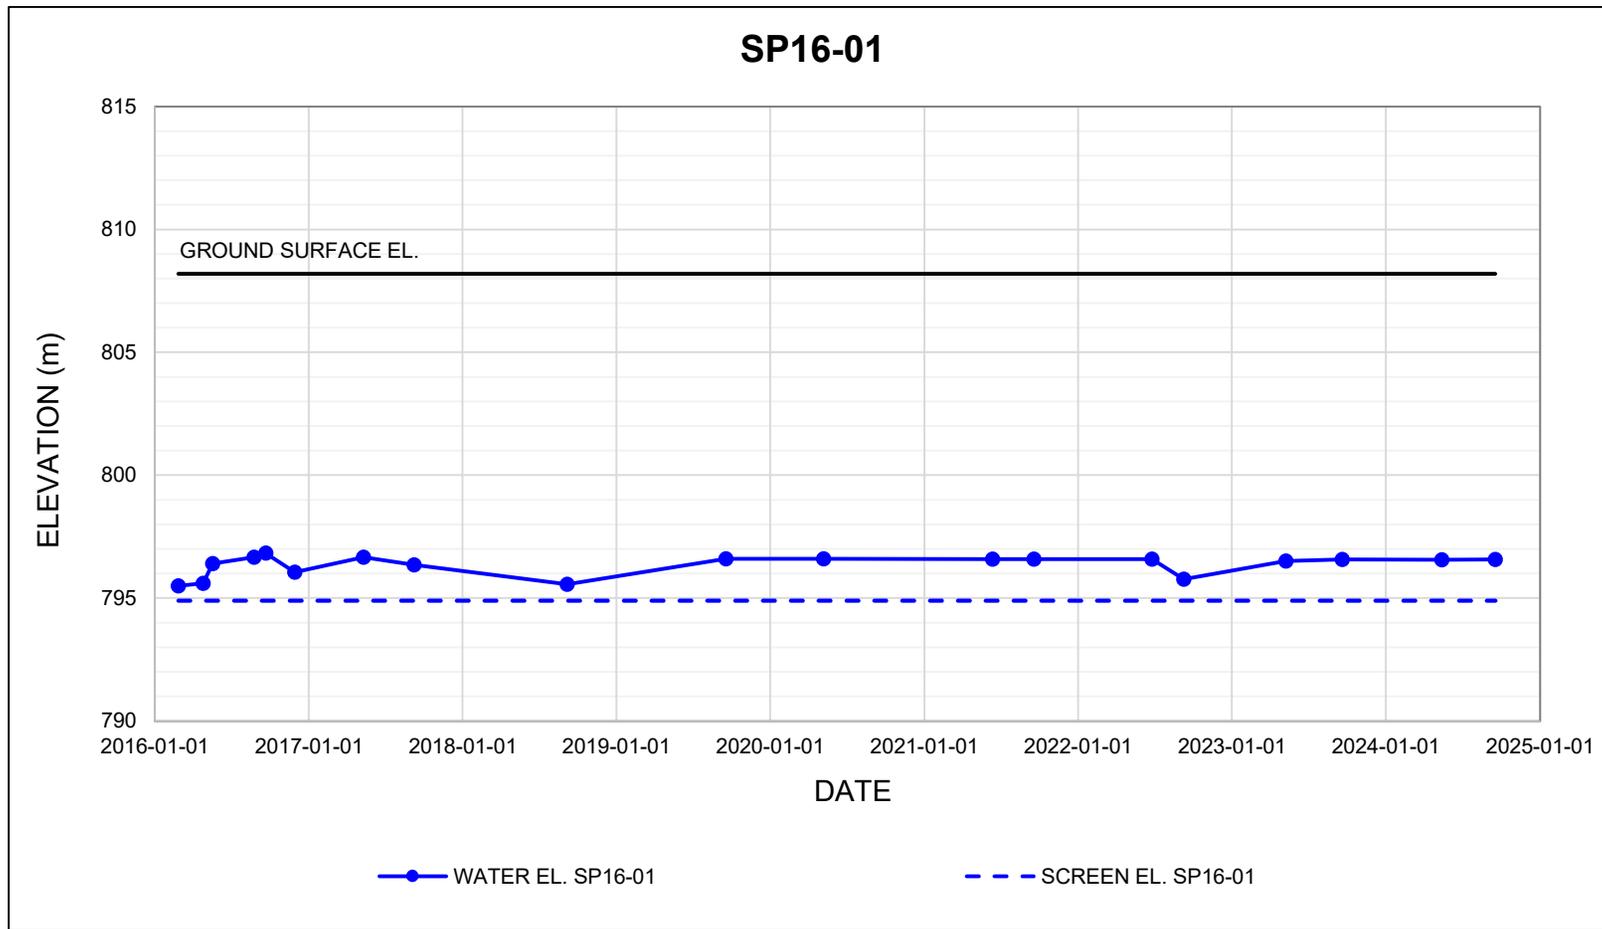
PROJECT CENTRAL REGION GEOHAZARD RISK MANAGEMENT PROGRAM		
	TITLE Piezometer Data C067 - Kneehill Creek Slide Hwy 21:14, km 12.988

Since installation in February 2016, water levels recorded in SP16-01 have been relatively steady varying from 11.4 m to 12.7 m below ground surface. The September 2024 reading of 11.6 m below ground surface was the same as the previous reading in May 2024 and is consistent with historical trends observed in this instrument.
