July 15, 2024

Alberta Transportation and Economic Corridors
4th Floor, Provincial Building
4920 – 51st Street
Red Deer, Alberta
T4N 6K8

CON0022160 Central Region GRMP Instrumentation Monitoring
Site C067; H21:14, km 12.988 Kneehill Creek Slide
Section C – 2024 Spring Readings

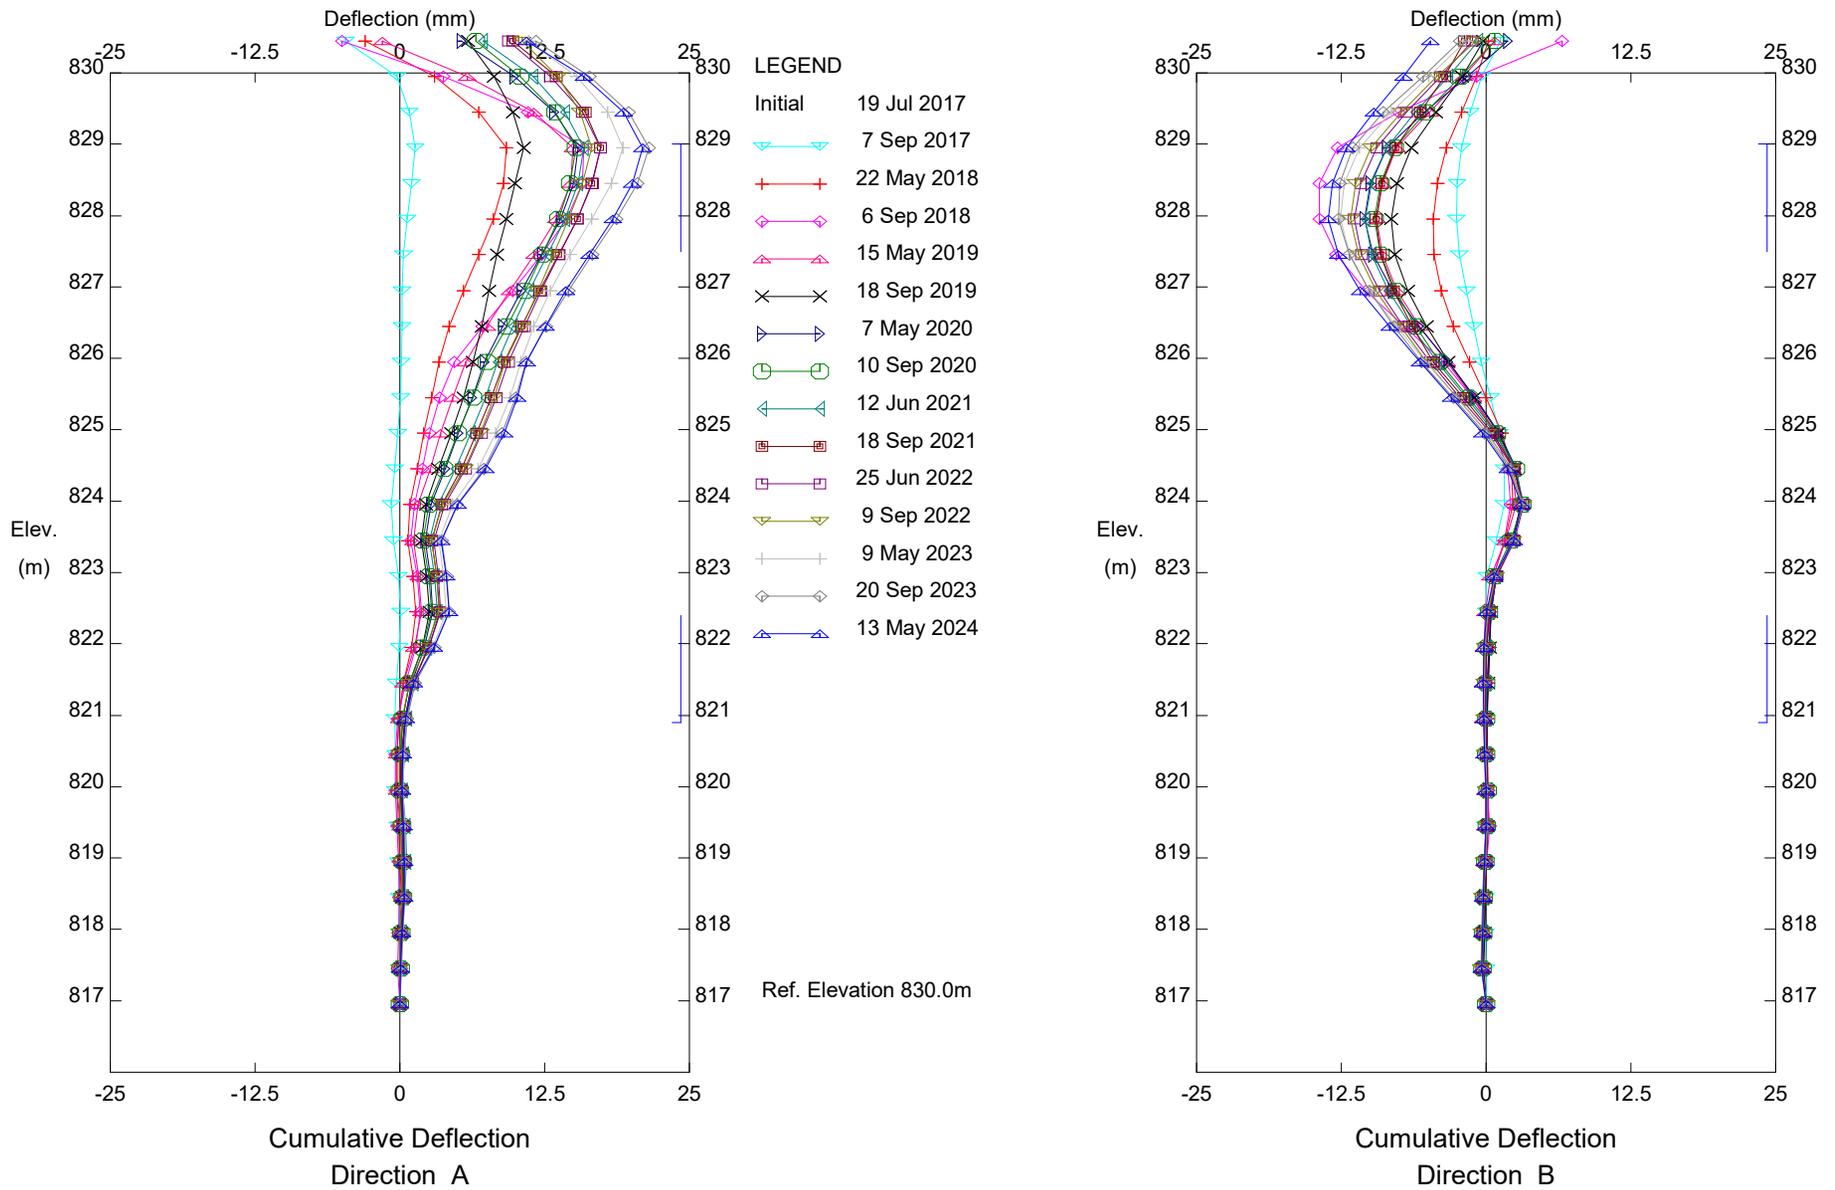
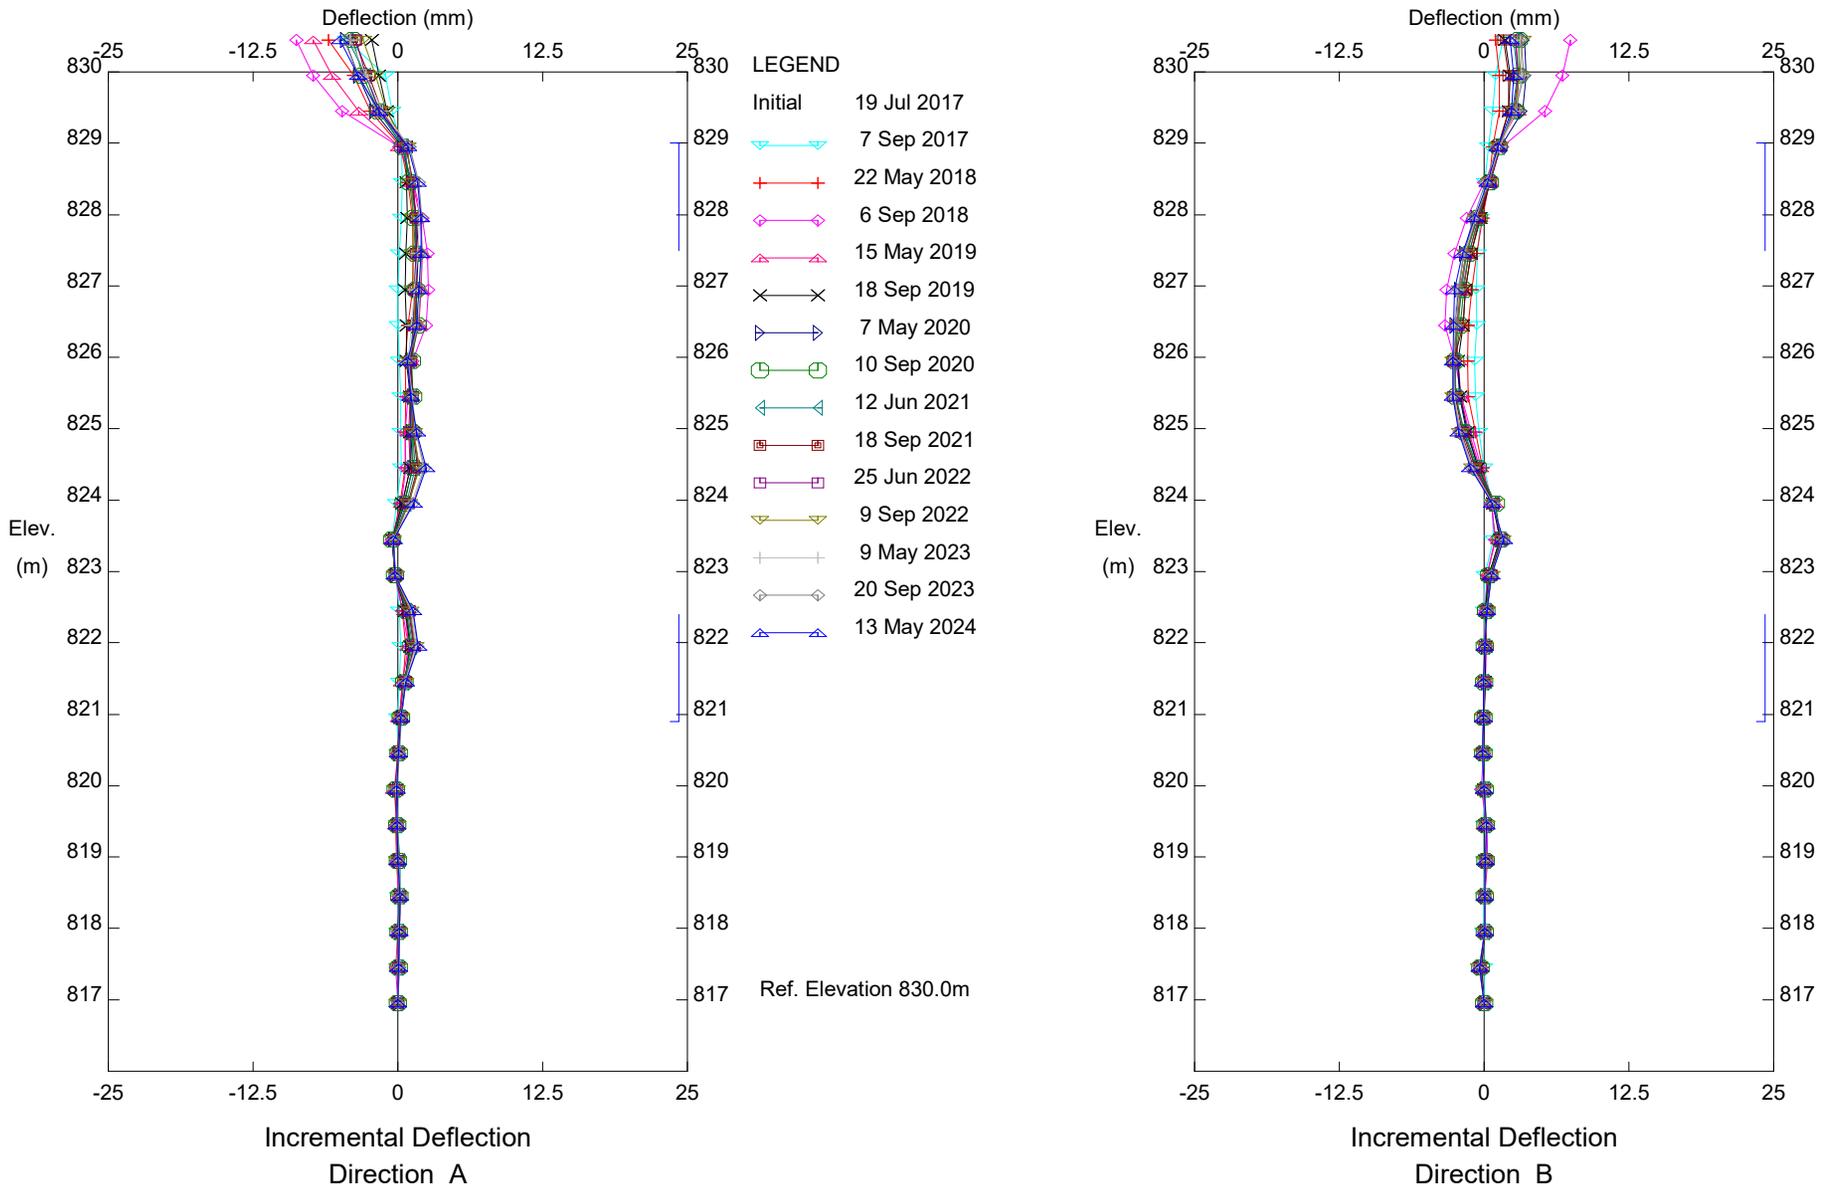
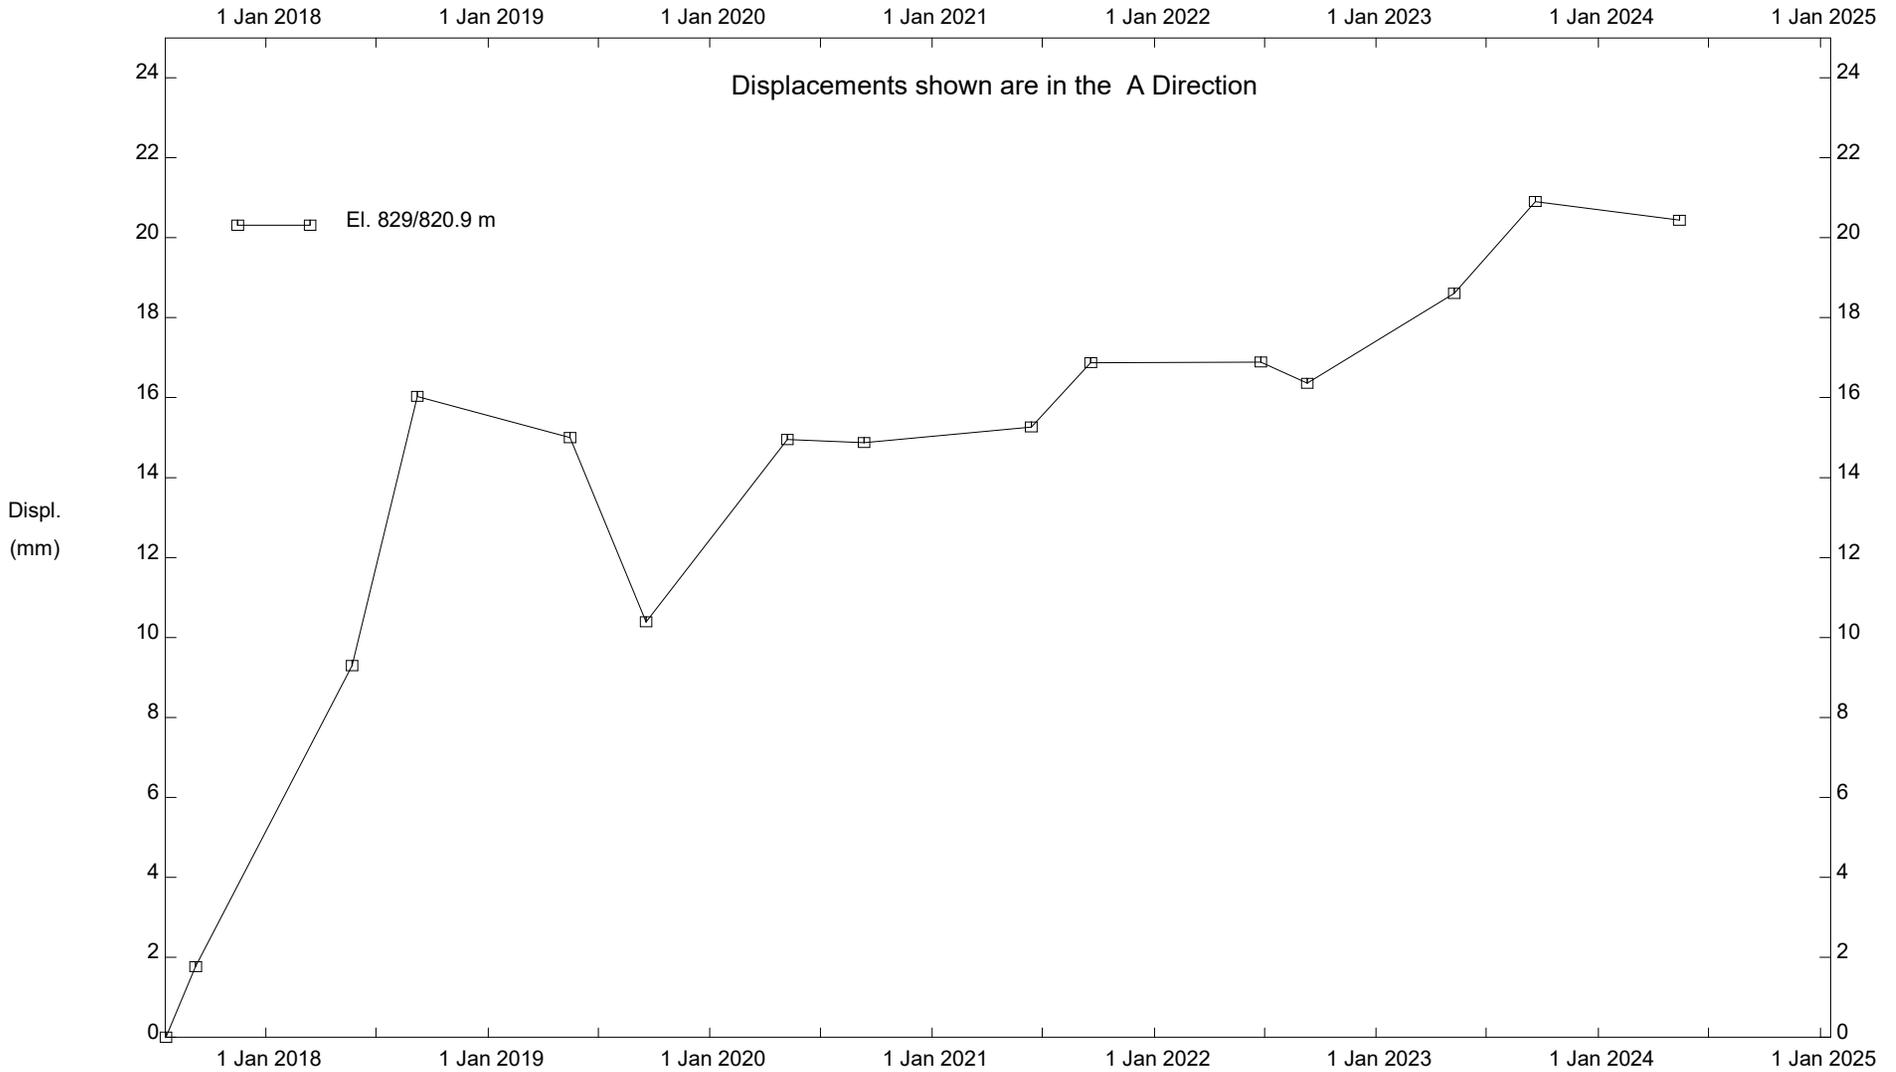
C067; H21:14, Kneehill Creek Slide, Inclinometer SI16-02

Distributed movement is being recorded in SI16-02 (downslope of the Site A H-pile wall) from near ground surface to approximately 9 m below ground surface or approximately 6.5 m above the base of the H-pile wall.

Data obtained from SI16-02 (installed upslope of the H-pile wall) indicates the active block upslope of the H-pile wall continues to creep as the H-pile wall stabilizes the sliding mass. Before the H-pile wall was installed, the maximum rate of movement recorded in SI16-02 was approximately 205 mm/year on February 21, 2017. Between April and May 2017, after installation of the H-pile wall, the rate of movement recorded in SI16-02 increased to approximately 345 mm/year. Since September 2018, the overall rate of movement recorded in this instrument has been relatively steady (less than 7 mm/year). The negative rate of displacement recorded in May 2024 (approximately -0.7 mm/year) indicates the rate of movement is slow, within the reading accuracy of the SI equipment, and is consistent with historical trends.

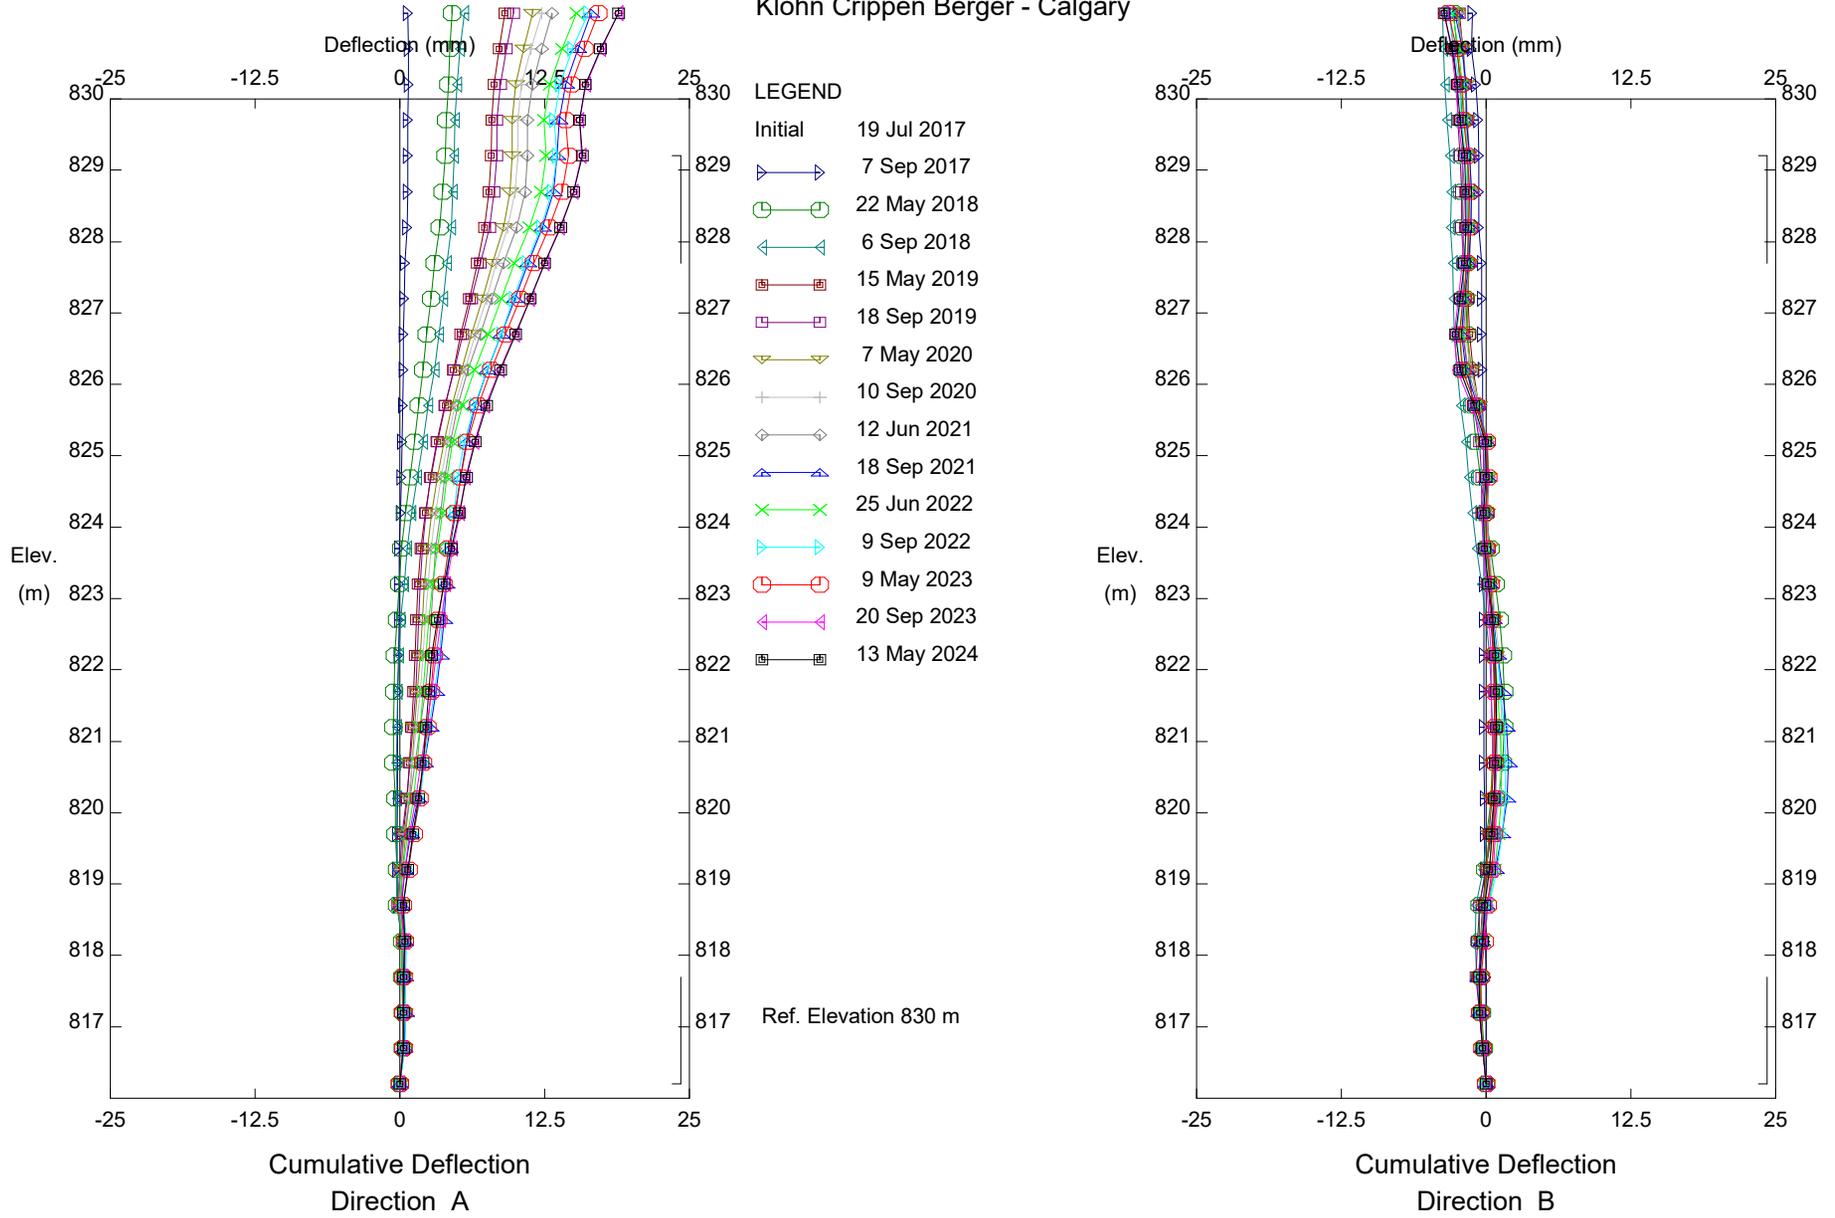
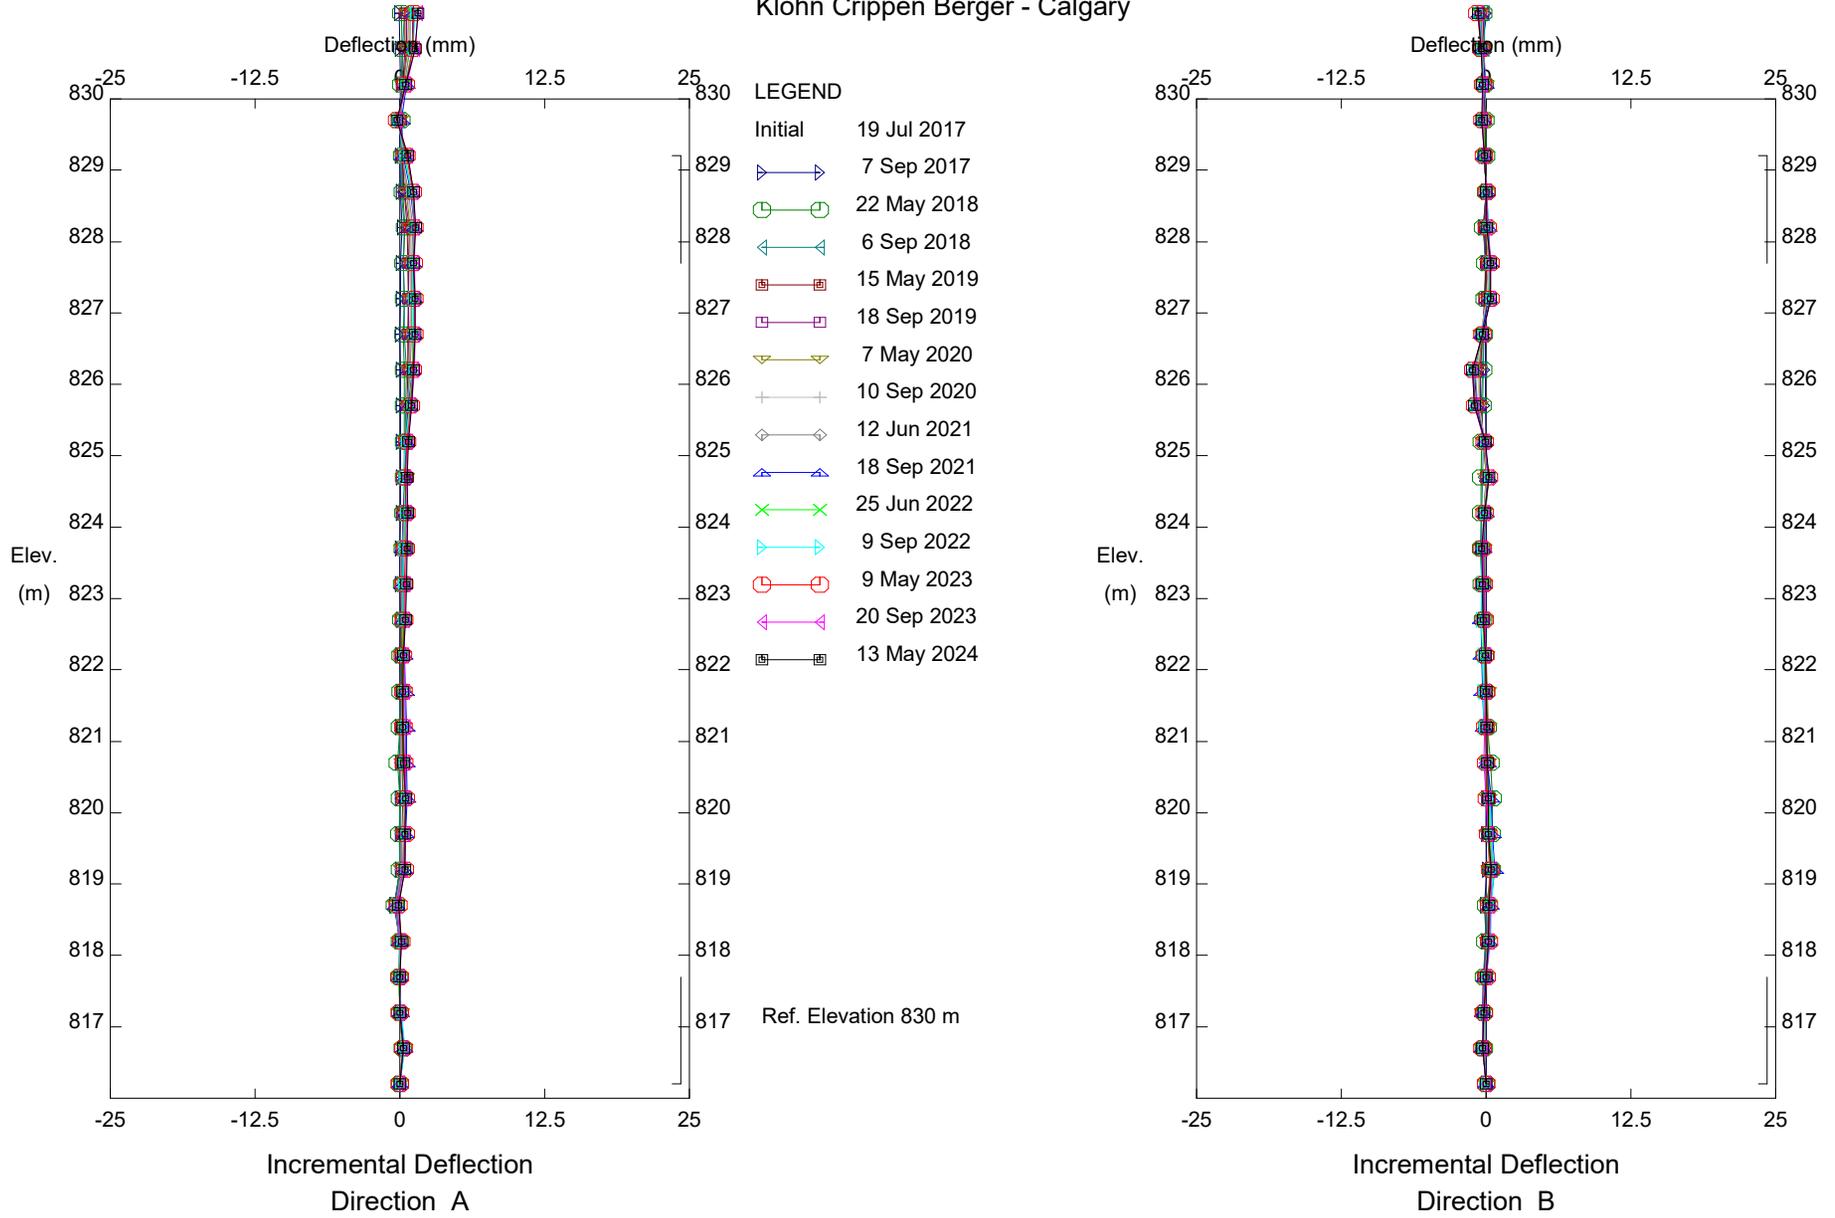
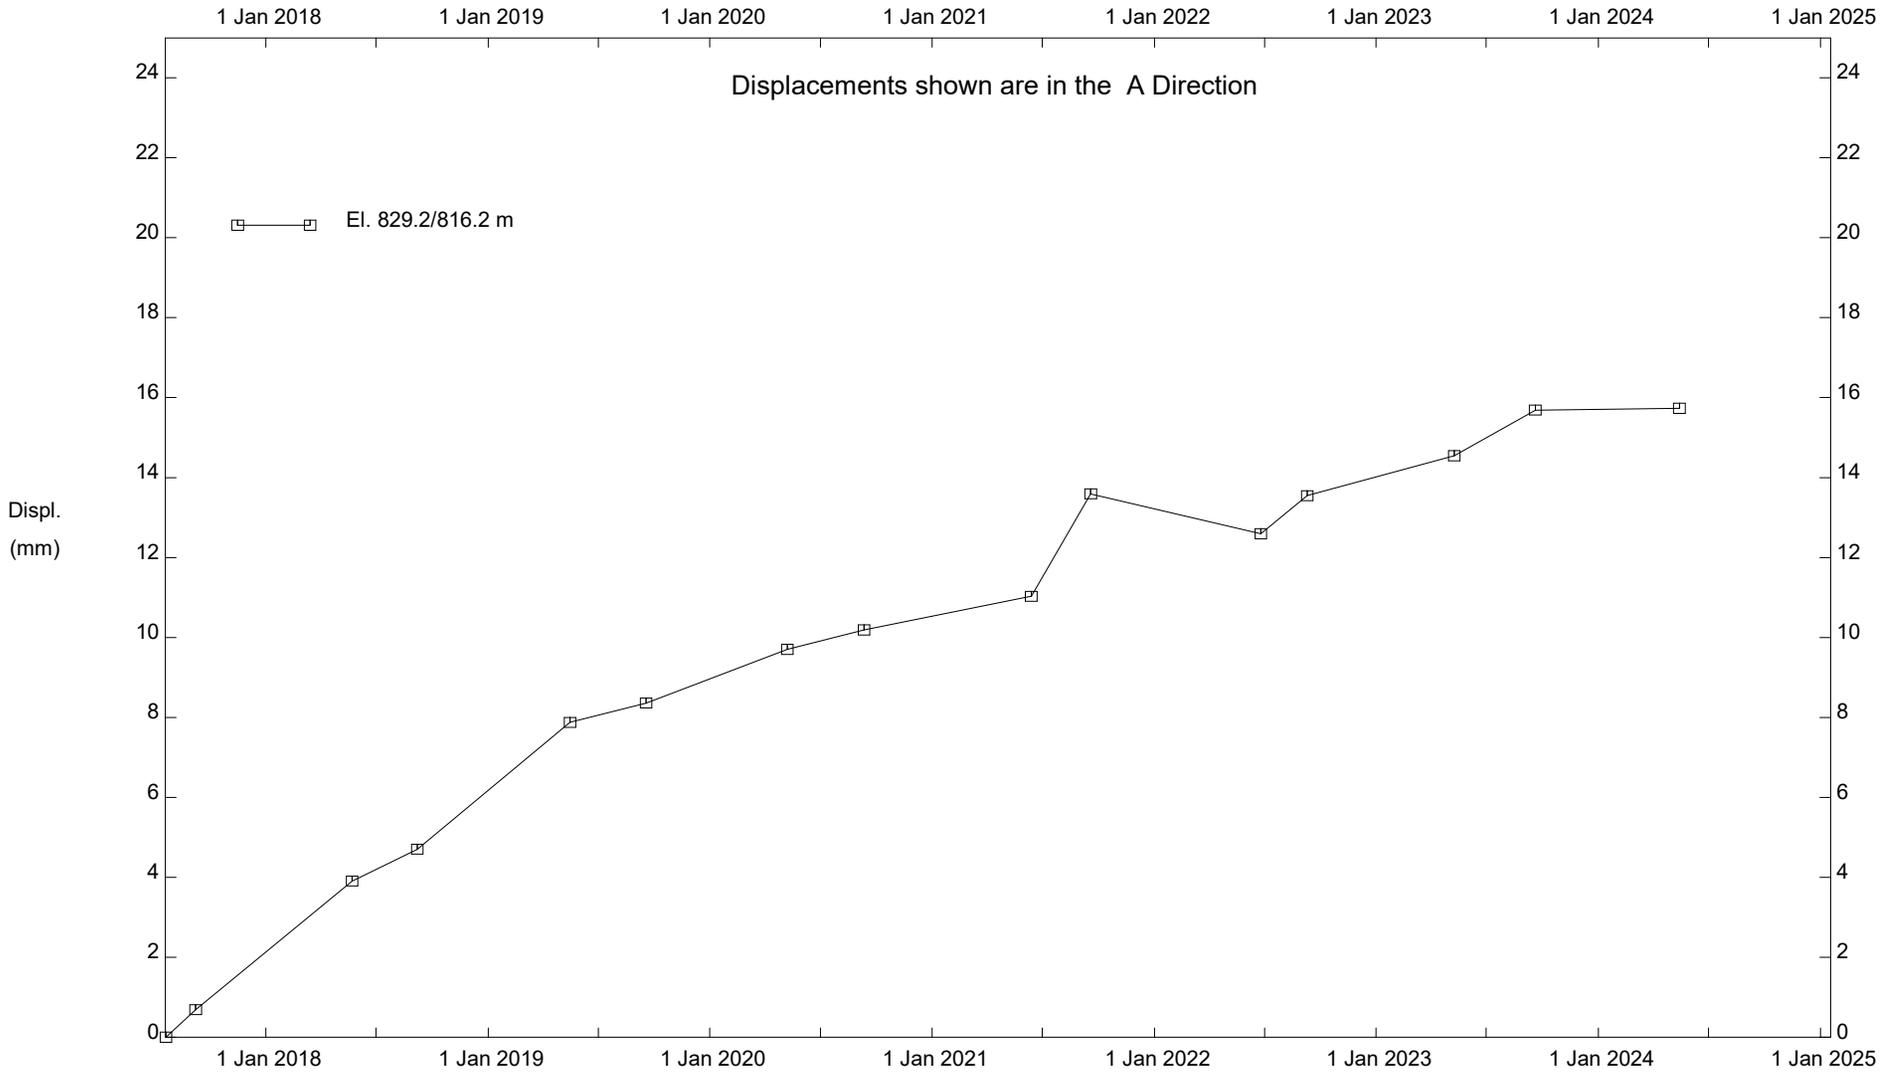
C067; H21:14, Kneehill Creek Slide, Inclinometer SI17-C67-01

Distributed movement is being recorded in the SIs installed in the H-pile wall (SI17-C67-01 and SI17-C67-02) from top of casing to an approximate depth of 11 m below ground surface or approximately 4 m above the base of the H-pile wall.

The deepest zone of movement being recorded in the pile-wall SIs (SI17-C67-01 and SI17-C67-02) appears to be approximately 2 m below the depth of movement recorded in SI16-02. This indicates the H-pile wall has intercepted the failure surface and is continuing to deflect, transferring load to depths below the failure plane as the piles stabilize the sliding mass.

The May 2024 data obtained from SI17-C67-01 and SI17-C67-02 indicates the top of the H-pile wall at Site A has deflected between approximately 16 mm and 23 mm since installation. In May 2017, the maximum rate of movement recorded in SI17-C67-01 and SI17-C67-02 was approximately 45 mm/year, one month after the H-pile wall was installed. The rate of movement has since slowed and is now generally less than 5 mm/year, except for between June and September 2022 when an increased rate of movement of approximately 4 mm/year and 9 mm/year was recorded in SI17-C67-01 and SI17-C67-02, respectively, likely in response to wet weather in June and July 2022.

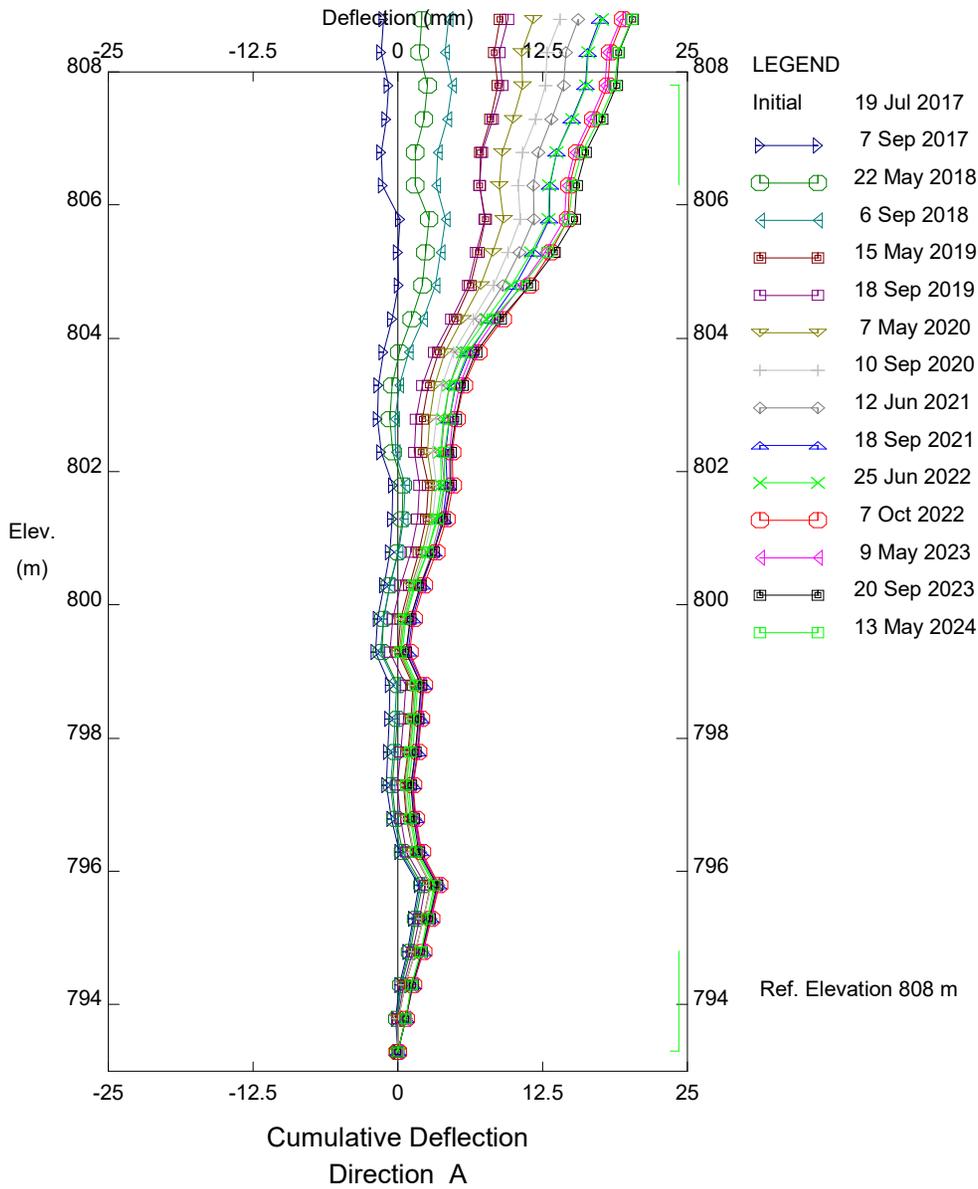
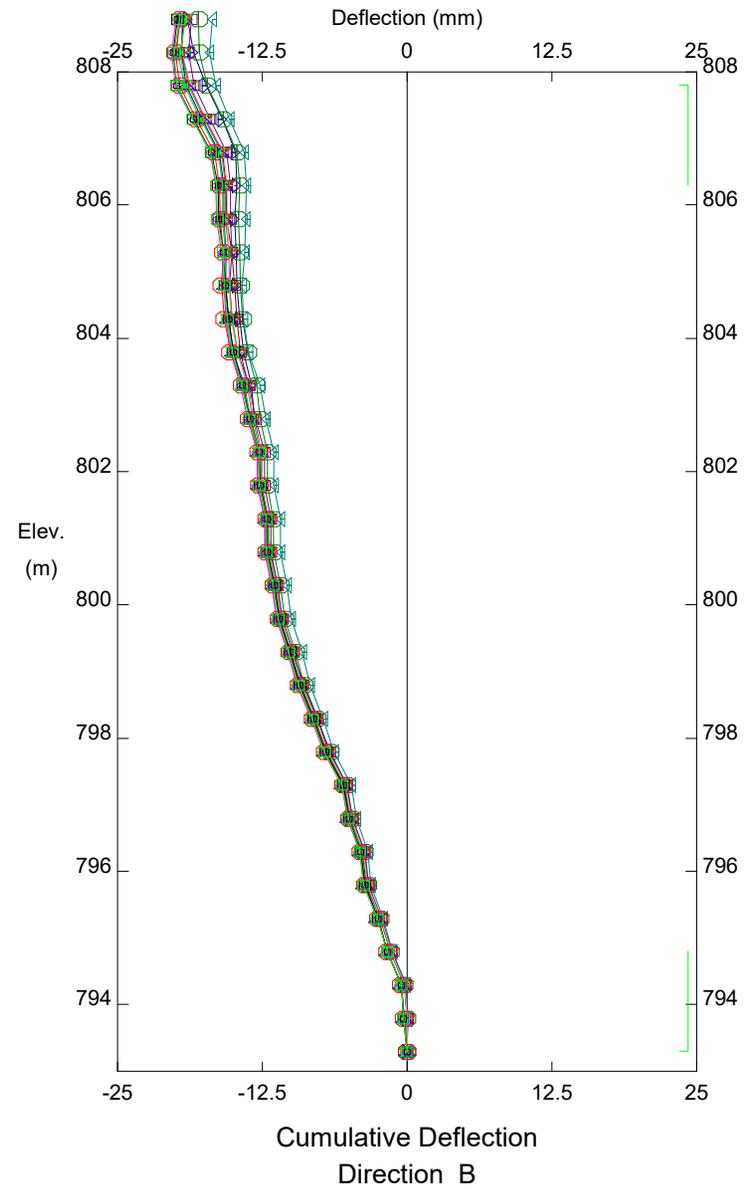
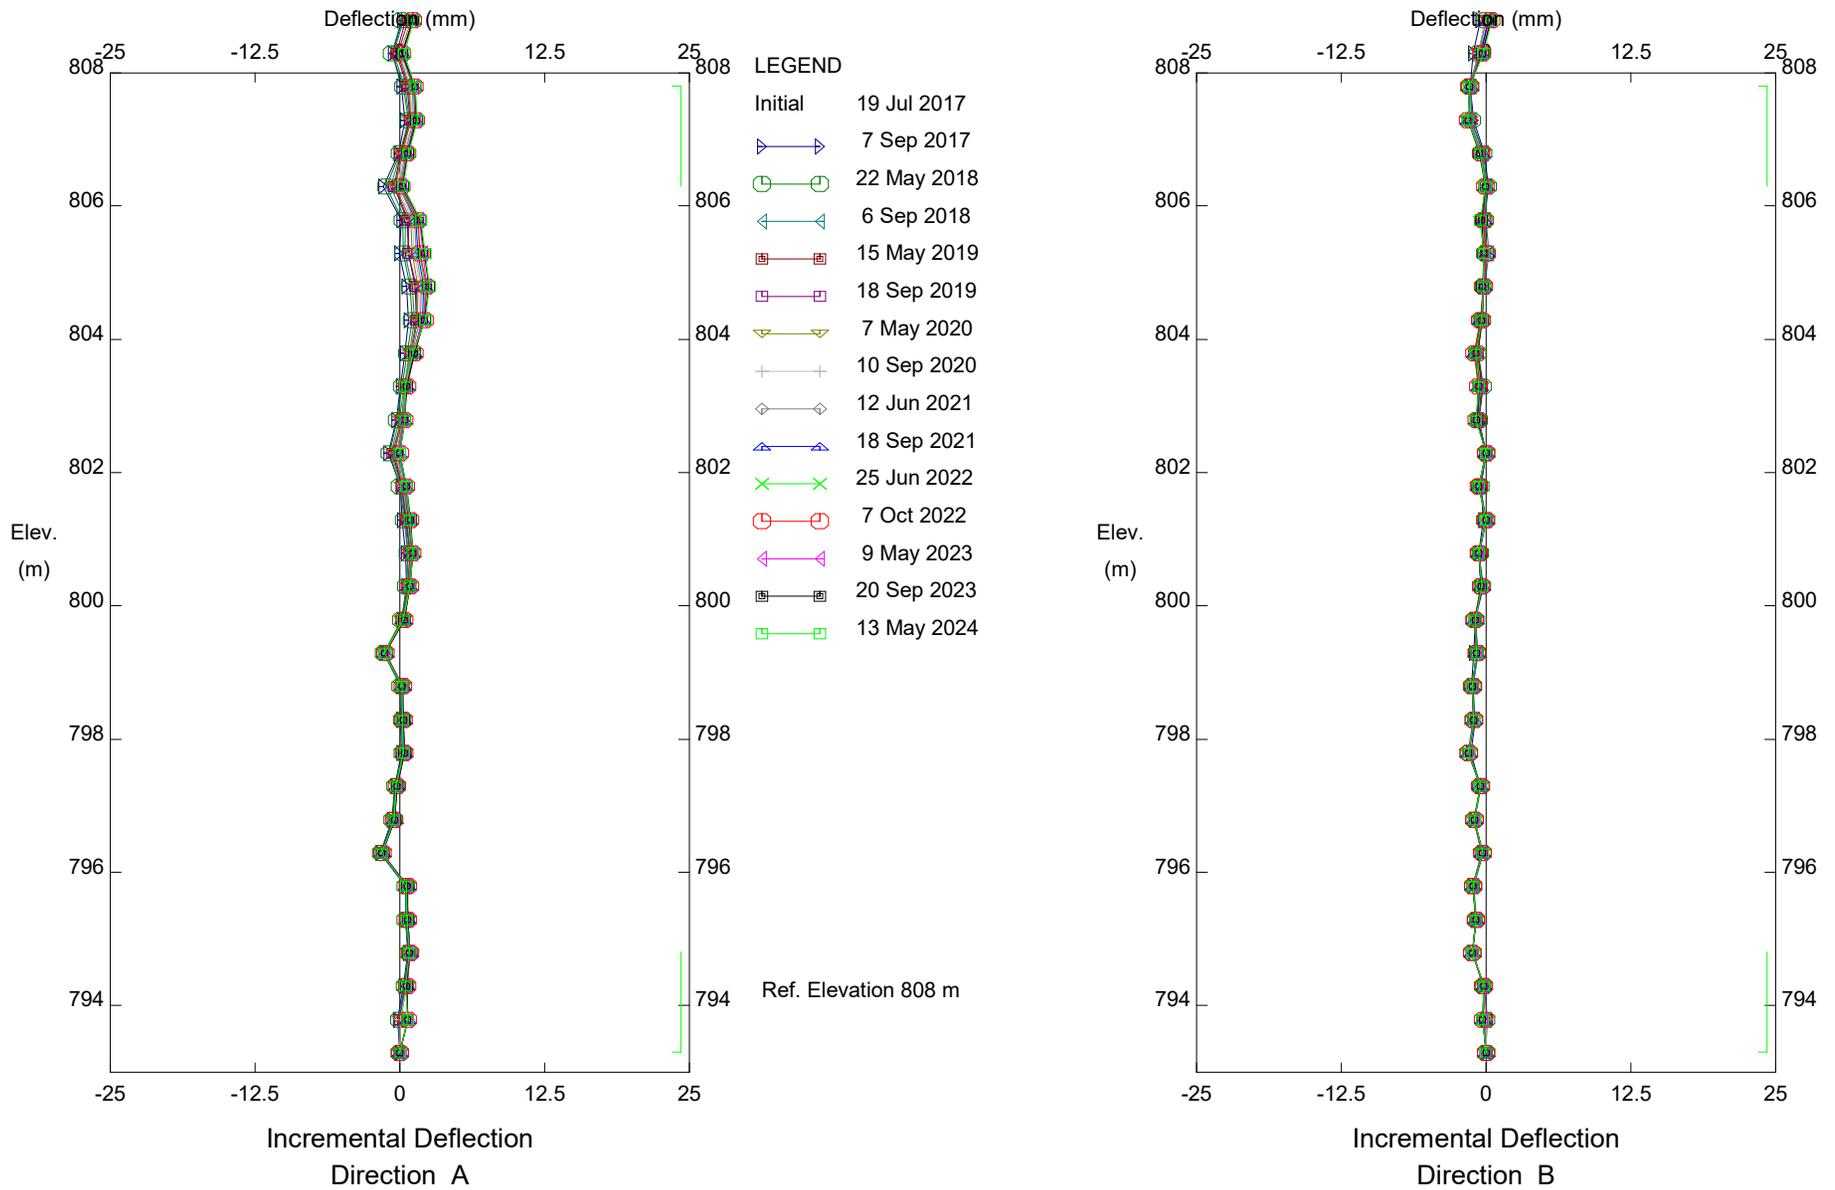
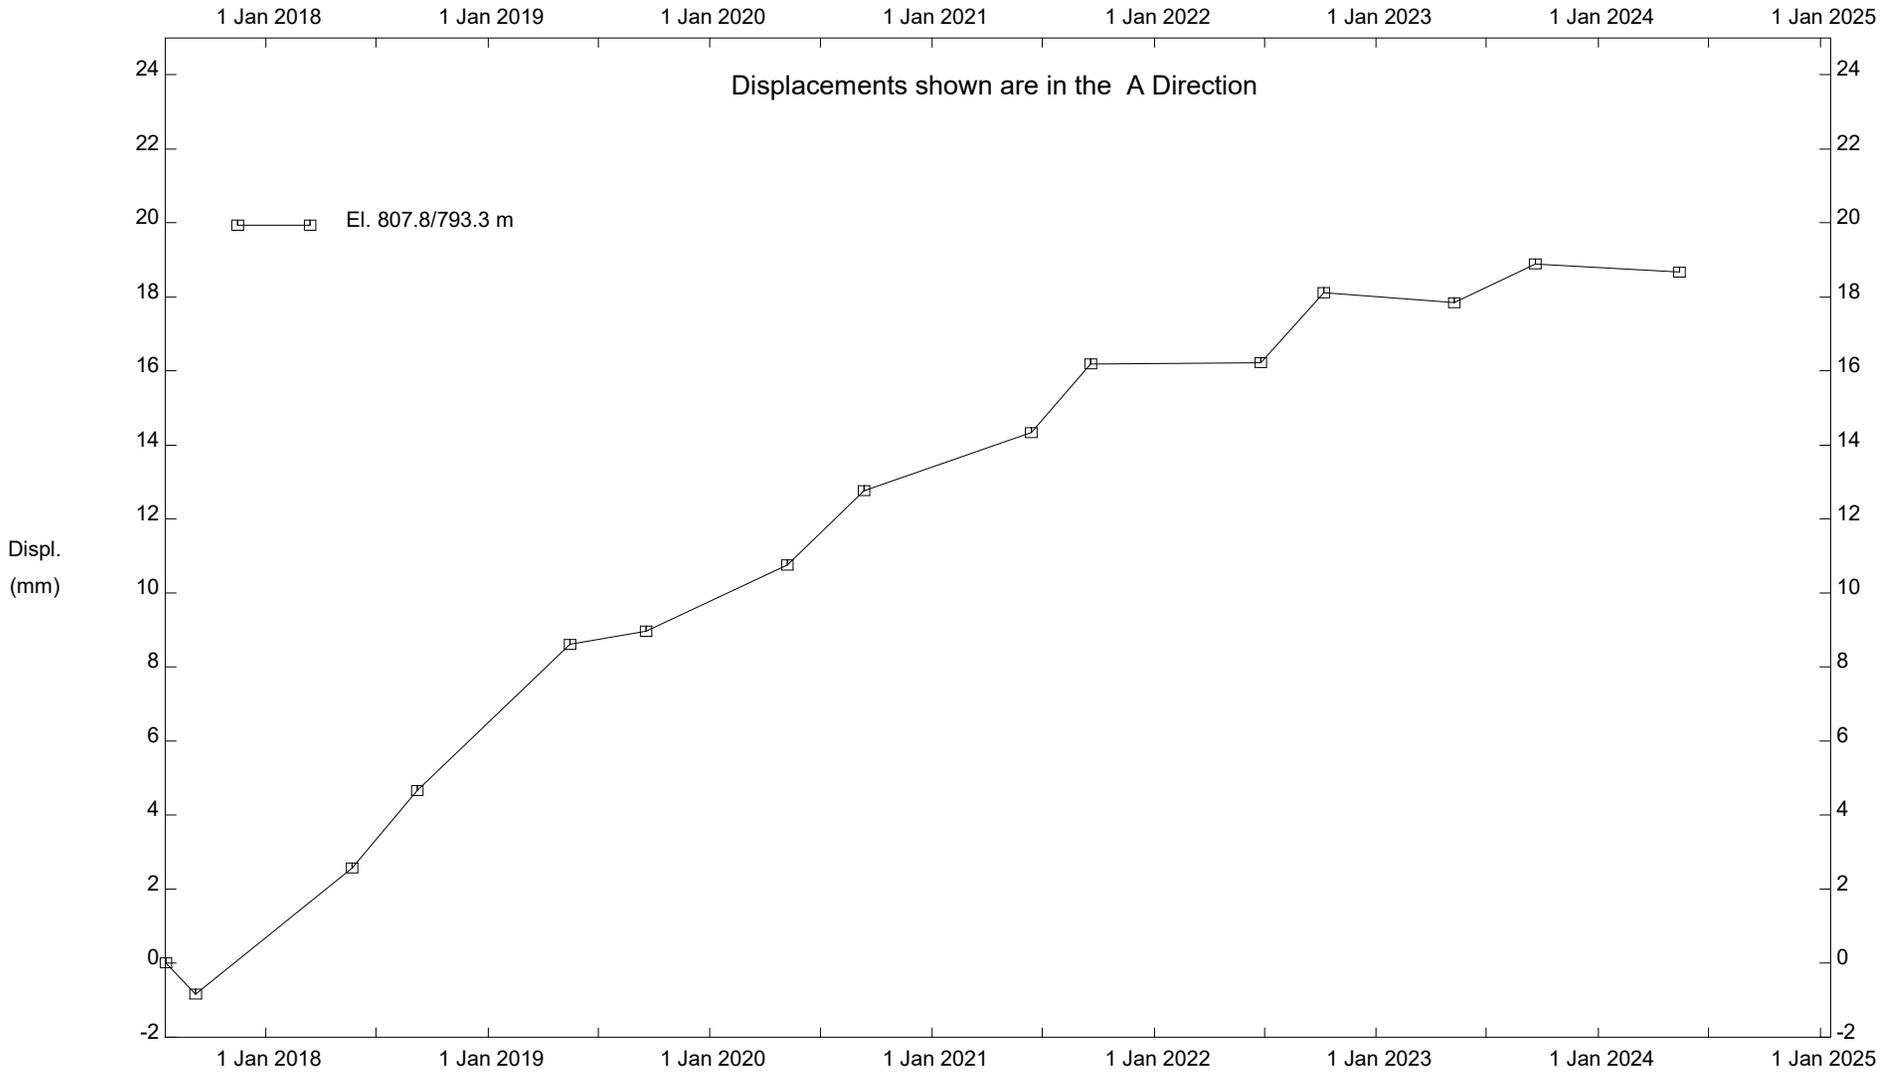
C067; H21:14, Kneehill Creek Slide, Inclinometer SI17-C67-03

Distributed movement is being recorded in the SIs installed in the H-pile wall (SI17-C67-03 though and SI17-C67-05) from top of casing to an approximate depth of 8.7 m, 7.8 m, and 6.5 m, respectively.

The depth of movement being recorded in the pile-wall SIs (SI17-C67-03 through SI17-C67-05) appears to be occurring 2 m to 4 m below the depth of movement previously recorded in SI16-01. This indicates the H-pile wall has intercepted the failure surface and is continuing to deflect, transferring load to depths below the failure plane as the piles stabilize the sliding mass.

The May 2024 data obtained from SI17-C67-03 through SI17-C67-05 indicates the top of the H-pile wall has deflected between approximately 17 mm and 29 mm since installation. The maximum rate of movement recorded in SI17-C67-03 through SI17-C67-05 was approximately 71 mm/year to 115 mm/year in May 2017, one month after the H-pile wall was installed. The rate of movement has since decreased and is now less than 3 mm/year.

Between June and September 2023, the rate of movement recorded in SI17-C067-03 through -05 increased to between approximately 3 mm/year and 7 mm/year. Although the movement recorded in September 2023 was within historical trends for these instruments, evidence of movement (pavement cracking and settlement) primarily in the south (eastbound) lane was observed during the 2023 Section B Inspection. The movement recorded in September 2023 may be attributed to

settlement of the highway subgrade and fill due to H-pile wall movement between 2017 (i.e., installation) and 2023. Between the September 2023 and May 2024 readings, the rates of movement recorded in SI17-C67-03 through SI17-C67-05 have decreased to less than 1.5 mm/year (negative movement recorded in SI17-C67-03 and SI17-C67-04 indicates the rate of movement is within the reading accuracy of the SI equipment).
