July 15, 2024

Alberta Transportation and Economic Corridors
4th Floor, Provincial Building
4920 – 51st Street
Red Deer, Alberta
T4N 6K8

CON0022160 Central Region GRMP Instrumentation Monitoring
Site C067; H21:14, km 12.988 Kneehill Creek Slide
Section C – 2024 Spring Readings

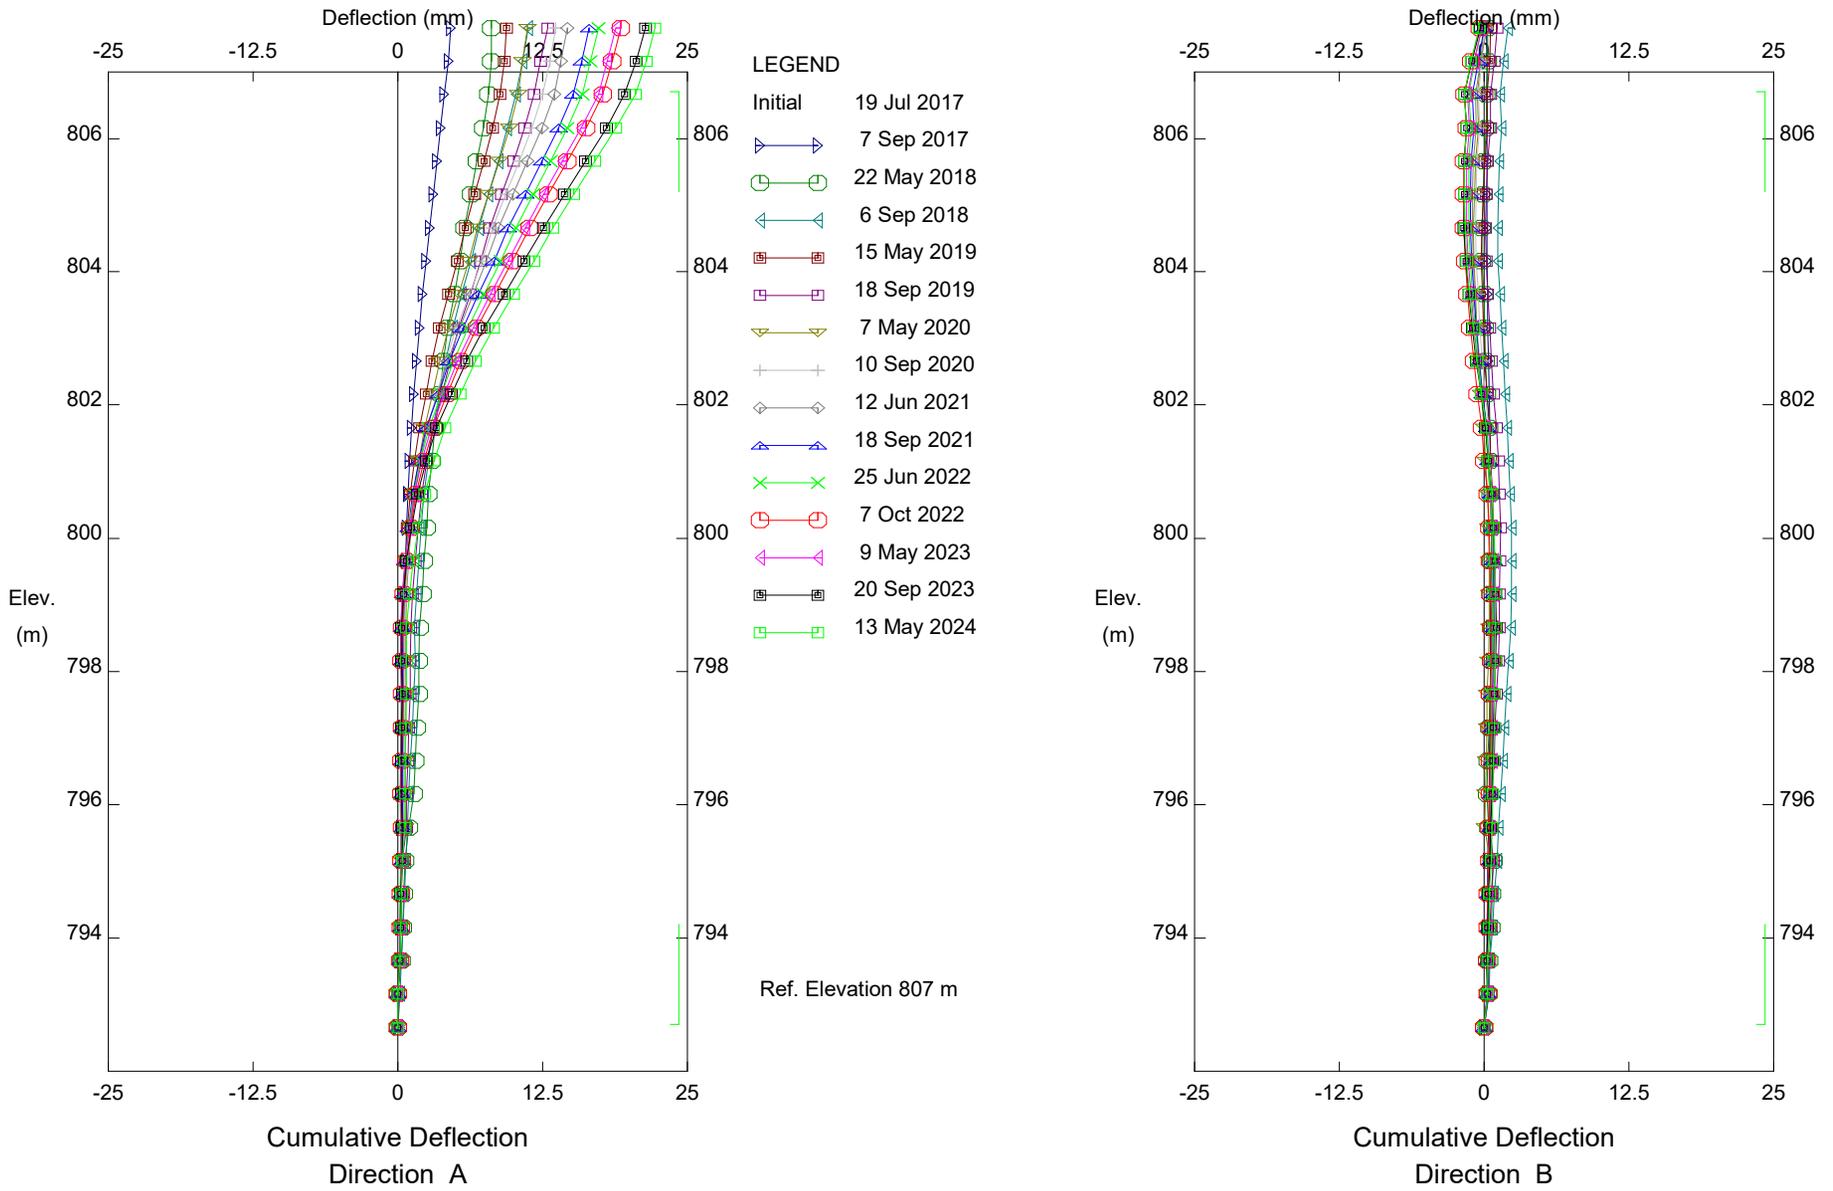
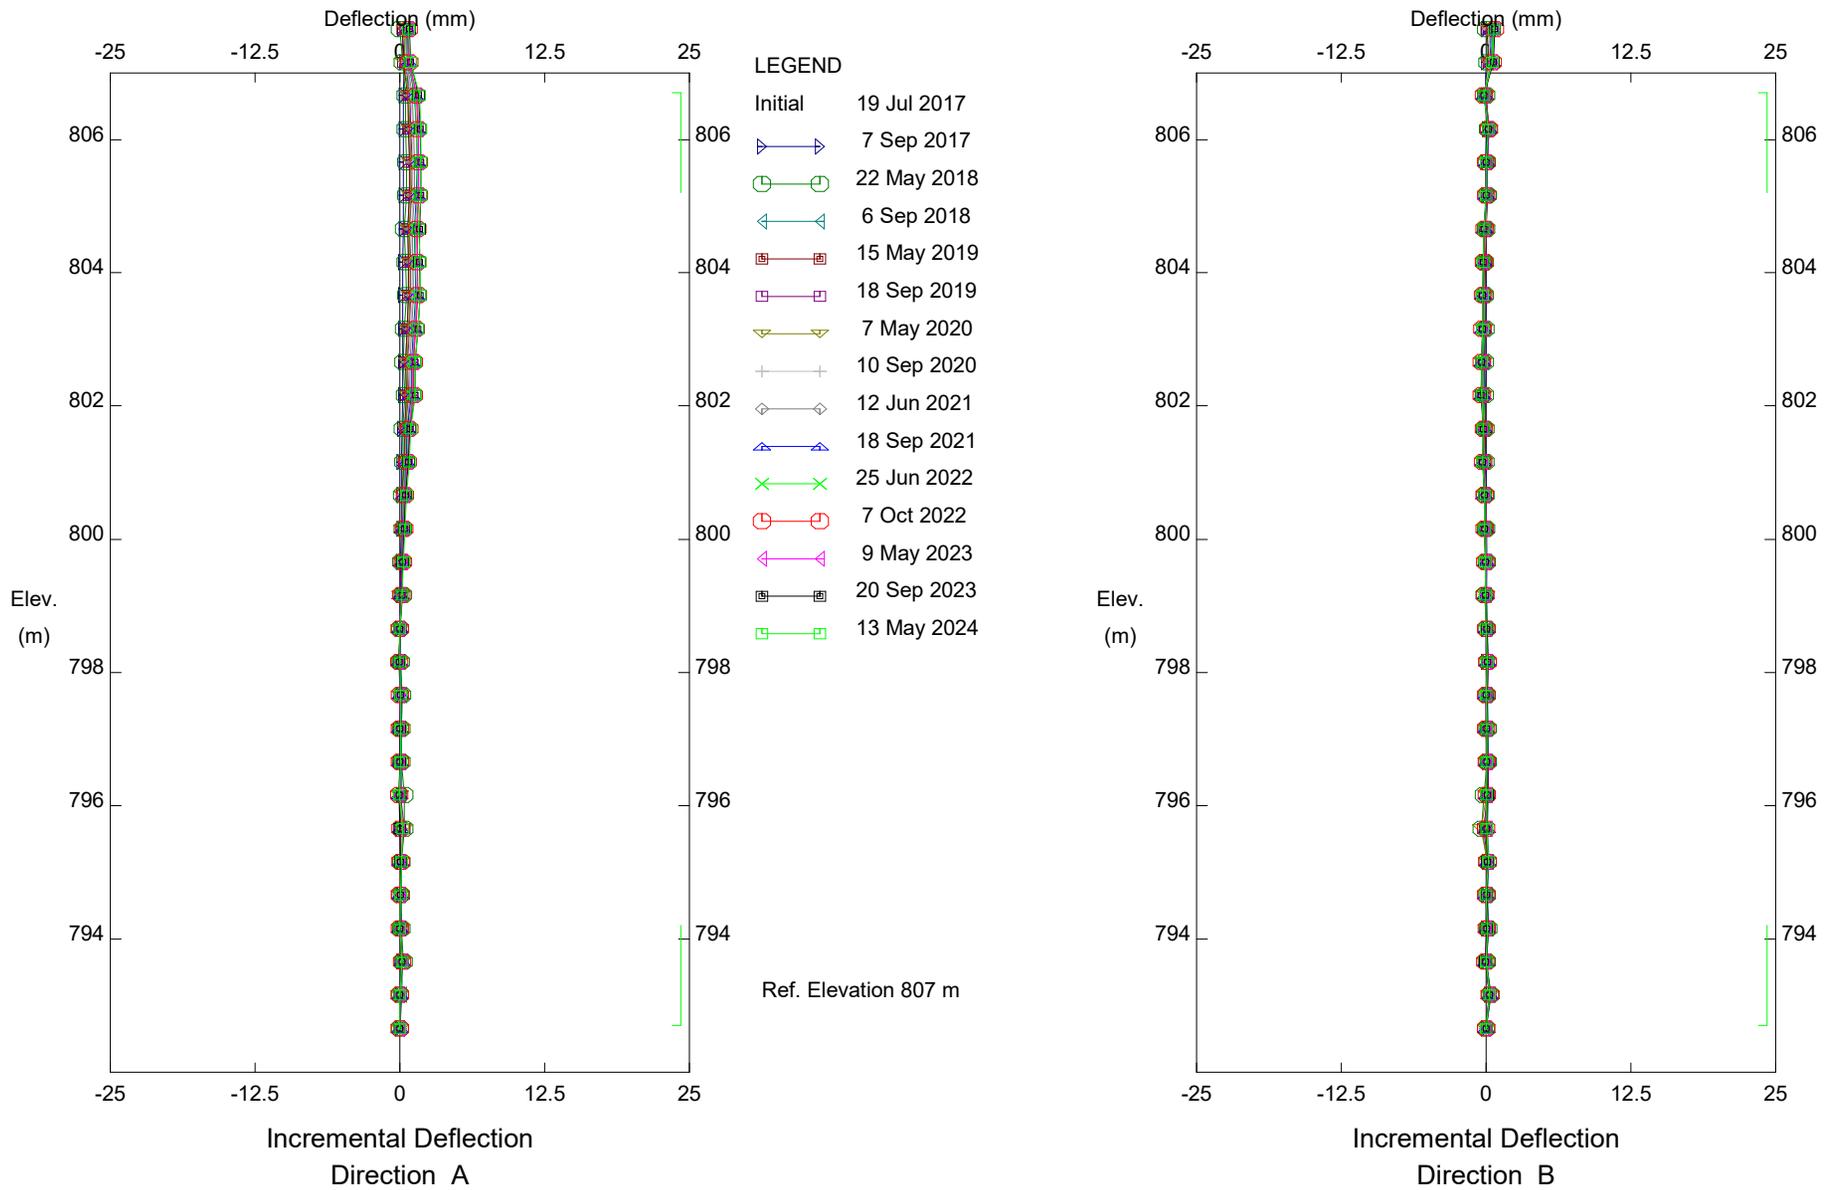
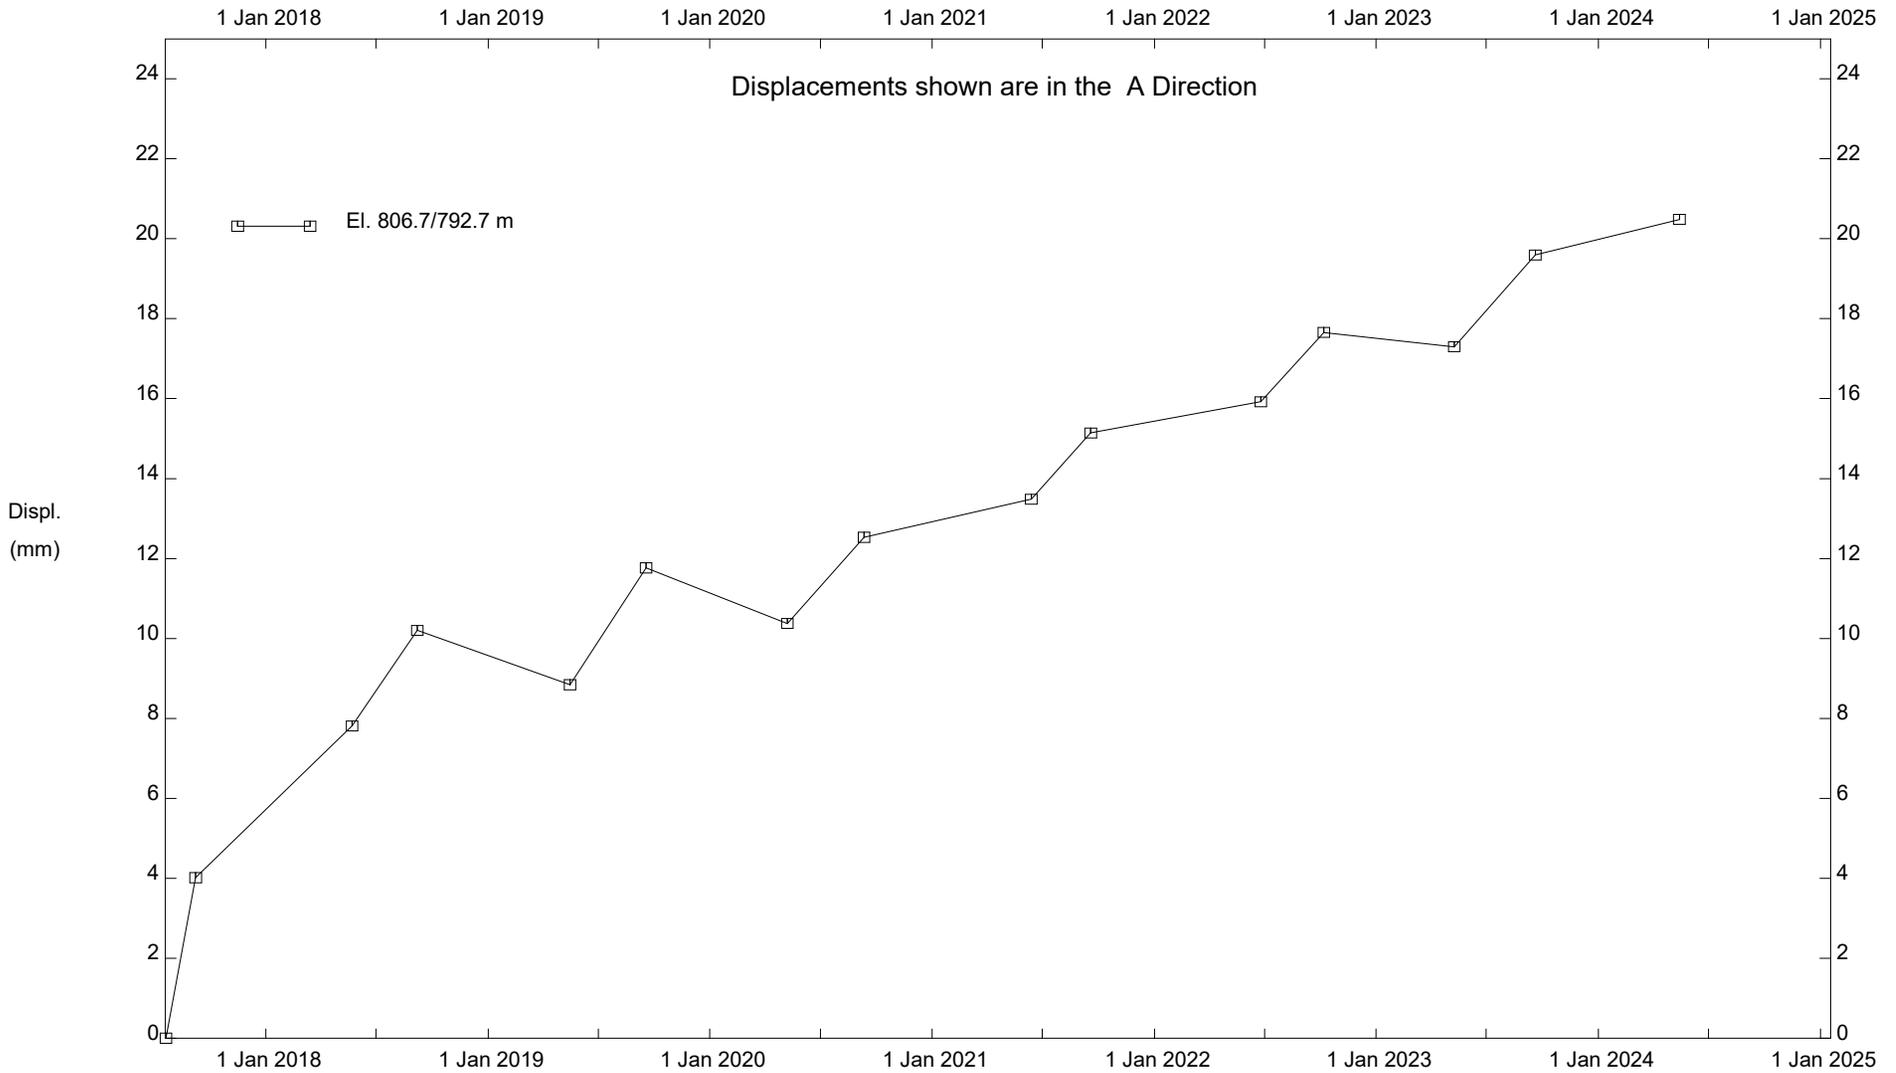
C067; H21:14, Kneehill Creek Slide, Inclinometer SI17-C67-04

Distributed movement is being recorded in the SIs installed in the H-pile wall (SI17-C67-03 though and SI17-C67-05) from top of casing to an approximate depth of 8.7 m, 7.8 m, and 6.5 m, respectively.

The depth of movement being recorded in the pile-wall SIs (SI17-C67-03 through SI17-C67-05) appears to be occurring 2 m to 4 m below the depth of movement previously recorded in SI16-01. This indicates the H-pile wall has intercepted the failure surface and is continuing to deflect, transferring load to depths below the failure plane as the piles stabilize the sliding mass.

The May 2024 data obtained from SI17-C67-03 through SI17-C67-05 indicates the top of the H-pile wall has deflected between approximately 17 mm and 29 mm since installation. The maximum rate of movement recorded in SI17-C67-03 through SI17-C67-05 was approximately 71 mm/year to 115 mm/year in May 2017, one month after the H-pile wall was installed. The rate of movement has since decreased and is now less than 3 mm/year.

Between June and September 2023, the rate of movement recorded in SI17-C067-03 through -05 increased to between approximately 3 mm/year and 7 mm/year. Although the movement recorded in September 2023 was within historical trends for these instruments, evidence of movement (pavement cracking and settlement) primarily in the south (eastbound) lane was observed during the 2023 Section B Inspection. The movement recorded in September 2023 may be attributed to

settlement of the highway subgrade and fill due to H-pile wall movement between 2017 (i.e., installation) and 2023. Between the September 2023 and May 2024 readings, the rates of movement recorded in SI17-C67-03 through SI17-C67-05 have decreased to less than 1.5 mm/year (negative movement recorded in SI17-C67-03 and SI17-C67-04 indicates the rate of movement is within the reading accuracy of the SI equipment).

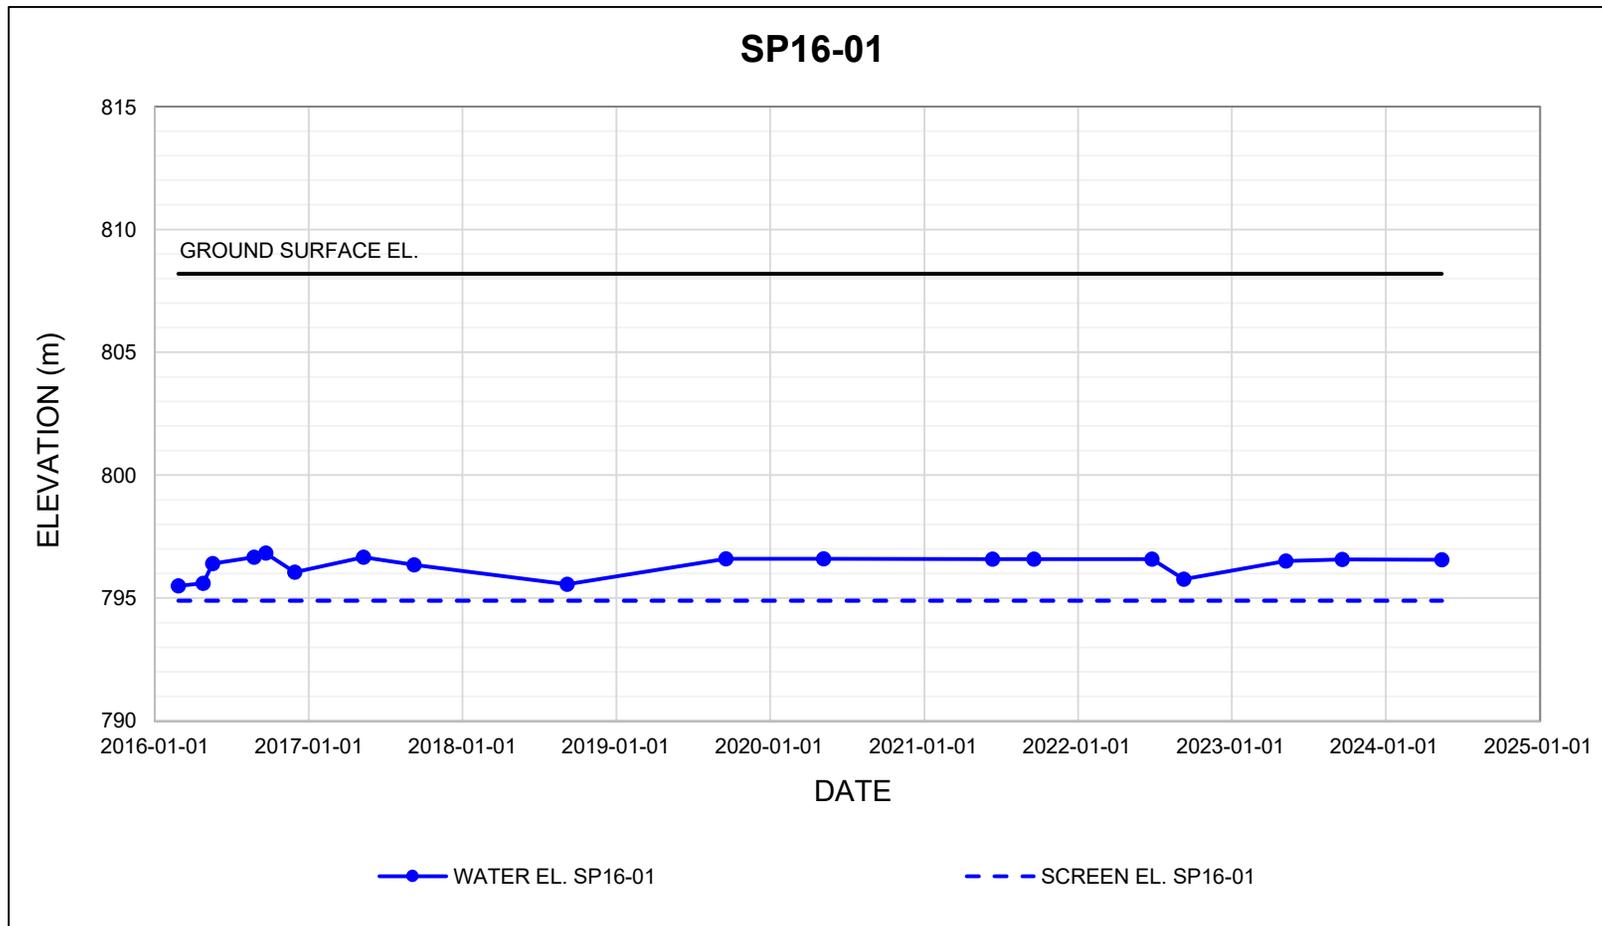
PROJECT CENTRAL REGION GEOHAZARD RISK MANAGEMENT PROGRAM		
	TITLE Piezometer Data C067 - Kneehill Creek Slide Hwy 21:14, km 12.988

Since installation in February 2016, water levels recorded in SP16-01 have been relatively steady varying from 11.4 m to 12.7 m below ground surface. The May 2024 reading of 11.6 m below ground surface was consistent with historical trends observed in this instrument.
