SITE NUMBER AND NAME: C072 Chicken Creek Slide		HIGHWAY & KM: 22:24, 9.8	PREVIOUS INSPECTION DATE: July 9, 2019	INSPECTION DATE: June 27, 2023
LEGAL DESCRIPTION: 09-33-040-07 W5M 12-34-040-07 W5M	NAD 83 COORDINATES: UTM Northing Easting 11 5817436 640058		RISK ASSESSMENT: PF: 1 CF: 4 TOTAL: 4	
AVERAGE ANNUAL DAILY TRAFFIC (AADT): 2,320(north) & 3,020 (south) (Ref No. 990020)			CONTRACT MAINTENANCE AREA (CMA): 514

PROJECT
 CENTRAL REGION GEOHAZARD RISK MANAGEMENT PROGRAM

TITLE
 Site Plan
 C072 - Chicken Creek Slide
 Hwy 22:24, km 9.8

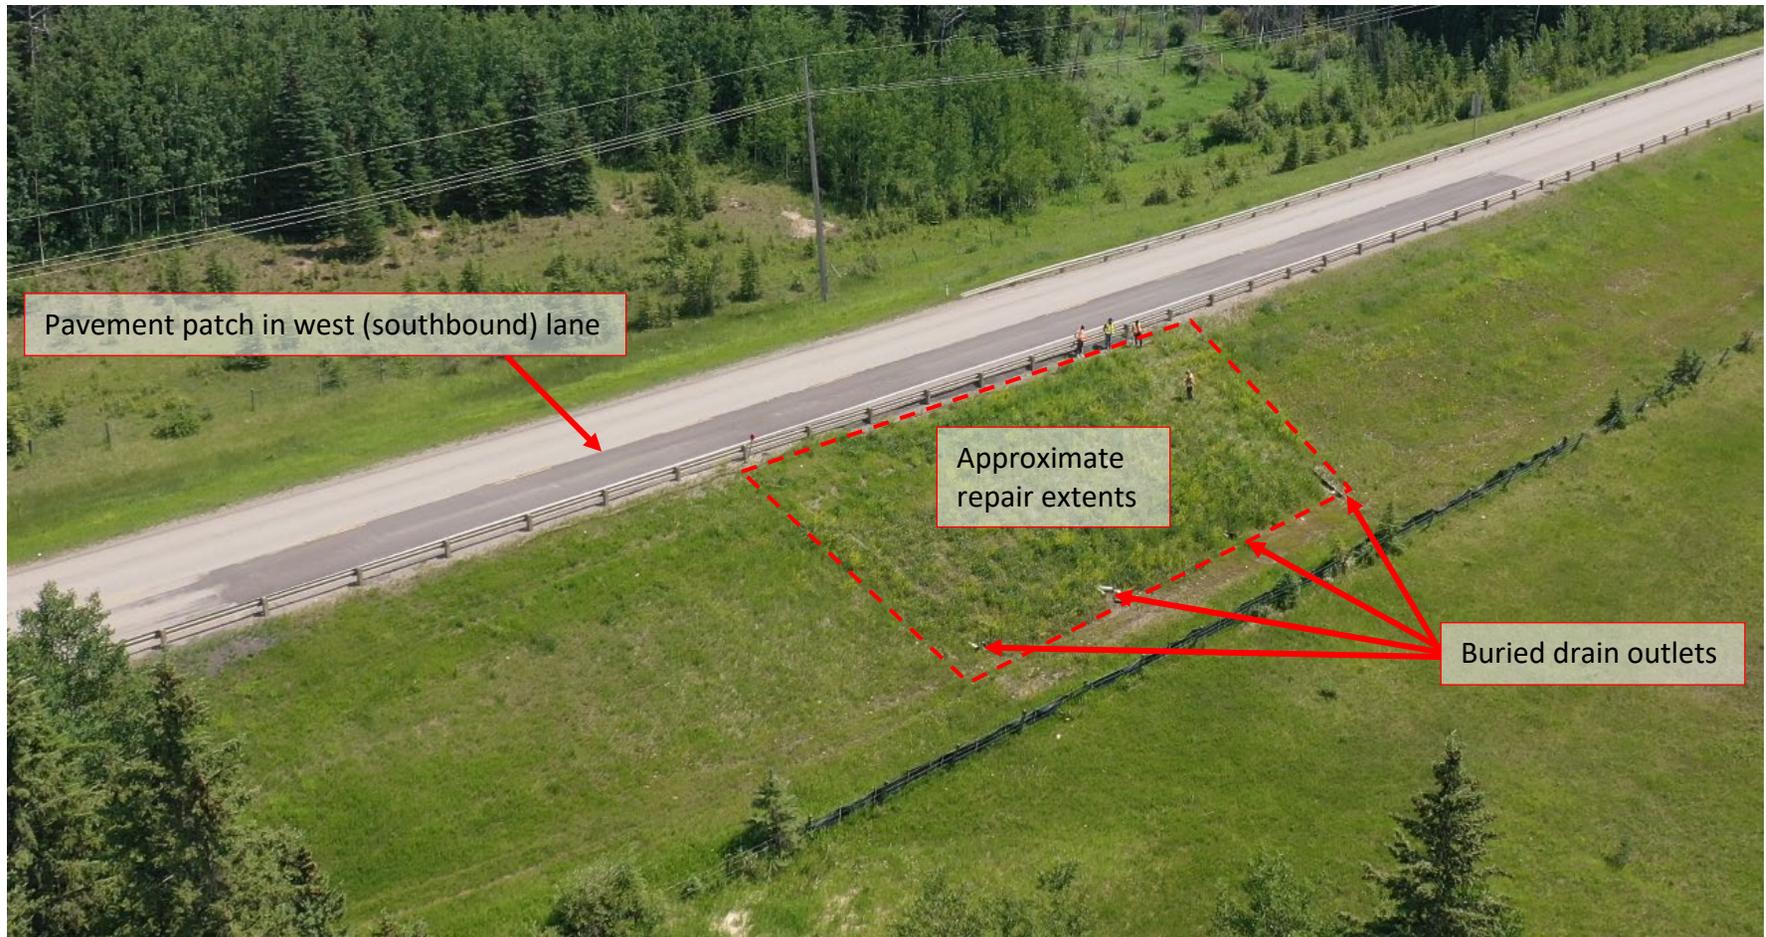
The west (southbound) lane was patched during 2021 construction (Photos 1, 2, and 3). A thin pavement crack (less than 10 mm wide) was observed in the patch upslope of the 2021 repair (Photo 5).

Photo 1 An aerial photo of the C072 site, highlighting the location of the recent pavement patch, slide repair extent, and buried drain outlets. Photo taken June 27, 2023, facing southeast.

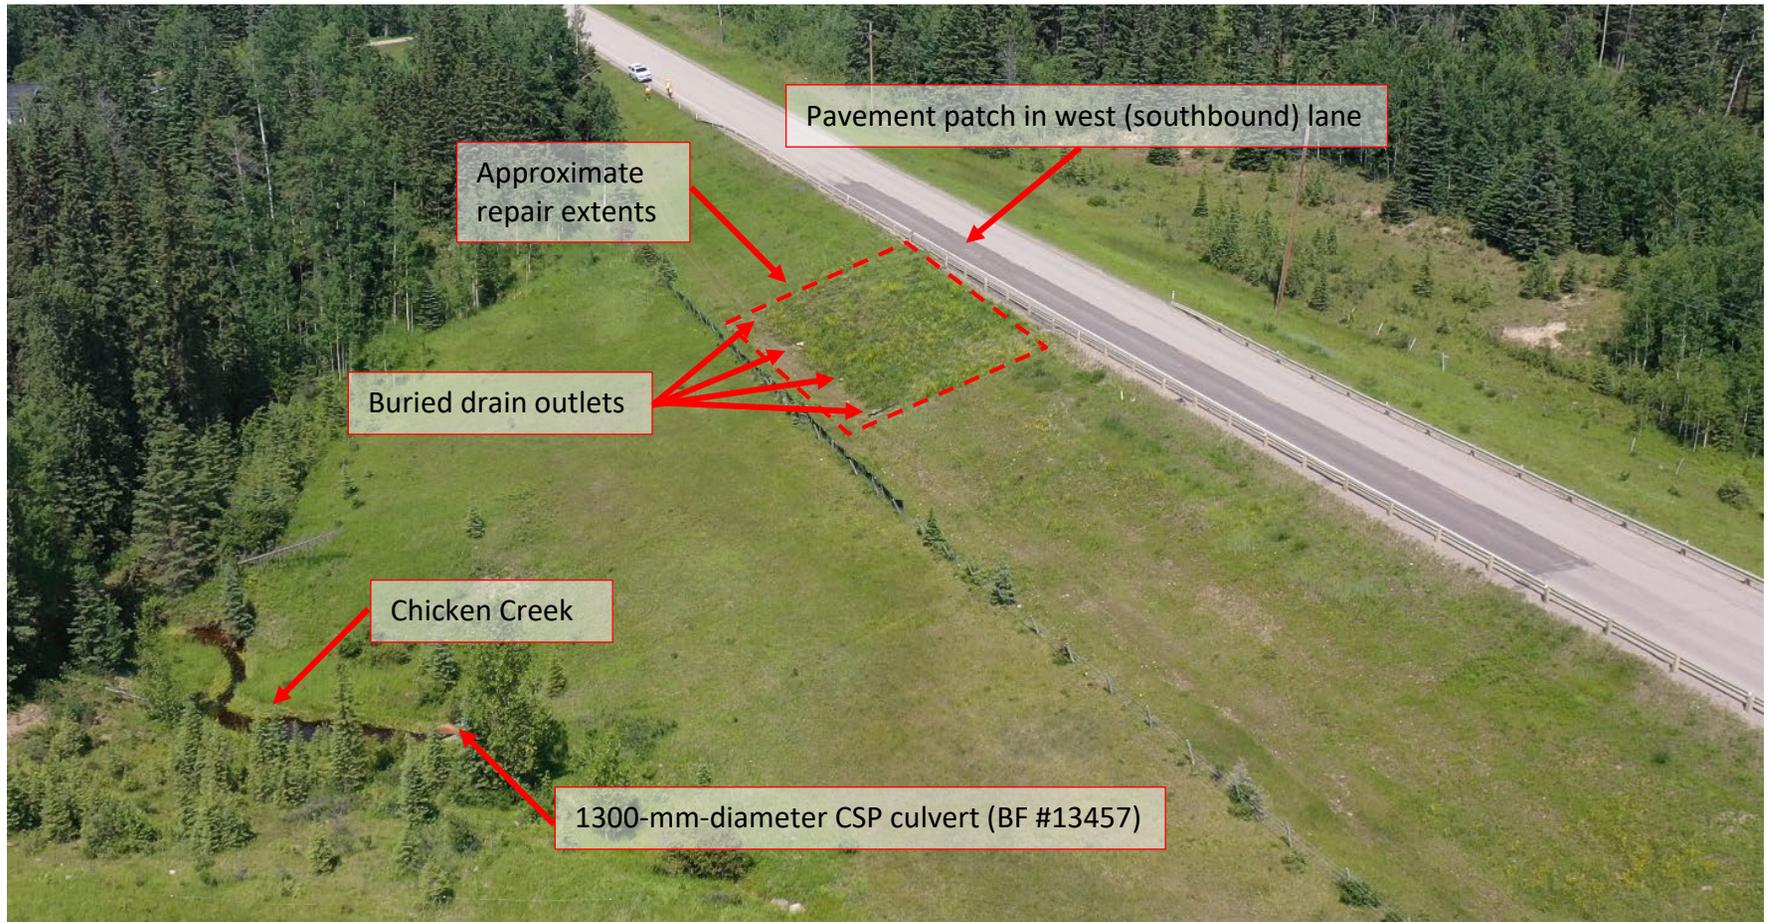
The 1800-mm-diameter multi-plate corrugated-steel-pipe (CSP) culvert (Bridge File #13457) was sleeved with a 1300-mm-diameter CSP culvert (date unknown). The culvert is underlying Hwy 22 (oriented east-west) south of the repaired slide (Photo 2). During the 2017 inspection, debris was observed at or just above the crown of the culvert inlet, indicating the culvert may have insufficient capacity to handle flow volumes during spring freshet or significant precipitation events. The culvert was not inspected during the 2023 inspection.

Photo 2 An aerial view of the C072 site, highlighting the slide repair, pavement patch, buried drain outlet locations, and Chicken Creek. Photo taken June 27, 2023, facing north-northeast.

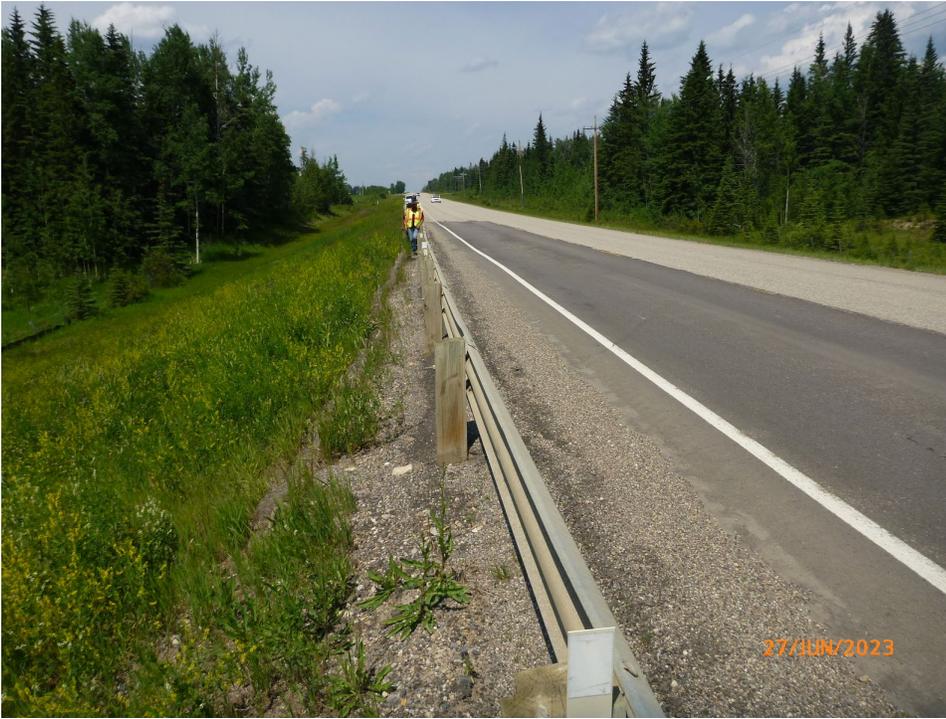
Photo 3 Guardrail and pavement patch in west (southbound) lane. Photo taken June 27, 2023, facing north.

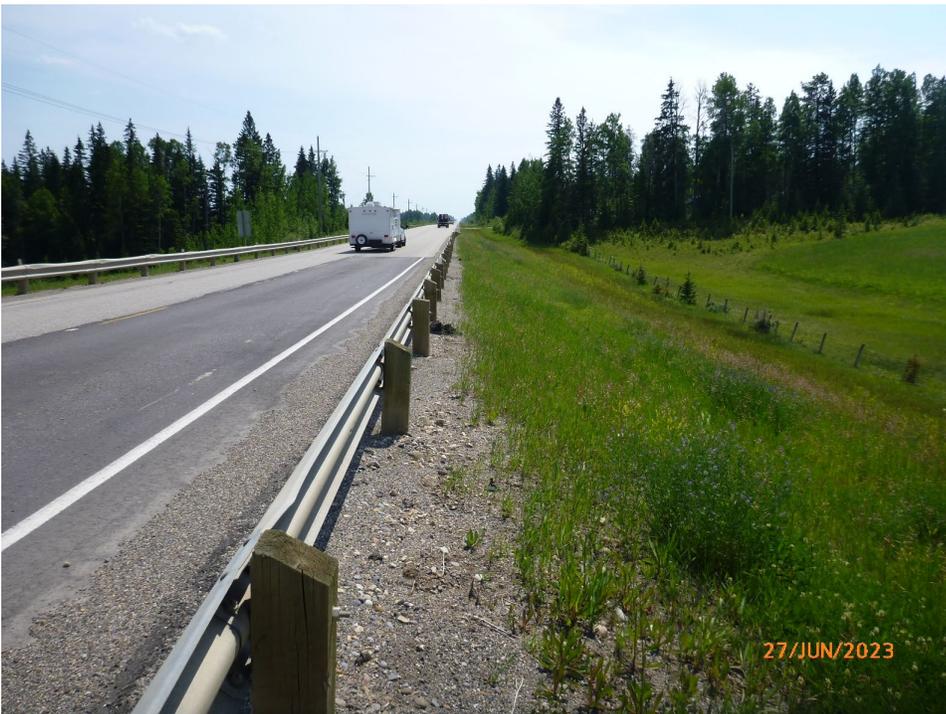
Photo 4 The repair of the highway embankment slope is well vegetated and appears to be performing well. Photo taken June 27, 2023, facing south.

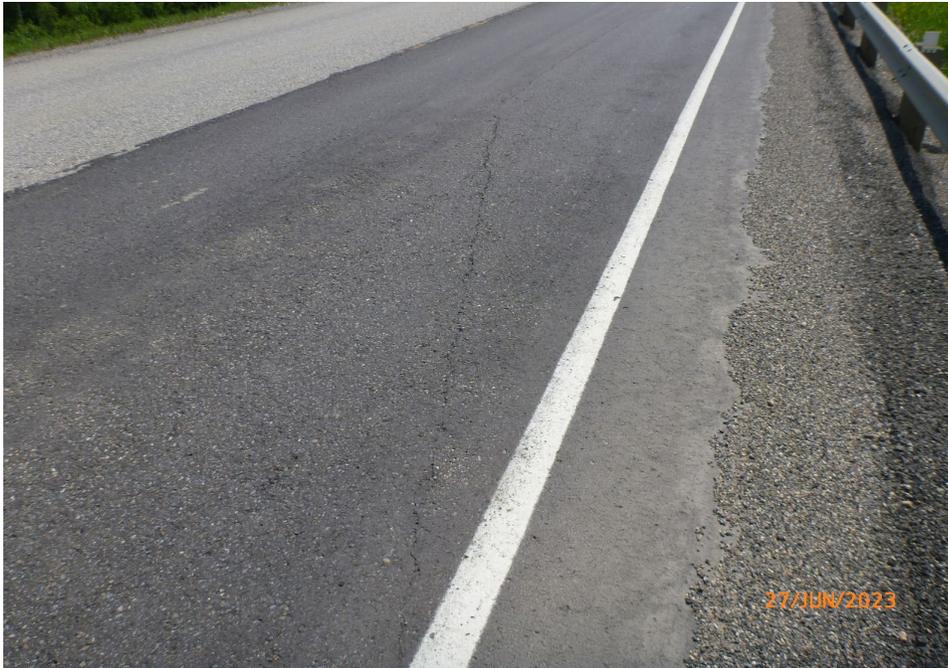
Photo 5 Thin (less than 10 mm) pavement crack in the west (southbound) pavement patch. The pavement crack may be attributed to construction and not additional slide movements. Photo taken June 27, 2023, facing south.

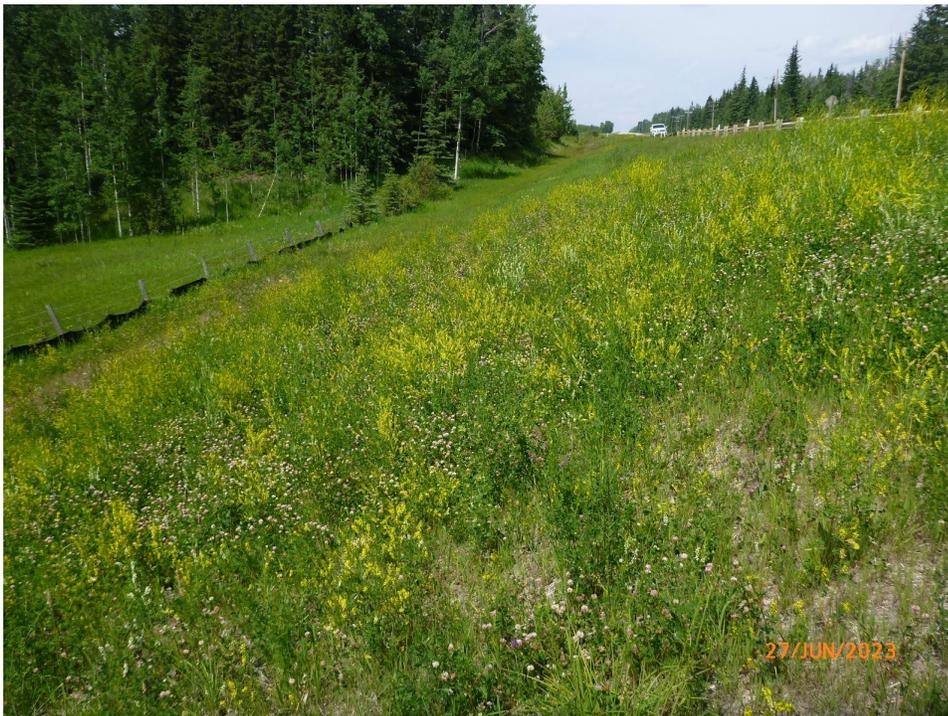
The 2021 repaired slope is well vegetated (grass and weeds) and appears to be performing well (Photo 6). The west highway embankment slope appears drier than inspections before the 2021 repair, indicating the drains are performing well.

Photo 6 The repair of the west highway embankment slope is well vegetated and appears to be performing well. Photo taken June 27, 2023, facing north.
