SITE NUMBER AND NAME: C062 Back Slope Failure North of Vermillion Dam		HIGHWAY & KM: 41:20, 2.889	PREVIOUS INSPECTION DATE: June 29, 2021	INSPECTION DATE: June 28, 2023
LEGAL DESCRIPTION: 16-31-050-06 W4M	NAD 83 COORDINATES: UTM Northing Easting 12 5912662 509163		RISK ASSESSMENT: PF: 9 CF: 3 TOTAL: 27	
Average Annual Daily Traffic (AADT): 3200 (north) & 4,070 (south) (Ref No. 997074 & 990207)			CONTRACTOR MAINTENANCE AREA (CMA): 512

PROJECT CENTRAL REGION GEOHAZARD RISK MANAGEMENT PROGRAM		
TITLE Site Plan C062 - Vermillion Backslope Hwy 41:02, km 2.889		
SCALE 1:1,500	PROJECT No. A05116A02	FIG No. 1

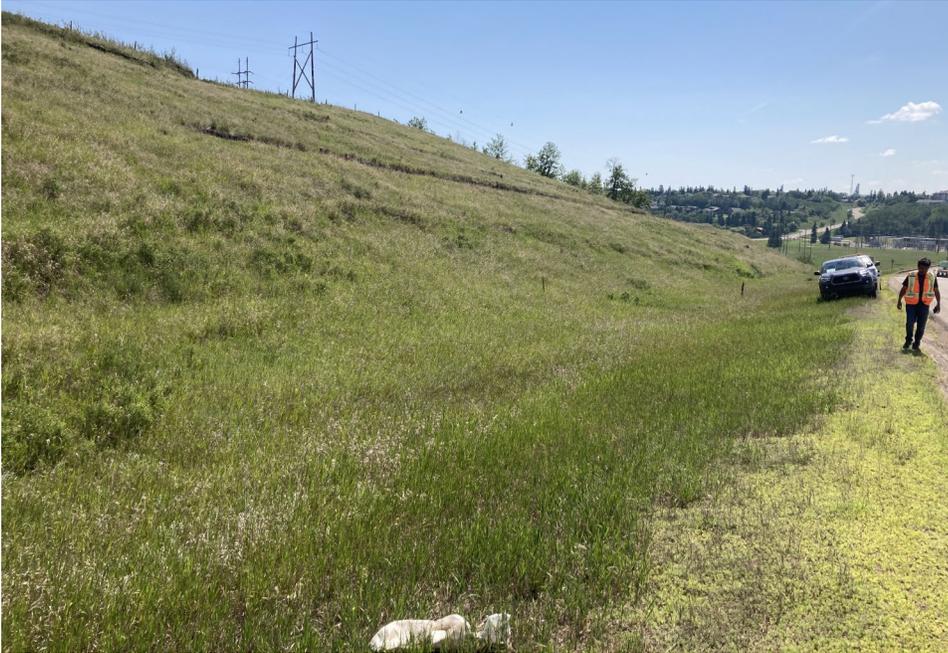
Between the 2020 and 2021 inspections, the toe roll of the slide appeared to have deformed further into the ditch. Between the 2021 and 2023 inspections, the toe roll appears more defined, but does not appear to extend further into the east (northbound) ditch (Photo 1 and 2). However, the amount of movement is difficult to assess due to tall vegetation.

- Photo 1** Backscarp and toe roll of slide. The toe roll appears more defined since the 2021 inspection. Benches cut into slope were completed during KCB's 2018 drilling and instrumentation installation program. Photo taken June 28, 2023, facing southeast.

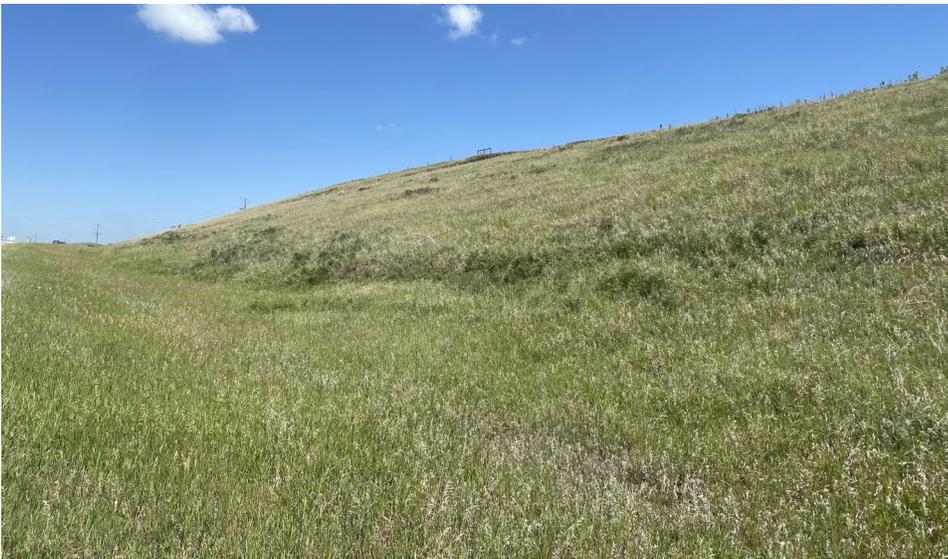
- Photo 2** East (northbound) ditch and toe roll. The ditch is well vegetated and the toe roll appears more defined since the 2021 inspection. Photos taken June 28, 2023, facing northeast.

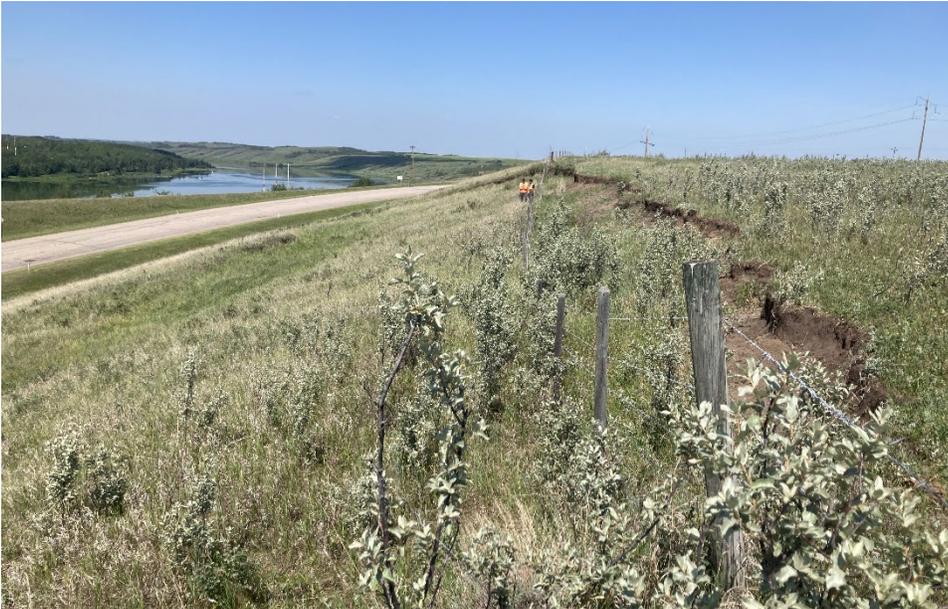
The slide appears to have progressed further north along the east (northbound) backslope since the 2021 inspection. The amount the slide has progressed is difficult to estimate. However, KCB estimates the slide has extended approximately 20 m to 30 m to the north between the 2021 and 2023 inspections. No significant change was observed at the crest of the slope between the 2021 and 2023 inspections (Photo 3).

Photo 3 No significant change in the slope, head scarp, and fence line at the crest of the slope since the 2021 inspection. Photo taken June 28, 2023, facing north.

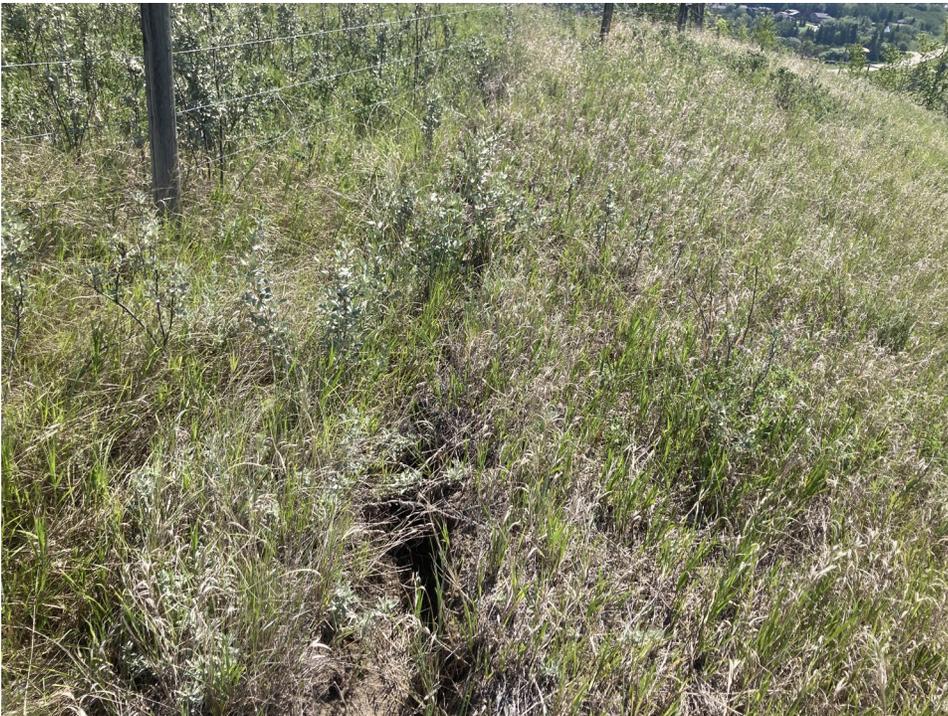
A tension crack was first observed in 2020 on the downslope bench created during the geotechnical investigation completed in April 2018 (bench constructed in March 2018). The tension crack is approximately 25 mm wide and doesn't appear to have changed between the 2020 and 2023 inspections (not found during the 2021 inspection).

Photo 4 Tension crack previously observed near the fence line at the crest of the slope. Photo taken June 28, 2023, facing south.

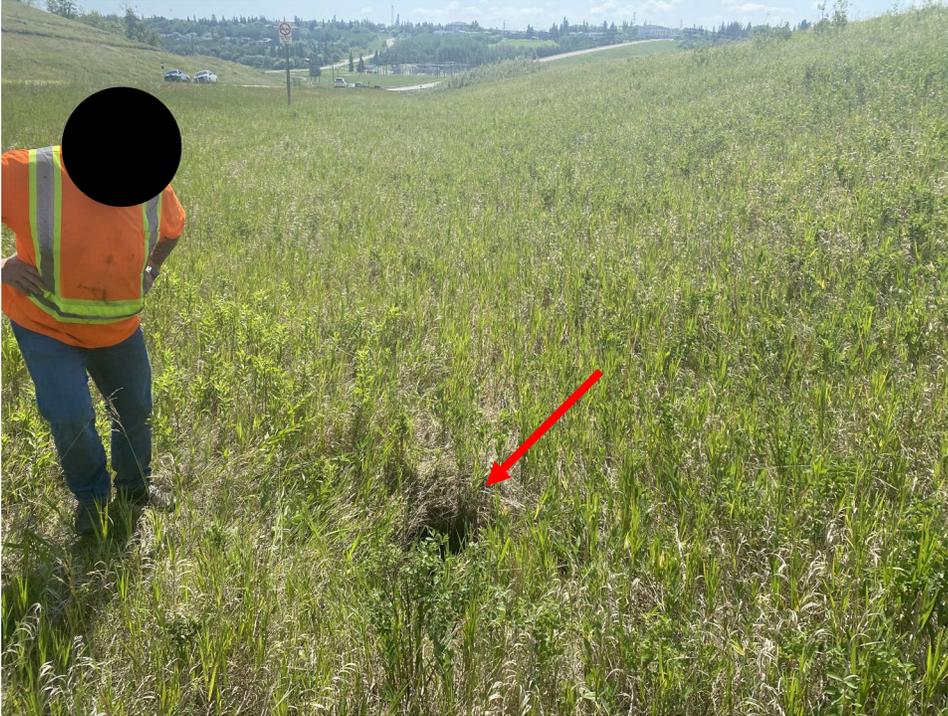
A sinkhole approximately 300 mm in diameter and 1 m deep was observed in the west (southbound) lane ditch, approximately 10 m from the edge of pavement (Photo 5)

Photo 5 Sinkhole approximately 0.5 m in diameter and 1.0 m deep observed in the west (southbound) ditch (indicated by red arrow). Photo taken June 28, 2023, facing south.

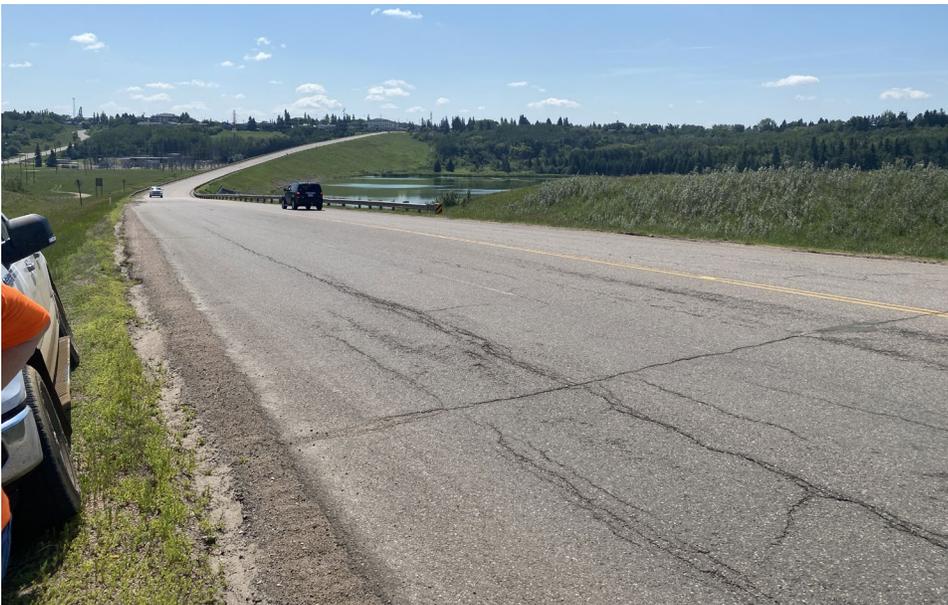
Pavement distress (i.e., alligator cracking) was observed in the highway surface along the length of the site (Photo 6). The cracking appeared worse in the east (northbound) lane than the west (southbound) lane.

Photo 3 Pavement distress (i.e., alligator cracking) was observed was in highway surface downslope of the C062 site. Photo taken June 28, 2023, facing south southwest.

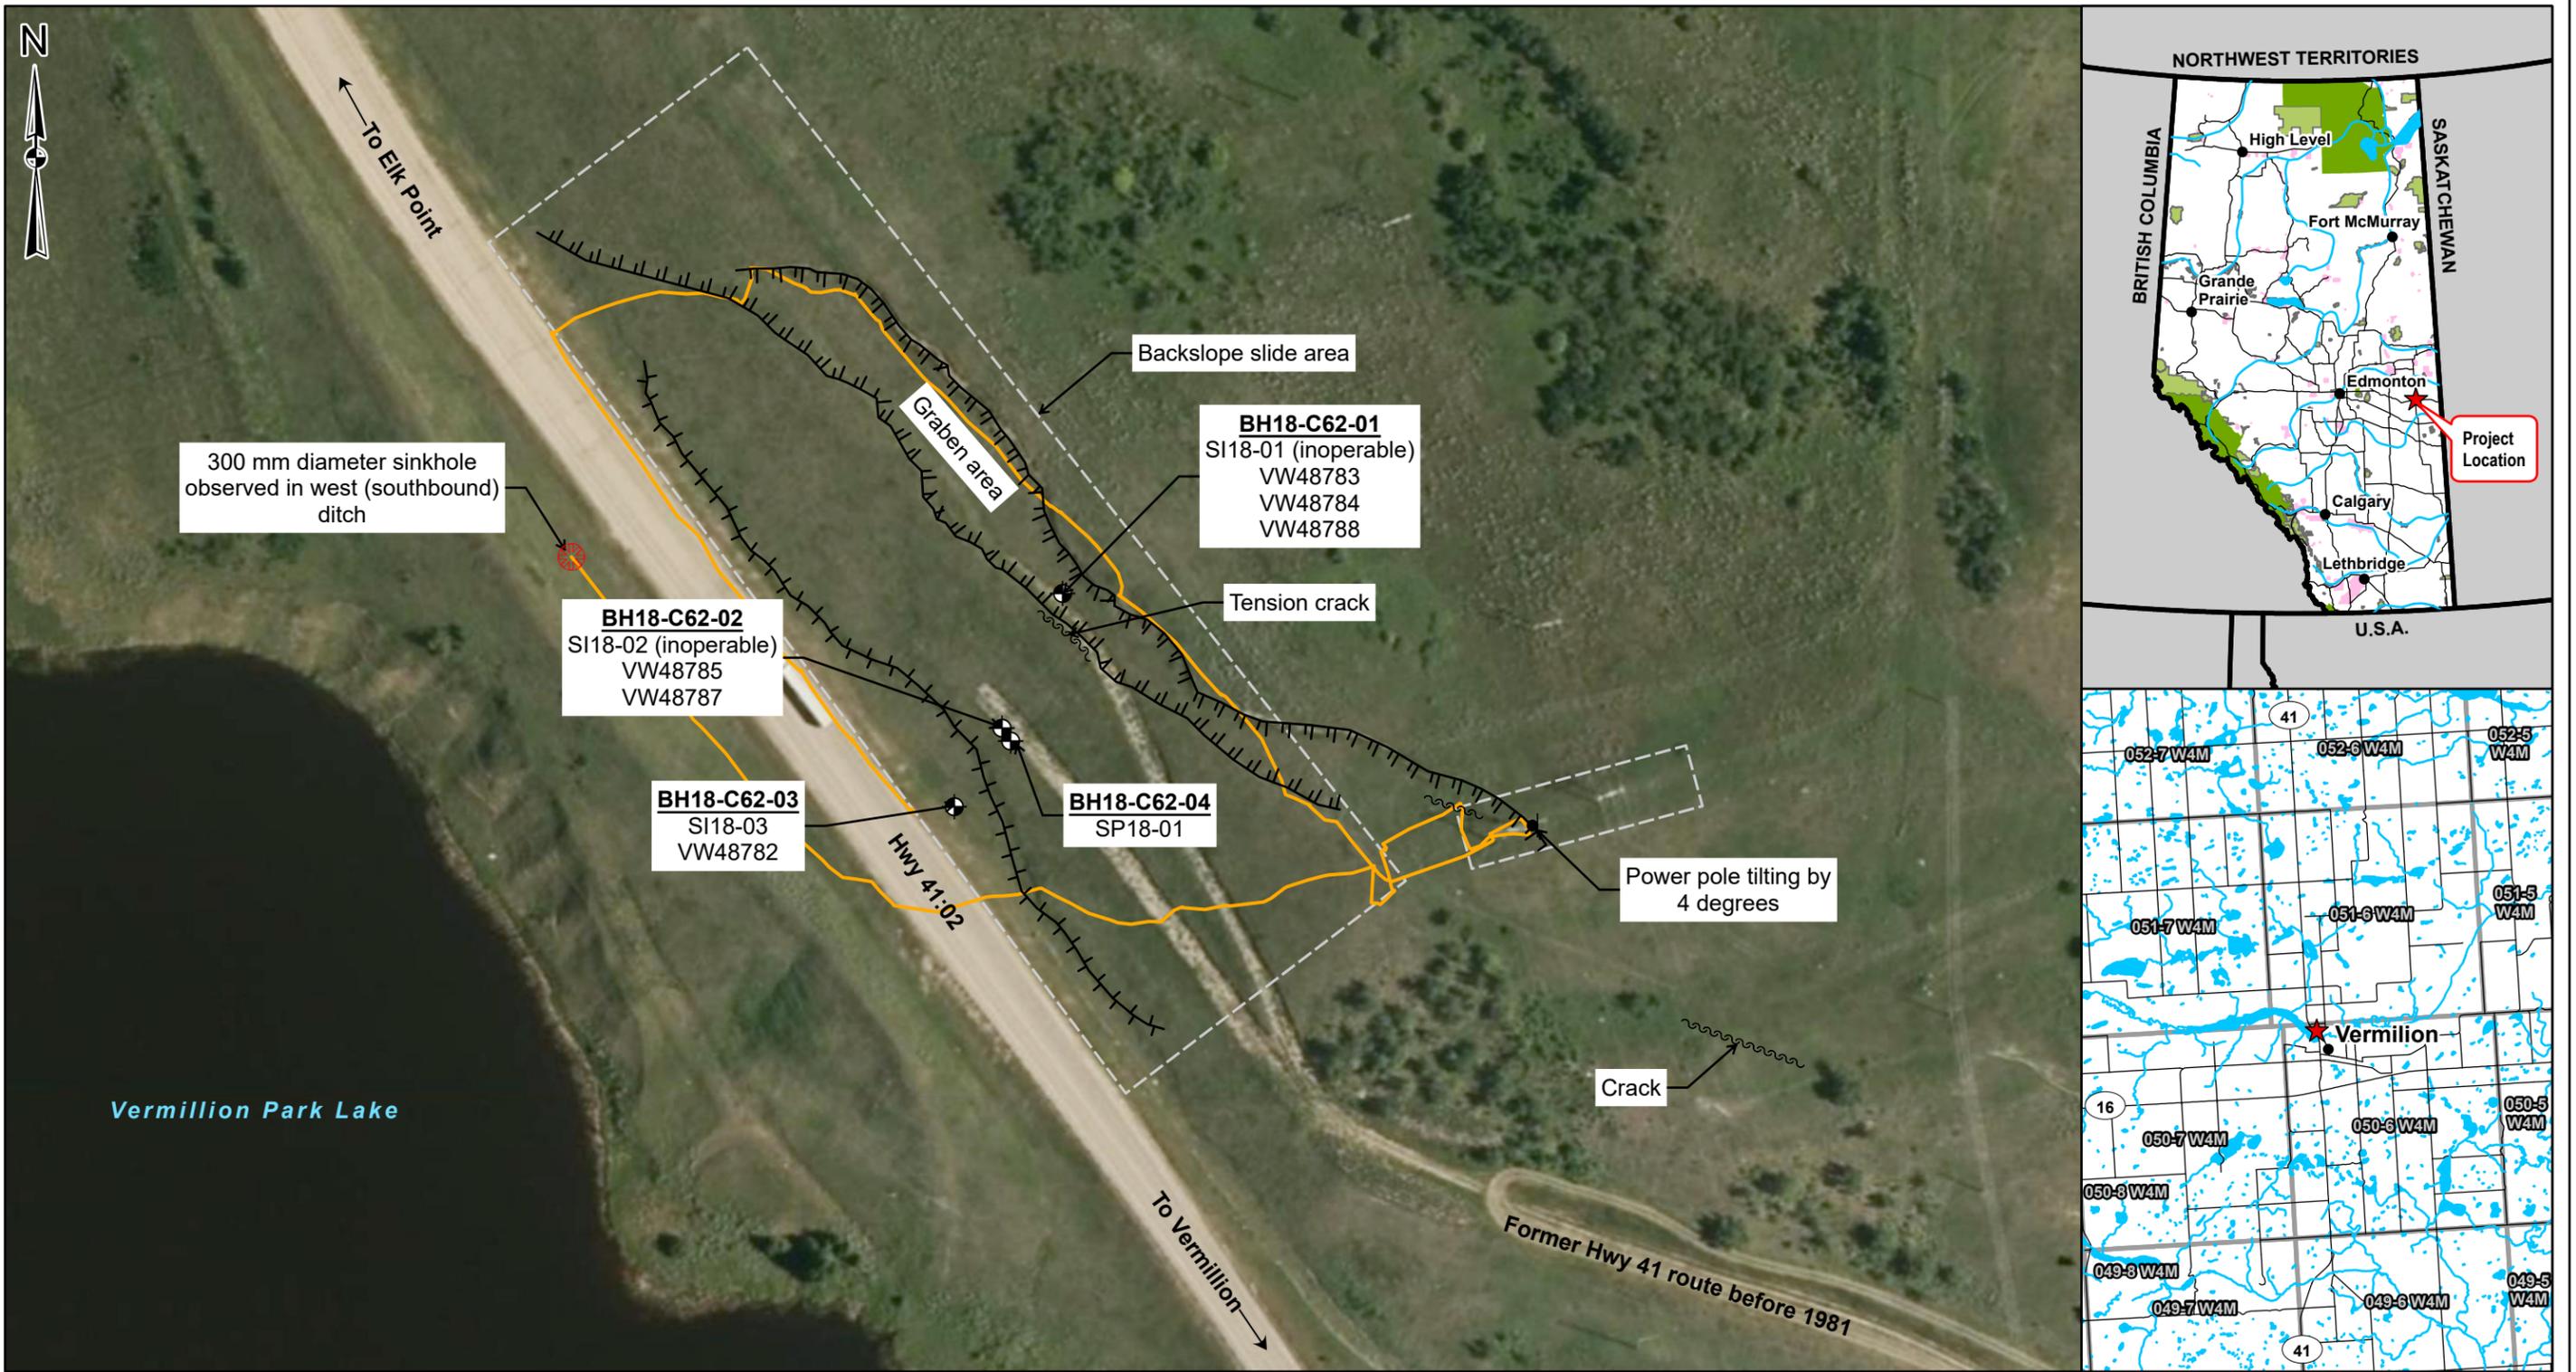
Slide area extends along the crest of the east (northbound) backslope to the river valley slope south of the ATCO power poles. Bench on river valley slope is located at the previous Hwy 41 alignment, before it was realigned across Vermilion Dam in 1981.

- Previous repair recommendations include installing either horizontal drains or flatten the slope (i.e., excavating the head of the slide). If TEC decides they want to flatten the slope to increase slope stability, they should consult with the Town of Vermilion on a material stockpile location, or if there is any local uses for the removed material.
