July 15, 2024

**CON0022160 Central Region GRMP Instrumentation Monitoring
Site C062; H41:02, km 2.889 Vermillion Backslope
Section C – 2024 Spring Readings**

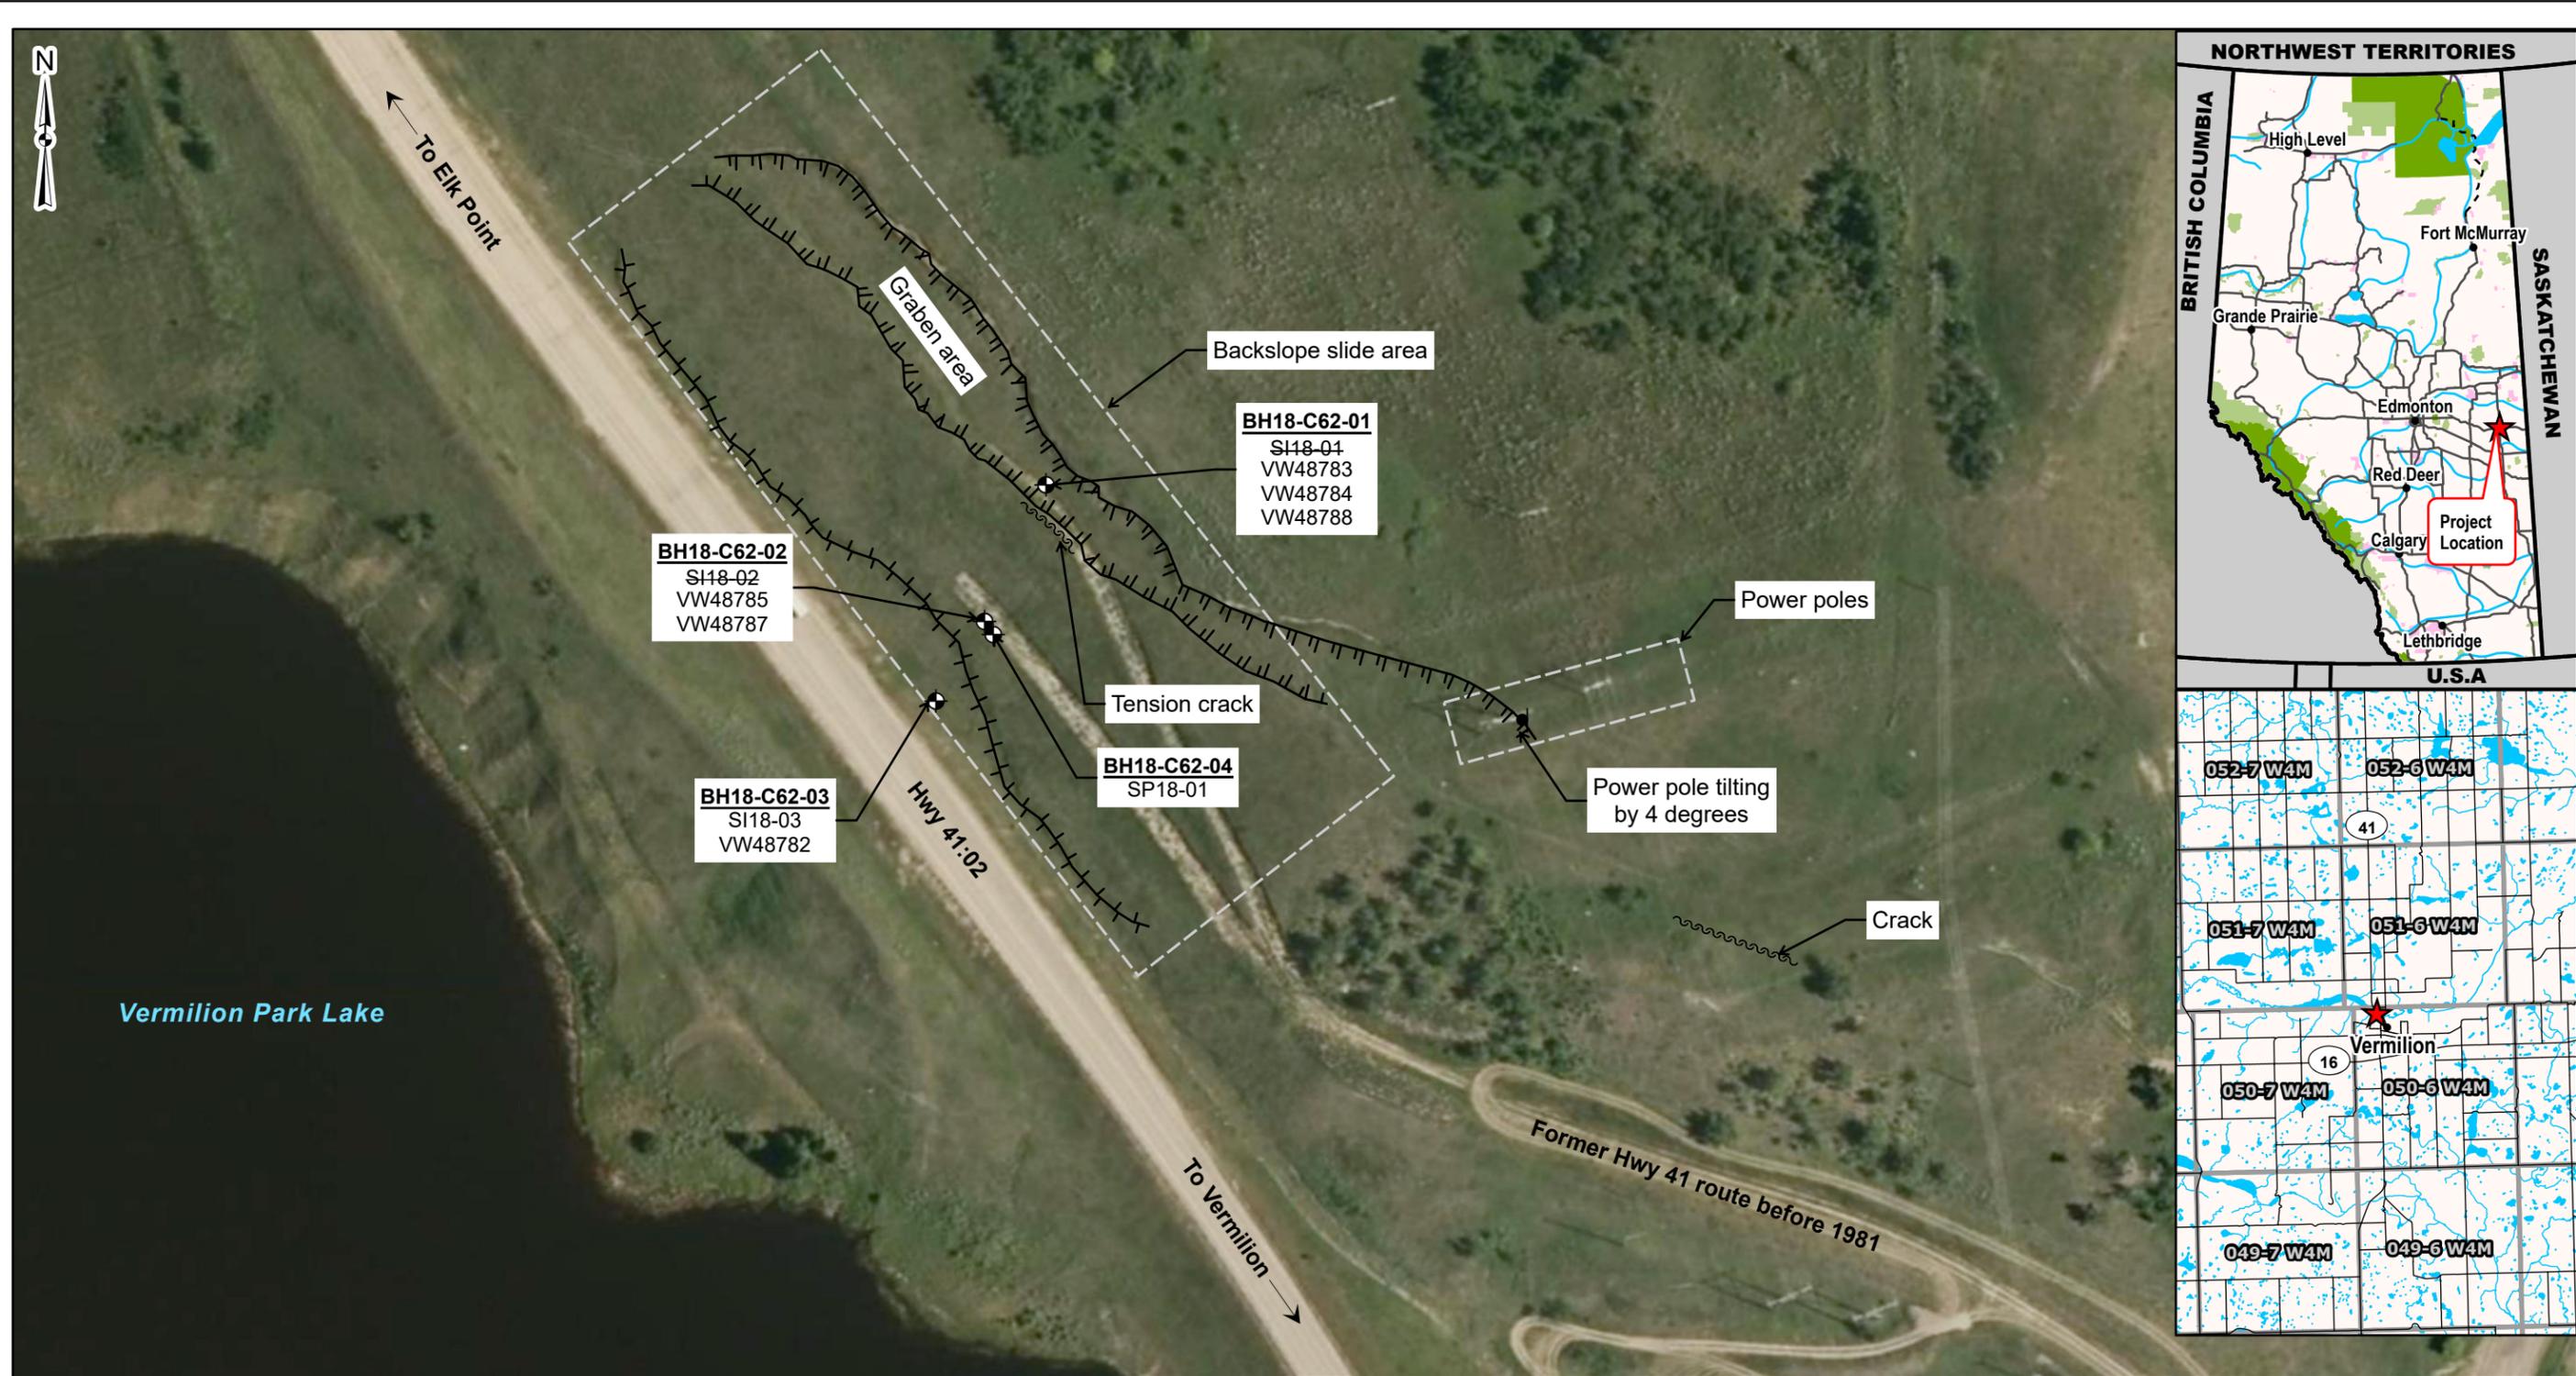
| TITLE Site Plan C062 - Vermillion Backslope Hwy 41:02, km 2.889 | | |

The geohazard at the C062 site consists of a large, deep-seated-translational earth slide on the east (northbound) backslope of Hwy 41:02.

Remedial options are currently being discussed between KCB and Alberta Transportation and Economic Corridors (TEC) and may include installing horizontal drains and/or flattening the slope. At this time, the highway below the slide has not been impacted by slope movements, but the toe roll is starting to block the ditch. If the rate of movement is observed to be increasing, as assessed by visual observations at the toe and crest of the slide, or the ditch becomes blocked, TEC will need to take action to ensure that the highway is not impacted (e.g., excavating material that is blocking the ditch to improve drainage).

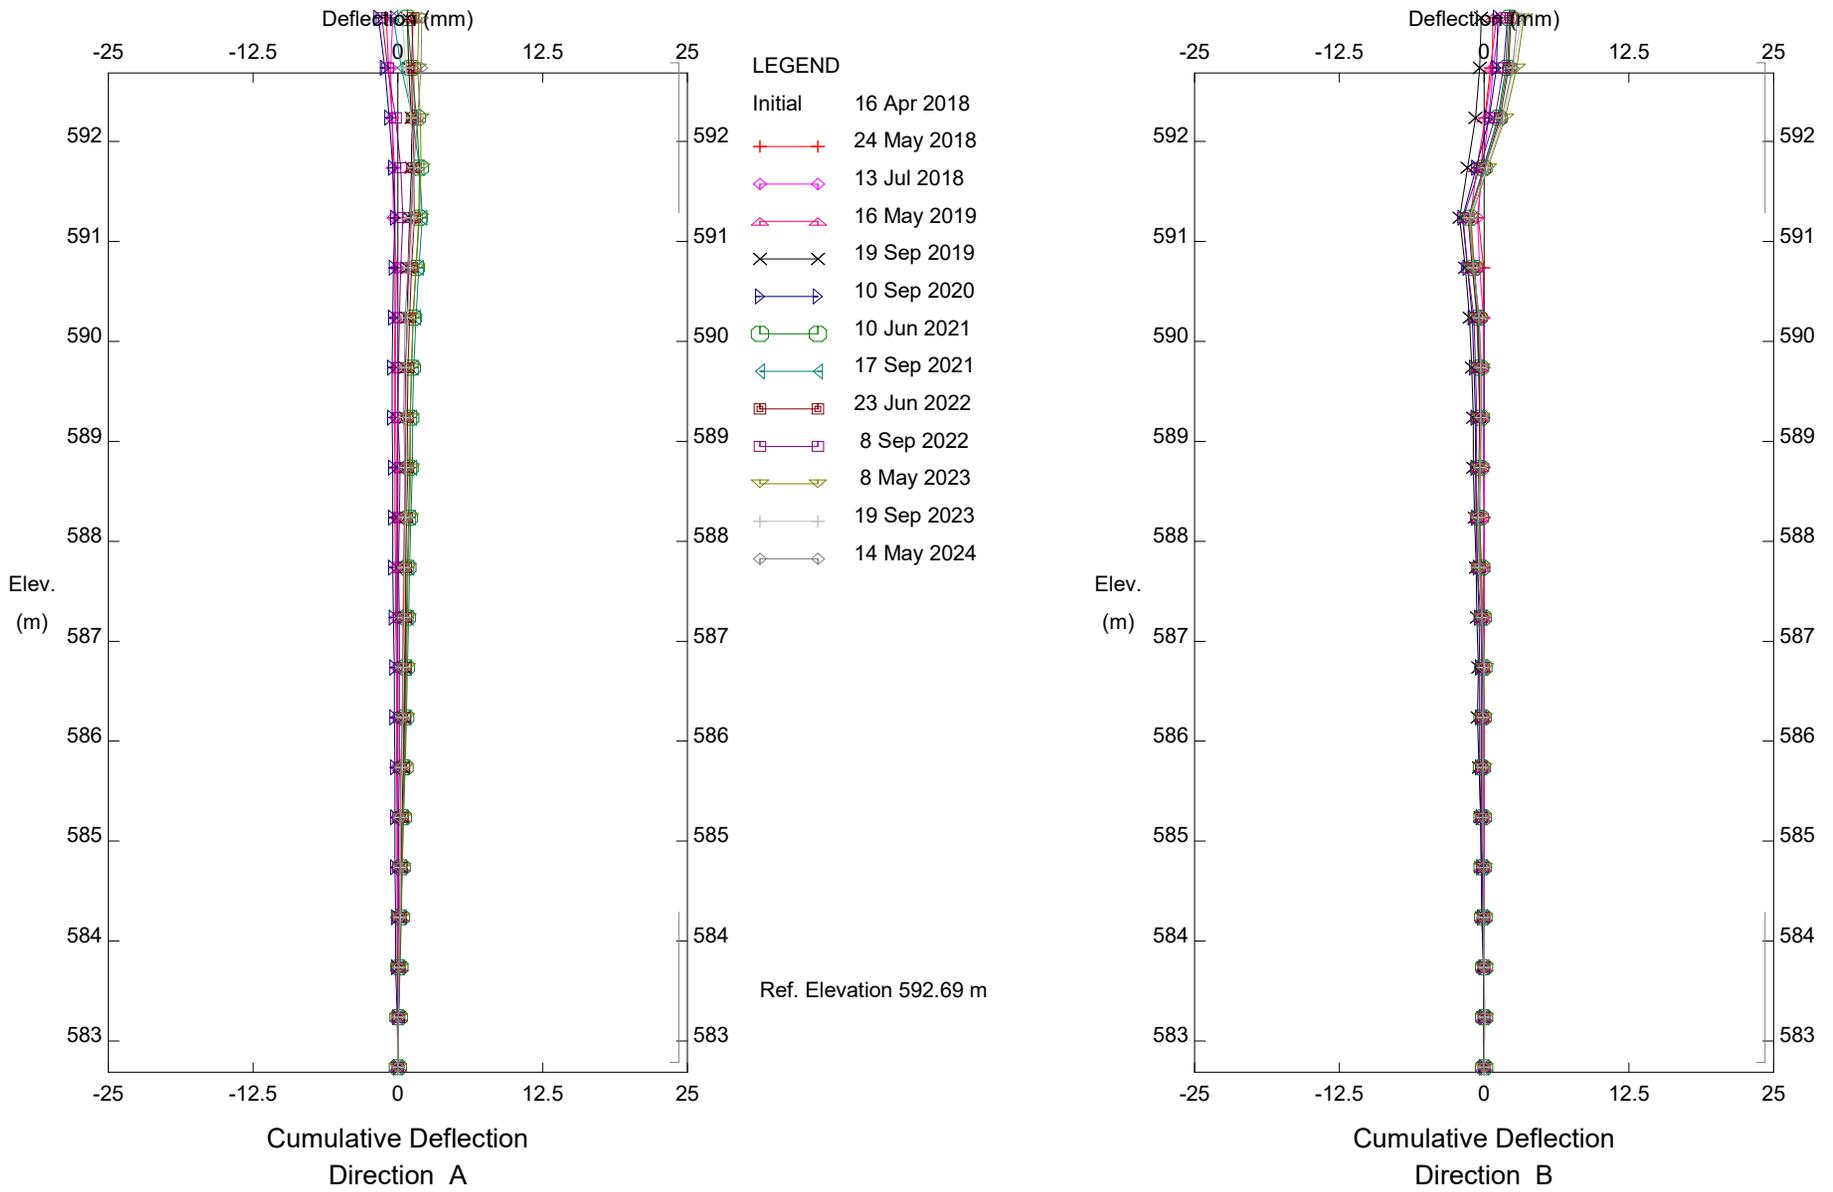
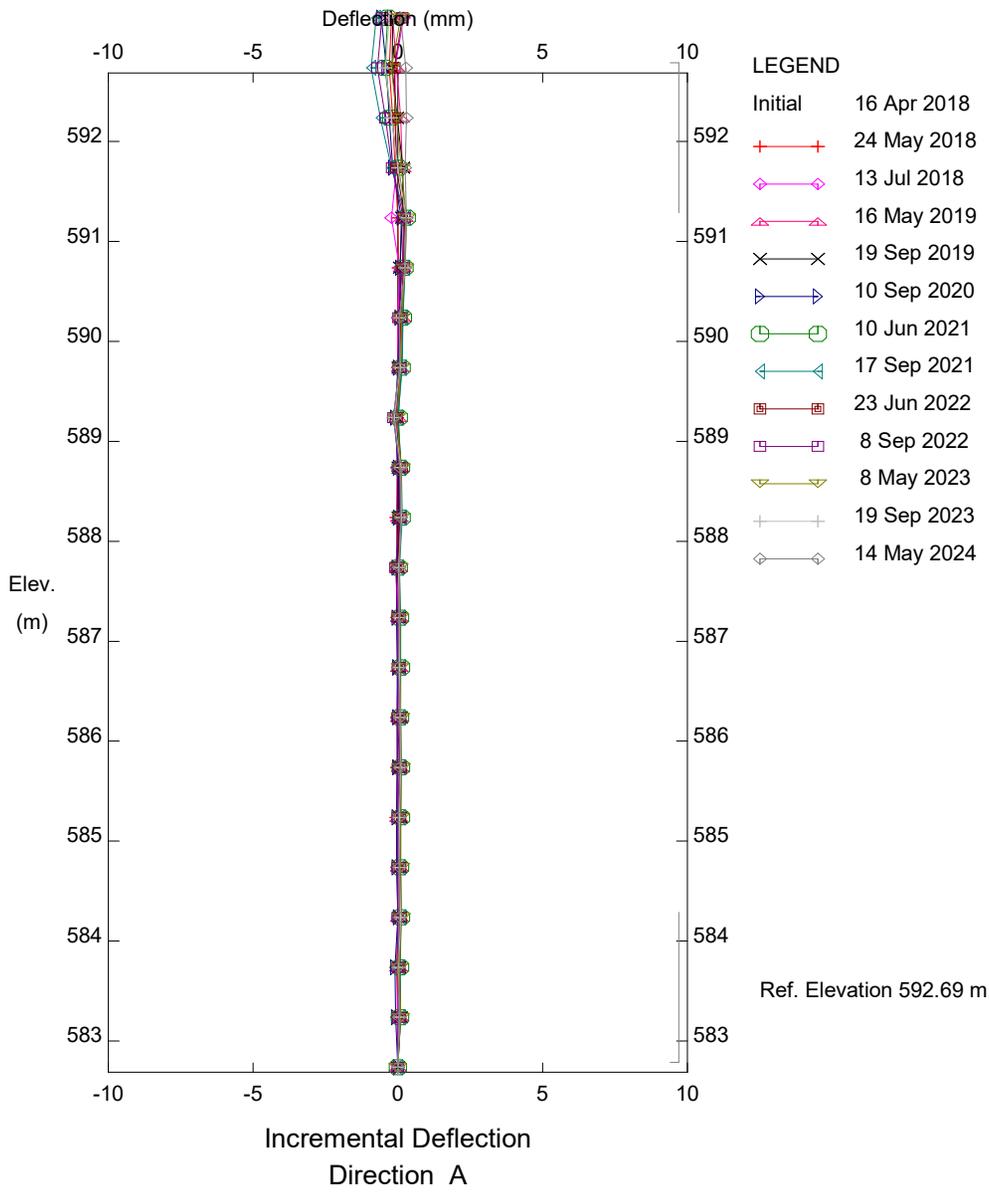
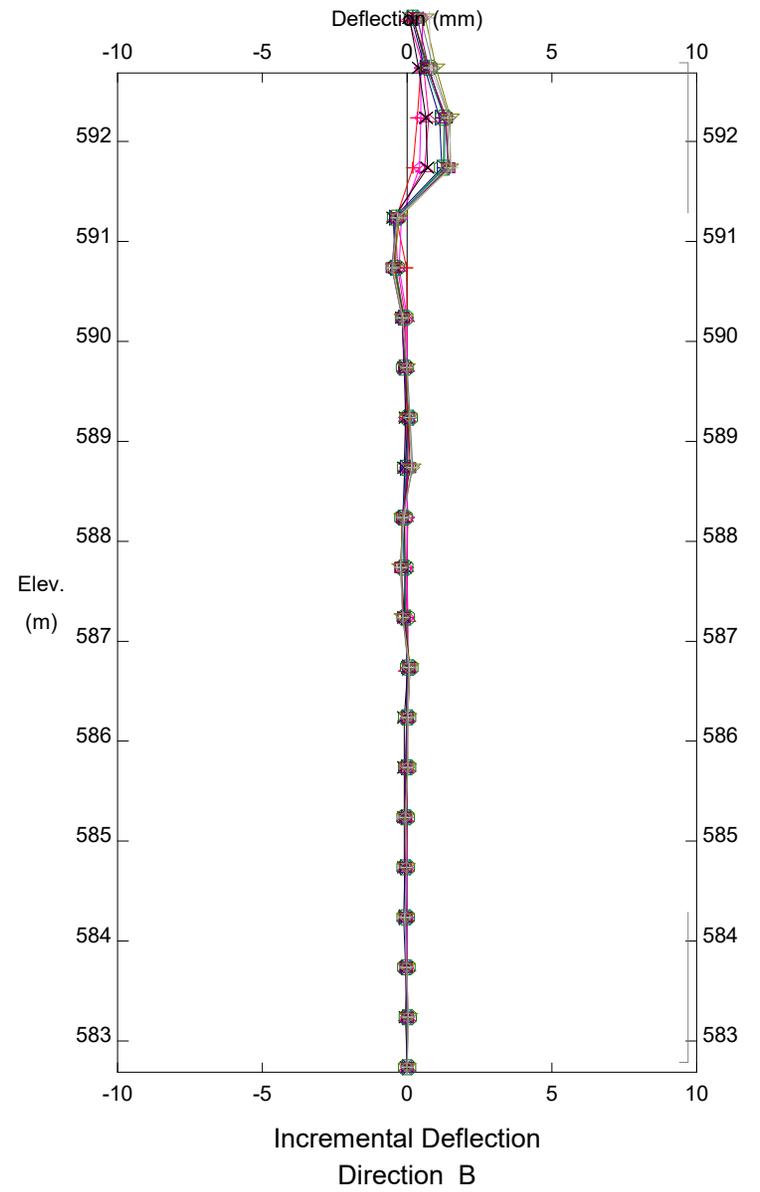
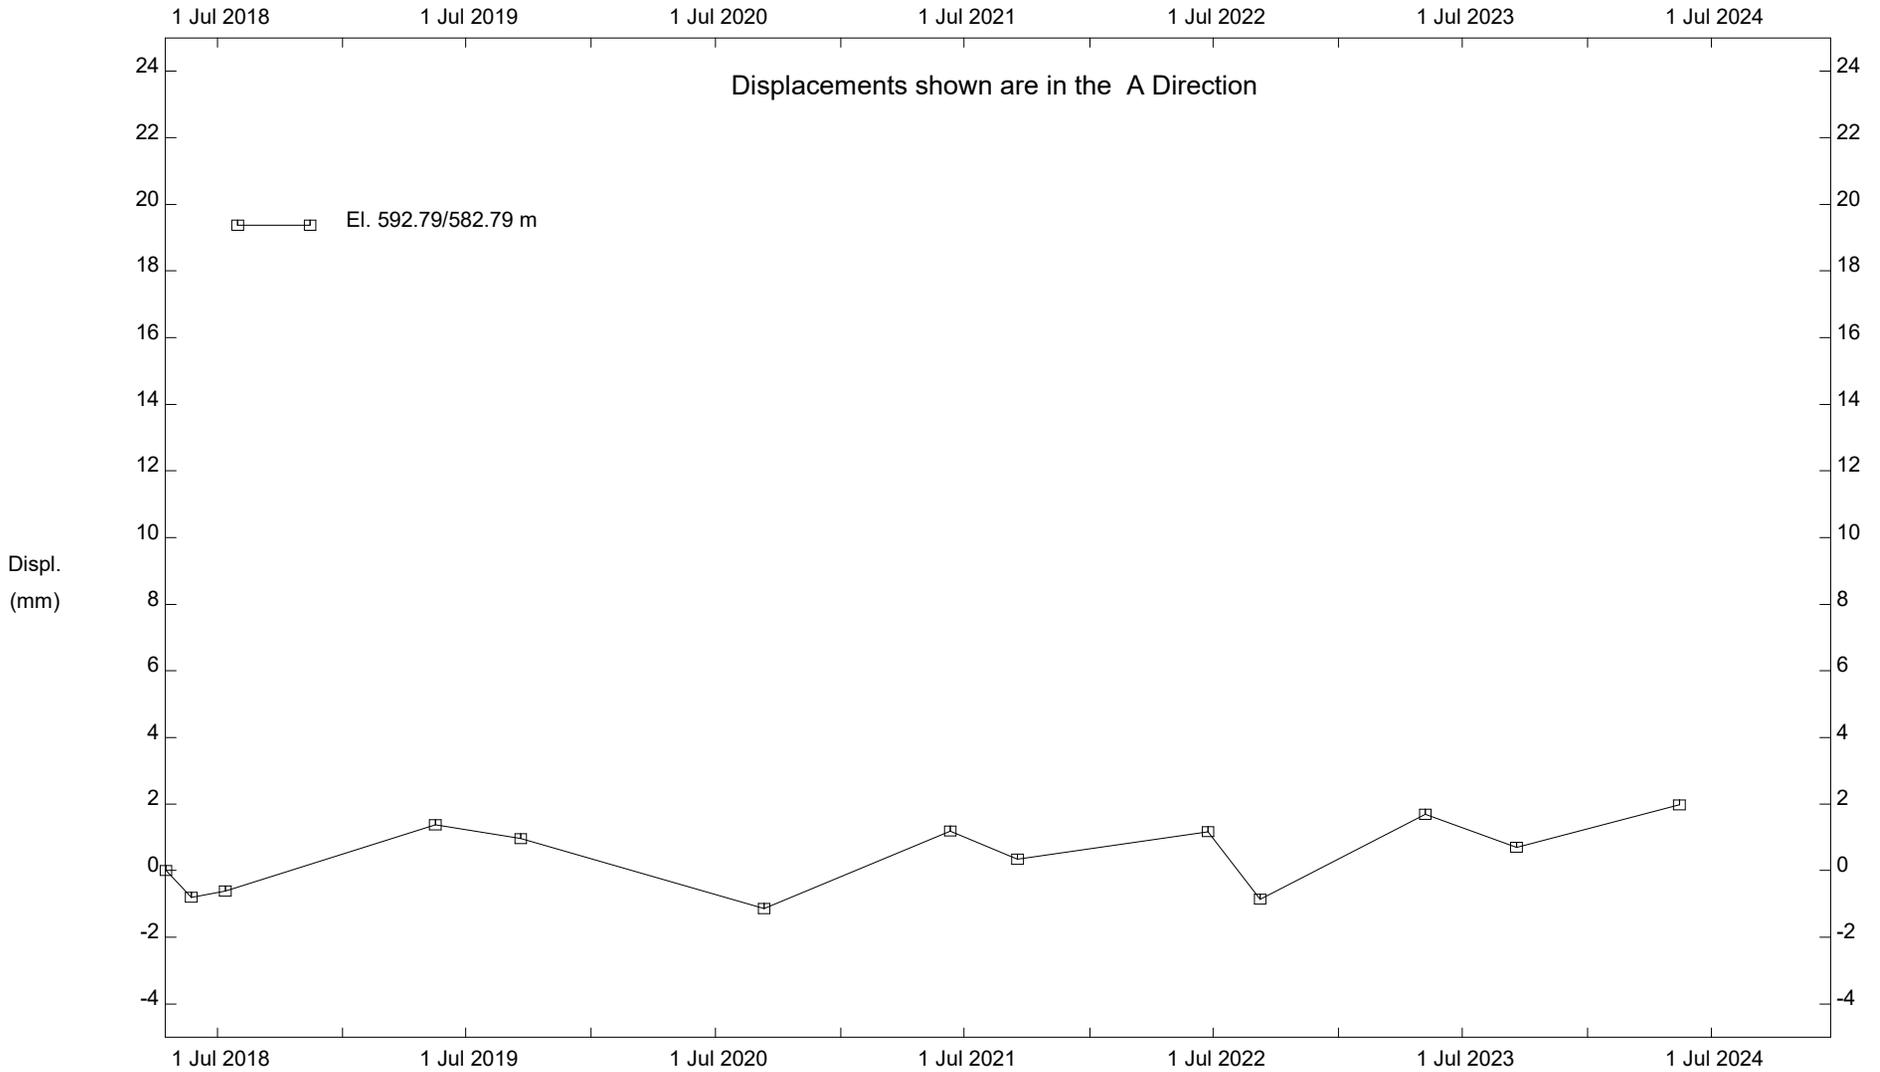
C062; H41:02, Vermilion Backslope, Inclinator SI18-C62-03
Alberta Transportation

Since installation, no discernible movement has been recorded in SI18-C62-03 (toe of slope).

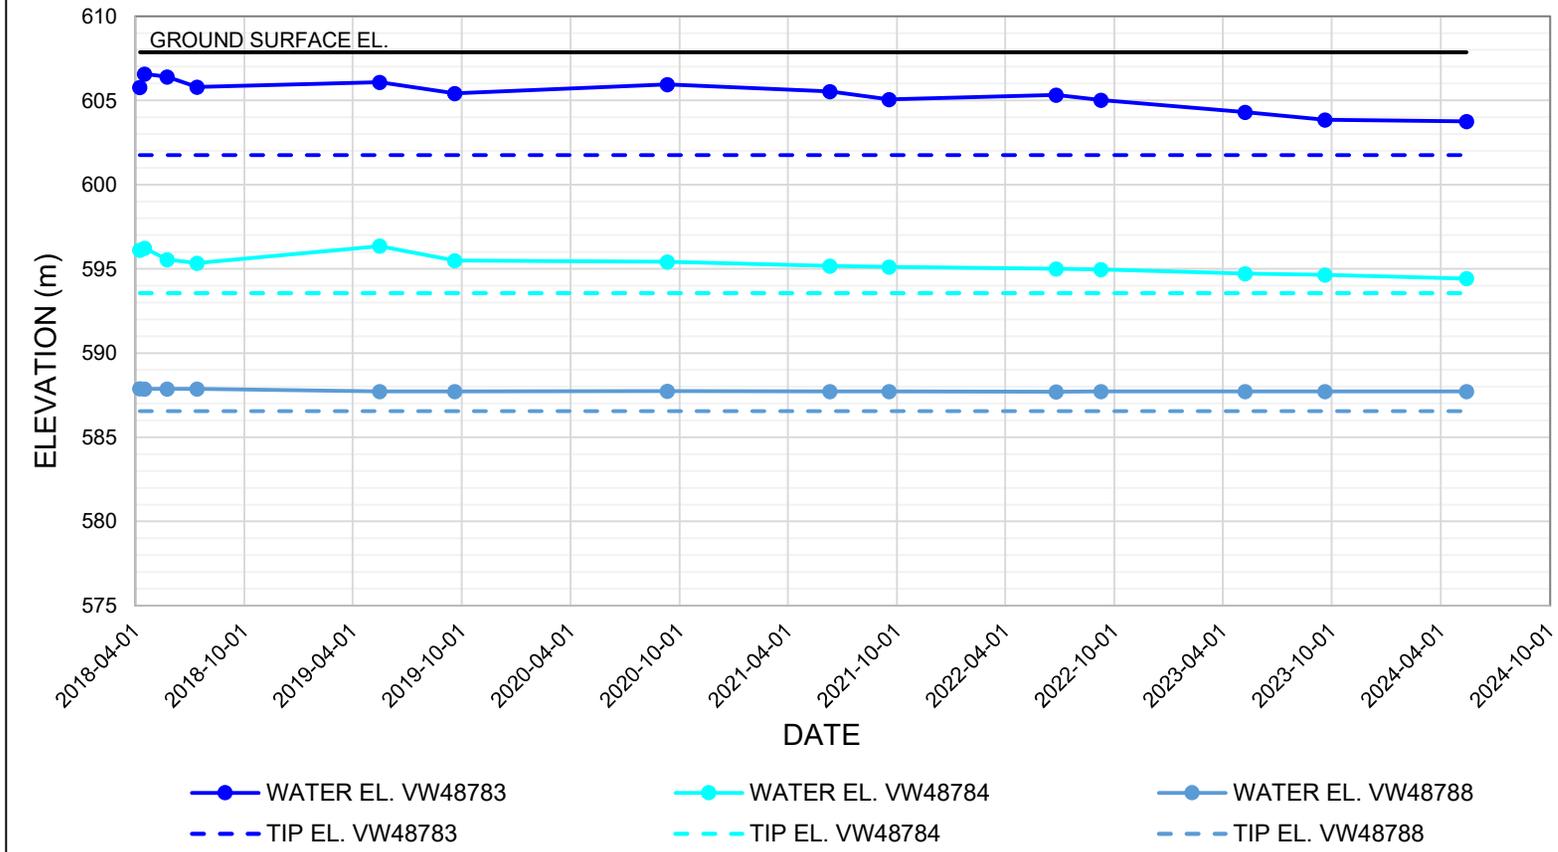
VW48783, VW48784, AND VW48788 (CREST OF SLOPE)

In the nested piezometers installed in BH18-C62-01 (VW48783, VW48784, and VW48788) at the crest of the slope, two independent water levels were detected in the clay till, which could indicate the presence of two perched groundwater tables. This is likely due to the presence of sand and silt lenses found interbedded within the clay till layer.

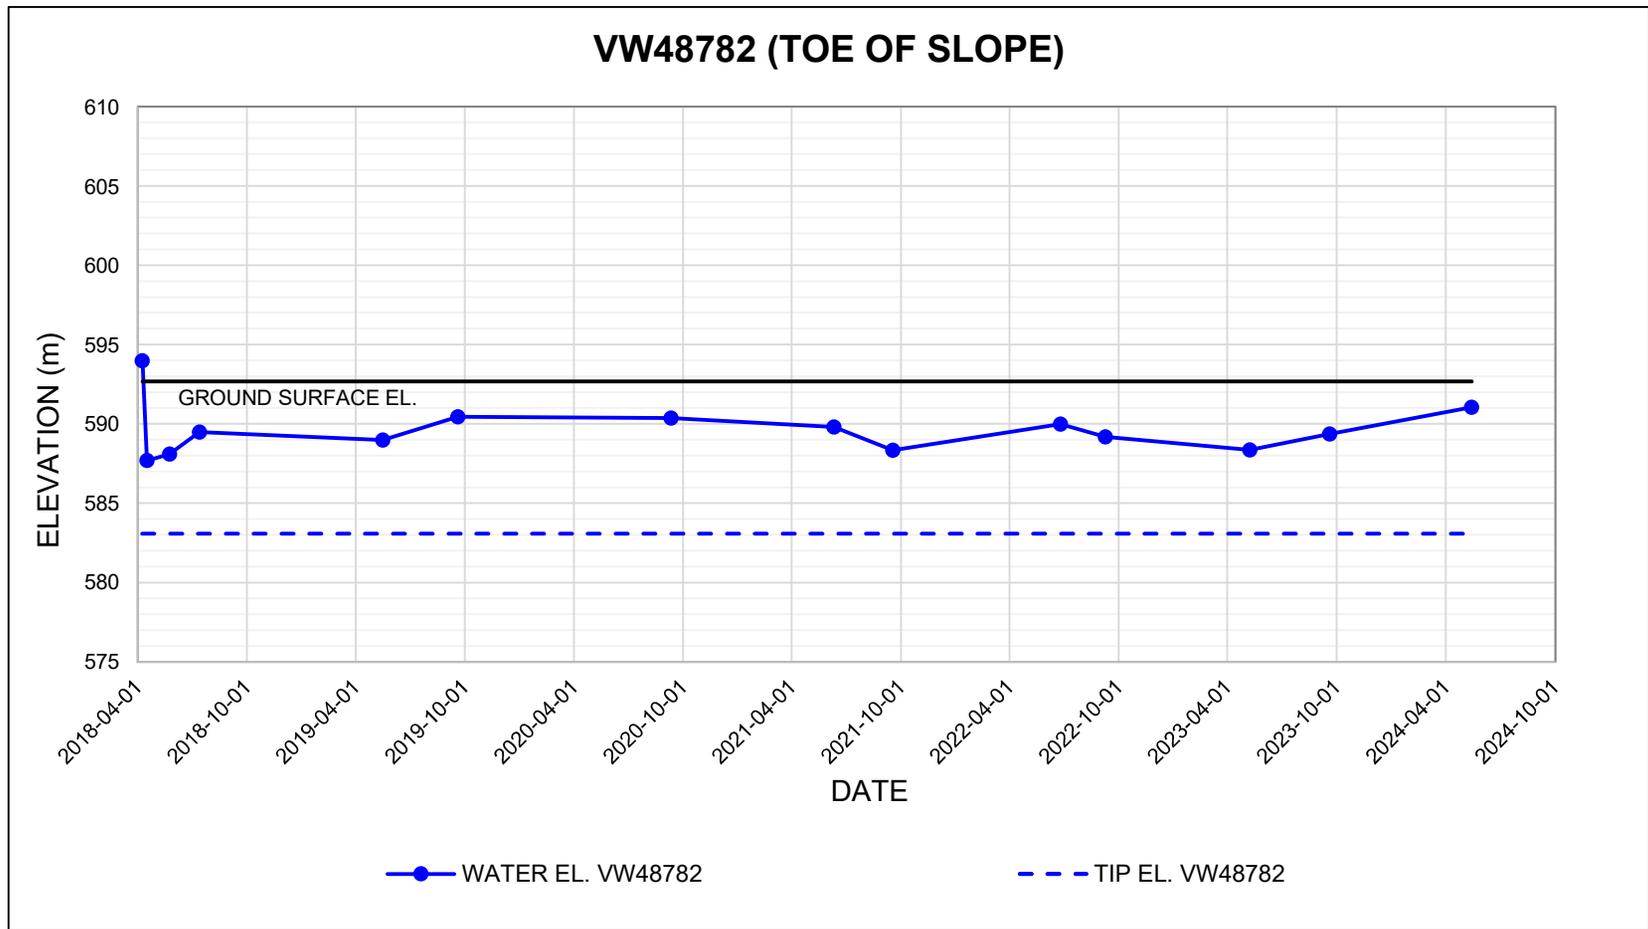
The piezometers have been either relatively steady (± 1.5 m) or dry since installation. The May 2024 readings were consistent with historical trends observed in these instruments, except for VW48782 at the toe of the slope which has recorded a 2.7 m increase since spring 2023. Precipitation data from the Alberta Climate Information Service (ACIS) Vermillion AGDM weather station, located approximately 2.5 km southwest of C062, recorded approximately 80 mm more precipitation in May 2024 than May 2023. As VW48782 is installed below the east (northbound) ditch below the slide, the increase in water level is likely in response to greater volumes of surface water runoff through the ditch and the resultant increased infiltration (likely exacerbated by the toe roll partially blocking the ditch).
