SITE NUMBER AND NAME C54 H56:16 Pavement Settlement		HIGHWAY & KM -23	PREVIOUS INSPECTION DATE June 19, 2012	INSPECTION DATE May 15, 2013
LEGAL DESCRIPTION NE 8-44-19-W4	NAD 83 COORDINATES N 5849337 E 384357		RISK ASSESMENT PF: 1 CF: 1 TOTAL: 1

CENTRAL REGION
GEOHAZARD RISK ASSESSMENT
SITE INSPECTION FORM

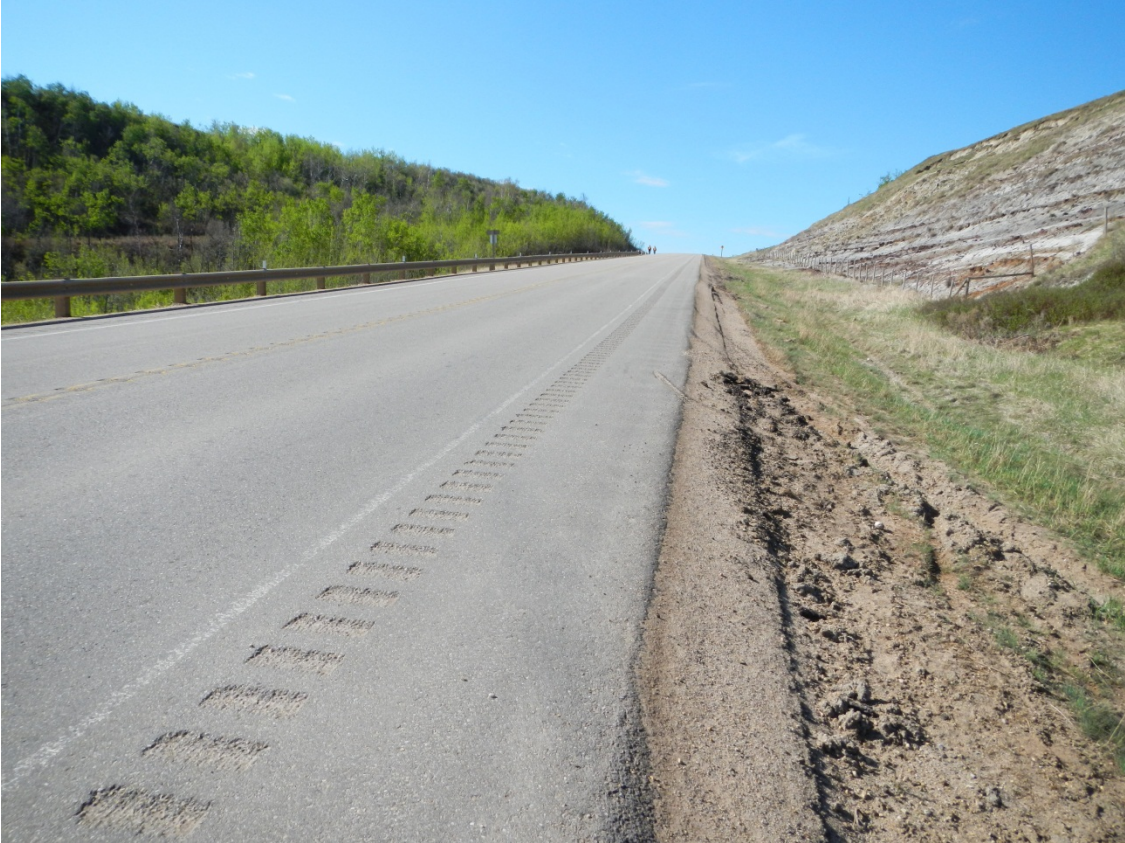
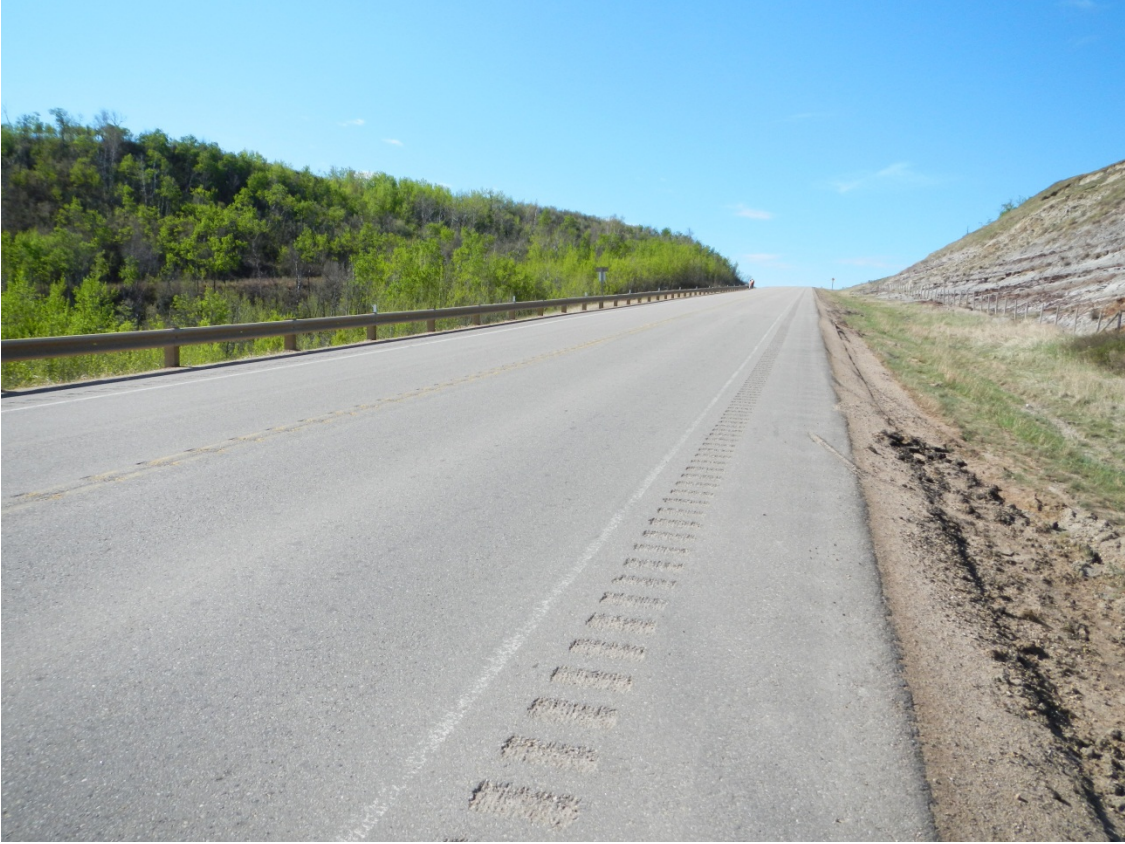
ITEM	CONDITION EXISTS		DESCRIPTION AND LOCATION	NOTICABLE CHANGE FROM LAST INSPECTION	
	YES	NO		YES	NO
Pavement Distress		X	No settlement or pavement distress has been observed since the foam injection and repaving work in August 2011.		X
Slope Movement		X			X
Erosion		X			X
Seepage		X			X
Culvert Distress		X			X

ITEM	CONDITION EXISTS		DESCRIPTION AND LOCATION	NOTICABLE CHANGE FROM LAST INSPECTION	
	YES	NO		YES	NO
Pavement Distress		X	No settlement or pavement distress has been observed since the foam injection and repaving work in August 2011.	X	
Slope Movement		X			X
Erosion		X			X
Seepage		X			X
Culvert Distress		X			X
COMMENTS					
A geotechnical site investigation was undertaken in 2008 in order to characterize the subgrade soils and design a repair. Foam injection was performed at this site in August 2011 to consolidate the soft clay formation below the road.					
The site should be monitored for another year, but if no pavement distress is observed, it can be removed from the geohazard program.

COMMENTS
A geotechnical site investigation was undertaken in 2008 in order to characterize the subgrade soils and design a repair. Foam injection was performed at this site in August 2011 to consolidate the soft clay formation below the road.
Remove from the geohazard program.
