# **Alberta Transportation**

**CON0017608 Central Region GRMP**

***Hwy 609:02, km 16.42***

***Call - Out Report***

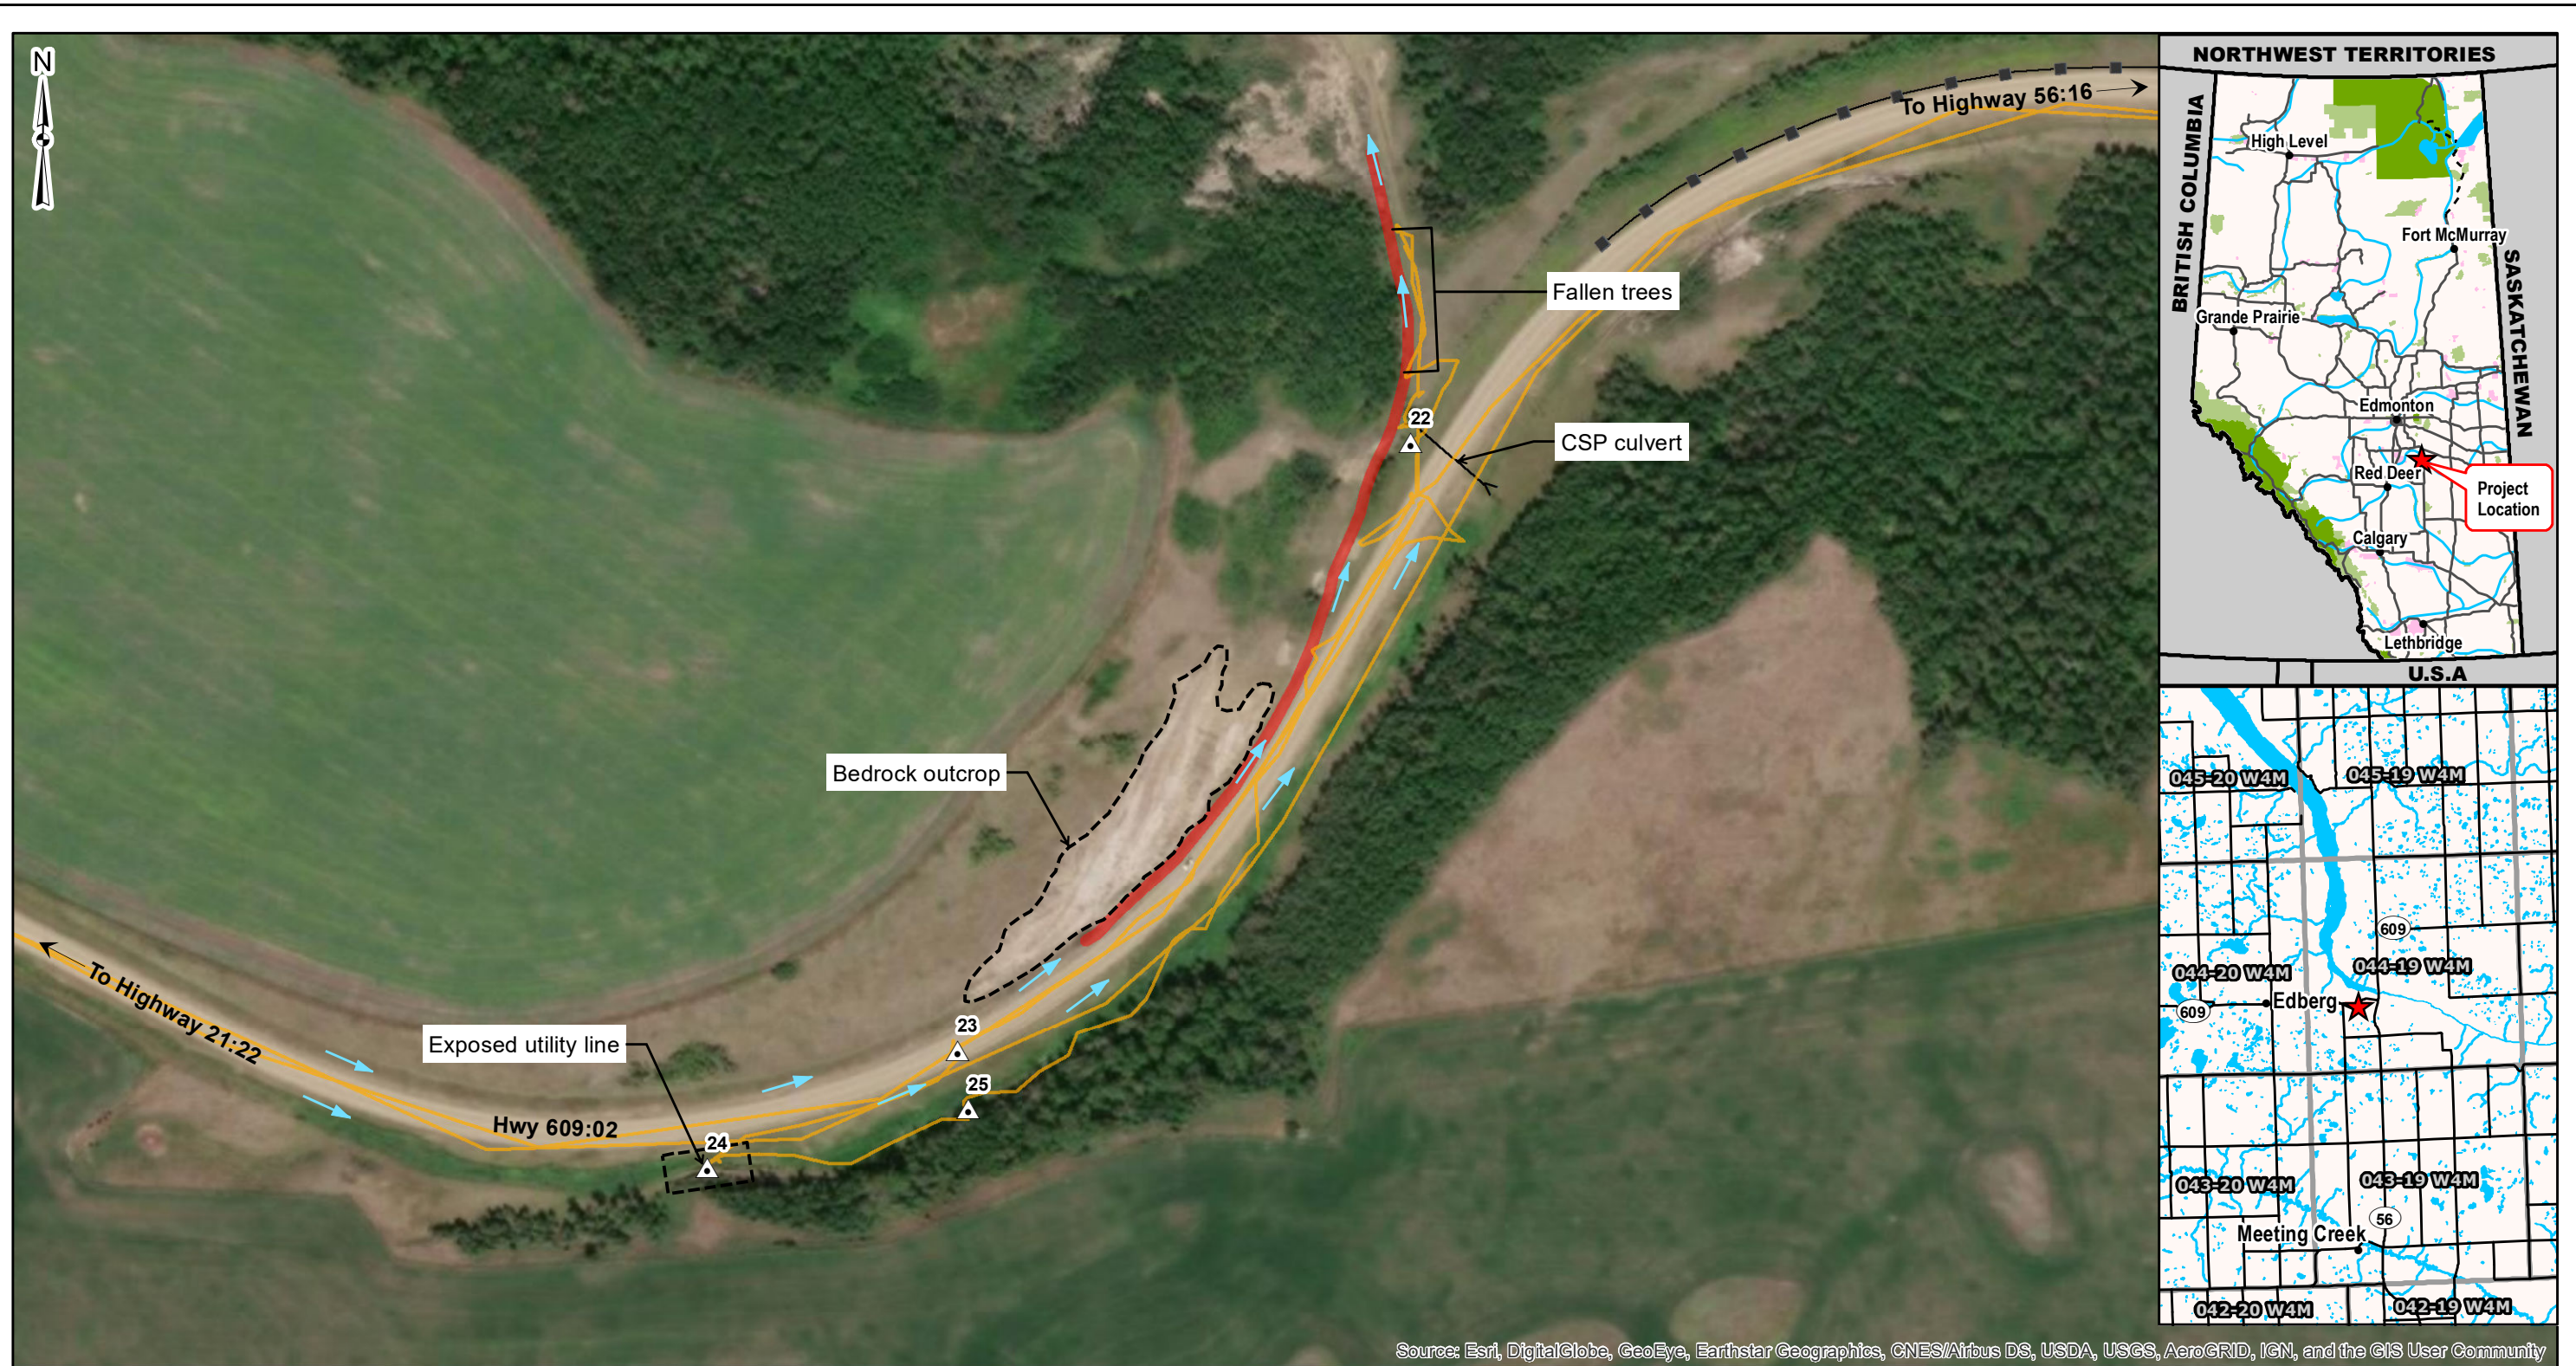
PROJECT	CENTRAL REGION GEOHAZARD RISK MANAGEMENT PROGRAM	
TITLE	Site Plan Unnumbered Site - South of Driedmeat Lake Erosion Hwy 609:02, km 16.42	
SCALE	PROJECT No.	FIG No.
1:2,500	A05115A02	1

Erosion is occurring in the ditch on the north side of Hwy 609:02. The ditch erosion begins at the west extent of the site near an outcrop of bedrock and extends east pass a culvert into a gully at the east extent of the site. The gully extends north outside of AT's Right of Way (ROW). The approximate extents of the erosion are shown on Figure 1. The highway embankment slopes are well vegetated and slope at approximately 4H:1V.

- Higher surface water flows over the backslope excavated into bedrock on the north side of the highway (Figure 1) could have attributed to the erosion upslope of the culvert outlet.

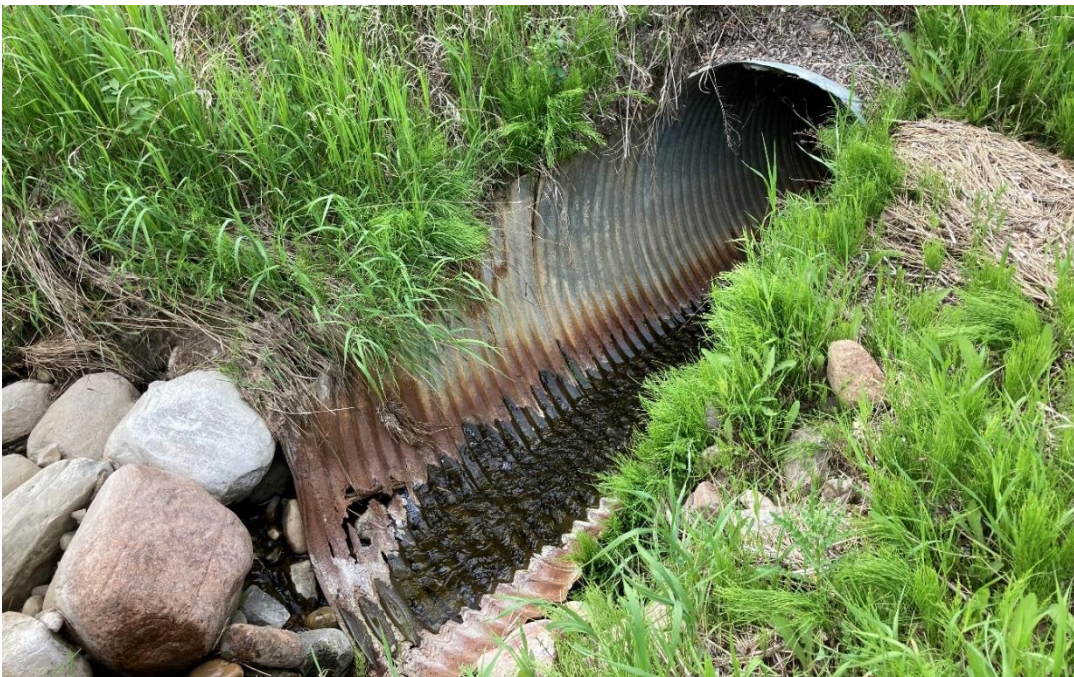
- A 1.0-m-diameter CSP culvert below Hwy 609:02 is orientated approximately north to south. Corrosion was observed at the bottom of the culvert inlet and outlet (Photo 1 and 2, respectively).

**Photo 2** Culvert inlet. The bottom of the culvert is corroded and water is leaking into the underlying material. Photo taken June 24, 2020 facing north.

- Repair the existing culvert, the culvert should be lined with a smaller diameter smooth walled steel culvert and the annulus between them should be backfilled with grout.

- Armour the culvert inlet and outlet with riprap that meets the specifications in AT's standard culvert drawings.
- Grade the ditch west/upslope of the culvert and reinforce the centerline of the ditch with geotextile and geocell and gravel armouring:

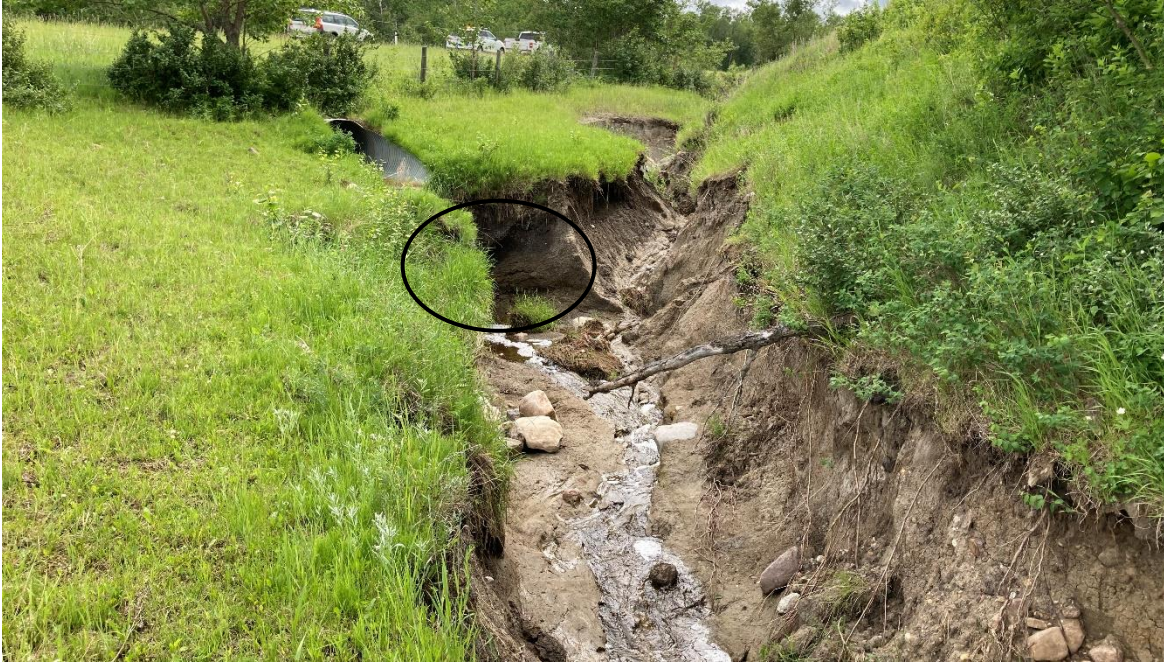
- Ditch erosion on the north side of Hwy 609:02 is impacting the fence between AT's ROW and private land (Photo 4).
- Water flowing from the culvert outlet has eroded an approximate 2-m-deep channel into the underlying bedrock (Photo 3, Waypoint 22). The gully erosion extends outside of AT's right of way (ROW). The gully erosion has extended into bedrock from the outlet of the culvert to where the erosion gully terminates on private land.
- The depth of erosion is upwards of 2 m to 3 m near the culvert outlet (Photos 5 and 6), 4 m to 5 m east/downslope of the culvert outlet (Photo 7).
- The deepest section of erosion begins approximately 10 m east/downslope of the culvert outlet and extends approximately 50 m north. Some trees have fallen into deepest section of the erosion gully east/downslope of the culvert outlet (Photo 7).

**Photo 3** Erosion at the culvert outlet. Water flowing from the culvert outlet is eroding a channel into the underlying bedrock (indicated by black ellipse). Photo taken June 24, 2020 facing south.

- Remove vegetation and other debris in the erosion gully downslope/east of the culvert outlet.
- Repair the erosion gully downslope/east of the culvert outlet. Some repair options include:

- ◆ Option 1: Backfill the erosion gully with common fill (e.g., till), grade a channel, and reinforce the channel with geotextile and geocells. This is KCB recommended option as it is more economical than Options 2 and 3 and would require less maintenance.

- ◆ Option 2: Backfill the erosion gully with common fill, grade a channel, and protect the channel with geotextile and riprap.
- ◆ Option 3: Install a slope drain beginning near the outlet of the existing culvert and ending northeast of where the erosion ends. This option would require the construction of an intake structure at the inlet of the slope drains and an energy dissipation structure at the outlet of the slope drain.

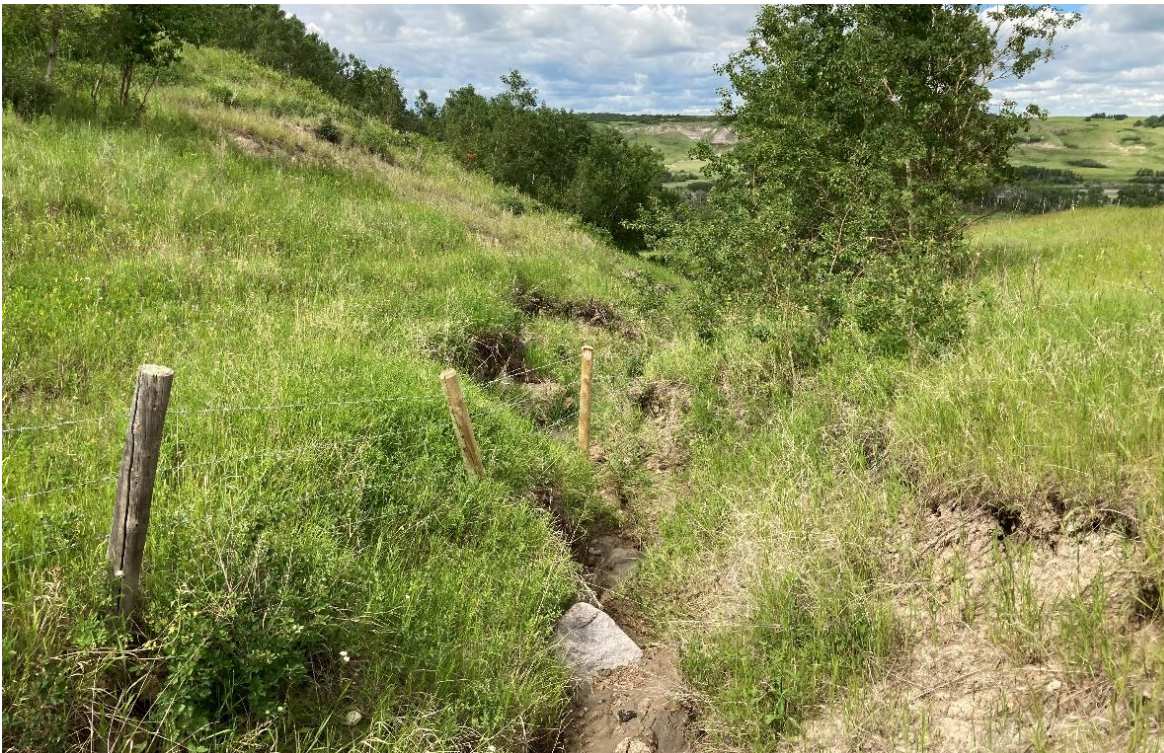
**Photo 4** Erosion upslope of the culvert outlet that is impacting the existing fence. Photo taken June 24, 2020 facing northeast.

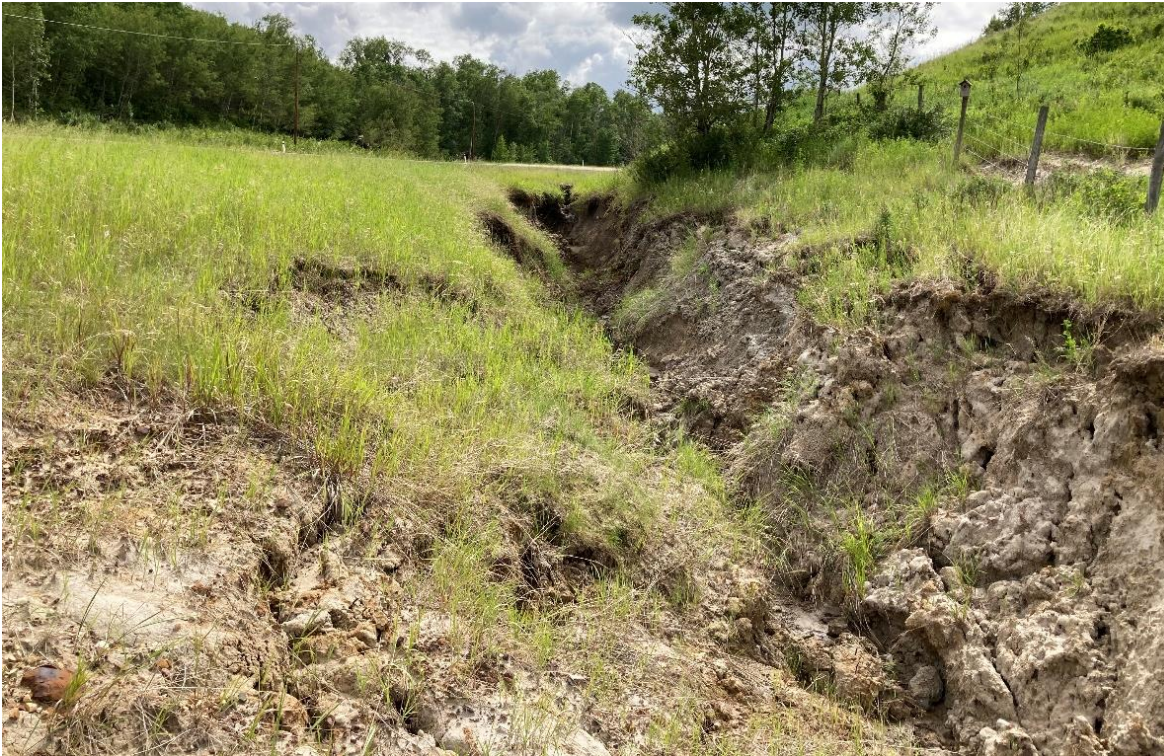
**Photo 5** Erosion in the ditch upslope of the culvert outlet. Photo taken June 24, 2020 facing southwest.

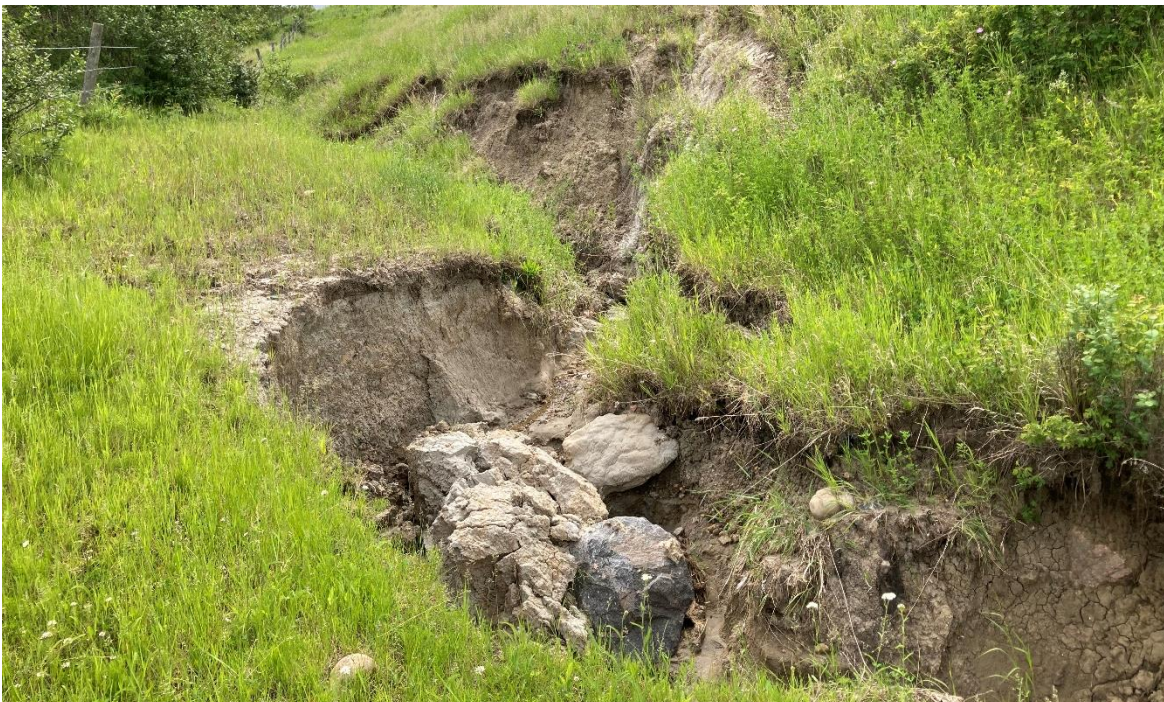
**Photo 6** Erosion increasing in depth upslope of the culvert outlet. Photo taken June 24, 2020 facing southwest.

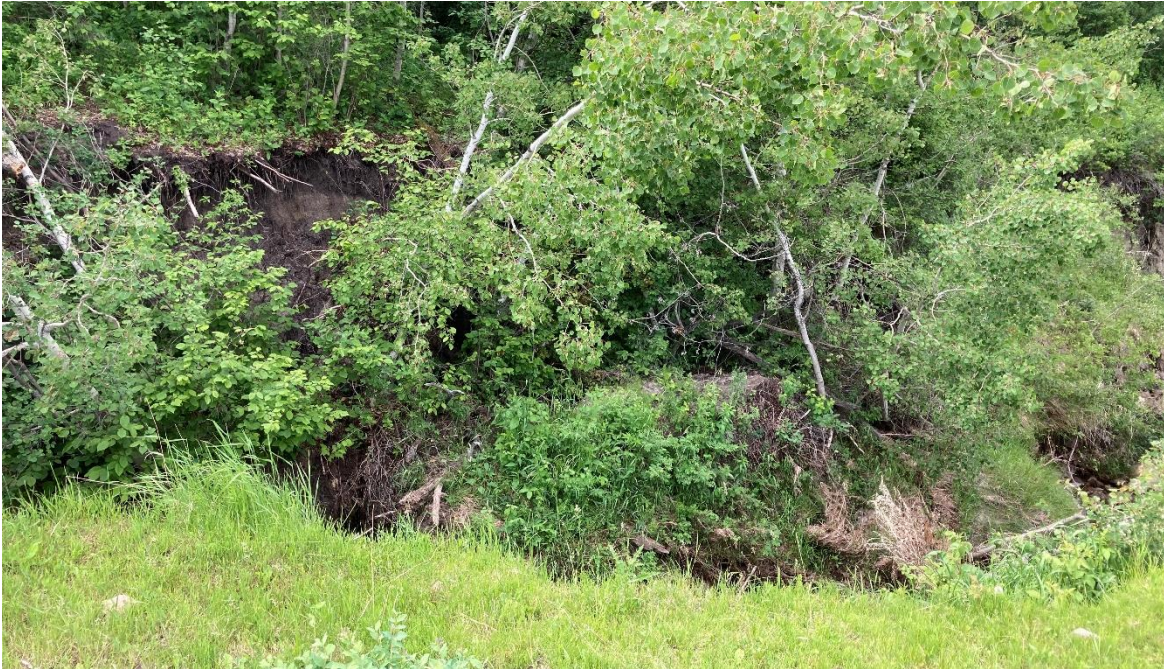
**Photo 7** Trees are falling into the erosion gully east/downslope of the culvert outlet. Photo taken June 24, 2020 facing north.

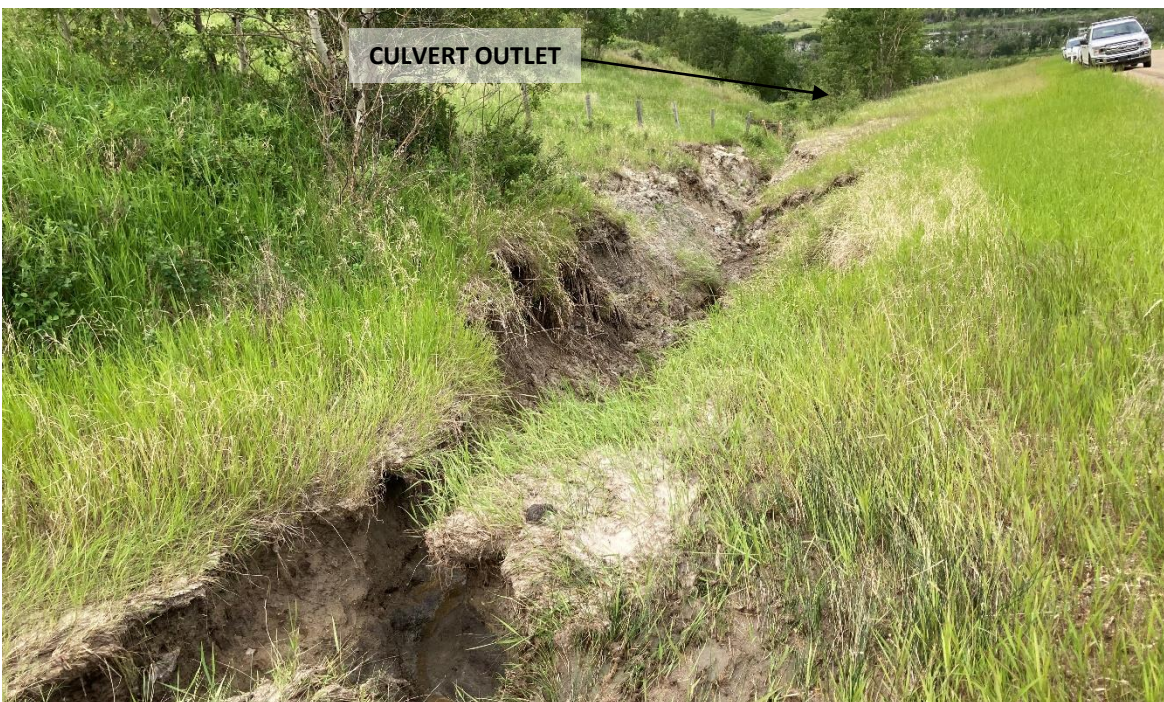
- The north ditch that discharges into the gully at the culvert outlet is less than 1 m to 1.5 m deep west/upslope of the culvert outlet (Photo 8 to 10). The erosion along this stretch of the ditch is typically 3 m to 4 m away from the highway but comes within 1.5 m near the north extent of the site.

**Photo 8** Erosion upslope of the culvert outlet. The approximate location of the culvert outlet is indicated by the black arrow. Photo taken June 24, 2020 facing northeast.

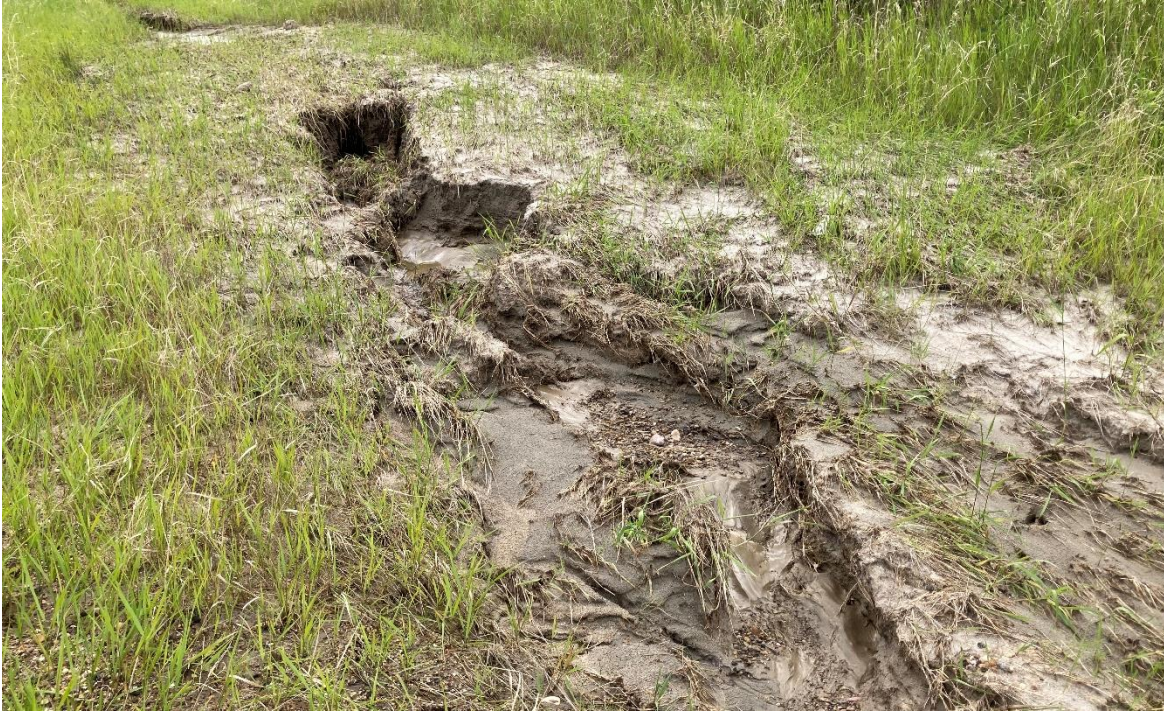
**Photo 9** Mild erosion and sedimentation upslope of the erosion presented in Photo 8 and near the east extent of the bedrock outcrop. Photo taken June 24, 2020 facing northwest.

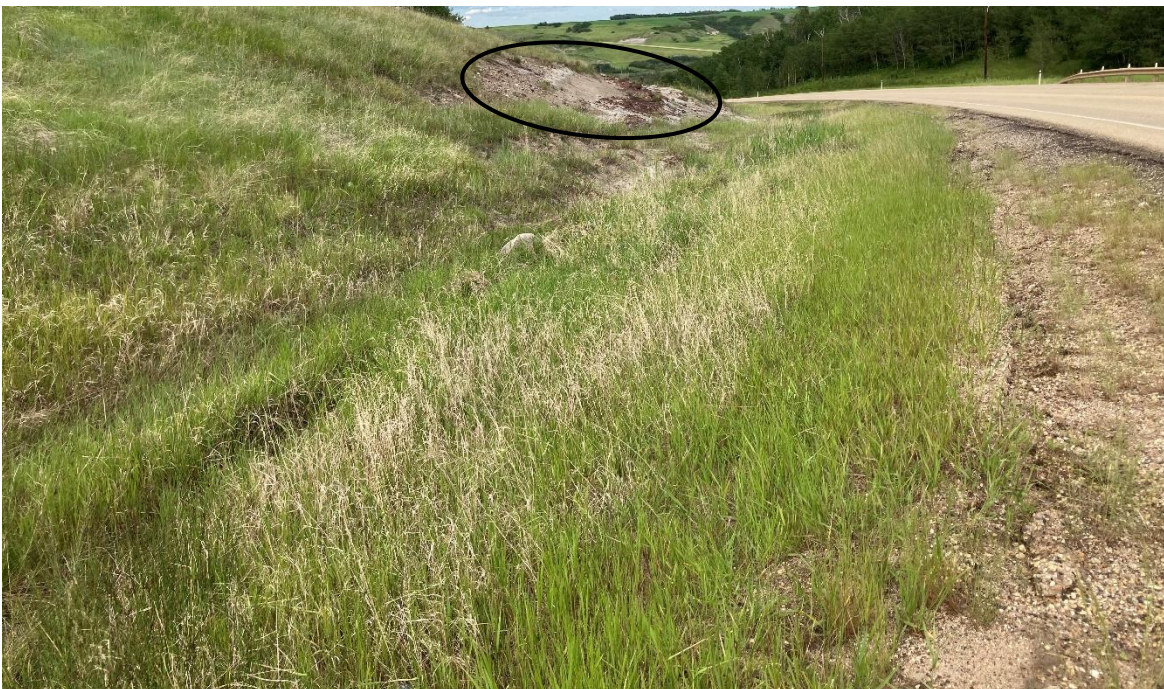
- The erosion in the base of the ditch (i.e., the ditch bottom), is steep-sided, and has eroded below the vegetation.
- The ditch west/upslope of the bedrock backslope is well vegetated and is performing well (Photo 10).

**Photo 10** The ditch is well vegetated upslope (northwest) of the bedrock outcrop (indicated by black ellipse). Photo taken June 24, 2020 facing southeast.

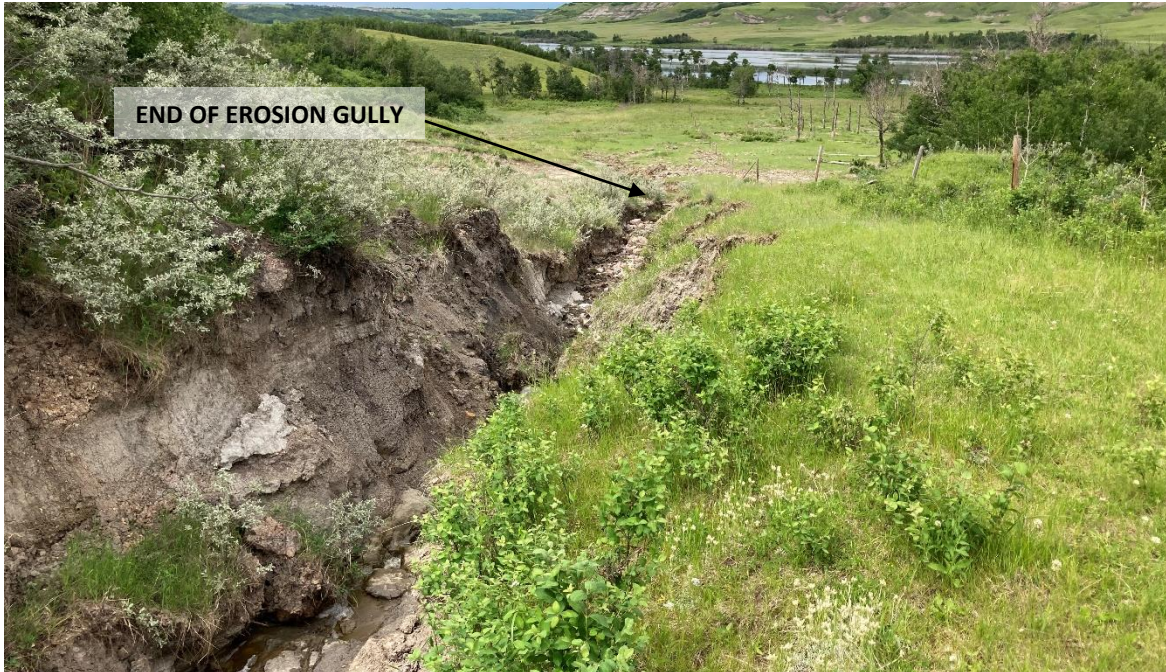
- There are cobbles at the erosion gully outlet, east/downslope of the culvert outlet (Photo 11). These cobbles are believed to have been from the soils that the gully eroded through.
- Eroded material from the erosion gully is being deposited at the outlet of the erosion gully outside AT's ROW.

**Photo 11** Erosion gully downslope of where the trees are falling into the erosion gully. Where the erosion gully terminates is indicated by the black arrow. Photo taken June 24, 2020 facing northeast.

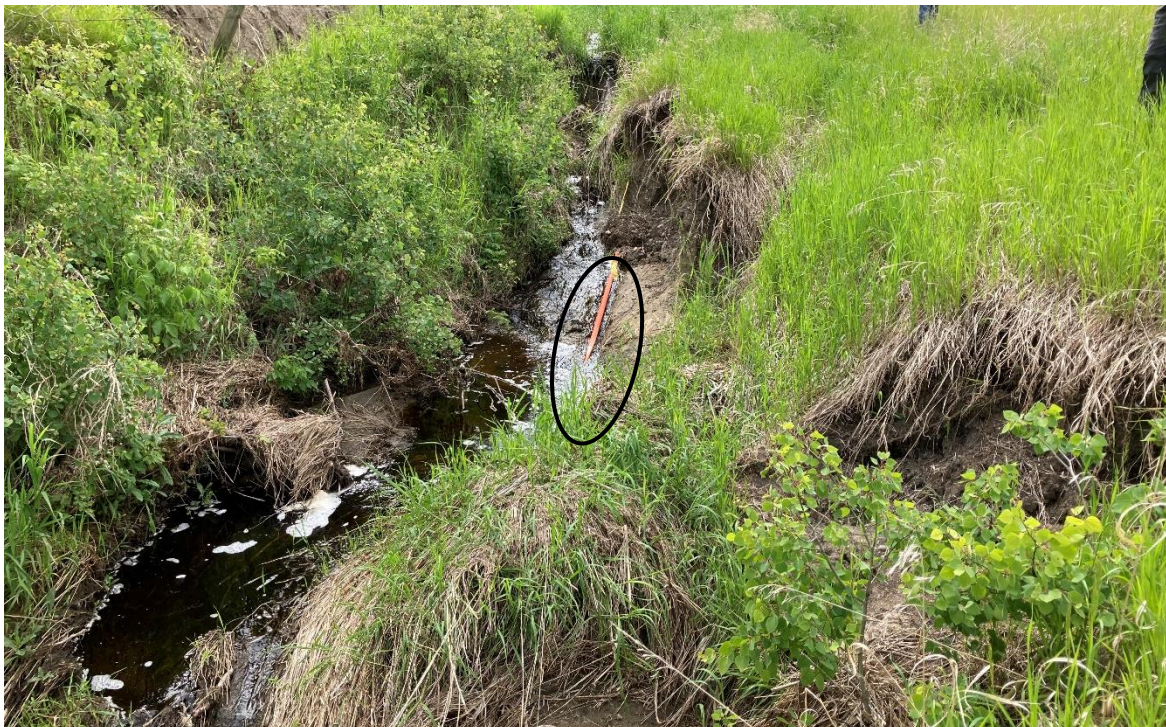
- The weather was 20°C to 25°C and mostly sunny.
- There is an exposed utility line in the ditch on the south side of Hwy 609:02 (Photo 12, Waypoint 24).
- There is ongoing erosion in the ditch on the south side of Hwy 609:02, but it is outside AT's Clearance Zone (approximately 8 m to 10 m) and is not as significant as the erosion in the ditch on the north side of Hwy 609:02.

**Photo 12** Erosion on the south side of Hwy 609:02 has exposed an underground utility line (indicated by black ellipse). Photo taken June 24, 2020 facing west.

- The MCI should continue to monitor the site to see if the ditch erosion retrogresses/expands towards the westbound lane of Hwy 609:02 and if there is leakage from the culvert (may result in subsurface voids that could impact the integrity of the highway).
- If the ditch erosion begins to impact the highway embankment/road surface, signage should be installed to warn the public of the hazard (e.g., hazard and speed reduction signs).
- Notify utility owner than line is exposed in the ditch on the south side of Hwy 609:02.

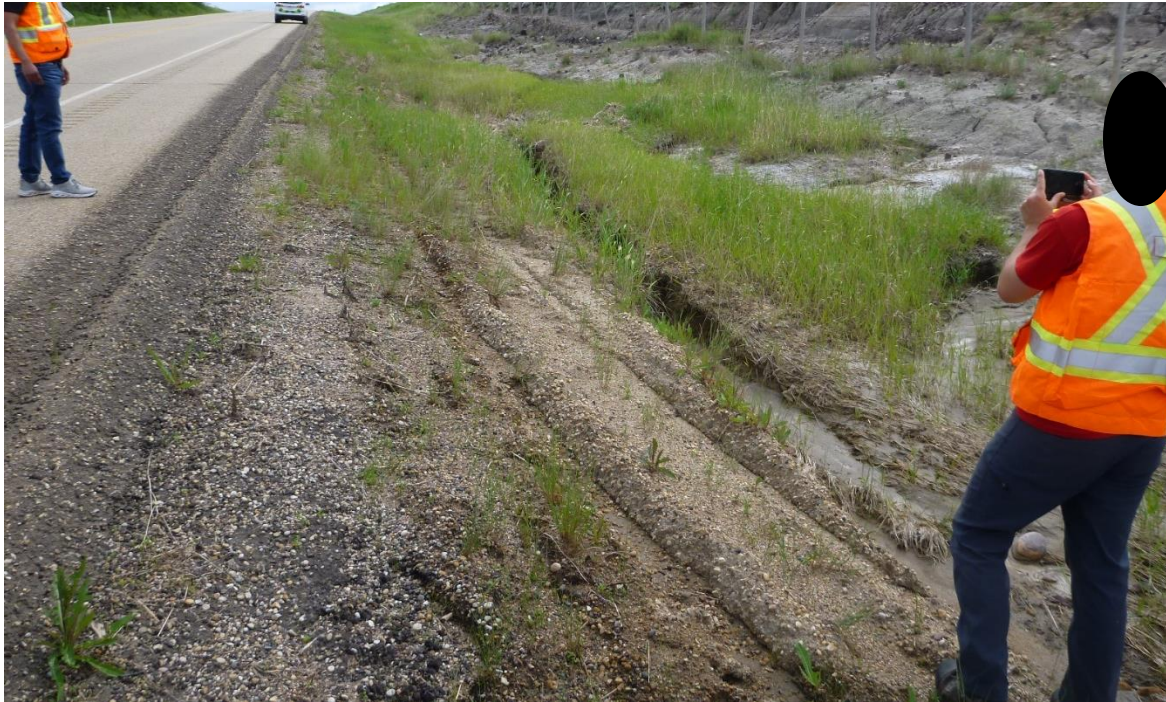
- The erosion in the ditch on the west side of Hwy 56:16 is minor (Photo 13 and 14) and could be regraded during repairs to the more significant ditch erosion on the north side of Hwy 609:02 and off highway ROW described earlier.
- The erosion gully east of Hwy 56:16 and just south of C054 (Photo 15). The erosion gully is approximately 2 m wide by 2 m deep at the inlet and increased in size further to the north (the length of the erosion gully was not inspected). However, since there is a guardrail installed east of the northbound lane and the erosion gully is located outside of AT's Clearance Zone of 8 m to 10 m (Photo 16), AT and KCB agree that repair recommendations are not required at the time this report was written.

**Photo 13** Mild erosion in the ditch on the west side of Hwy 56:16 (south of C054). Photo taken June 24, 2020 facing south.

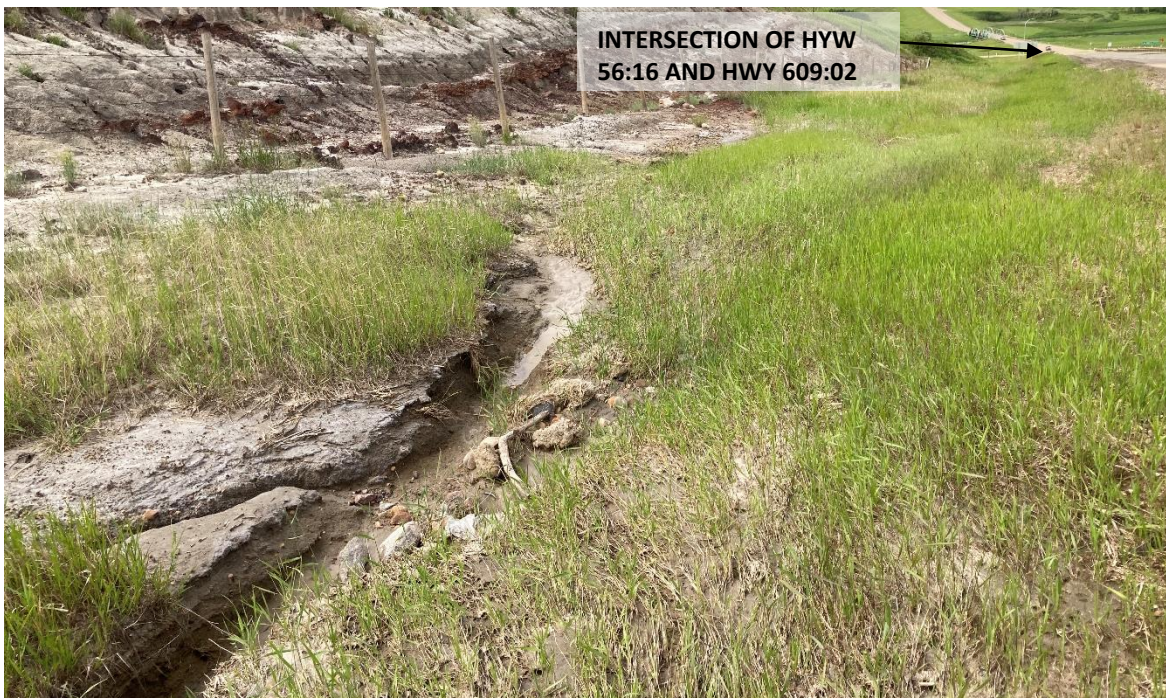
**Photo 14** Mild in the ditch on the west side of Hwy 56:16 (south of C054). Photo taken June 24, 2020 facing north.

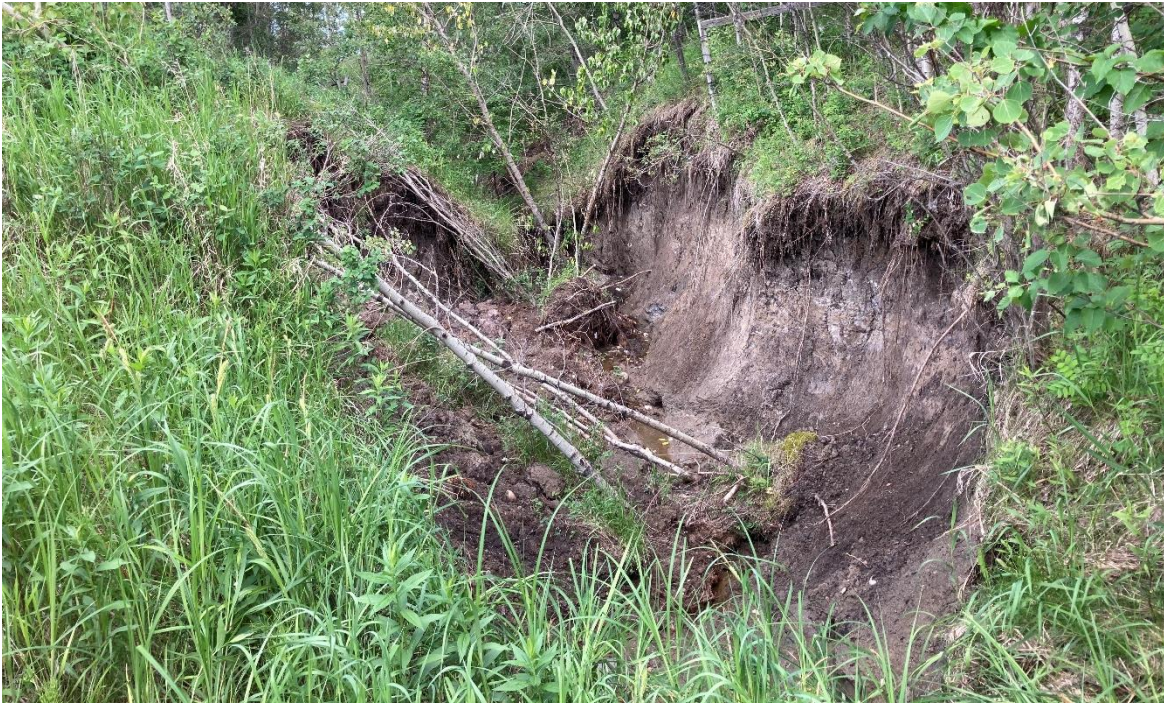
**Photo 15** Erosion gully inlet view from the ditch east of Hwy 56:16. Photo taken June 24, 2020 facing northeast.

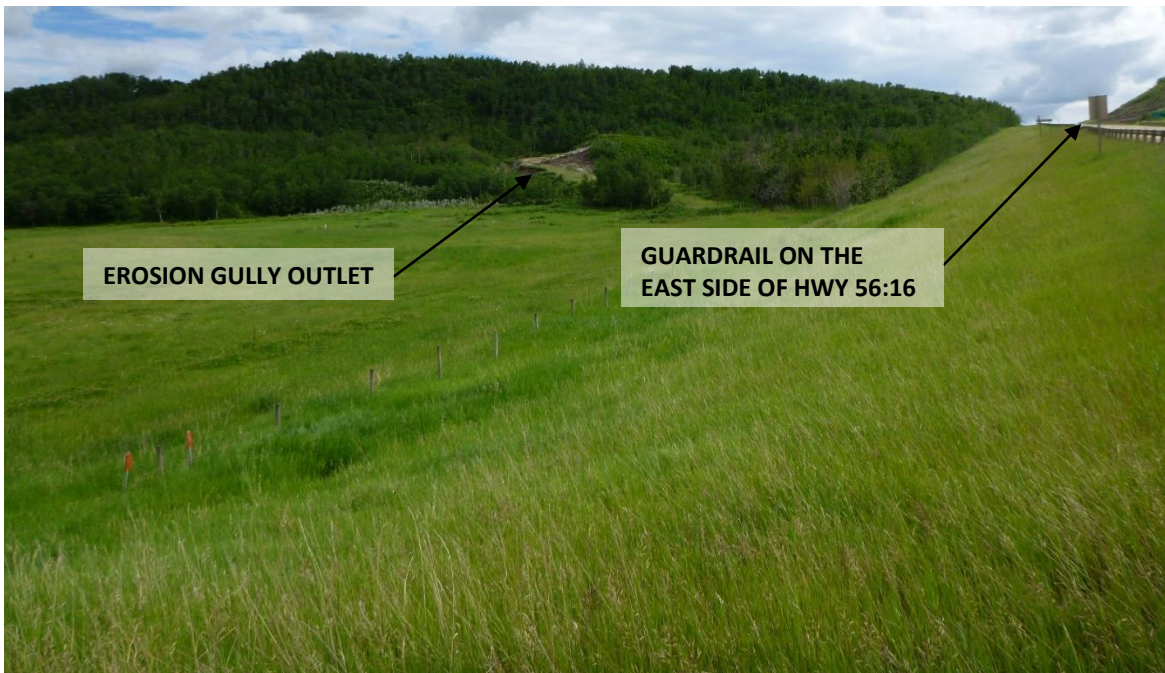
**Photo 16** Outlet of the erosion gully on the east side of Hwy 56:16 (southeast of C054). Photo taken June 24, 2020 facing south.
