SITE NUMBER AND NAME: <b>C058-1, -2, &amp; -3 Sinkholes</b>		HIGHWAY & KM: 570:02, 8.3, 9.2, 9.8	PREVIOUS INSPECTION DATE: June 24, 2021	INSPECTION DATE: <b>June 26, 2023</b>
LEGAL DESCRIPTION: 10-08-27-17 W4M	NAD 83 COORDINATES: UTM Northing Easting <b>C058-1</b> 12 5683470 405475 <b>C058-2</b> 12 5683845 404934 <b>C058-3</b> 12 5684148 404224		RISK ASSESSMENT: <b>C058-1:</b> PF: 8 CF: 5 TOTAL: 40 <b>C058-2:</b> PF: 8 CF: 5 TOTAL: 40 <b>C058-3:</b> PF: 8 CF: 5 TOTAL: 40	
AVERAGE ANNUAL DAILY TRAFFIC (AADT): 500 (west) & 400 (east) (Ref No. 116220 & 997198)			CONTRACT MAINTENANCE AREA (CMA): 521

PROJECT CENTRAL REGION GEOHAZARD RISK MANAGEMENT PROGRAM		
TITLE Site Plan C058-I - Sinkholes Hwy 570:01, km 8.3		
SCALE 1:750	PROJECT No. A05116A02	FIG No. 1

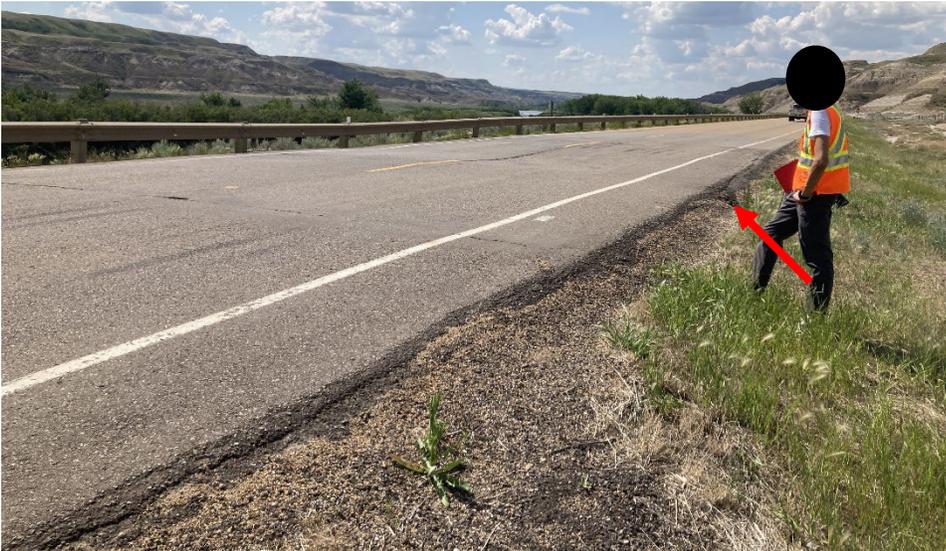
- The highway was last patched in 2021 (Photo 1). The dip in the highway surface (across both lanes) appears more significant than during the 2021 inspection.
- A small sinkhole (0.3 to 0.5 m in diameter) has formed on the north edge of the pavement (Photo 1 and 2). The sinkhole is located across the highway diagonally from a dip in the pavement surface on the south side of the highway indicating the presence of a void.
- A sinkhole at the culvert inlet (north of the highway) was filled in October 2018. The grout is intact and has not subsided since 2018.

**Photo 1** There appears to be a more significant dip in the pavement surface at C058-1 since the 2021 inspection. A small sinkhole (first observed in 2018) is on the north edge of the pavement (indicated by red arrow). Photo taken June 26, 2023, facing west-southwest.

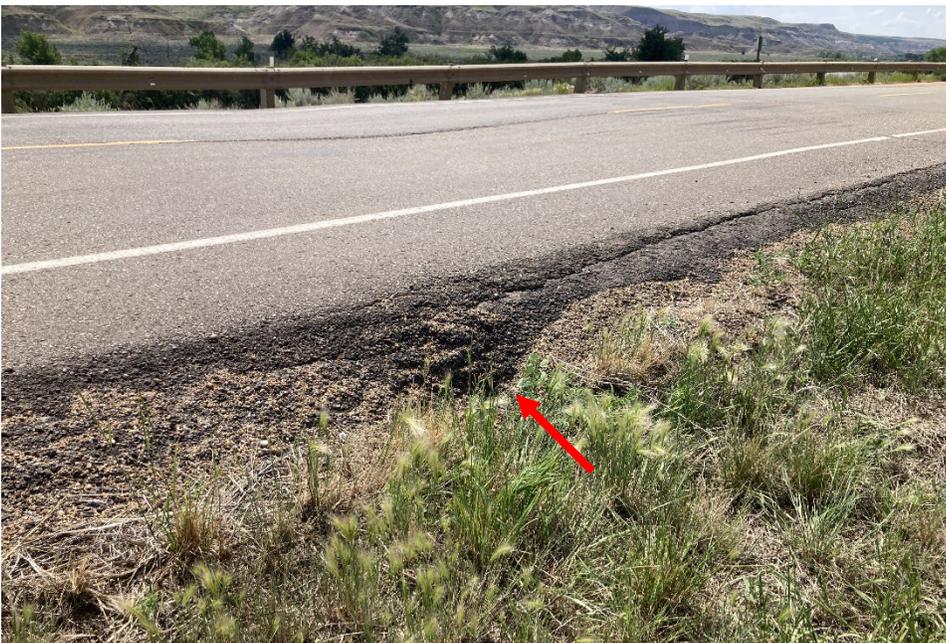
**Photo 2** The sinkhole first observed in 2018 along the north edge of pavement at C058-1 was backfilled with asphalt during the 2021 pavement patch. Photo taken June 26, 2023, facing southwest.

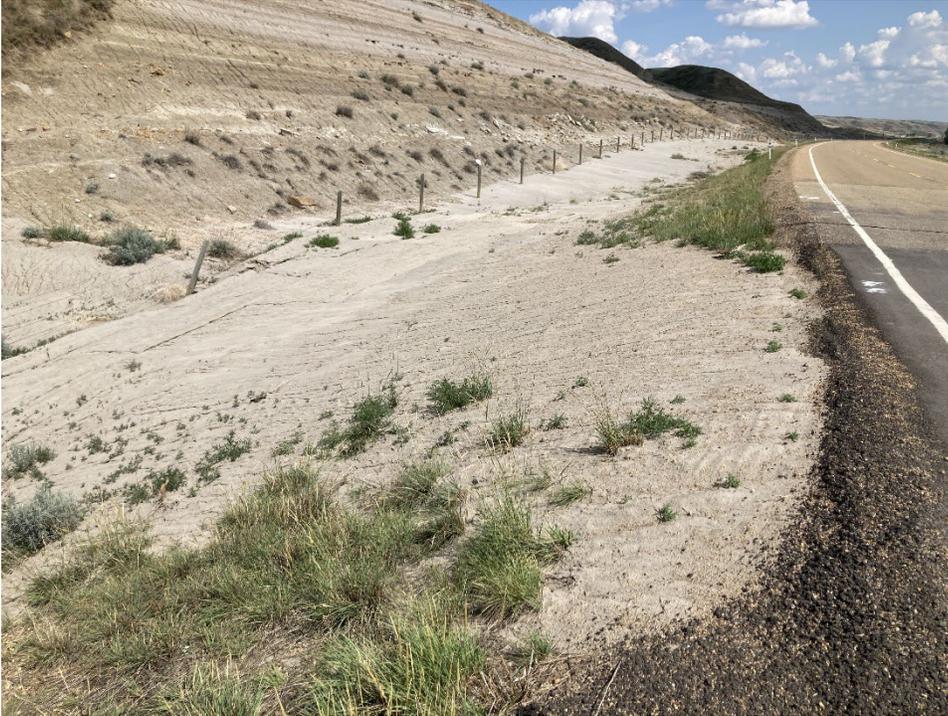
**Photo 3** Local material was spread in the north (westbound) ditch at the C058-2 site between the 2021 and 2023 inspections (most likely to backfill sinkholes previously observed at the site). Photo taken June 26, 2023, facing east.

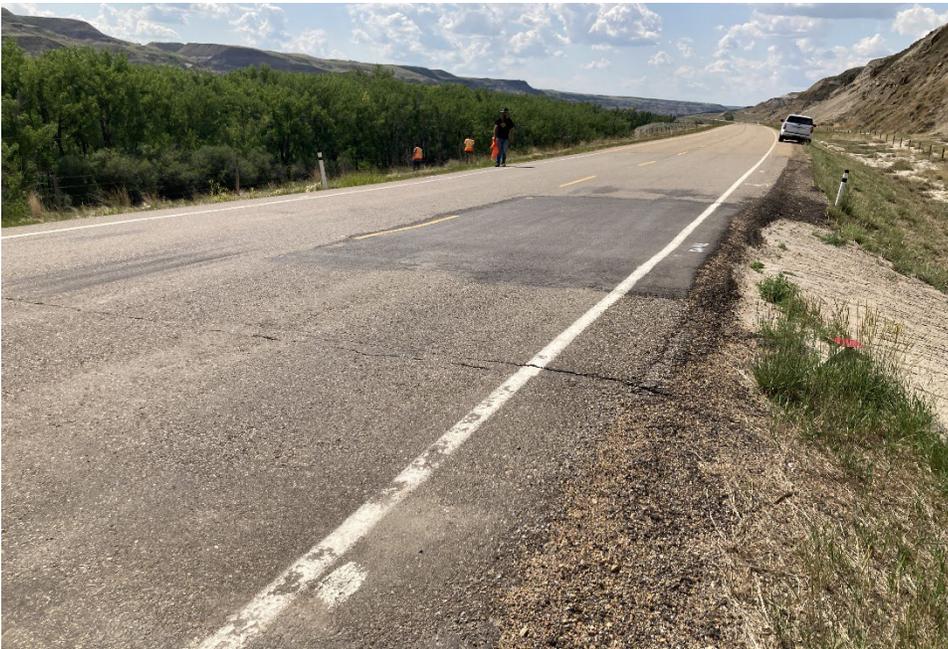
- Pavement has been recently patched in both lanes. The patch has settled since the 2021 pavement patch (Photo 4).
- A large sinkhole was discovered north of the highway at the fence line during the 2018 inspection. The sinkhole has expanded since the 2021 inspection (north of the pavement patch).
- A sinkhole was discovered along the valley draw above the highway in 2018 that lines up with the sinkhole downslope of the road.
- Additional sinkholes have been observed since 2018, below the fence line on the south side of highway at the culvert outlet and near the toe of the slope.
- Local material was placed in the north (westbound) highway ditch, east of the culvert inlet (Photo 3). This fill was most likely placed to backfill erosion features on the north highway embankment slope and ditch.

**Photo 4** A pavement patch was completed in the north (westbound) lane at the C058-2 site between the 2021 and 2023 inspections in an area of previously observed settlement. Photo taken June 26, 2023, facing west.

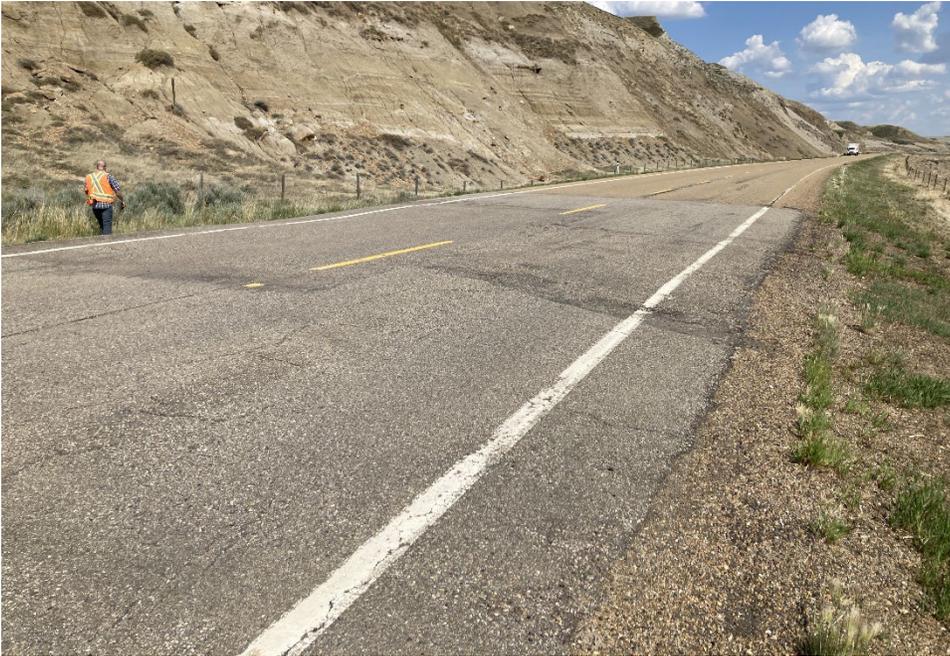
**Photo 5** C058-3 has not been patched between the 2021 and 2023 inspections. Photo taken June 26, 2023, facing northeast.

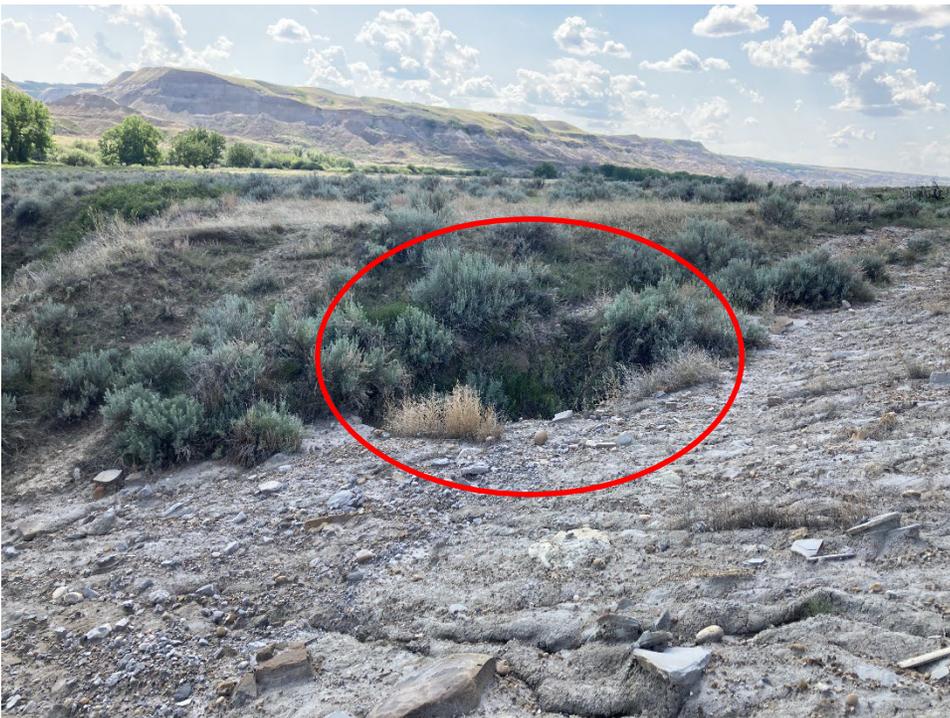
- A large sinkhole is located at the toe of the south highway embankment slope (first observed during the 108 inspection) (Photo 6). The sinkhole appears to have enlarged since the 2021 inspection.

**Photo 6** Large sinkhole (indicated by a red circle) at the toe of the south highway embankment at C058-3 appears to have expanded since the 2021 inspection. Photo taken June 26, 2023, facing southwest.
