<b>SITE NUMBER AND NAME:</b> C077 H570 Slide and Rockfall		<b>HIGHWAY &amp; KM:</b> 570:01, 8.8	<b>PREVIOUS INSPECTION DATE:</b> June 26, 2023	<b>INSPECTION DATE:</b> <b>June 18, 2024</b>
<b>LEGAL DESCRIPTION:</b> 04-17-027-17 W4M 03-07-027-17 W4M 13-08-027-17 W4M 14-08-027-17 W4M		<b>NAD 83 COORDINATES:</b> UTM    Northing    Easting 12      5684270    404558	<b>RISK ASSESSMENT:</b> Slide:    PF: 9      CF: 4      TOTAL: 36 Rockfall: PF: 11    CF: 4      TOTAL: 44	
<b>AVERAGE ANNUAL DAILY TRAFFIC (AADT):</b> 500 (west) & 400 (east) (Ref No. 116220 & 997198)			<b>CONTRACT MAINTENANCE AREA (CMA):</b> 519

PROJECT CENTRAL REGION GEOHAZARD RISK MANAGEMENT PROGRAM		
TITLE Site Plan C077 - H570 Slide and Rockfall Hwy 570:01, km 8.8		
SCALE 1:4,000	PROJECT No. A05116A02	FIG No. 1

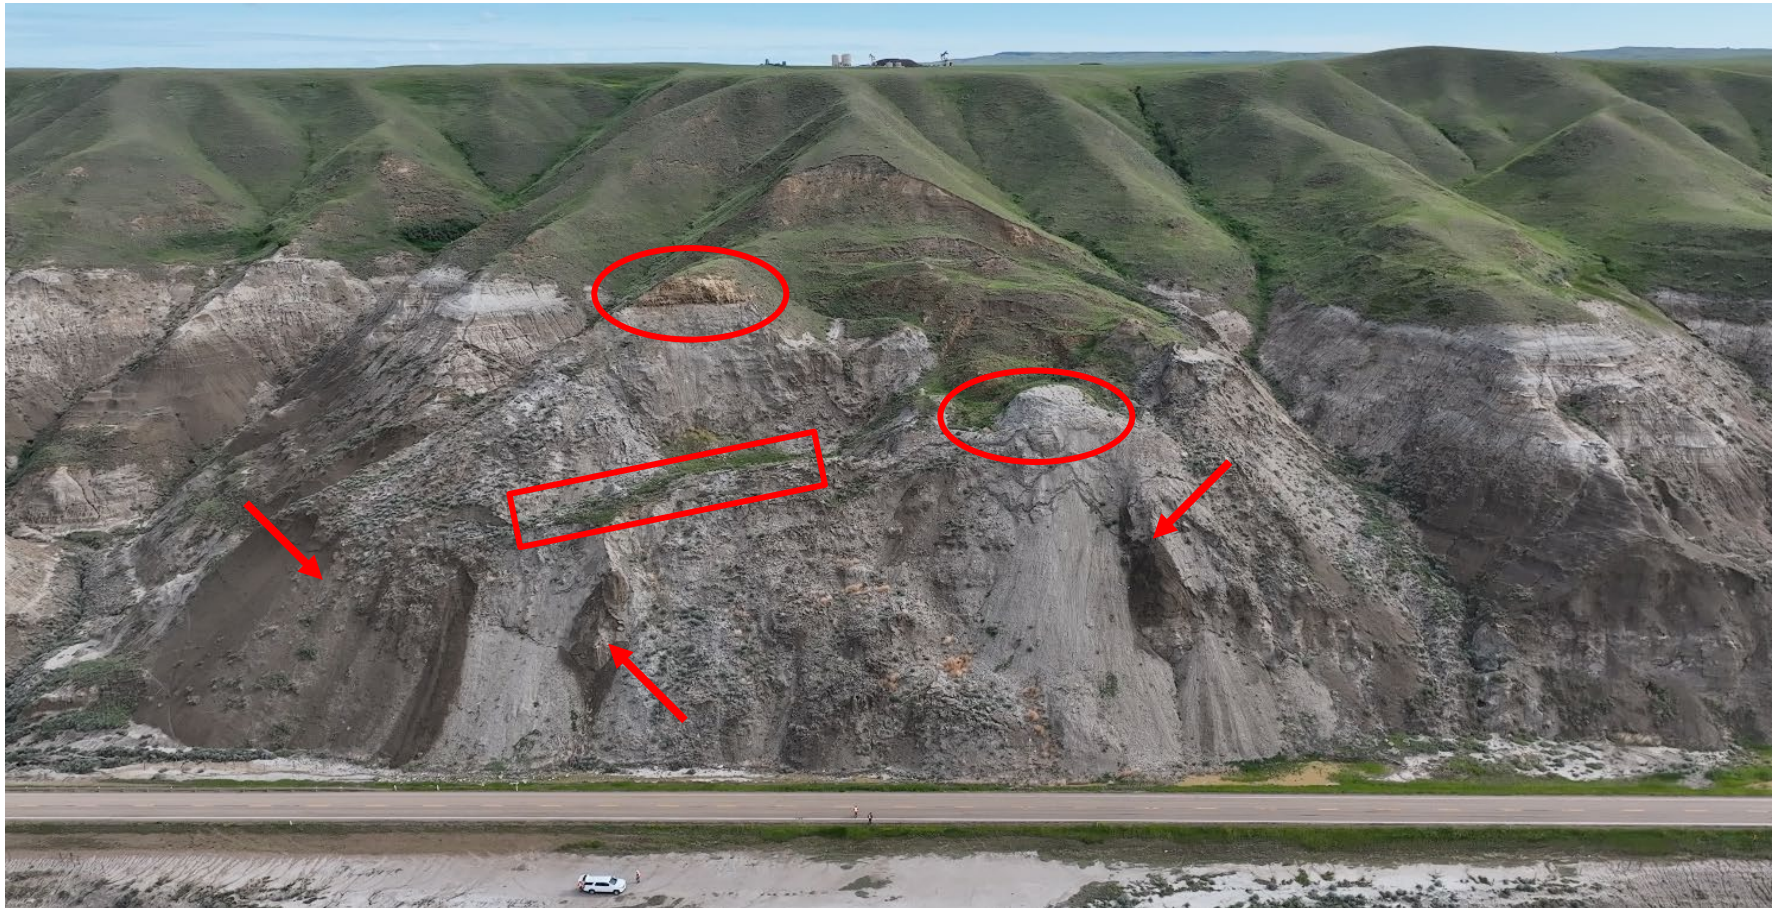
<b>COMMENTS</b>
<p><u>C077 Slide:</u></p> <ul style="list-style-type: none"> <li>• There are many large relict translational slides along the slope north of Hwy 770 near the C077 site.</li> <li>• Some evidence of sliding within the talus slope was observed with a possible mid-slope bulge and ground cracking in upper slope well above the highway (below and west of where rock scaling was completed in 2022).</li> <li>• A weathered and fractured bedrock outcrop was observed near the west extent of the site, approximately midslope and above an area of sliding within the talus slope (Photo 1 and 2).</li> <li>• Ground cracking was observed near the west portion of the site at a near-vertical rock scarp (Photos 1 through 5).</li> </ul>

- A weathered bedrock outcrop was observed near the east side of the site, east of the where cracking was observed (Photos 1 through 3). The bedrock outcrop is located approximately halfway to two-thirds up the slope.

**Photo 1** Aerial photo of the C077 site. Locations of recent movement are indicated by red arrows, location of new (late-2023 or early-2024) ground cracking observed on the slope is indicated by red rectangle, and previous scaling completed in 2022 is indicated by red circles (note the area of ground cracking was also scaled in 2022). Photo taken June 18, 2024, facing north.

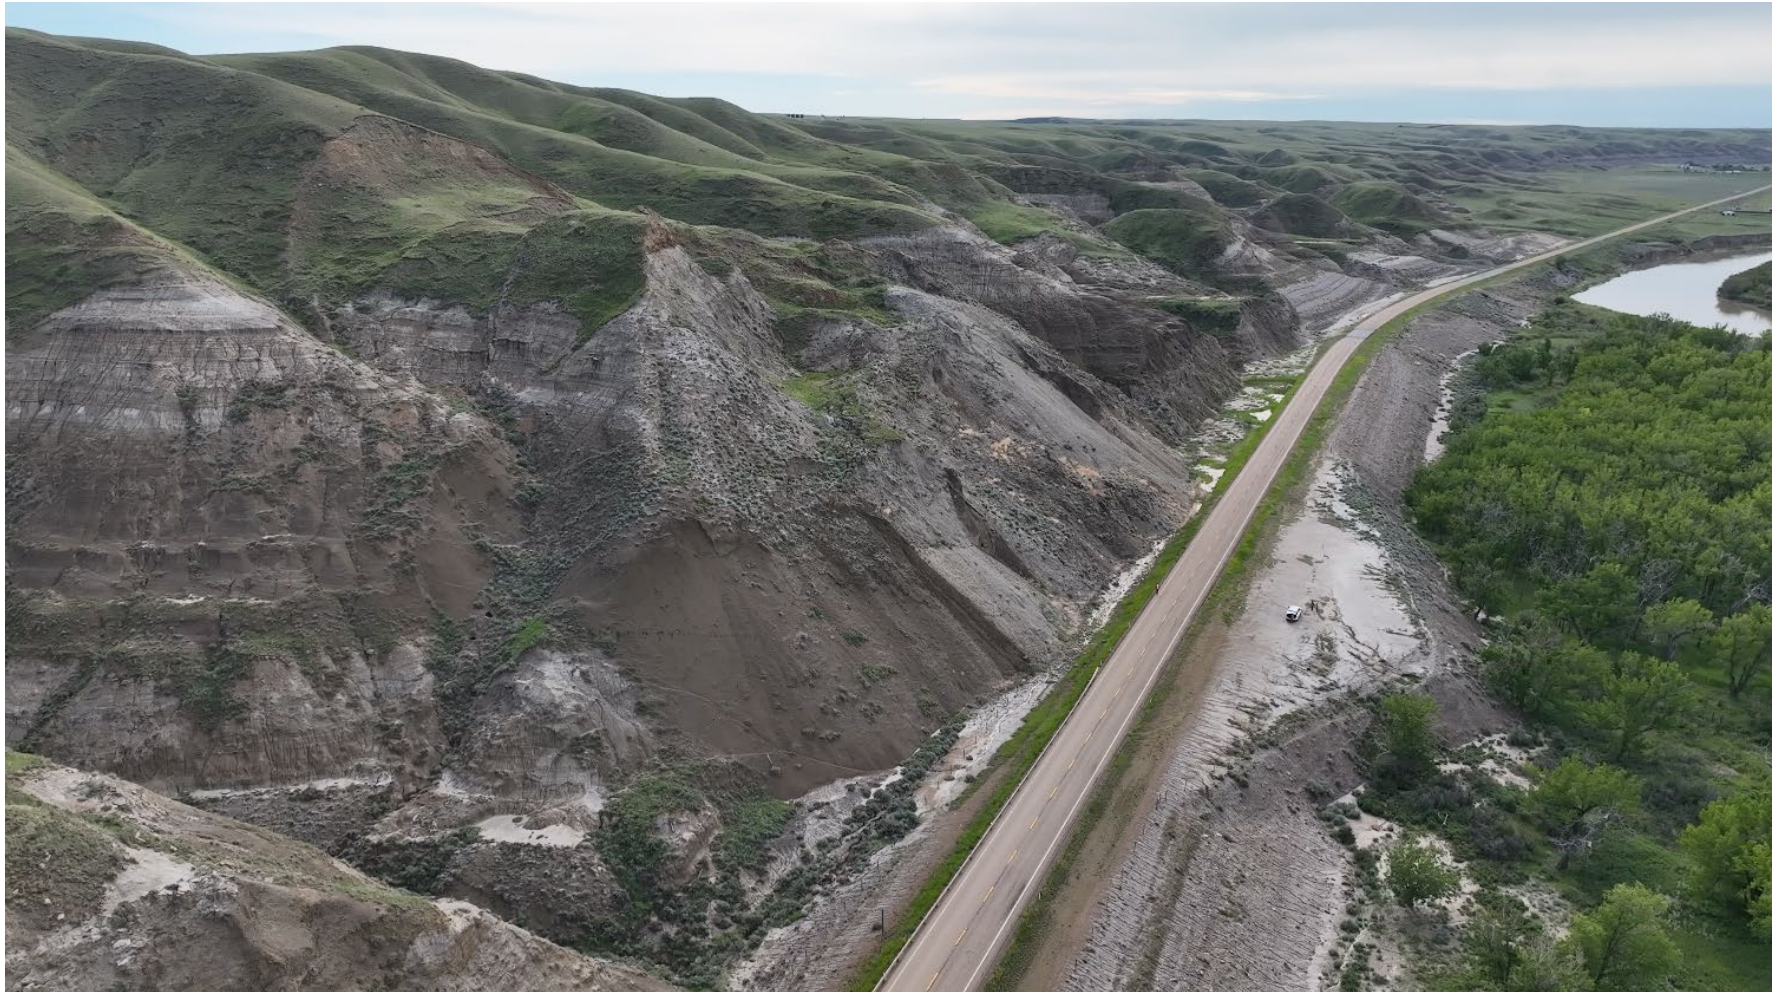
**Photo 2**      **Oblique aerial view of the site. Photo taken June 18, 2024, facing east-northeast.**

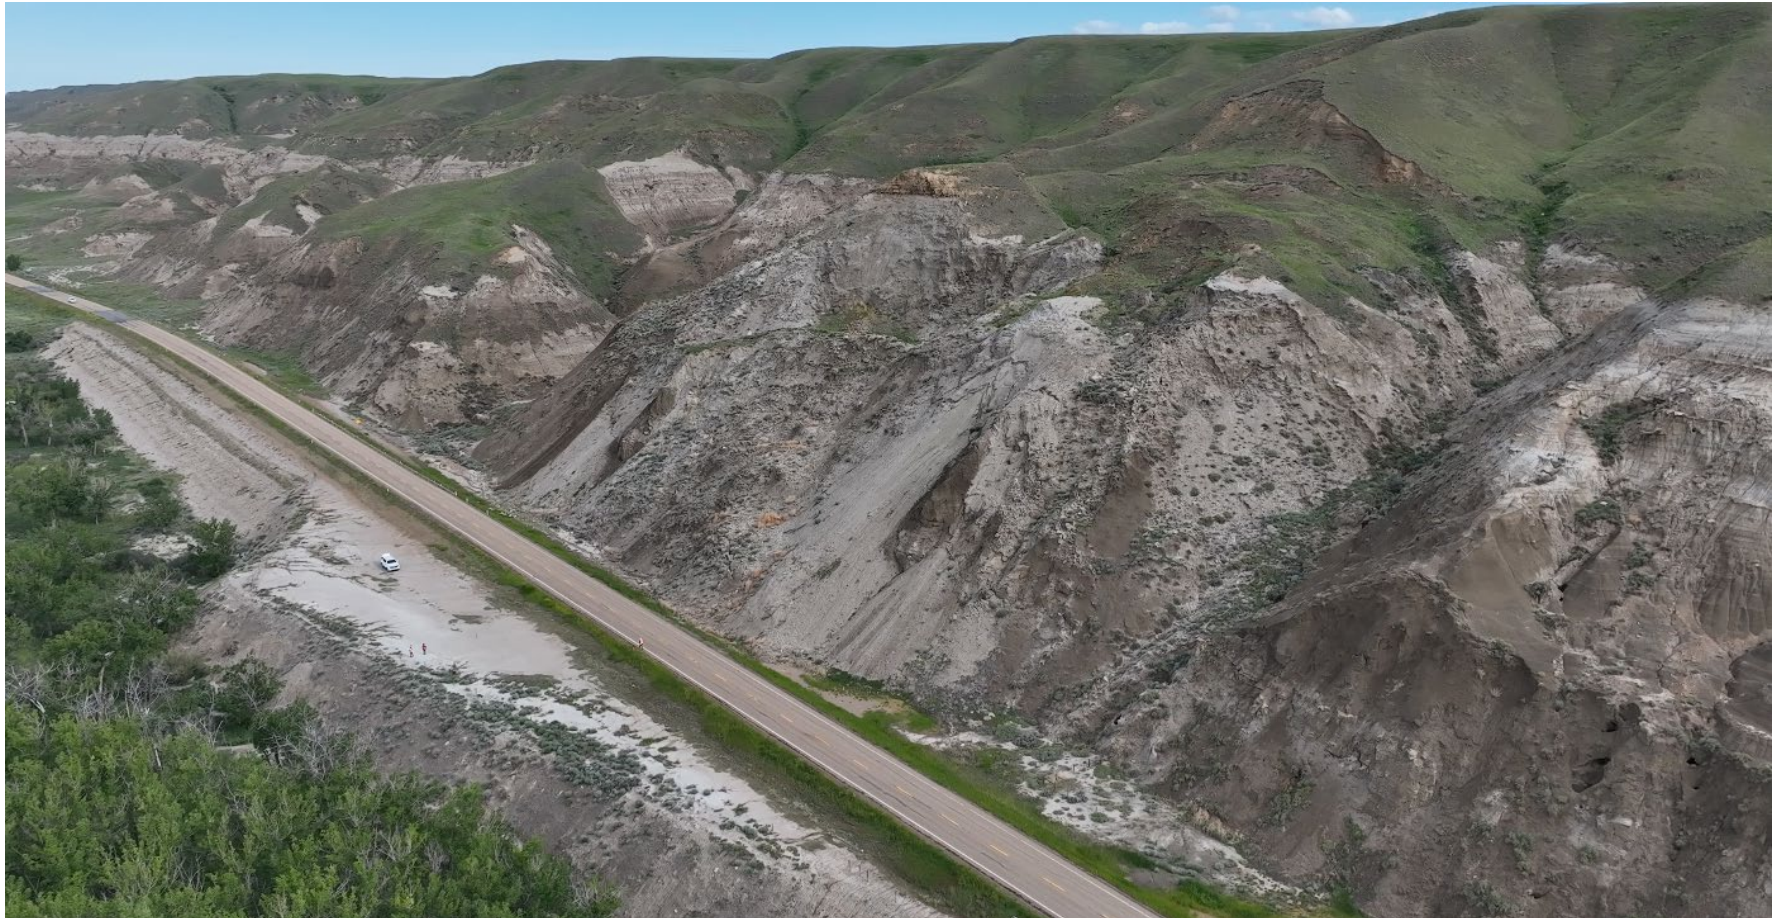
**Photo 3**      **Oblique aerial view of the site. Photo taken June 18, 2024, facing northwest.**

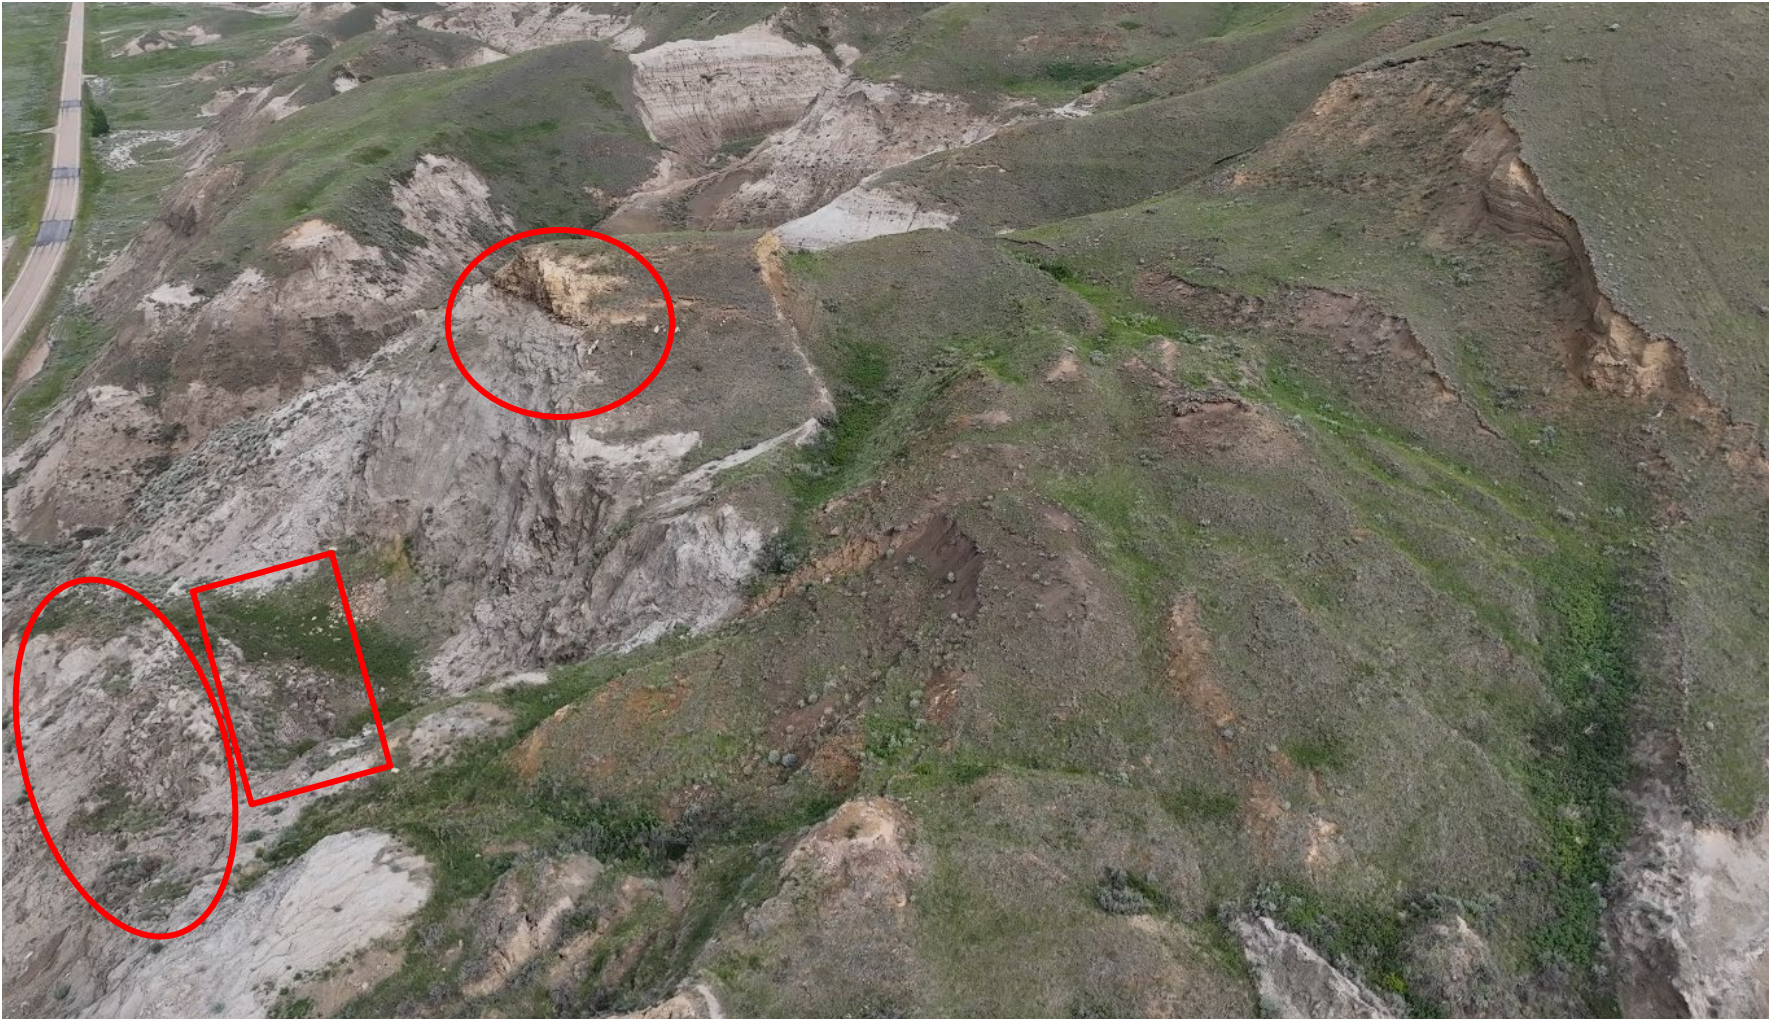
**Photo 4** Aerial photo of the upper portion of the slope. Area where new ground cracks were observed indicated by red rectangle and areas previously scaled in 2022 are indicated by red circles. Photo taken June 18, 2024, facing west.

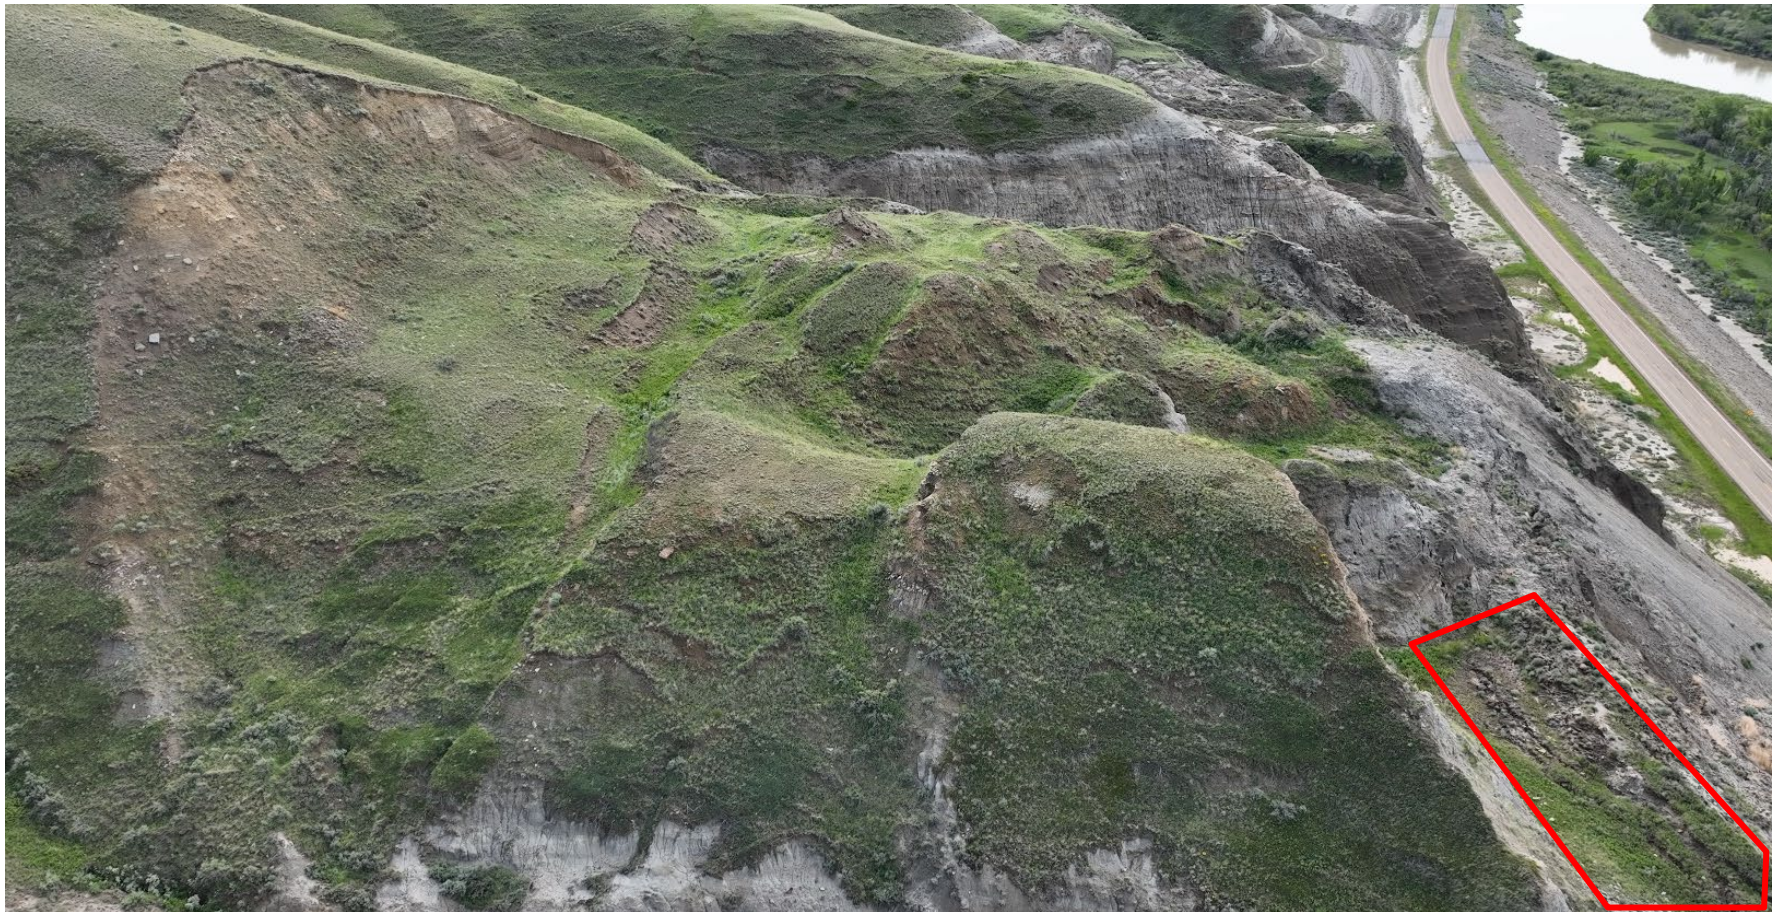
**Photo 5**      **Aerial view of the top portion of the slide. Area of new ground cracks indicated by red polygon. Photo taken June 18, 2024, facing east.**

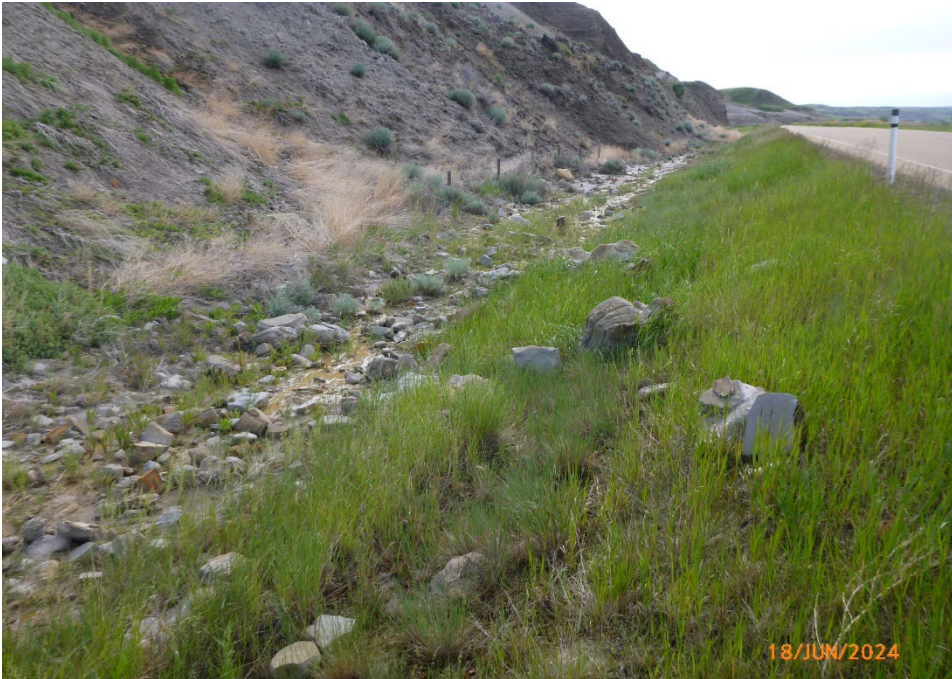
- During the 2024 inspection, no new rockfall particles were observed on the highway surface or on the south side of the highway.
- Rock particles were observed in the north (westbound) highway ditch (up to approximately 1 m x 0.6 m x 0.6 m) (Photo 6). KCB suspected the particles were from the 2022 scaling work that was completed at the site, since the particles edges did not appear fresh and blue spray paint was observed on several of the particles.

**Photo 6** Particles observed in the north (westbound) ditch are up to 1 m x 0.6 m x 0.6 m in size. Blue spray paint was observed on the particles, and they do not appear fresh, indicating they could have been removed during the 2022 scaling activities. Photo taken June 18, 2024, facing east.

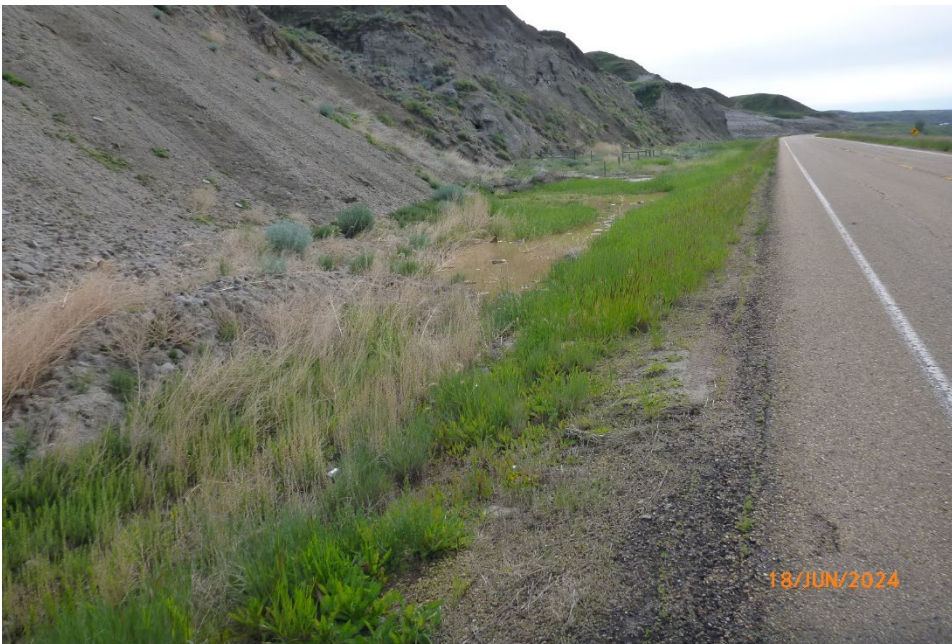
Ponded water was observed in the north (westbound) ditch near the east extent of the site (Photo 7), indicating the ditch drainage is poor. The east extent of the site is relatively close to the C058 site, where there are sinkholes/voids impacting the highway surface, due to the dispersive soils present. Sinkholes/voids could form at the C077 site due to the dispersive nature of the soil.

**Photo 7** Ponded water along the north (westbound) ditch near the east extent of the site. Photo taken June 18, 2024, facing east.
