SITE NUMBER AND NAME: C048-1 and -3 Slides		HIGHWAY & KM: 575:04, 14.5	PREVIOUS INSPECTION DATE: June 23, 2021	INSPECTION DATE: June 26, 2023
LEGAL DESCRIPTION:	NAD 83 COORDINATES:		RISK ASSESSMENT:	
C048-1 03-28-29-22 W4M	UTM	Northing	Easting	C048-1: PF: 3 CF: 5 TOTAL: 9
C048-3 14-21-29-22 W4M	12	5707777	358483	C048-3: PF: 6 CF: 5 TOTAL: 30
AVERAGE ANNUAL DAILY TRAFFIC (AADT): 920 (west) and 860 (east) (Ref No. 106230 & 105240)			CONTRACT MAINTENANCE AREA (CMA): 517

SUMMARY OF SITE INSTRUMENTATION:	INSPECTED BY:
Operable: Three slope inclinometers (SIs) were installed at C048-1 in 2021.	Chris Gräpel (KCB)
Inoperable: One slope inclinometer (SI) installed at C048-1 in 2011.	James Lyons (KCB)
LAST READING DATE: September 20, 2023	Tony Penney (TEC)
	Rishi Adhikari (TEC)
	Pramaya Kannel (TEC)
PRIMARY SITE ISSUE: C048-1 and -3: two shallow slides in the highway embankment fill. Both slides are located on the south side (eastbound lane) of Hwy 575 near the east and west abutments, respectively.	
APPROXIMATE DIMENSIONS: C048-1 and -3 are approximately 20 m and 100 m wide, respectively.	
DATE OF ANY REMEDIAL ACTION: C048-1: July 2010 – soil nails launched (52 nails, 4 rows); July 2014 –

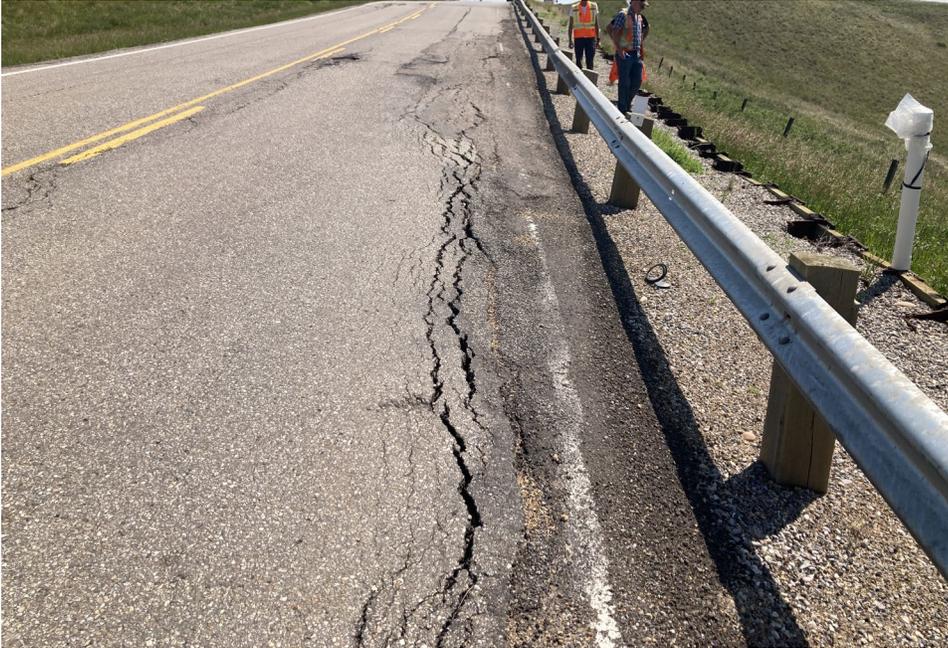
- Three SIs were installed, one in the west upper pile wall extension and two SIs in the new (lower) pile wall.
- The pavement cracking and settlement upslope (north) of the pile walls appear to have increased in severity since the 2021 inspection (Photo 1). The pavement cracking is between approximately 25 mm to 50 mm.

Photo 1 Pavement cracking along the edge of the south (eastbound) lane. The pavement cracks are between approximately 25 mm and 50 mm wide. Photo taken June 26, 2023, facing east.

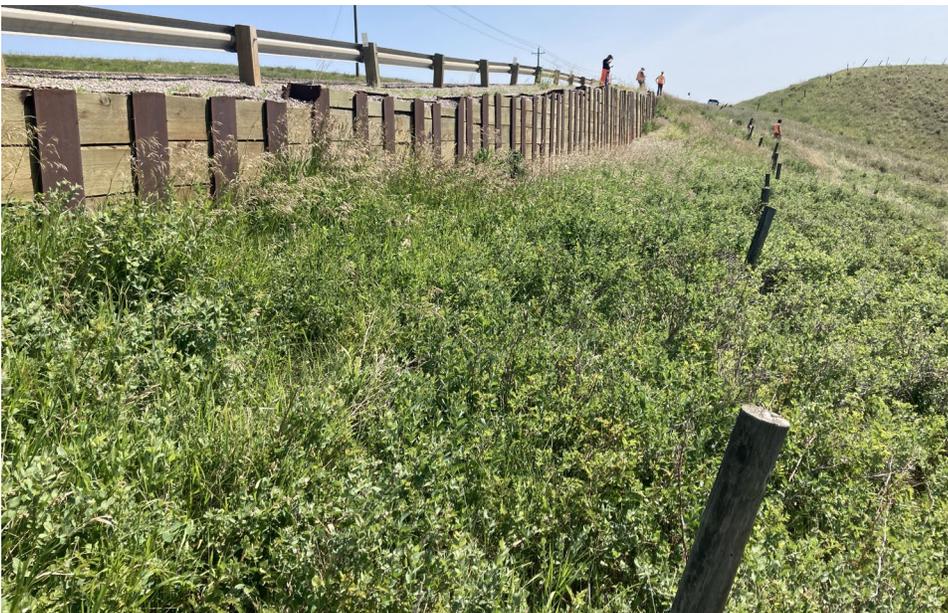
Photo 2 Timber lagging and west h-pile wall extension installation completed in early-2021. Photo taken June 26, 2023, facing east.

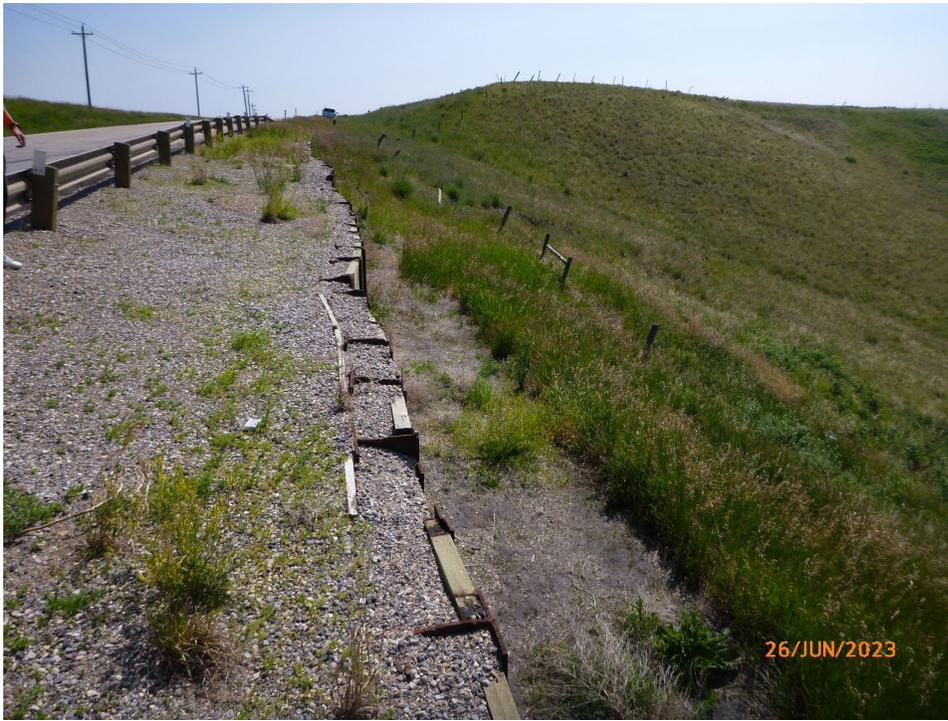
- The above-ground portions of the 2021 H-piles at the upper pile wall were cut off at ground surface between the 2021 and 2023 inspections. The upper pile wall appears to have deflected since the 2021 inspection (Photo 3).

Photo 3 **The upper pile wall has deflected since the 2021 inspection. Photo take June 26, 2023, facing east.**

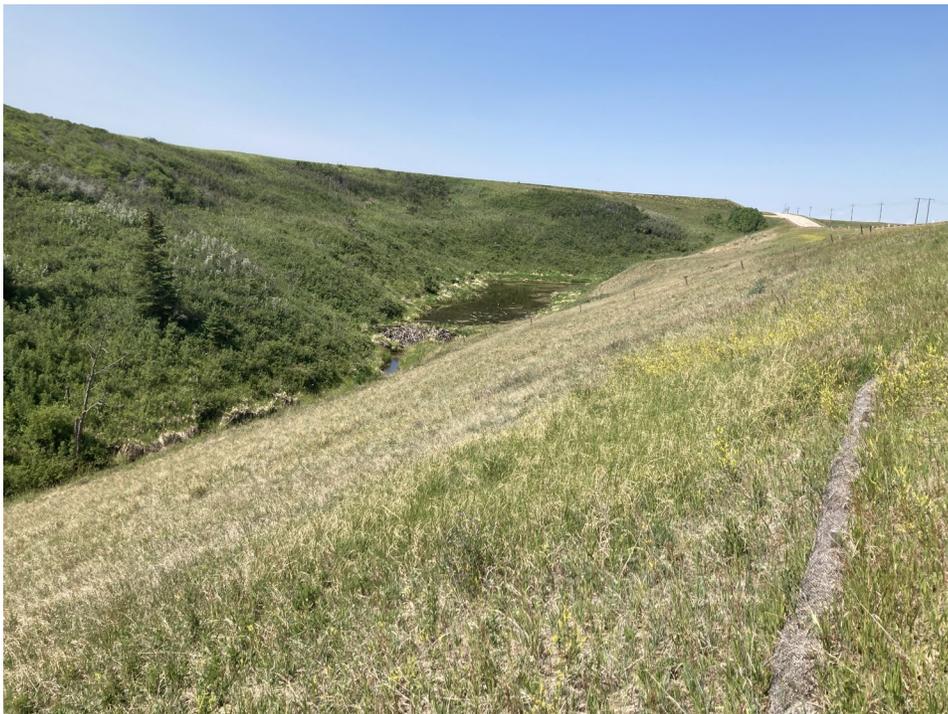
Photo 4 **Beaver dam located at the toe of the south highway embankment slope downslope of the C048-3 site. Photo taken June 26, 2023, facing west.**

- The beaver dam at the toe of the slope at C048-3 should be removed, as the ponded water could saturate and soften the toe of the highway embankment, potentially resulting in increased rates of movement which could impact the highway surface.
- The silt fencing at the downslope extent of the repair should be removed.

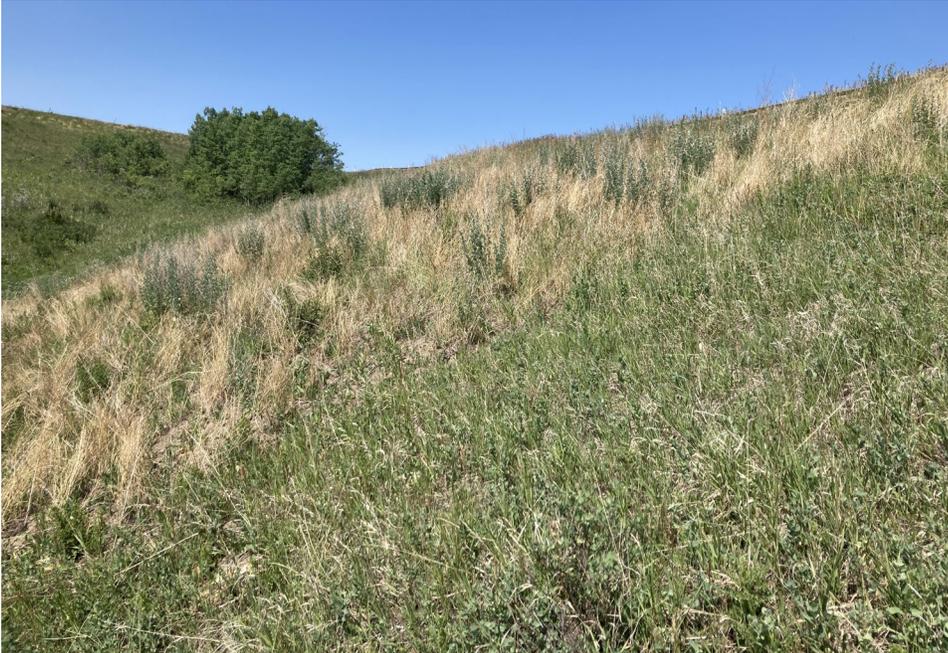
Photo 5 The vegetation coverage at the C048-3 slide repair (completed fall of 2020) has improved since the 2021 inspection. Photo taken June 26, 2023, facing west northwest.

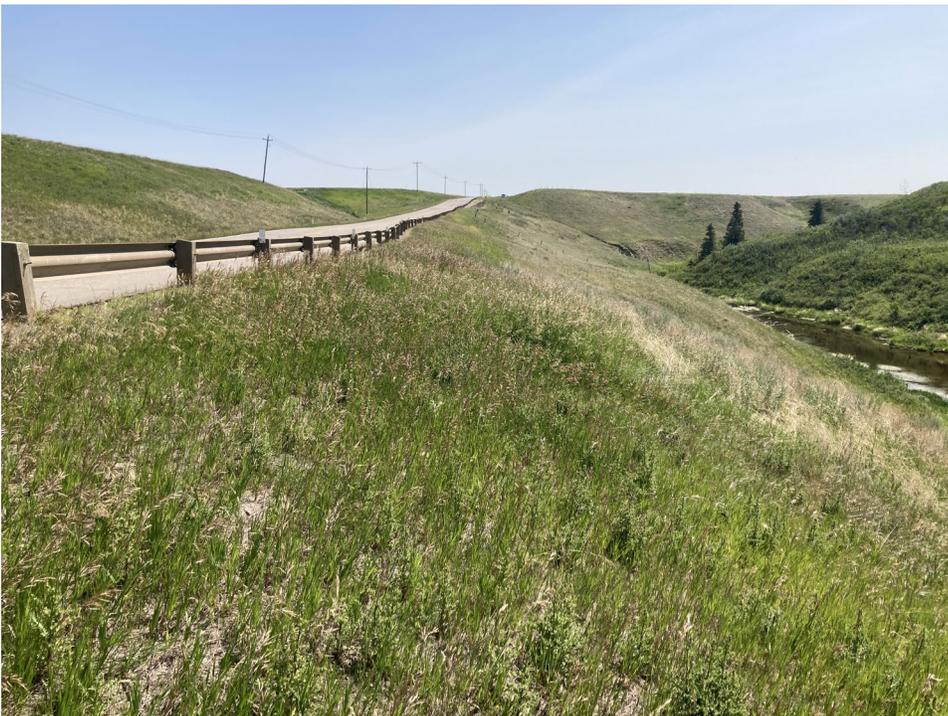
Photo 6 The vegetation coverage at the C048-3 slide repair (completed fall of 2020) has improved since the 2021 inspection. Photo taken June 26, 2023, facing east.
