November 15, 2024

**CON0022160 Central Region GRMP Instrumentation Monitoring
Site C048-1; H575:04, km 14.500 Slide West of Carbon Creek
Section C – 2024 Fall Readings**

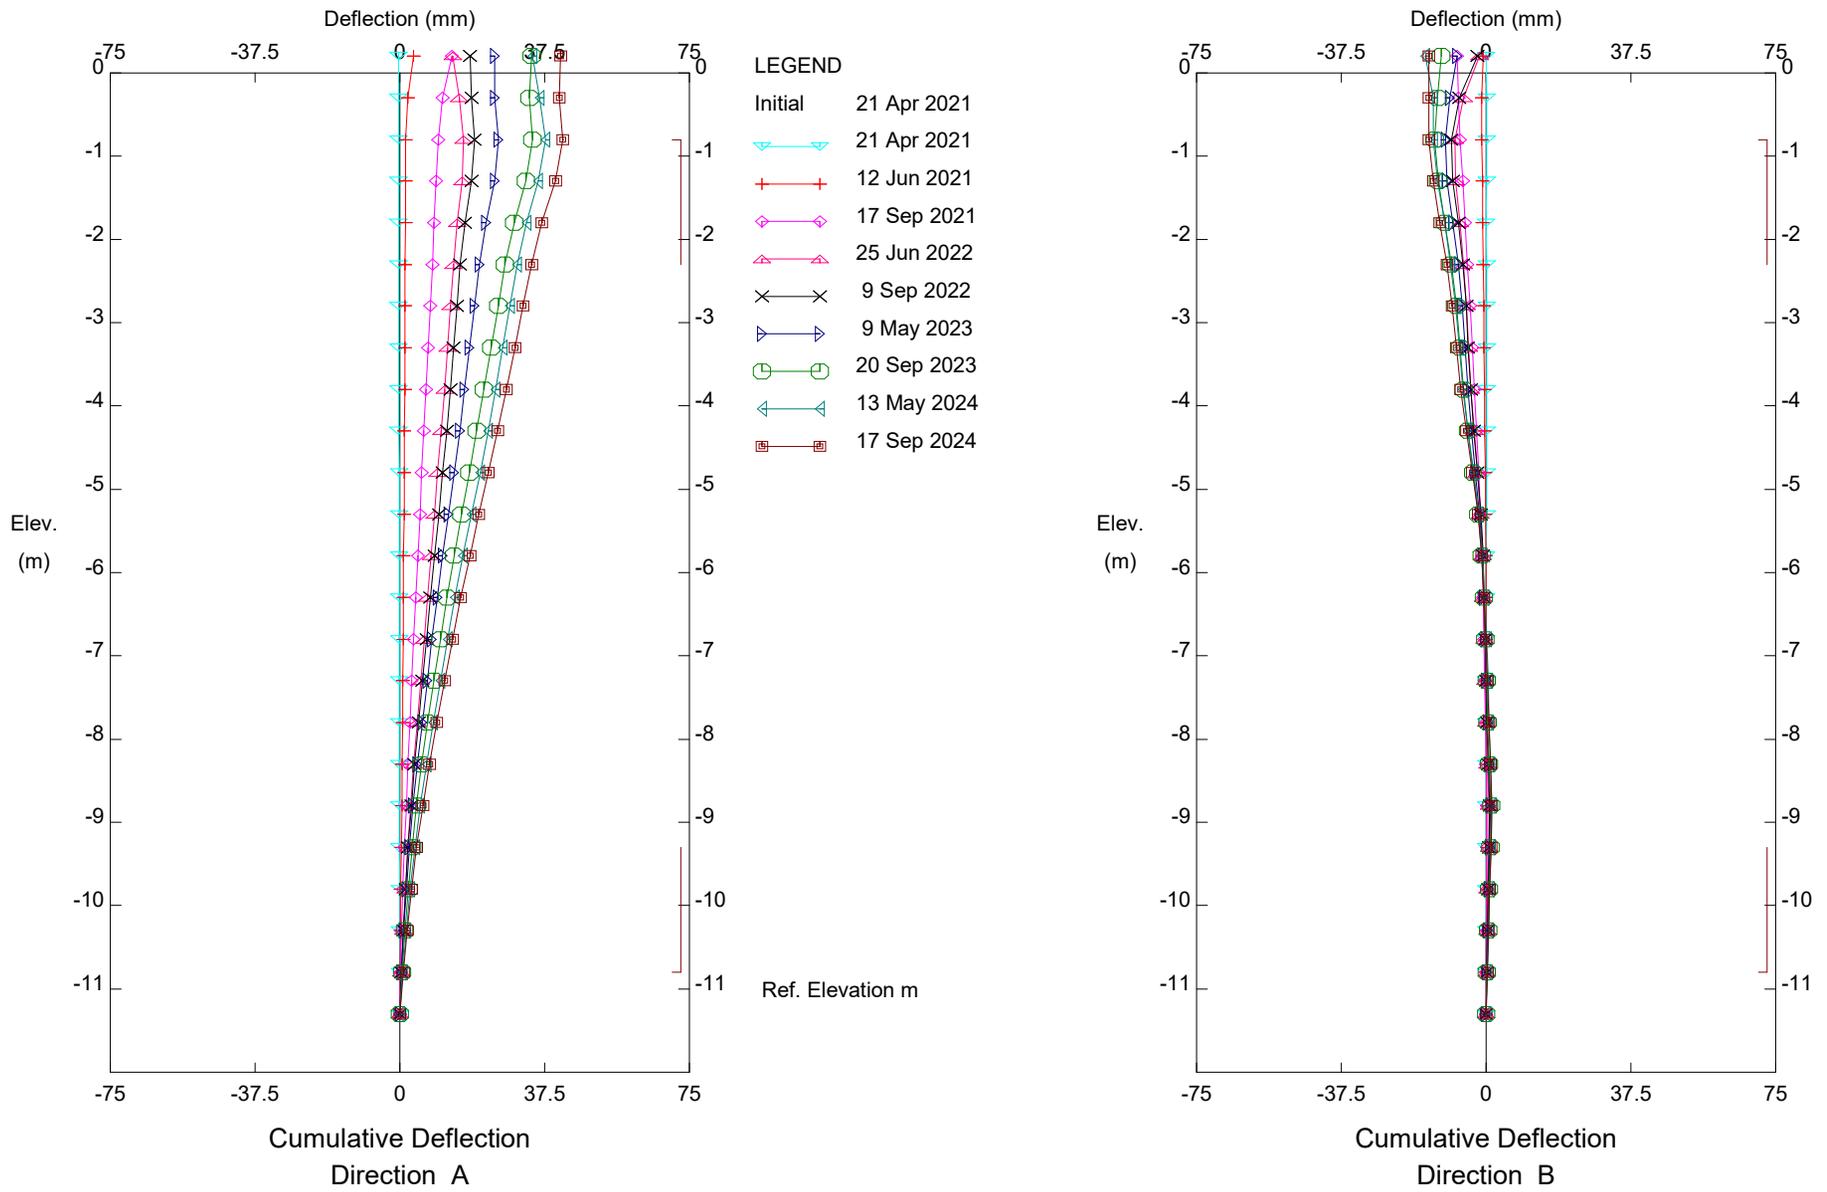
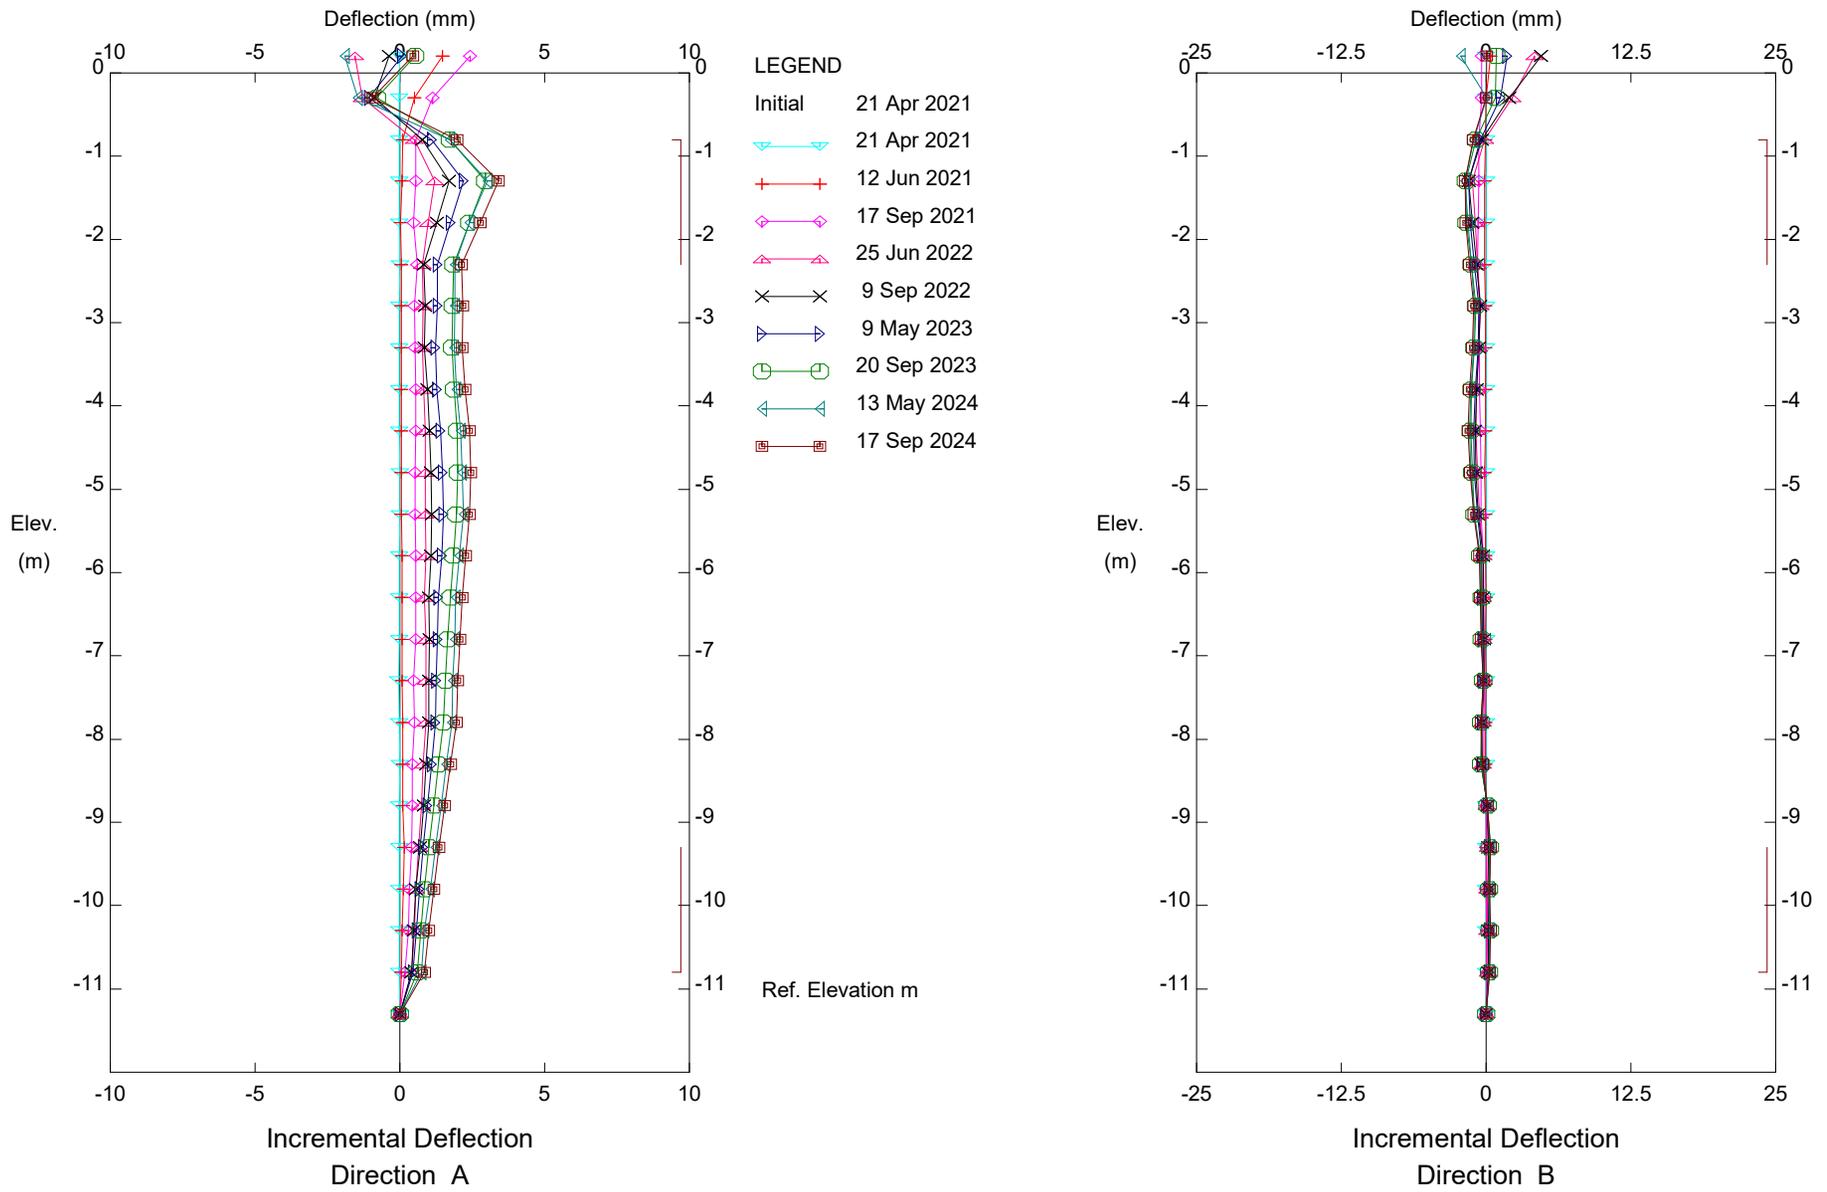
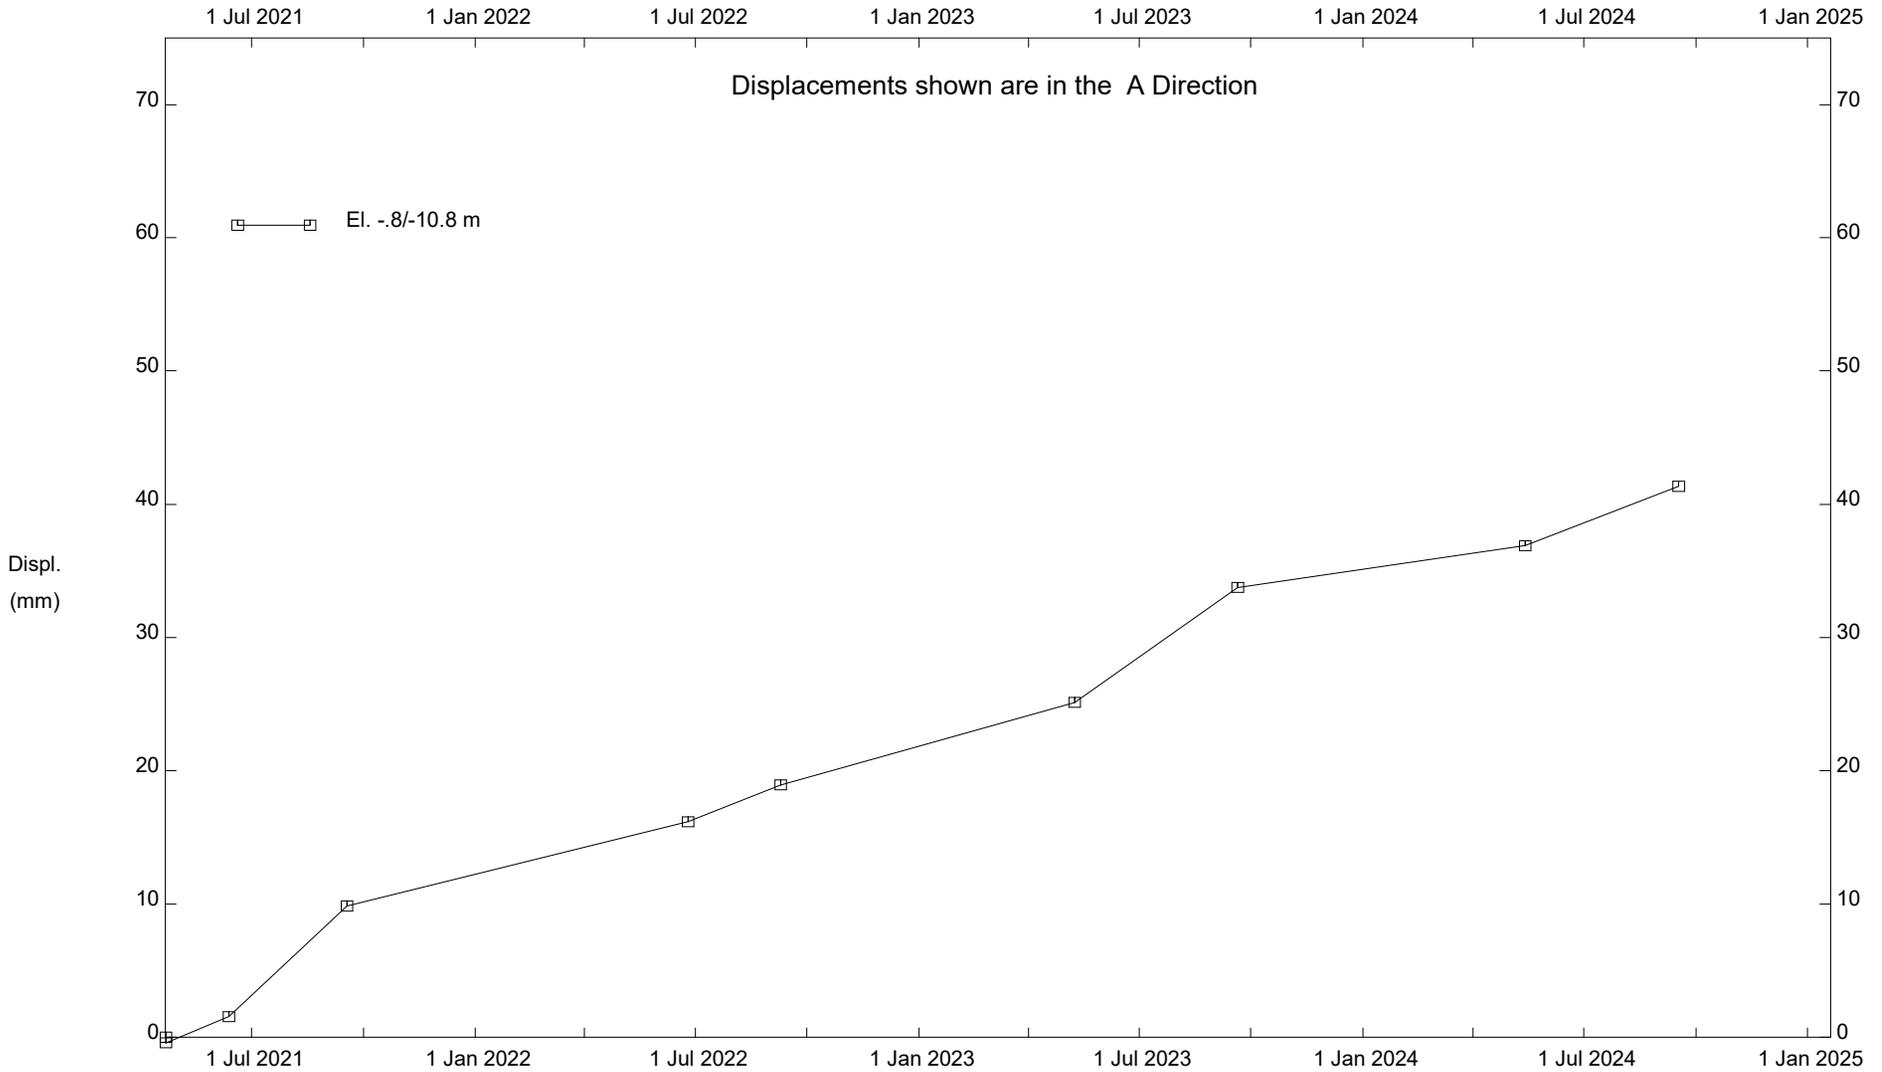
C048; H575:04; Slide W of Carbon Creek, Inclinometer SI21-C48-01
 Alberta Transportation

Distributed movement is being recorded in SI21-C48-01 (upper H-pile wall) along the length of the instrument from near ground surface to approximately 11 m below ground surface.

The depth of movement being recorded in the upper H-pile wall SI appears to be occurring near the base of the H-pile wall, while the movement recorded in the lower H-pile wall appears to be occurring between 2 m and 3 m above the base of the H-pile walls. This indicates that the H-pile walls have intercepted the failure surface and have transferred the load to depths below the failure plane as the piles stabilize the slide mass. The fall 2024 data obtained from the pile-wall SIs indicates that the tops of the upper and lower H-pile walls have deflected up to approximately 41 mm and 54 mm, respectively, since installation.

In the fall of 2021, shortly after construction of the H-pile walls, the maximum rate of movement recorded in SI21-C48-01 (upper H-pile wall) was approximately 31 mm/year. Since fall of 2021, the rate of movement recorded in SI21-C48-01 has been relatively steady (approximately 10 mm/year) excluding increases recorded in fall of 2023 and 2024. The increased rate of movement recorded in fall of 2023 (approximately 24 mm/year) is likely attributed to construction activities (discussed in Section 1) completed in summer 2023. The increased rate of movement recorded in fall of 2024 (approximately 13 mm/year) may be attributed to wet weather in August 2024 (55 mm versus the historic average of 45 mm recorded between 2015 and 2024).

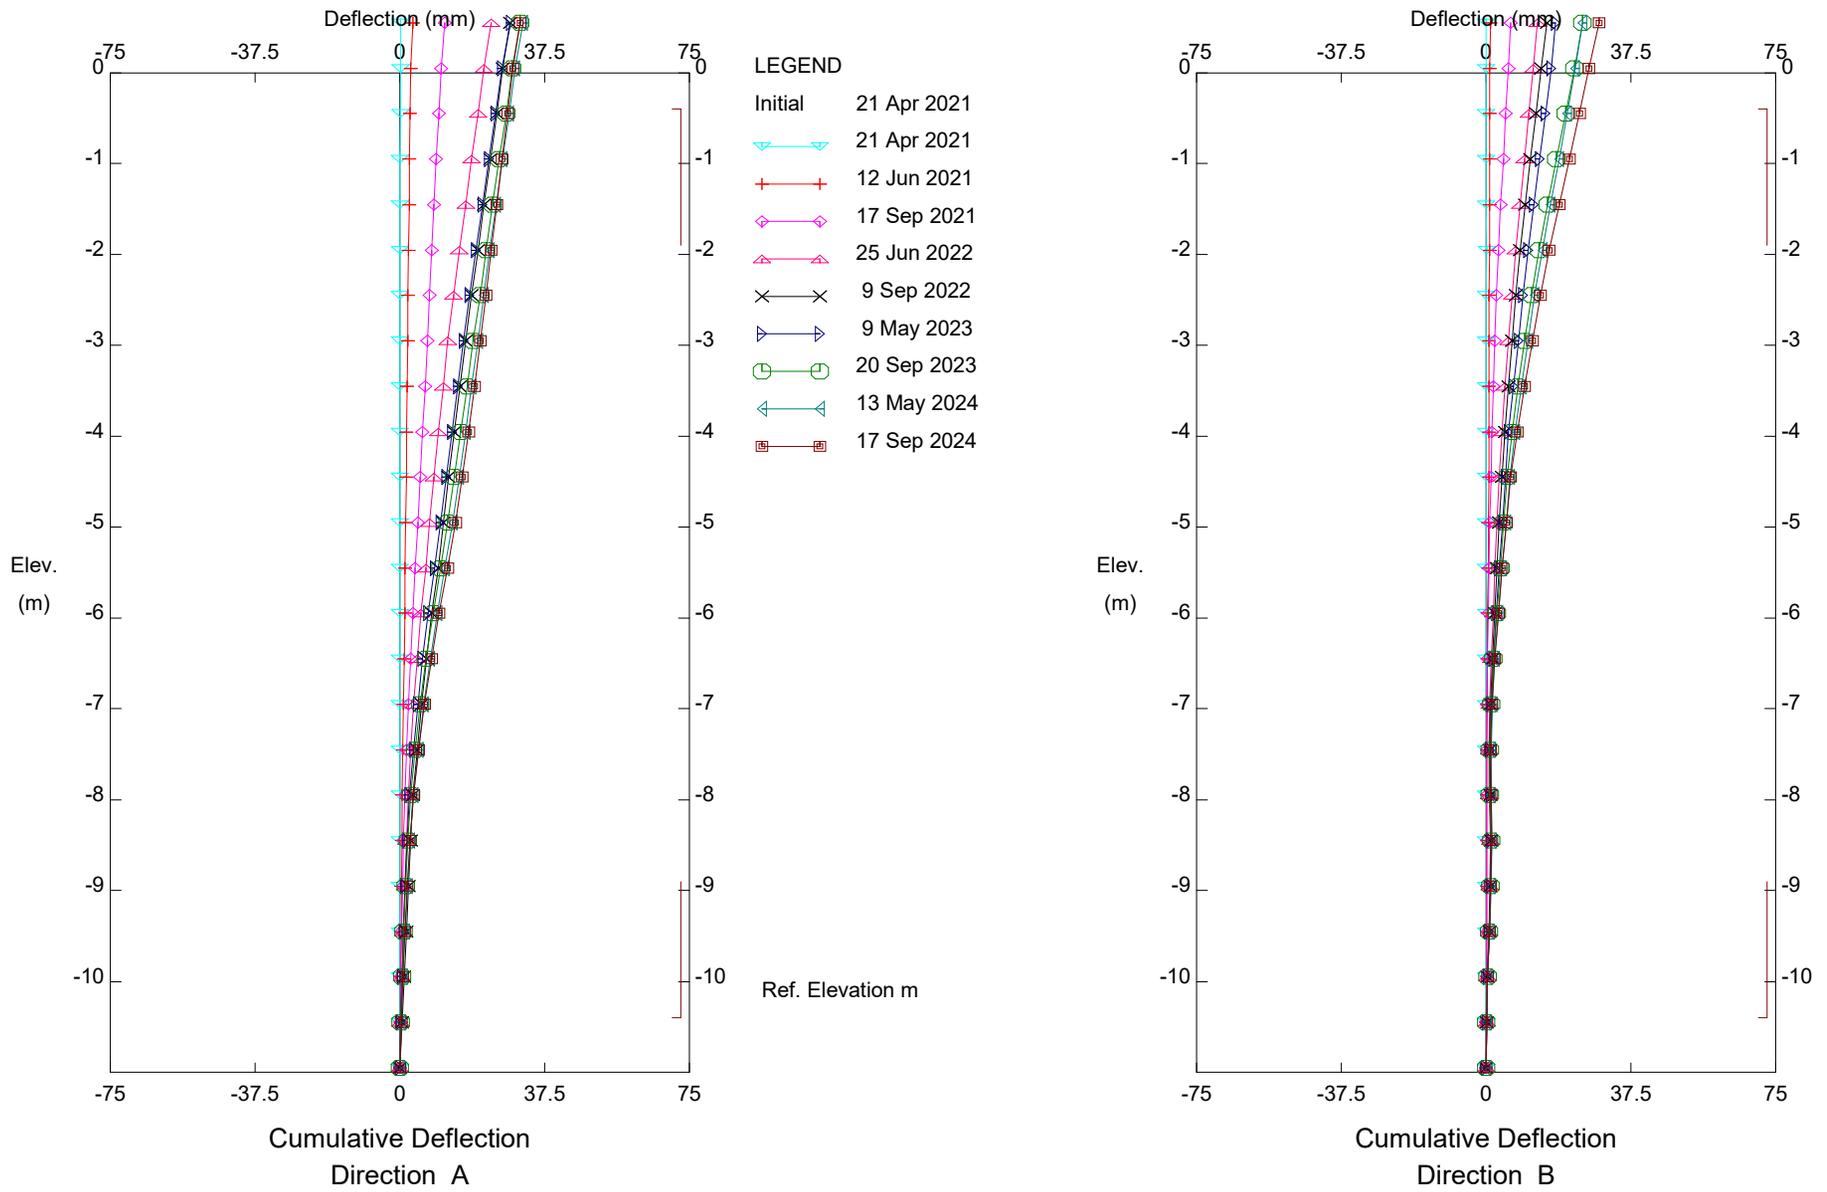
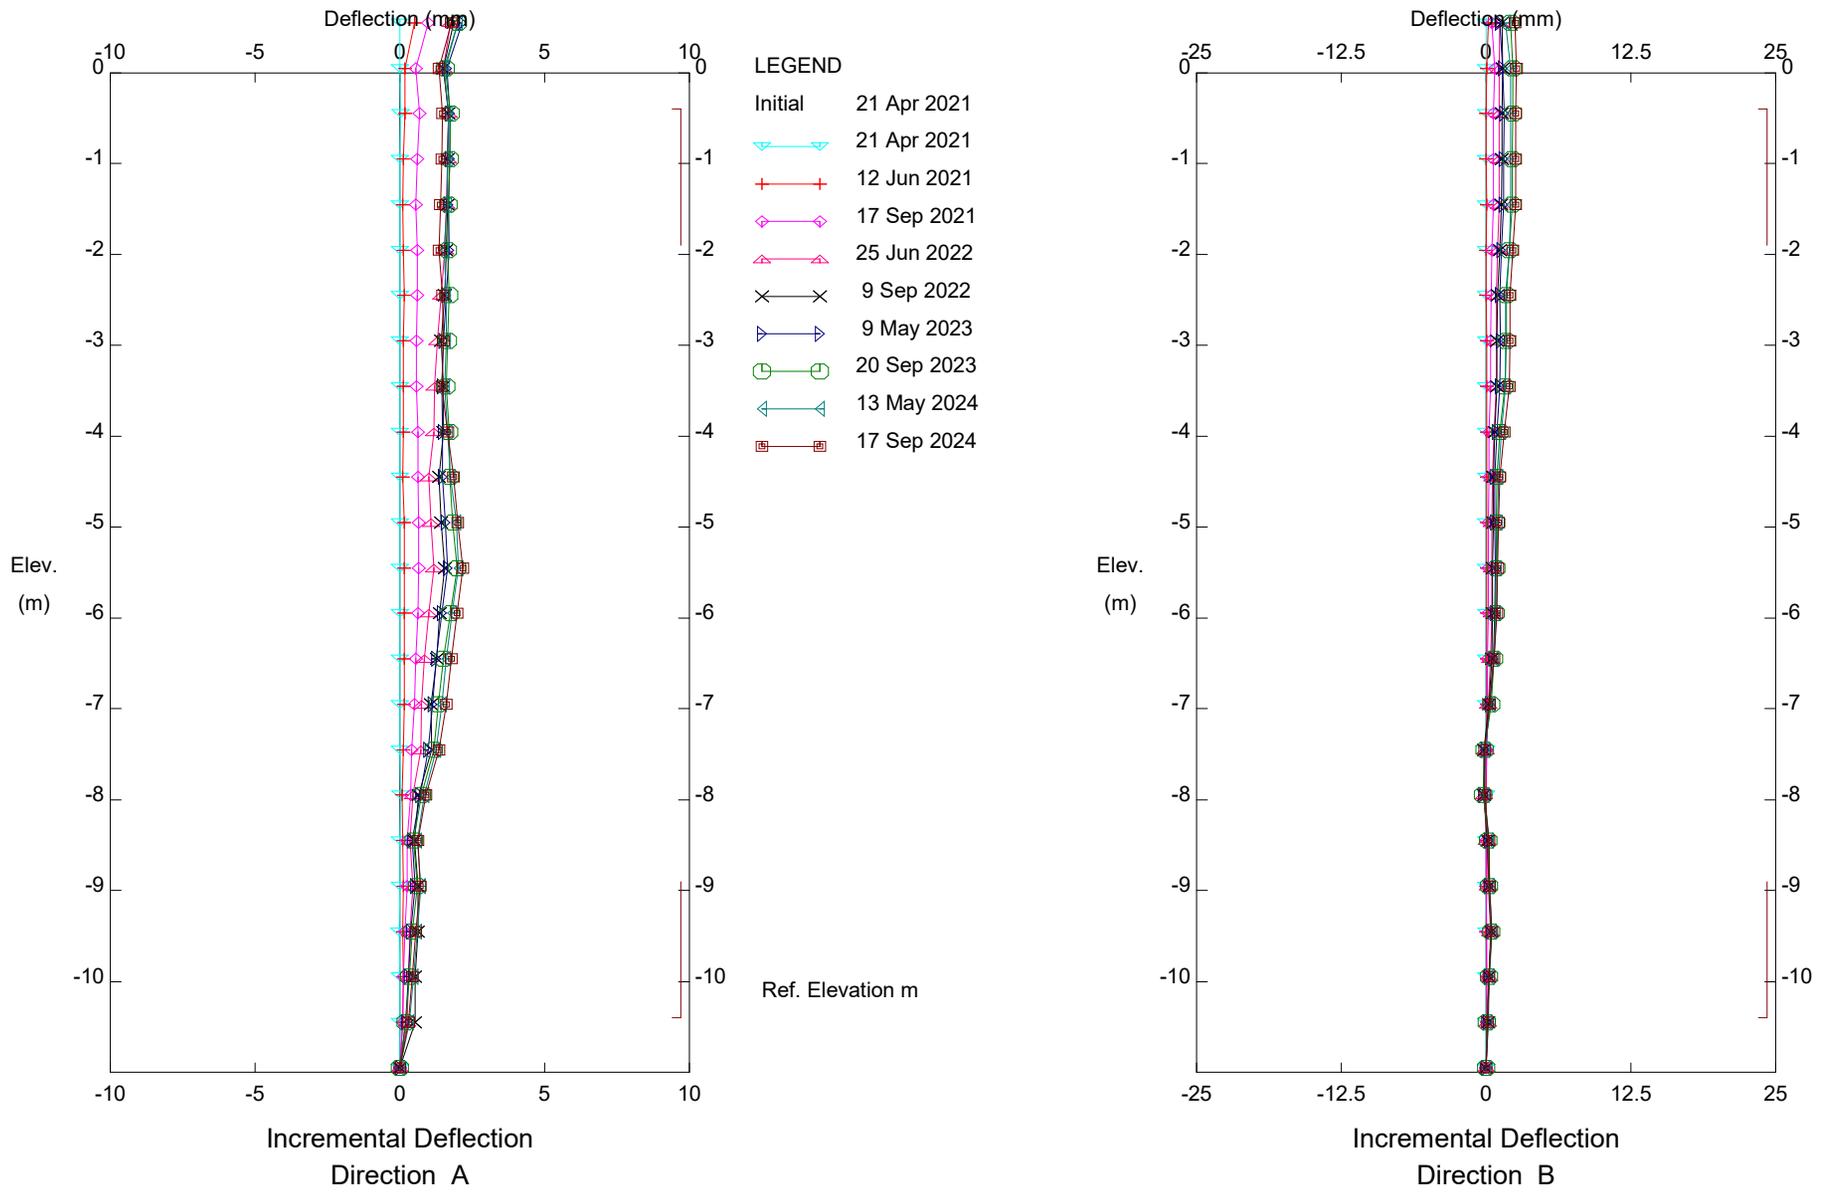
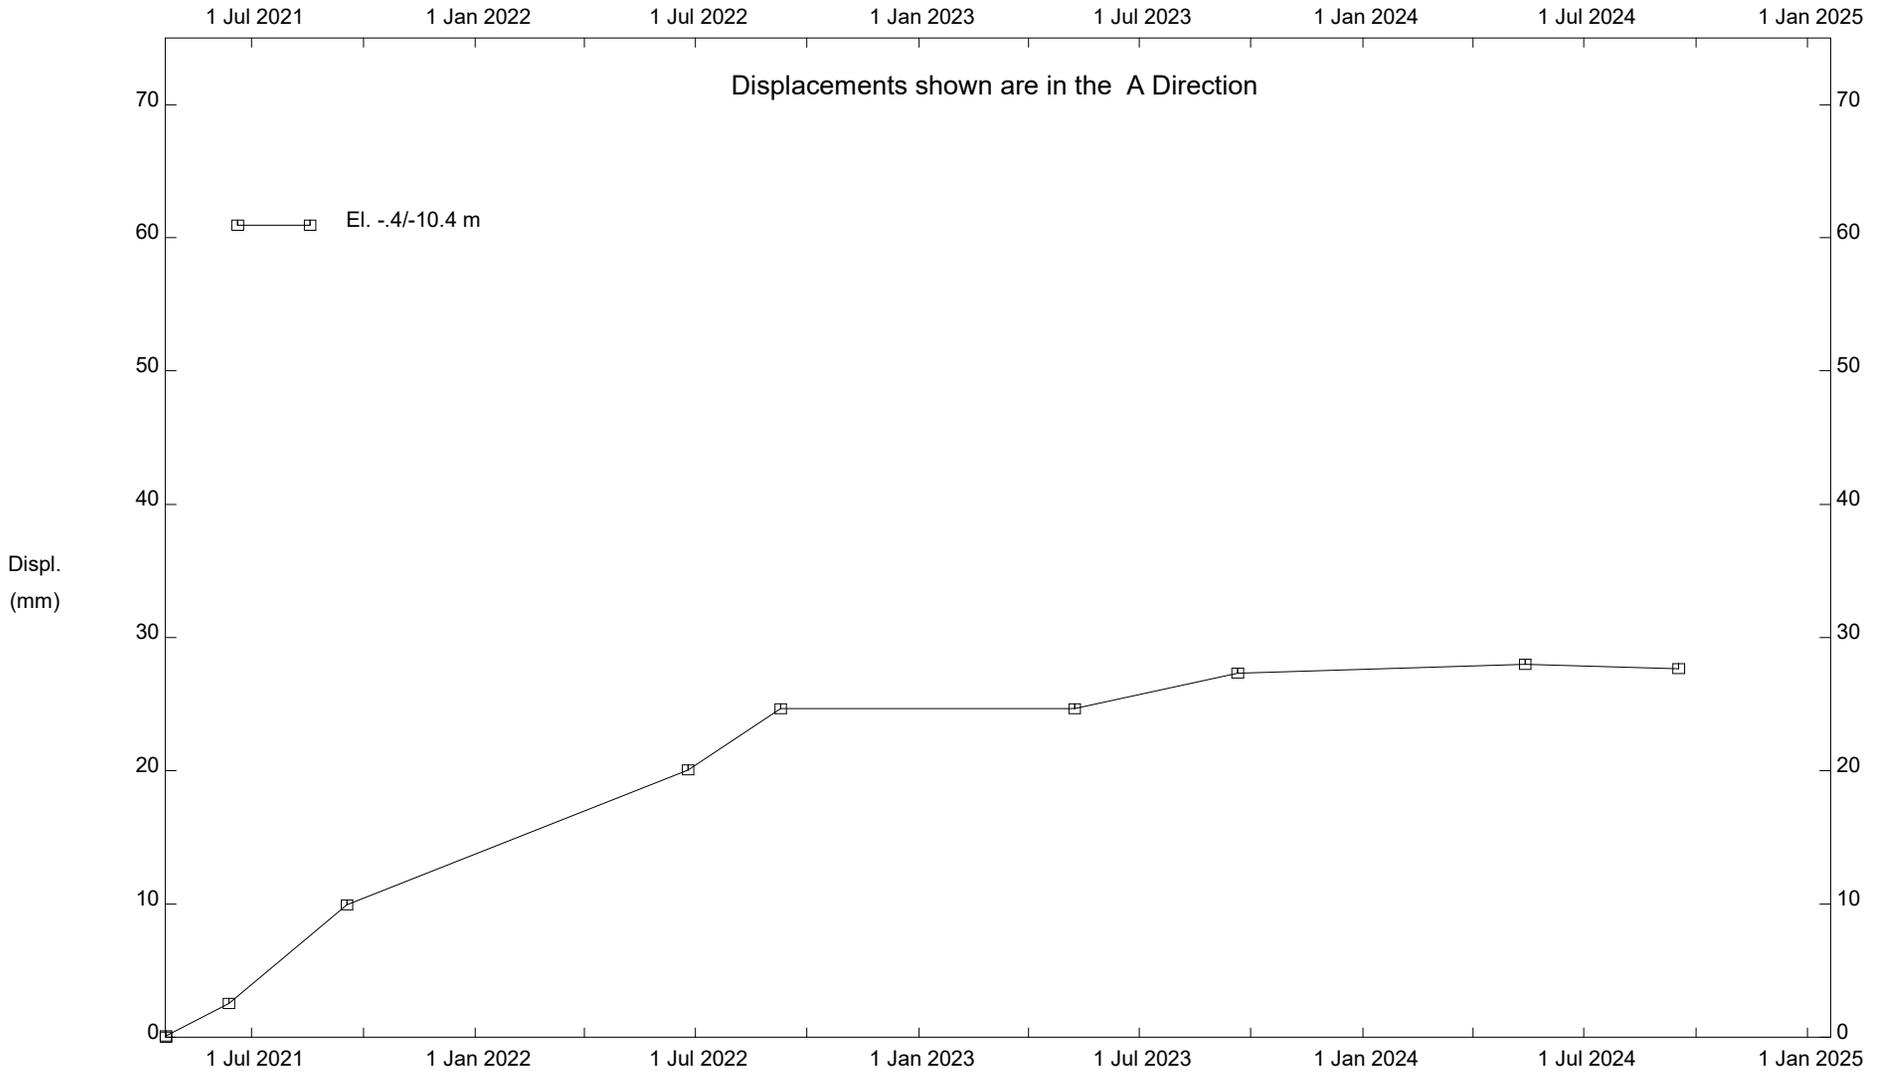
C048; H575:04; Slide W of Carbon Creek, Inclinator SI21-C48-02

Distributed movement is being recorded in SI21-C48-02 and SI21-C48-03 (lower H-pile wall) along the length of the instruments from near ground surface to approximately 9 m below ground surface.

In the fall of 2021, shortly after construction of the H-pile walls, the maximum rate of movement recorded in SI21-C48-02 and -03 (lower H-pile wall) was 28 mm/year and 59 mm/year, respectively. Since fall of 2022, the rate of movement recorded in SI21-C48-02 has been slow (approximately 1 mm/year) excluding an increased rate of movement recorded in fall of 2023 of 7 mm/year (likely attributed to construction activities completed in summer 2023). The movement recorded in SI21-C48-03 appears to fluctuate seasonally (decreases and increases recorded in the spring and fall, respectively) between approximately 3 mm/year and 29 mm/year, with the overall rate of movement recorded between fall of 2021 and fall of 2024 being approximately 11 mm/year.
