July 15, 2024

Alberta Transportation and Economic Corridors
4th Floor, Provincial Building
4920 – 51st Street
Red Deer, Alberta
T4N 6K8

**CON0022160 Central Region GRMP Instrumentation Monitoring
Site C048-1; H575:04, km 14.500 Slide West of Carbon Creek
Section C – 2024 Spring Readings**

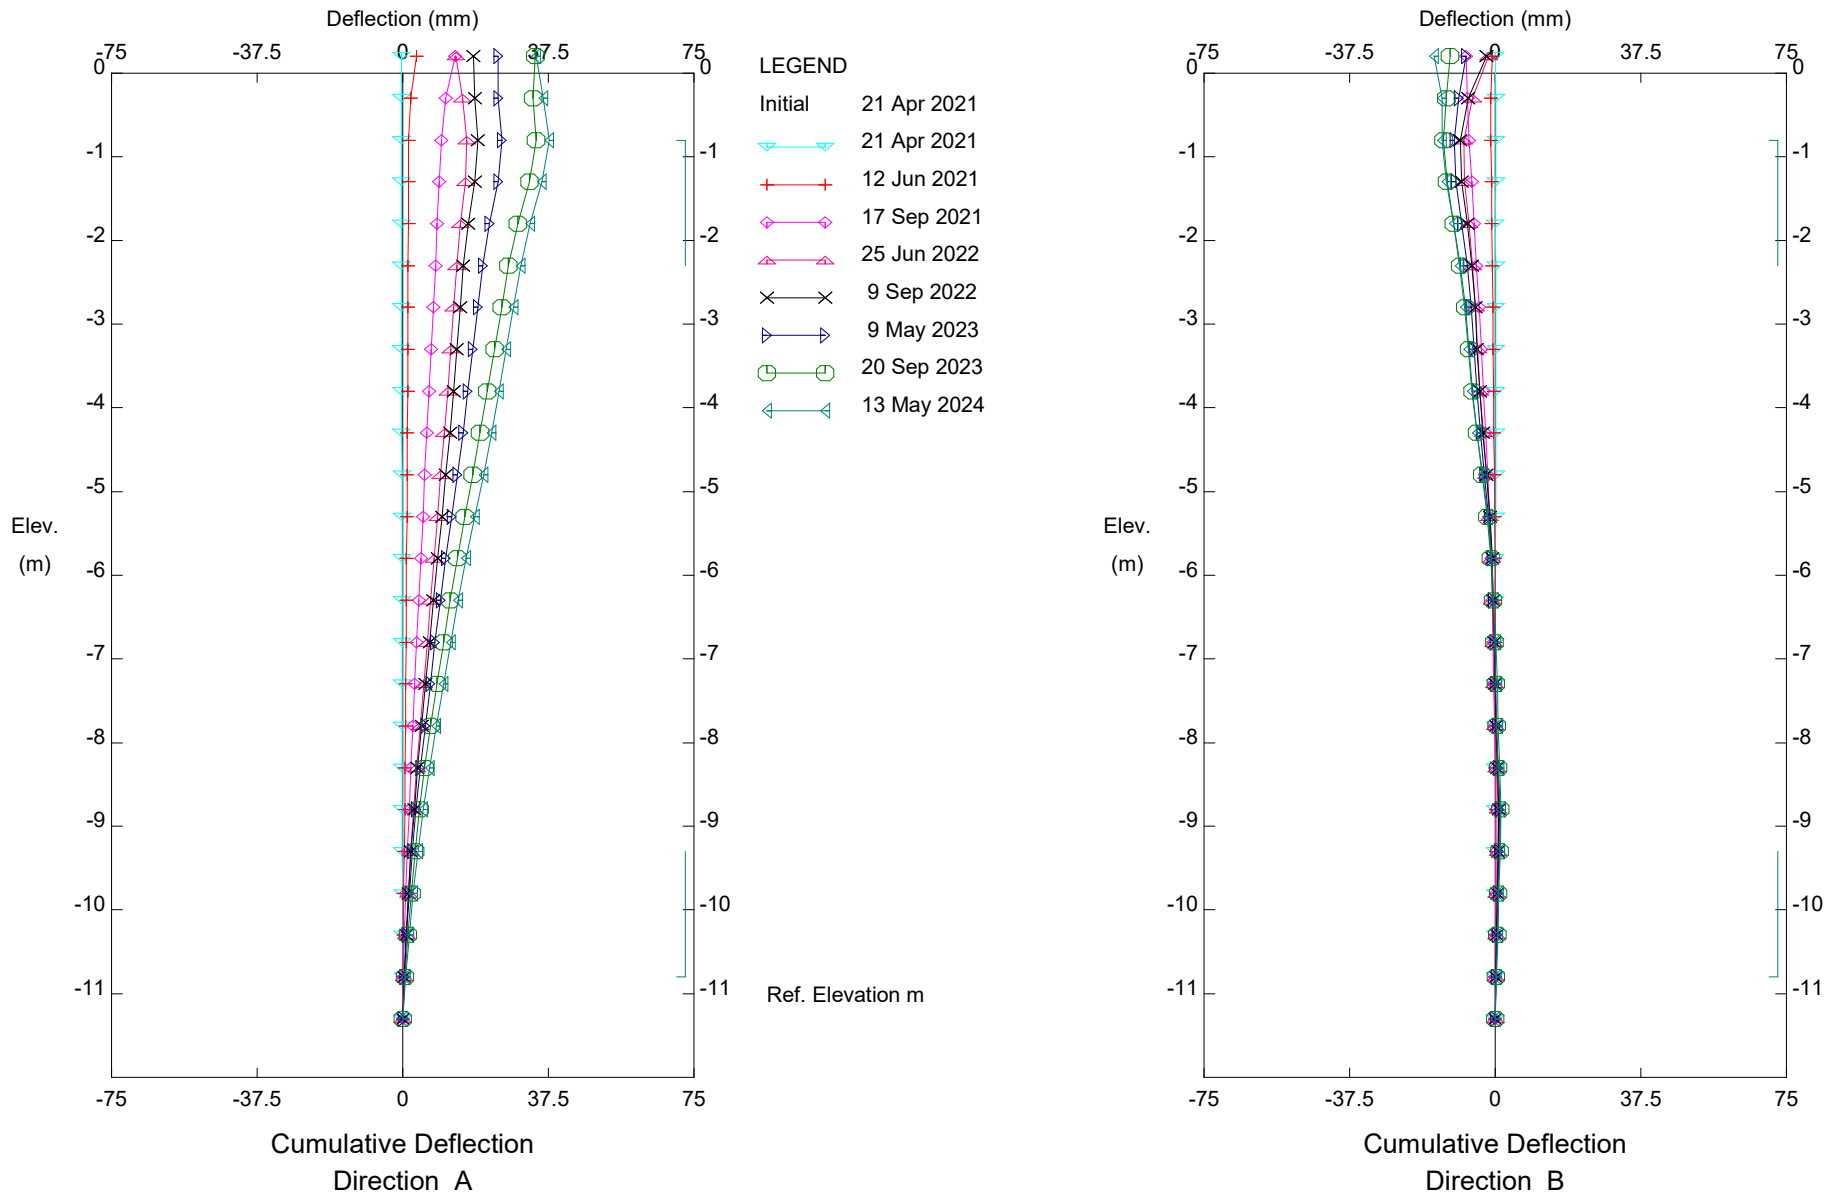
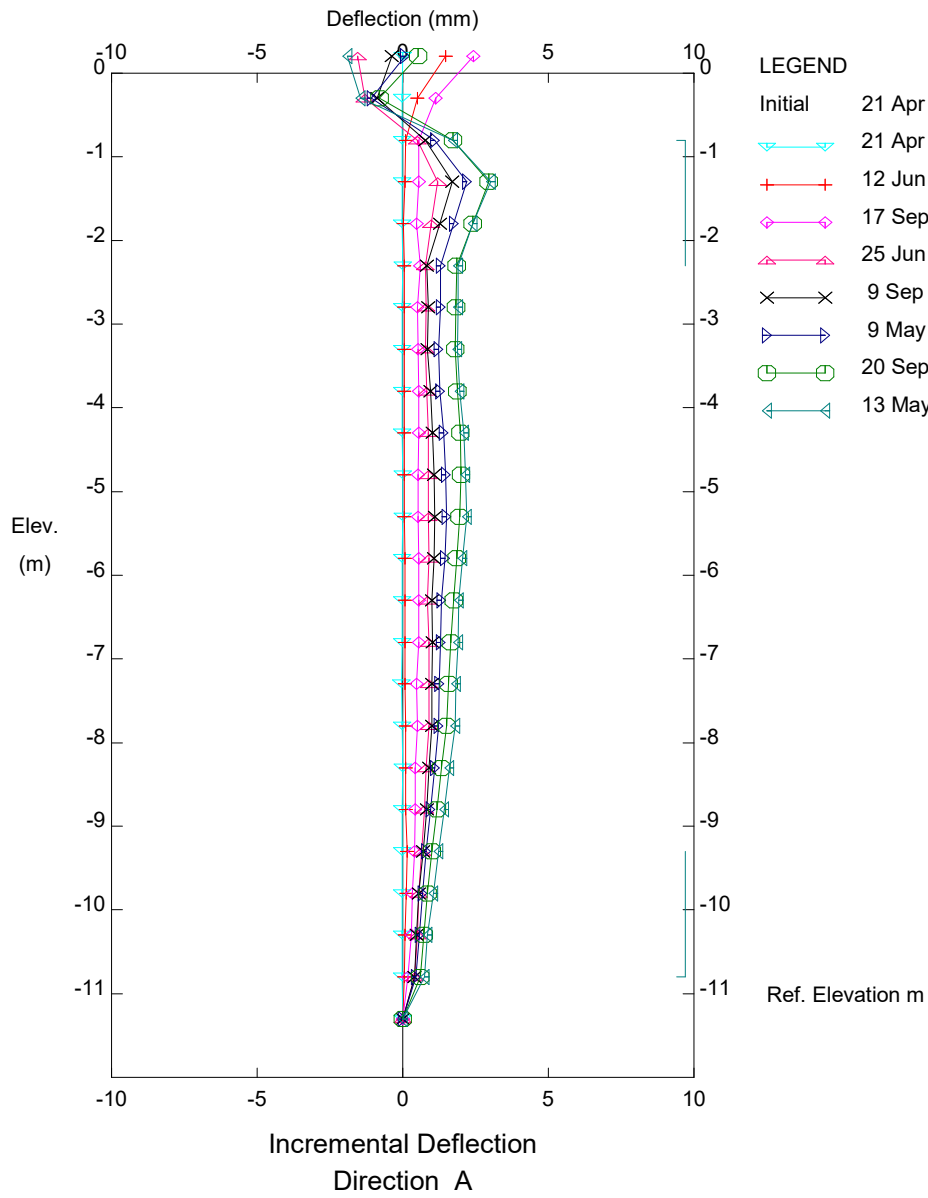
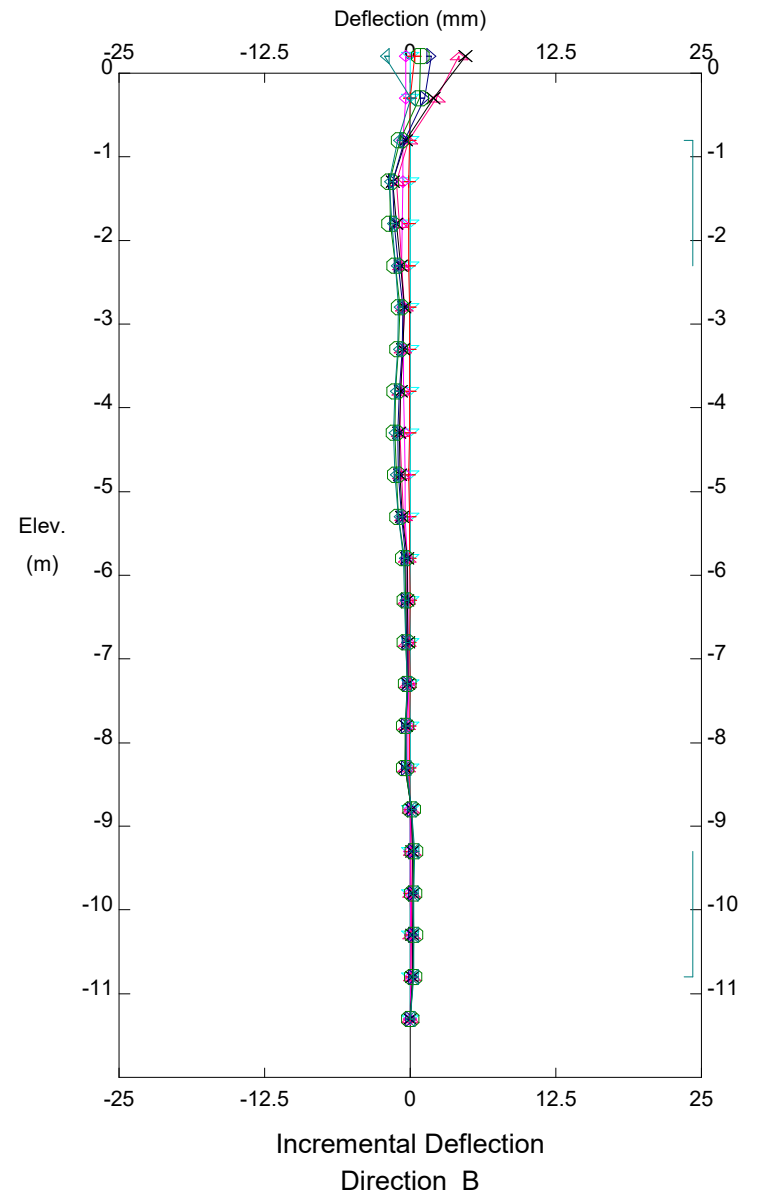
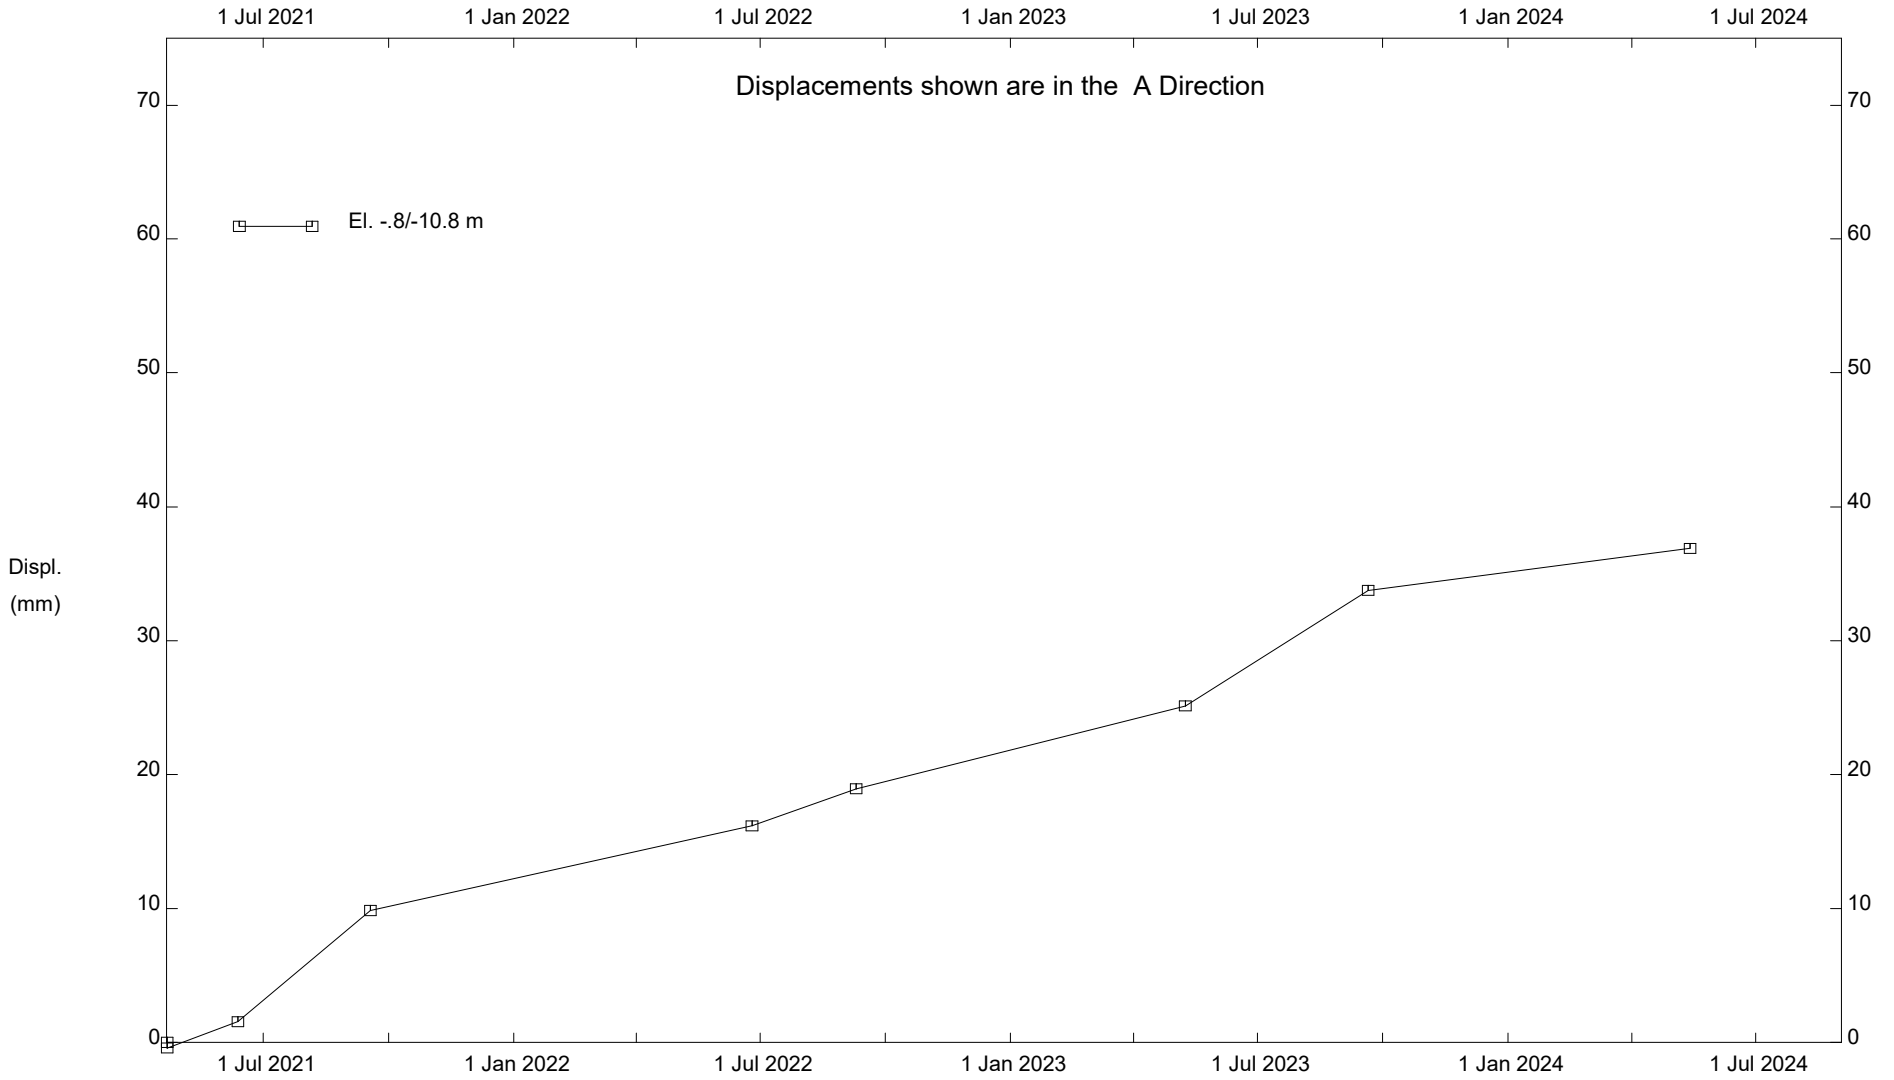
Distributed movement is being recorded in SI21-C48-01 (upper H-pile wall) along the length of the instrument from near ground surface to approximately 11 m below ground surface.

In the fall of 2021, shortly after construction of the H-pile walls, the maximum rate of movement recorded in SI21-C48-01 (upper H-pile wall) was approximately 31 mm/year. Between fall of 2021 and spring of 2023, the rate of movement was relatively steady (less than 15 mm/year) before increasing in the fall of 2023 (24 mm/year) likely due to construction activities at the site. The rate of movement has since slowed and is now less than 5 mm/year.

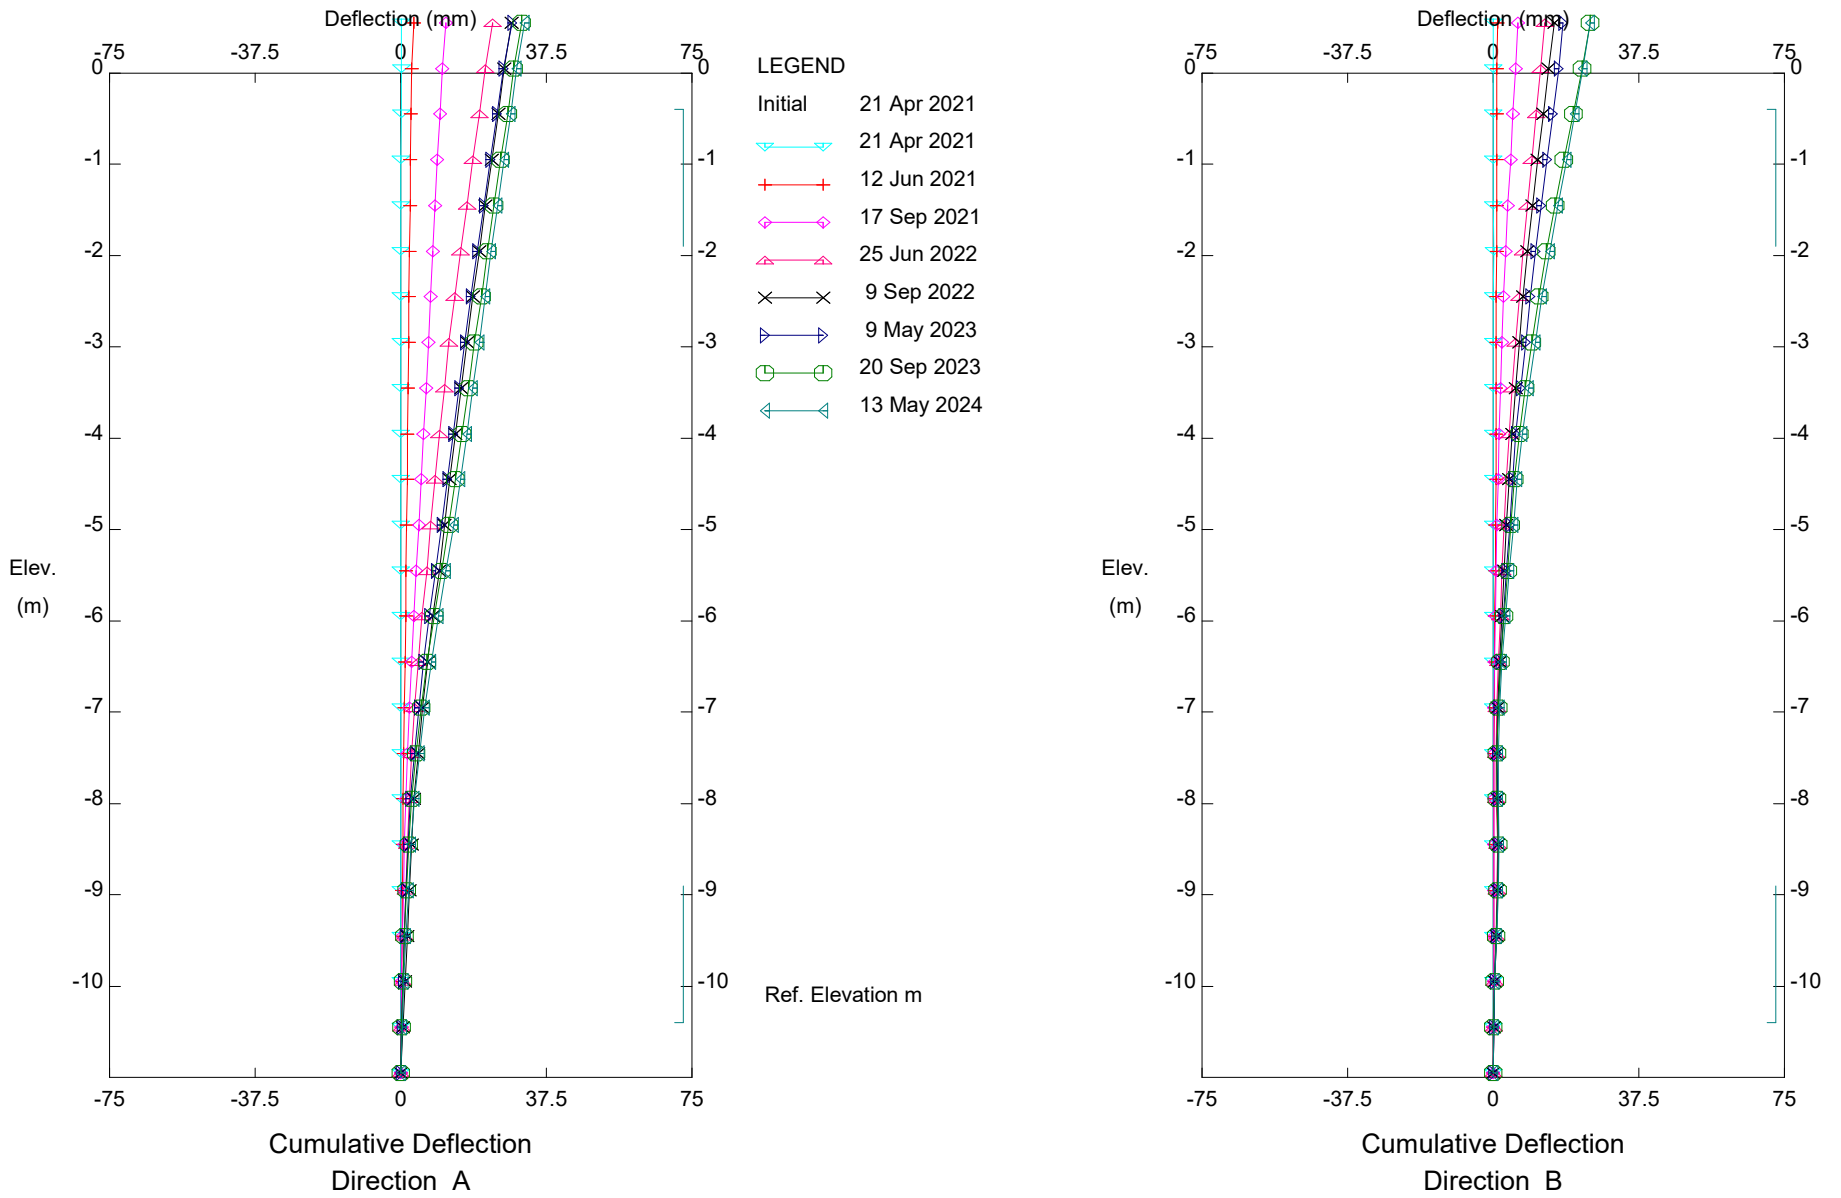
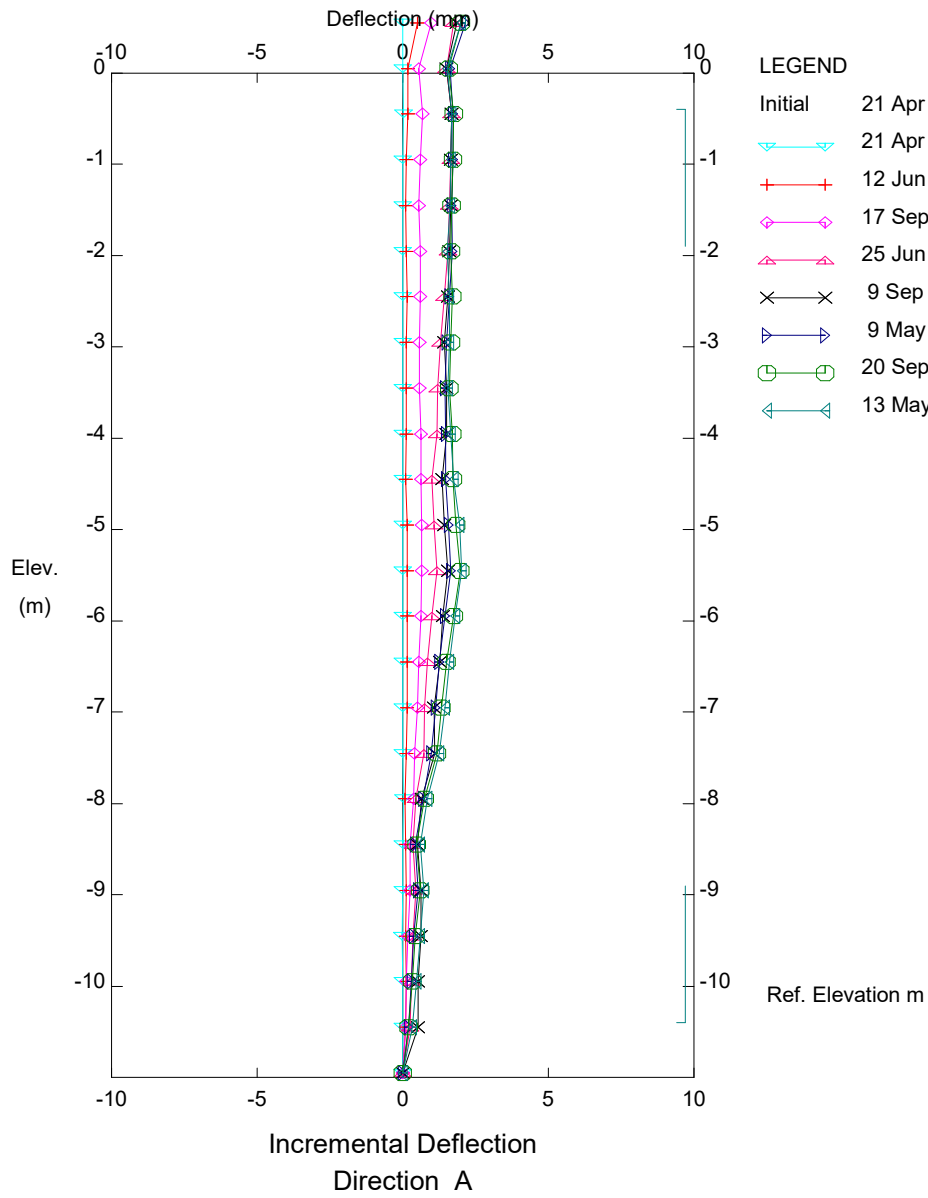
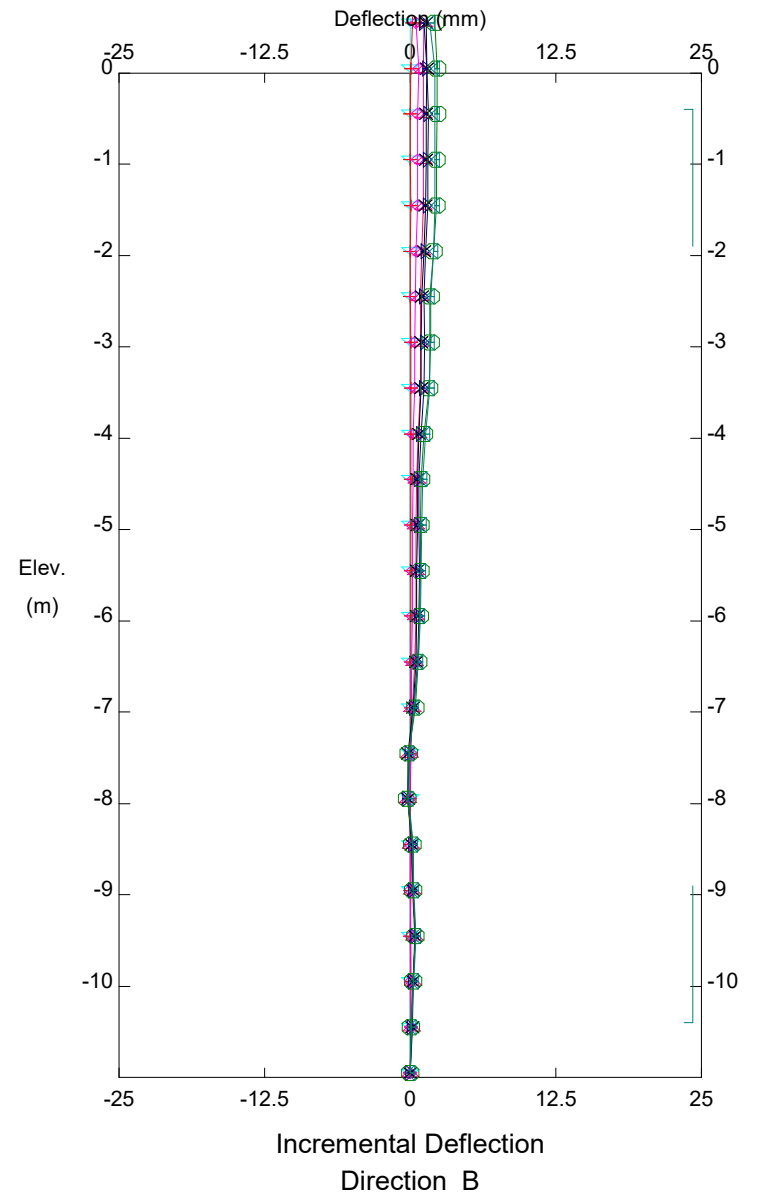
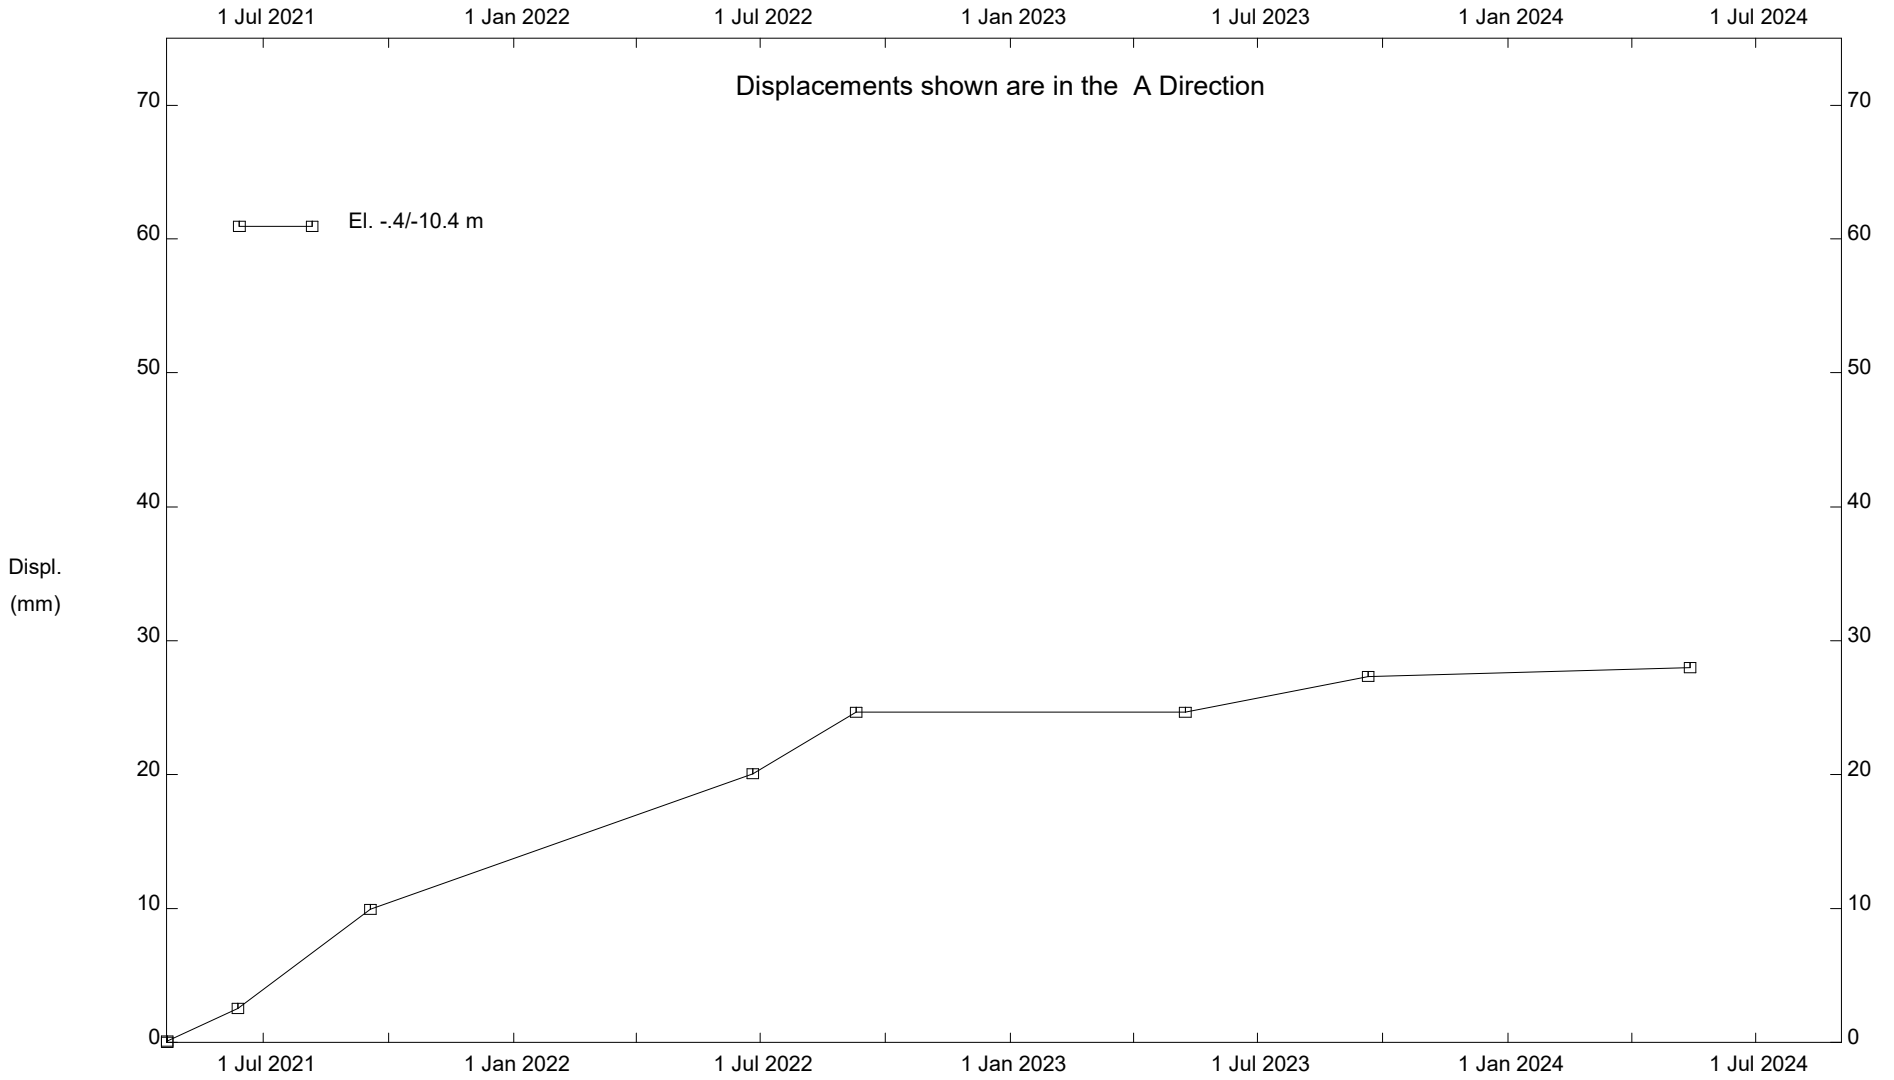
Distributed movement is being recorded in SI21-C48-02 and SI21-C48-03 (lower H-pile wall) along the length of the instruments from near ground surface to approximately 9 m and 8 m below ground surface, respectively.

Between spring of 2021 of fall of 2022, relatively steady movement of approximately 18 mm/year was recorded in SI21-C48-02 (lower H-pile wall). Since fall of 2022, the rate of movement has slowed and is currently approximately 1 mm/year.

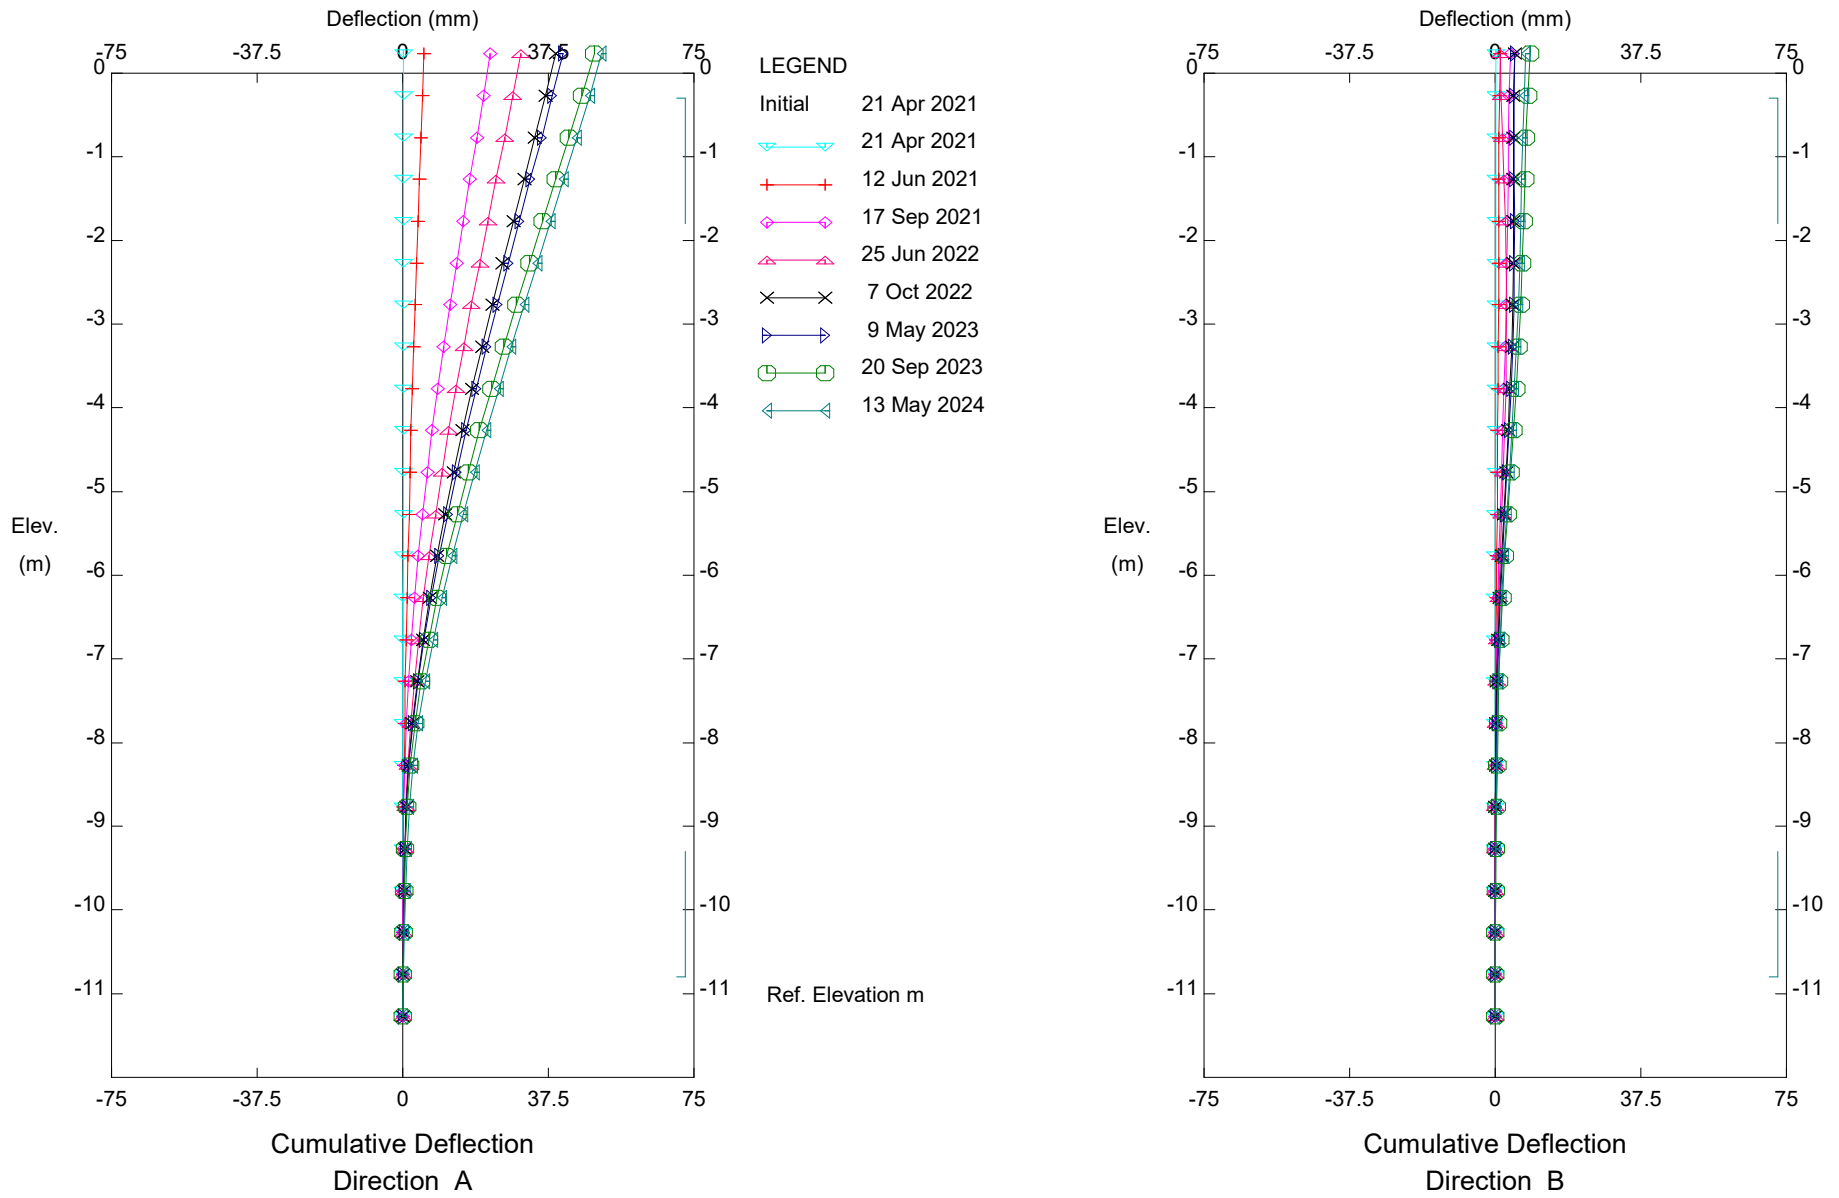
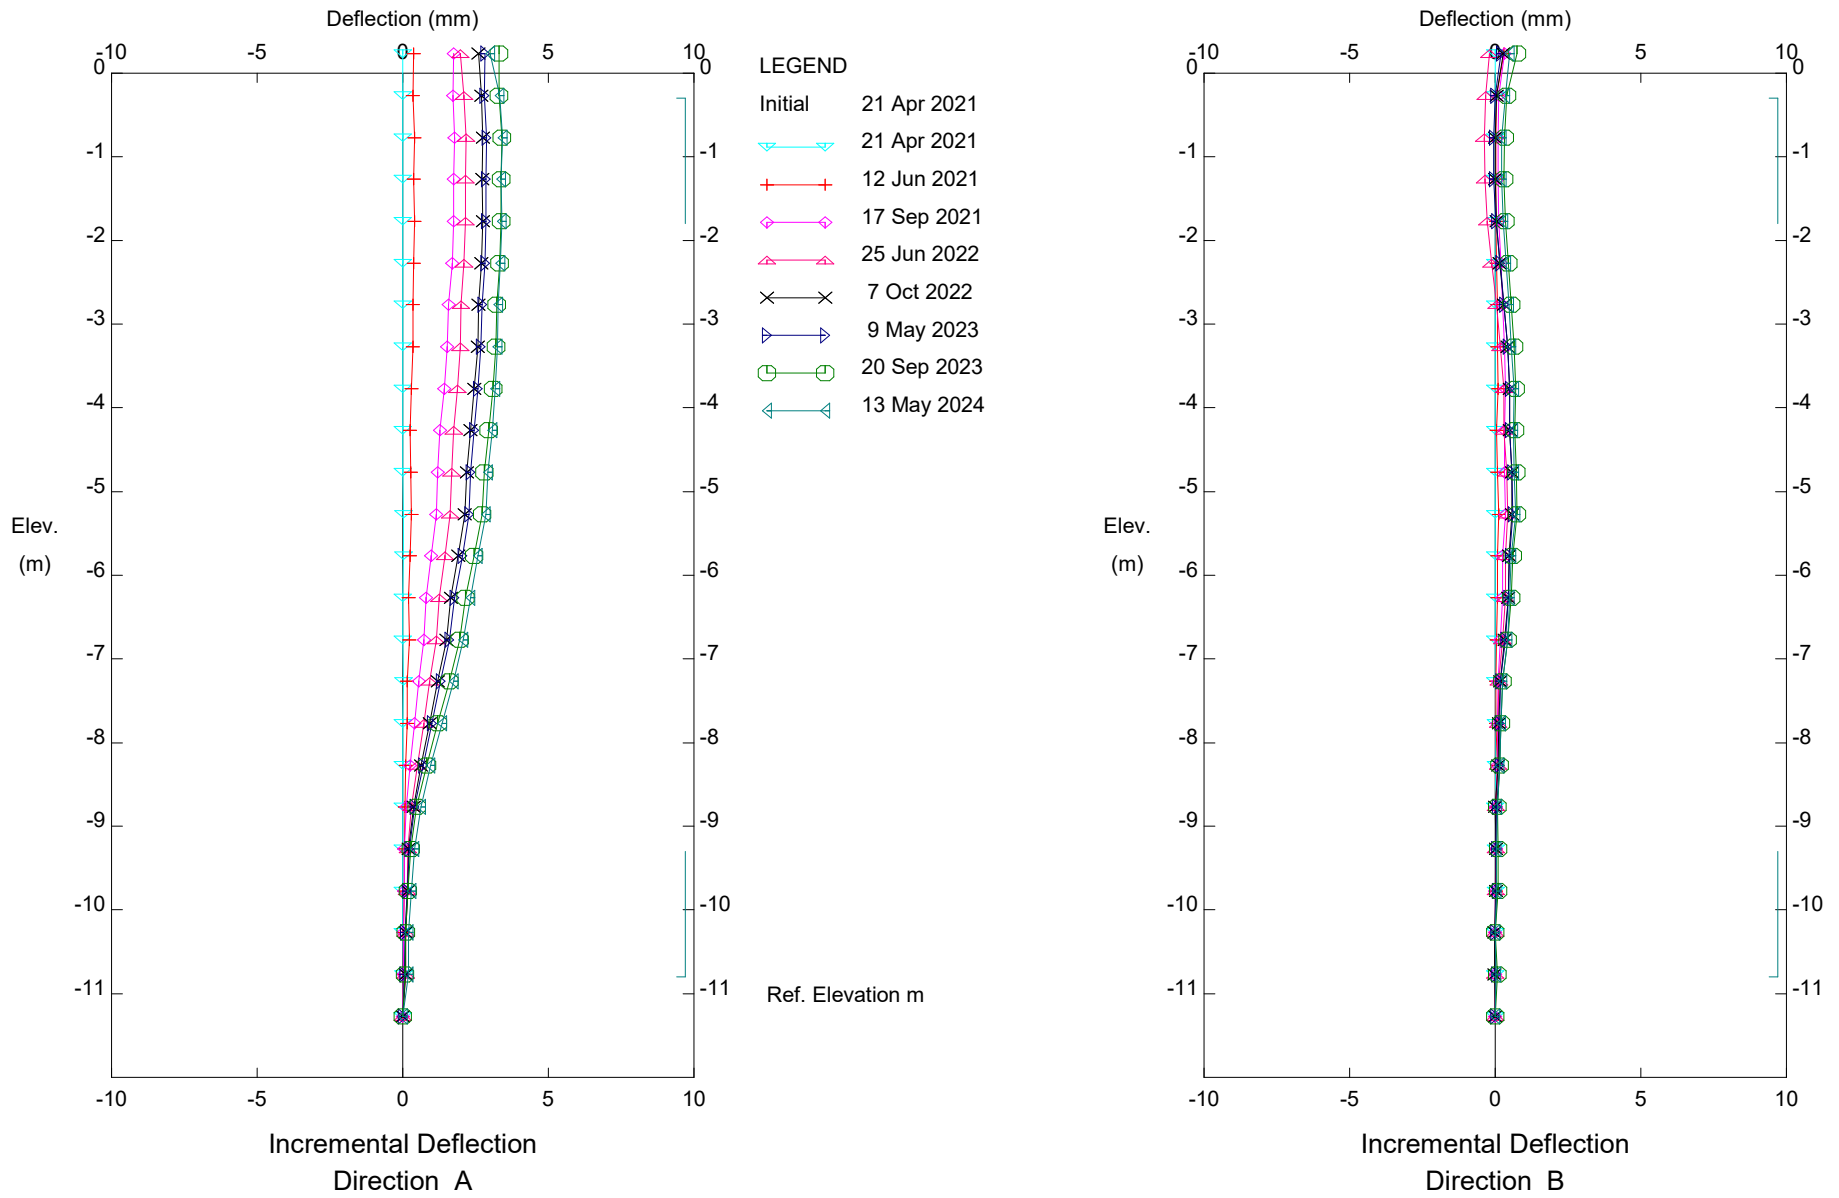
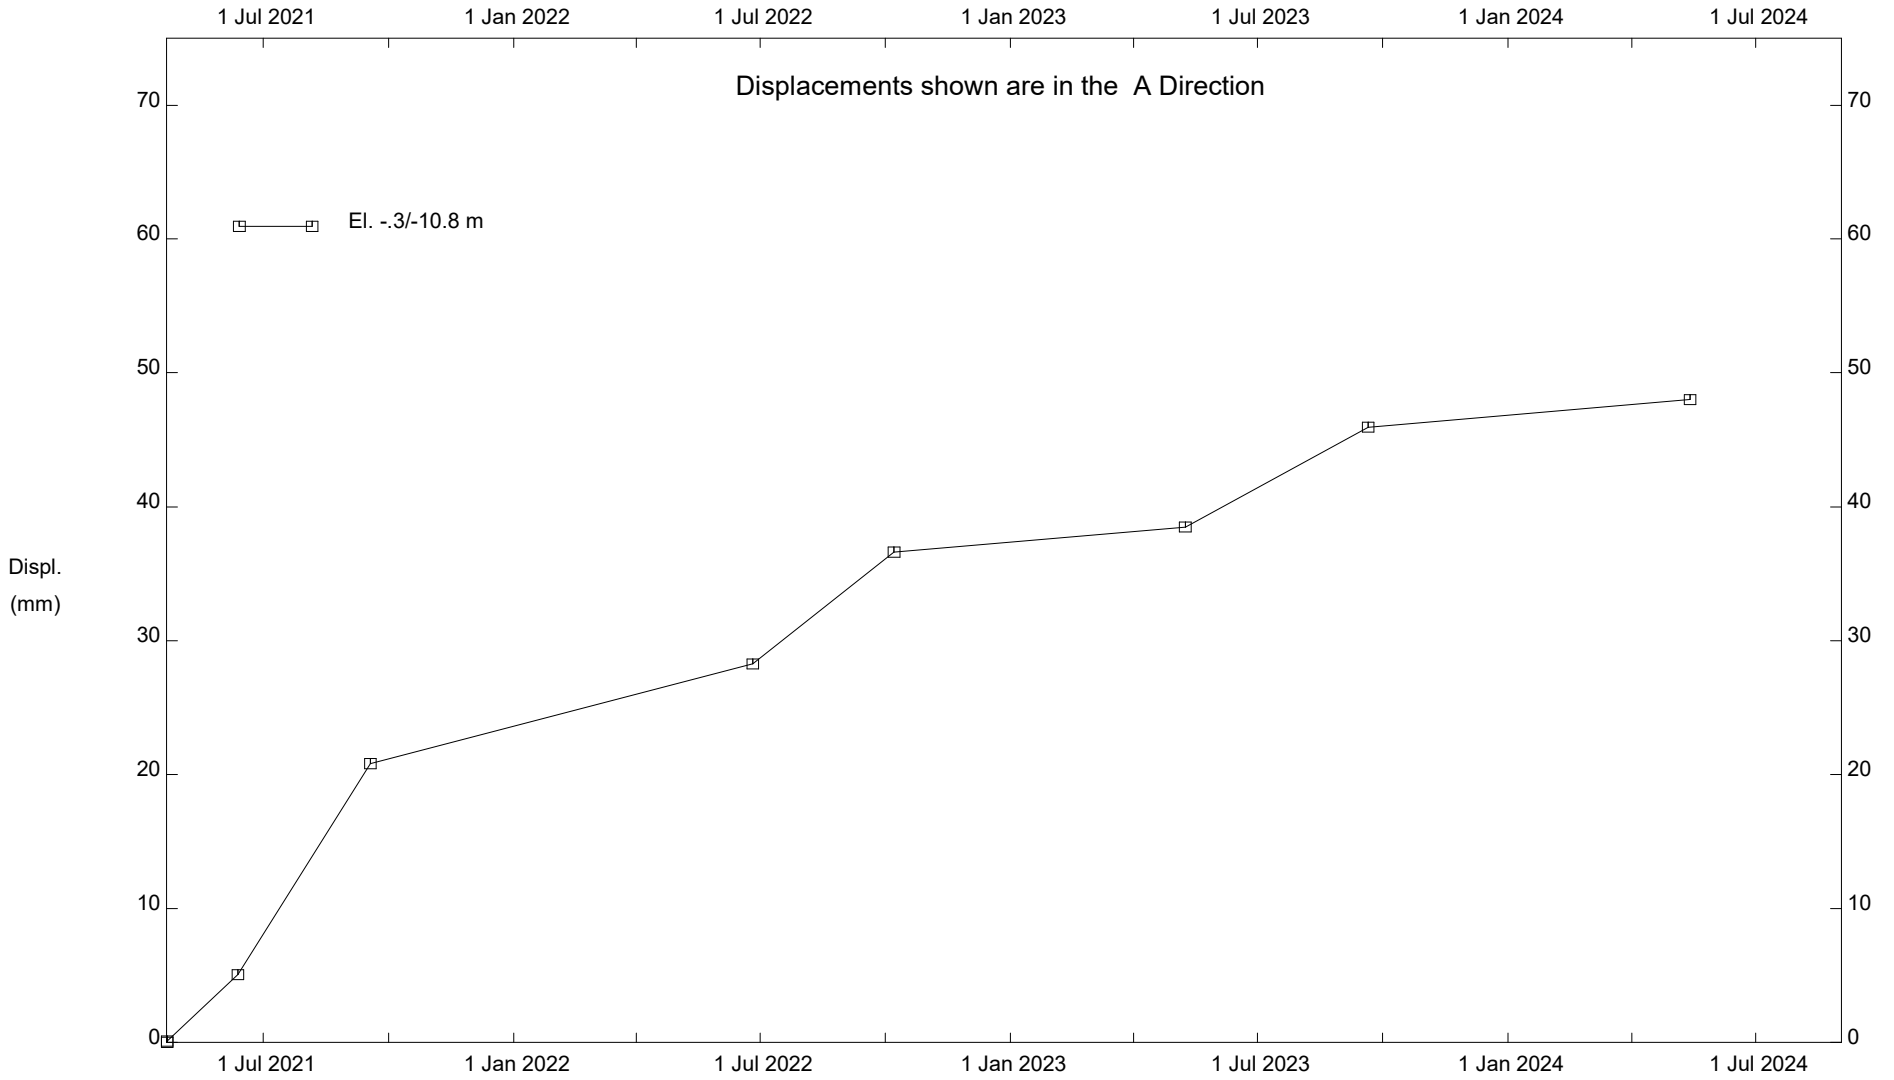
In the fall of 2021, shortly after construction of the H-pile walls, the maximum rate of movement recorded in SI21-C48-03 (lower H-pile wall) was approximately 59 mm/year. Between the fall of 2021 and spring of 2024, the overall rate of movement has been approximately 10 mm/year. The rate of movement appears to fluctuate seasonally for this instrument (i.e., increases and decreases recorded in the fall and spring, respectively) between approximately 3mm/year and 29 mm/year.
