**CON0022160 Central Region GRMP Instrumentation Monitoring
Site C042; H579:02 km 36.540 West of Water Valley Slide
Section C – 2024 Spring Readings**

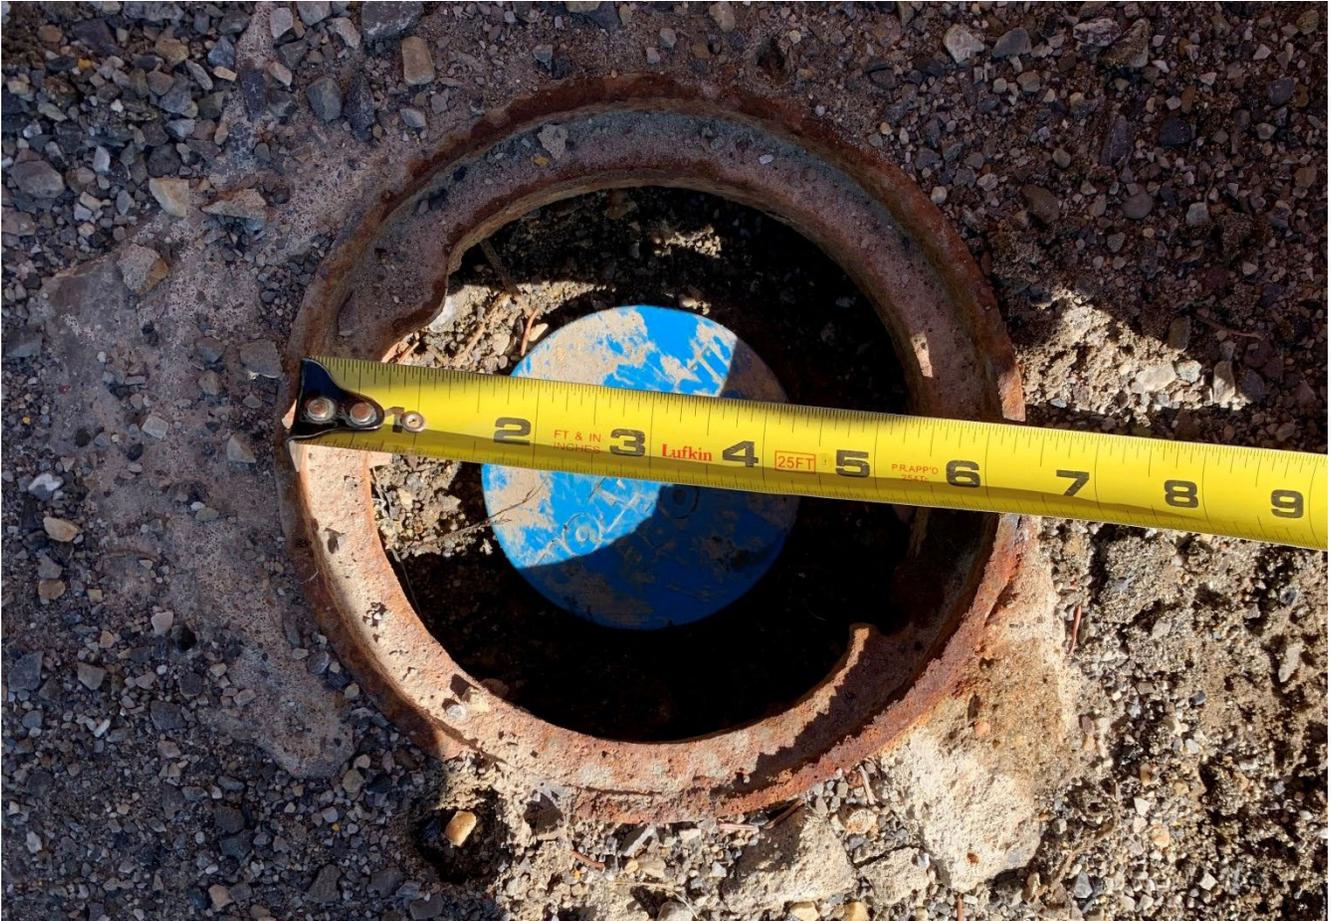
The flush-mounted casing protectors installed in the south shoulder of Hwy 579:02 to protect SI05-07 is missing a cover (Photo 1). KCB attempted to attach a new cover during the spring 2022 readings. However, it could not be attached to the existing flush-mounted casing protector. The old flush-mounted casing protector should be replaced.

Photo 1 Flush-mounted casing protector installed in the south shoulder of Hwy 579:02 to protect the SI05-07.

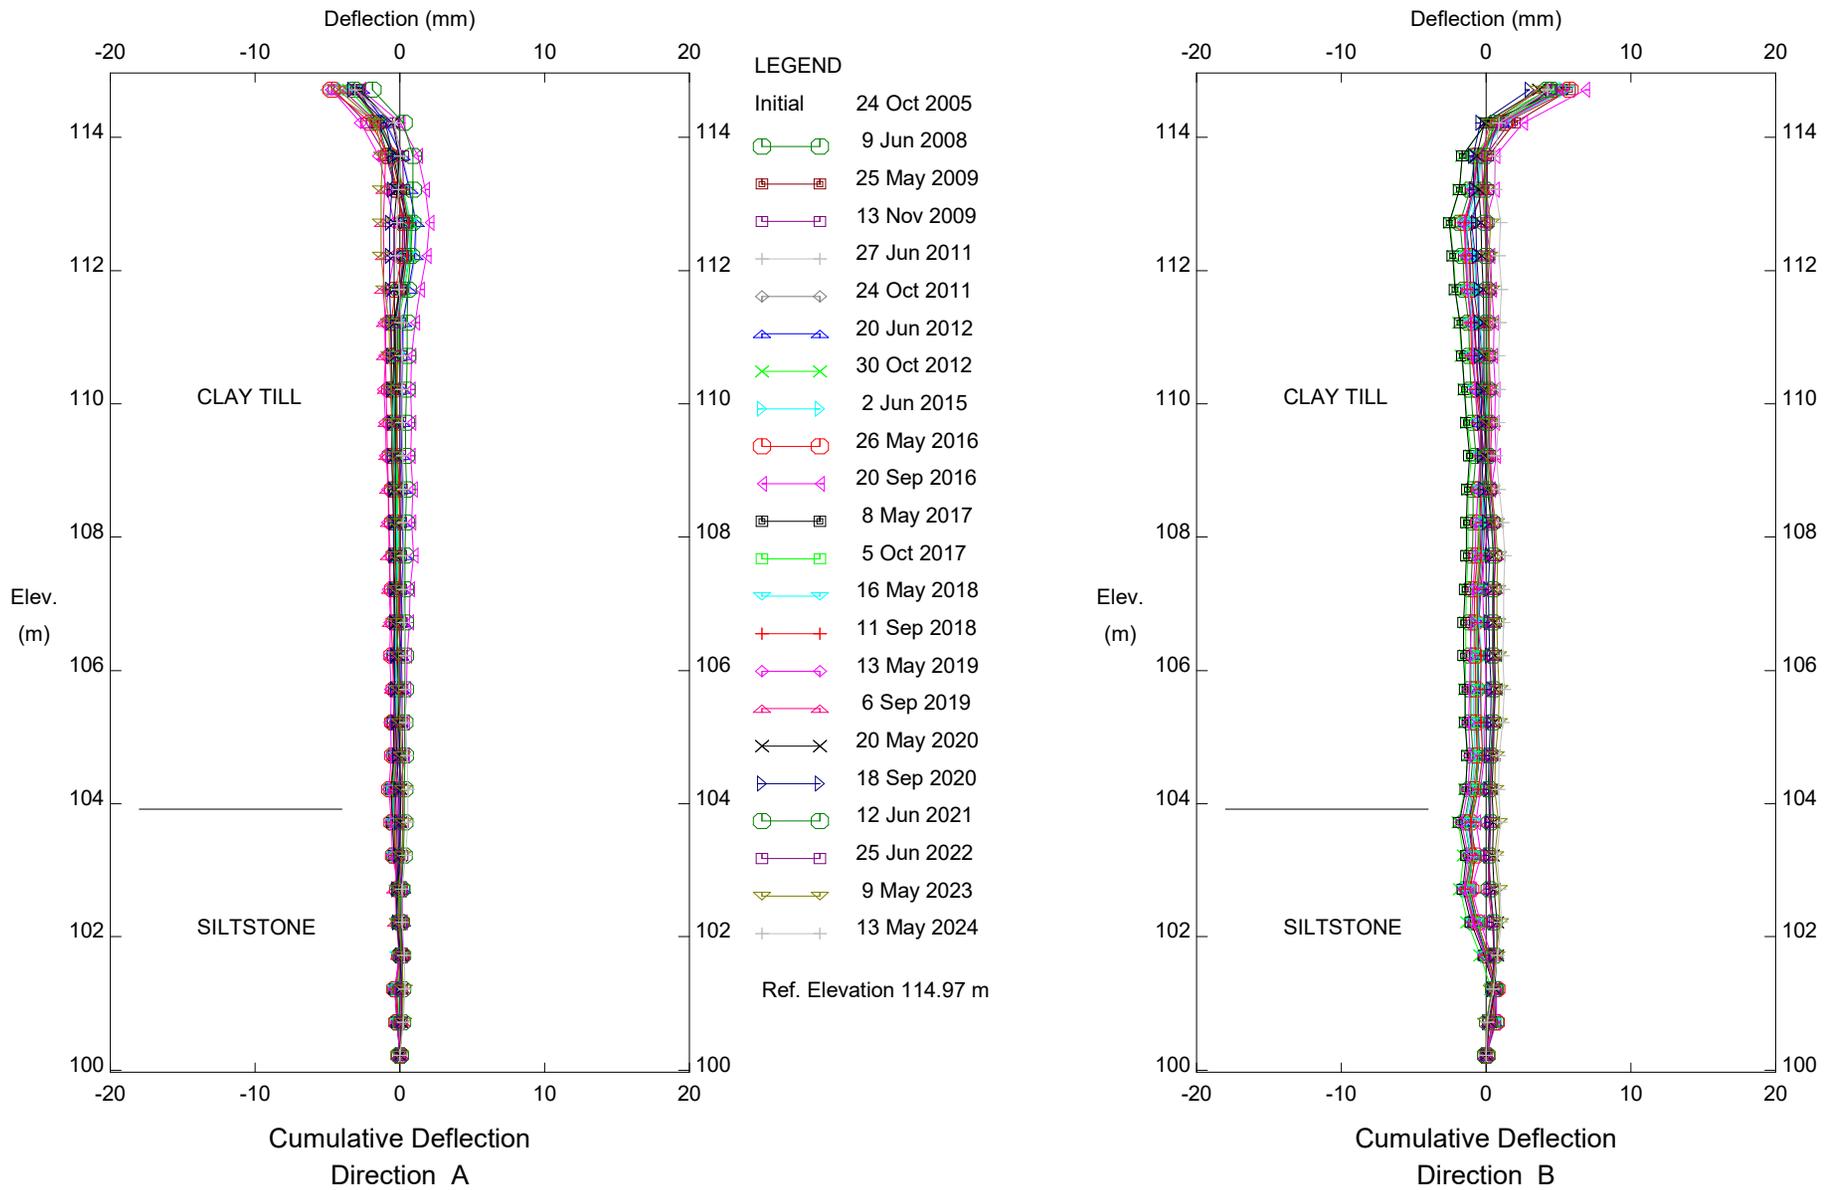
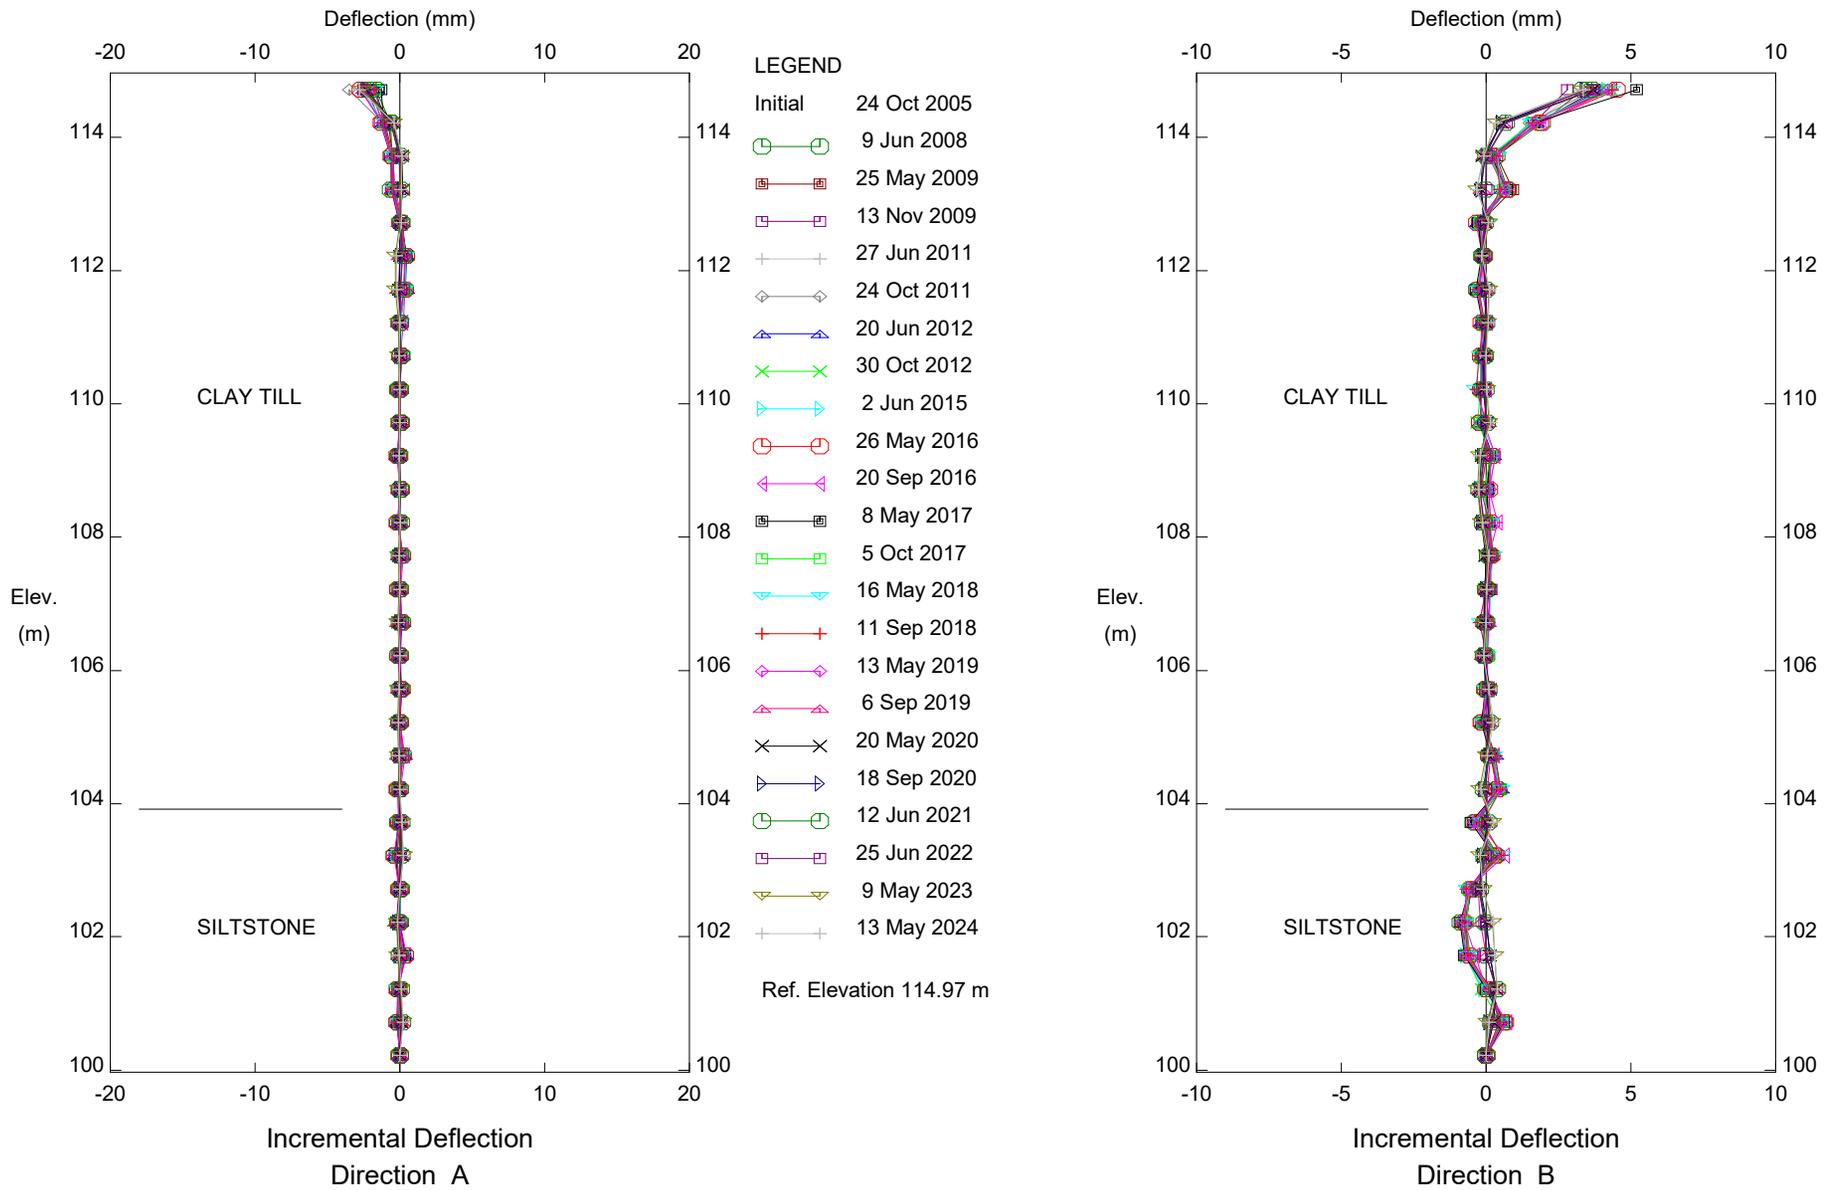
C042; H579:02, West of Water Valley Slide, Inclinometer SI05-05
 Alberta Transportation

No discernible movement has been recorded in SI05-05 since installation.

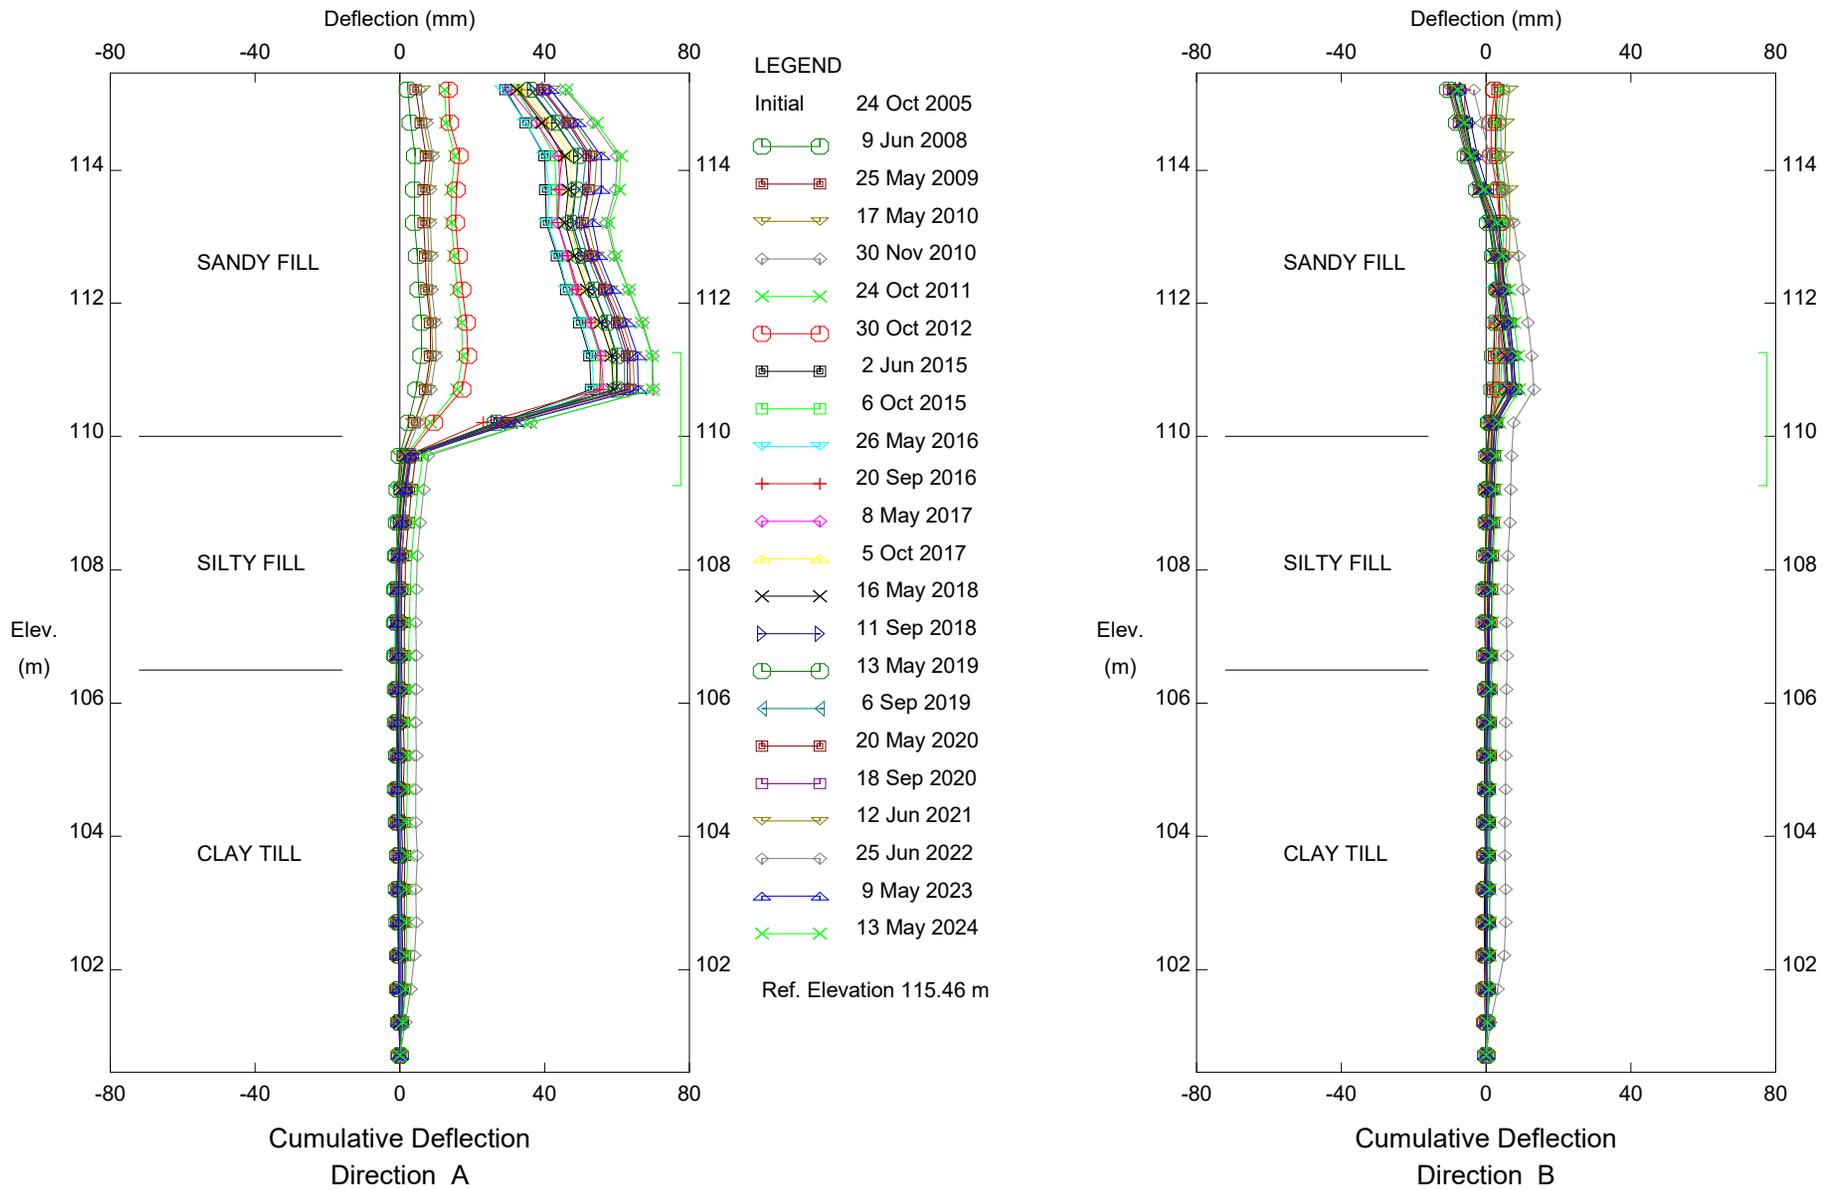
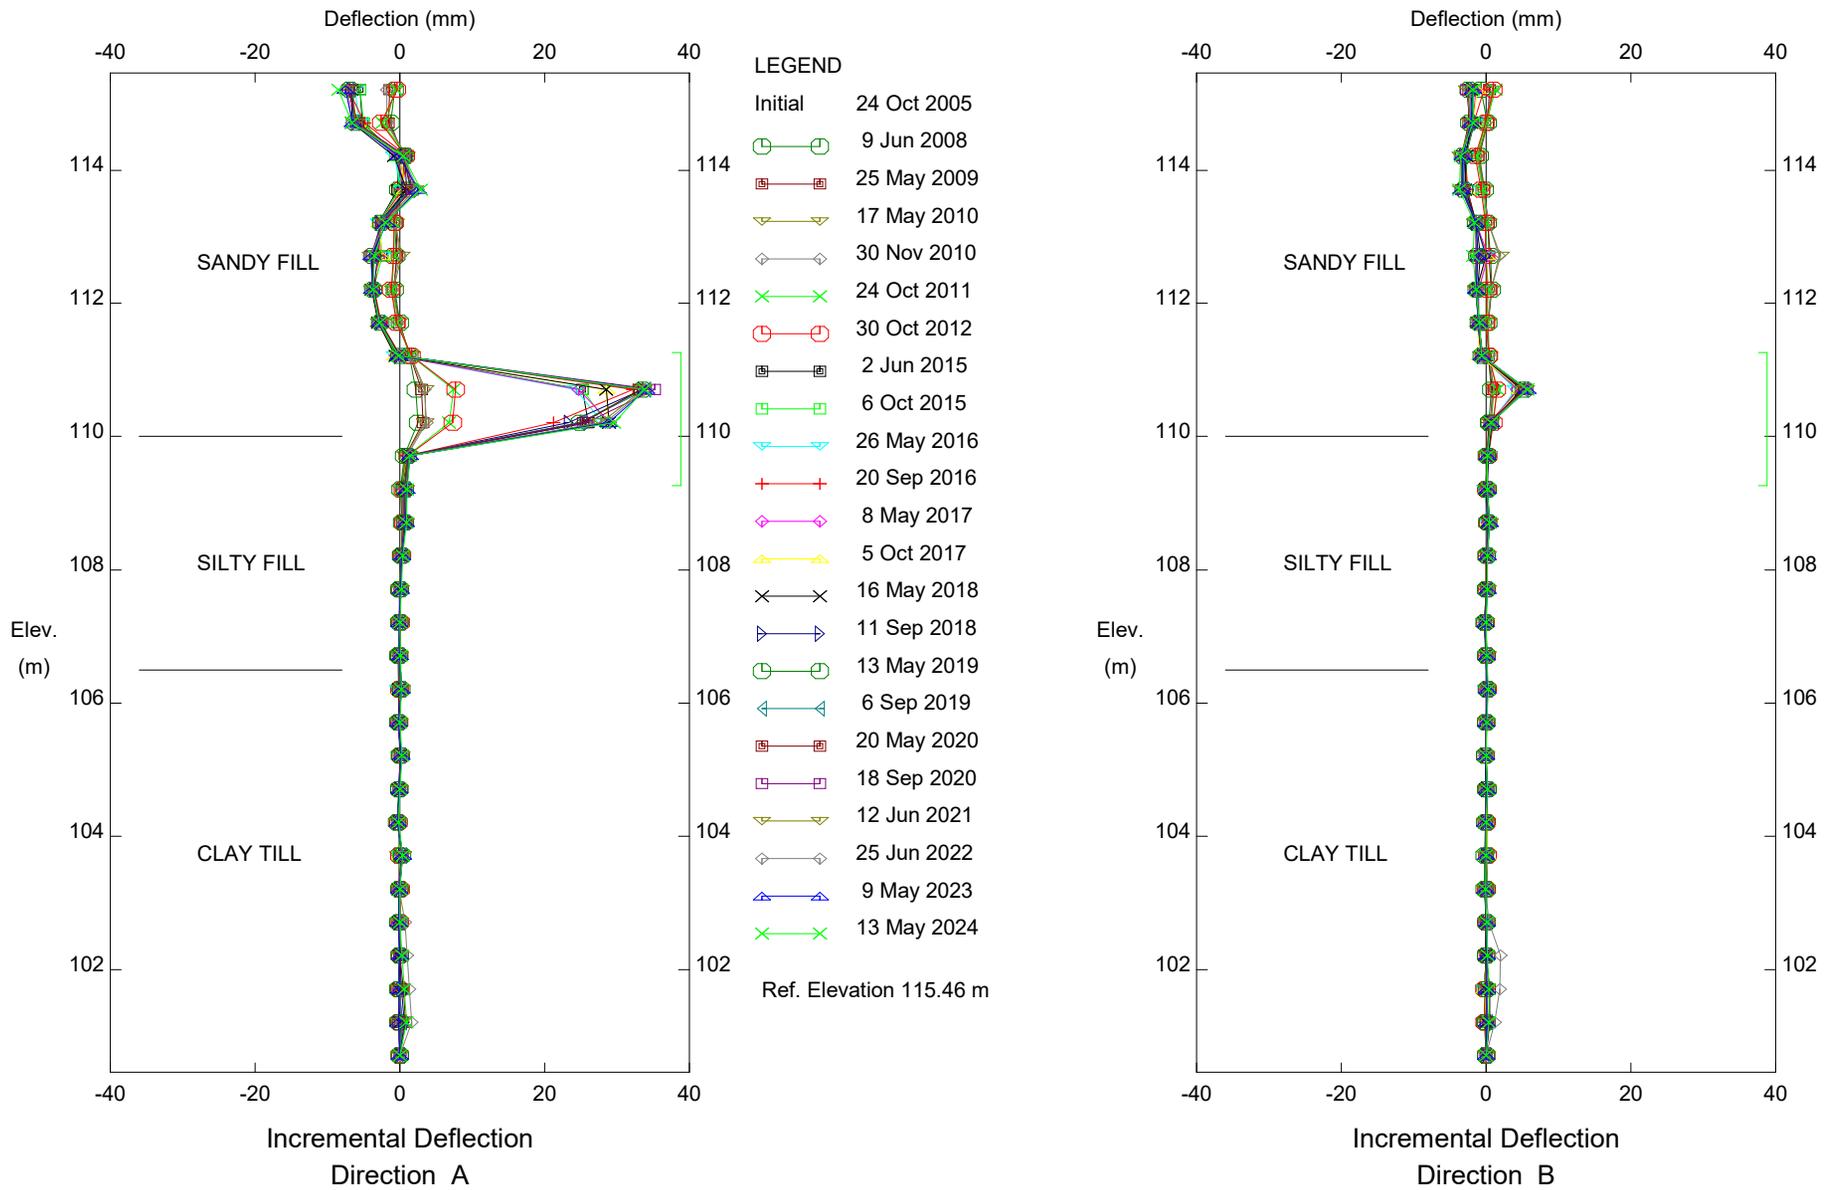
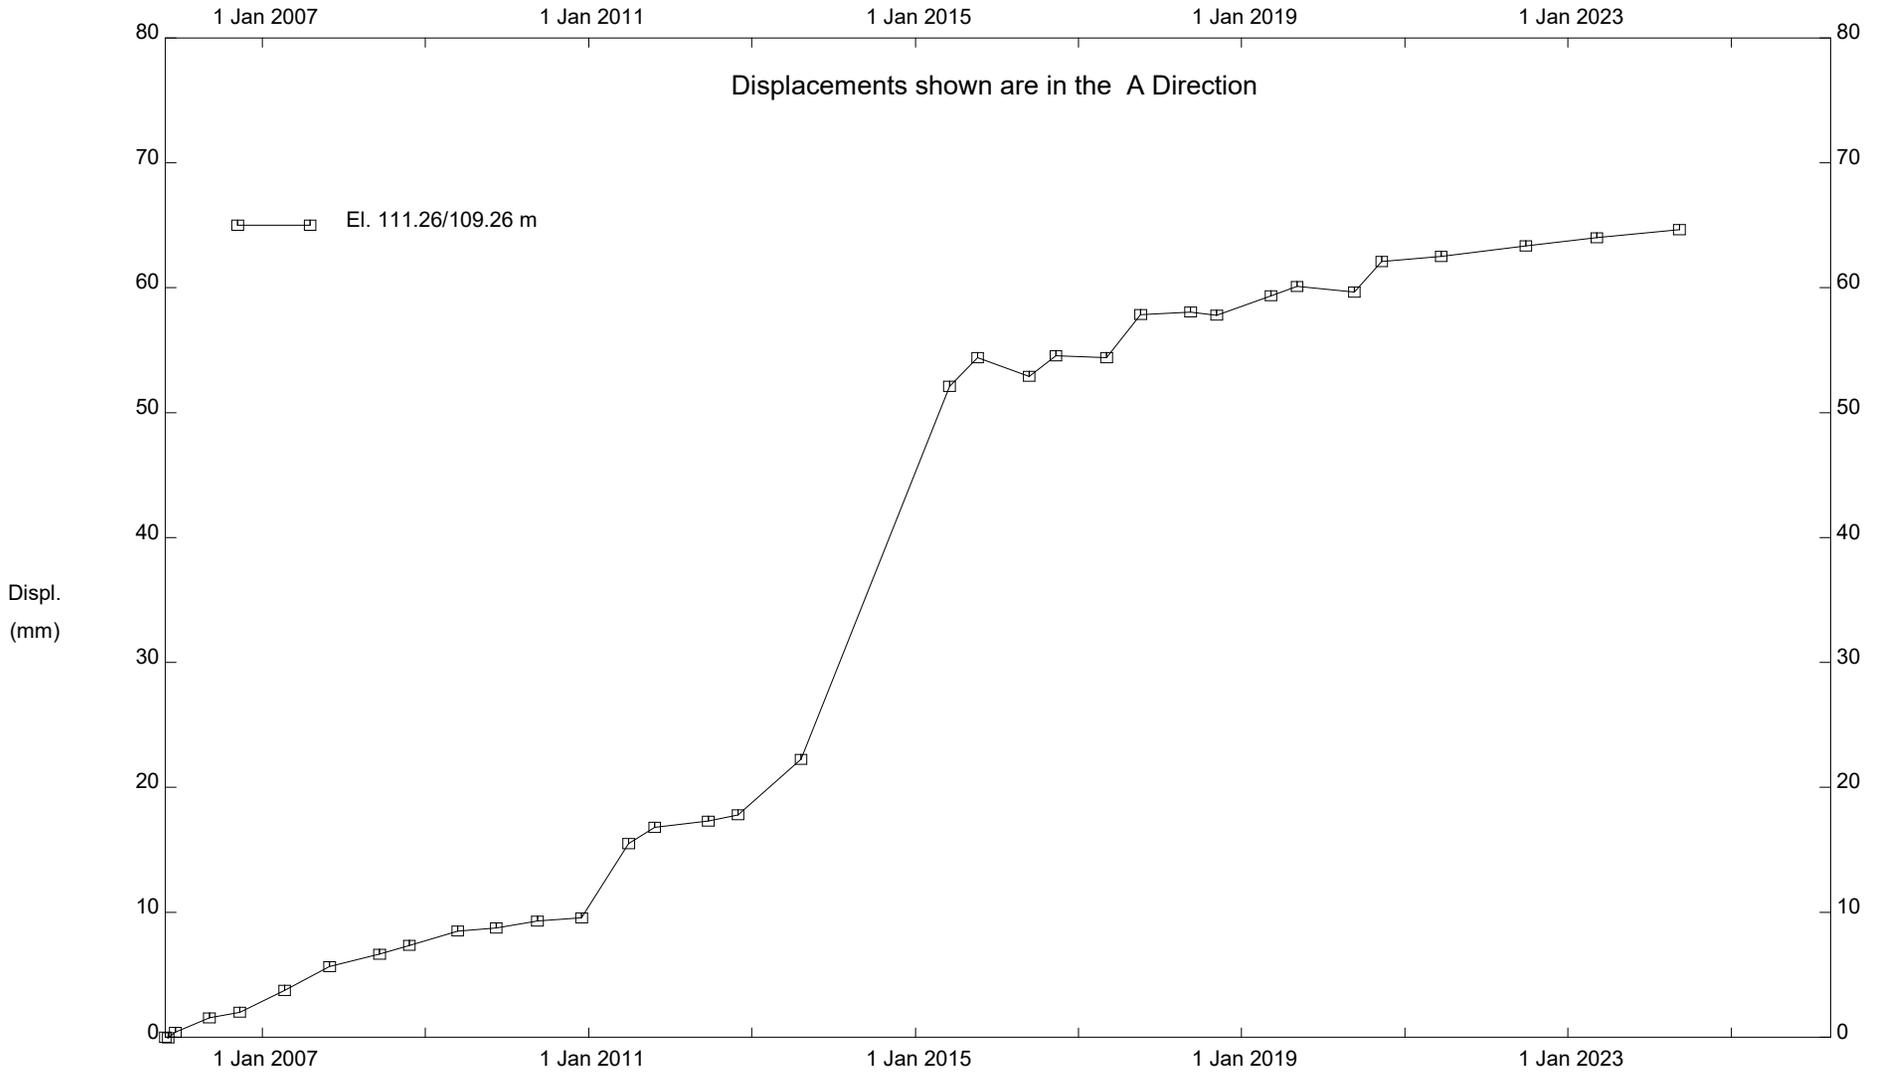
C042; H579:02, West of Water Valley Slide, Inclinometer SI05-07
 Alberta Transportation

Discrete movement is being recorded in SI05-07 at an approximate depth of 5.8 m below ground surface, in the highway embankment fill.

Historically, movement was recorded in SI05-07 at a rate of less than 10 mm/year, except between August 2013 and June 2015, when the rate of movement increased to approximately 17.5 mm/year. Since June 2015, the rate of movement being recorded in SI05-07 is generally negligible during the winter months (i.e., between the fall and spring readings) and up to 10 mm/year (overall) during the summer months (i.e., between the spring and fall readings).

The rate of movement recorded since spring 2021 has been slow (less than 1 mm/year). This was likely due to relatively dry weather throughout the past 3 years (excluding June and July 2022, see the precipitation data plotted on the piezometer plots). For comparison, the rate of movement in the previous wet year (2020) was approximately 7 mm/year. Increased movement may occur in response to periods of heavy or prolonged rainfall, resulting in higher groundwater conditions.

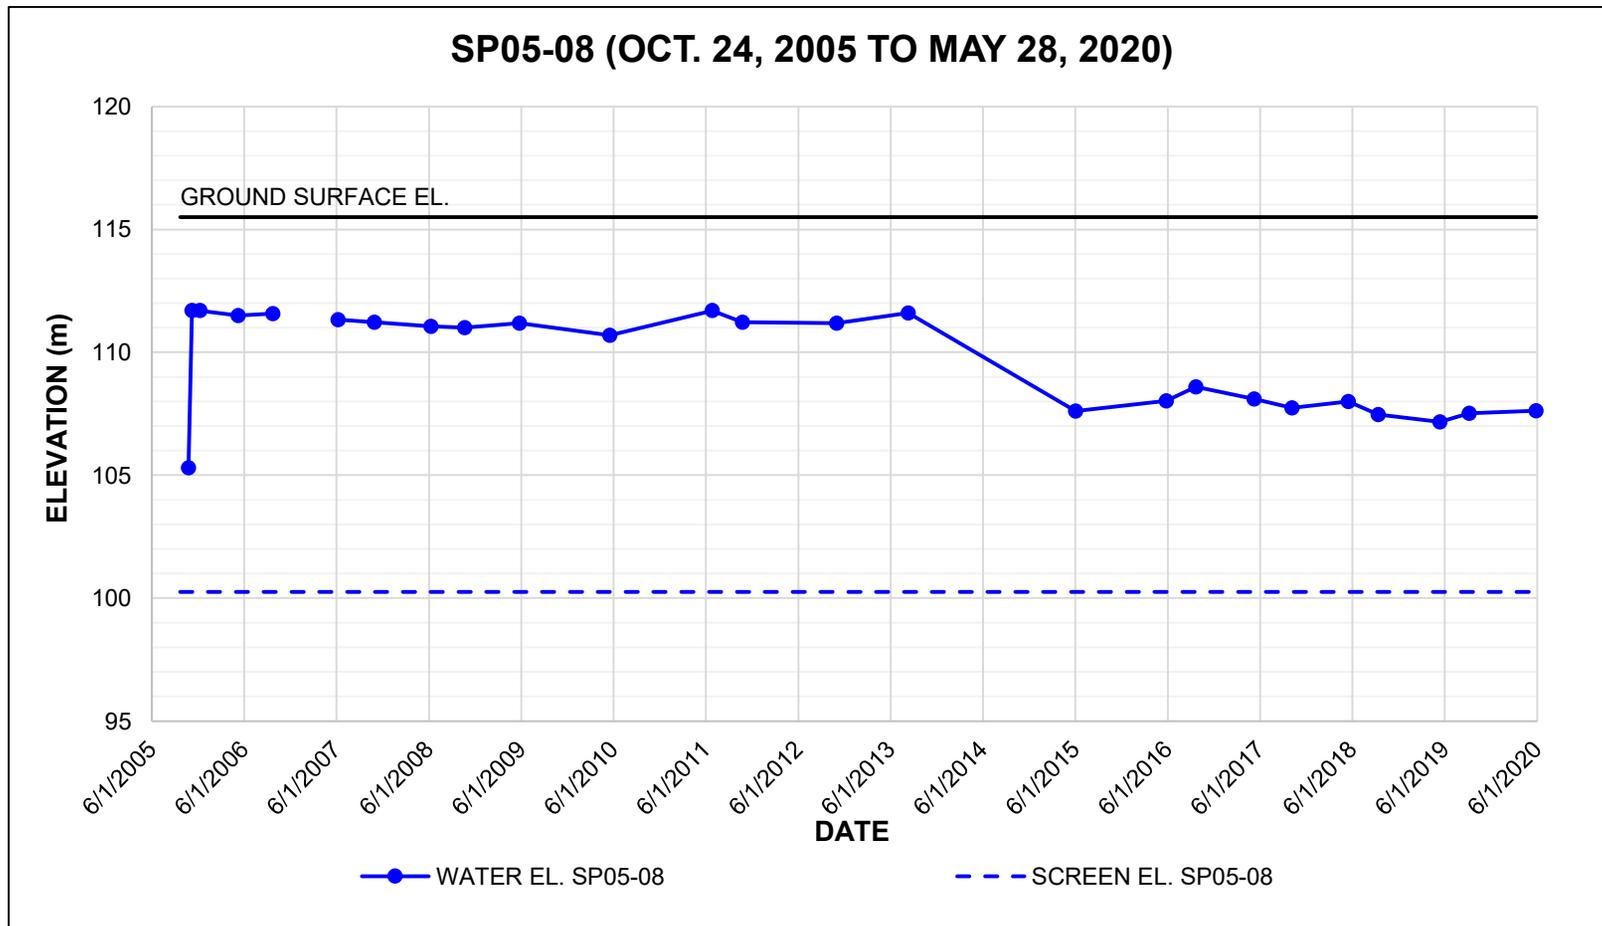
PROJECT CENTRAL REGION GEOHAZARD RISK MANAGEMENT PROGRAM	
	TITLE Piezometer Data C042 - West of Water Valley Slide Hwy 579:02, km 36.540	
SCALE	PROJECT No. A05116A02	FIG No. I-1

Upon review of the data obtained from the Heron data logger between May 2020 and May 2024, there appears to be a relatively strong relationship between precipitation (heavy or prolonged rainfall, or spring freshet) and water level response recorded in SP05-08 (e.g., water level increases in response to increased rainfall in fall 2021). There are multiple precipitation events where there is no response recorded in SP05-08. However, these events were during winter months when the ground was frozen and there was no infiltration. Since we have a better understanding of the groundwater response to precipitation events, the Heron data logger was removed during the spring 2024 reading, to be installed at a different GRMP site.

The water level fluctuations (resulting in a water level above ground surface) may be due to condensation in the venting of the instrument cap and modification to the vent cap will be considered to see if there is a more muted response in water level.
