SITE NUMBER AND NAME: C073-I and -II: Slide and Erosion Sites		HIGHWAY & KM: 580:02, 23.604 2A:12, 15.725	PREVIOUS INSPECTION DATE: August 14, 2020	INSPECTION DATE: June 23, 2021
LEGAL DESCRIPTION: C073-I: SE 06-30-01-W5M C073-II: NE 29-30-01-W5M	NAD 83 COORDINATES: UTM Northing Easting 11 5713022 699532 11 5720905 701123		RISK ASSESSMENT: PF: 1 CF: 2 TOTAL: 2 PF: 1 CF: 7 TOTAL: 7	
AVERAGE ANNUAL DAILY TRAFFIC (AADT): C073-I: 1240 (east) & 1620 (west) (Reference No. 68250 & 76260) C073-II: 4660 (north) & 2760 (south) (Reference No. 70000526 & 70000216)			CONTRACT MAINTENANCE AREA (CMA): 514

Inspection Photographs

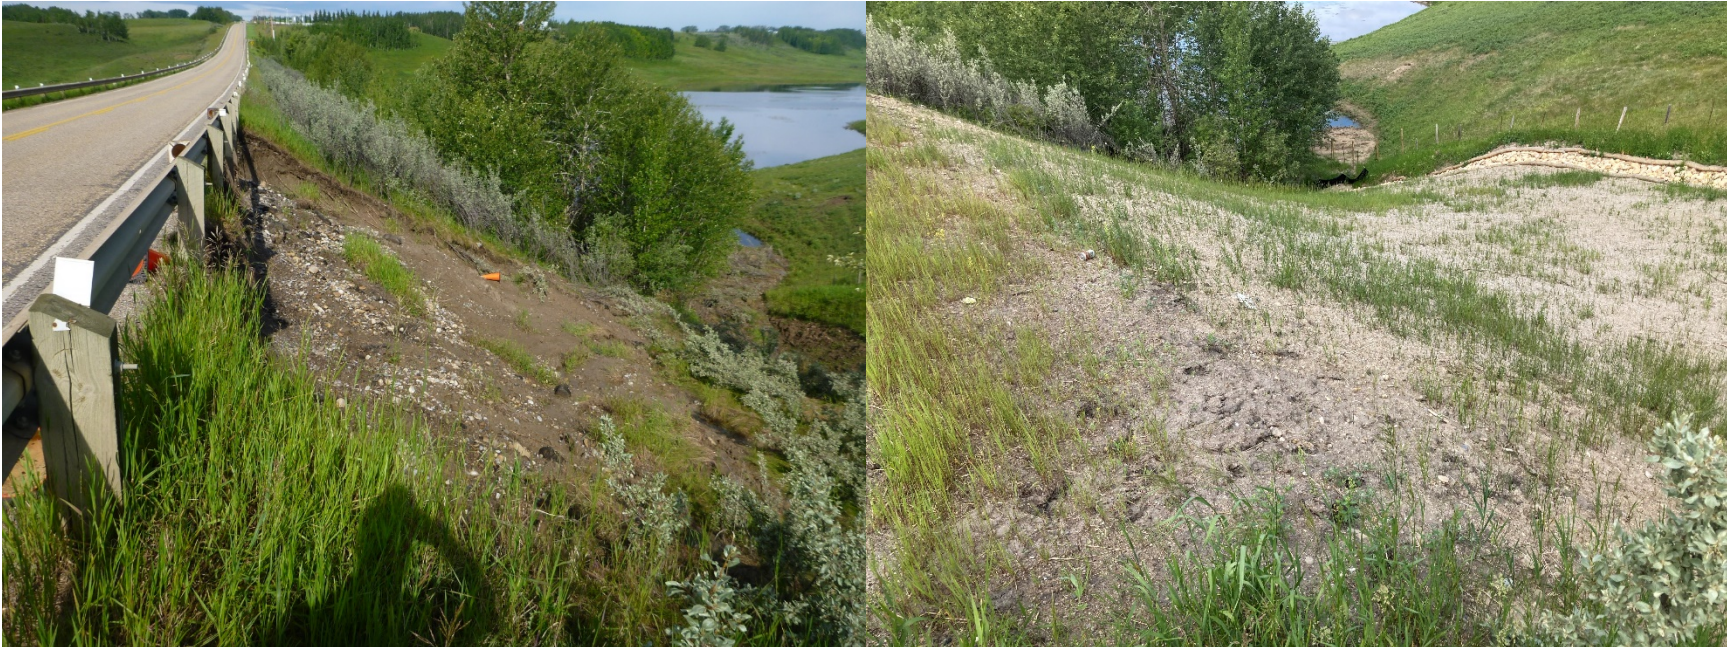
- During the June 2021 inspection, the repaired slope, toe berm, and culvert appeared to be in good condition. However, the vegetation growth/coverage on the repaired slope and upstream ditch is poor and requires additional seeding (Photos 1, 3, and 4).

Photo 1 An overview of the C073 slide area from the north (westbound) shoulder of Hwy 580, before and after repairs. Photos taken July 10, 2019 and June 23, 2021 facing west and northwest, respectively.

- The HMC should re-seed the C073-I site in 2021. The HMC could hydro-seed the repaired slope and upstream ditch from westbound lane of Hwy 580.

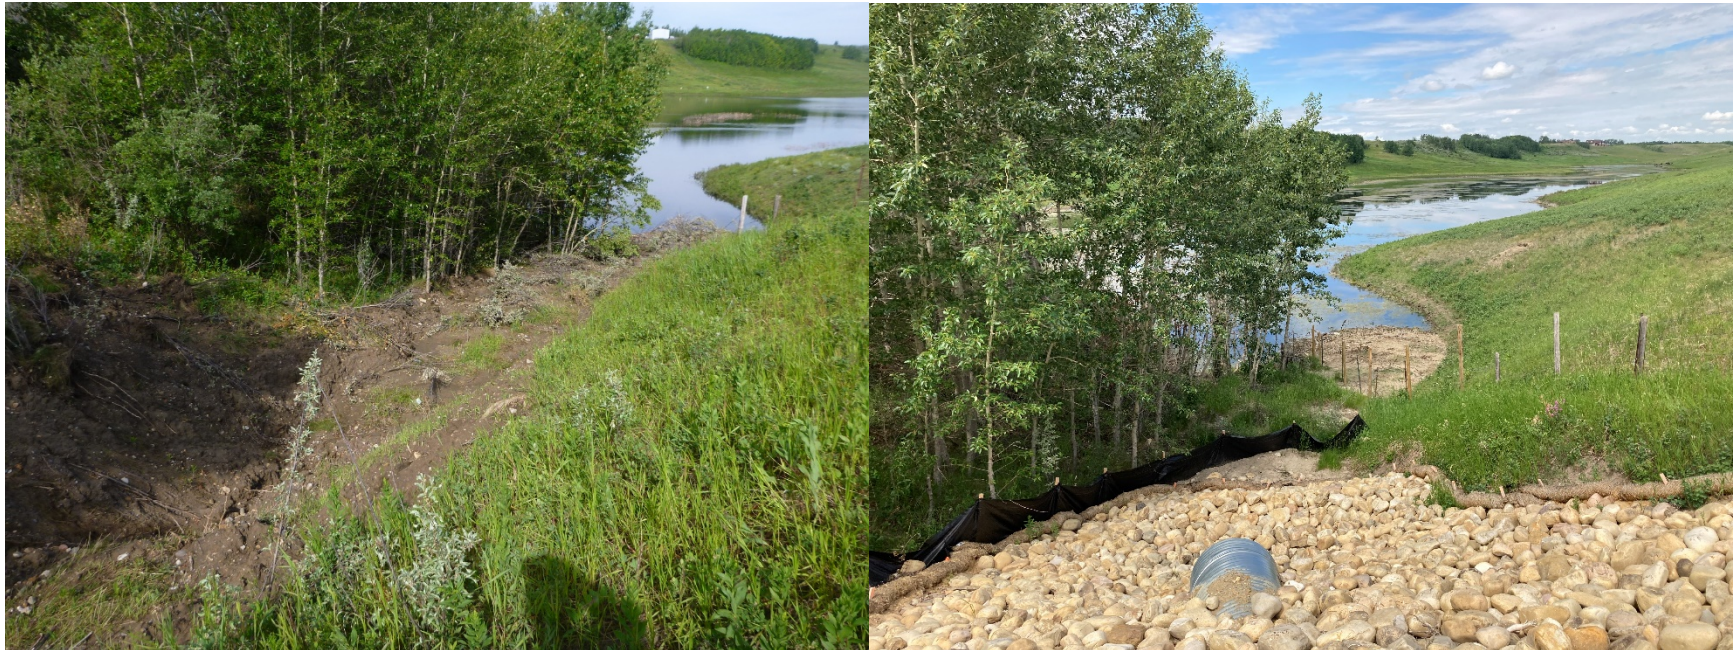
Photo 2 Area near Carstairs Creek where failed material from the C073 slide sloughed into when the embankment failed in 2019, before and after the 2020 repairs. Photo taken July 10, 2019 and June 23, 2021 facing northwest.

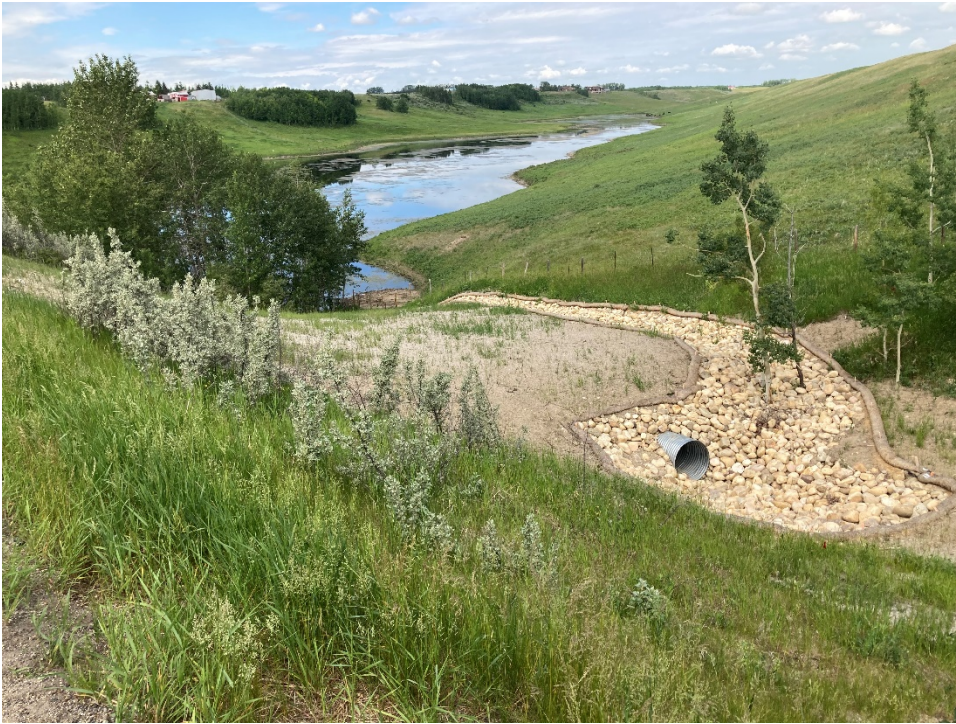
Photo 3 The east side of the slide repair, 900 mm diameter CSP culvert inlet, riprap apron, and overflow channel. Photo taken June 23, 2021 facing northwest.

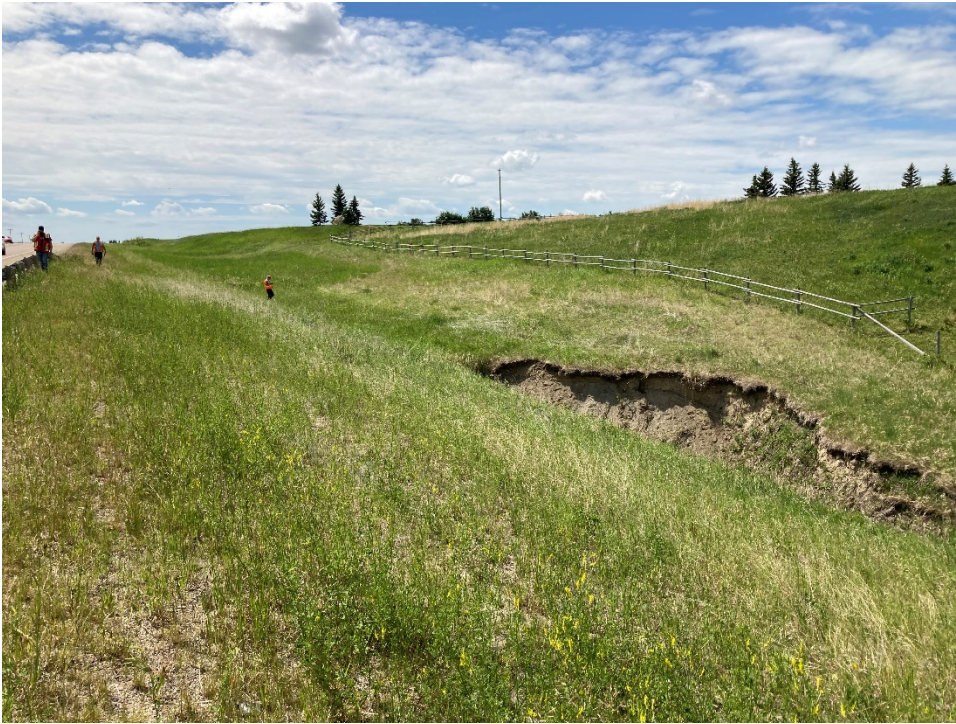
- An erosion gully has formed in the west (southbound) ditch, approximately 20 m west of Hwy 2A. The erosion gully is approximately 5 to 8 m wide (crest to crest), 3 m deep, and 30 m long. The erosion gully has 45° side slopes and is east (downslope) of a private landowner's fence.

- KCB and AT believe the erosion gully formed due to the steepness of the ditch at the erosion site (estimated to be between 12.5% to 14%), large catchment area, and inadequate erosion protection (i.e., only vegetation). Erosion is likely exacerbated by periods of increased precipitation.

Photo 5 Erosion site approximately 4.7 km north of Carstairs, in the west (southbound) ditch of Hwy 2A. Photo taken June 23, 2021 facing southwest.

- AT should have the HMC (Volker) complete the repairs at the C073-II site. The repair options could include backfilling the erosion gully with fine-grained material (e.g., clay till), grading the ditch to allow for positive drainage, and hydro-seeding. However, due to the steepness of the ditch, the repair may need to incorporate more permanent erosion control measures (e.g., geocell armoring, TRM with bonded-fibre matrix, geosynthetics, riprap etc.).
- KCB will complete a hydrotechnical assessment to determine the flow the ditch will have to accommodate (e.g., maximum flow for the 1:10 year rain event) and provide sketches to the HMC for the repair work.

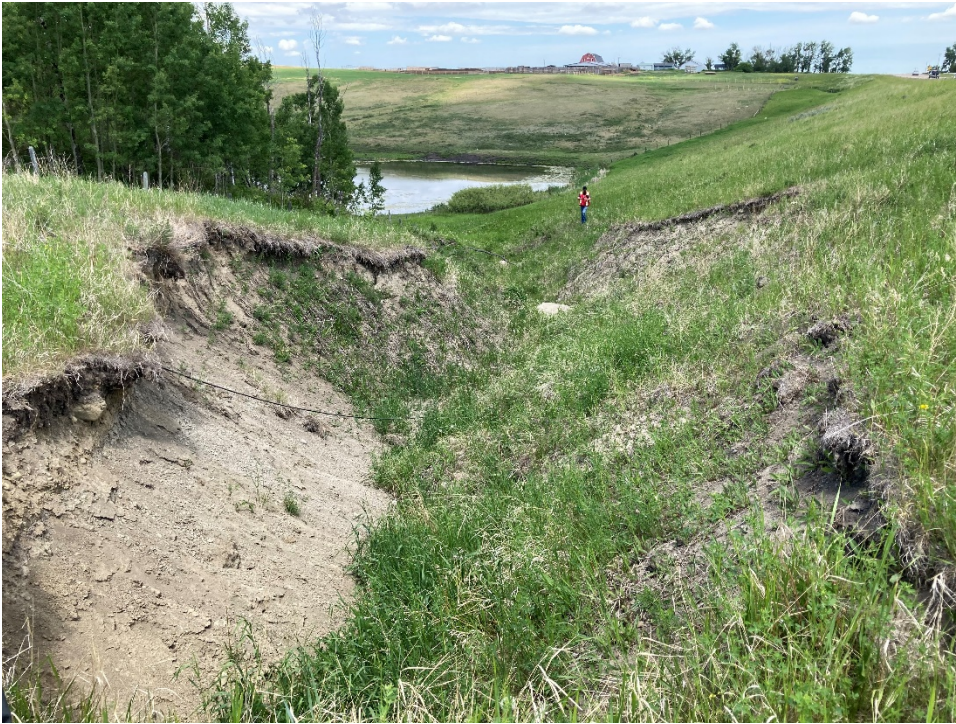
- The depth of the erosion gully decreases further downstream (north) where a well-vegetated area acts as a sediment trap. No sediments were observed at the outlet of the erosion gully.

Photo 7 The sides of the erosion gully are near-vertical, and the depth of the erosion gully decreases as it progresses north. Photo taken June 23, 2021 facing northwest.
