SITE NUMBER AND NAME: <b>C073-I and -II: Slide and Erosion Sites</b>		HIGHWAY & KM: 580:02, 23.604 2A:12, 15.725	PREVIOUS INSPECTION DATE: June 23, 2021	INSPECTION DATE: <b>May 30, 2022</b>
LEGAL DESCRIPTION: <b>C073-I:</b> SE 06-30-01-W5M <b>C073-II:</b> NE 29-30-01-W5M	NAD 83 COORDINATES: UTM    Northing    Easting 11     5713022    699532 11     5720905    701123		RISK ASSESSMENT: <b>C073-I:</b> PF: 1    CF: 2    TOTAL: 2 <b>C073-II:</b> PF: 1    CF: 7    TOTAL: 7	
AVERAGE ANNUAL DAILY TRAFFIC (AADT): <b>C073-I:</b> 1270 (east) & 1670 (west) (Reference No. 68250 & 76260) <b>C073-II:</b> 3740 (north) & 3080 (south) (Reference No. 70000526 & 70000216)			CONTRACT MAINTENANCE AREA (CMA): 514

PROJECT CENTRAL REGION GEOHAZARD RISK MANAGEMENT PROGRAM		
TITLE Site Plan C073-I - Southwest of Carstairs Hwy 580:02, km 26.304		
SCALE 1:750	PROJECT No. A05116A02	FIG No. 1

PROJECT CENTRAL REGION GEOHAZARD RISK MANAGEMENT PROGRAM		
TITLE Site Plan C073-II - North of Carstairs Hwy 2A:12, km 15.725		
SCALE 1:1,500	PROJECT No. A05116A02	FIG No. 1

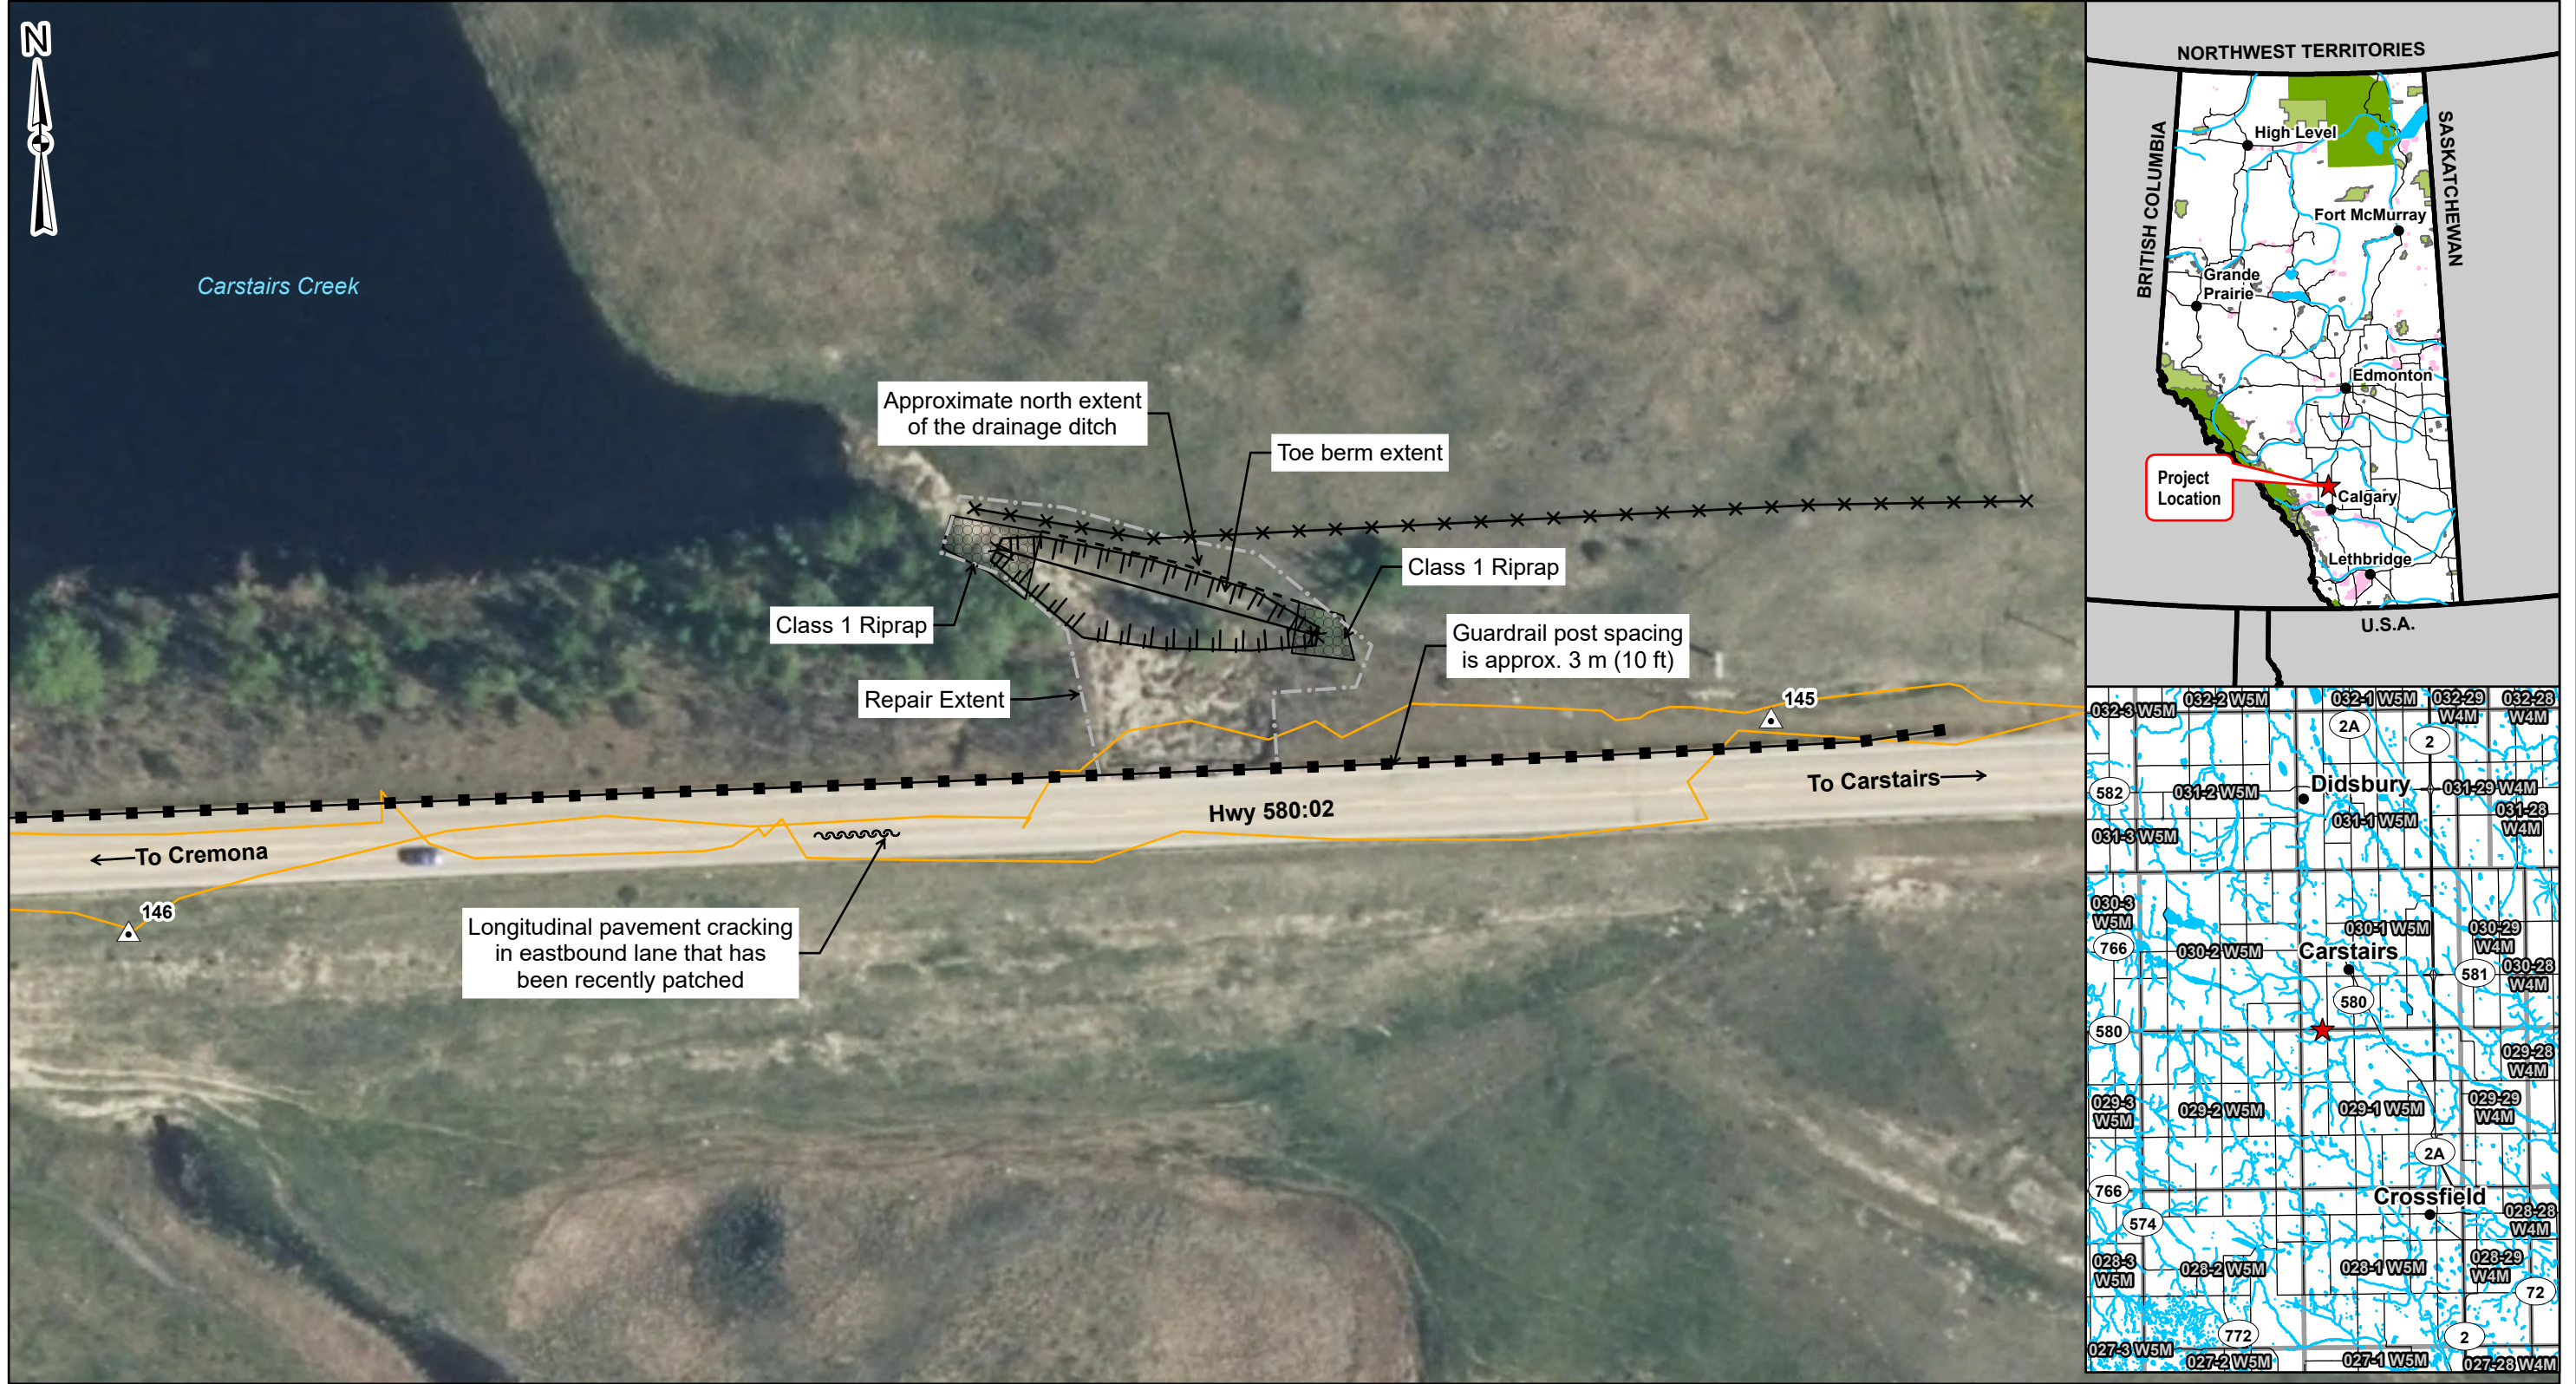
- Pavement cracking and settlement in the south (eastbound) lane approximately 110 m west from the original slide was observed by AT's Highway Maintenance Contactor (HMC) in March 2021 (WP 146). The area was inspected by KCB and AT during the 2022 inspection. There is a longitudinal pavement crack (Photo 6) approximately 75 mm wide and 15 m long that was recently filled. The pavement cracking and settlement may be attributed to an over steepened highway embankment slope. No movement was observed on the south slope downslope of the pavement crack or settlement of the south guardrail.

- If the pavement cracking and settlement continues to impact the south (eastbound) lane, a repair like the C073-I repair (i.e., geogrid reinforced granular fill) could be completed to improve the embankment stability. The MCI should regularly inspect the site for signs of movement.

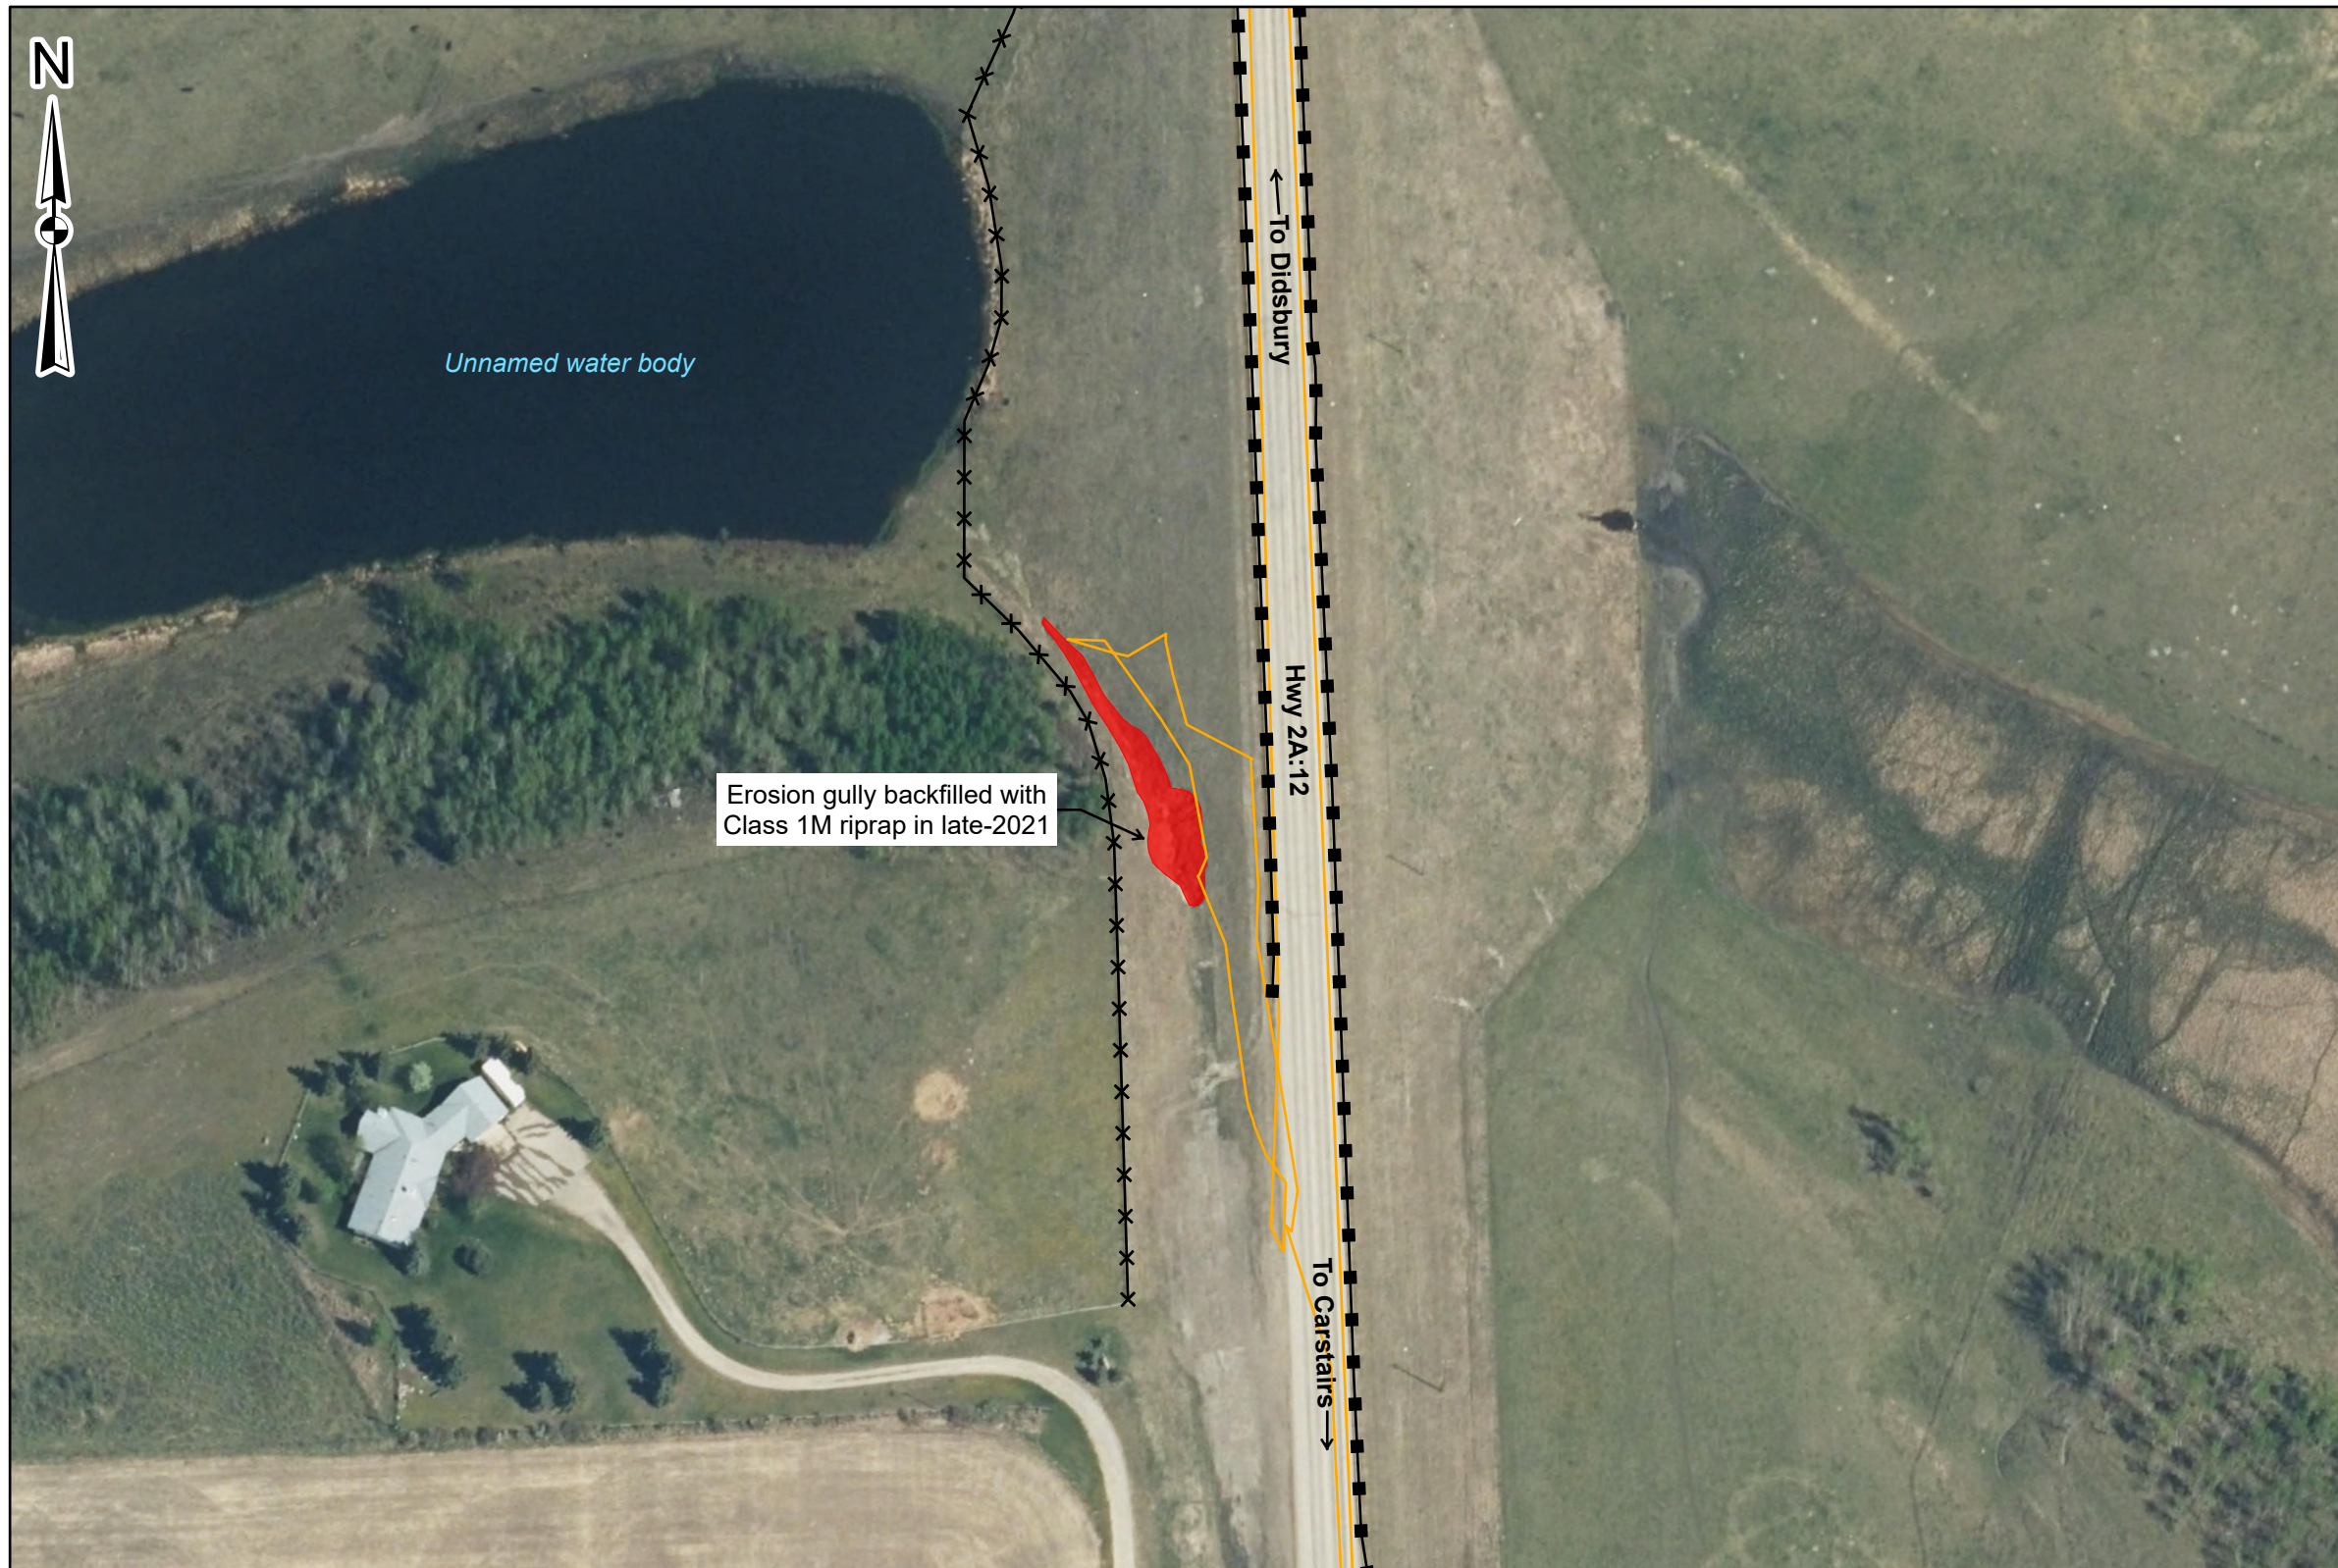
Erosion gully backfilled with Class 1M riprap in late-2021

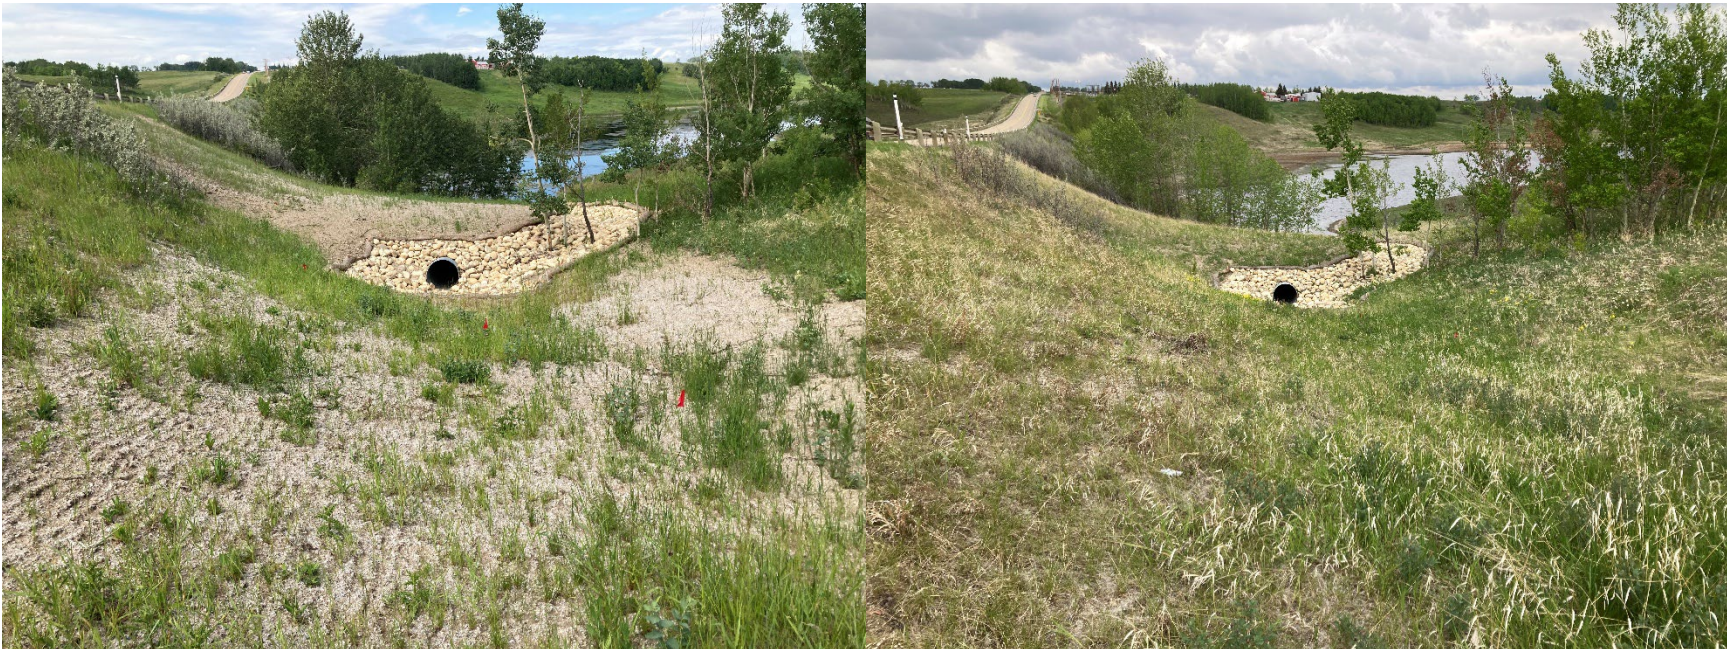
- The repaired slope, toe berm, and culvert are in good condition and have not changed since the 2021 inspection. The vegetation growth/coverage on the repaired slope and upstream ditch appears to have improved significantly since the 2021 inspection (Photos 1 through 3).

**Photo 1** The vegetation cover in the north (westbound) ditch and repaired slope has increased significantly since the 2021 inspection. Photos taken June 23, 2021 and May 30, 2022, facing west.

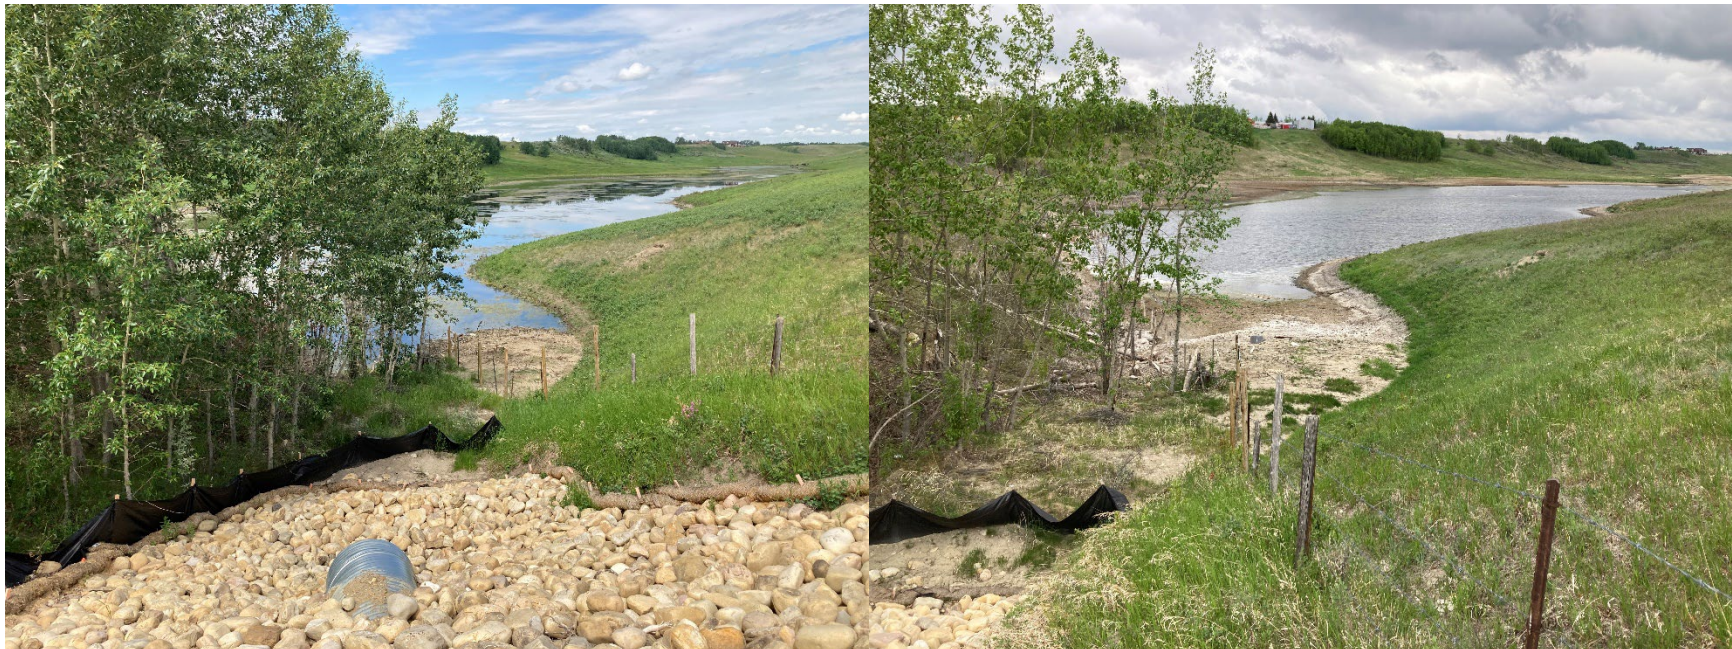
- August 2020 and June 2021 – A local resident spoke with KCB and AT regarding a beaver dam on the upstream side of the culvert below the highway embankment (oriented north-south, along Carstairs Creek). There has been beaver damming of the culvert inlet since KCB and AT first inspected the site in July 2019. There still appears to be beaver damming activity at the site. However, the Carstairs Creek water level appears to 0.5 m to 1.0 m lower than during the 2021 inspection

**Photo 2**      **The Carstairs Creek water level has decreased by 0.5 m to 1.0 m between the 2021 and 2022 inspections. Photo taken June 23, 2021 and May 30, 2022, facing northwest.**

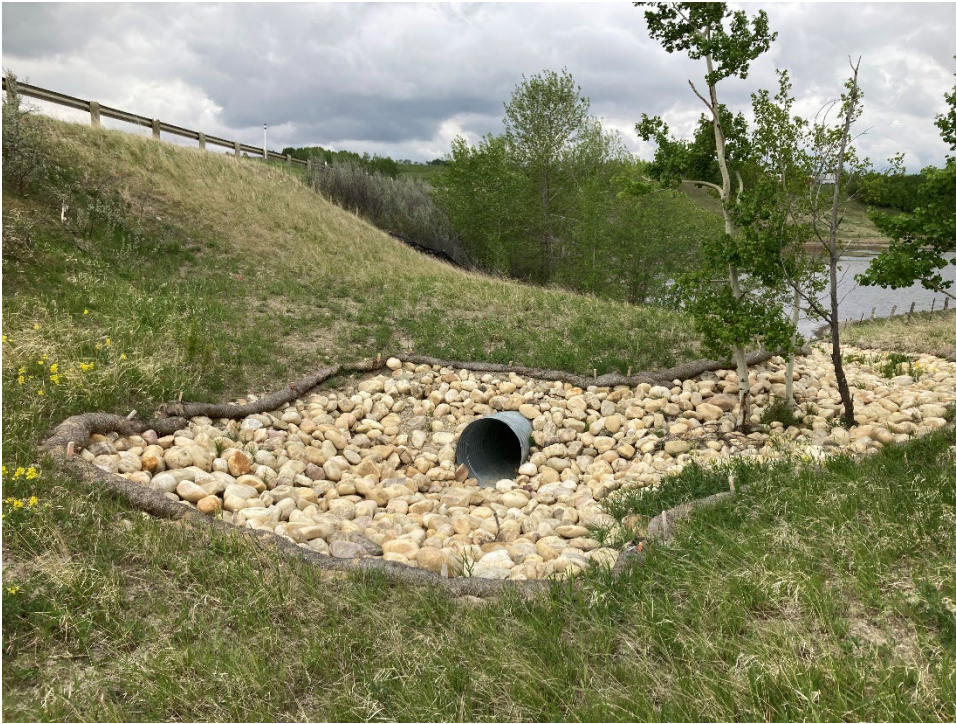
**Photo 3** The east side of the slide repair, 900 mm diameter CSP culvert inlet, riprap apron, and overflow channel. Photo taken May 30, 2022, facing west.

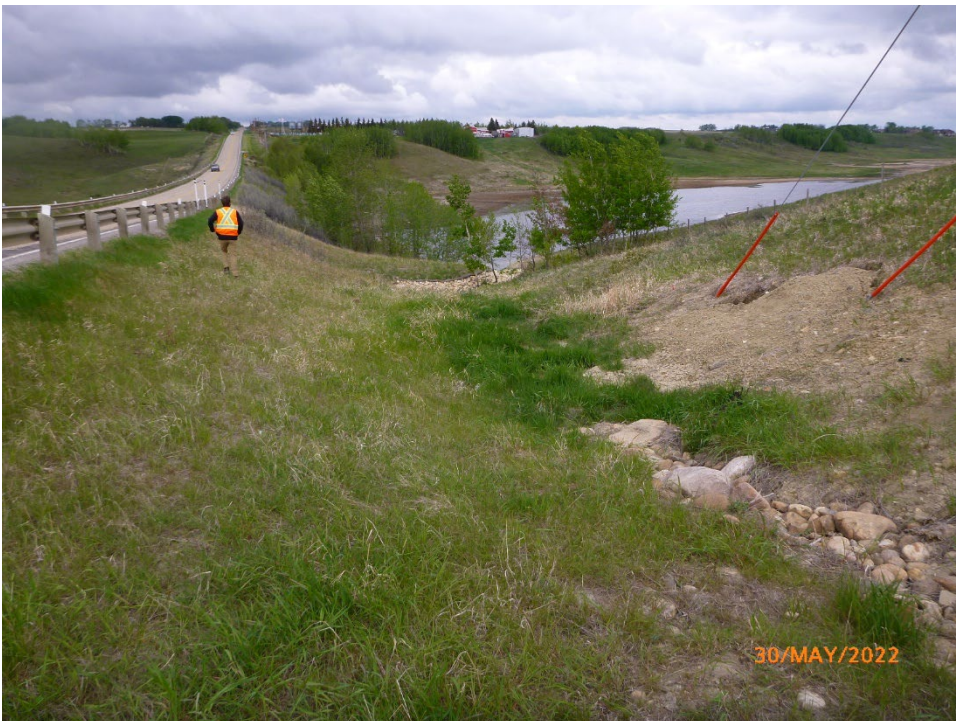
**Photo 4** Maintenance work was completed in late-2021 or early-2022 on the ATCO power pole east of the slide repair. Photo taken May 30, 2022, facing west.

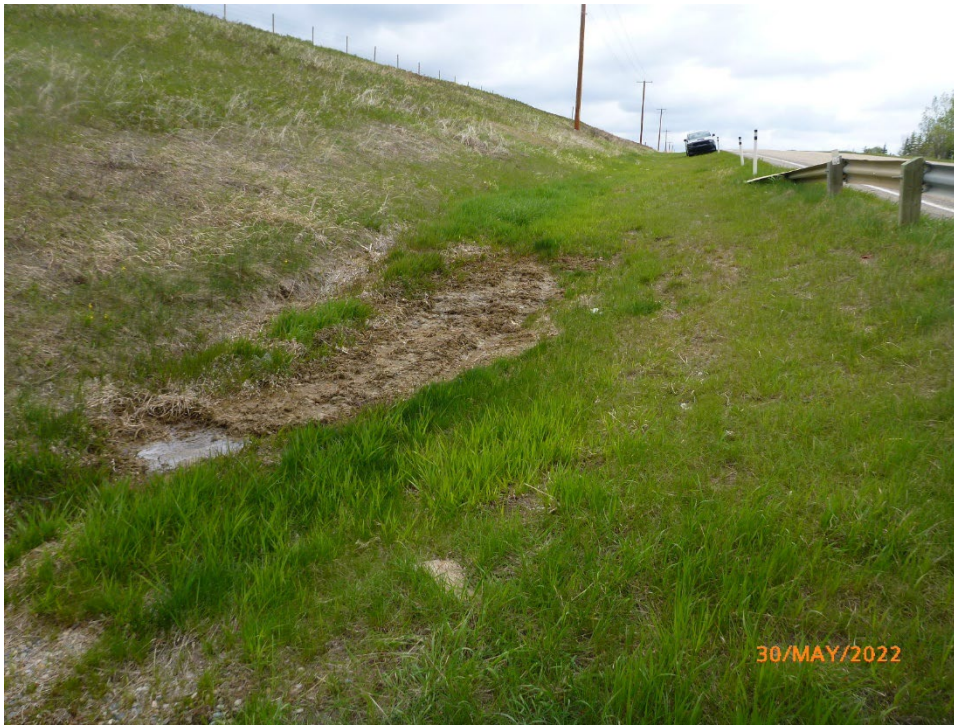
**Photo 5** A wet spot was observed in the north (westbound) ditch (WP 145) east of the slide repair. Photo taken May 30, 2022, facing east.

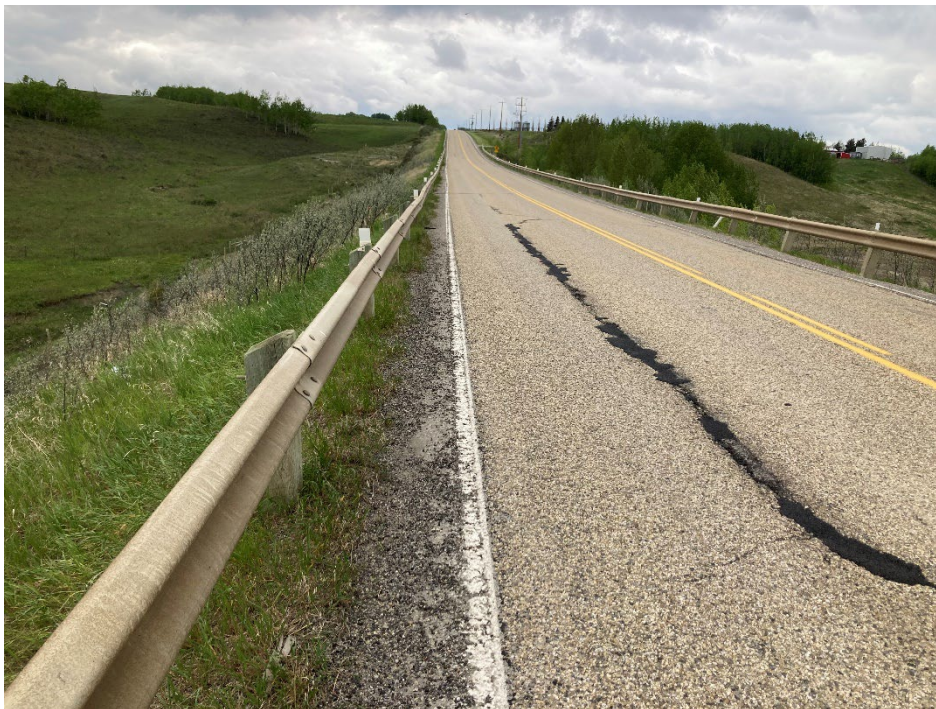
**Photo 6** Pavement cracking in the eastbound lane, west of the C073-I site that was repaired in August 2020. Photo taken May 30, 2022, facing west.

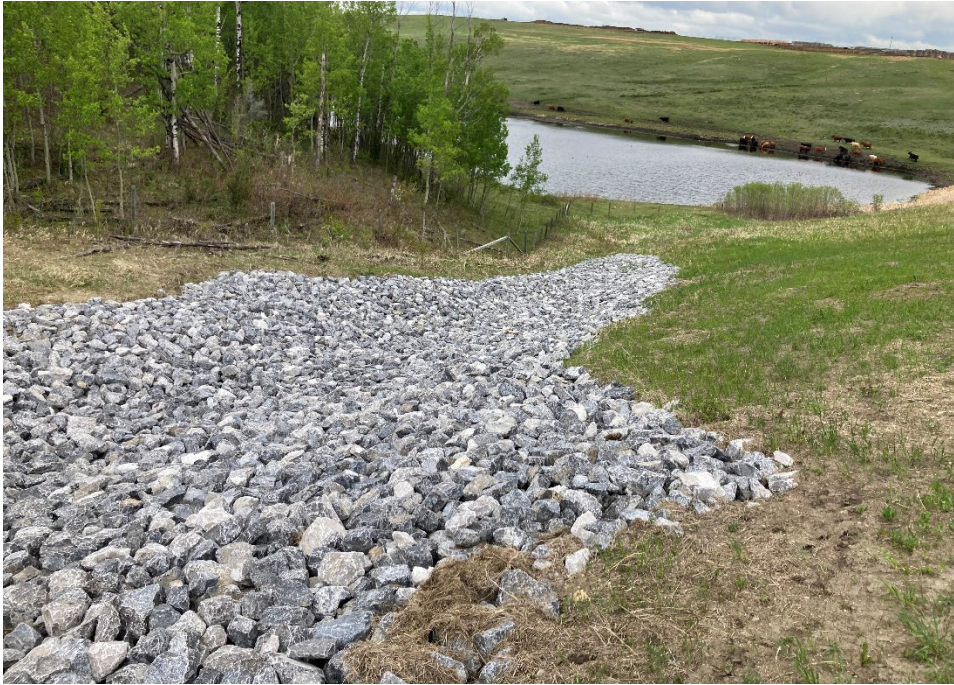
- The erosion gully was repaired by the HMC by backfilling the erosion gully with Class 1M riprap in November 2021. The repair is in good condition. (Photos 7 through 10). However, upstream of the repair, the ditch and embankment slope are poorly vegetated and small riprap particles up to 200 mm in diameter were observed along the slope (Photos 9 and 10). The MCI should monitor the vegetation growth and the HMC may have to reseed.

**Photo 7** The erosion gully north of west of Hwy 2A was backfilled with Class 1M riprap in November 2021. Photo taken May 30, 2022, facing northwest.

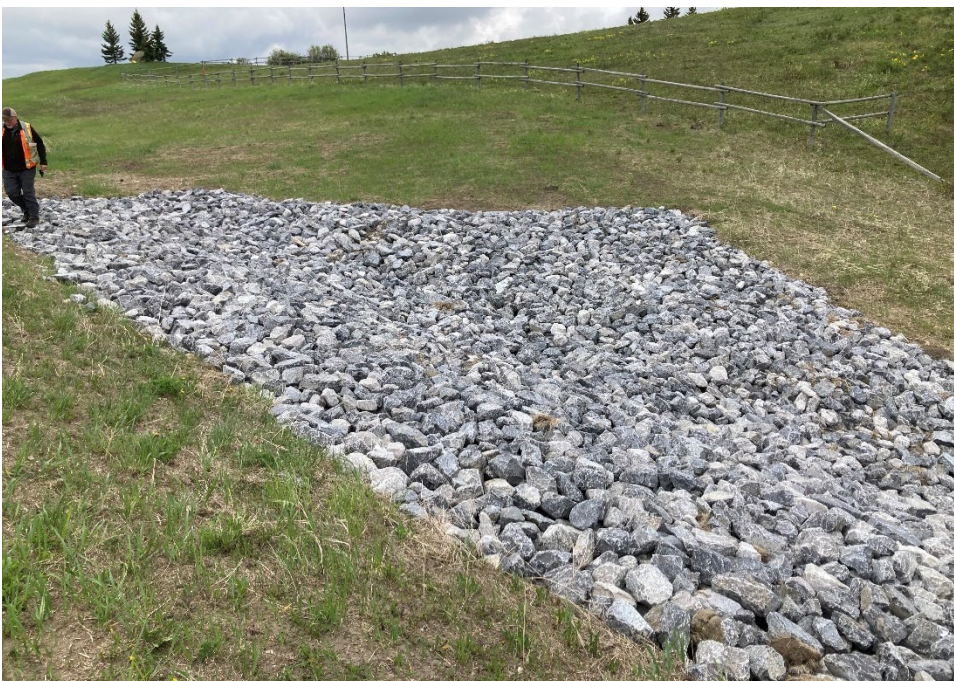
**Photo 8** The backfilled erosion gully near the top of the slope. Photo taken May 30, 2022, facing southwest.

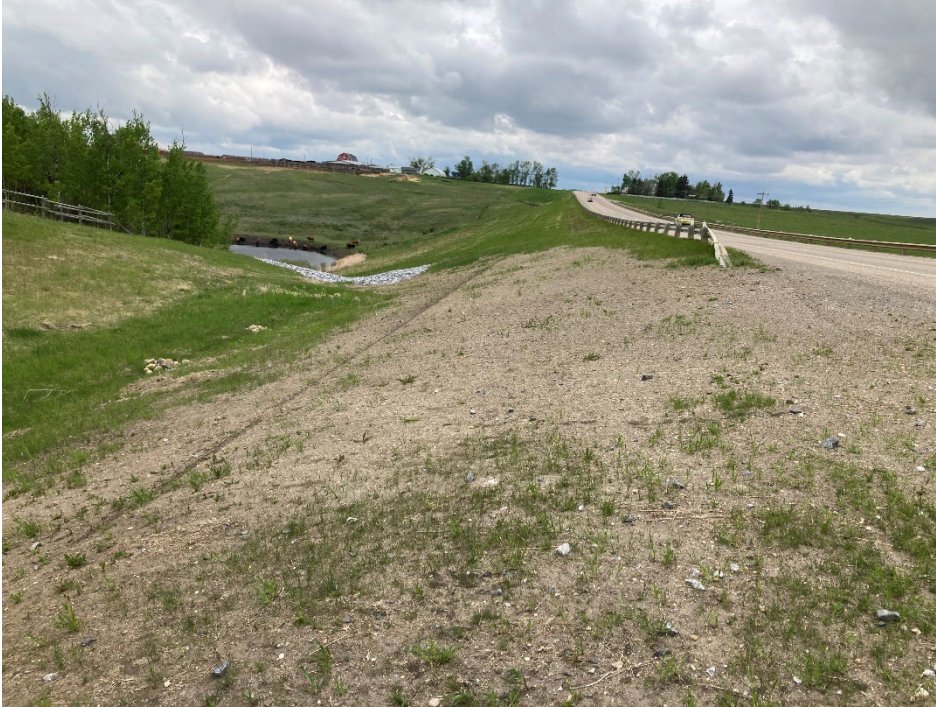
**Photo 9** Poor vegetation cover along the west (southbound) ditch, south of the C073-II repair. Small riprap particles (up to 200 mm diameter) were observed along the west embankment slope. Photo taken May 30, 2022, facing north.

- The 2021 repair was successful and appears to be in good condition. If the vegetation cover does not improve, the HMC should reseed the site in fall 2022.

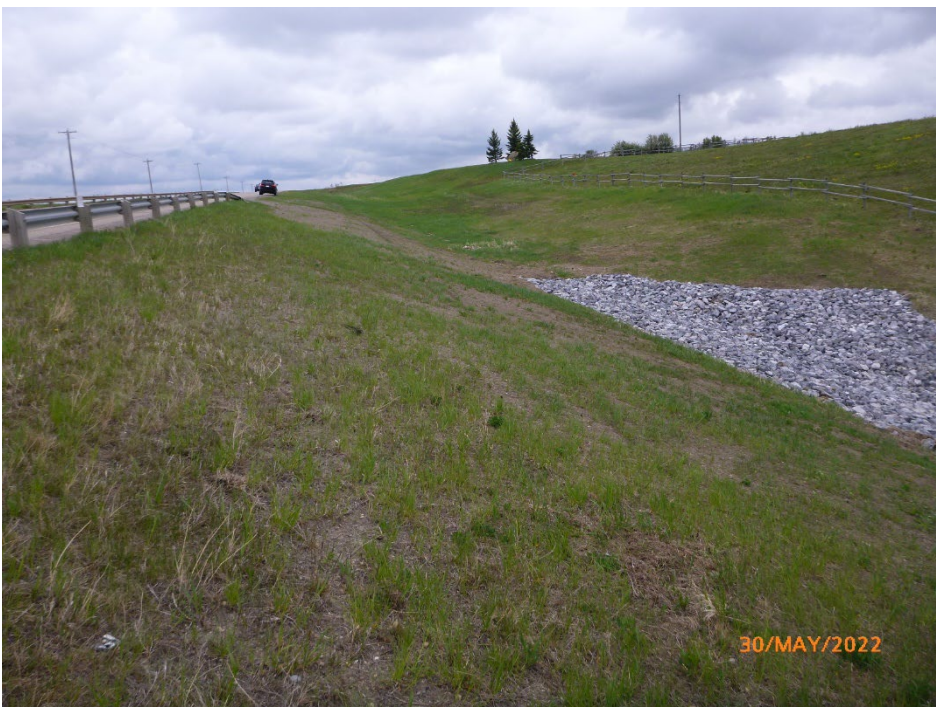
**Photo 10** The west embankment slope and south portion of the C073-II 2021 repair. Photo taken May 30, 2022, facing south.
